6. DEFECT SCHEDULE

6.1. AUTOMATIC FIRE DETECTION AND ALARM SYSTEM (INCLUDING SMOKE ALARMS)

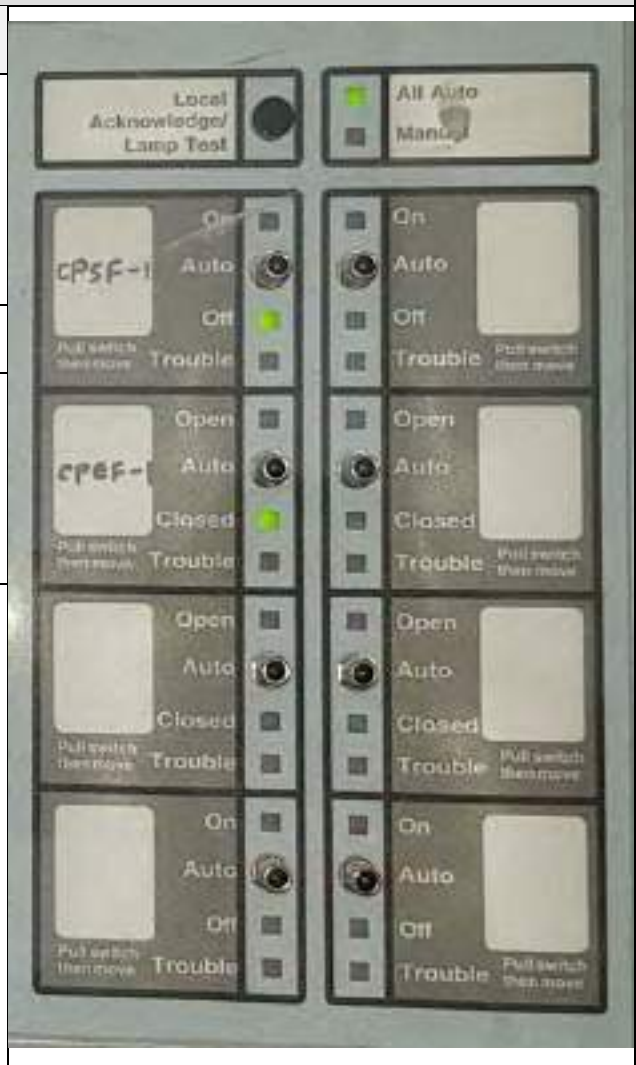
6.1.1.	DEFECT	FIRE FAN CONTROLS NOT LABELLED
	DESCRIPTION	<p>Labelling specifying that the manual fan controls should only be operated by authorised personnel has not been provided at the fire indicator panel.</p> <p>To comply with Clause 7.15.7 of AS1670.1 – 2015, a label shall be provided on the FFCP in lettering not less than 5mm height with the following wording: THESE CONTROLS SHALL BE OPERATED BY AUTHORIZED PERSONNEL ONLY</p>
	LOCATION(S)	Main fire indicator panel Ground floor
	BREACH(ES)	<p>Failure to comply with:</p> <ol style="list-style-type: none"> 1 Home Building Act 1989 NSW under Section 18B Clauses (a) & (c) 2 BCA – Table E2.2a – General Provisions 3 Clause 5.5 of AS1668.1 – 2015 4 Clause 7.15.7 of AS1670.1 – 2015
	METHOD OF REPAIR	<p>Install a label on the FFCP in lettering not less than 5mm height with the following wording: THESE CONTROLS SHALL BE OPERATED BY AUTHORIZED PERSONNEL ONLY</p>

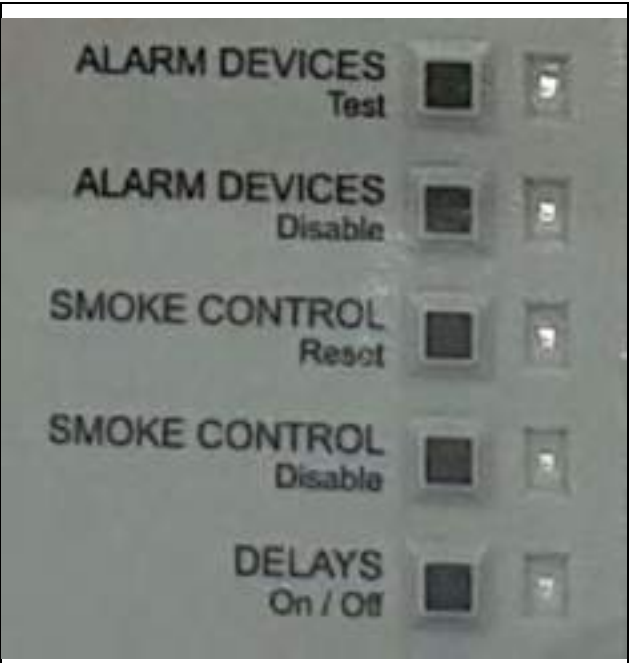
6.1.2.	DEFECT	FIRE FAN CONTROLS INCORRECTLY LABELLED

DESCRIPTION	<p>Labelling to identify the fan control reset switch does not satisfy the requirements of Clause 7.15.4 of AS1670.1 – 2015.</p> <p>To comply with Clause 7.15.4 of AS1670.1 – 2015, the fire mode indicator and reset shall be clearly labelled FIRE MODE RESET in letters not less than 5mm height.</p>	
	LOCATION(S)	Main fire indicator panel Ground floor	
	BREACH(ES)	<p>Failure to comply with:</p> <ol style="list-style-type: none"> 1 Home Building Act 1989 NSW under Section 18B Clauses (a) & (c) 2 BCA – Table E2.2a – General Provisions 3 Clause 5.5 of AS1668.1 – 2015 4 Clause 7.15.4 of AS1670.1 – 2015 	
	METHOD OF REPAIR	<p>Install a label on the fire mode indicator and reset module in lettering not less than 5mm height with the following wording:</p> <p>FIRE MODE RESET</p>

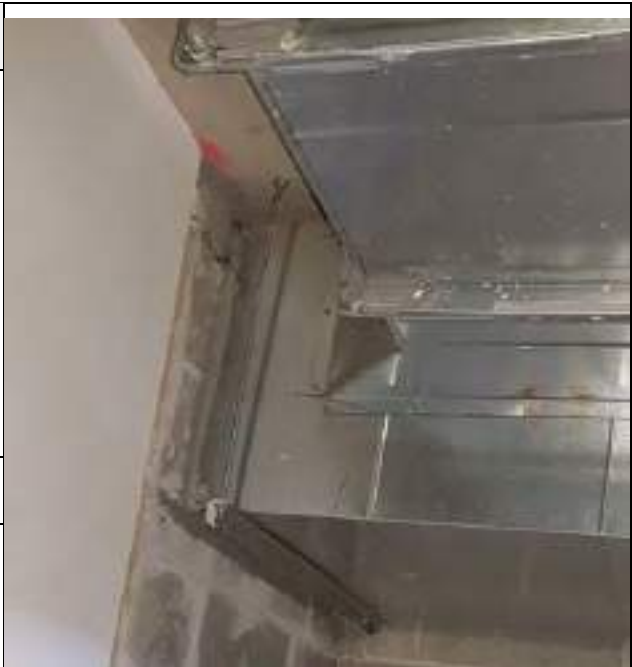
6.3.5.	DEFECT	NO FIRE DAMPER INSTALLED

DESCRIPTION	<p>No fire damper has been installed where the carpark exhaust ducting enters the shaft to the roof of the building.</p> <p>Additionally the gaps surrounding the ductwork have not been sealed around the perimeter of the duct.</p> <p>To comply with Table 3 of Specification C1.1 of the BCA the walls to a ventilation shaft in a Class 7a part of the building shall achieve a FRL of 120/90/90 (if loadbearing) or -/90/90 (if non-loadbearing).</p> <p>To comply with Clause 3.3 of AS1668.1, openings in building elements that are required to have an FRL shall be protected with fire dampers.</p> <p>To comply with Clause 2.5 of AS1668.1, fire dampers must comply with AS1682.2.</p>	
	LOCATION(S)	Level B1 adjacent lift	
	BREACH(ES)	<p>Failure to comply with:</p> <ol style="list-style-type: none"> 1 Home Building Act 1989 NSW under Section 18B Clauses (a) & (c) 2 BCA – Table 3 of Specification C1.1 – Type A construction: FRL of building elements 3 Clause 3.3 of AS1668.1 – 2015 4 Clause 2.5 of AS1668.1 – 2015 5 Section 6 of AS1682.2 – 2015.

METHOD OF REPAIR	<p>A fire damper will need to be installed in the ductwork where it penetrates the shaft wall.</p> <p>The fire damper selected and installed shall comply with Section 6 of AS1682.2 – 2015 and all relevant manufacturers' installation instructions, including provision of an access panel in the ductwork.</p>

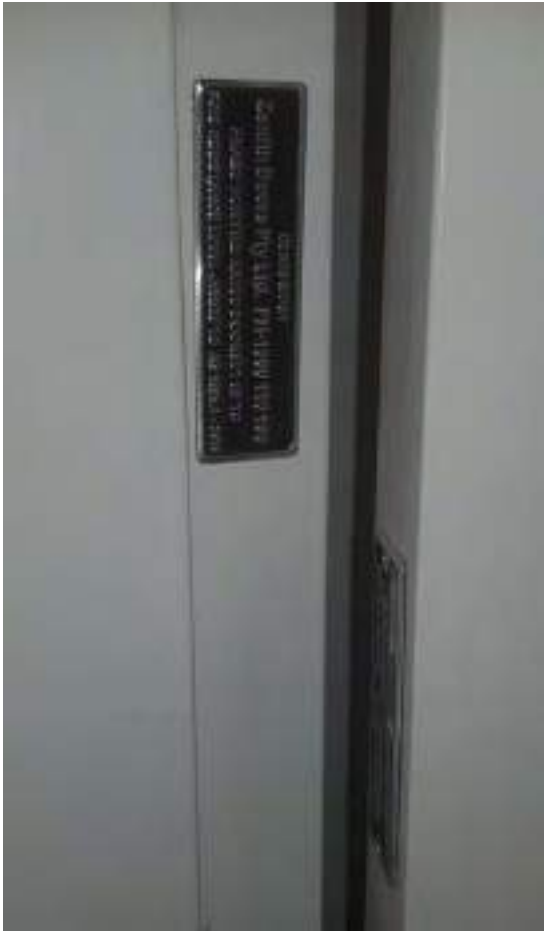
It is also noted that the Door Schedule (Drawing No. A6102) details this door as having a FRL of -/120/30.

LOCATION(S)	NBN Room on Level LG	
BREACH(ES)	<p>Failure to comply with:</p> <ol style="list-style-type: none"> 1 Home Building Act 1989 NSW under Section 18B Clauses (a) & (c) 2 Clause C3.11 of the BCA – Bounding construction: Class 2 and 3 buildings and Class 4 parts 3 Spec C3.4 of the BCA – Fire doors, smoke doors, fire windows and shutters 4 Clause 5.1 of AS1905.1 – 2015 	
METHOD OF REPAIR	<p>The existing door frame will need to be removed and replaced with a fire door frame that has a rebate of 25mm. This door frame will need to be back-filled with concrete, mortar, plaster or plasterboard, as per the manufacturer's installation requirements. Alternatively (if permitted by the manufacturer as a variation to the tested prototype), the doorframe may be built-up to provide a 25mm rebate. Any build-up to the existing frame would need to be carried out strictly as required by the manufacturer (including weld joints and any back-filling requirements).</p>

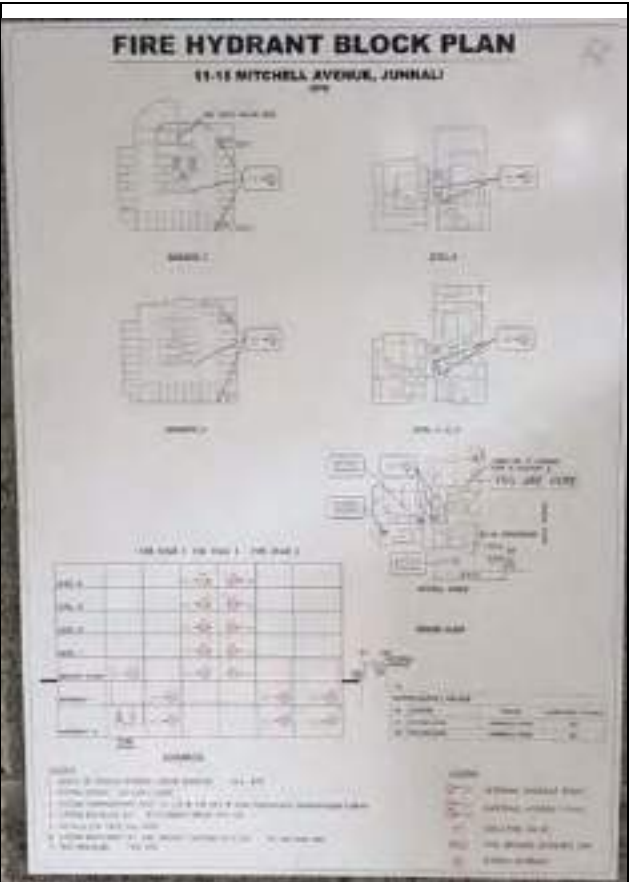
6.6.2.	DEFECT	HYDRANT BLOCK PLANS DO NOT INCLUDE DESIGN FLOWS				
	DESCRIPTION	<p>Hydrant block plans at the booster connection, booster pump and fire indicator panel do not include the design flows.</p> <p>According to the Sydney Water pressure and flow enquiry, a flow rate of 12L/sec can only be achieved.</p> <p>Therefore the Fire Engineering Report 138309.FER001b provides a Performance Solution to permit one hydrant flowing rather than the BCA minimum of two hydrants flowing for the carpark area, which would otherwise be based on the floor area of the carpark and would require a flow rate of 20L/sec.</p> <p>To comply with Clause 1.4 Schedule of Works in the Fire Engineering Report (refer Item 3.2 in Table 1.2), the block plan for the hydrant system is to state the design supply flows and pressures.</p> <table border="1" data-bbox="539 571 1541 703"> <tr> <td data-bbox="539 571 757 703">3.2 - Hydrant Signage</td> <td data-bbox="757 571 1339 703">The block plan for the hydrant system is to state the design supply flows and pressures, as well as show the proposed carpark separation, access points to each fire compartment, and corresponding fire hydrant locations.</td> <td data-bbox="1339 571 1541 703">Architect / Fire Services Contractor</td> </tr> </table>		3.2 - Hydrant Signage	The block plan for the hydrant system is to state the design supply flows and pressures, as well as show the proposed carpark separation, access points to each fire compartment, and corresponding fire hydrant locations.	Architect / Fire Services Contractor
3.2 - Hydrant Signage	The block plan for the hydrant system is to state the design supply flows and pressures, as well as show the proposed carpark separation, access points to each fire compartment, and corresponding fire hydrant locations.	Architect / Fire Services Contractor				
	LOCATION(S)	<p>Fire brigade booster connection</p> <p>Fire hydrant pump room on B1 level</p> <p>Adjacent the fire indicator panel</p>				
	BREACH(ES)	<p>Failure to comply with:</p> <ol style="list-style-type: none"> 1 Home Building Act 1989 NSW under Section 18B Clauses (a) & (c) 2 BCA – Performance requirement EP1.3 3 Item 3.2 in Table 1.2 of Fire Engineering Report 138309.FER001b 				
	METHOD OF REPAIR	<p>The fire hydrant block plans at all three locations will need to be amended to state the design pressures and flows.</p>

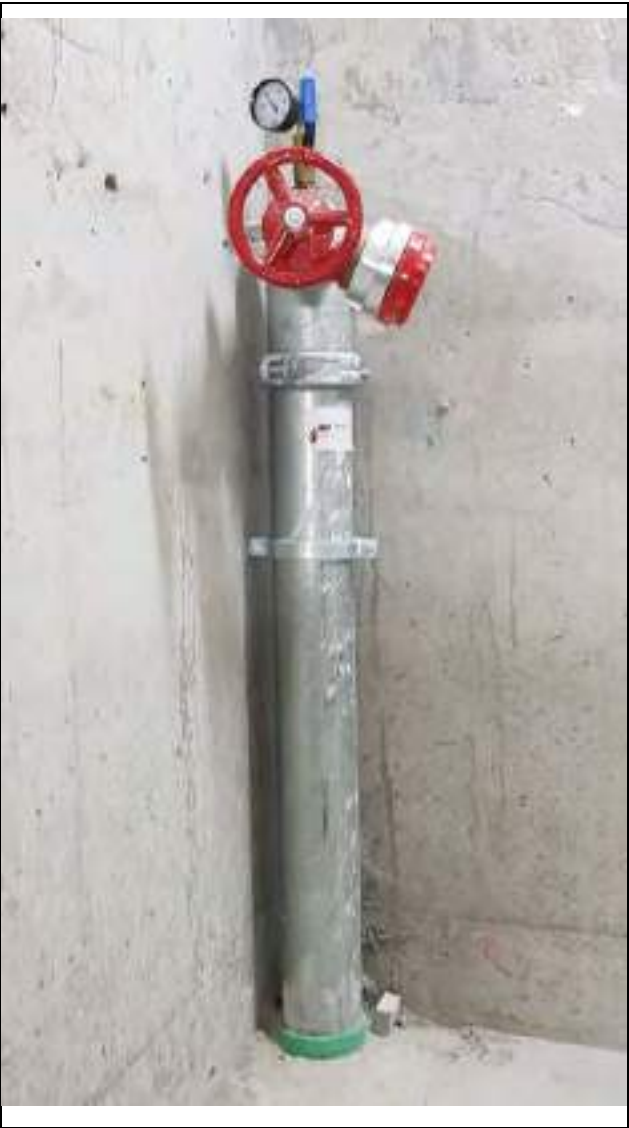
6.6.5.	DEFECT	NO DRAINAGE PROVIDED FOR MOST DISADVANTAGED HYDRANT
	DESCRIPTION	<p>The most disadvantaged hydrant is located on the fire stair landing on level 8 of the building and this hydrant does not have access to any drain suitable for the discharge of water during flow testing.</p> <p>To comply with Clause E1.3 of the BCA a fire hydrant system must comply with AS2419.1.</p> <p>To comply with Clause 8.5.10 of AS2419.1 – 2005, provision shall be made for the purpose of flow testing as required in Section 10 of the standard.</p> <p>If testing cannot be readily accomplished from a fire hydrant outlet, a permanent test facility should be provided together with a suitable means for disposing of test water.</p>
	LOCATION(S)	Level 4 fire stair
	BREACH(ES)	<p>Failure to comply with:</p> <ol style="list-style-type: none"> 1 Home Building Act 1989 NSW under Section 18B Clauses (a) & (c) 2 BCA – Clause E1.3 – Hydrants 3 Clause 8.5.10 of AS2419.1 – 2005

METHOD OF REPAIR	A suitable test connection, drain and/or holding tank or other means of disposing of test water will need to be provided to facilitate flow testing of the hydrant system at the most disadvantaged hydrant (Level 4).

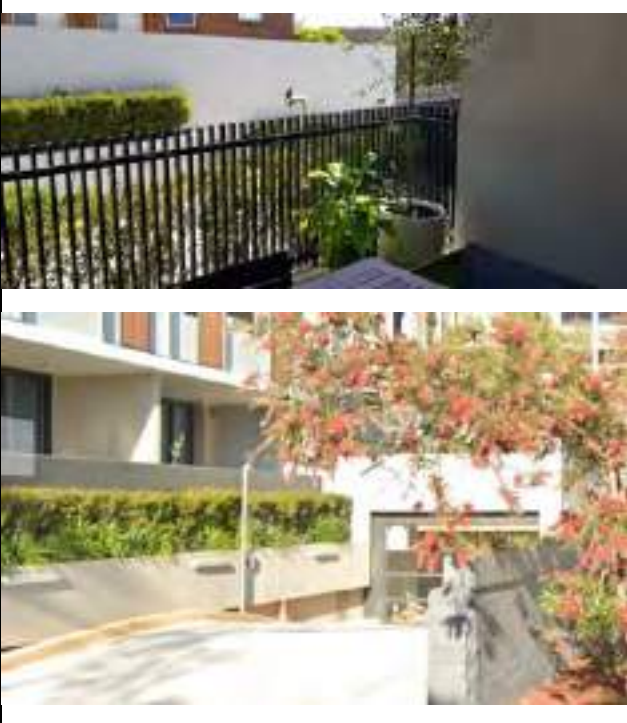
6.6.7.	DEFECT	DIESEL PUMP EXHAUST DISCHARGE

DESCRIPTION	<p>The diesel pump exhaust discharge is located approximately 3m from the balcony door to unit G01.</p> <p>The resident of this unit has expressed concerns of a strong diesel odour whenever the pump is tested.</p> <p>Whilst not strictly addressed in any Australian Standard (known to the author), this arrangement would not be considered to be appropriate or good industry practice for provision of acceptable air quality for the occupants within unit G01.</p>	
	LOCATION(S)	Driveway adjacent to Unit G01 balcony	
	BREACH(ES)	<p>Failure to comply with:</p> <ol style="list-style-type: none"> 1 Home Building Act 1989 NSW under Section 18B Clauses (a) & (c) 	
	METHOD OF REPAIR	<p>Relocate and/or extend the diesel exhaust pipework to discharge at a location remote from the balcony door to unit 105 and any other openable windows or doors.</p> <p>One possible discharge location – above garage vehicle entry door, midway between the residential building and the site boundary.</p>

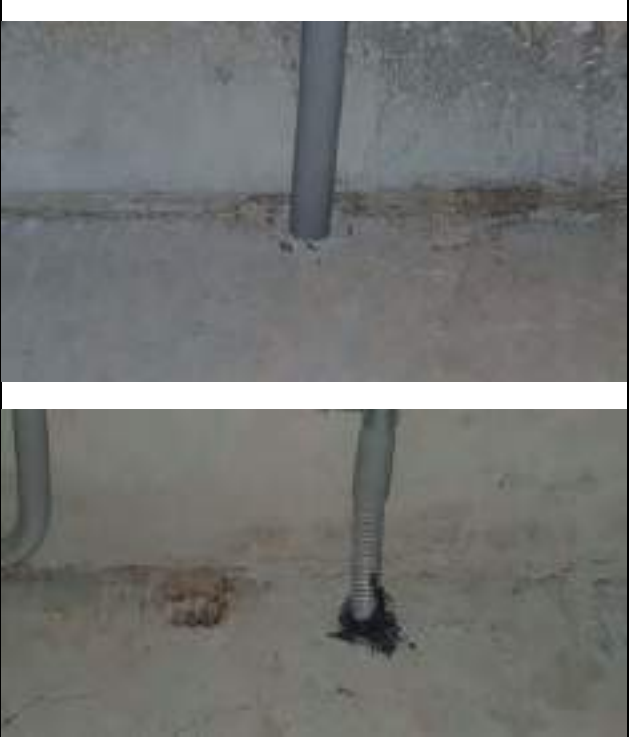
6.8.4.	DEFECT	PVC CONDUIT NOT FIRE STOPPED

DESCRIPTION	<p>The conduit for the fire detection system has not been adequately fire stopped where it passes through the wall to the north fire stair.</p> <p>To comply with C3.15 of the BCA, service penetrations through fire rated construction must be identical to a tested prototype that has been tested in accordance with AS4072.1 & AS1530.4.</p> <p>An intumescent mastic has been used to partially seal this conduit on the fire stair side of the wall, however there is no mastic visible on the carpark side of the wall.</p>	
	LOCATION(S)	Level B2 north fire stair	
	BREACH(ES)	<p>Failure to comply with:</p> <ol style="list-style-type: none"> 1 Home Building Act 1989 NSW under Section 18B Clauses (a) & (c) 2 BCA – Clause C3.15 – Openings for service installations 3 Manufacturer’s tested or approved system 	
	METHOD OF REPAIR	<ol style="list-style-type: none"> 1 Either: <ol style="list-style-type: none"> a. Install suitable fire collars to the PVC conduit on both sides of the wall. OR b. Cut back conduit and remove section of conduit where it passes through the wall. Then reseal the cable using and acrylic fire rated mastic where it passes through the wall

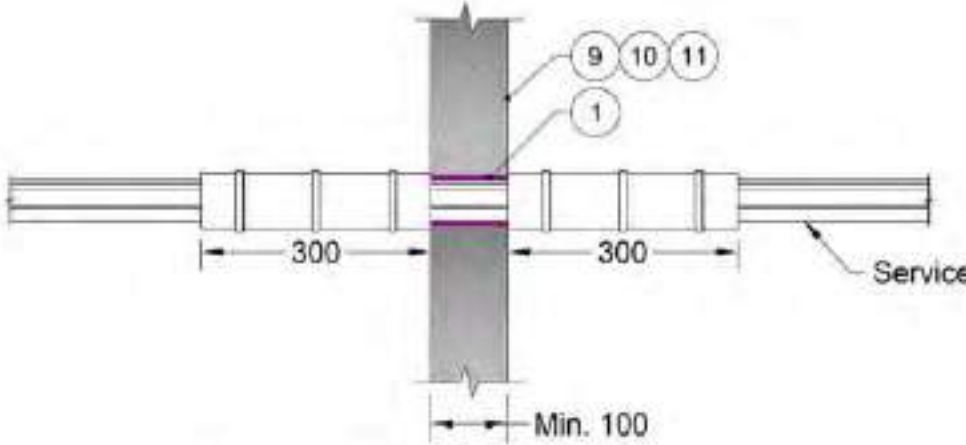
LOCATION(S)	Main switch room

6.8.11.	DEFECT	MAINS CABLE INADEQUATELY INSULATED
	DESCRIPTION	<p>A mains cable has not been adequately insulated in accordance with a tested system, where it passes through the wall of the main switch room.</p> <p>Insulation wrap has been applied to the cable on the carpark side of the wall, however no wrap has been installed on the main switch room side of the wall.</p> <p>To comply with C3.15 of the BCA, service penetrations through fire rated construction must be identical to a tested prototype that has been tested in accordance with AS4072.1 & AS1530.4.</p> <p>To comply with the manufacturer's tested system that achieves a FRL of -/120/120, the insulation wrap (TBA Firefly Penowrap) must extend 300mm and be fixed using 3 stainless steel cable ties on both sides of the wall. Refer below extract from Warringtonfire report 23671 RIR11.0 dated 09/04/20.</p>

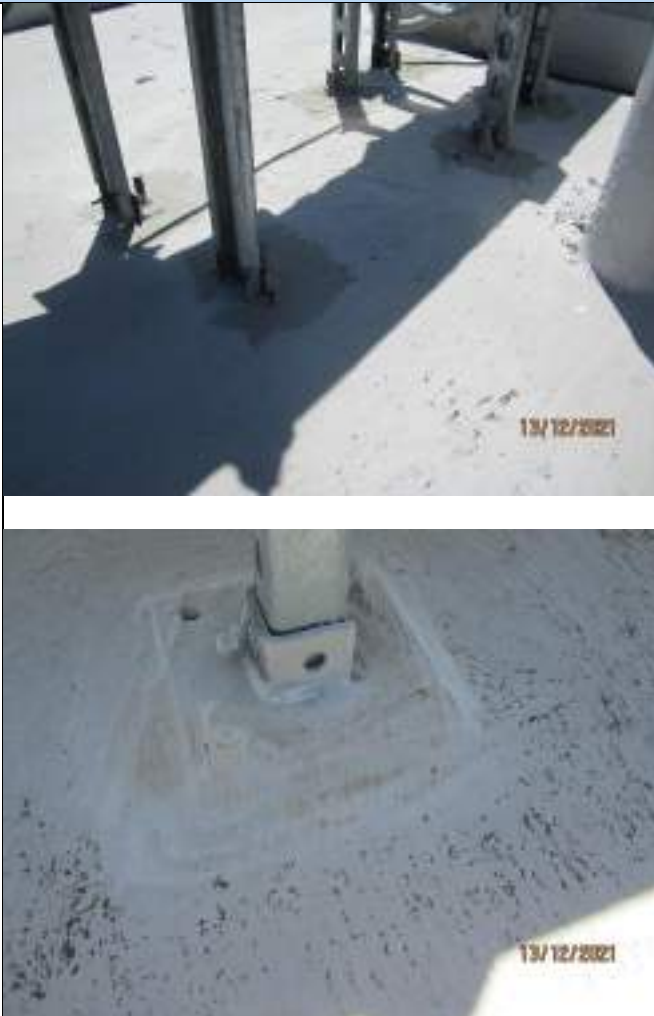
ITEM	COMMENTARY	PHOTOGRAPH(S)
R-1		
A	<p>Location & Description Roof – Waterproofing</p> <p>Waterproofing System</p> <p>The Author has observed that the waterproofing contract JQC Constructions Pty Ltd waterproofing certificate states that the only product applied to the roof waterproofing system was <i>Sikalastic-488 polyurethane UV</i>. The Author found on review of the Sika product data sheet that Sikalastic 488 is the base coat used within the SikaRoof MTC-UV systems.</p> <p>On review of the SikaRoof MTC-12 UV product data sheet the Author found that the standard SikaRoof MTC-12 UV system is a three stage process consisting of primer, basecoat, and topcoat layers.</p> <p>The Author is of the view, that the waterproofing has not been carried out in accordance with manufacturers guidelines or to the AS4654.2-2012 Waterproofing membranes for external above-ground use Part 2: Design and installation.</p> <p>For clarity, please refer to the extract in R-1-1 of this table for details sketch on system structure from the SikaRoof MTC-12 UV product data sheet and R1-1-4 copy of Waterproofing certificate provided by JQC Constructions Pty Ltd.</p> <p>Sikalastic 488 application</p> <p>The Author conducted testing of the membrane thickness applied to the roof using a ultrasonic coating thickness gauge and found the thickness of the membrane varied significantly over the roof area ranging from 209 to 919 microns. On review of Sika 488 product data sheet the Author that Sika specifies a minimum thickness of 1.2mm DFT consisting of 2 x coats of 750 micron to provide 1500 micron total thickness.</p> <p>For testing details and location, please refer to the extract in R-1-2 & R1-1-3 of this table.</p>

<p>Support and waterproofing not in accordance with AS4654.2</p>

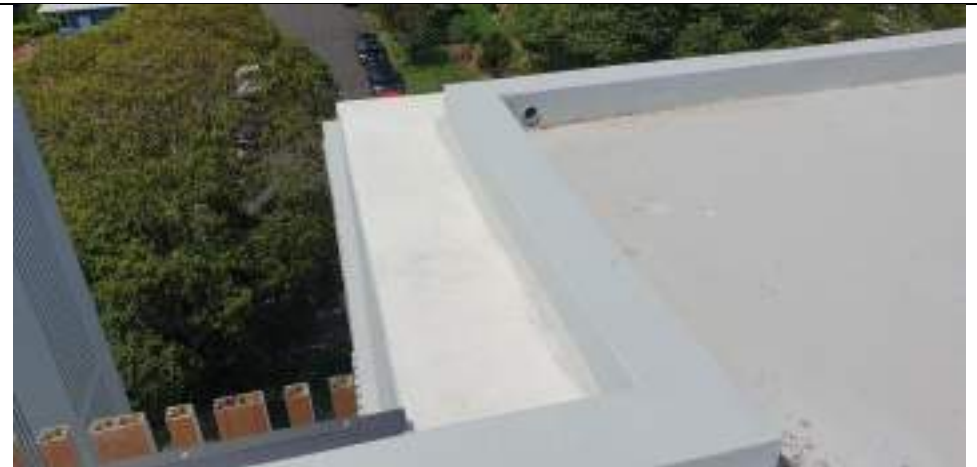
Southern side of roof Building U

Building U – Section of the roof to the southeast over unit 403 not waterproofed

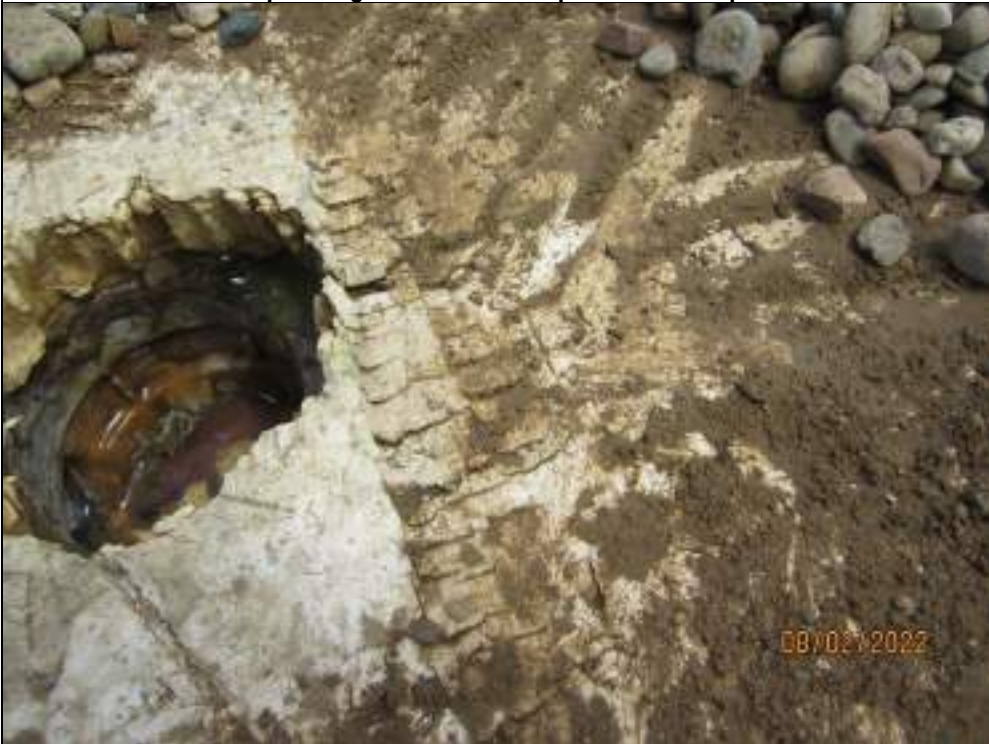
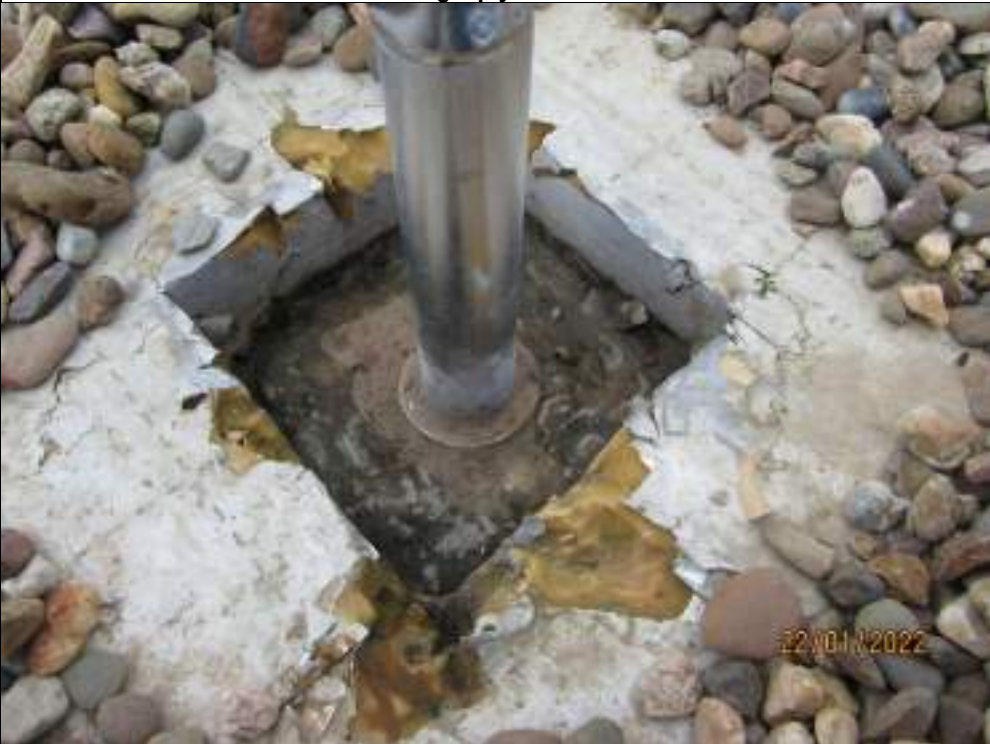
Evidence of deterioration of insulation	Evidence of deterioration of insulation

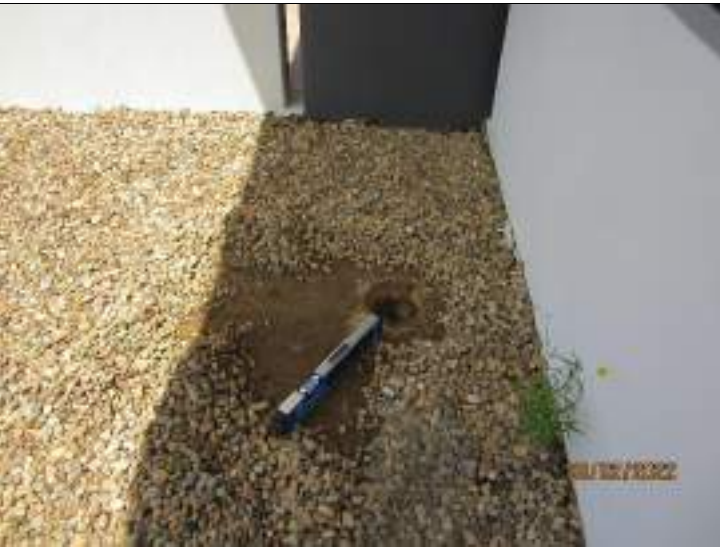
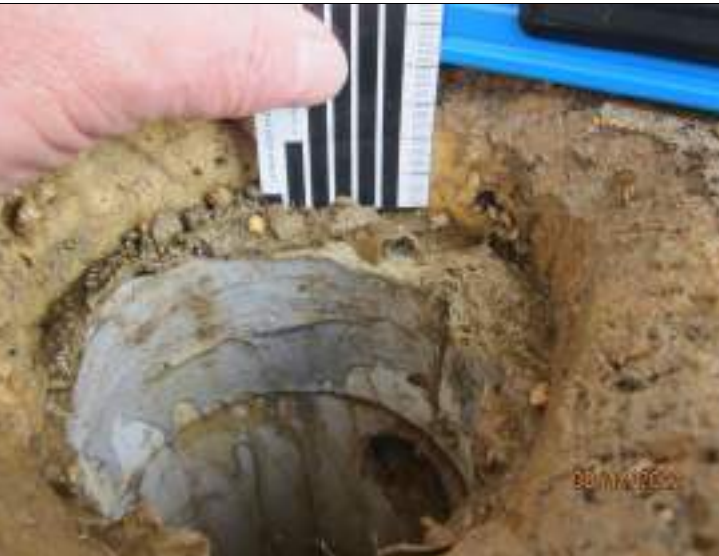
<p>Extract RECTICEL Flat Roof Specification Guide requires minimum finish fall of 1:80</p>	<p>Insufficient fall to drainage inlets</p>

<p>Location of drainage inlet lower roof southwest of Building L</p>	<p>Thickness measured 40mm. Author noted, 90mm thickness to achieve R4.0 as to BASIX commitments</p>

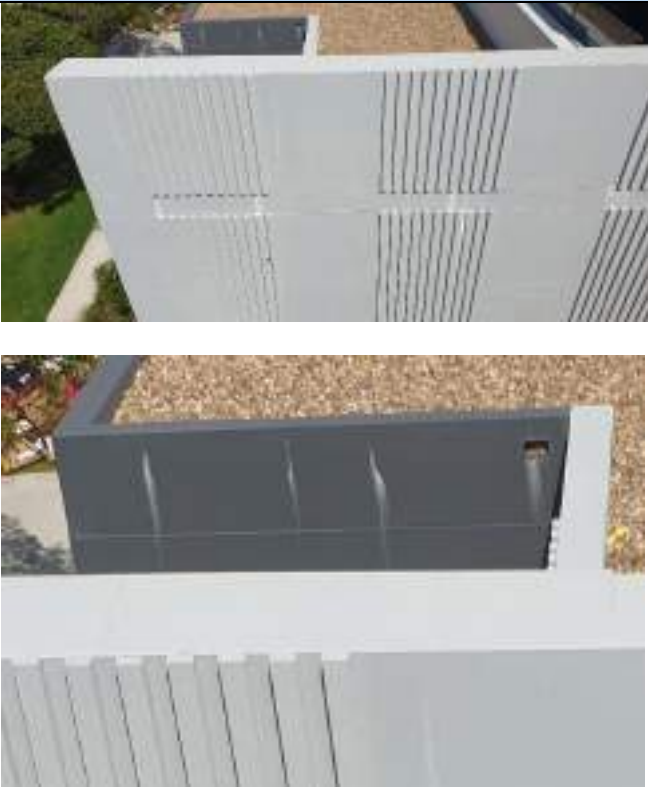
ITEM	COMMENTARY	PHOTOGRAPH(S)
C-2		
A	<p>Location & Description Efflorescence</p> <p>The Author has observed that there is efflorescence staining to the buildings rendered façade on all elevations and primary located below areas of the building that have no flashing provided or waterproofing to the building parapets, hobs, or roof perimeter.</p> <p>The Author noted that Mr Giaouris had identified the issue in his report, and that no rectification works had been carried by the builder.</p> <p>Furthermore, the Author is of the view, that based on the Mr Giaouris observations, the presents of efflorescence staining had increased following his inspection of the building works.</p> <p><u>Metal flashing and defective render to terrace balcony balustrade units 401 and 403</u></p> <p>The Author has observed that metal flashing has been installed to the rendered terrace balcony balustrade of units 401 and 403, and repair works had been carried but not completed to the rendered finish, to the balustrade wall of unit 403.</p> <p>The Owner occupant stated to the Author at the time of inspection, that the builder had commenced repair works to the render as the render was delaminating and found to be drummy, and that the builders repair works had failed to resolve the issue.</p>

<p>Efflorescence staining to building façade</p>

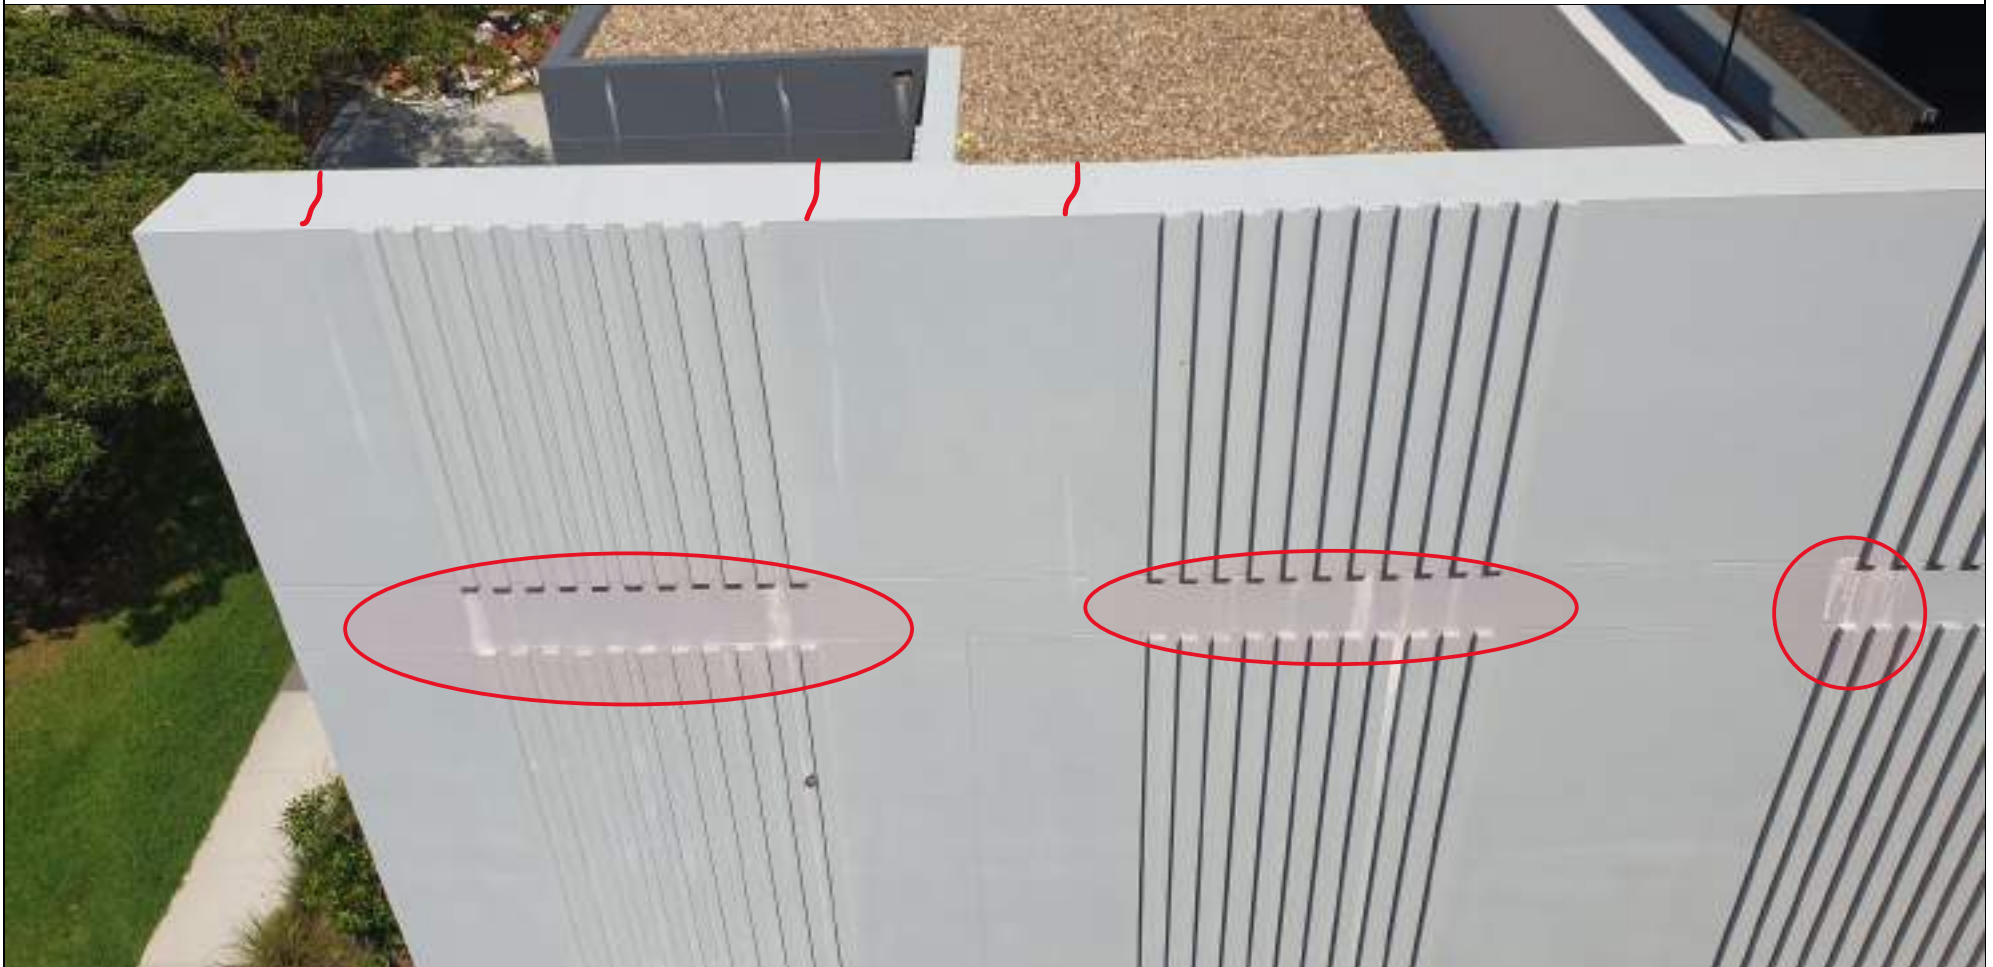
Efflorescence staining to western of building U façade above entry inline with cracks on top of façade parapet indicated in and horizontal joint

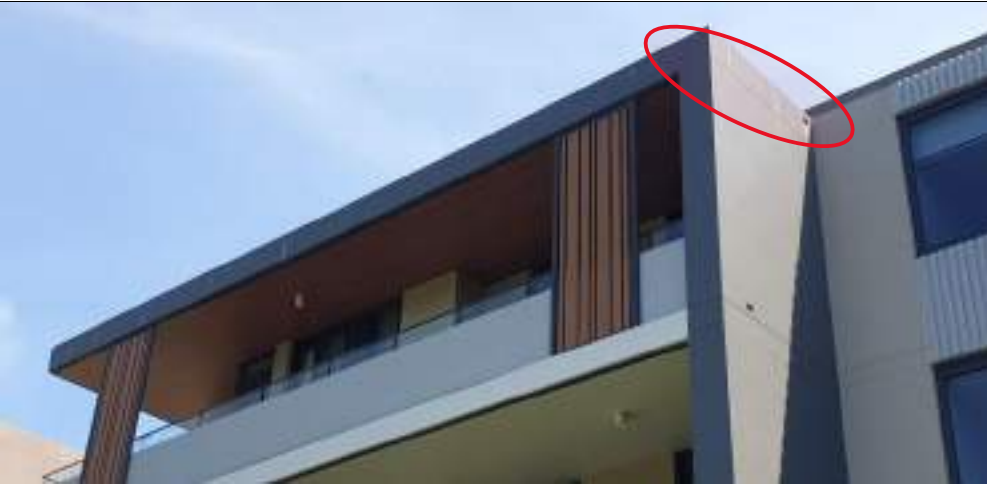
Location of efflorescence staining to building façade above balcony to unit 305

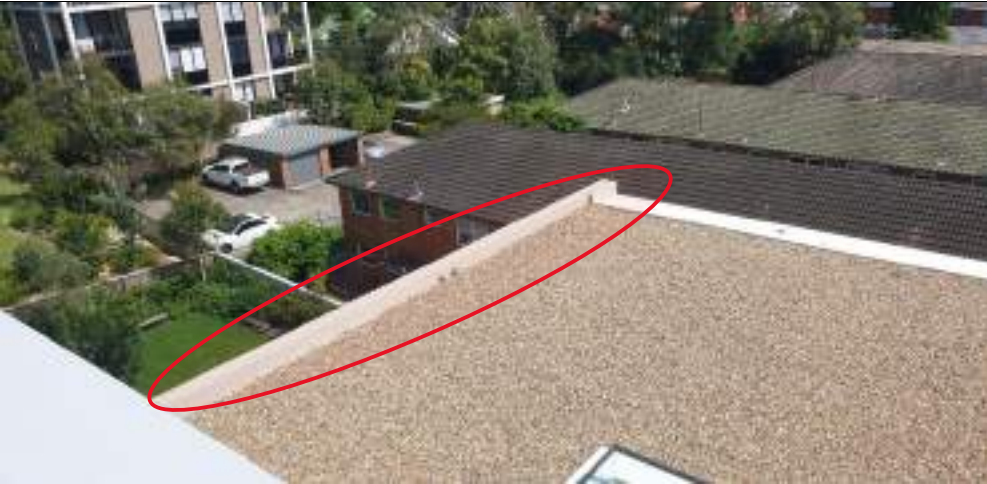
No flashing or waterproofing provided to building parapets

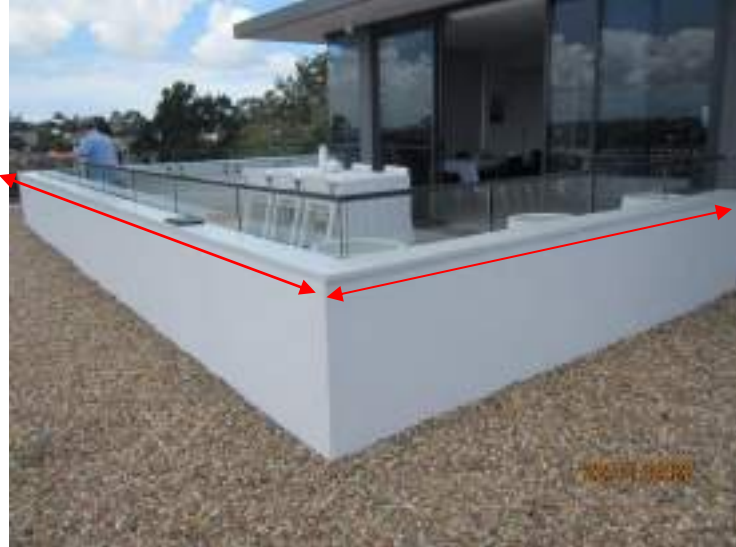
Image showing metal flashing installed to rendered balustrade to unit 401

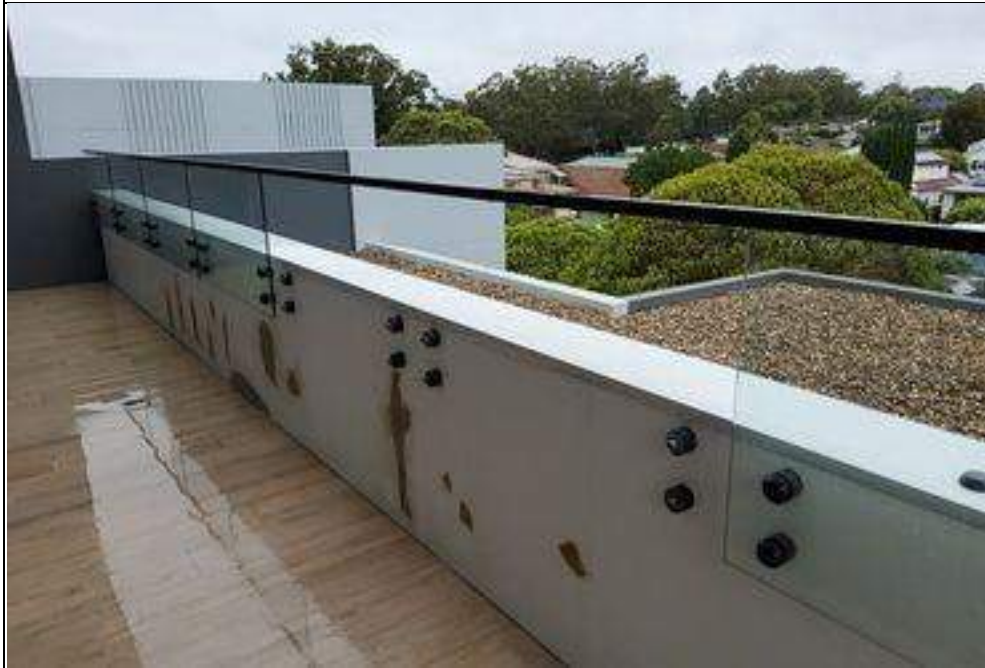
Image showing balustrade metal capping and evidence of Builders repair to unit 403 to southern side of balcony terrace

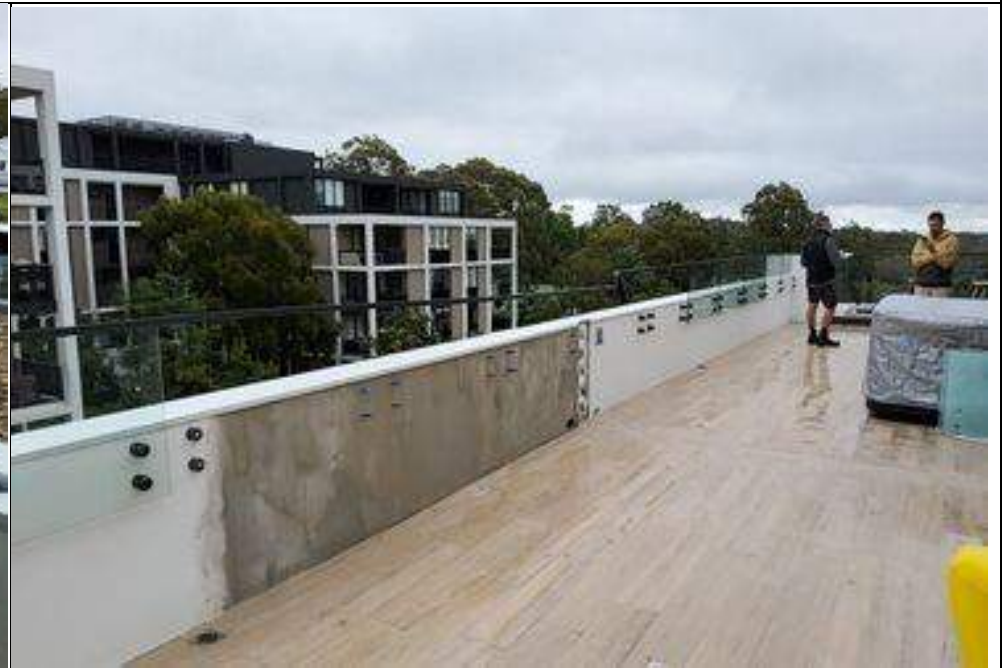
Image showing balustrade metal capping and evidence of builders repair to unit 403 to western side of balcony terrace

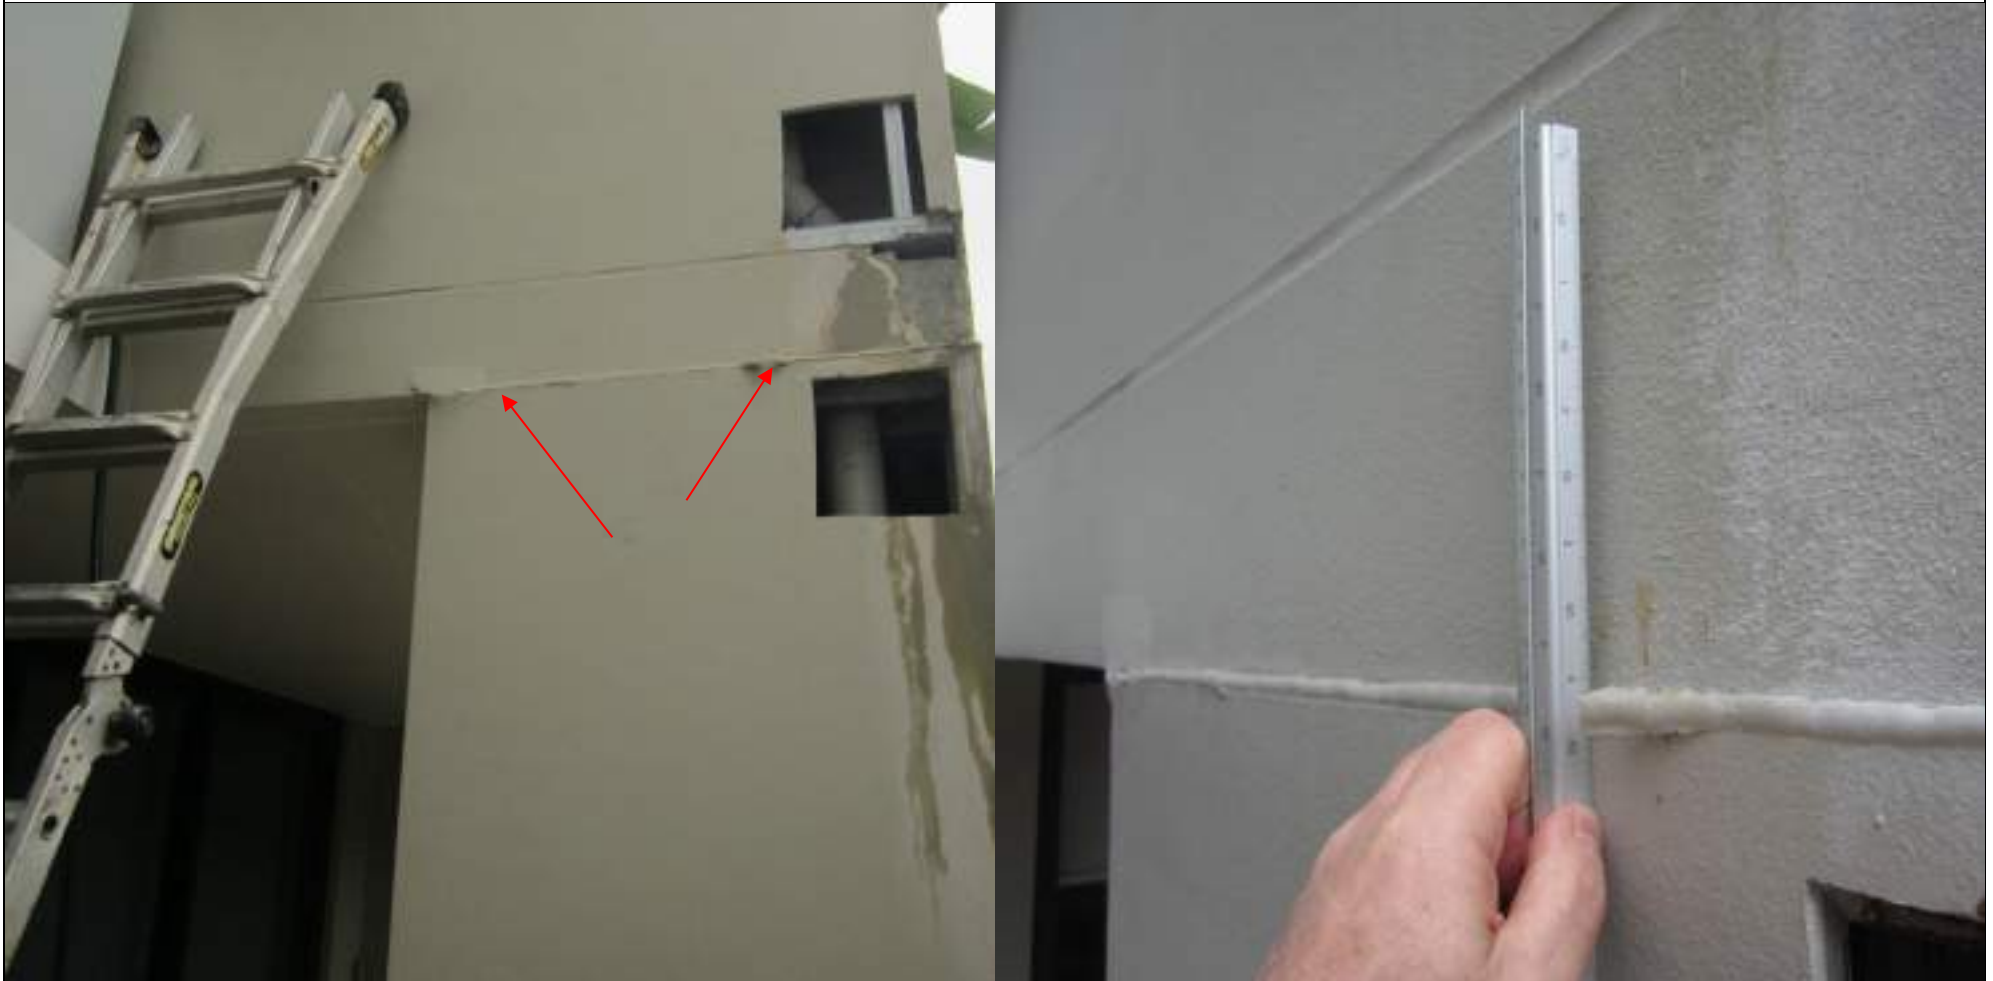
**EVIDENCE OF DEFLEXION (SAG) TO CANTILEVERED CONCRETE SLAB CAUSING DISLODGE-
MENT OF SEALANT AND DAMAGE TO RENDERED LININGS TO NO
STRUCTURAL LIGHT WEIGHT WALL AT GROUND LEVEL TO NORTHEAST COLUMN OF BUILDING U.**

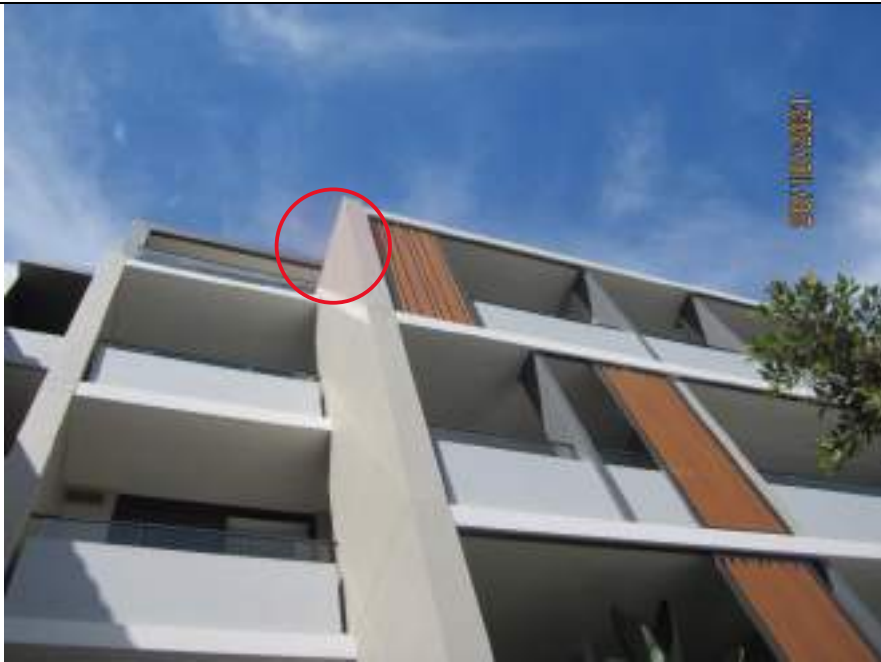
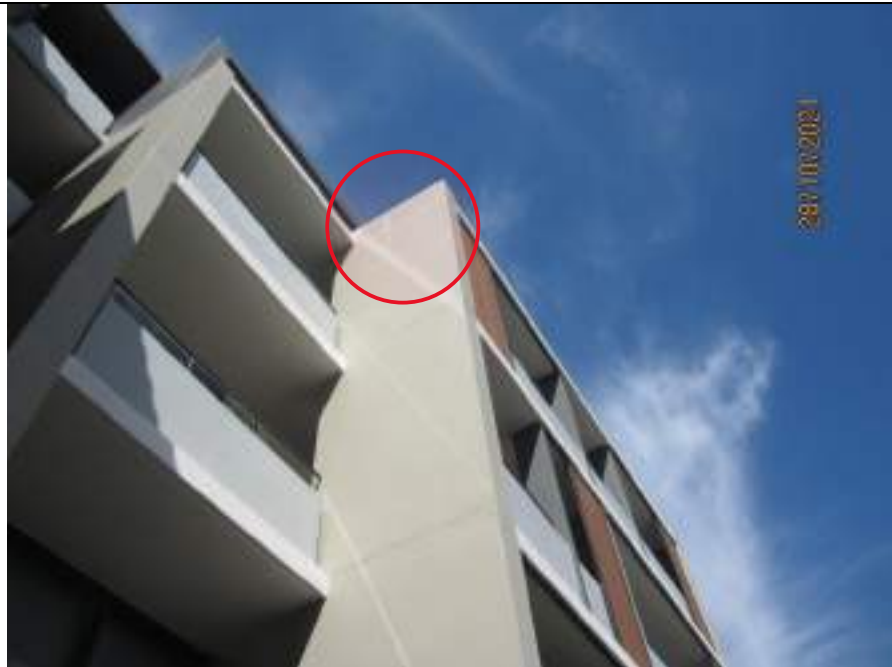
No flashing provided to top of columns on northern side of building. Evidence of efflorescence staining to eastern side of parapet.

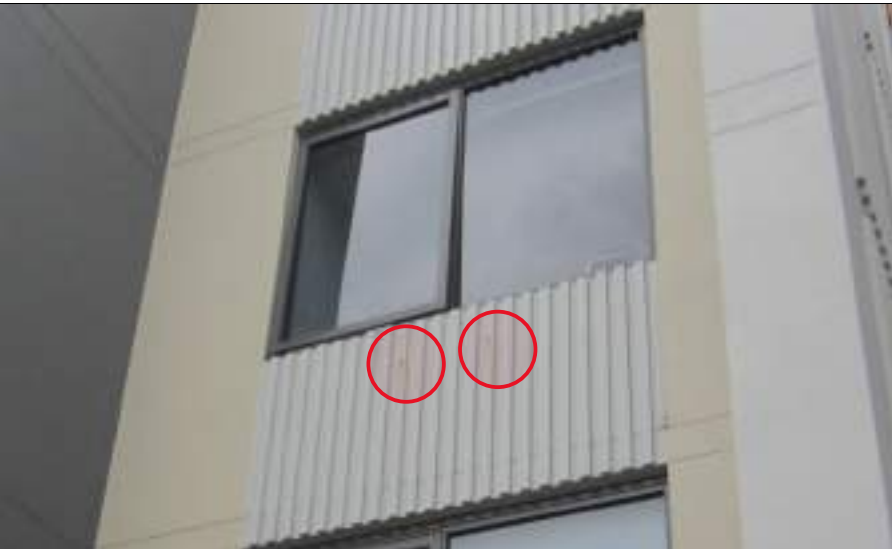
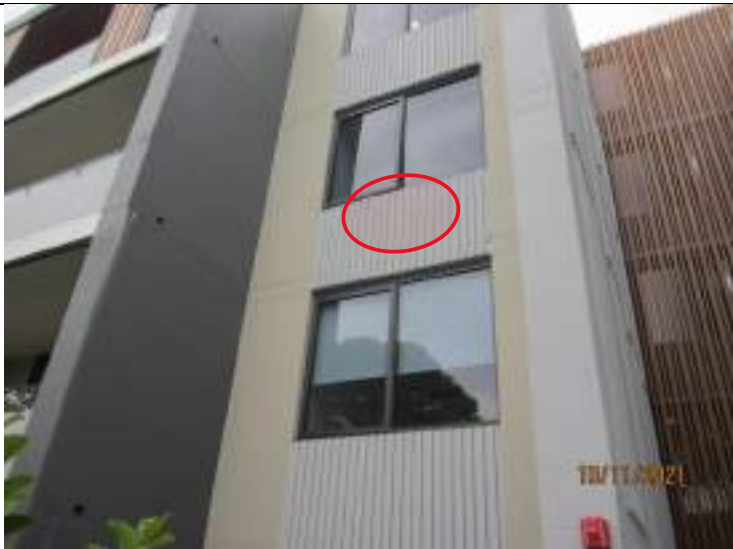
Evidence of corrosion to aerated concrete battening to upper levels on western side of main entry

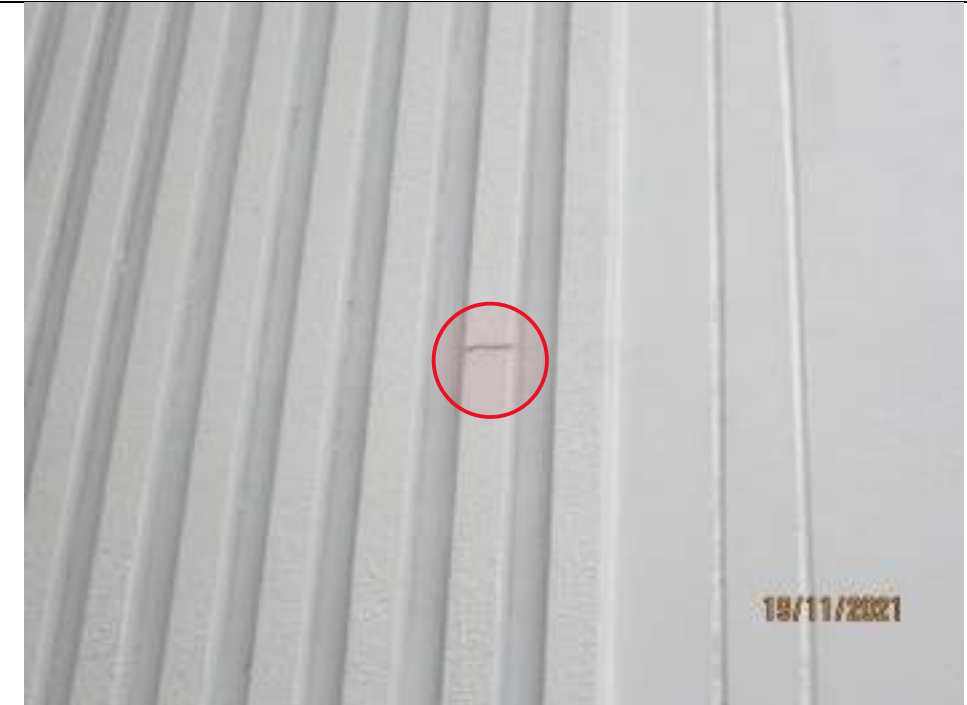
Evidence of damage to aerated concrete battening to eastern wall of main entry

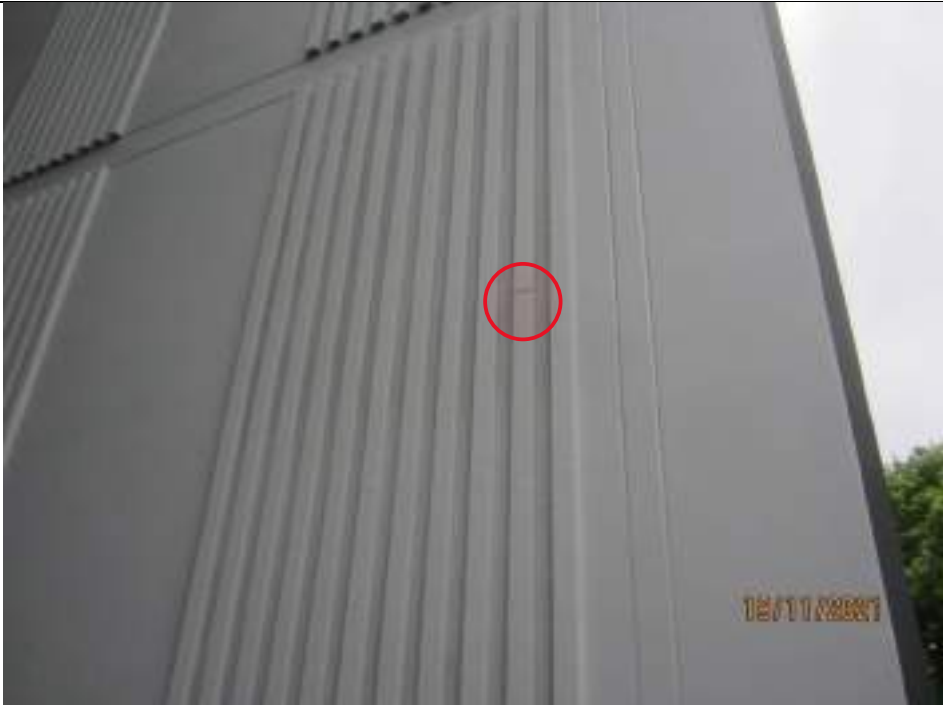
Evidence of damage to aerated concrete battening to eastern wall of main entry
