6. DEFECT SCHEDULE

6.1. AUTOMATIC FIRE DETECTION AND ALARM SYSTEM (INCLUDING SMOKE ALARMS)

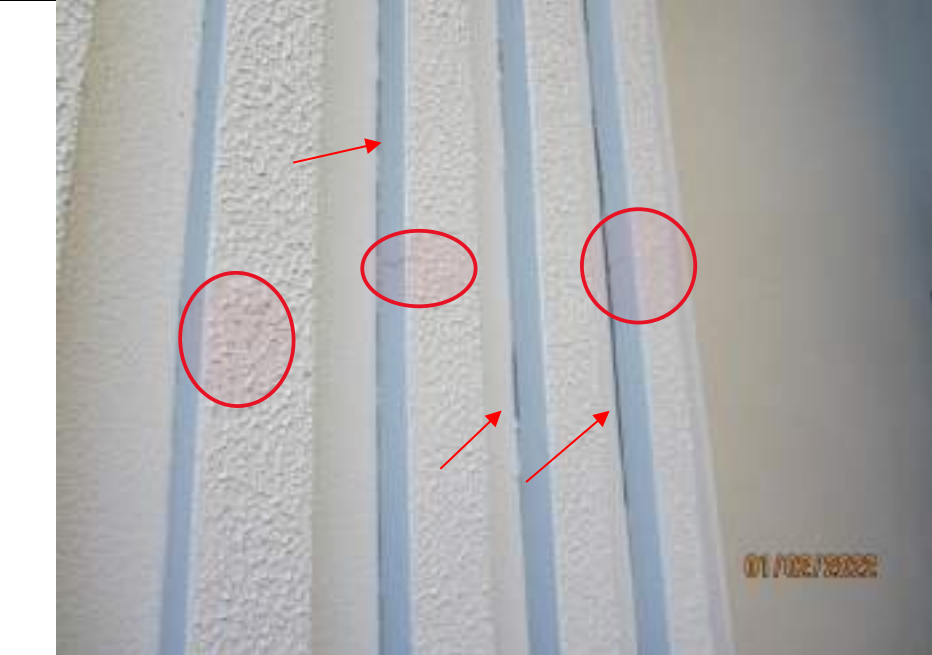
Image showing cracks and gaps to battens

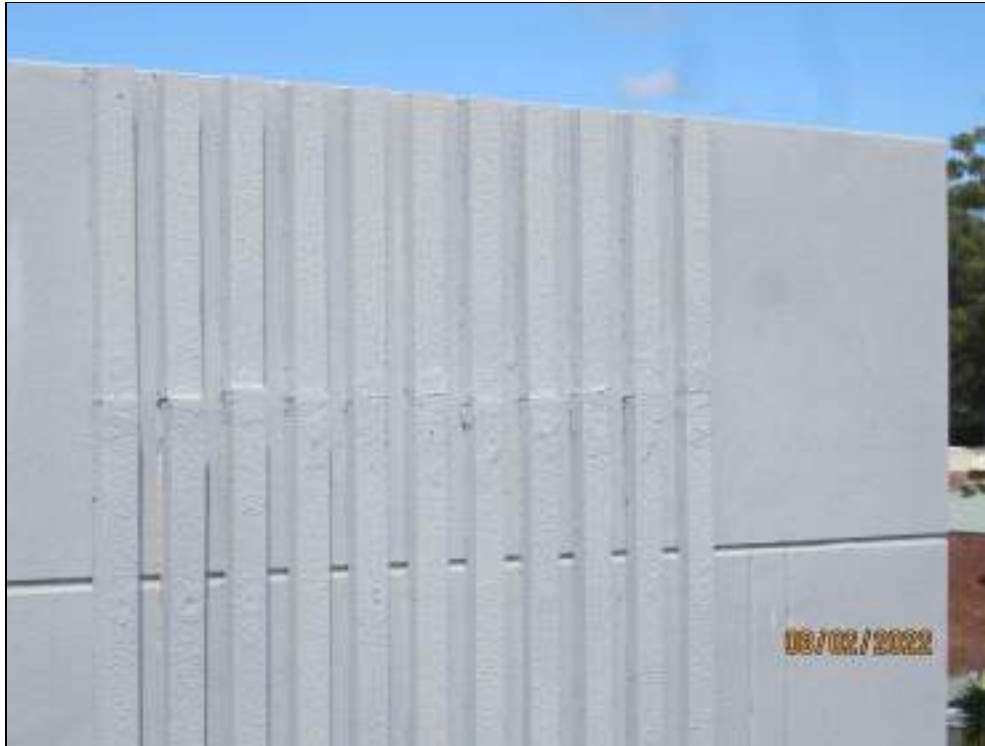
Evidence of poor workmanship to install to Building L façade battens above southern entry

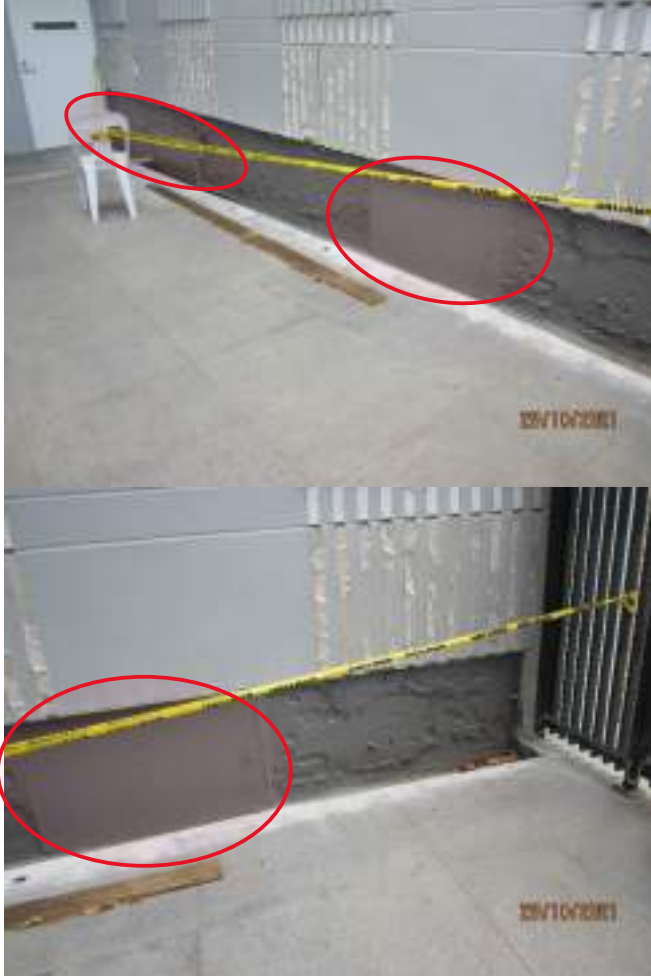
<p>Waterproofing repair to east side of entry above Unit G04. Location of blue board used to close voids to base of wall.</p>

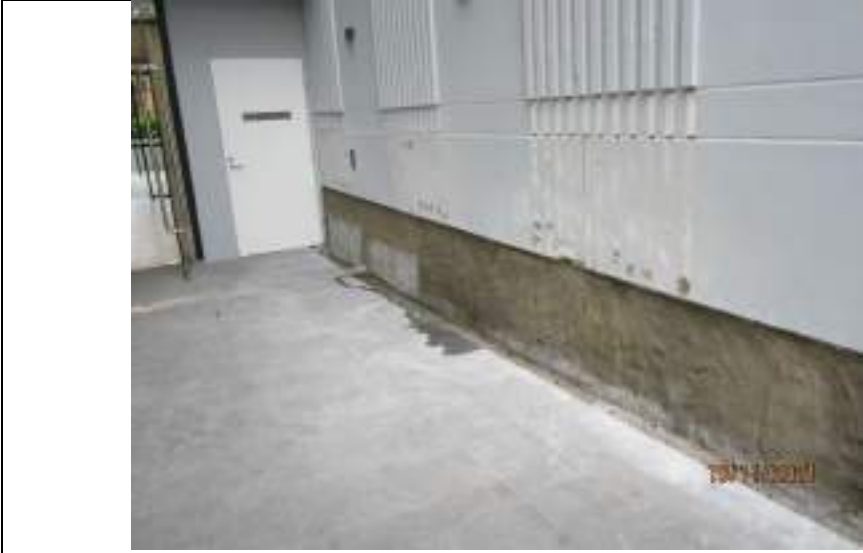
Render base coat applied to waterproofing membrane

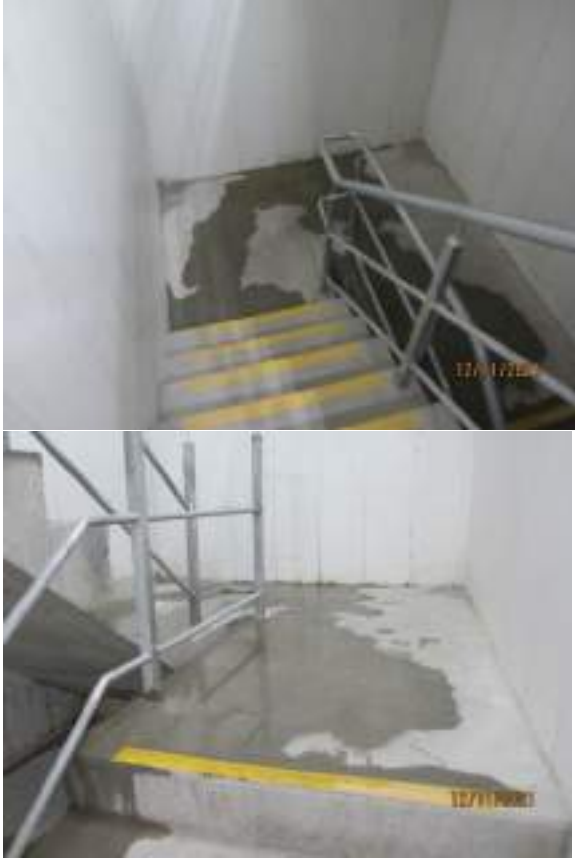
B	<p>Cause(s)</p> <ul style="list-style-type: none"> • Poor workmanship employed by the Builder at the time of construction. 	<p>Water pooling on floor due to water leak from Dintel at northern wall above stair landing Basement 2 level of the Firestair 2</p>
C	<p>Breach(es) Failure to comply with the following:</p> <ul style="list-style-type: none"> ▪ Home Building Act 1989 (NSW) under Section 18B Clauses 1(a) ▪ Manufacturers guidelines ▪ Plans and specifications

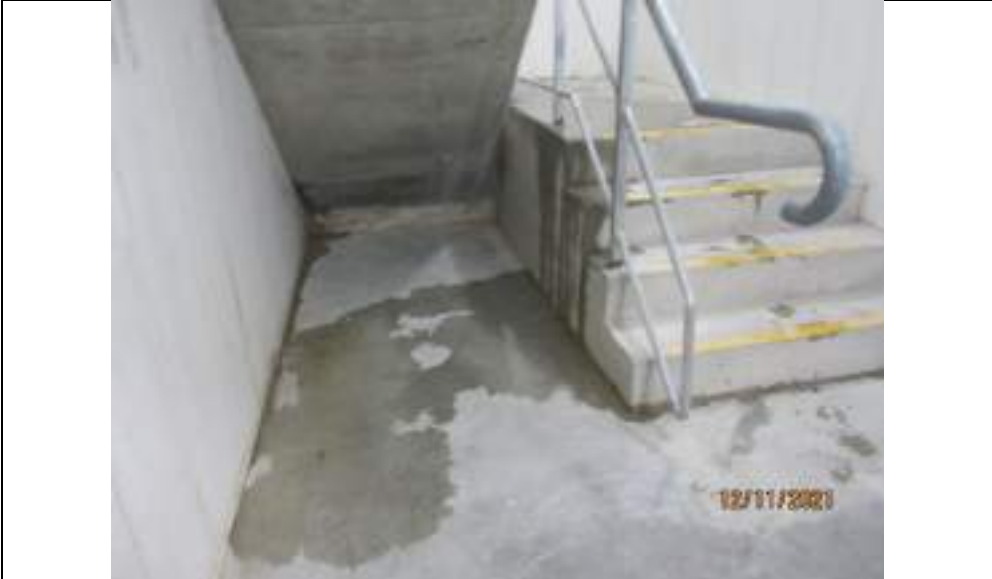
Water pooling on floor at Basement 2 level in Stairway 2 orinating from water leak to northern wall above stair landing

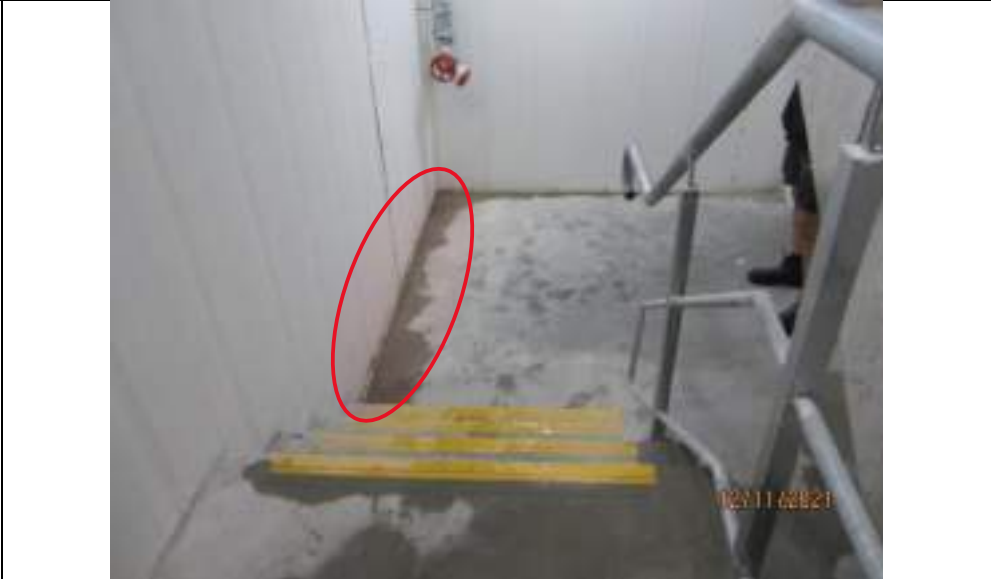
Water penetrating base of Dintel to southern wall in Stairway 2 at Basement 2 level

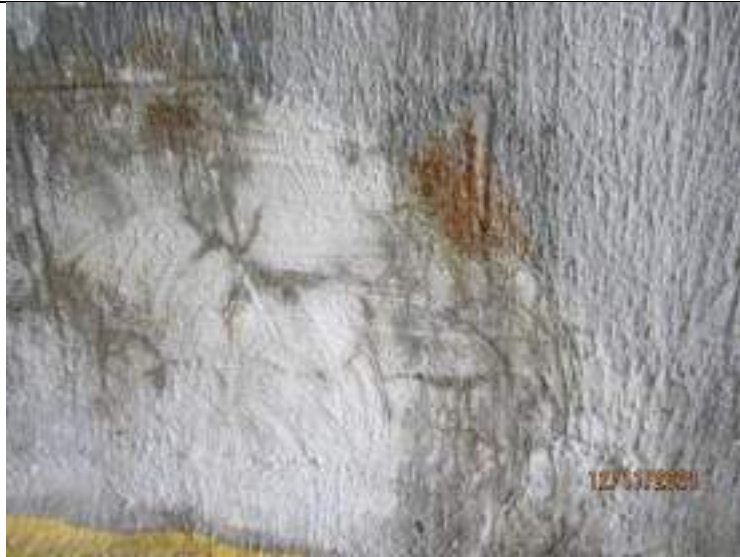
Evidence of failed waterproofing repair to water leaks

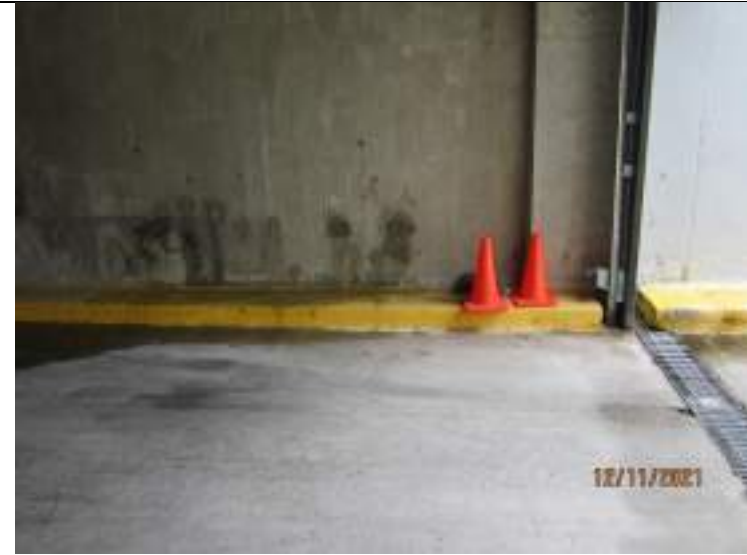
Evidence of failed waterproofing repair to water leaks

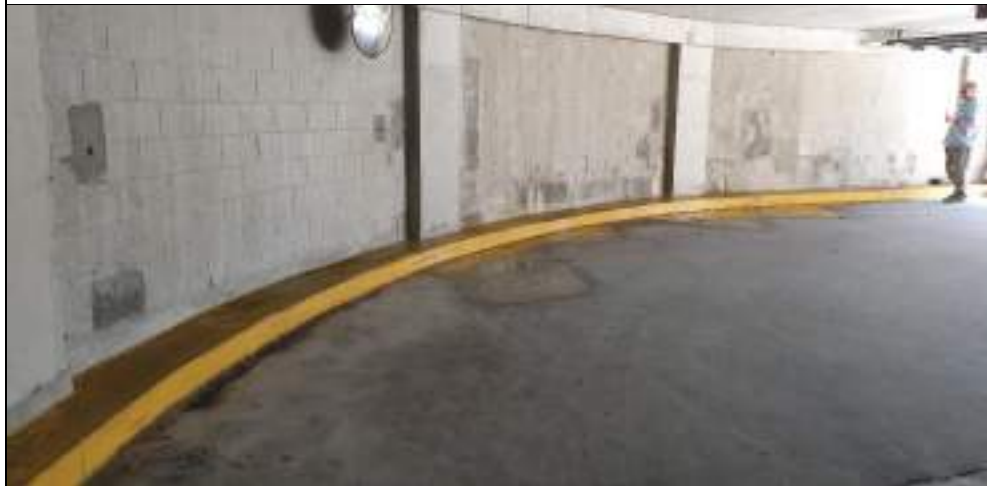
Image of northern retaining at basement entry with evidence of waterproofing repair

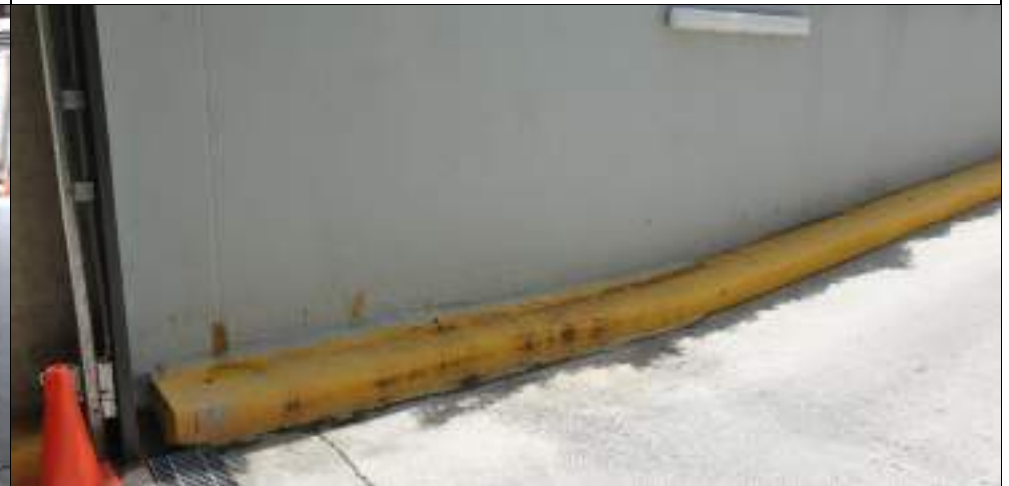
Evidence of waterleak to base of retaining wall on northern side of basement entry

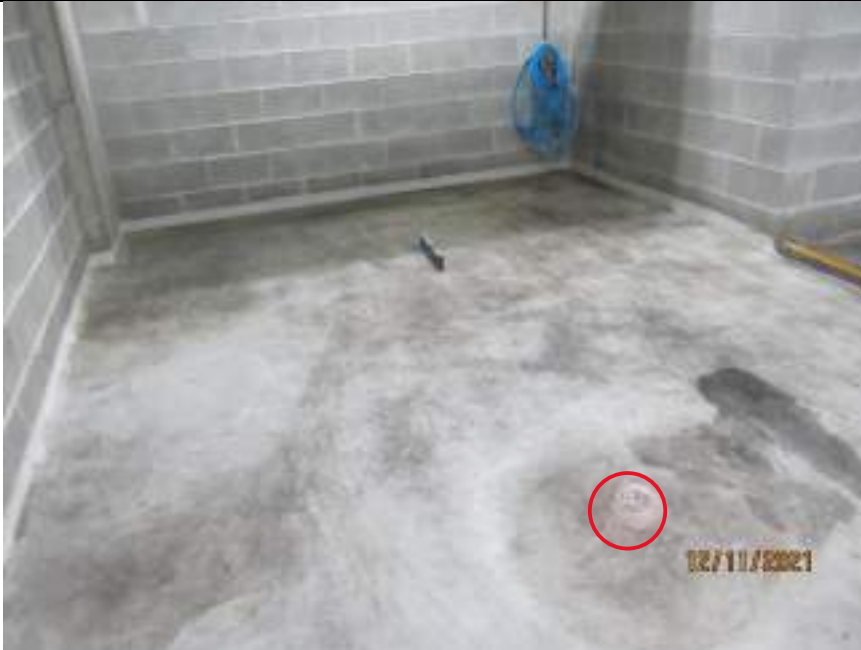
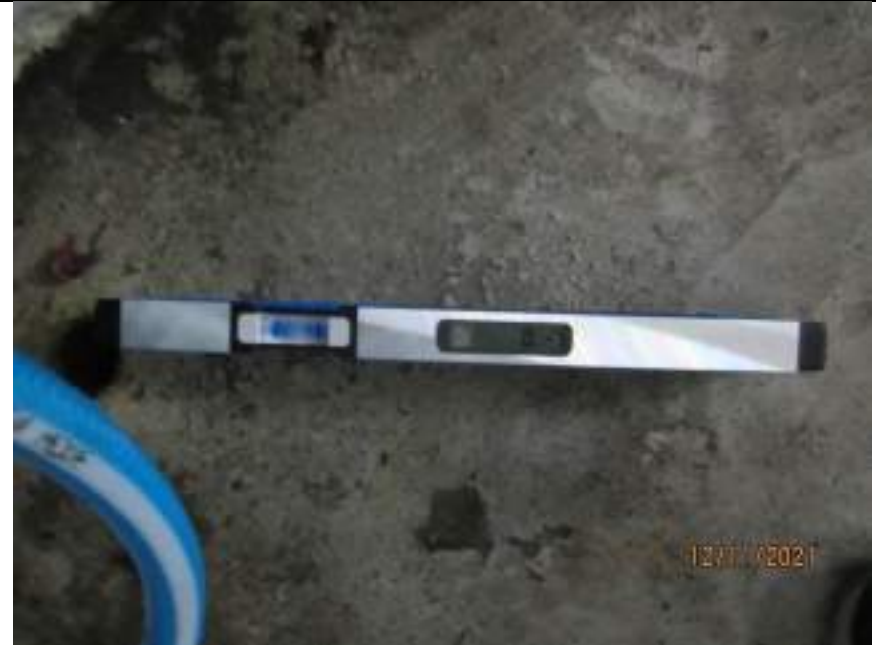
Zero fall indicated to eastern side of drainage inlet

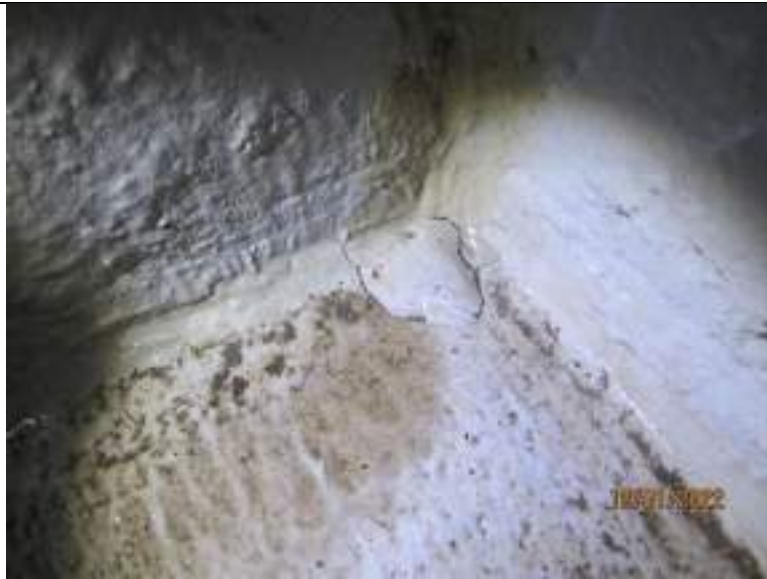
Evidence of bond breaker failure to waterproofing repair at rear of southwest wall of switch room

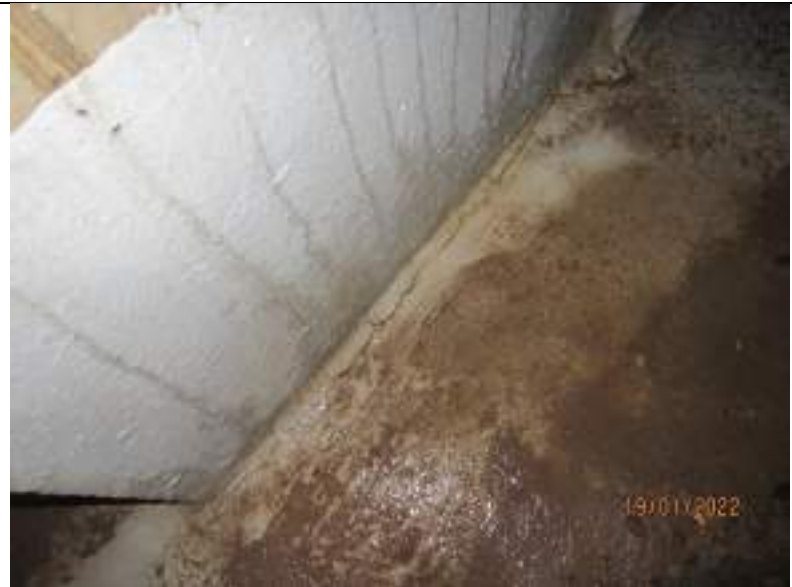
Evidence of bond breaker failure to waterproofing repair at rear of southwest wall of switch room

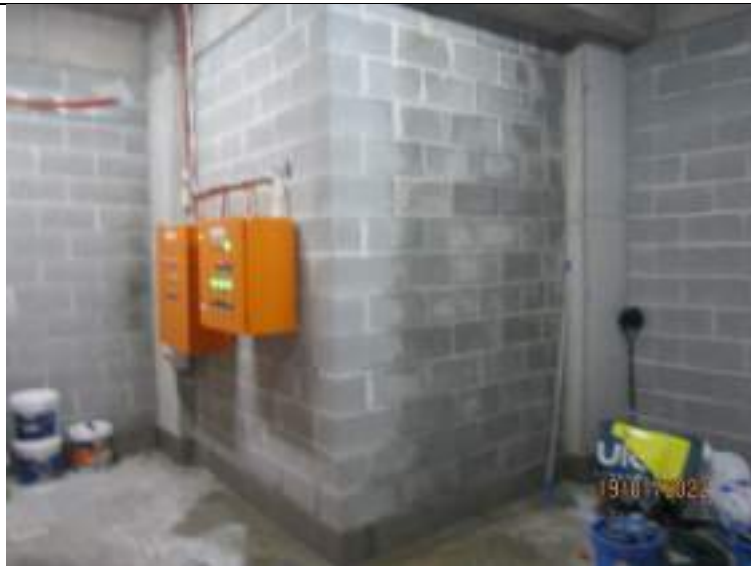
Image showing moisture penetrating southwestern masonry wall above waterproofing membrane

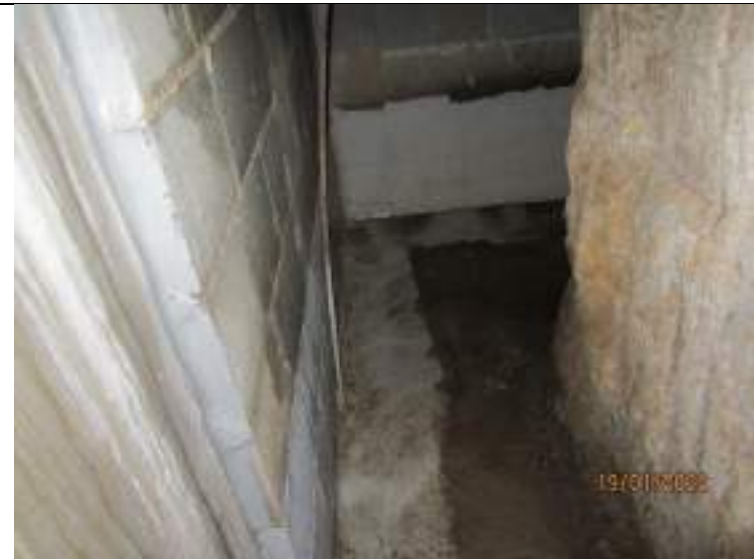
Waterproofing membrane terminated approximately 400mm above rear of southwestern wall

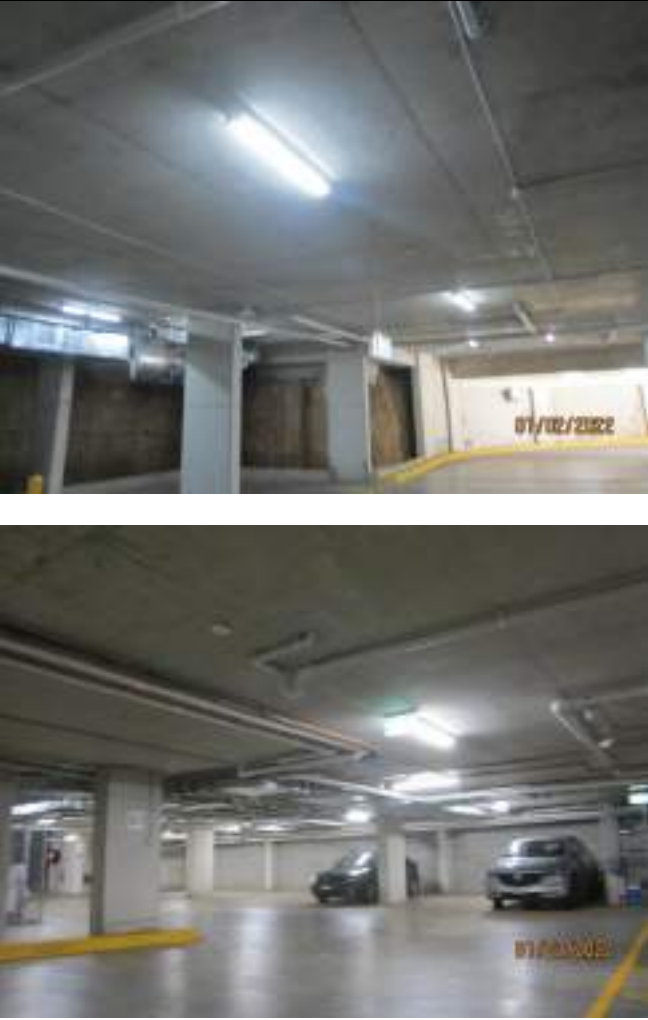
ITEM	COMMENTARY	PHOTOGRAPH(S)																											
B1-7																													
A	<p>Location & Description Basement 1 – Floor insulation Units G01 to G07</p> <p>The Author has observed that there is no insulation installed to the concrete floor slab to units G01 to G07 as specified on the construction certificate architectural plans.</p> <p>For clarity, please refer to following from BASIX commitments on drawings A0000 construction certificate plans prepared by PBD Architects -</p>

<p data-bbox="1496 1283 2141 1347">No evidence of insulation to under side of concrete slab of units G01 to G07.</p>
Certification Number: 0003200790																													
Unit No.	Floor Insulation R2.0	Wall insulation R1.5																											
G001	X	X																											
G002	X																												
G003	X																												
G004	X	X																											
G005	R3.0	X																											
G006	X																												
G007	X																												
B	<p>Cause(s)</p> <ul style="list-style-type: none"> <li data-bbox="434 1353 1458 1385">Failure by the Builder to carry out the works in accordance with the plans and specifications.

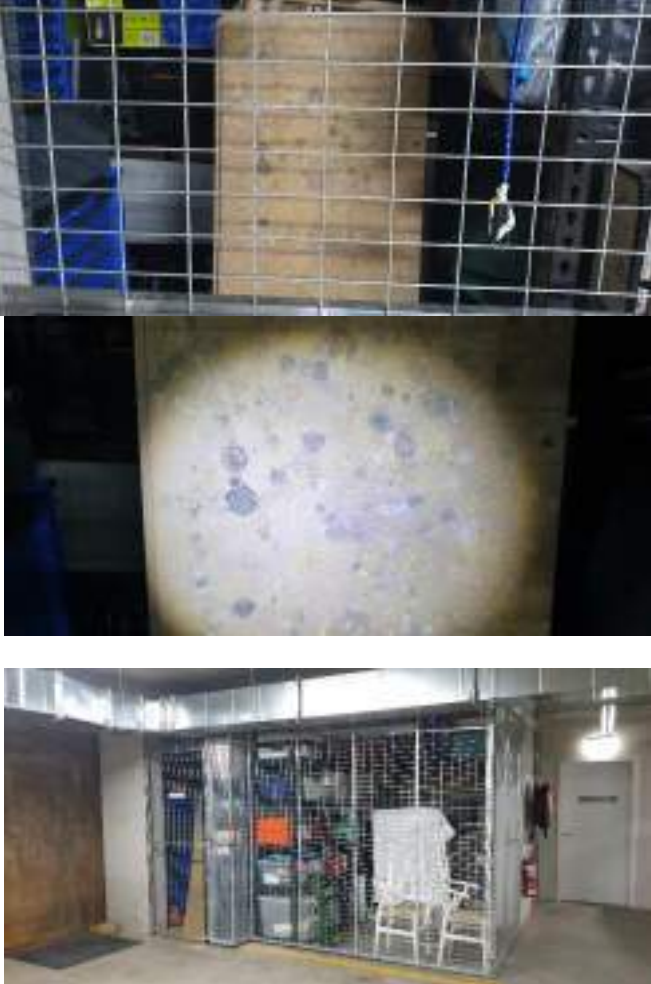
<p>Evidence of mould on surface of materials on storage to southeast of Basement 2</p>

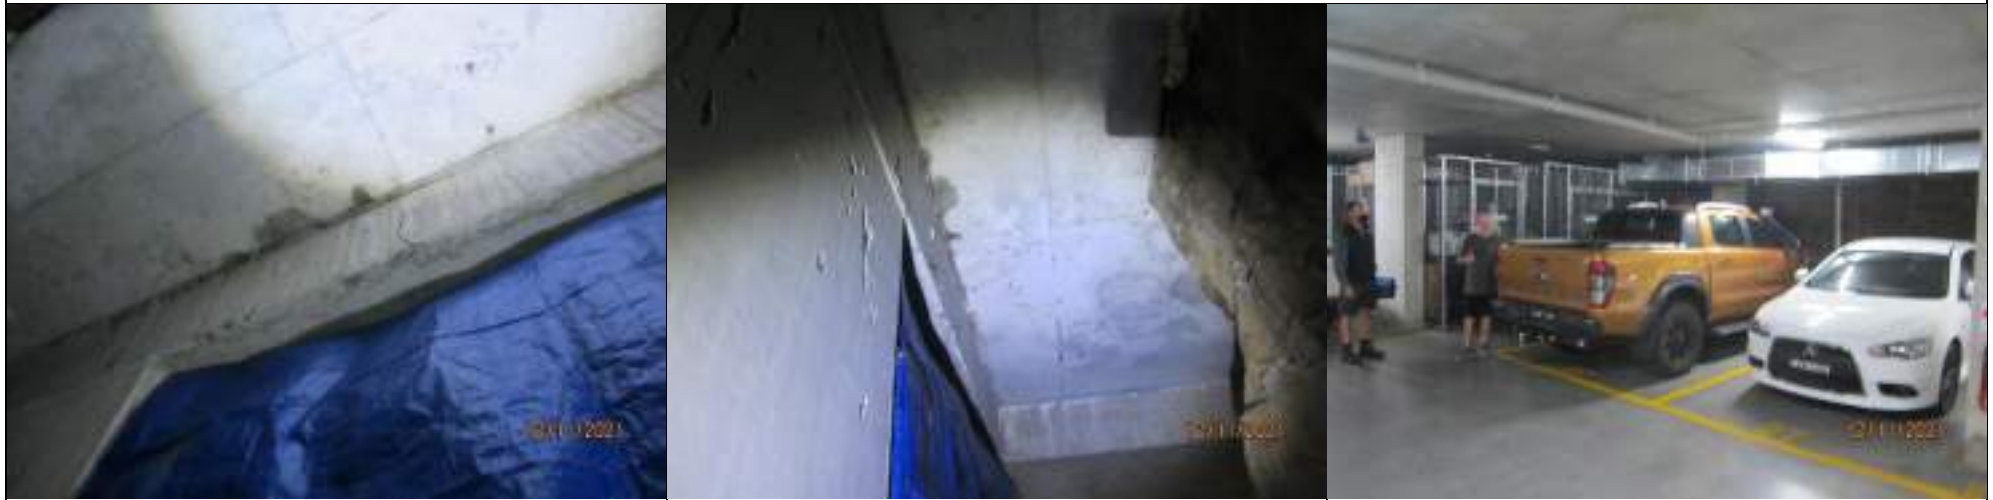
Tarp installed by lot owner to prevent moisture damage originating from slab to southwest storage of Basement 2

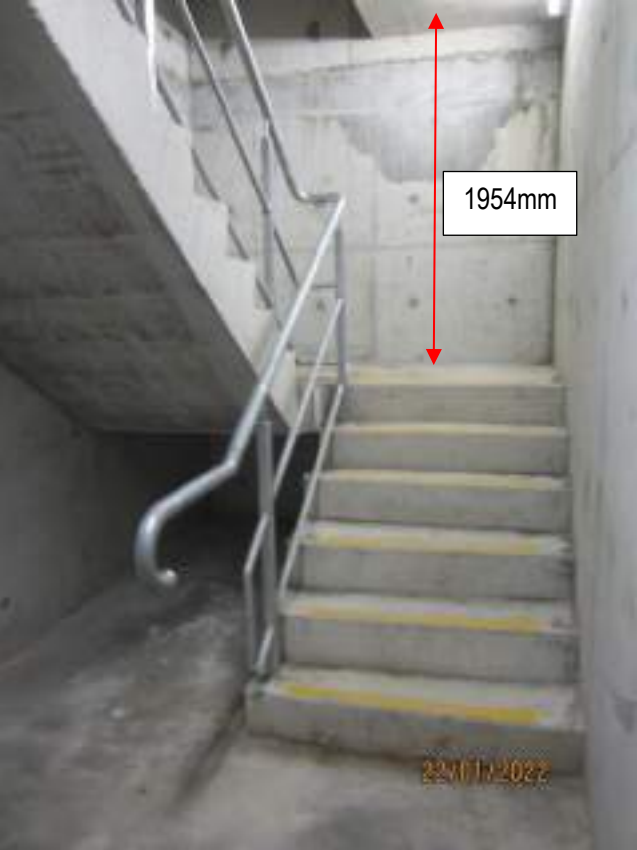
<p>Height clearance measured from landing 1954mm</p>

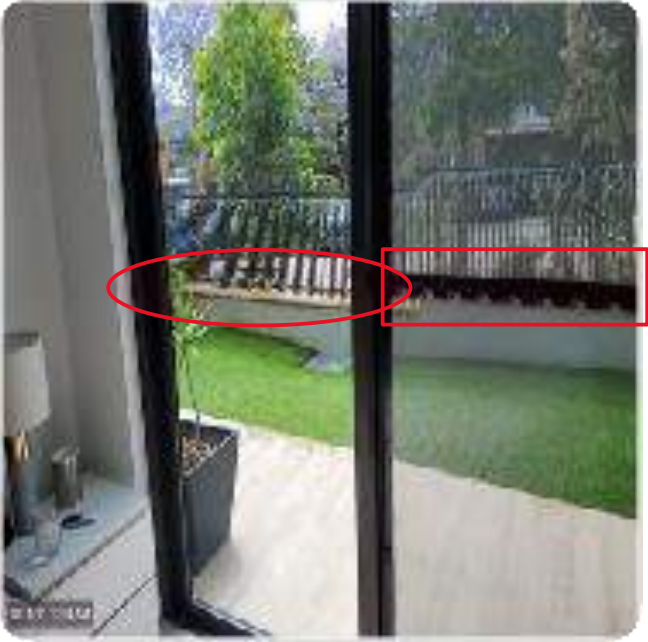
ITEM	COMMENTARY	PHOTOGRAPH(S)
4-G03		
A	<p>Location & Description</p> <p>Eastern exterior – Painting masonry fence</p> <p>The occupant reported to the Author at the time of inspection that the Builder changed landscaping levels to rectify drainage issues to the eastern lawn area. The resulting change of landscape levels has exposed unpainted sections of the eastern rendered wall.</p> <p>The Author is of the view, that the Builder has failed to complete the rectification works and make good, affected finishes.</p>

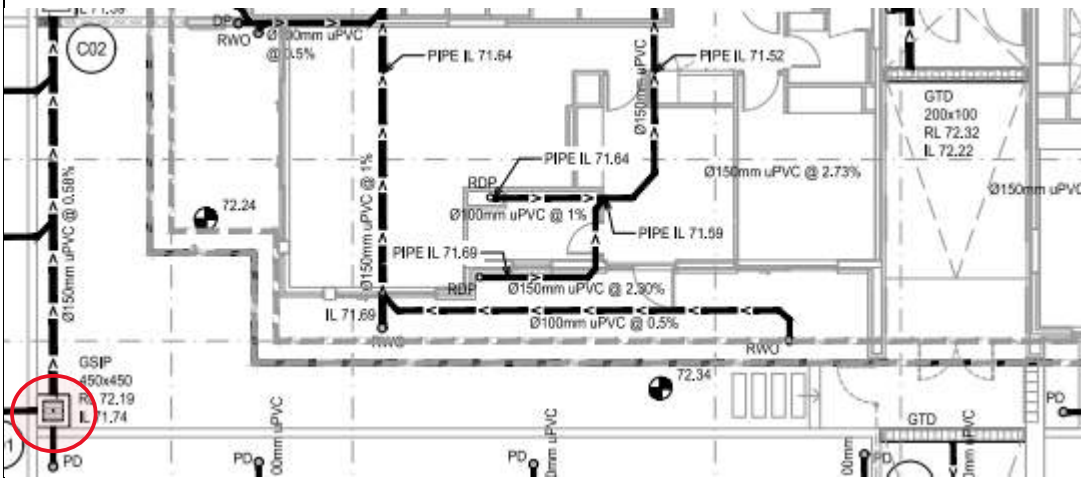
<p>The Author is of the view, that to provide adequate drainage extra drainage inlets are required to the mid-section of the lawn areas to the western and southern exterior.</p>

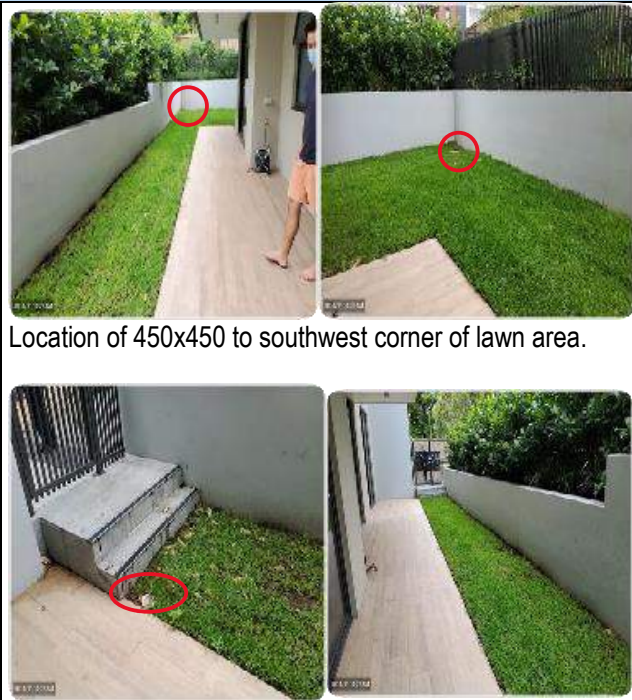
<p>Location of 450x450 to southwest corner of lawn area.</p> <p>Location of 90mm stormwater inlet to southeast of lawn area.</p>
