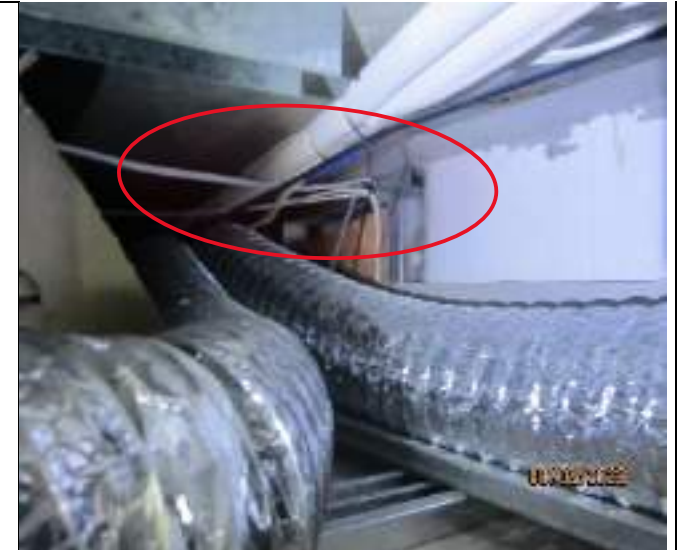
| ITEM | COMMENTARY | PHOTOGRAPH(S) |
|---|--|--|
| 3-G05 | | |

| ITEM | COMMENTARY | PHOTOGRAPH(S) |
|---|--|--|
| A | <p>Location & Description Party wall – Fire Separation</p> <p>The Author has observed that the sections of the common wall adjoining unit G06 fire protection is missing. The Author is of the view that the works to not conform to the requirements under C2.7(b)(i) Separation by fire walls of the NCC Vol 1 2016. For clarity, please refer to following extract before mentioned - Extract NCC Volume 1 2016 C2.7(b)(i) Separation by fire walls -</p> <p>The fire wall extends through all storeys and spaces in the nature of storeys that are common to that part and any adjoining part of the building.</p> <p>The Author noted issue was identified in TCA (Giaouris) report Attachment F Defect schedule U G05.1</p> <p>The Author is of the view that the work has not been carried out accordance with relevant requirements of the NCC, and that the defect originated from poor workmanship employed by the Builder at the time of construction.</p> | <p>Images showing missing fire separation to common wall to east of location from ceiling access</p> |
| B | <p>Cause(s)</p> <ul style="list-style-type: none"> Poor workmanship employed by the Builder at the time of construction. | |
| C | <p>Breach(es) <i>Failure to comply with the following:</i></p> <ul style="list-style-type: none"> Home Building Act 1989 (NSW) under Section 18B Clauses 1 (a); NCC Volume 1 2016 C2.7(b)(i) Separation by fire walls | |

Images showing missing fire separation to common wall to west of location from ceiling access

| ITEM | COMMENTARY | PHOTOGRAPH(S) |
|---|--|--|
| D | <p>Proposed Rectification Scope of Works Allow to:</p> <ol style="list-style-type: none"> Provide site supervision. Supervisor to coordinate access and facilitate the works throughout the whole process. Gain access to required areas in accordance with Safework requirements. Cover and protect adjacent surfaces during the rectification work. Labour to isolate electrical services to make safe Labour to demolish and remove ceiling linings to provide access to rectify defective works | |

6. Labour to install fire rated materials in accordance with NCC
7. Labour repair and reinstate plasterboard linings and finishes
8. Labour to paint ceiling and affected finishes
9. Labour to restore electrical service and commission
10. Supply fire rated material, plasterboard, paint and ancillaries
11. Make good any surfaces affected as part of the works, to their prior condition.
12. Clean site and leave in a tidy condition upon completion of work
13. Waste disposal

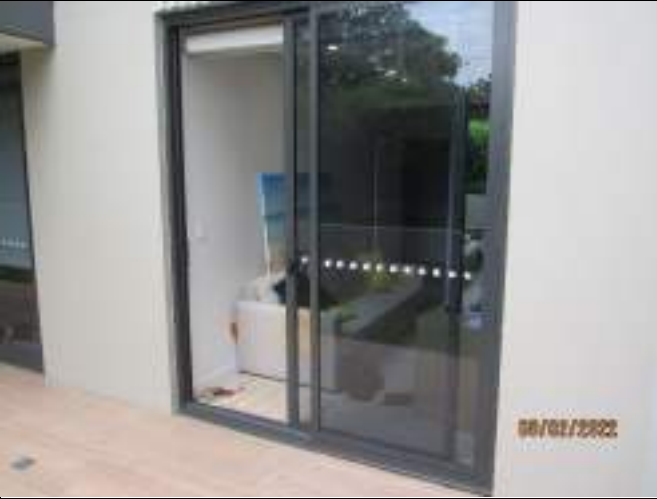
Location of bedroom 2 sliding door Unit G05 looking west

| <p>Location of exterior southern wall to bedroom 2 Unit G05</p> | <p>High elevated moisture levels indicted to exterior light weight wall lining to wall adjoining main entry ramp and southeast corner at Unit G05 bedroom 2</p> | <p>High elevated moisture levels indicted to exterior HEBEL wall cladding to southern wall of bedroom 2 Unit G05</p> |

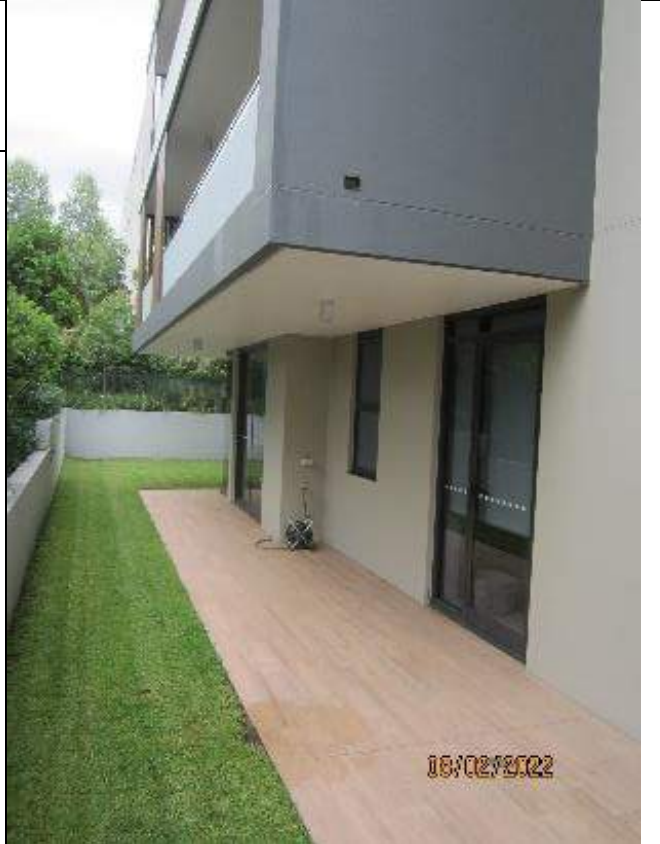
| ITEM | COMMENTARY | PHOTOGRAPH(S) |
|---|---|---|
| A | <p>Location & Description Southern facade – Hebel cladding installation</p> <p>The Author has observed no Pressure Equalisation PE/weep hole drainage outlets have been provided to the southern façade of unit G05.</p> <p>The Author noted that the defective works had been identified in Section 10.6 and 8.26 of Mr Giaouris report dated 7 December 2020. However, the Author noted that Hebel installation guidelines referenced by Mr Giaouris states PE/drainage slots to be located no greater than 3 metre spacing. Therefore, the Author is of the view that work is defective in the locations where the spacing exceed or do not conform to the manufacturers guidelines.</p> <p>To clarify, please refer to extract from Section 8.26.3 of Mr Giaouris report -</p> <p>Pressure Equalisation Slots</p> <div style="border: 1px solid red; border-radius: 10px; padding: 5px; margin: 10px 0;"> <p>PE Slots (Weepa) allow pressure equalisation to the wall cavity and permit drainage of any water from the cavity. Ideally located at control joints (CJ) and at no greater than 3 metre spacing.</p> </div> <p>The Author noted issue was specifically identified to unit G05 in TCA (Giaouris) report Attachment F Defect schedule U G05.27</p> <p>The Author is of the view that where the works have not been carried out in accordance with manufacturers guidelines that the works are defective and the defect originated due to poor workmanship employed by the Builder at the time of construction.</p> | <p>No pressure equalisation slots or cavity drainage provide to southern façade of Unit G05HEBEL cladding system</p> |
| B | <p>Cause(s)</p> <ul style="list-style-type: none"> Poor workmanship employed by the Builder at the time of construction. | |

| C | Breach(es) <i>Failure to comply with the following:</i> <ul style="list-style-type: none">▪ <i>Home Building Act 1989 (NSW) under Section 18B Clauses 1 (a);</i>▪ <i>Manufactures guidelines</i> | <p style="text-align: right;">Southern façade of Unit G05</p> |

| D | Proposed Rectification Scope of Works Allow to: <ol style="list-style-type: none">1. Provide site supervision. Supervisor to coordinate access and facilitate the works throughout the whole process.2. Gain access to required areas in accordance with Safework requirements.3. Cover and protect adjacent surfaces during the rectification work.4. Labour to cut slot in Hebel panel to install Weepa protector, install Weepa protectors and patch and repair affected finishes in accordance with manufacturers guidelines.5. Labour to repair render and paint façade to provide even finish6. Supplier Weepa protectors7. Supply Dulux render system materials, paint and ancillaries8. Make good any surfaces affected as part of the works, to their prior condition.9. Clean site and leave in a tidy condition upon completion of work10. Waste disposal | |

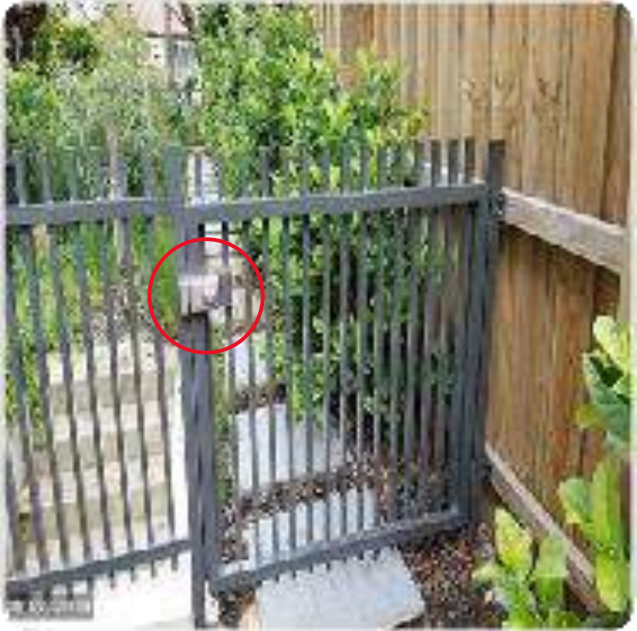
| ITEM | COMMENTARY | PHOTOGRAPH(S) |
|---|---|--|
| A | <p>Location & Description Southwestern exterior – Gate lock</p> <p>It was reported by the occupants to the Author at the time of inspection, that no key for the southwestern gate was supplied by the Builder.</p> <p>The Author is of the view, that the occupants statement is true and correct.</p> | |
| B | <p>Cause(s)</p> <ul style="list-style-type: none"> • Failure of the Builder to complete the works in accordance with the building contract. | |

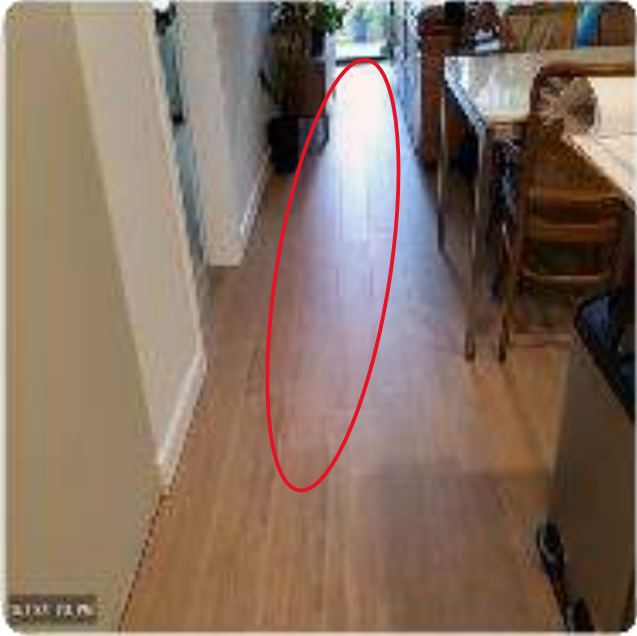
| ITEM | COMMENTARY | PHOTOGRAPH(S) | |
|---|---|---|--|
| A | <p>Location & Description Living area – Tiling – Cleaning</p> <p>The occupant reported to the Author at the time of inspection, there was a residue stain on the floor tiles on the western side of living area that was reported to the Builder.</p> <p>The Author observed that there was evidence of a cloudy film of the area described by the occupant.</p> <p>The Author has assumed the occupants statement is true and correct.</p> <p>The Author is of the view, that the defect originated at the time of construction due to poor workmanship employed by the Builder at the time of construction.</p> | | |
| B | <p>Cause(s)</p> <ul style="list-style-type: none"> • Poor workmanship employed by Builder at the time of construction | | |

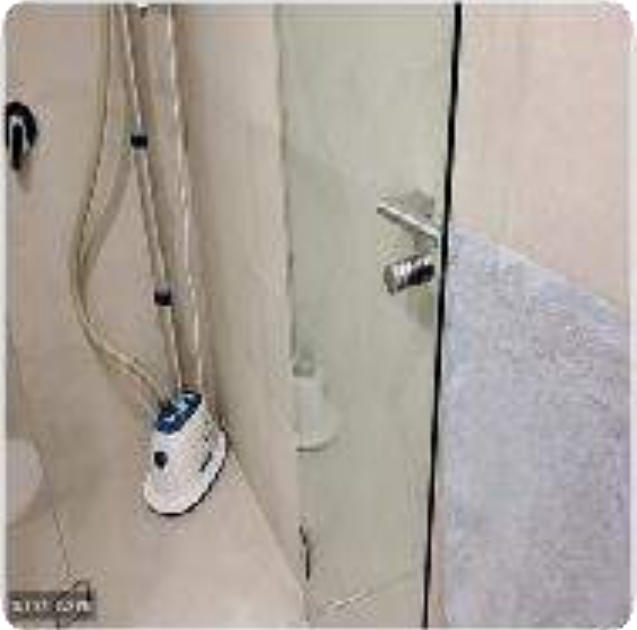
| ITEM | COMMENTARY | PHOTOGRAPH(S) |
|---|---|---|
| A | <p>Location & Description Main bathroom – Towel rail</p> <p>The Author has observed that the bathroom shower screen door is striking the wall mounted metal towel rail.</p> <p>The Author is of the view, that there is a possibility that the shower rail may impact with glass and cause the glass to break creating a safety hazard to the occupants. The National Construction Code requires that a wet area be constructed to avoid the likelihood of the creation of any unhealthy or dangerous conditions.</p> <p>For clarity, please refer to the following extract from the National Construction Code 2016 Vol.2 F2.4.1</p> <div style="background-color: #fff9c4; padding: 5px;"> <p>F2.4.1 Wet areas A building is to be constructed to avoid the likelihood of—</p> <ul style="list-style-type: none"> (a) the creation of any unhealthy or dangerous conditions; or (b) damage to building elements, </div> | |
| B | <p>Cause(s)</p> <ul style="list-style-type: none"> • Failure of the Builder to carry out the works with due care and skill | |

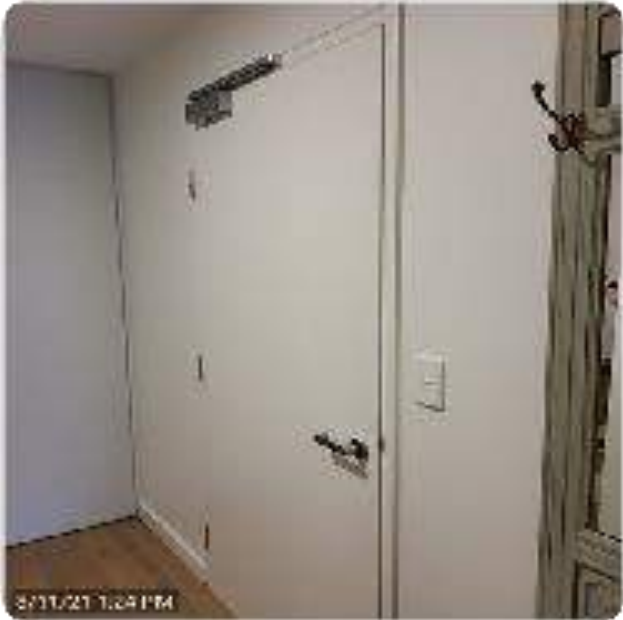
| ITEM | COMMENTARY | PHOTOGRAPH(S) |
|---|---|---|
| A | <p>Location & Description Entry door – Binding The Author has observed the entry door is binding on the door jamb.</p> <p>The Author is of the view, The Author is of the view, that the defect is the responsibility of the Builder under the building contract maintenance period and under Section 18E(1)(b) of the Home Building Act 1989.</p> | |
| B | <p>Cause(s)</p> <ul style="list-style-type: none"> • Poor workmanship employed by Builder at the time of construction; • Failure of the Builder to provide sufficient clear at the time of construction. | |

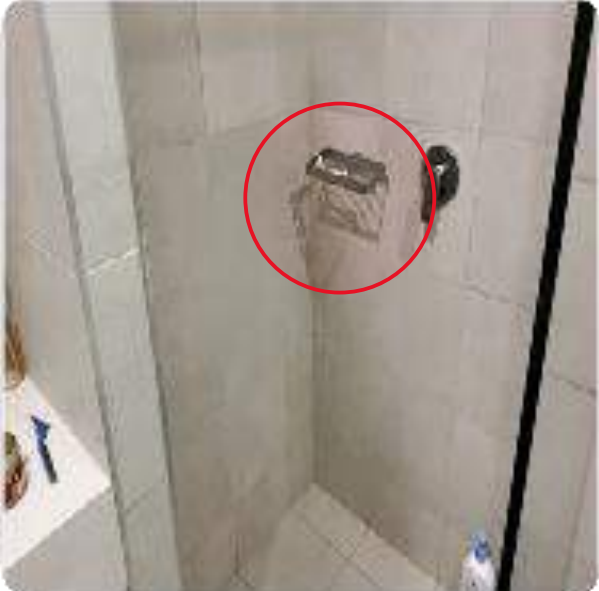
| ITEM | COMMENTARY | PHOTOGRAPH(S) |
|---|--|--|
| A | <p>Location & Description Ensuite – Soap holder</p> <p>The Author has observed the soap holder in the shower is loose.</p> <p>The Author is of the view, that the defect is the responsibility of the Builder under the building contract maintenance period and under Section 18E(1)(b) of the Home Building Act 1989.</p> | |
| B | <p>Cause(s)</p> <ul style="list-style-type: none"> • Poor workmanship employed by Builder at the time of construction; | |

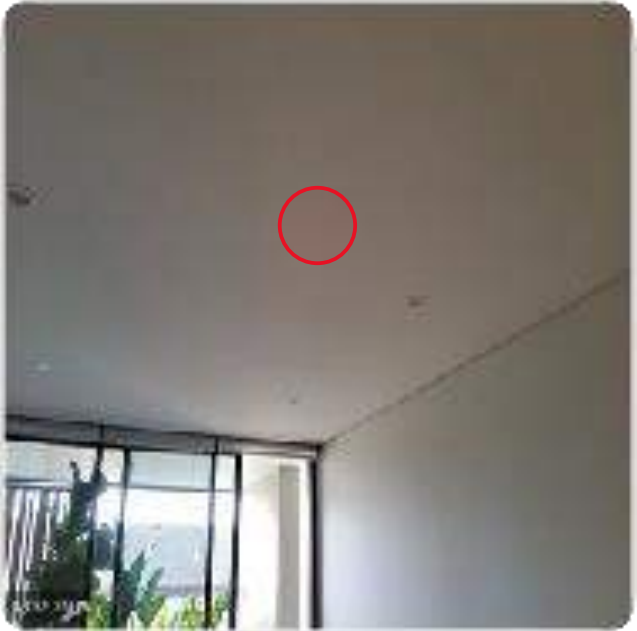
| ITEM | COMMENTARY | PHOTOGRAPH(S) |
|---|---|---|
| A | <p>Location & Description Living room – Ceiling painting</p> <p>It was reported to the Author at the time of inspection, that paint blemish identified to the ceiling plasterboard was present prior to handover.</p> <p>The Author has assumed that the occupants statement is true and correct.</p> | |
| B | <p>Cause(s)</p> <ul style="list-style-type: none"> • Poor workmanship employed by Builder at the time of construction; | |

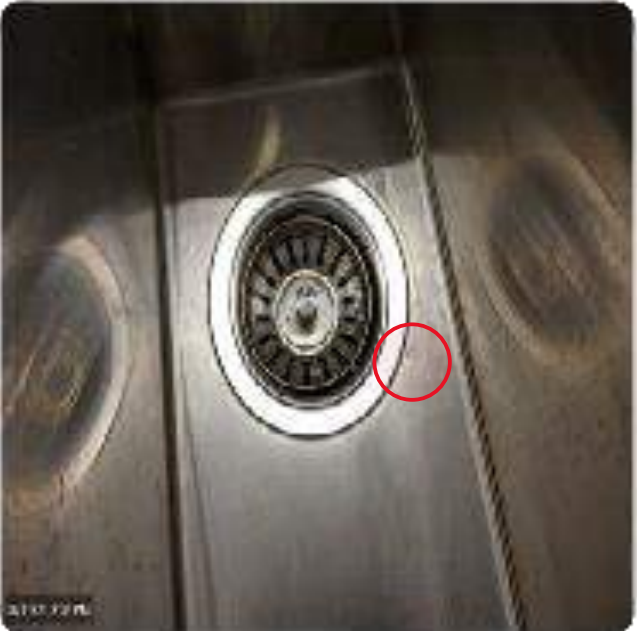
| ITEM | COMMENTARY | PHOTOGRAPH(S) |
|---|---|--|
| A | <p>Location & Description Kitchen sink – Damage</p> <p>The lot owner reported to the Author at the time of inspection, that the dint to the side of drain in the kitchen sink was reported to the Builder prior to hand over.</p> <p>The Author has assumed that the lot owners statement is true and correct.</p> | |
| B | <p>Cause(s)</p> <ul style="list-style-type: none"> Poor workmanship employed by Builder at the time of construction; | |

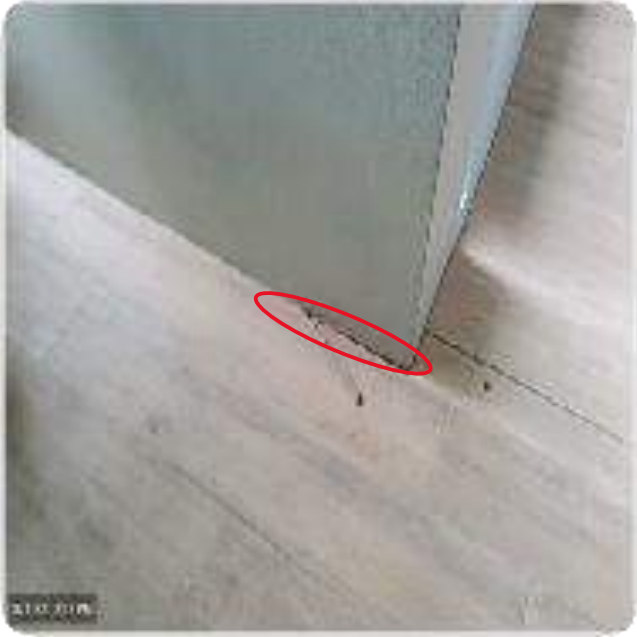
| ITEM | COMMENTARY | PHOTOGRAPH(S) |
|---|--|---|
| A | <p>Location & Description Balcony – Waterproofing</p> <p>The lot owner reported to the Author at the time of inspection, flexible sealant removed at the base at the floor tile junction to the western side of the rendered column at the centre of the balcony, was removed by the Builder to carry out invasive testing to investigate the cause of moisture damage to the light weight rendered column that extends to the ground floor below and to the levels above.</p> <p>On inspection the Author found no evidence that the waterproofing membrane to the balcony floor return and terminated at a level above the tiled surface.</p> <p>In the Authors view, further investigation should be undertaken to determine if the waterproofing membrane has been terminated above the tiles surface and if possible whether moisture migration has been caused by a failure to install the waterproofing to the balcony in accordance with AS4654.2</p> <p>The Author has determined the proposed scope of works in relation to this item on an 'if found basis' and has included to conduct an invasive testing to investigate the cause of the defect.</p> | |
| B | <p>Cause(s)</p> <ul style="list-style-type: none"> • Poor workmanship employed by Builder at the time of construction; • Failure of Builder to carry out the waterproofing in accordance with AS4654.2 | |

| D | <p>Proposed Rectification Scope of Works</p> <p>Allow to:</p> <p>If found waterproofing is defective</p> <ol style="list-style-type: none">1. Provide site supervision. Supervisor to coordinate access and facilitate the works throughout the whole process.2. Gain access to required areas in accordance with Safework requirements.3. Labour to demolish and remove tiling, tile bed (screed) to nearest junction4. Labour to expose concrete slab substrate, remove demolition waste and place in waste bin for disposal5. Labour to grind concrete surface and prepare surface for new waterproofing system6. Labour to apply waterproofing system in accordance with AS4654.1&2 to affected area and as to building contract specifications7. Labour to repair render8. Supply Dulux render materials9. Labour to place sand and cement tile screed and provide positive falls to drainage inlets in accordance with AS3958.1 and in accordance with building contract specifications10. Labour to mix sand and cement for tile screed and assist trades11. Supply sand and cement for tile screed12. Supply 'Efflock' to prevent efflorescence13. Supply and apply waterproofing system on top of tile bed to prevent efflorescence as to building contract specifications14. Supply and install preformed tile movement joint in accordance with AS3958.1 and building contract specifications if required15. Supply and fix new selected tiles and grout in accordance with AS3958.1:2007 and building contract specifications16. Supply 'Efflock' for tile adhesive and grouts to prevent efflorescence17. Labour to repair paint work to affected finishes18. Supply paint and ancillaries19. Remove and dispose of all building waste20. Make good any surfaces affected as part of the works, to their prior condition.21. Clean site and leave in a tidy condition upon completion of work | |

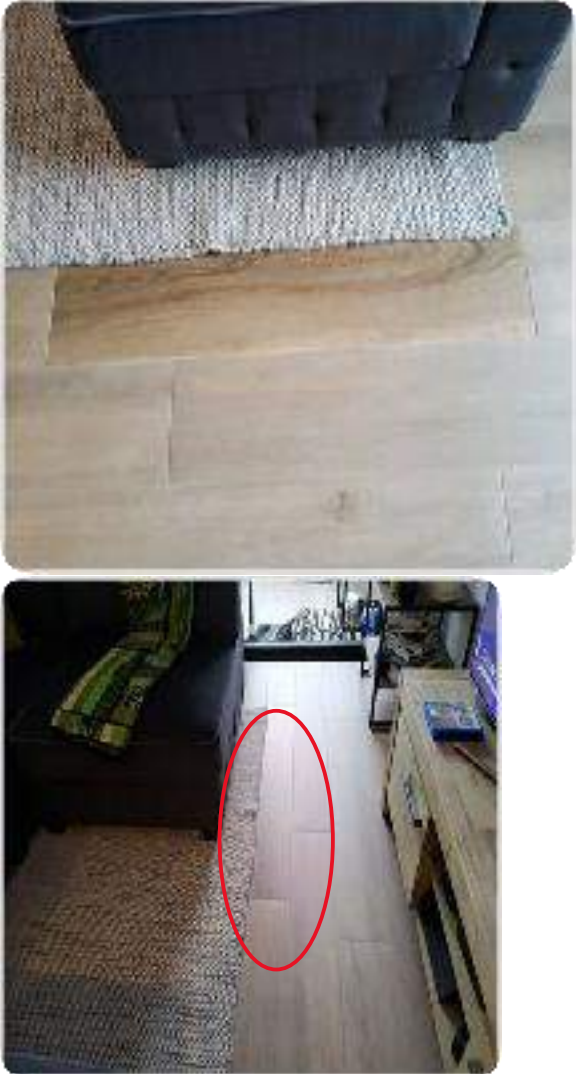
| ITEM | COMMENTARY | PHOTOGRAPH(S) |
|---|---|--|
| A | <p>Location & Description Living area – Tile repair</p> <p>It was reported to the Author at the time of inspection that the Builder replaced a damaged floor tile in the living area. The Author observed that the tile replacement tile does not match existing tile finishes.</p> <p>The Author is of the view, that the tile repair does not match the surrounding materials.</p> | |
| B | <p>Cause(s)</p> <ul style="list-style-type: none"> • Repair material does not match existing finishes. | |

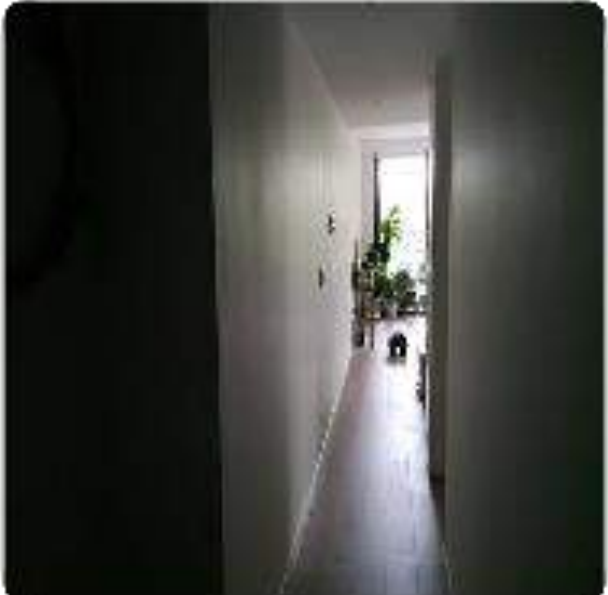
| ITEM | COMMENTARY | PHOTOGRAPH(S) |
|---|--|--|
| A | <p>Location & Description Main hallway northern wall – Painting</p> <p>The Author has observed the main entry hallway northern wall has uneven paint cover.</p> <p>The Author is of the view, that the defect originated from poor workmanship employed by the Builder at the time of construction.</p> | |
| B | <p>Cause(s)</p> <ul style="list-style-type: none"> • Poor workmanship employed by Builder at the time of construction | |

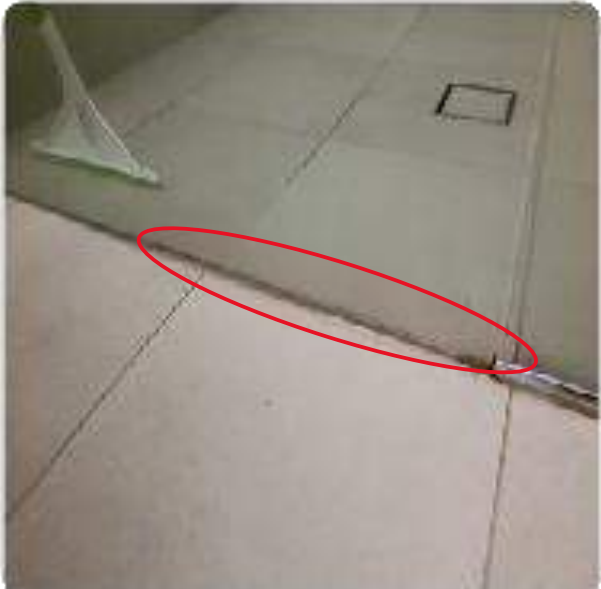
| ITEM | COMMENTARY | PHOTOGRAPH(S) |
|---|--|--|
| A | <p>Location & Description Ensuite shower screen</p> <p>The Author has observed water leaks at the bottom of the fixed shower screen in the ensuite, the silicone to the bottom of the shower screen towards the door has gaps</p> <p>The Author is of the view, that the defect originated from poor workmanship employed by the Builder at the time of construction.</p> | |
| B | <p>Cause(s)</p> <ul style="list-style-type: none"> Poor workmanship employed by Builder at the time of construction | |

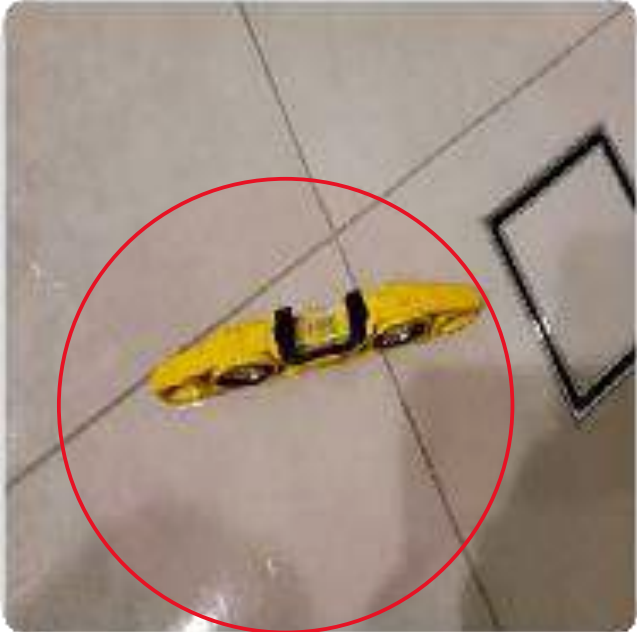
| ITEM | COMMENTARY | PHOTOGRAPH(S) | |
|---|--|---|--|
| A | <p>Location & Description Main bathroom shower floor tiling</p> <p>The Author has observed water is ponding on the eastern side of the drain the main bathroom shower. The Author conducted testing with a spirit level and found there was insufficient fall on the tile surface to the eastern side of the drain.</p> <p>The Author is of the view, that the defect originated due to poor workmanship employed by the Builder at the time of construction.</p> | | |
| B | <p>Cause(s)</p> <ul style="list-style-type: none"> • Poor workmanship employed by Builder at the time of construction • Failure of Builder to carry out the tiling in accordance with AS3958.1:2007 and in accordance with building contract specifications | | |

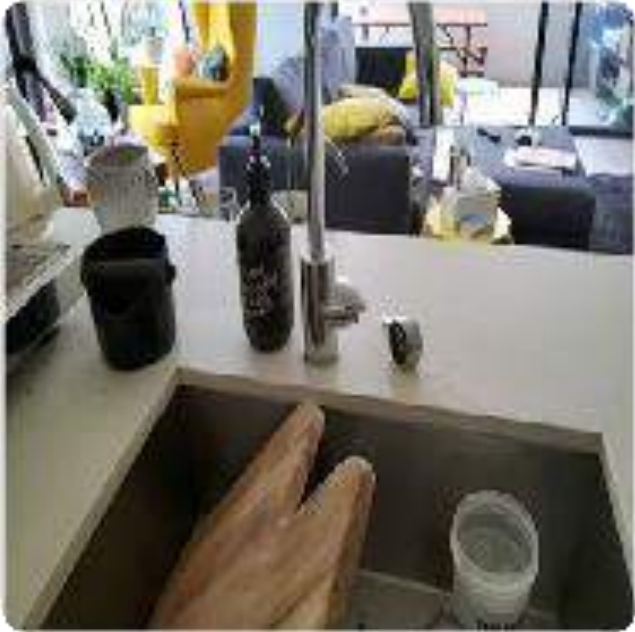
| ITEM | COMMENTARY | PHOTOGRAPH(S) |
|---|---|---|
| A | <p>Location & Description Kitchen mixer tap</p> <p>The Author has observed the Kitchen tap mixer handle is loose.</p> <p>The Author is of the view, that the defect is the responsibility of the Builder under the building contract maintenance period and under Section 18E of the Home Building Act.</p> | |
| B | <p>Cause(s)</p> <ul style="list-style-type: none"> Poor workmanship employed by Builder at the time of construction; | |

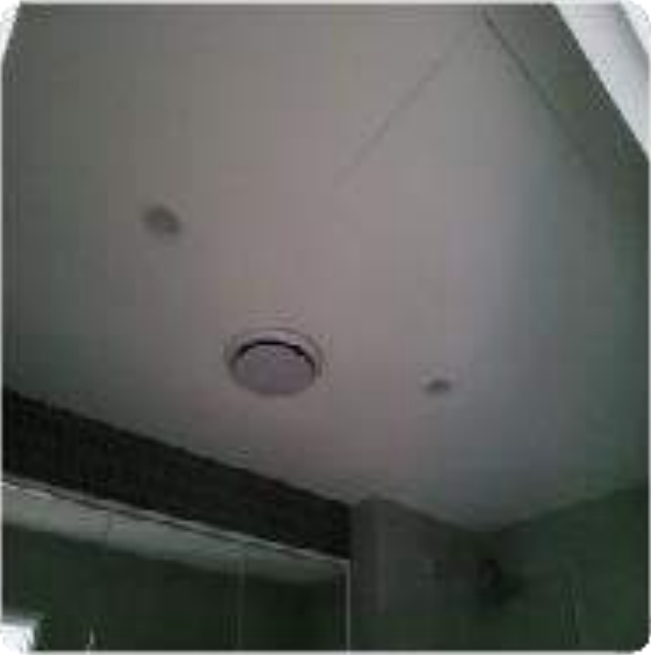
| ITEM | COMMENTARY | PHOTOGRAPH(S) | |
|---|--|---|--|
| A | <p>Location & Description Bathroom ceiling – Paint repair</p> <p>The occupant reported to the Author at the time of inspection that the Builder carried out rectification work to the ceiling due to water leak from bathroom above.</p> <p>The Author observed that the ceiling had uneven paint cover.</p> <p>The Author is of the view, that the defect originated due to poor workmanship employed by the Builder at the time of construction.</p> | | |
| B | <p>Cause(s)</p> <ul style="list-style-type: none"> Poor workmanship employed by Builder at the time of construction | | |

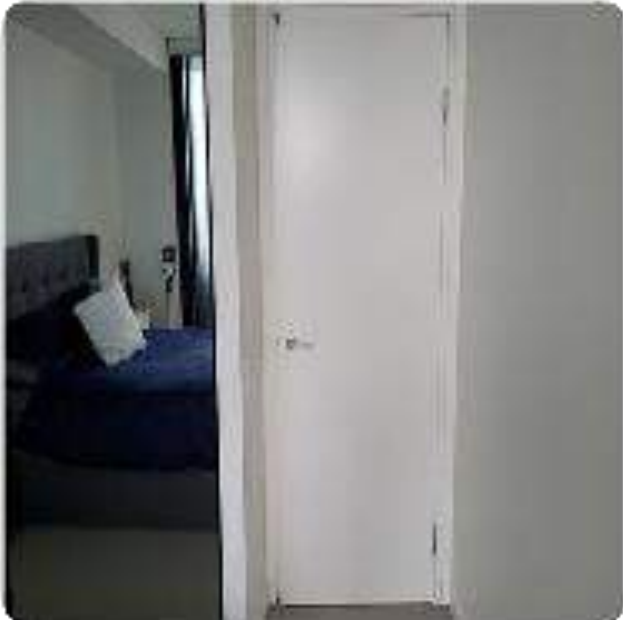
| ITEM | COMMENTARY | PHOTOGRAPH(S) |
|---|--|---|
| A | <p>Location & Description Bedroom door – Binding The Author has observed the bedroom passage door is binding on the jamb</p> <p>The Author is of the view, the Builder has failed to provide sufficient clearance at time of construction and that the defect originated from poor workmanship employed by the Builder at the time of construction.</p> | |
| B | <p>Cause(s)</p> <ul style="list-style-type: none"> • Poor workmanship employed by Builder at the time of construction; • Failure of the Builder to provide sufficient clear at the time of construction. | |

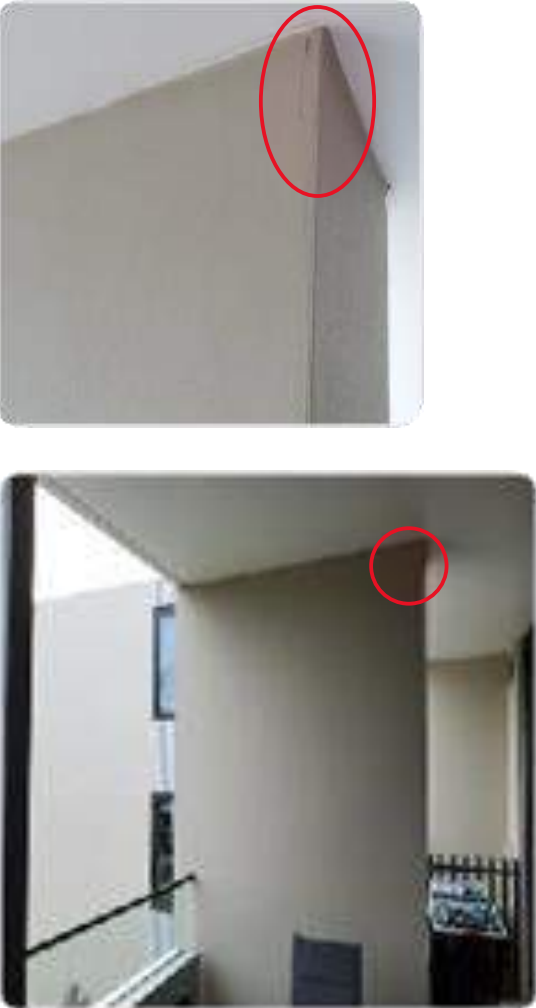
| ITEM | COMMENTARY | PHOTOGRAPH(S) |
|---|--|--|
| A | <p>Location & Description Balcony column – Waterproofing</p> <p>The Author has observed there is a crack in the render at the top of the column on the southwest corner.</p> <p>The Author is of the view, that the crack is a consequence of defective waterproofing to the balcony above.</p> | |
| B | <p>Cause(s)</p> <ul style="list-style-type: none"> • Failure of Builder to carry out the waterproofing works in accordance with AS4654.2 | |

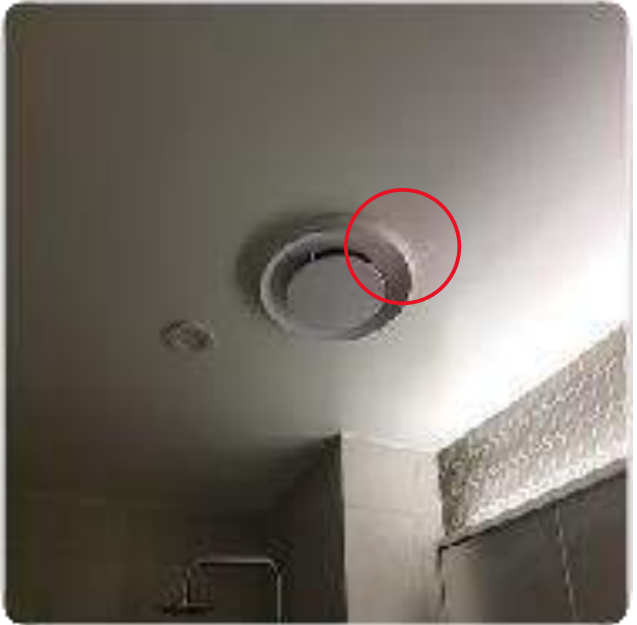
| ITEM | COMMENTARY | PHOTOGRAPH(S) |
|---|---|---|
| A | <p>Location & Description Main bathroom ceiling – Damage</p> <p>The occupant reported to the Author at the time of inspection, that the Builder conducted to maintenance to the mechanical ventilation to the main bathroom damaged the ceiling lining to the northwestern side of the exhaust fan vent.</p> <p>The Author has assumed to occupants statement is true and correct.</p> <p>The Author is of the view, that the damaged due to poor workmanship employed by the Builder to carry out the maintenance.</p> | |
| B | <p>Cause(s)</p> <ul style="list-style-type: none"> Poor workmanship employed by Builder to carry out the maintenance. | |

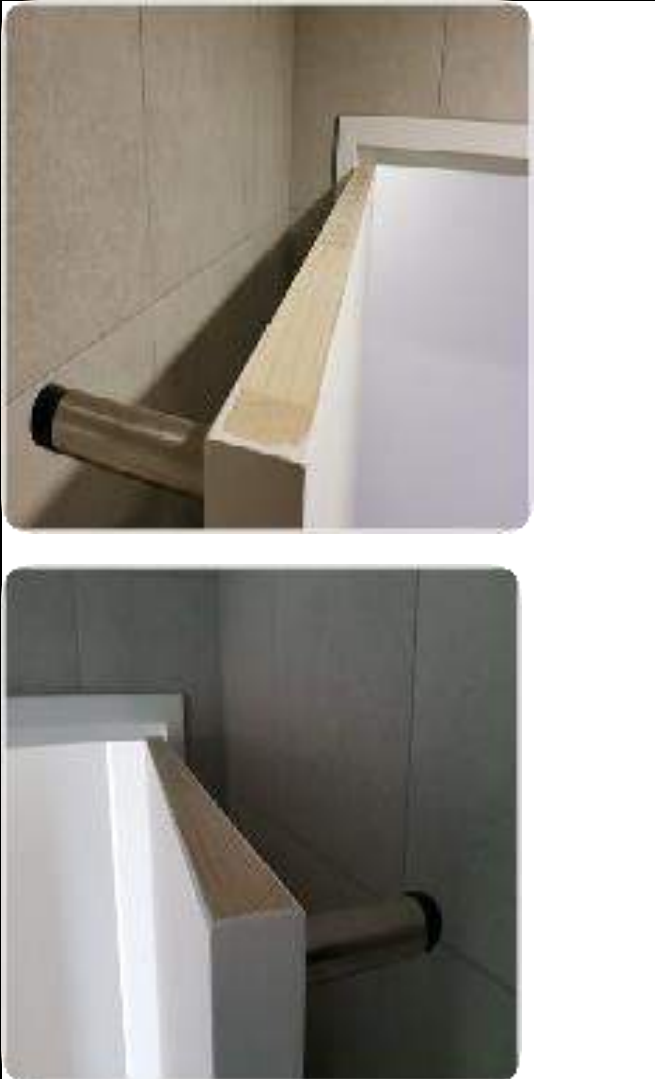
| ITEM | COMMENTARY | PHOTOGRAPH(S) |
|---|--|--|
| A | <p>Location & Description Bathroom and ensuite doors – Painting</p> <p>The Author has observed that the main bathroom door and bedroom ensuite door have not been sealed.</p> <p>The Author is of the view, that the defect originated due to poor workmanship employed by the Builder at the time of construction.</p> | |
| B | <p>Cause(s)</p> <ul style="list-style-type: none"> Poor workmanship employed by Builder at the time of construction; | |

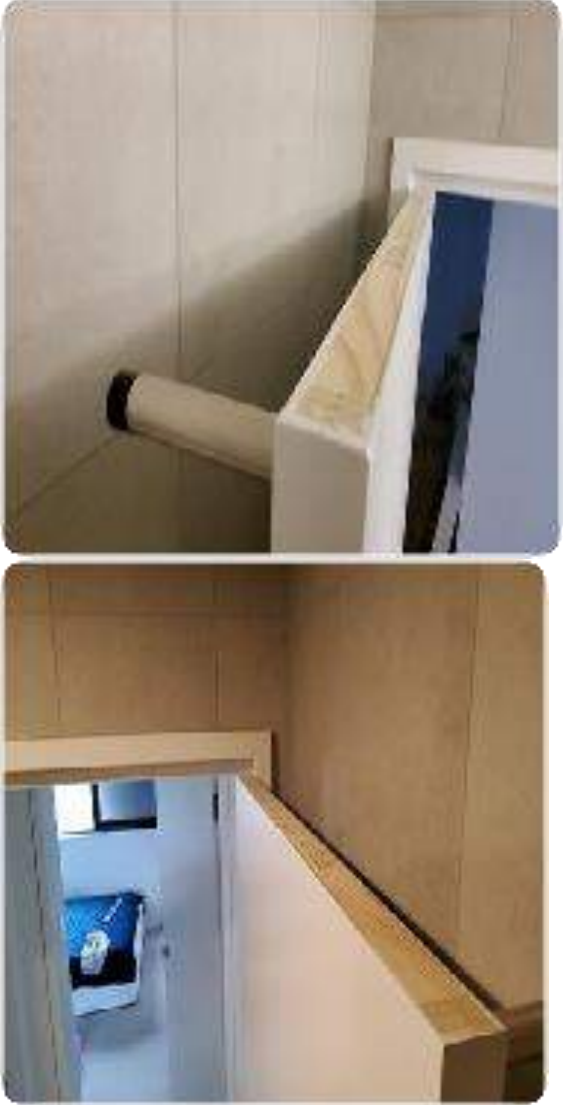
| ITEM | COMMENTARY | PHOTOGRAPH(S) |
|---|--|--|
| A | <p>Location & Description Bathroom and ensuite door – Painting</p> <p>The Author has observed that the main bathroom door and bedroom ensuite door have not been sealed.</p> <p>The Author is of the view, that the defect originated due to poor workmanship employed by the Builder at the time of construction.</p> | |
| B | <p>Cause(s)</p> <ul style="list-style-type: none"> • Poor workmanship employed by Builder at the time of construction; | |

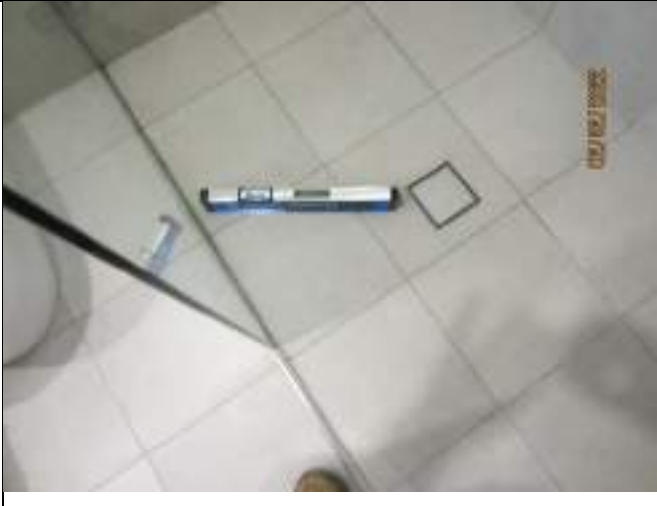
| ITEM | COMMENTARY | PHOTOGRAPH(S) |
|---|--|--|
| A | <p>Location & Description Ensuite – Water ponding in shower</p> <p>The Author has observed the ensuite fixed shower screen silicon fixing is loose, and water is ponding on the tile surface to the northeastern side of the floor waste.</p> <p>The Author conducted fall test using a digital level and found the fall was sufficient, however the ponding is caused due to the floor waste is sitting higher than the tile surface.</p> <p>The Author noted ponding issue was identified in TCA (Giaouris) report item U 304.7 Attachment F Defect schedule.</p> <p>The Author is of the view, that the defect originated due to poor workmanship employed by the Builder at the time of construction.</p> | |
| B | <p>Cause(s)</p> <ul style="list-style-type: none"> Poor workmanship employed by Builder at the time of construction | |

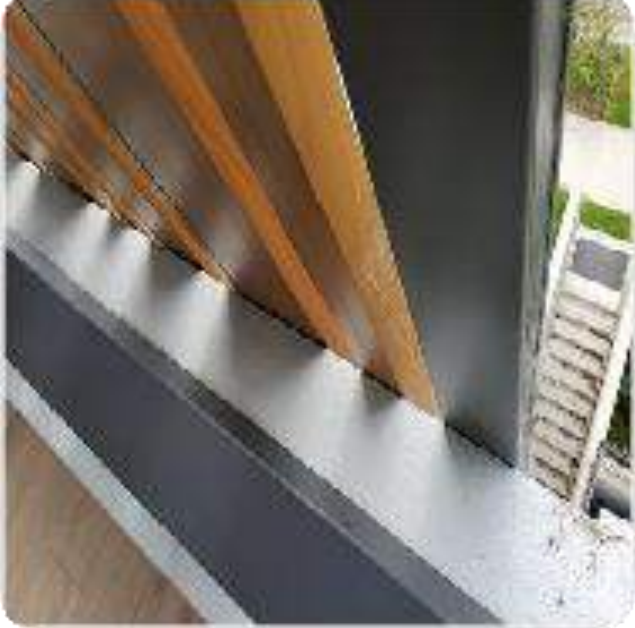
| ITEM | COMMENTARY | PHOTOGRAPH(S) |
|---|--|--|
| A | <p>Location & Description Balcony – Metal screen installation</p> <p>The Author has observed the screen to the eastern side of the balcony is binding with the balcony rendered balustrade.</p> <p>The Author is of the view, that the resulting contact of the metal screen and the rendered balustrade wall will result in surface damage to the metal screening.</p> | |
| B | <p>Cause(s)</p> <ul style="list-style-type: none"> Poor workmanship employed by Builder at the time of construction | |

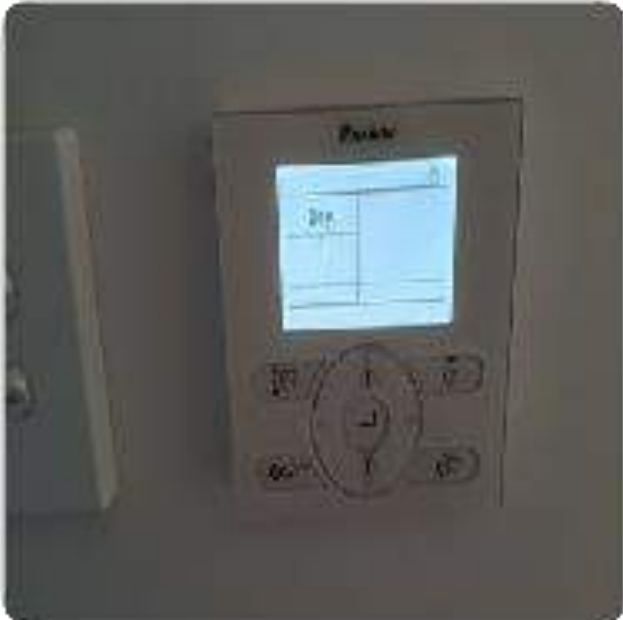
| ITEM | COMMENTARY | PHOTOGRAPH(S) |
|---|--|---|
| A | <p>Location & Description Main hallway – Air conditioning control</p> <p>The occupant reported to the Author at the time of inspection, that the dehumidifier function on the air conditioning is not working. The Author conducted testing and observed that the air condition control display did not indicate this function was active.</p> <p>The Author is of the view, that the defect is the responsibility of the Builder under the building contract maintenance period.</p> | |
| B | <p>Cause(s)</p> <ul style="list-style-type: none"> Mechanical fault. | |

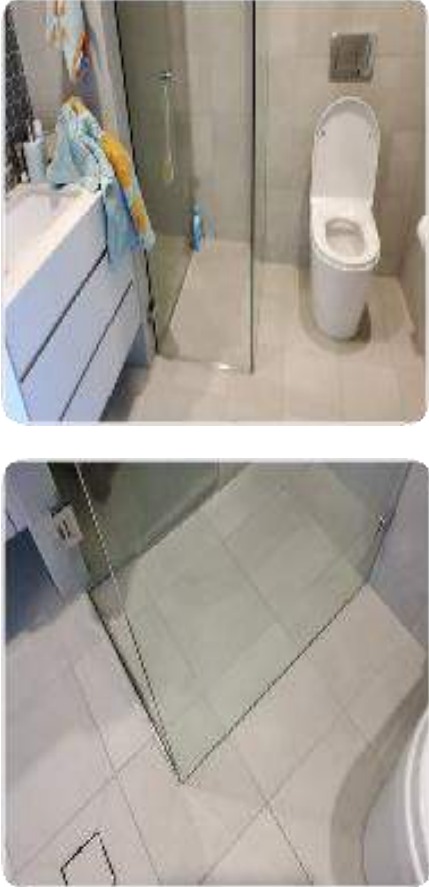
| ITEM | COMMENTARY | PHOTOGRAPH(S) |
|---|--|--|
| A | <p>Location & Description Main bathroom – Shower screen</p> <p>The Author has observed silicon fixing to the fixed shower screen is loose.</p> <p>The Author is of the view, that the defect originated due to poor workmanship employed by the Builder at the time of construction.</p> | |
| B | <p>Cause(s)</p> <ul style="list-style-type: none"> Poor workmanship employed by Builder at the time of construction | |

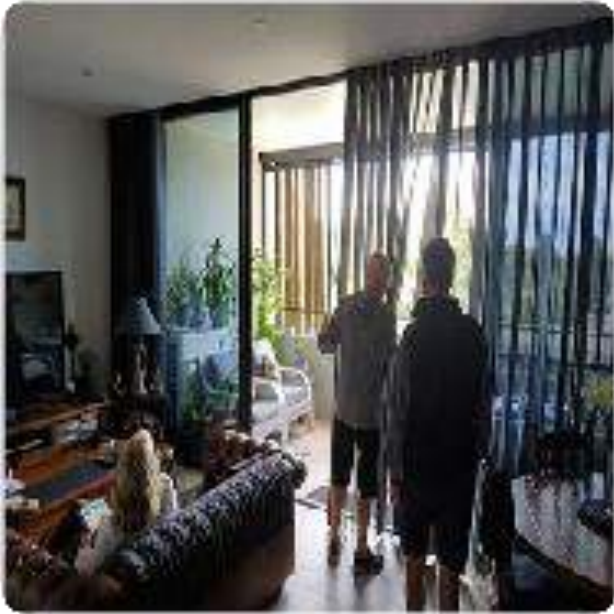
| ITEM | COMMENTARY | PHOTOGRAPH(S) |
|---|--|---|
| A | <p>Location & Description Living Balcony sliding door</p> <p>The occupant reported to the Author at the time of inspection, that the sliding door panel to the western side of the side balcony sliding door was sticking and difficult to open. The Author tested the door sliding function and found the occupants statement was true and correct.</p> <p>The Author is of the view, that the that the defect is the responsibility of the Builder under the building contract maintenance period.</p> | |
| B | <p>Cause(s)</p> <ul style="list-style-type: none"> Doors do not operate as intended by the manufacturer | |

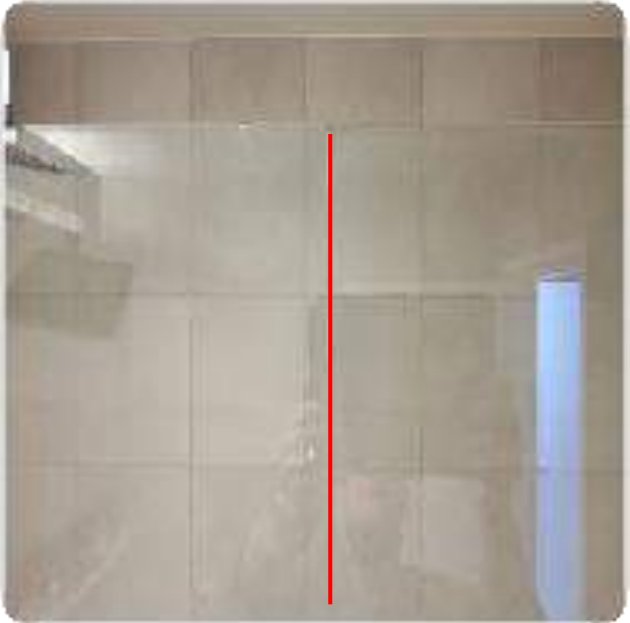
| ITEM | COMMENTARY | PHOTOGRAPH(S) |
|---|---|--|
| A | <p>Location & Description Main bathroom – Shower screen</p> <p>The Author has observed there is insufficient clearance between the shower screen door in the main bathroom and the fixed panel at the top of the door and needs adjustment to provide a more clearance.</p> <p>The Author is of the view, that the defect originated due to poor workmanship employed by the Builder at the time of construction.</p> | |
| B | <p>Cause(s)</p> <ul style="list-style-type: none"> Poor workmanship employed by Builder at the time of construction | |

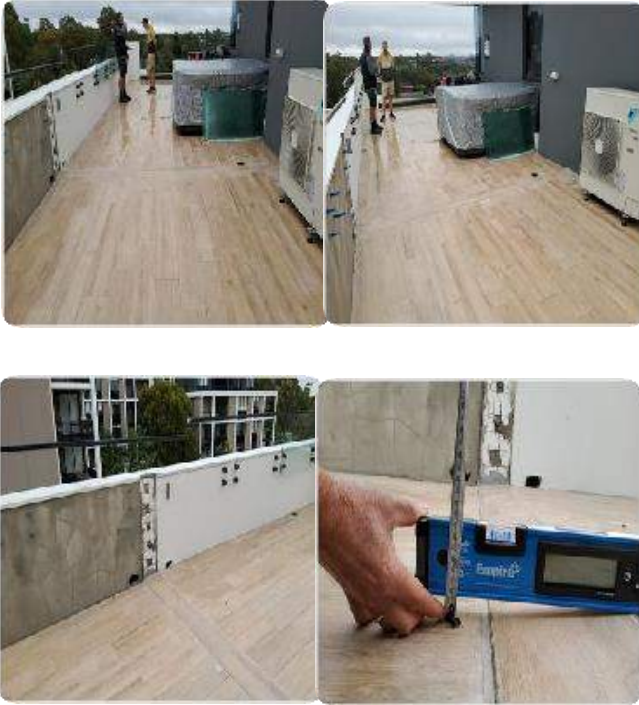
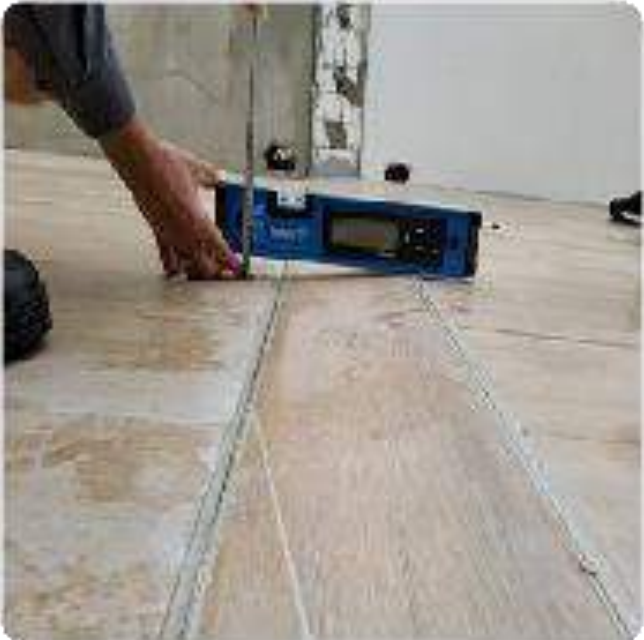
| ITEM | COMMENTARY | PHOTOGRAPH(S) |
|---|--|--|
| A | <p>Location & Description Balcony terrace wall</p> <p>The Author observed that there is a junction to the floor tiling at the mid-section on the western side of the balcony terrace.</p> <p>The developer has reported to the Author that the in the location of the tile junction was where the Builder had constructed a wall to form a planter box that was shown on the architectural drawings.</p> <p>The owner occupant reported to the Author at the time of inspection, that he undertook to remove the wall as the wall divided the terrace restricting the intended use and function of the terrace.</p> <p>The Author observed that the tiling over the subject wall location had been installed perpendicular to the main floor and sloping to the south. The Author measured the difference in levels of the tile surfaces abutting the location of where the wall had been removed and found the south side of intersection was approximately 25mm lower than the northern side.</p> <p>The Owner occupant reported to the Author at the time of inspection that he had repaired the waterproof membrane following removal of the wall and installed tiling to the affected area.</p> <p>The Author noted on review of the construction architectural plans that there is a wall shown of the drawings and notation stating 'planter box' in the location of where the wall was removed by the lot owner.</p> <p>The Author assumed that the developer and lot owners' statements are true and correct.</p> <p>The Author is of the view,</p> <ul style="list-style-type: none"> that the Builder has not considered the intended use of the balcony terrace by dividing the balcony terrace with a wall, that has affected the occupants use and function of the property. that the Builder has failed to consider the finish floor levels to the balcony terrace that form the entire lot of the apartment balcony terrace. | <p>The photographs show the balcony terrace wall, the tiling junction, and a level measurement. The top-left photo shows a wide view of the balcony with a wall and tiling. The top-right photo shows a closer view of the wall and tiling. The bottom-left photo shows a view of the balcony railing and tiling. The bottom-right photo shows a hand holding a blue level against the tiling to measure the difference in levels.</p> |

| <p>B</p> | <p>Cause(s)</p> <ul style="list-style-type: none"> • Poor workmanship employed by Builder at the time of construction; • Failure of Builder to carry out the works for the intended use and function | |
| <p>C</p> | <p>Breach(es) <i>Failure to comply with the following:</i></p> <ul style="list-style-type: none"> ▪ <i>Home Building Act 1989 (NSW) under Section 18B Clauses 1(a) & (f)</i> | |

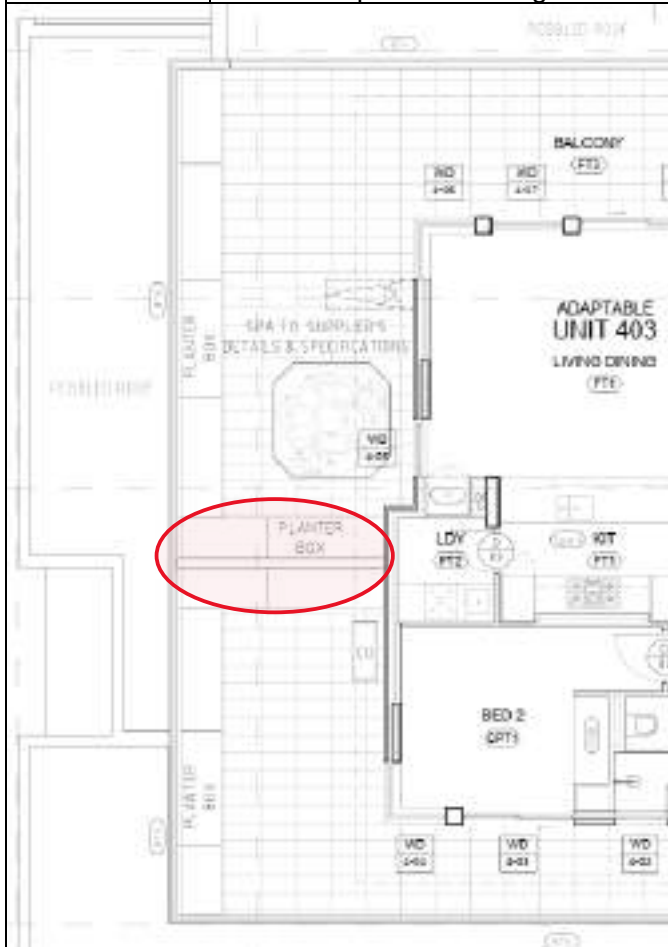
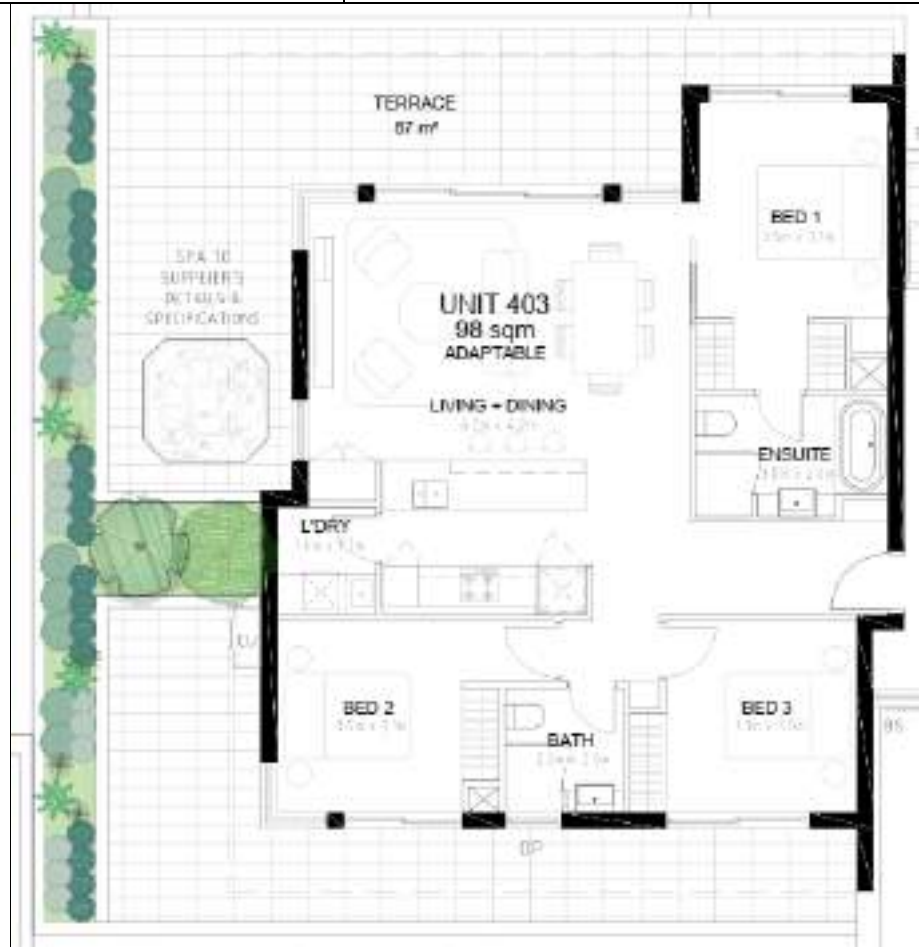
Extract from construction architectural drawings showing subject wall removed by lot owner
