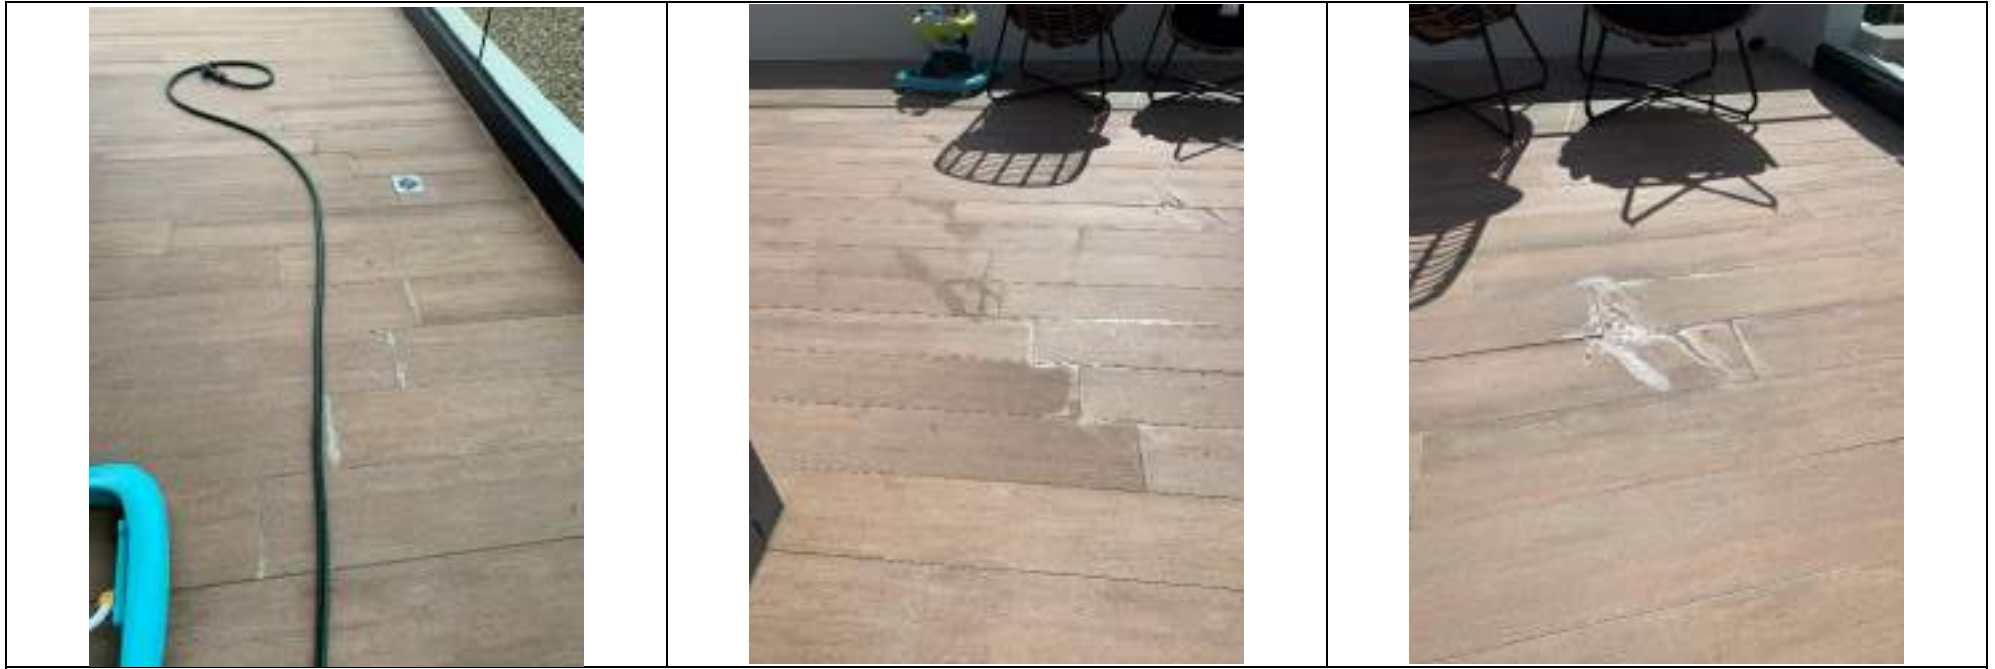
Owner occupants images reported to have been taken following handover showing efflorescence or similar substance discharging from the tile joints on northern side of balcony terrace.

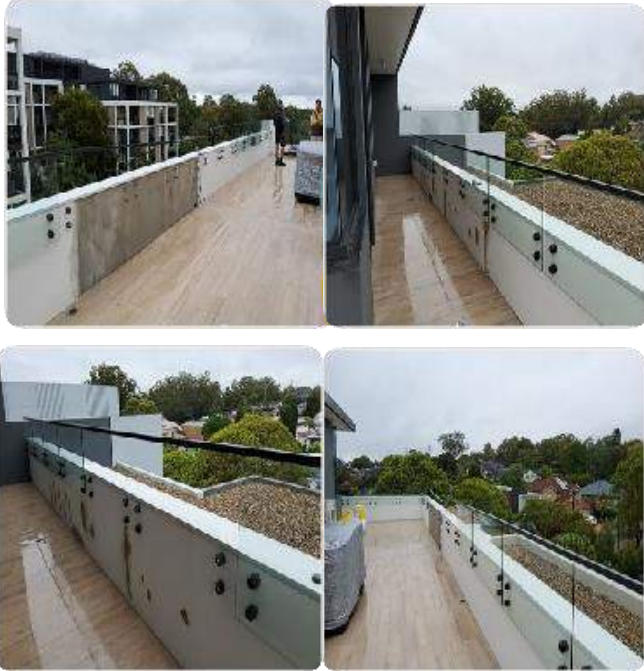
| ITEM | COMMENTARY | PHOTOGRAPH(S) |
|---|--|--|
| A | <p>Location & Description Balcony terrace – Builders remediation works</p> <p>The Author has observed that sections of the glass balustrade have been removed from the western and southern side of the balcony terrace.</p> <p>The owner occupant reported to the Author at the time of inspection, that the Builder had carried out remedial work to repair defective rendering to the balustrade walls. The Author observed patching to render of the balustrade walls in the locations where the glass balustrade had been removed. The Author observed that the removed glass balustrade had been stacked against the spa on the western side of the balcony terrace and adjacent to the staked glass balustrade was a bucket with the balustrade fixtures.</p> <p>The Author has found on conducting a percussion test that area where the render has been repaired to the external wall of balcony terrace was drummy and observed the render finish had significant craze cracks.</p> <p>The Author is of the view, that the Builder has failed to satisfactory apply the render system to the walls in accordance with the manufacturers guidelines and complete the repair works.</p> <p>The Author is also of the view, that the glass balustrade having not been reinstated by the Builder has created a significant safety risk to the occupants.</p> | |

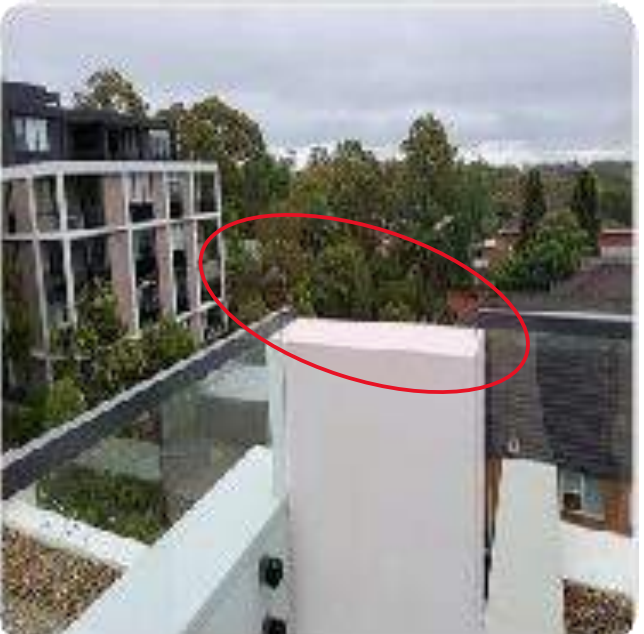
| ITEM | COMMENTARY | PHOTOGRAPH(S) |
|---|---|--|
| A | <p>Location & Description</p> <p>Northwestern and Southeast balustrade connection</p> <p>The Author has observed that the balustrade rail to the northwest and southeast corners of the balcony terrace are not securely connected.</p> <p>The Author is of the view, that the balustrade rail installation does not comply with the NCC 2016 Vol2 3.9.2.2</p> <p>3.9.2.2 Barriers to prevent falls</p> <p>(a) A continuous barrier must be provided along the side of a trafficable surface, such as—</p> <p>(i) a stairway, ramp or the like; and</p> <p>(ii) a floor, corridor, hallway, balcony, deck, verandah, mezzanine, access bridge or the like; and</p> | |

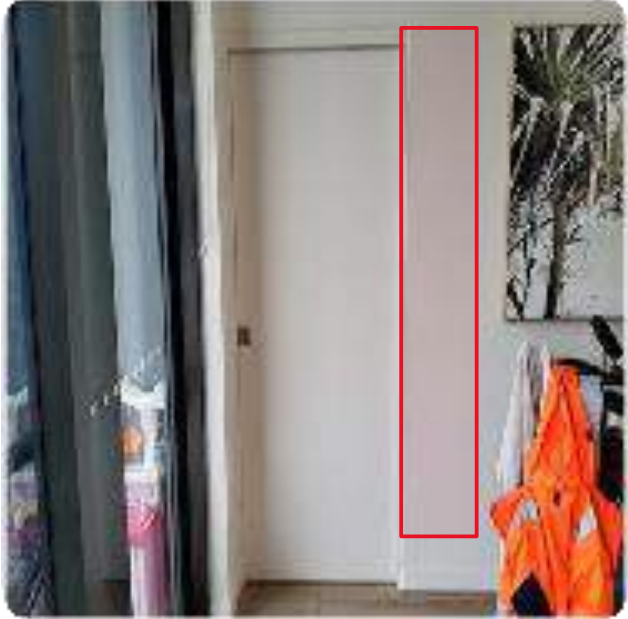
| ITEM | COMMENTARY | PHOTOGRAPH(S) |
|---|---|---|
| A | <p>Location & Description Southern side of main bedroom door – Painting</p> <p>The Author has observed poor setting to plasterboard at southern side of doorway on living area side of main bedroom door when viewed from a normal viewing position.</p> <p>The Author is of the view, that the defect originated due to poor workmanship employed by the Builder at the time of construction.</p> | |

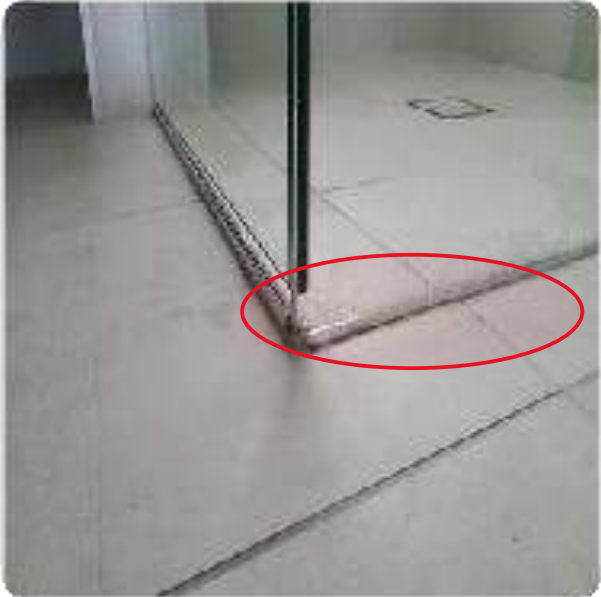
| ITEM | COMMENTARY | PHOTOGRAPH(S) |
|---|---|--|
| A | <p>Location & Description Main bathroom shower screen – Damage</p> <p>The lot owner reported to the Author at the time of inspection, that the shower screen had been removed to by the Builder to conduct some remedial work, the Author observed that there is evidence that the fixed panel to the northern side of the shower has been damaged to the northeast corner with evidence the glass has been chipped.</p> <p>The Author is of the view, that the damaged due to poor workmanship employed by the Builder to carry out the maintenance.</p> | |

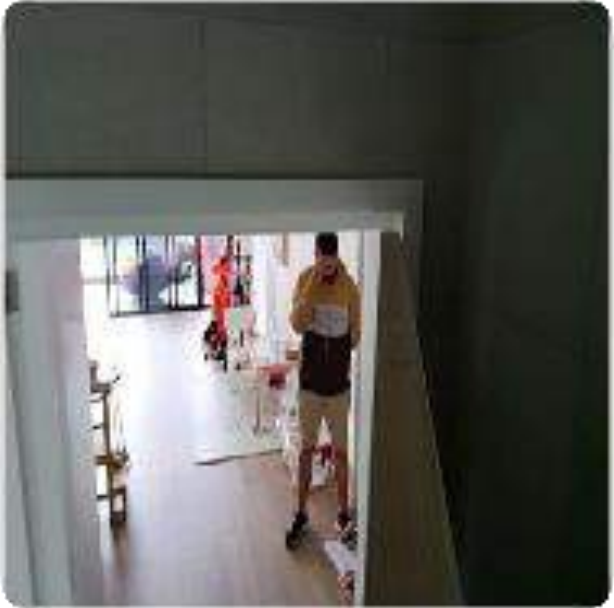
| ITEM | COMMENTARY | PHOTOGRAPH(S) |
|---|--|---|
| A | <p>Location & Description Bathroom door – Painting</p> <p>The Author has observed that the bathroom door has not been sealed to the top of the door and the bottom.</p> <p>The Author is of the view, that the defect originated due to poor workmanship employed by the Builder at the time of construction.</p> | |

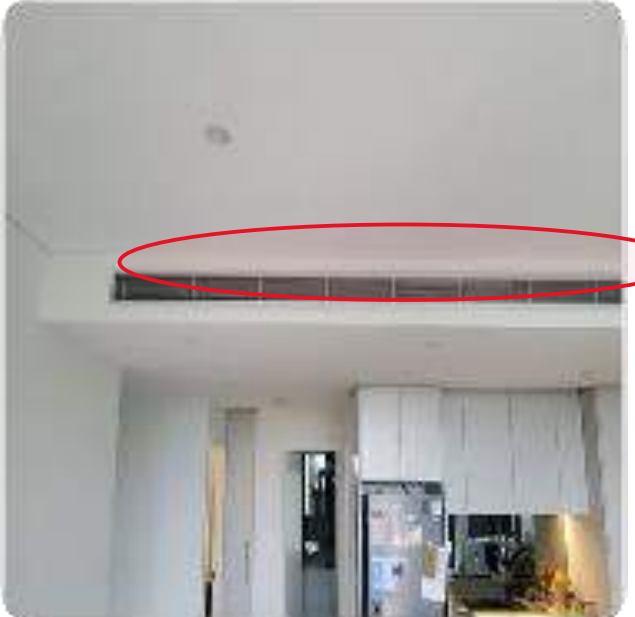
| ITEM | COMMENTARY | PHOTOGRAPH(S) |
|---|---|---|
| A | <p>Location & Description Main living area ceiling above air conditioning vent - Distortion</p> <p>The Author has observed that there is evidence that the ceiling is just ordered and sagging above the air conditioning vent the kitchen bulkhead</p> <p>The Author is of the view, that the defect originated due to poor workmanship employed by the Builder at the time of construction.</p> | |

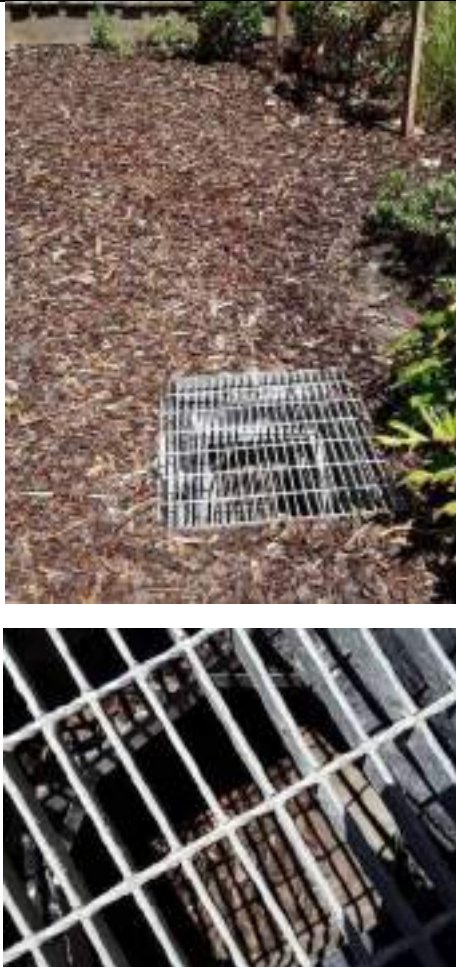
| DEFECT NO. | LOCATION | AREA | BREACH | PHOTOGRAPH | DEFECT DESCRIPTION |
|---|---|---|---|---|--|
| C 1 | Landscape (north of site) | Storm water pit | Not fit for purpose | | <p>Bark is washing down storm water pit</p> <p>HARPER OBSERVATIONS AND COMMENTS – RESOLVED – SCREEN MESH INSTALLED.</p> |

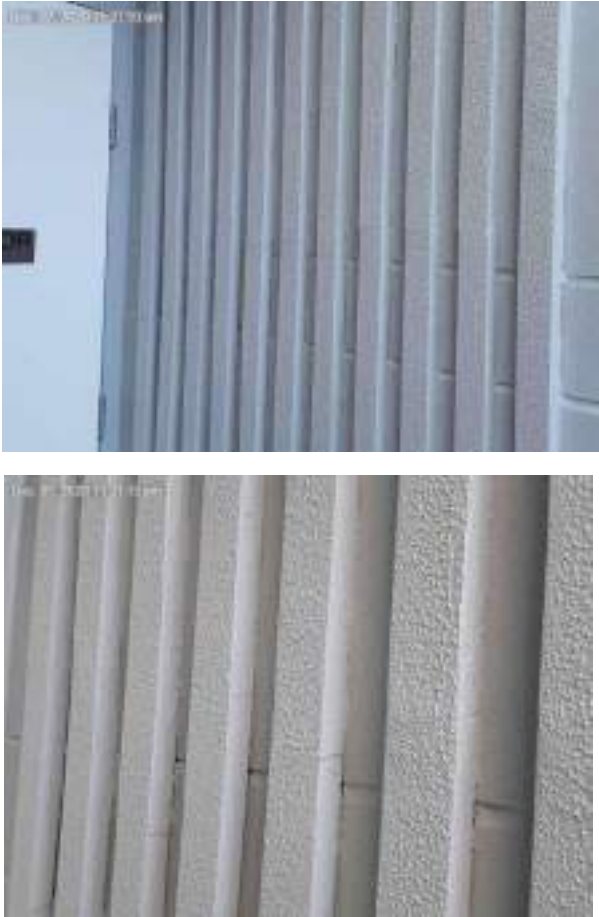
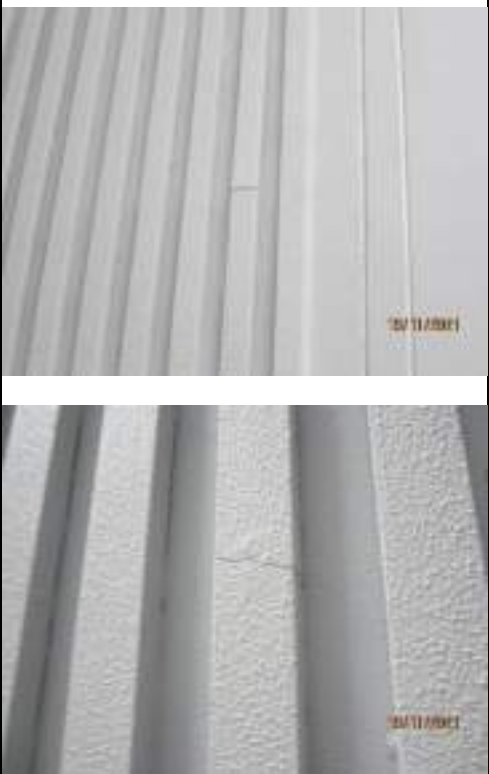
| DEFECT NO. | LOCATION | AREA | BREACH | PHOTOGRAPH | DEFECT DESCRIPTION |
|---|---|---|--|---|---|
| C 20 | East facade | Cladding | See sections 8.5 and 8.6 of this report. | | <p>Crack</p> <p>HARPER OBSERVATIONS AND COMMENTS – CONCUR, OUTSTANDING, REFER ITEM C-6 SECTION 10 HARPER DEFECT SCHEDULE.</p> |

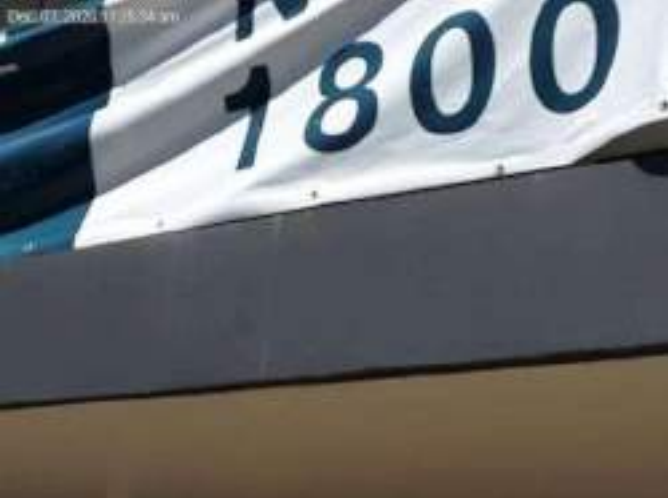
| DEFECT NO. | LOCATION | AREA | BREACH | PHOTOGRAPH | DEFECT DESCRIPTION |
|---|---|---|---|---|---|
| C 27 | East facade | Balcony slab edge | See section 8.9 of this report. | | Efflorescence. HARPER OBSERVATIONS AND COMMENTS – CONCUR – ON GOING, CONCUR, OUTSTANDING REFER ITEM C-2 SECTION 10 HARPER DEFECT SCHEDULE. |

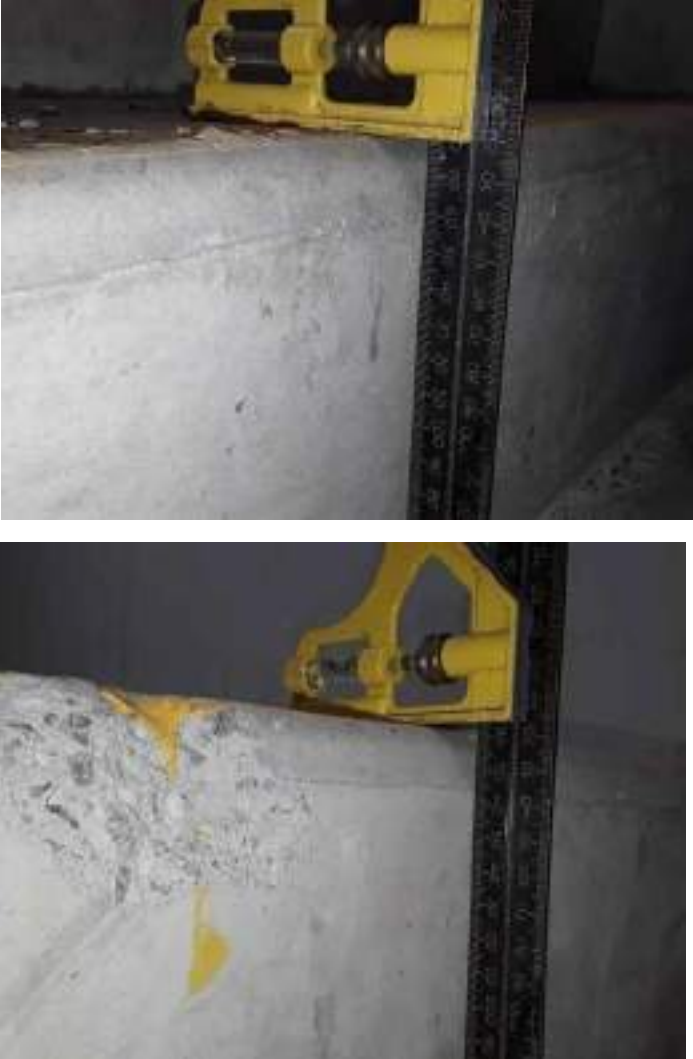
| DEFECT NO. | LOCATION | AREA | BREACH | PHOTOGRAPH | DEFECT DESCRIPTION |
|---|---|---|--|---|--|
| C 61 | Basement 1 | South east fire stair to ground lev | Breach of D2.13 of the BCA. See section 8.17 of this report. | | <p>First riser is 179mm, adjacent riser is 185mm. Greater than 5mm difference in adjacent riser</p> <p>HARPER OBSERVATIONS AND COMMENTS – DEVIATION IN RISERS HEIGHTS COMPLY WITH NCC 2019 3.9.1.2</p> |

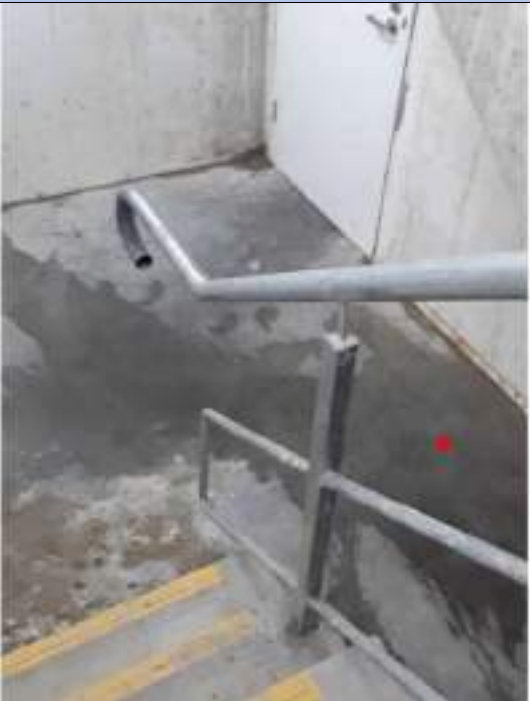
| DEFECT NO. | LOCATION | AREA | BREACH | PHOTOGRAPH | DEFECT DESCRIPTION |
|---|---|---|---|---|--|
| C 63 | Basement 2 | South east fire stair to ground level | Safety issue. | | <p>Water from base of stair entering adjacent storage area.</p> <p>Water ponding on the floor of the emergency exit is a potential slip hazard.</p> <p>HARPER OBSERVATIONS AND COMMENTS –OUTSTANDING REFER ITEM B-1 SECTION 10 HARPER DEFECT SCHEDULE</p> |

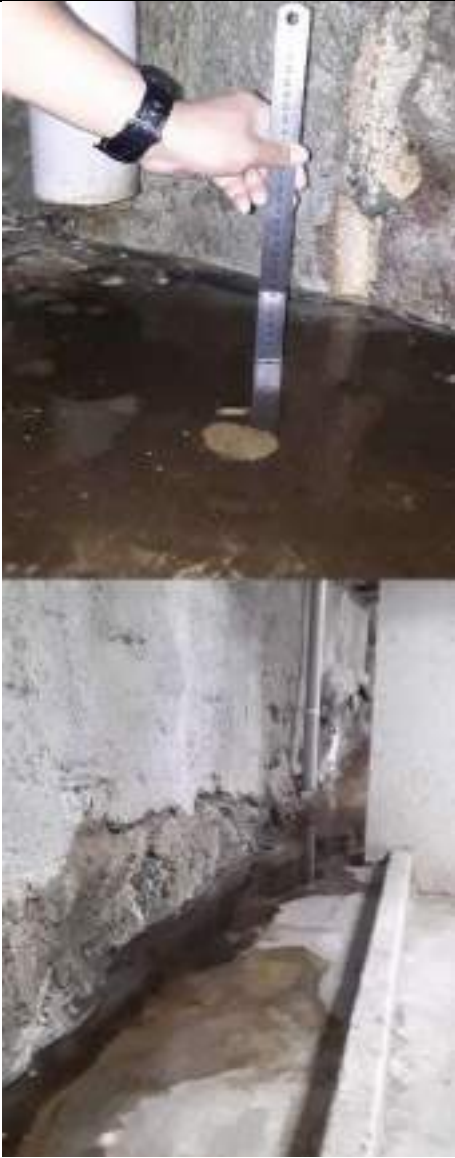
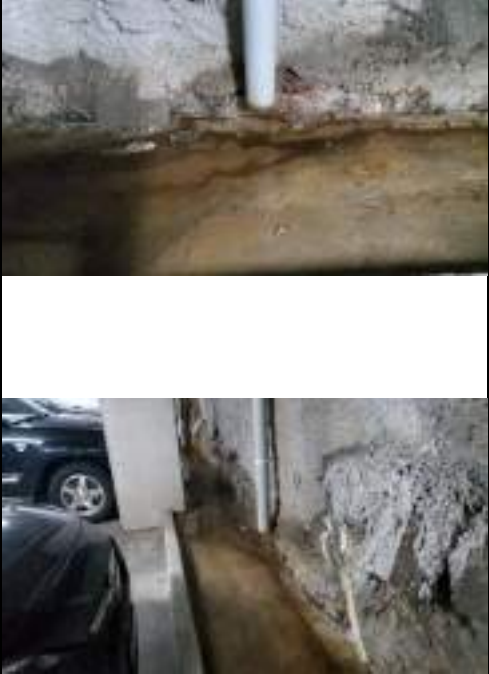
| DEFECT NO. | LOCATION | AREA | BREACH | PHOTOGRAPH | DEFECT DESCRIPTION |
|---|---|--|---|---|--|
| C103 | Basement 1 | South – in front of parking bay 18 (floor waste) | See section 8.4 of this report. | | <p>Water ponding.</p> <p>HARPER OBSERVATIONS AND COMMENTS –RESOLVED</p> |

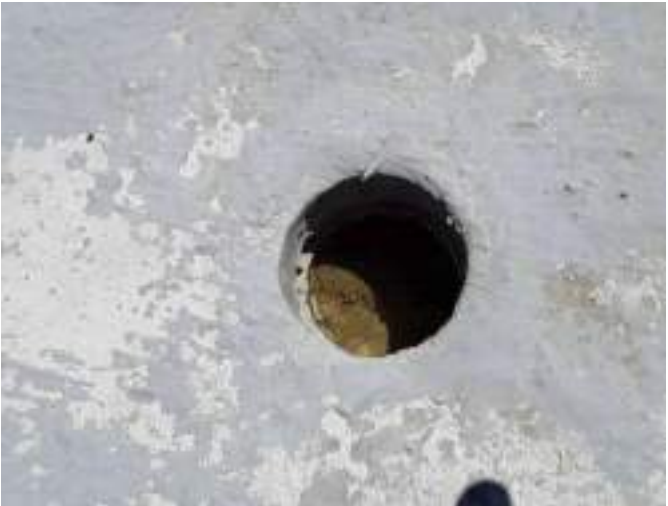
| DEFECT NO. | LOCATION | AREA | BREACH | PHOTOGRAPH | DEFECT DESCRIPTION |
|---|---|---|---|---|--|
| C 150 | Building L - Roof | Floor waste | See section 8.11 of this report. | | <p>B. Waterproofing not turned down into floor waste. Puddle flange has not been provided. Drain cover not installed as required by AS4654.2.</p> <p>HARPER OBSERVATIONS AND COMMENTS – CONCUR B & C. OUTSTANDING REFER ITEMS R-1 SECTION 10 HARPER DEFECT SCHEDULE</p> |

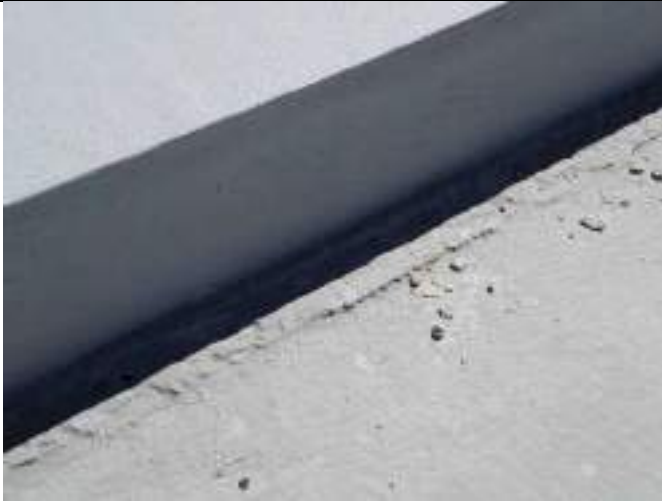
| DEFECT NO. | LOCATION | AREA | BREACH | PHOTOGRAPH | DEFECT DESCRIPTION |
|---|---|---|--|---|---|
| C 151 | Building L - Roof | Concrete hob | Works have not been completed with due care and skill. | | Rough substrate not compliant with AS4654.2 and manufacturers requirements. HARPER OBSERVATIONS AND COMMENTS – CONCUR, OUTSTANDING REFER ITEMS R-1 SECTION 10 HARPER DEFECT SCHEDULE |

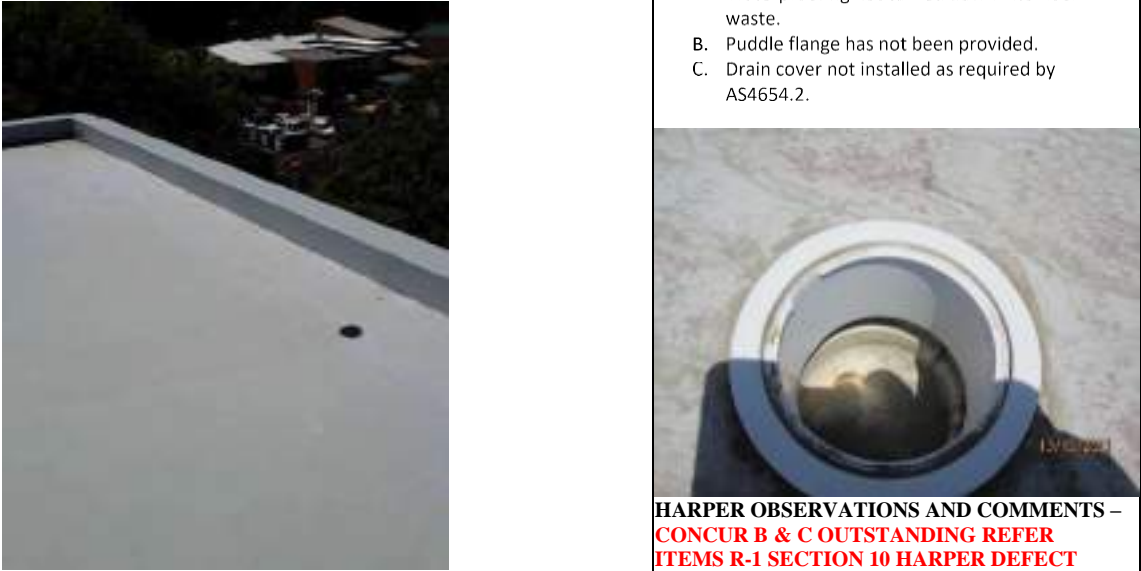
| DEFECT NO. | LOCATION | AREA | BREACH | PHOTOGRAPH | DEFECT DESCRIPTION |
|---|---|---|---|---|---|
| C 154 | Building L - Roof | Floor waste | See section 8.11 of this report. | | <p>A. Waterproofing not turned down into floor waste. B. Puddle flange has not been provided. C. Drain cover not installed as required by AS4654.2.</p> <p>HARPER OBSERVATIONS AND COMMENTS – CONCUR B & C OUTSTANDING REFER ITEMS R-1 SECTION 10 HARPER DEFECT SCHEDULE</p> |

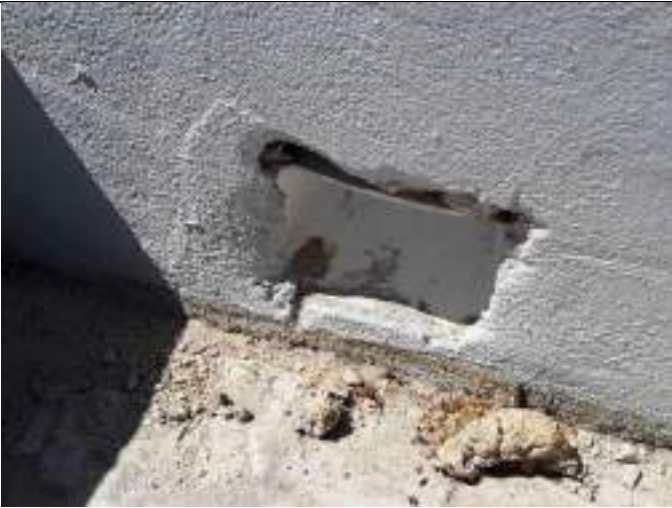
| DEFECT NO. | LOCATION | AREA | BREACH | PHOTOGRAPH | DEFECT DESCRIPTION |
|---|---|---|---|---|--|
| C156 | Building L - Roof | Overflow | See section 8.8 of this report. | | <p>Waterproofing does not turn into overflow</p> <p>HARPER OBSERVATIONS AND COMMENTS – RESOLVED</p> |

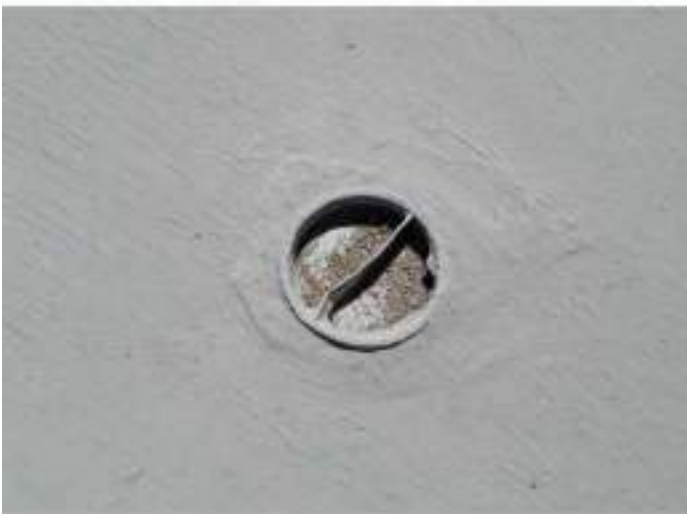
| DEFECT NO. | LOCATION | AREA | BREACH | PHOTOGRAPH | DEFECT DESCRIPTION |
|---|---|---|---|---|--|
| C158 | Building L - Roof | Floor waste | See section 8.11 of this report. | | <p>Removal of plug will result in tearing of the waterproof membrane.</p> <p>HARPER OBSERVATIONS AN COMMENTS – OUTSTANDING REFER ITEMS R-1 SECTION 10 HARPER DEFECT SCHEDULE</p> |

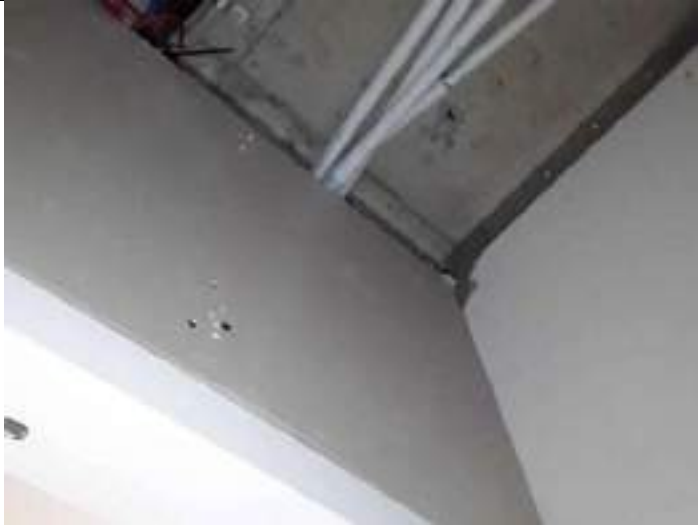
| DEFECT NO. | LOCATION | AREA | BREACH | PHOTOGRAPH | DEFECT DESCRIPTION |
|---|---|---|--|---|--|
| C 178 | Level G lobby | Service riser | Fire engineer to inspect. | | <p>Possible non-compliant fire rating.</p> <p>HARPER OBSERVATION AND COMMENTS – RESOLVED</p> <p>FIRE SAFETY COMPLIANCE CERTIFICATE PROVIDED.</p> |
