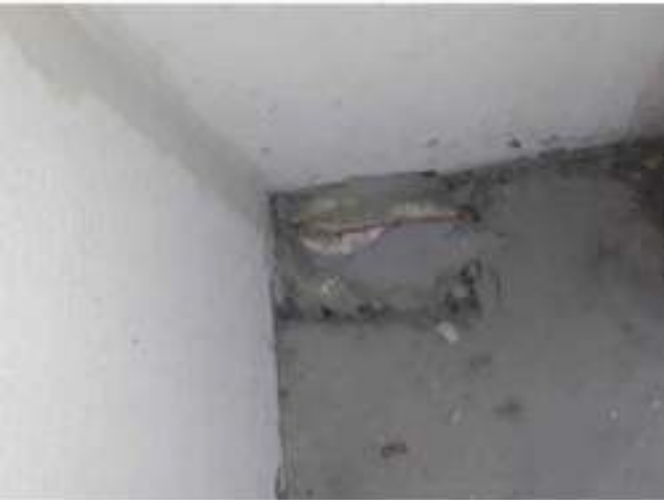
Fire pillow installation.

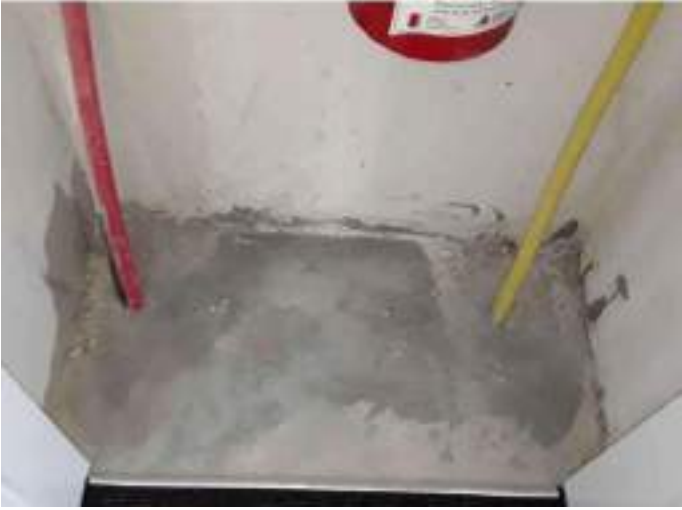
<p>Poly pipes to be inspected by fire engineer.</p> <p>HARPER OBSERVATION AND COMMENTS – RESOLVED</p> <p>FIRE SAFETY COMPLIANCE CERTIFICATE PROVIDED.</p>
C 207	Level U4 lobby	Service risers	Fire engineer to inspect

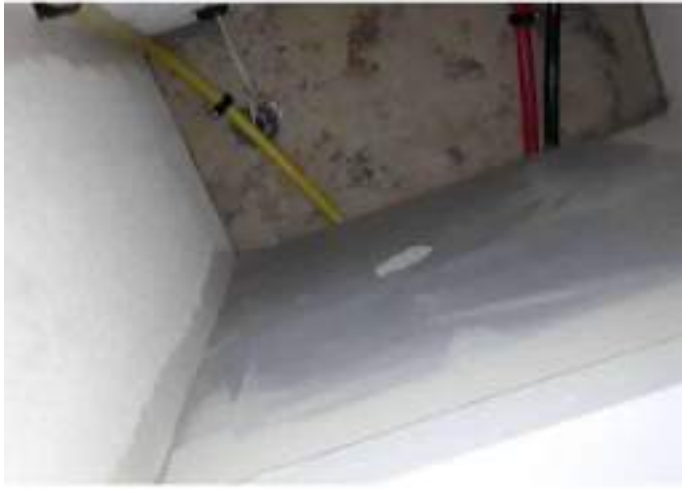
<p>Moisture resistant plaster used to services riser</p> <p>Fire consultant to inspect and advise.</p> <p>HARPER OBSERVATION AND COMMENTS – RESOLVED</p> <p>FIRE SAFETY COMPLIANCE CERTIFICATE PROVIDED.</p>

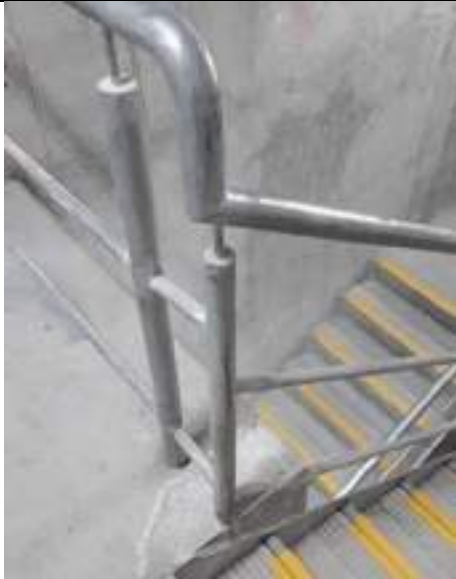
<p>A. Handrail not continuous. B. No nosing or compliant non-slip finish. Details of paint to be provided to identify if non-compliant and tested to AS4586.</p> <p>HARPER OBSERVATION AND COMMENTS – HANDRAIL RESOLVED.</p> <p>NO DETAILS OF PAINT USED ON TREADS PROVIDED.</p>
C 209	Fire stair level U4	Stair nosing	See section 8.15 of this report.

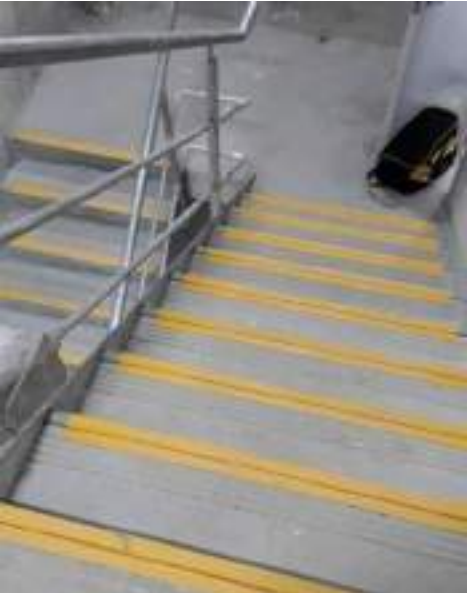
<p>A. No nosing or compliant non-slip finish. B. Details of paint to be provided to identify if non-compliant and tested to AS4586.</p> <p>HARPER OBSERVATION AND COMMENTS – NO DETAILS OF PAINT USED ON TREADS PROVIDED.</p>

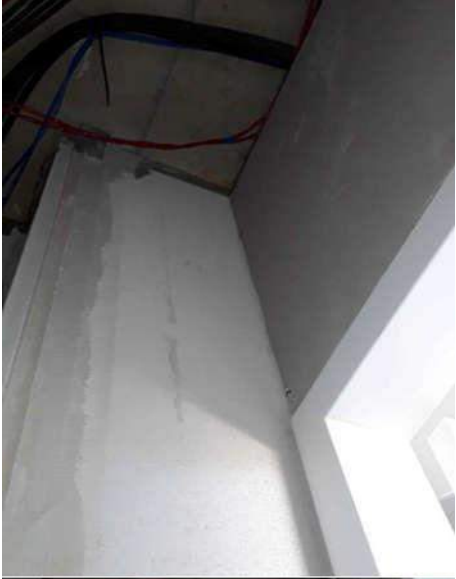
Services over wall.
C 211	Level 4 Lobby	Service risers	Fire engineer to inspect .

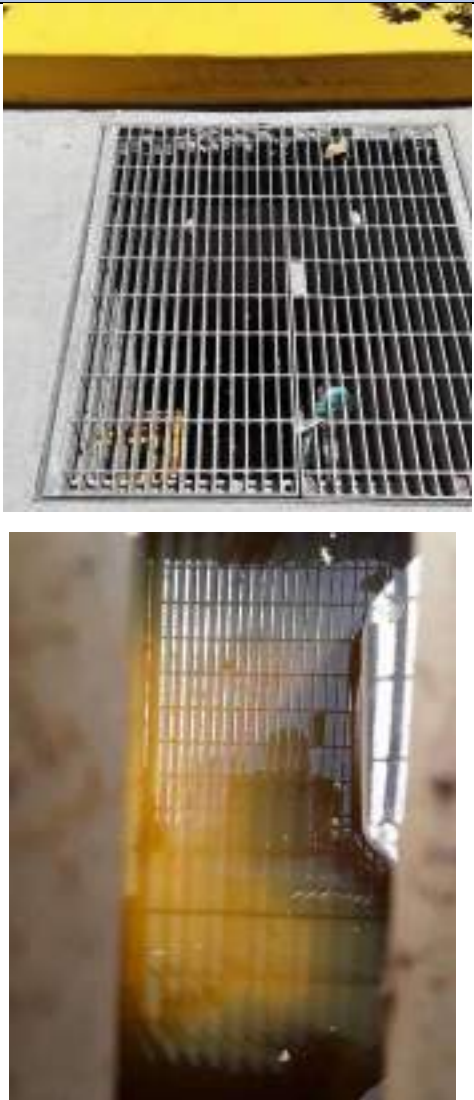
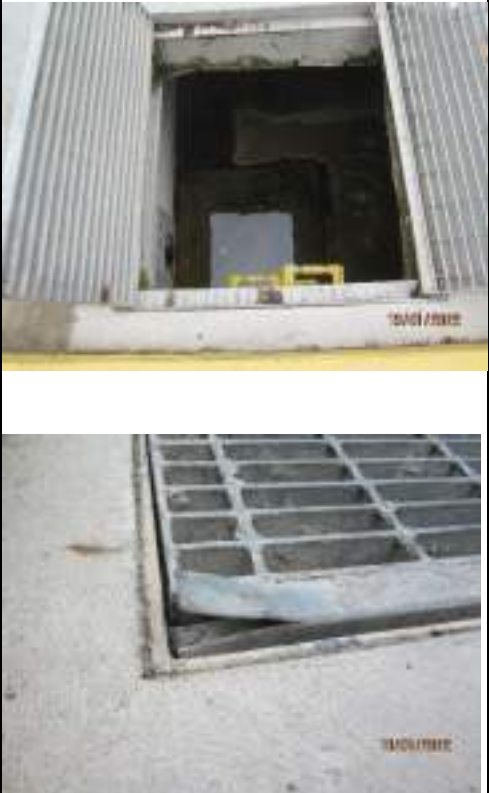
<p>Water ponding in base of driveway pit.</p>

<p>HARPER OBSERVATION AND COMMENTS – WATER RETAINED IN OSD SUMP.</p> <p>NOTE – DAMAGE TO GRATE REQUIRES REPAIR.</p> <p>REFER ITEM OSD-1 SECTION 10 HARPER DEFECT SCHEDULE</p>

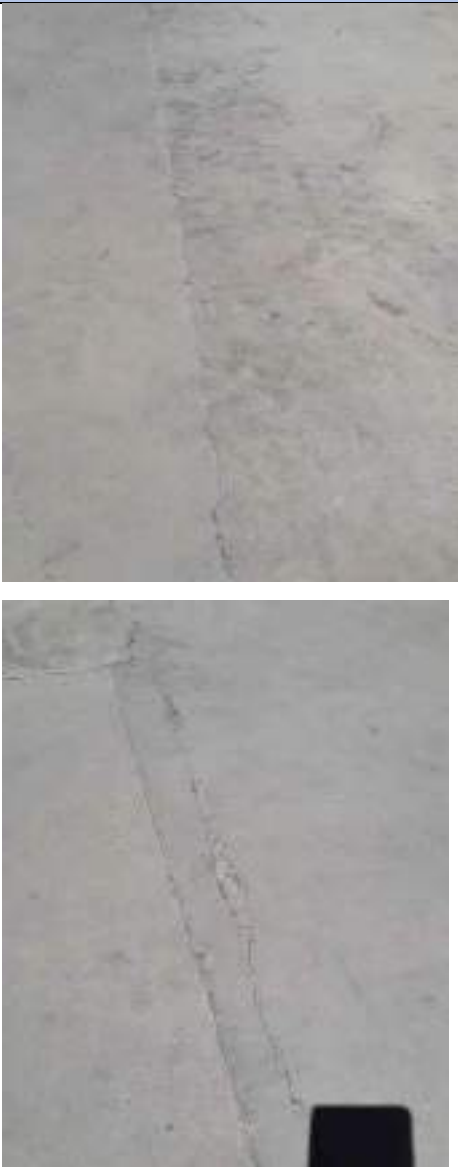
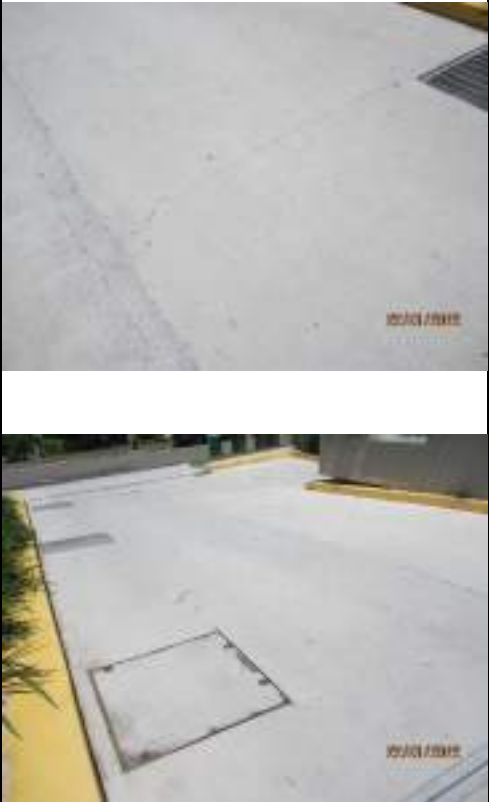
<p>Cold joint or crack to concrete driveway.</p>

<p>HARPER OBSERVATION AND COMMENTS – RESOLVED</p>

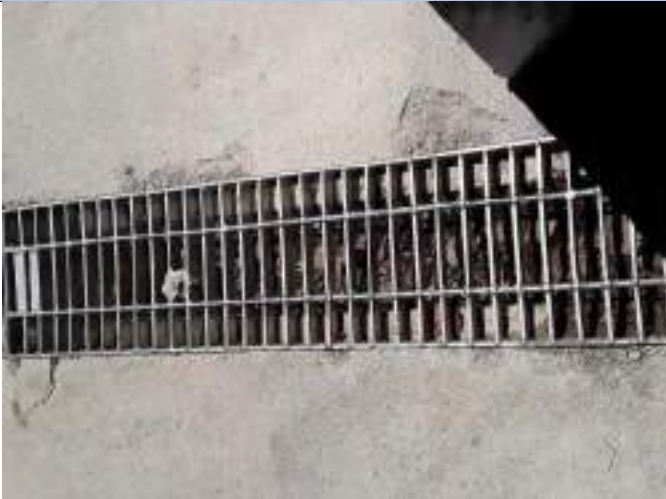
Hydraulic engineer to confirm capacity of strip drain.
C 222	Drive way	Planter box	Works have not been completed with due care and skill.

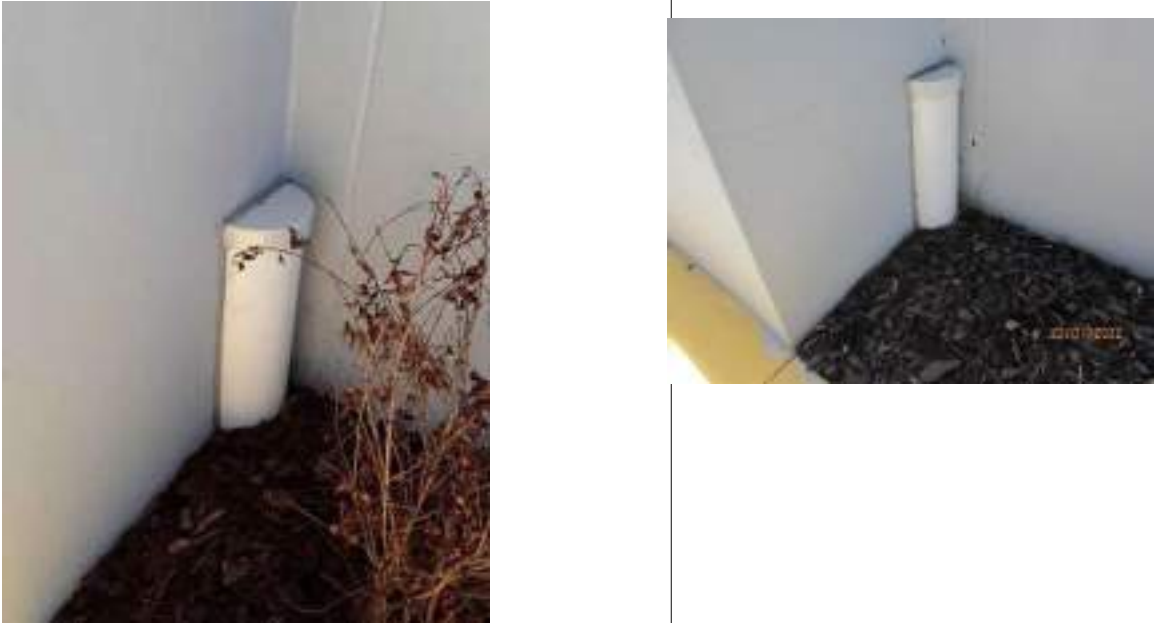
Incomplete pipe in block wall.

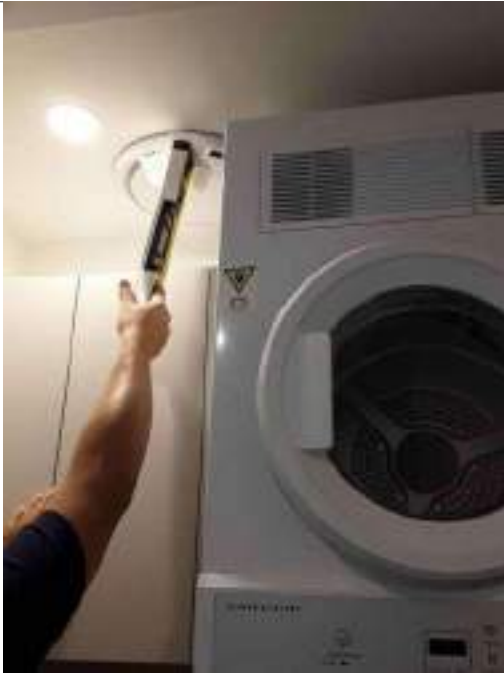
<p>Exhaust not operational.</p> <p>HARPER OBSERVATION AND COMMENTS - RESOLVED</p>
<p>U G05.8</p>	<p>Bathroom</p>	<p>Floor waste</p>	<p>See section 8.12 of this report</p> <p>Works not completed with due care and skill.</p> <p>Inadequate substrate preparation</p>

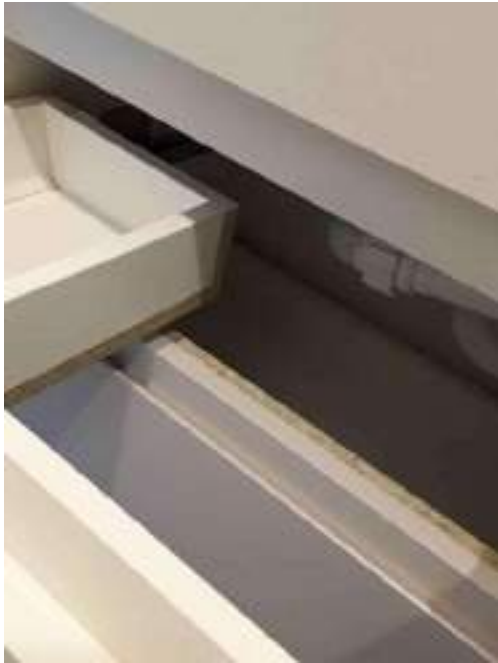
<p>Exposed mellamine edges.</p>

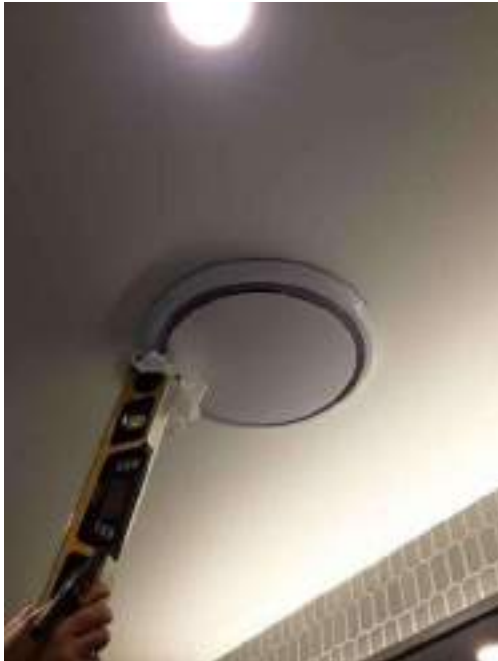
<p>Mechanical exhaust not operational.</p> <p>HARPER OBSERVATION AND COMMENTS – RESOLVED, EXHAUST FAN OPERATING.</p>

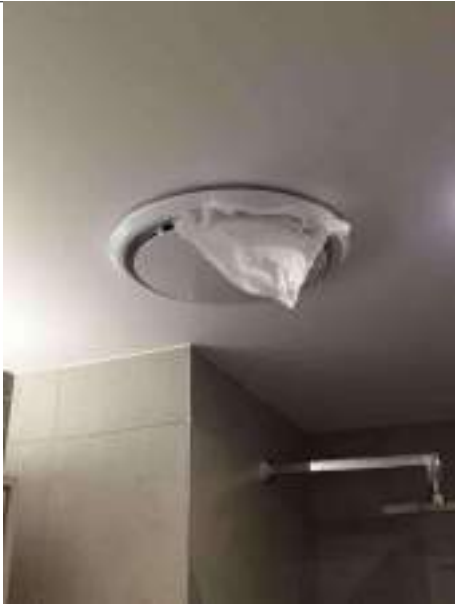
Exhaust operational.
U 304.6		Top of door	See section 8.16 of this report

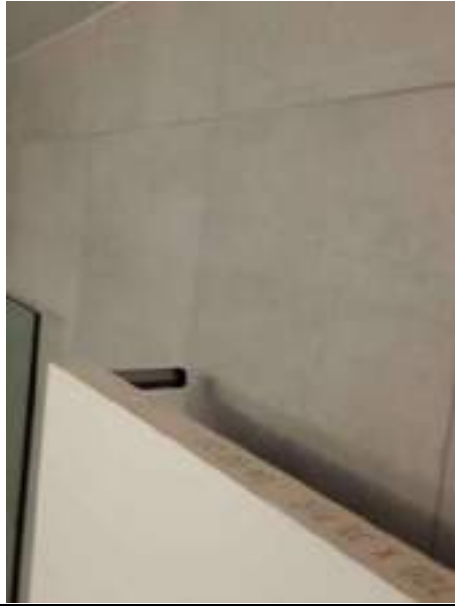
Top of door has not been sealed HARPER COMMENTS AND OBSERVATIONS – OUTSTANDING REFER ITEM 1-304SECTION 10 HARPER DEFECT SCHEDULE

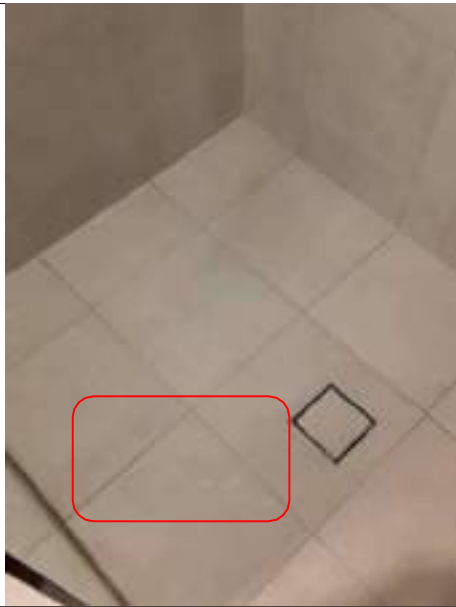
<p>Water is ponding</p>

<p>HARPER OBSERVATION AND COMMENTS - OUTSTANDING, SUFFICIENT FALL IN TILE SURFACE, WATER IS PONDING DUE TO DRAINAGE INLET EDGE IS HIGHER THAN TILE SURFACE</p>
U 304.8	Ensuite	Mechanical exhaust	See section 8.25 of this report.

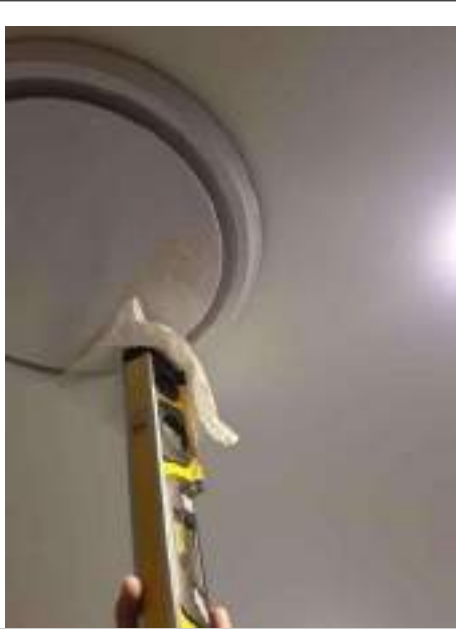
<p>Mechanical exhaust not operational.</p>

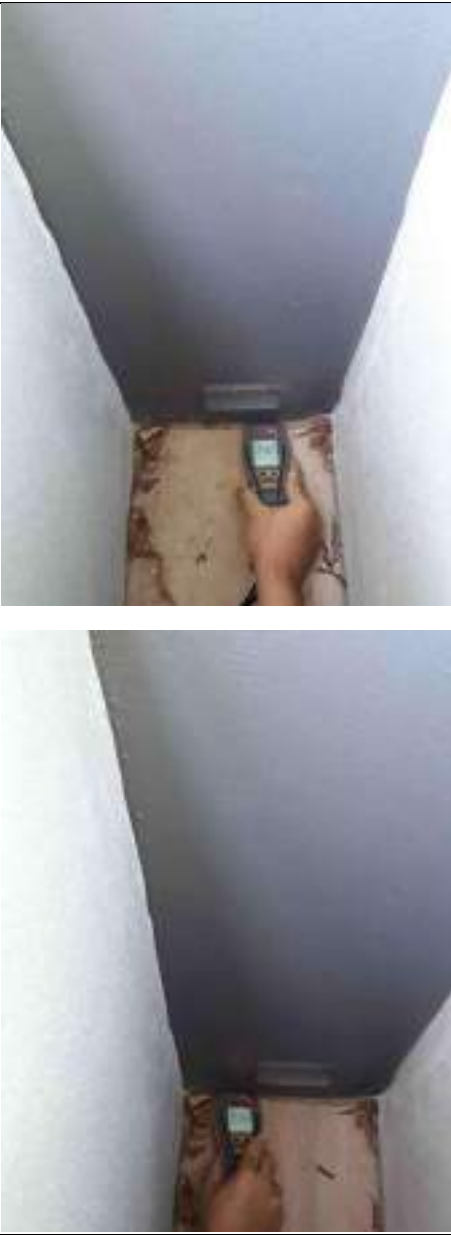
Cladding does not have a drainage provision.

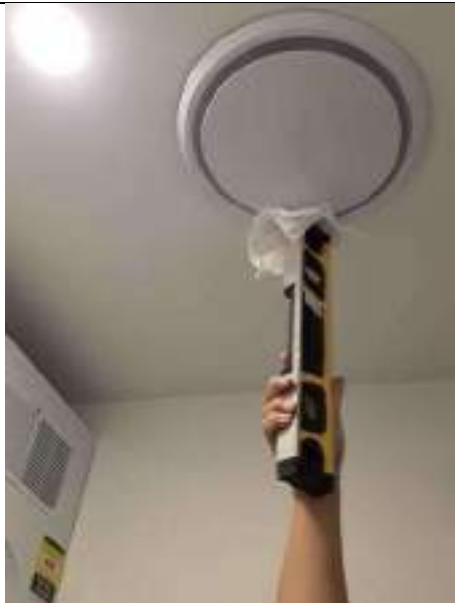
Mechanical exhaust not operational. HARPER OBSERVATIONS AND COMMENTS – RESOLVED - MECHANICAL EXHAUST IS OPERATING.
U 306.4	Laundry	Top of door	See section 8.16 of this report

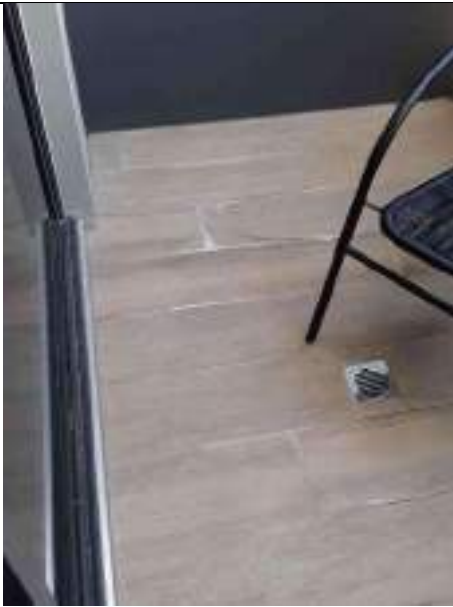
<p>A. No waterstop. B. Sliding door installed in contact with cement. C. Efflorescence.</p>

<p>HARPER OBSERVATIONS AND COMMENTS – NO EFFLORESCENCE PRESENT REFER ITEM C-1 SECTION 10 HARPER DEFECT SCHEDULE</p>
<p>U 306.13</p>	<p>Main bedroom balcony</p>	<p>Sliding door threshold</p>	<p>See section 8.3 of this report</p>

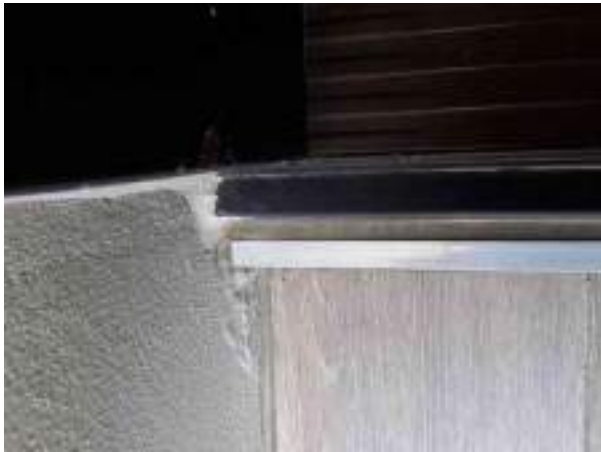
<p>Tile installed proud of subsill not behind as detailed by AS4654.2.</p>

<p>Crack sealant will allow moisture from weepholes to enter behind tiles.</p>   <p>HARPER OBSERVATIONS AND COMMENTS – OUTSTANDING</p> <p>REFER ITEM 2-306 SECTION 10 HARPER DEFECT SCHEDULE</p>
--	--	--	--	--	--

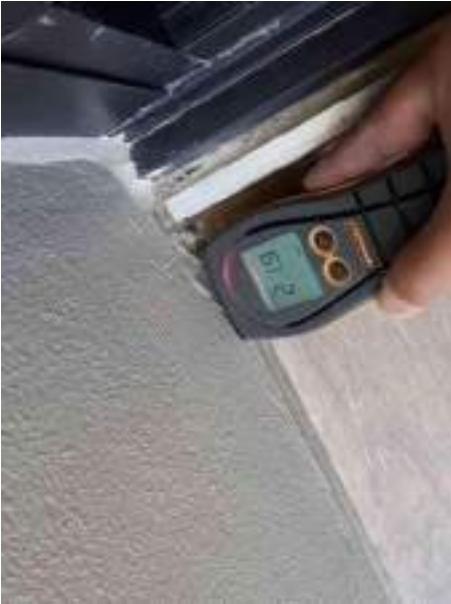
Elevated moisture to base of wall due to a failure to install a drainage provision. HARPER OBSERVATIONS AND COMMENTS - LOW LEVEL OF MOISTURE
U 306.15	Main bedroom balcony	Floor waste	See section 8.6 of this report.

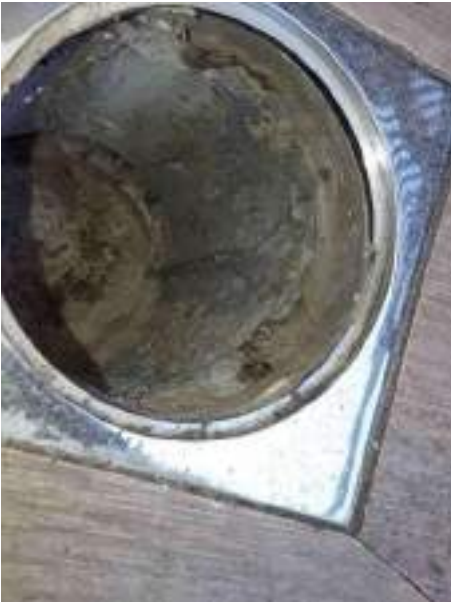
No cavity drain provided for Hebel. HARPER OBSERVATIONS AND COMMENTS - HEBEL IS LOCATED WITHIN BALCONY ENVELOPE AND NOT FULLY EXPOSED TO WEATHER, SO NO REQUIREMENT FOR DRAINAGE PIPE TO STORMWATER INLET.

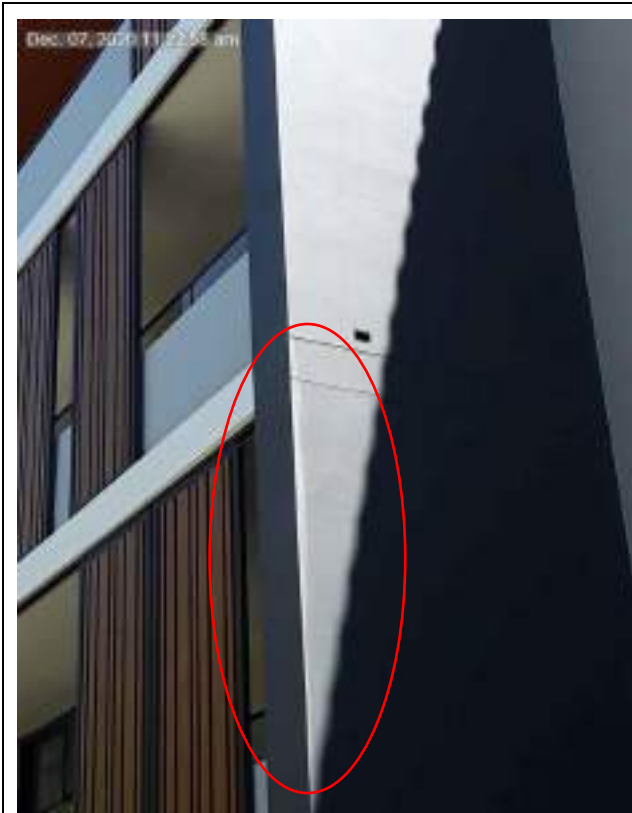
C 50– South facade (Mitchell Avenue), cladding
Efflorescence.

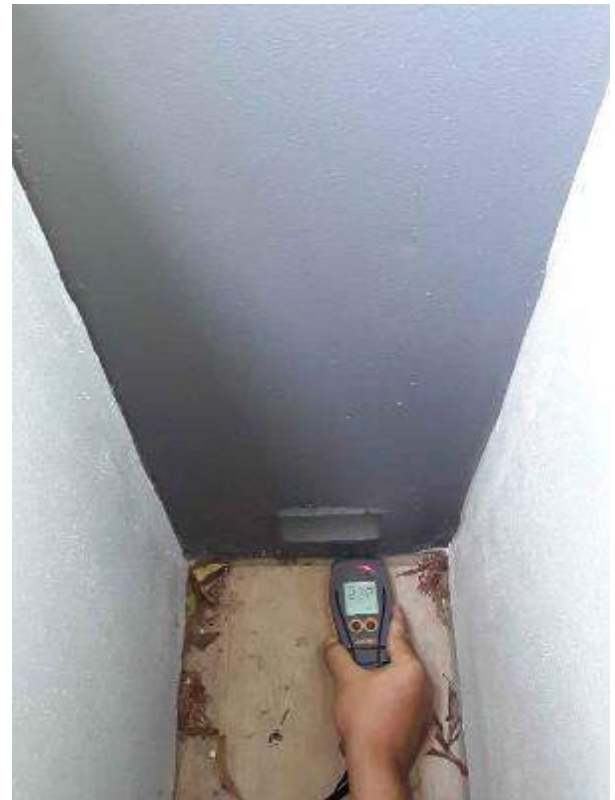
U 304.12– Unit 304 bedroom 2, FC cladding
Cladding does not have a drainage provision.

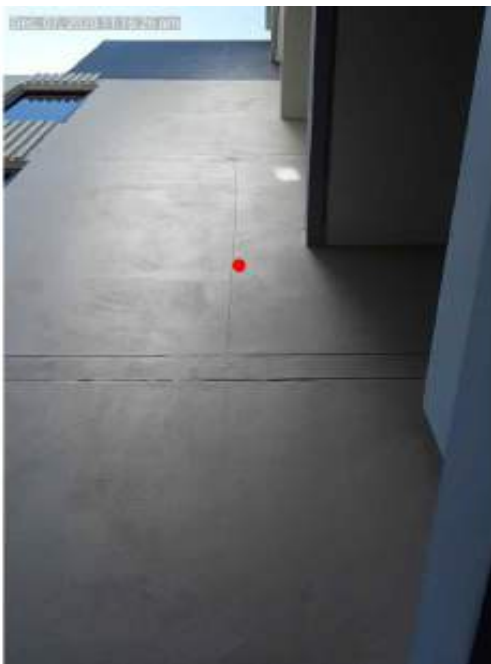
C 36 – West facade, Hebel cladding

Drip from the facade, as moisture has built up inside Hebel and escaping from control joint to Hebel and concrete junction.

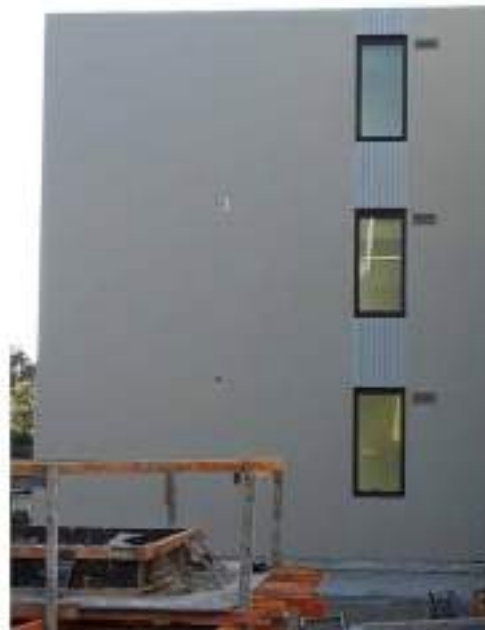
C 41 – North facade, Hebel cladding

Missing pressure equalisation slots to Hebel.

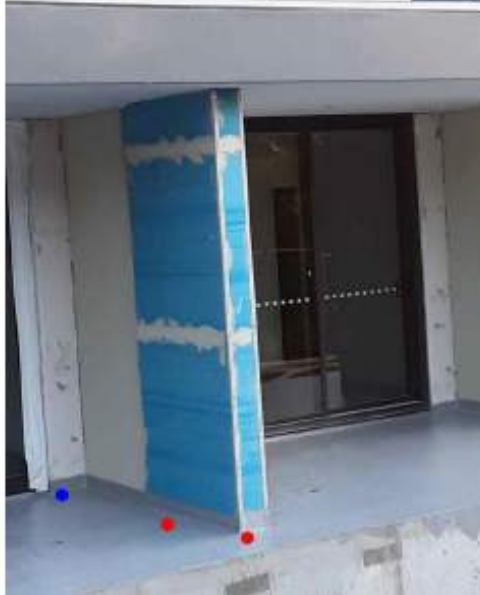
C 10 – East facade, balcony cladding
 Hebel with no cavity drains (blue).

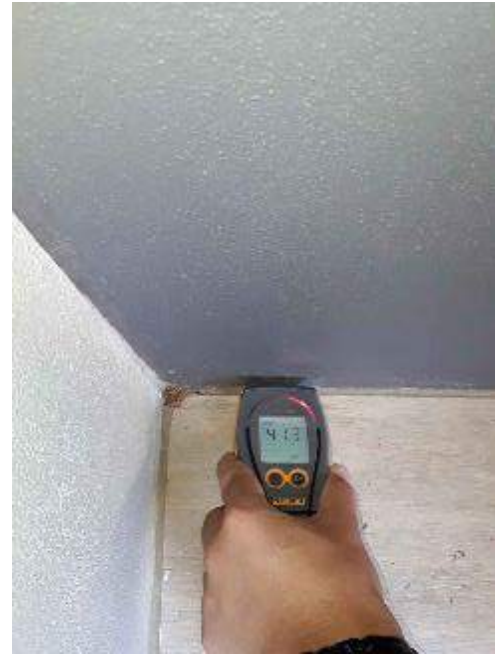
U 306.17 – Unit 306 main bedroom balcony, base of Hebel cladding
 Elevated moisture to the base of the wall.

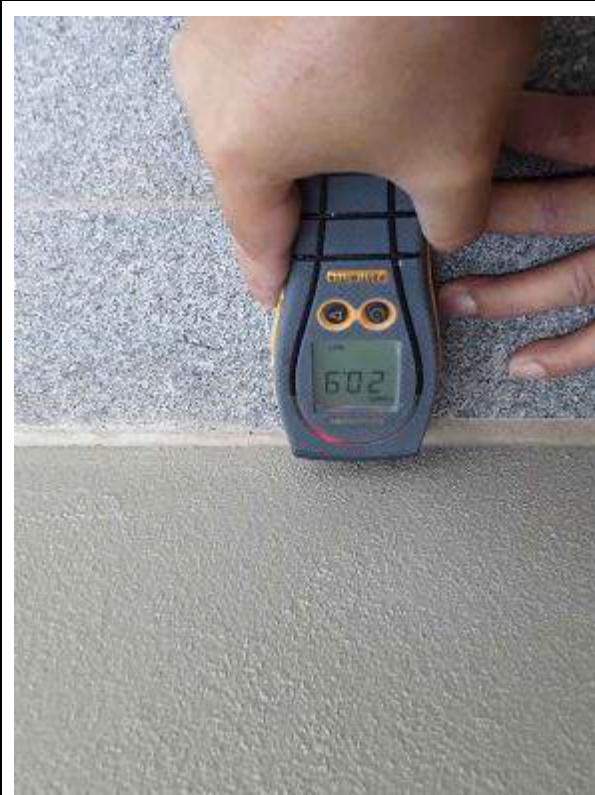
C 4 – Ground floor north entry, Hebel cladding
Elevated moisture to base of Hebel wall.

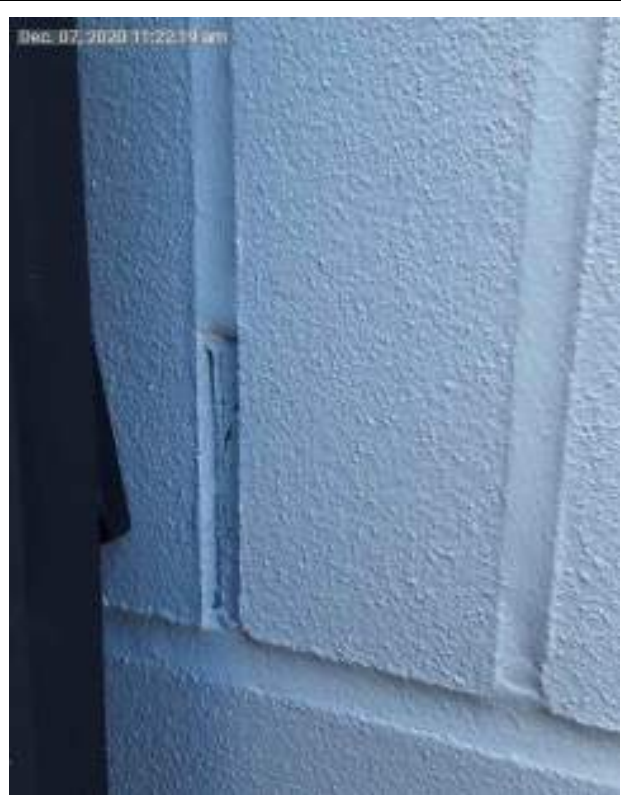
C 25 – East facade, Hebel cladding
Drainage provisions are partly covered throughout the facade.

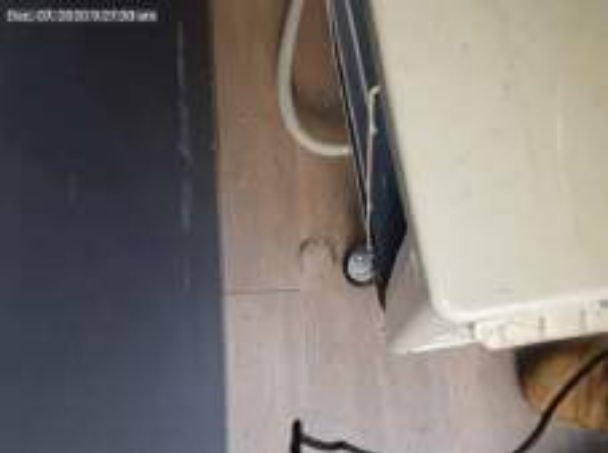
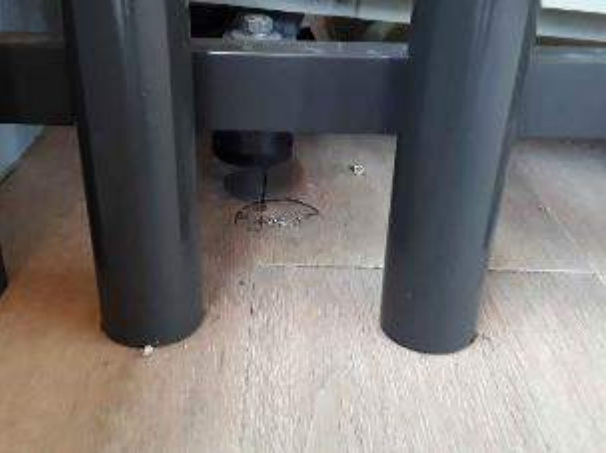
<p><u>U G05.28 – Unit 28 balcony, AC condenser</u></p> <p>AC condenser is not fixed in position.</p>	<p><u>U 304.17 – Unit 304 balcony, AC condenser</u></p> <p>AC condenser has not been mechanically fixed into position.</p>

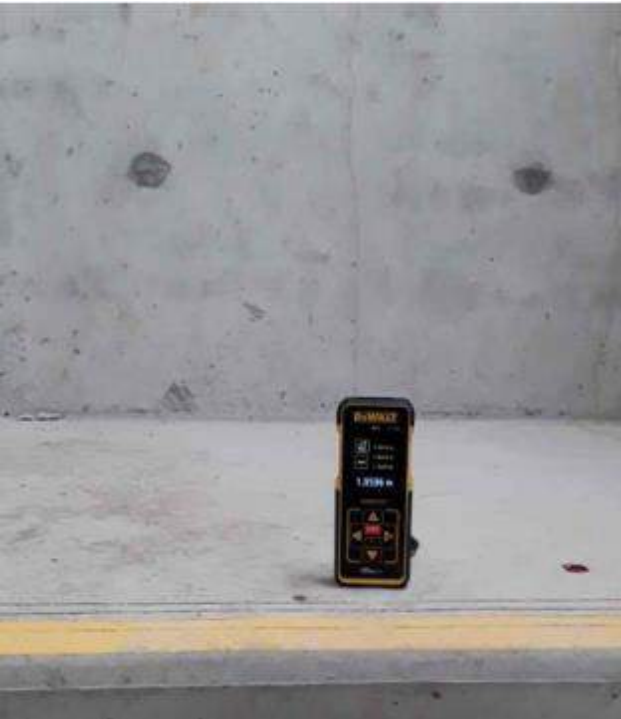
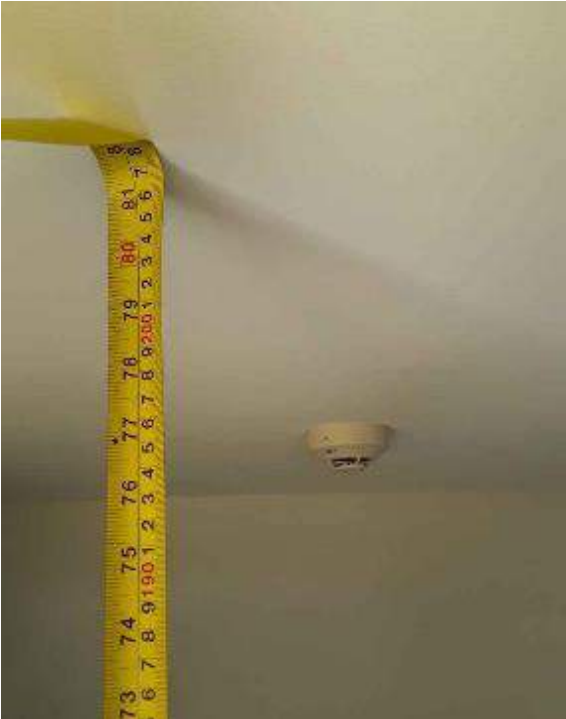
<p><u>C.80 – Basement 2, north-east fire stair landing</u> Ceiling height 1.95 metres.</p>	<p><u>C.8 – Common area, toilet ceiling</u> Ceiling height is 2.08 metres.</p>

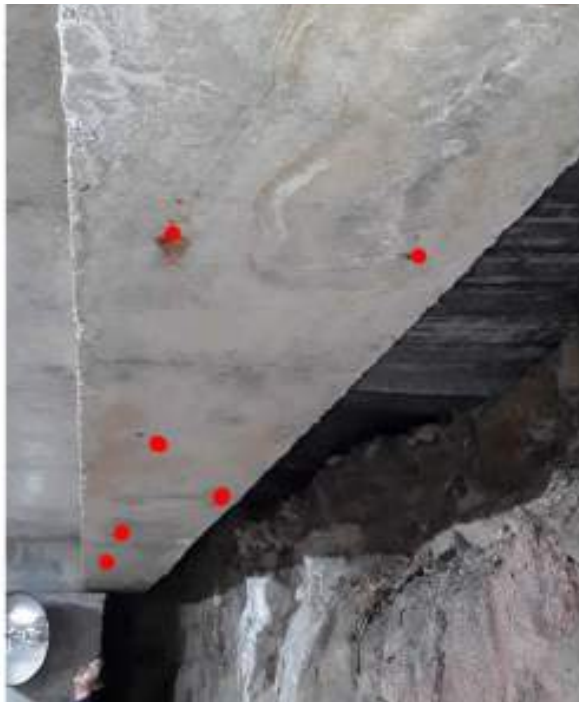
C 128 – Basement 2, north of building adjacent to the ramp

Corroding reinforcement.

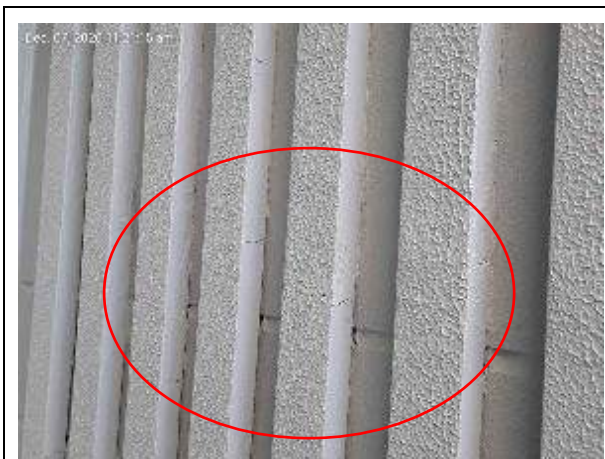
C 21 – East facade, Hebel cladding textured wall

Crack.

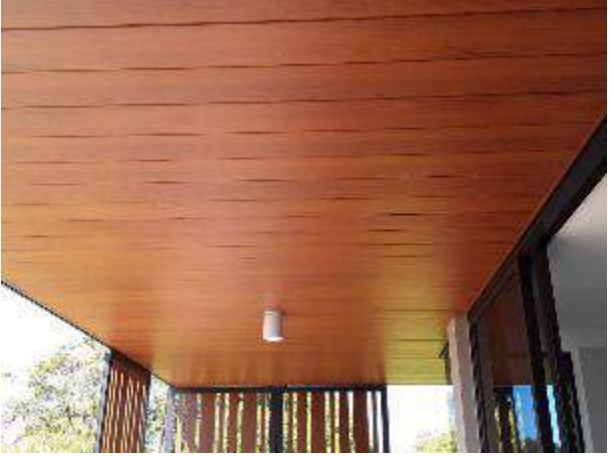
<p><u>C 304.21 – Unit 304, balcony ceiling</u></p> <p>Timber-look eaves to be tested for combustibility.</p>
--	---
