Mitchell Ave Developments P/L vs Fore Sydney Constructions P/L  
Report issued: 25 February 2022  
Both Tramex and Protometre moisture meters are used to attain comparative Moisture readings

## **10.6 Attachment F - Defects Schedule**

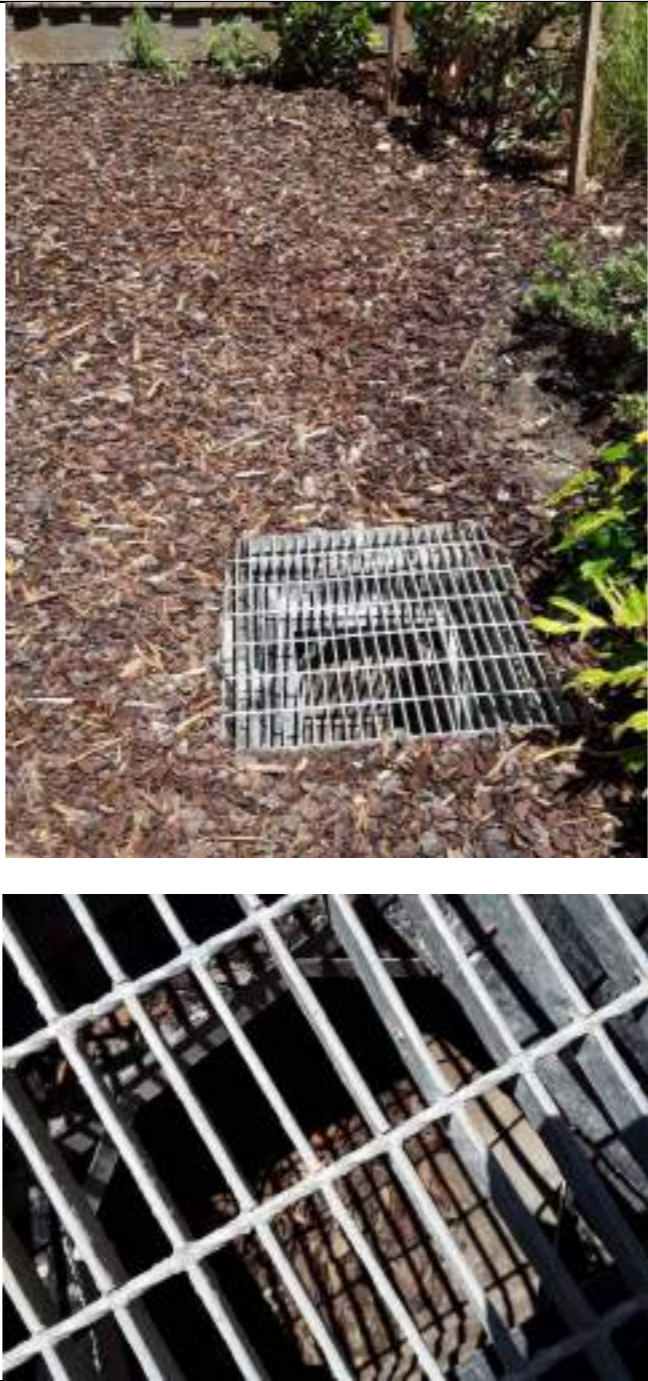
DEFECT NO.	LOCATION	AREA	BREACH	PHOTOGRAPH	DEFECT DESCRIPTION
<b>Ground level entry area</b>					
C 1	Landscape (north of site)	Storm water pit	Not fit for purpose.

Bark is washing down storm water pit.

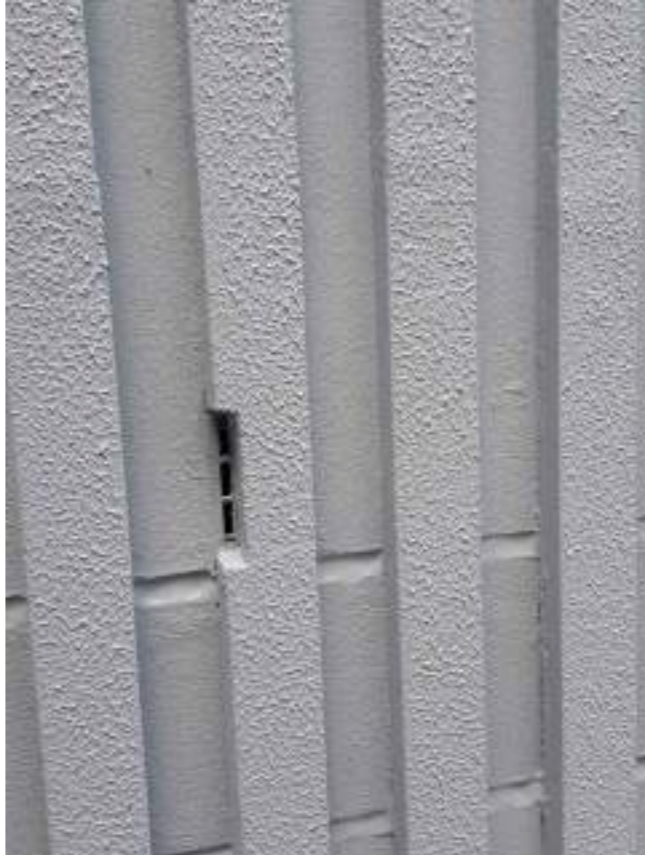
Some weepholes have been installed to the Hebel facade.
C 6	Ground floor south entry	Hebel cladding	See section 8.7 of this report.

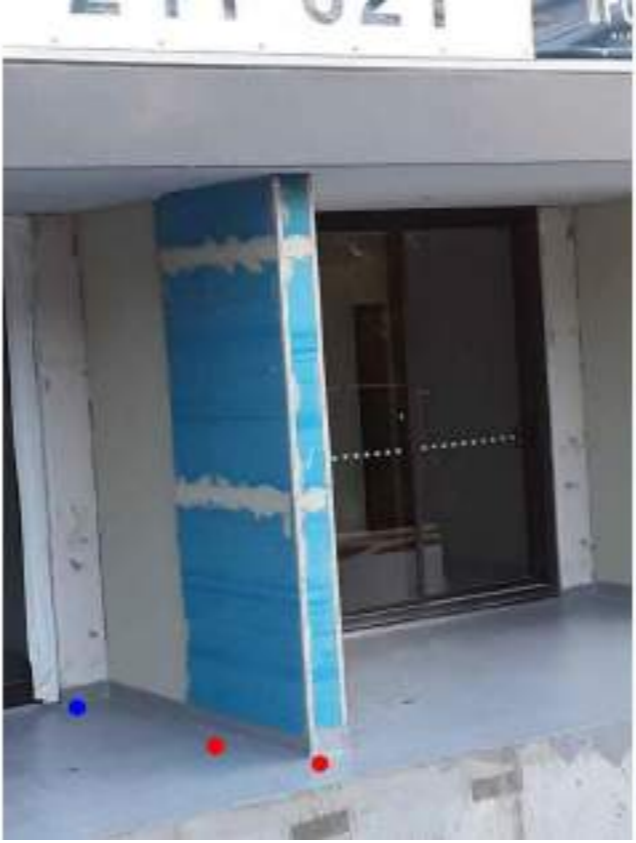
DEFECT NO.	LOCATION	AREA	BREACH	PHOTOGRAPH	DEFECT DESCRIPTION
C 10	East facade	Cladding	See sections 8.5 and 8.6 of this report.

Red - waterproofing turned up base of FC sheets. Blue - Hebel with no cavity drains.
C 11	East facade	Hebel cladding	See sections 8.5 and 8.6 of this report.

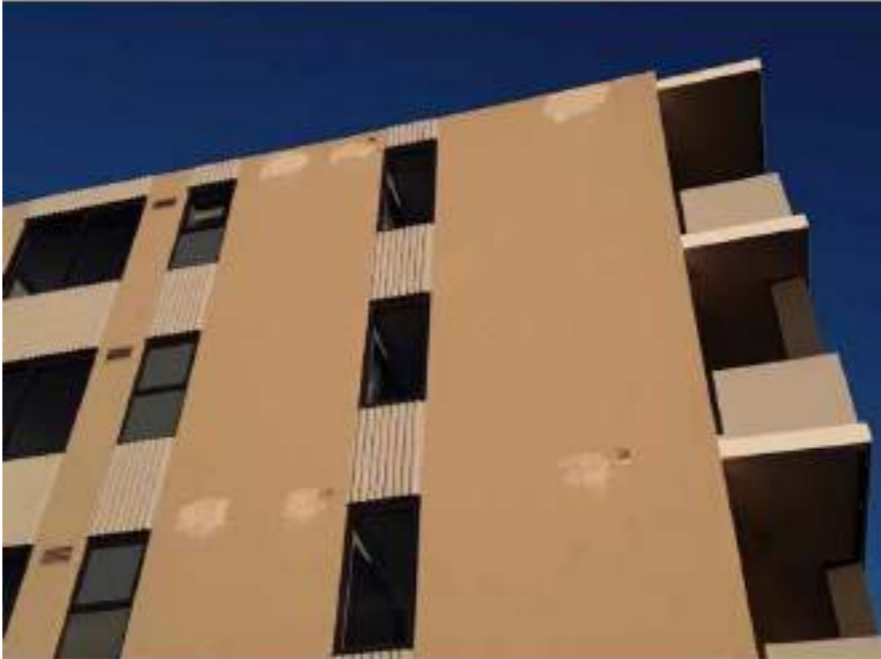
DEFECT NO.	LOCATION	AREA	BREACH	PHOTOGRAPH	DEFECT DESCRIPTION
C 14	East facade	Hebel cladding	See section 8.26 of this report.

No visible pressure equalisation slots as required by Hebel manufacturer.
C 15	East facade	FC cladding	See section 8.5 and 8.6 of this report.

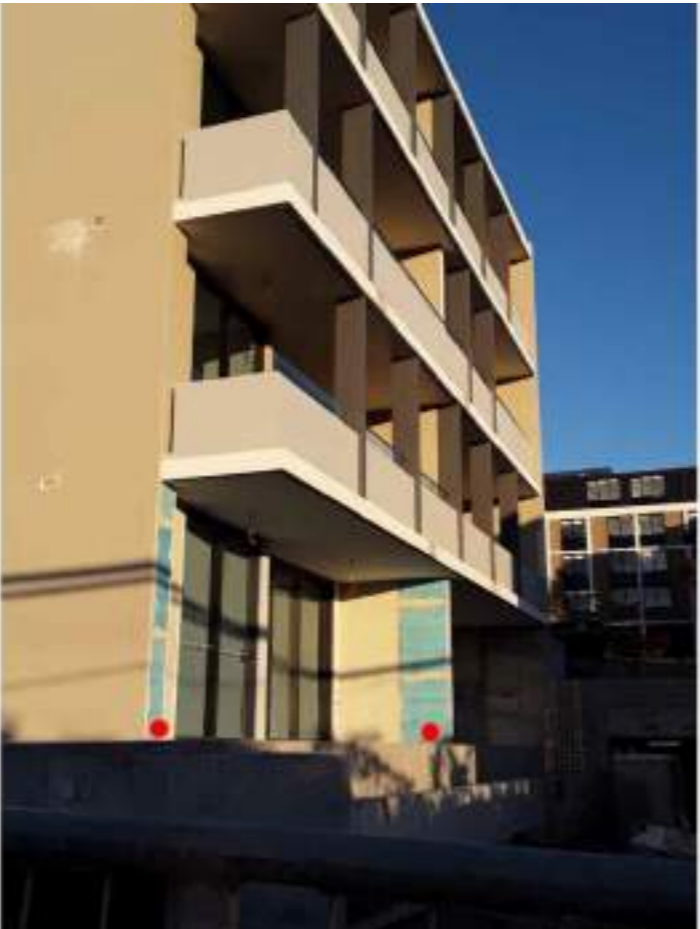
Base of FC sheets have been waterproofed up.

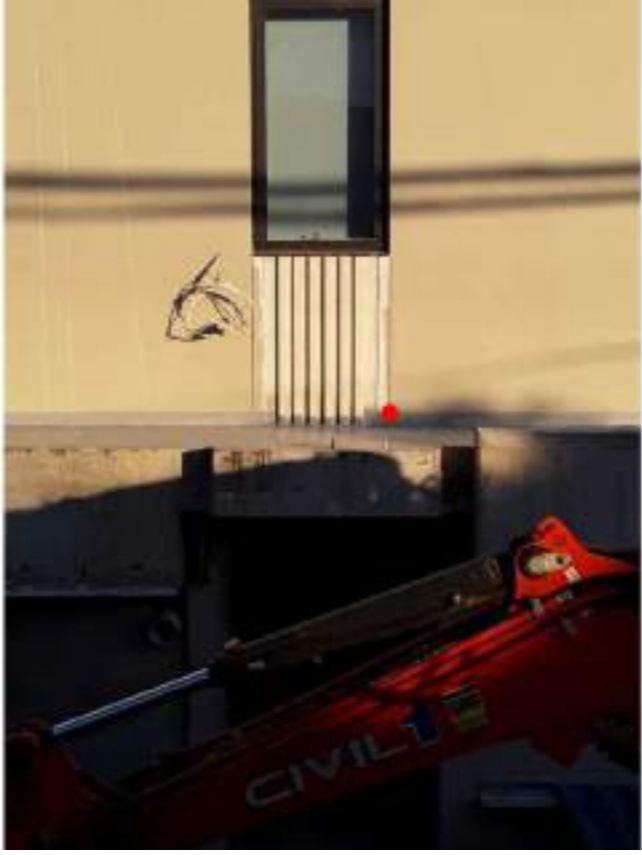
DEFECT NO.	LOCATION	AREA	BREACH	PHOTOGRAPH	DEFECT DESCRIPTION
C 18	East facade	Hebel cladding	See section 8.26 of this report.

The single drainage provision has been waterproofed over.
C 19	East facade	Hebel cladding	Note

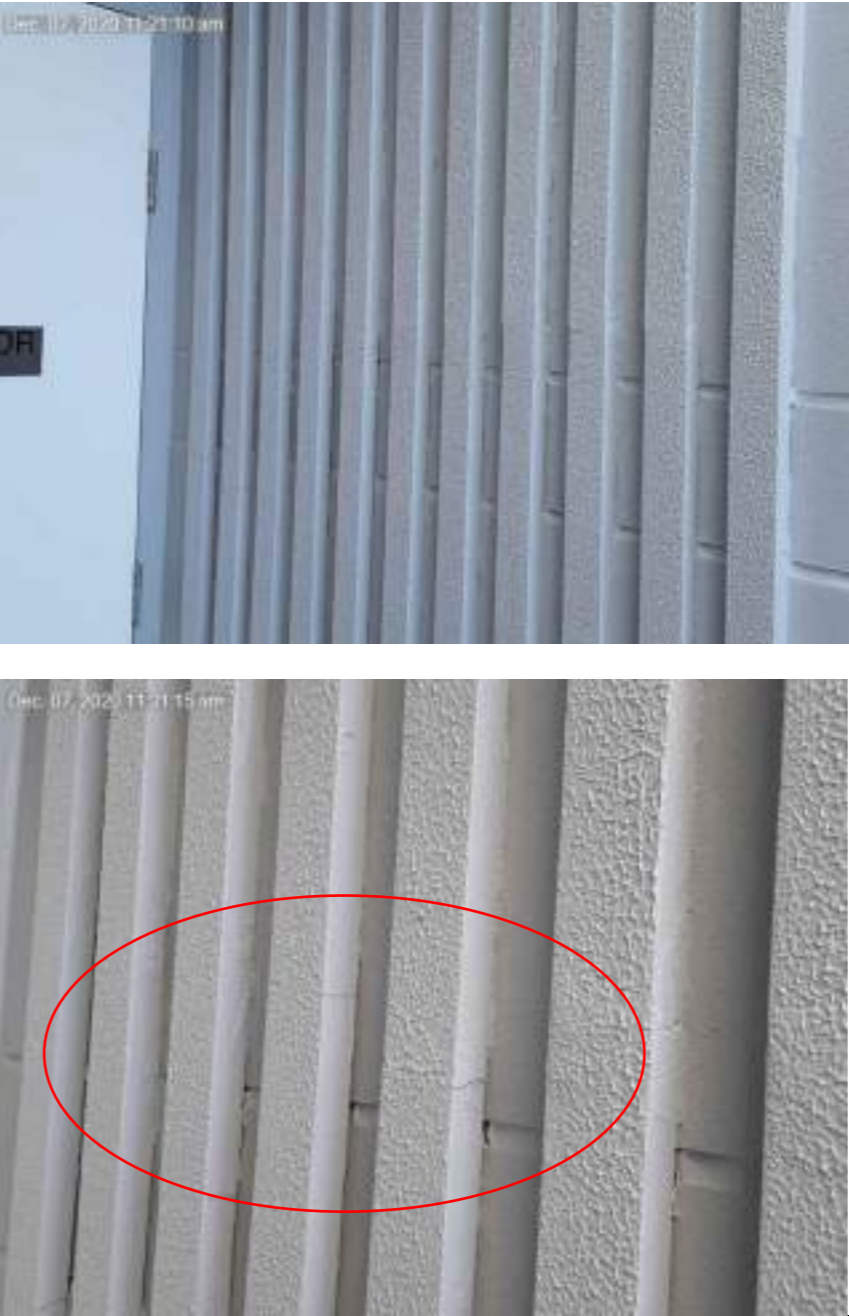
DEFECT NO.	LOCATION	AREA	BREACH	PHOTOGRAPH	DEFECT DESCRIPTION
C 20	East facade	Textured Wall	See section 8.21 of this report.

Crack

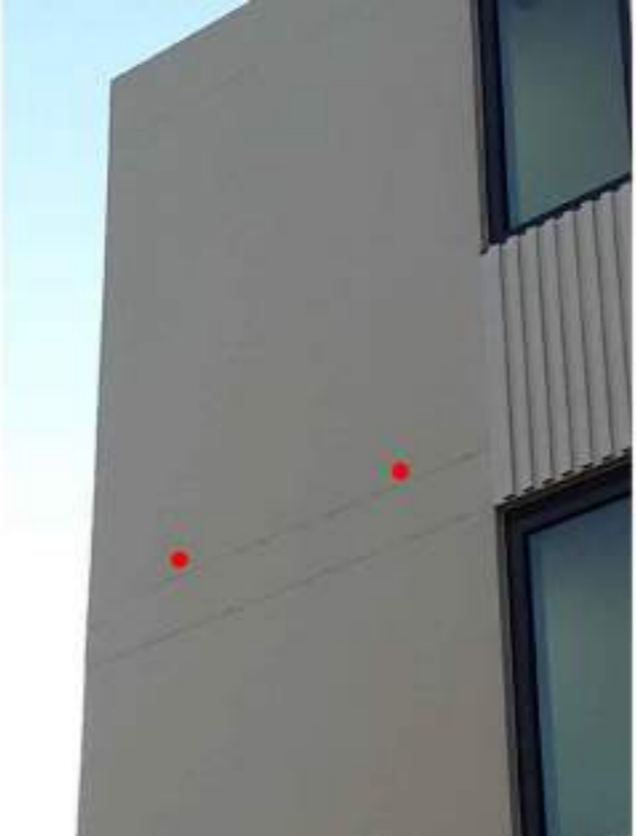
Missing drainage provisions to Hebel.

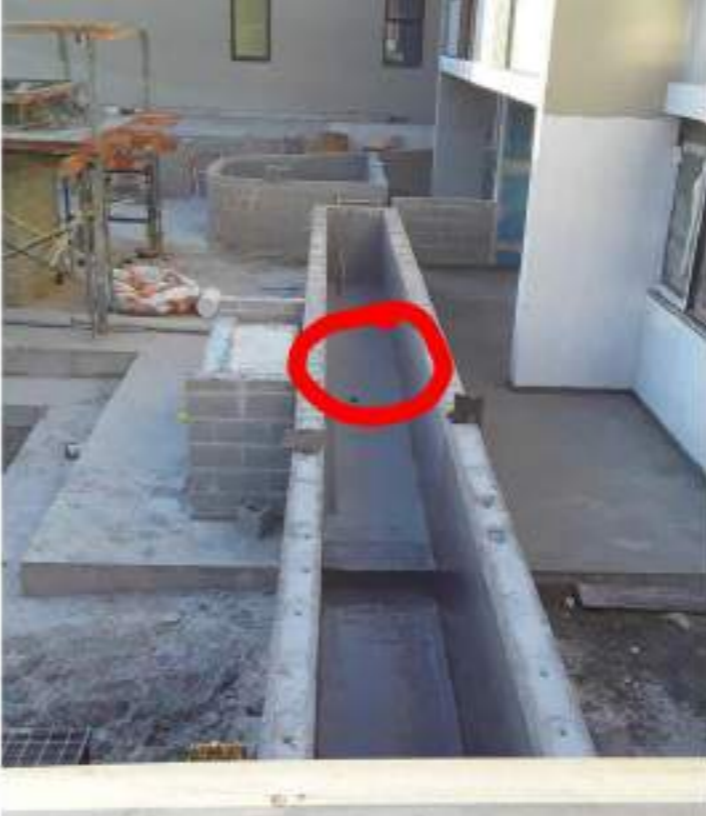
Missing drainage provisions to Hebel.
C 38	North Facade	Planter box	See section 8.4 of this report.  Breach of 2.13 and 2.5.2 of AS4654.2 requiring falls to the base of the planter.

Water is ponding in base of planter. Breach of AS4654.2.

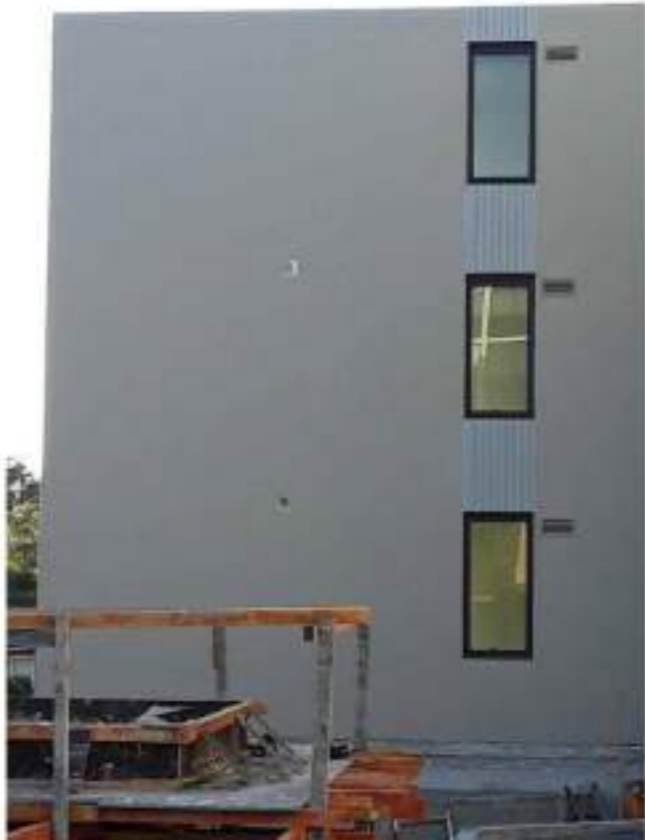
DEFECT NO.	LOCATION	AREA	BREACH	PHOTOGRAPH	DEFECT DESCRIPTION
C 41	North Facade	Hebel cladding	See section 8.26 of this report.

Missing pressure equalisation slots to Hebel.
C 42	North Facade	Privacy screen	See sections 8.5 and 8.26 of this report.

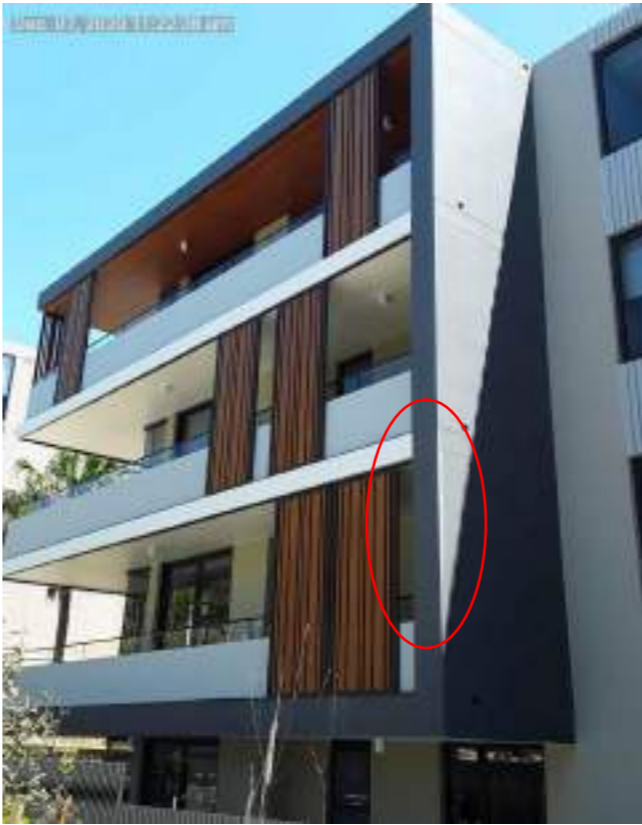
<p>Eaves to be tested for combustibility.</p> <p>Efflorescence</p>

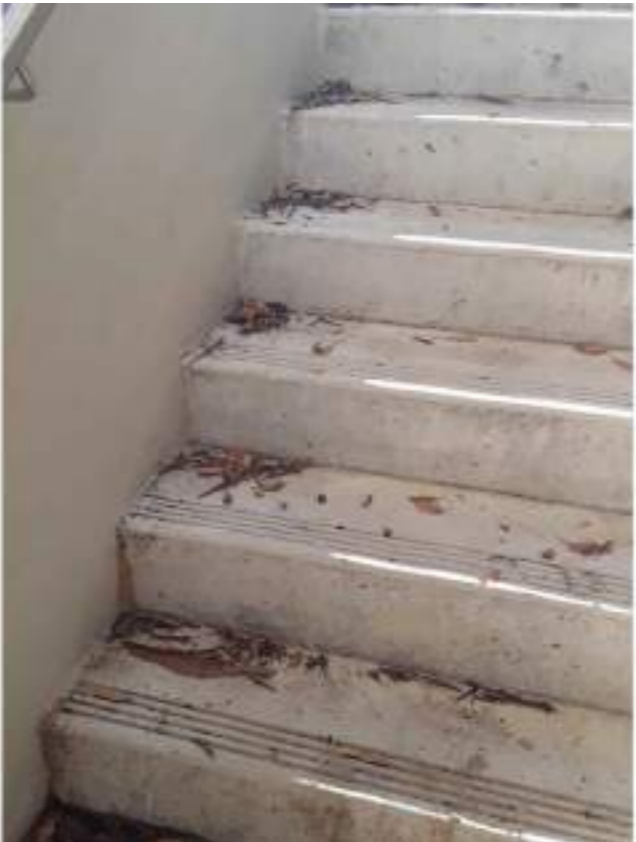
Missing nosing or compliant non-slip finish to steps.

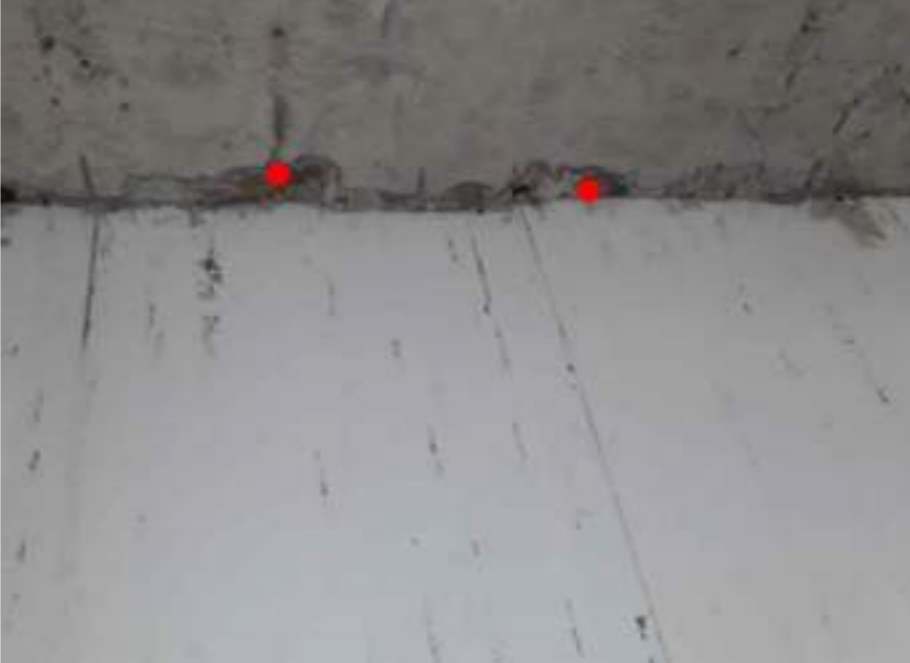
Sawdust and debris in concrete.

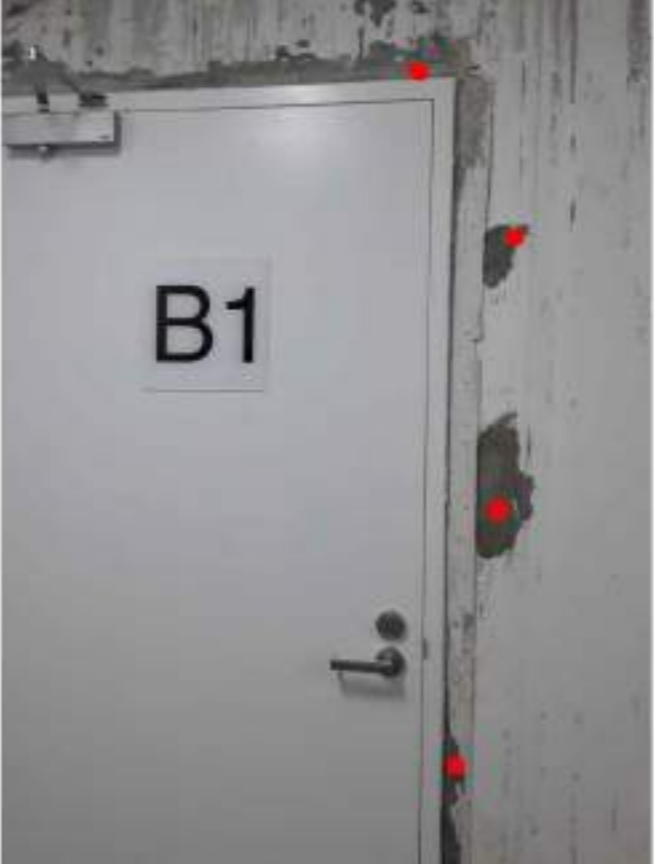
<p>Visible patching and slurry over pour from construction.</p>

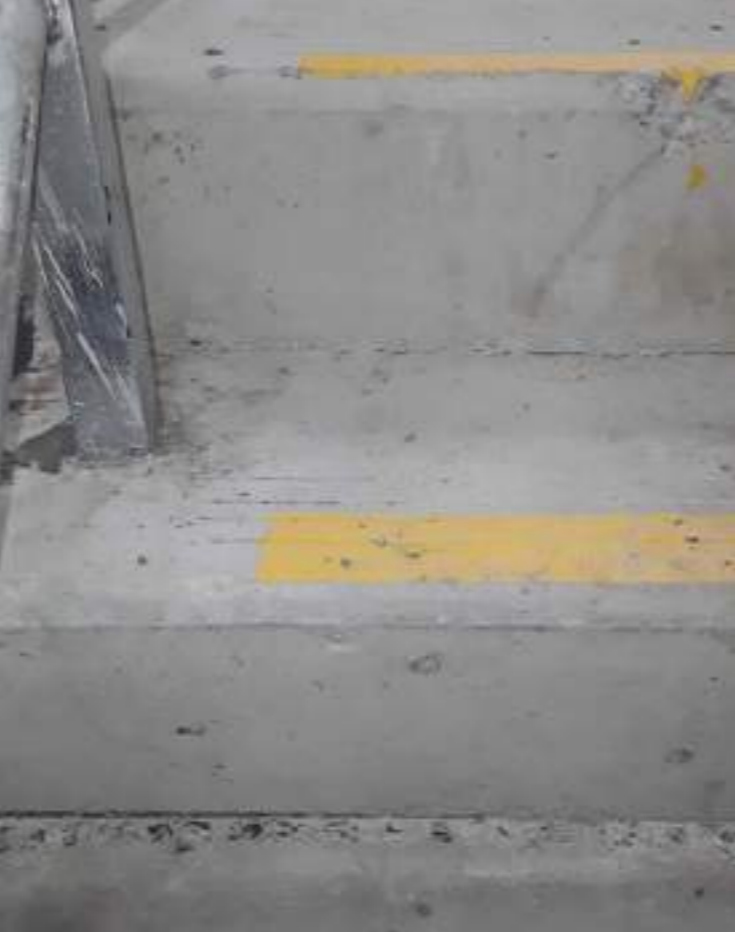
No nosing or non-slip finish.  Details of paint to be provided to identify if non-compliant and tested to AS4586.

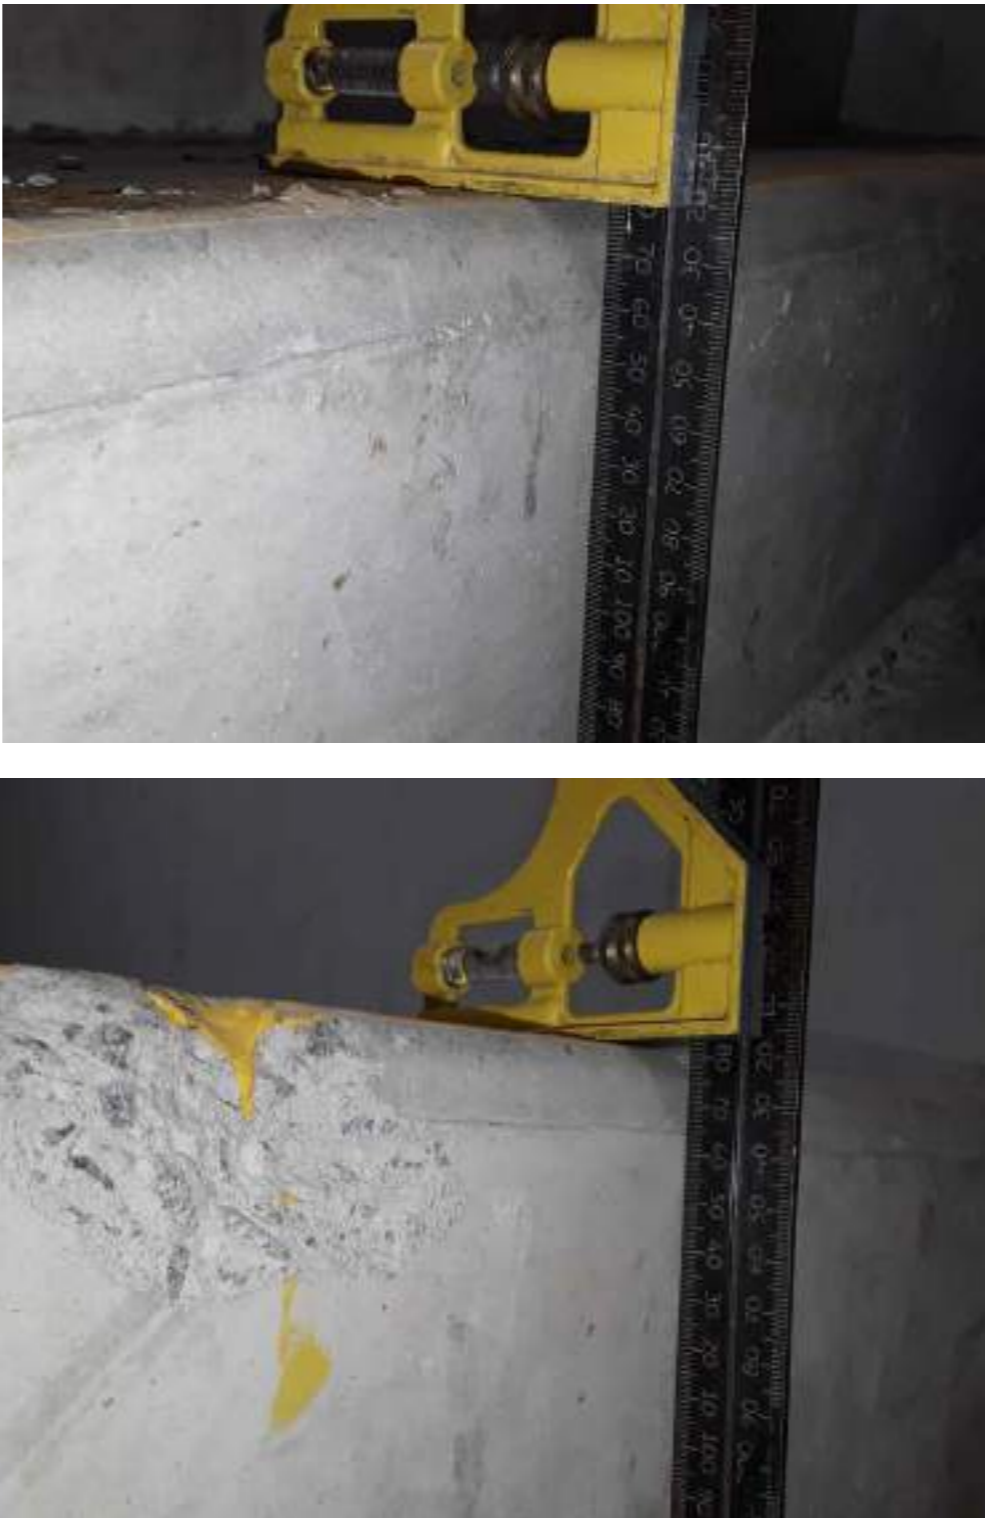
DEFECT NO.	LOCATION	AREA	BREACH	PHOTOGRAPH	DEFECT DESCRIPTION
C 61	Basement 1	South east fire stair to ground level	Breach of D2.13 of the BCA. See section 8.17 of this report.

<p>First riser is 179mm, adjacent riser is 185mm.</p> <p>Greater than 5mm difference in adjacent riser.</p>

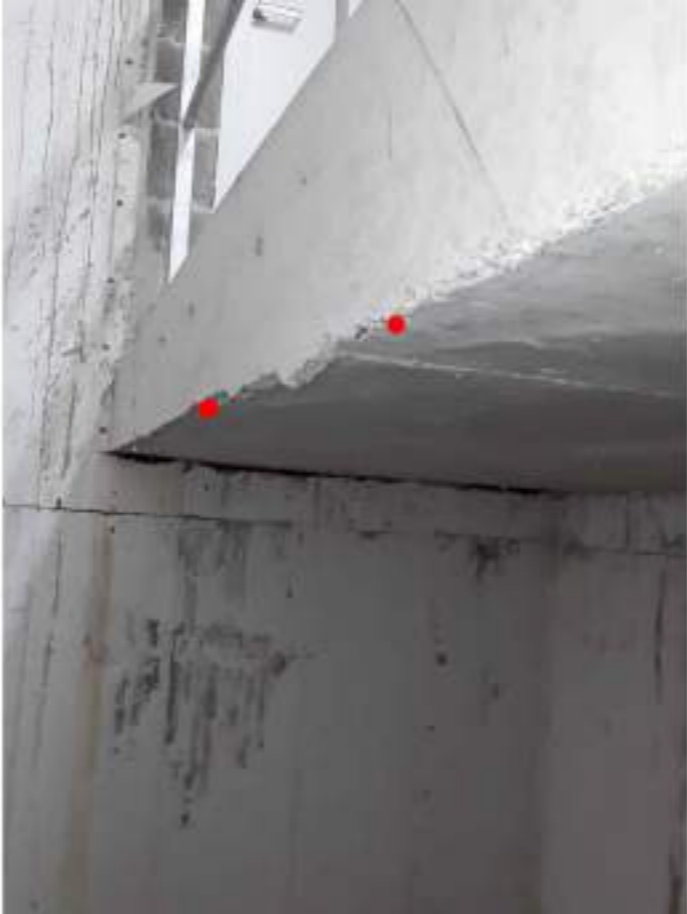
DEFECT NO.	LOCATION	AREA	BREACH	PHOTOGRAPH	DEFECT DESCRIPTION
C 62	Basement 1	South east fire stair to ground level	Works have not been completed with due care and skill.

Rough concrete edge.

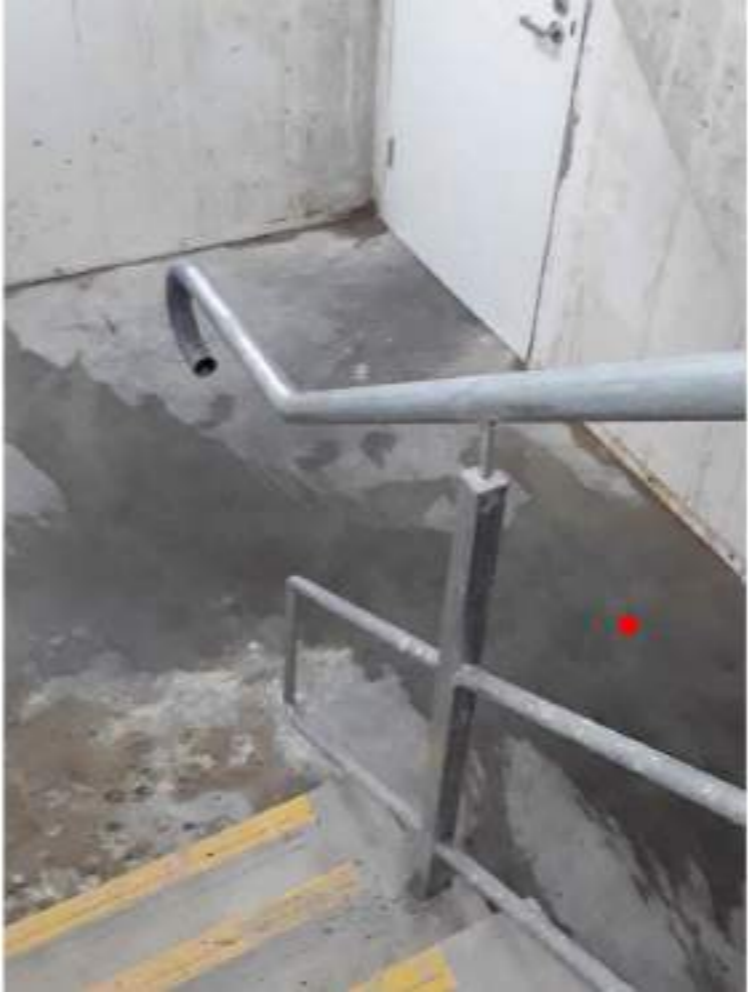
DEFECT NO.	LOCATION	AREA	BREACH	PHOTOGRAPH	DEFECT DESCRIPTION
C 63	Basement 2	South east fire stair to ground level	Safety issue.

<p>Water from base of stair entering adjacent storage area.</p> <p>Water ponding on the floor of the emergency exit is a potential slip hazard.</p>
C 64	Basement 2	South east fire stair to ground level	Not fit for purpose.

C 63	Basement 2	South-east fire stairs to ground level	Water from the base of stair entering the adjacent storage area.	Install kerb and drain.
C 64	Basement 2	South-east fire stairs to ground level	The surface to the base of the stair is not only wet but very rough in the finish as such not fit for purpose as could cause slips and falls.	Install kerb to divert water as safety issue. Skim base of stair with commercial grade topping.
C 65	Basement 2	South-east fire stairs to ground level	Groundwater entering fire stair area and adjacent storage.	Install kerb and drain.
C 66	Basement 2	South-east fire stairs to ground level	The sarking tape used around the penetration.	Remove tape. Install no-shrink grout.
C 67	Basement 2	South-east fire stairs to ground level	Concrete slurry on treads.	Clean treads.
C 68	Basement 2	South-east fire stairs to ground level	Concrete hump poor workmanship.	Scabble off hump. Install topping.

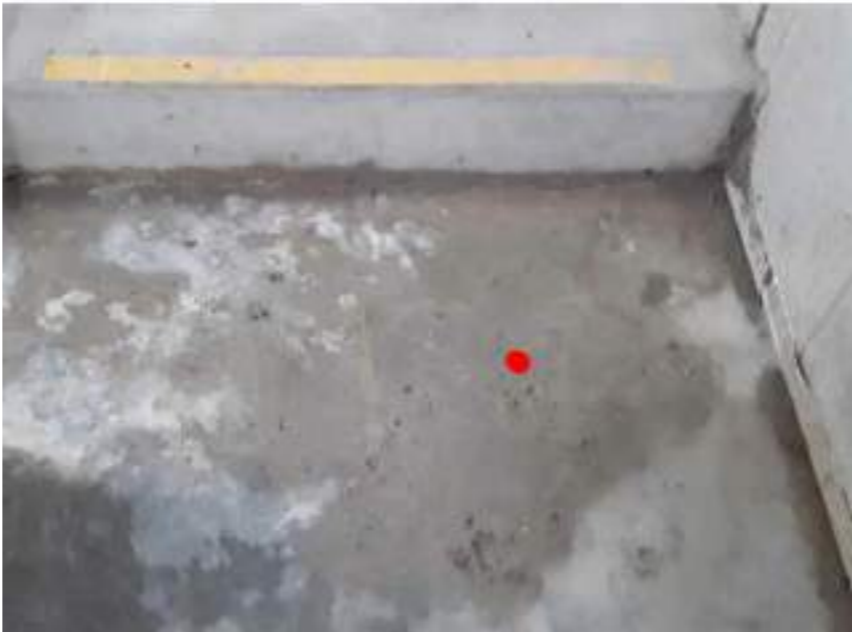
<p>The surface to the base of the stair is not only wet, but very rough in finish as such is not fit for purpose as it could cause slips and falls.</p>

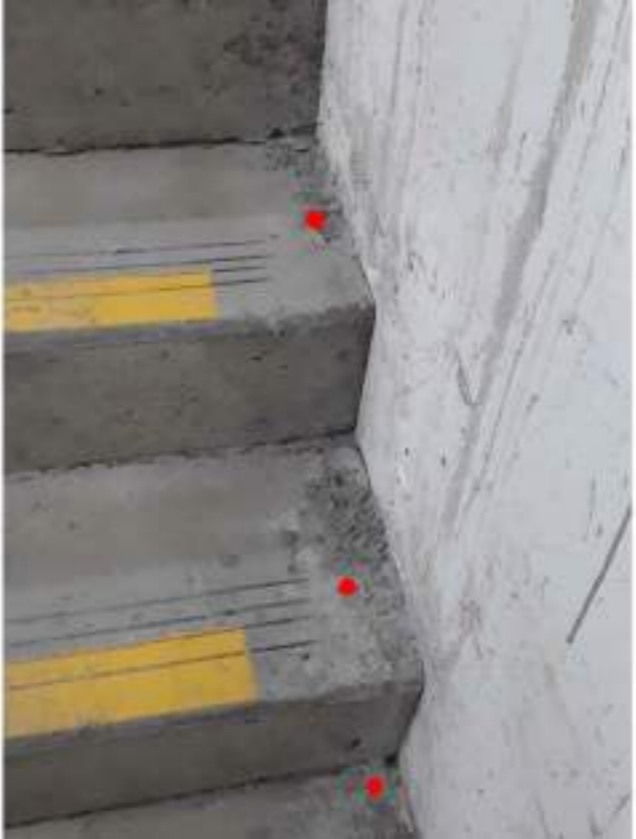
DEFECT NO.	LOCATION	AREA	BREACH	PHOTOGRAPH	DEFECT DESCRIPTION
C 67	Basement 2	South east fire stair to ground level	Works have not been completed with due care and skill.

Concrete slurry on treads.
C 68	Basement 2	South east fire stair to ground level	Works have not been completed with due care and skill.

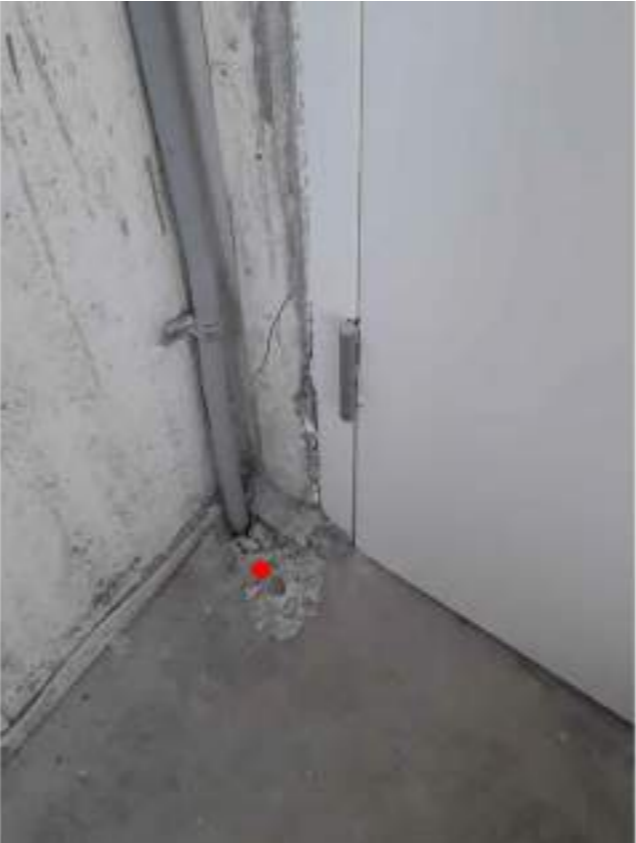
Concrete hump poor workmanship.

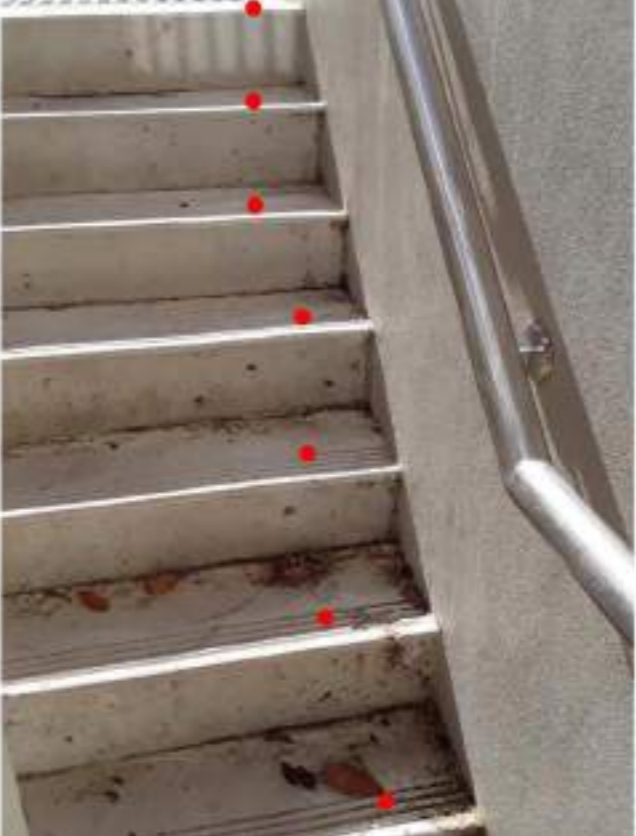
No nosing or compliant non-slip finish.

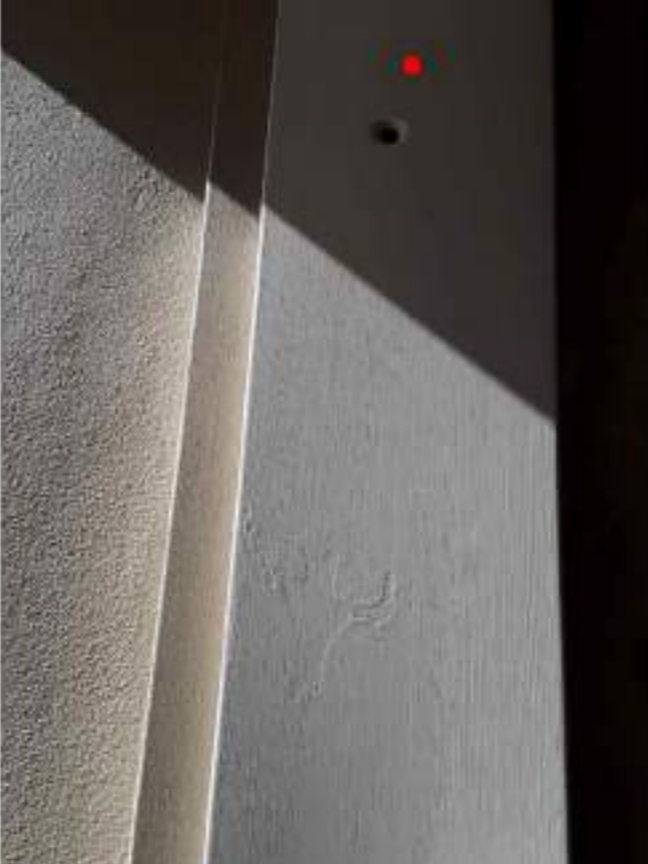
Hollow fire rated frame.

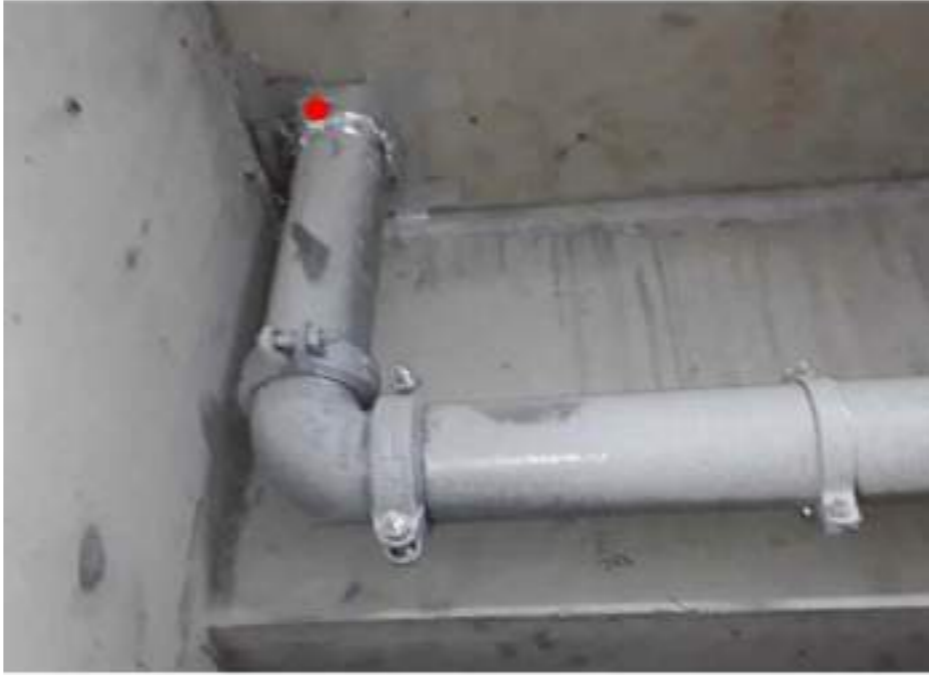
DEFECT NO.	LOCATION	AREA	BREACH	PHOTOGRAPH	DEFECT DESCRIPTION
C 77	Basement 1	North east fire stair to ground level	Incomplete work.

Sarking tape installed around pipe.
C 78	Basement 1	North east fire stair to ground level	See section 8.20 of this report.	 	Insufficiently vibrated concrete.

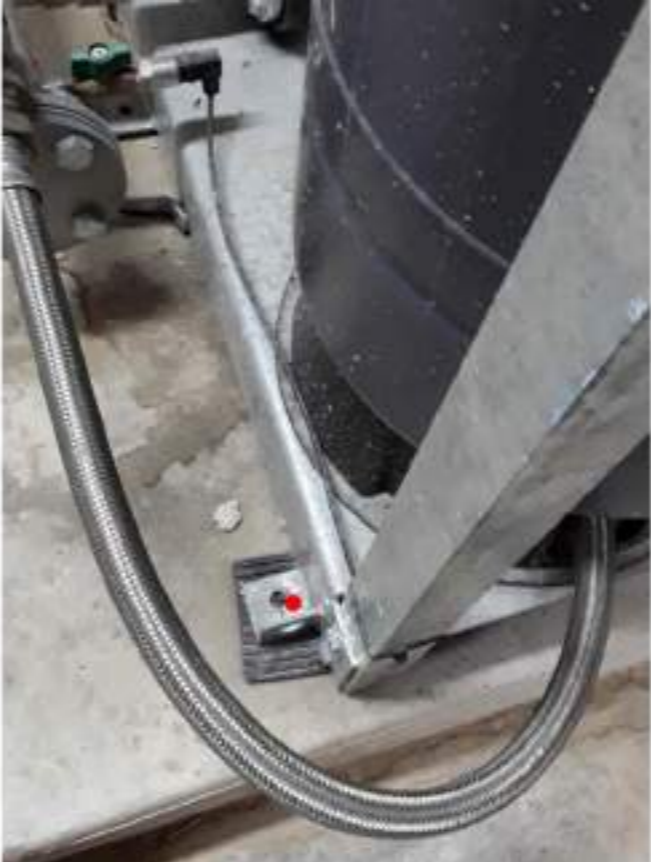
Missing fixings throughout.

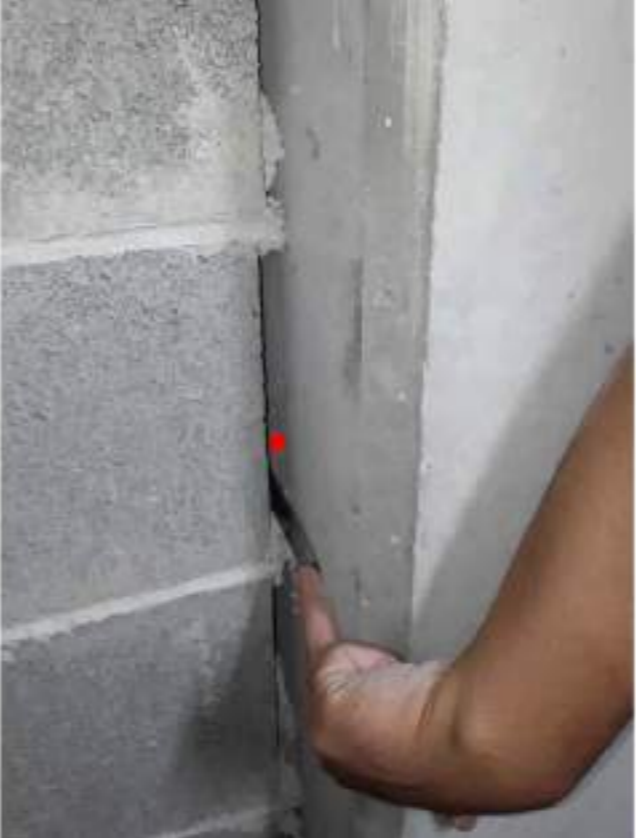
<p>A close-up photograph showing a person's hand using a metal tool to inspect a vertical crack in a grey concrete block wall. A red dot is visible on the wall near the crack.</p>	Void to fire rated wall.

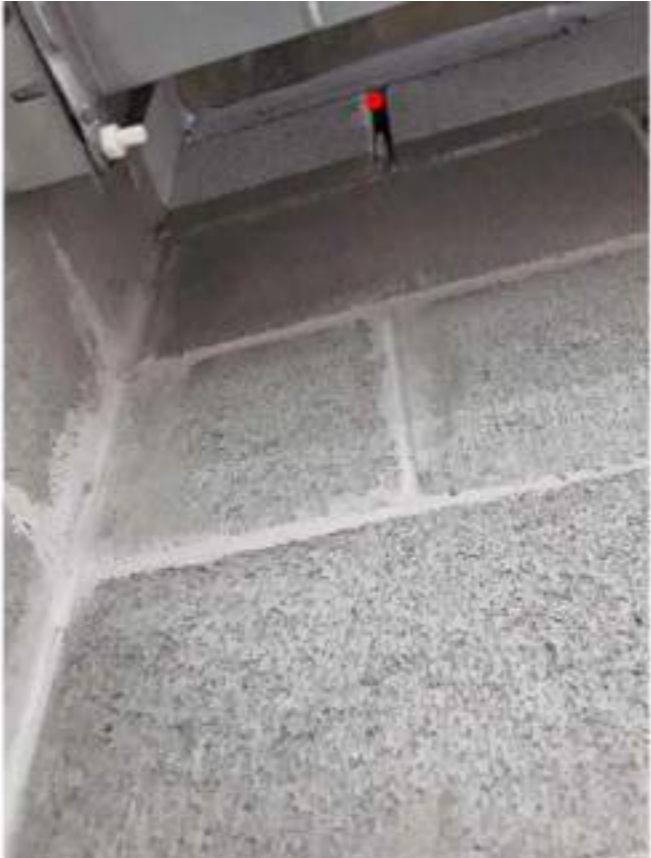
Void in fire rated wall.

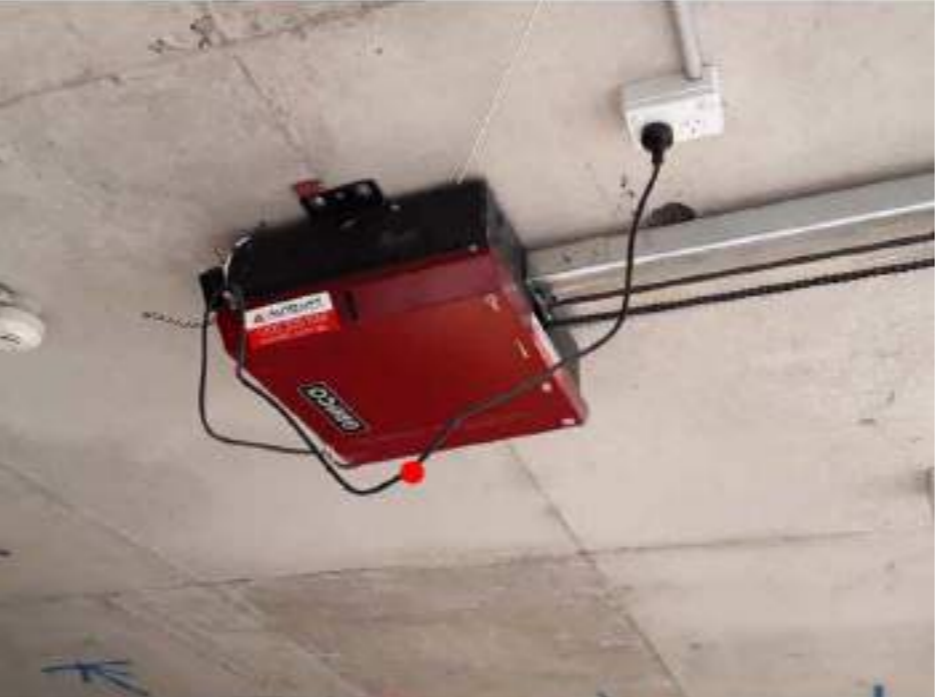
DEFECT NO.	LOCATION	AREA	BREACH	PHOTOGRAPH	DEFECT DESCRIPTION
C 97	Basement 1	Main entry	Works have not been completed with due care and skill.

Power cable to be shortened and clipped to concrete.
C 98	Basement 1	West wall	Incomplete work.	 	Builders set out has not been cleaned off.

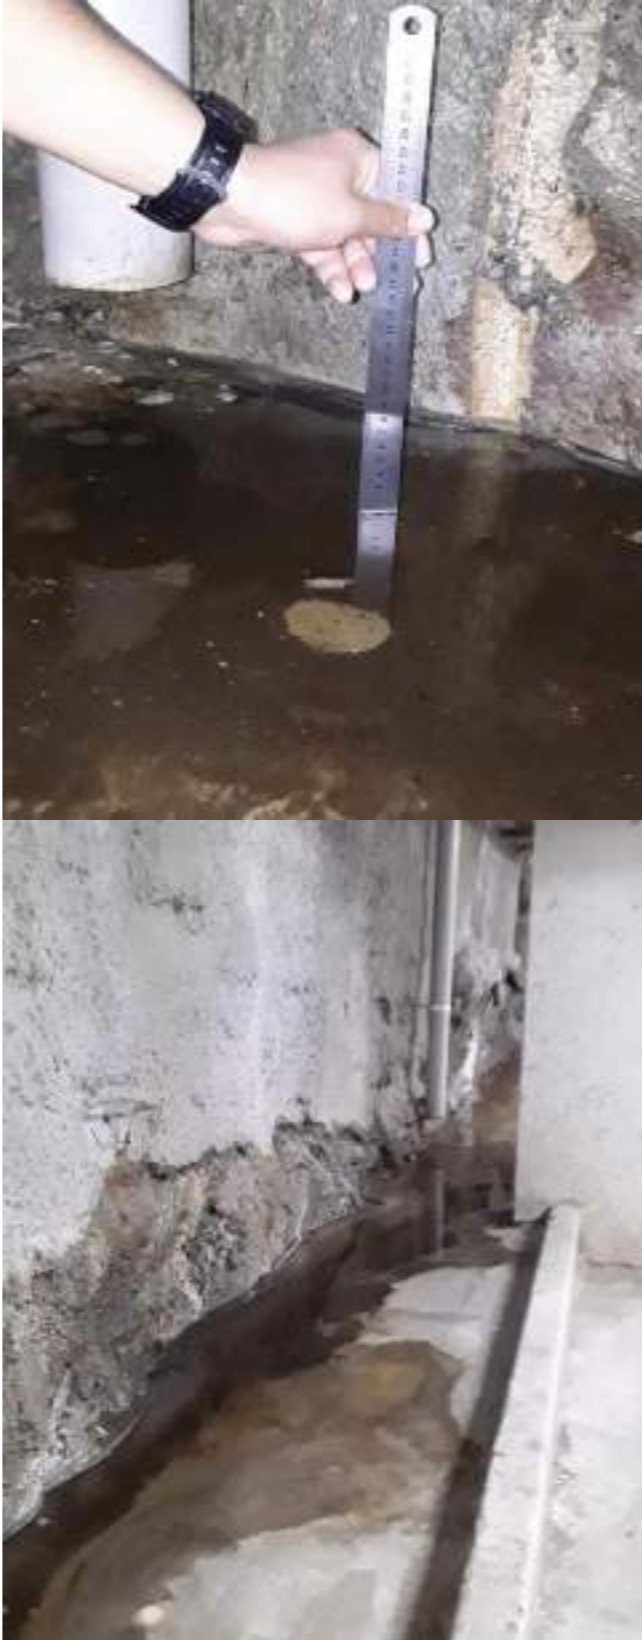
DEFECT NO.	LOCATION	AREA	BREACH	PHOTOGRAPH	DEFECT DESCRIPTION
C 103	Basement 1	South – infront of parking bay 18 (floor waste)	See section 8.4 of this report.

Water ponding.

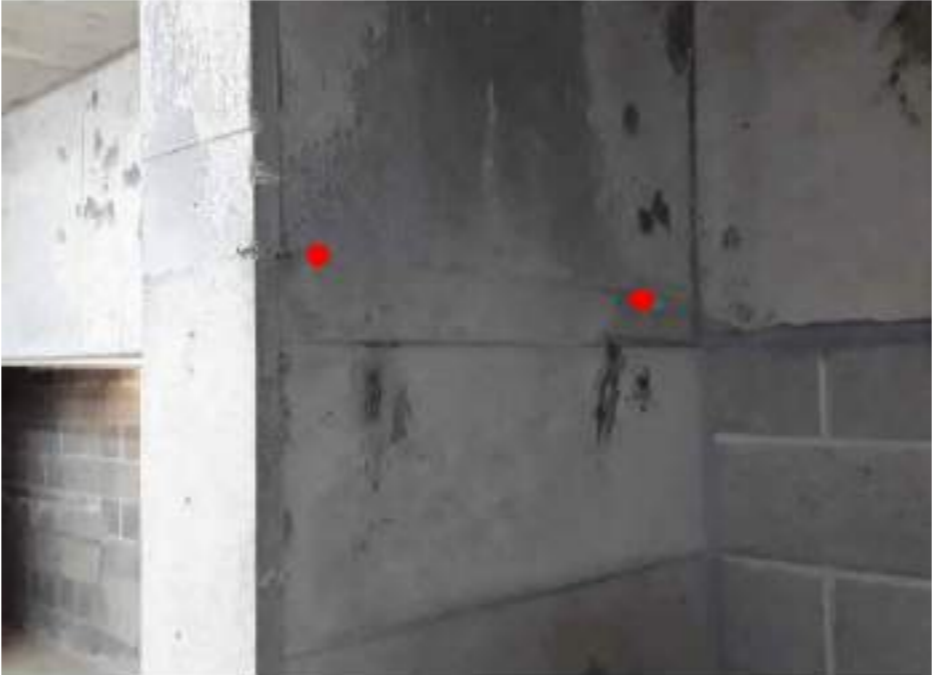
Cold joint in structural column adjacent to ramp.
C 108	Basement 1	Exit	Works have not been completed with due care and skill.

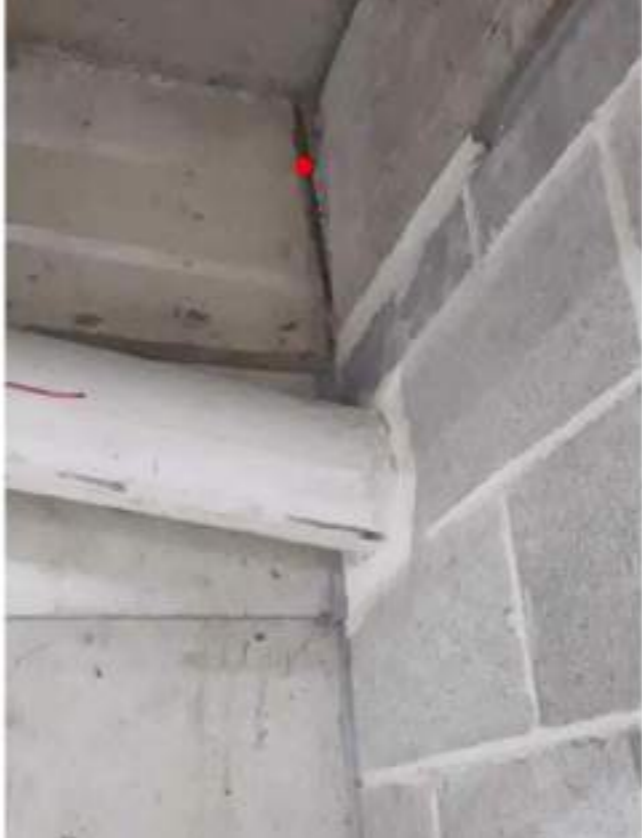
Form work retained to parking bay 2.

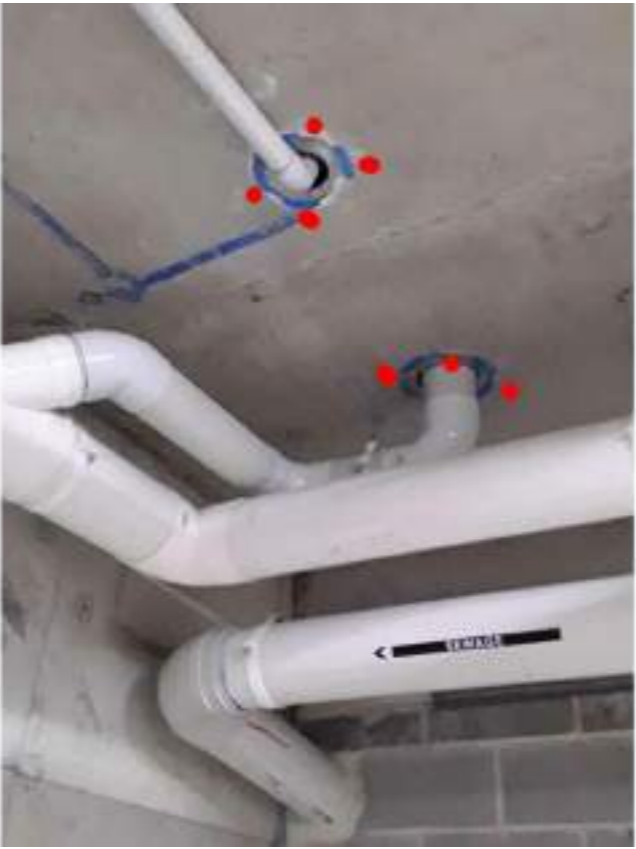
<p>A. Nails retained in soffit.</p> <p>Nails protruding from soffit are a safety hazard for maintenance plumbing work.</p> <p>B. Builders setout retained on soffit.</p>
C 114	Basement 1	B1 and B2 ramp	Incomplete work.

C 113.A	Basement 1	Parking bay 2	Nails retained in the soffit.	Remove and patch with render.

C 113.B	Basement 1	Parking bay 2	Builders setout retained on the soffit.	Sand and clean marks off soffit.
C 114	Basement 1	B1 and B2 ramp	6 open conduits to concrete.	Remove and patch with render.
C 115	Basement 1	Ceiling area	Builders' set out marks retained throughout	Sand and clean marks off soffit.
C 116	Basement 1	Ceiling clearance height	Note clearance of 2.2m required to the basement. Exit sign inside the basement is under 2100mm high.	Electrician to adjust exit light heights.
C 118.A	Basement 2	North wall	Saturated formwork to parking bay 30. Dish drain not draining as such not fit for purpose.	Jet blast drains. Remove for work. Top dish drain with screed for falls.
C 122	Basement 2	Behind parking bay 25	Dish drain incomplete behind parking bay 25. Restricted with the rock in way of water flow.	Jet blast drains. Scabble rock. Install concrete dish drain with screed for falls.
C 123	Basement 2	North of building - adjacent to the ramp	Exposed reinforcement bars adjacent to the ramp.	Cut off and treat exposed reinforcement.
