Mitchell Ave Developments P/L vs Fore Sydney Constructions P/L  
Report issued: 25 February 2022  
Both Tramex and Protometre moisture meters are used to attain comparative Moisture readings

## **10.6 Attachment F - Defects Schedule**

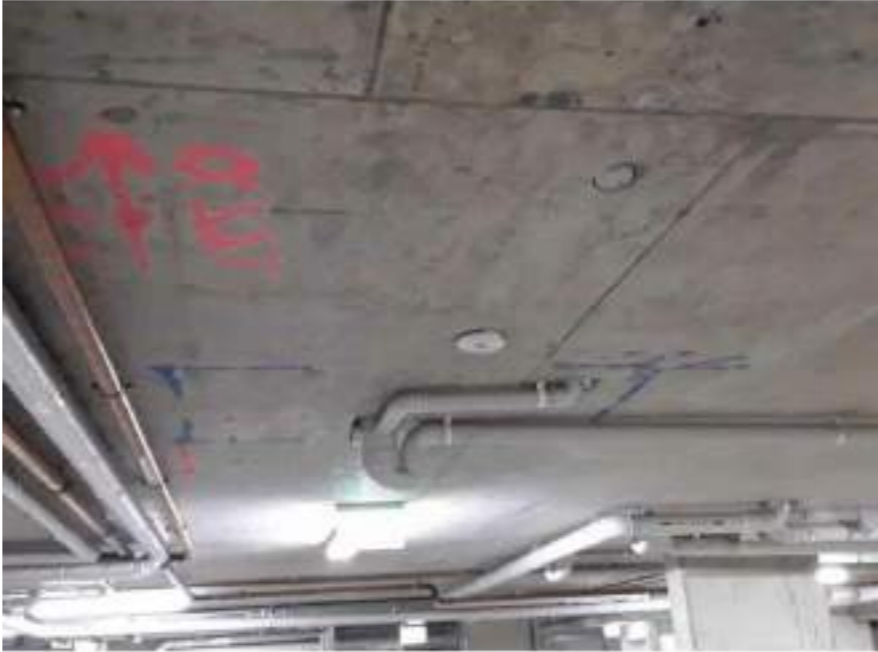
Builders set out marks retained throughout.
C 116	Basement 1	Ceiling clearance height	Works have not been completed with due care and skill.

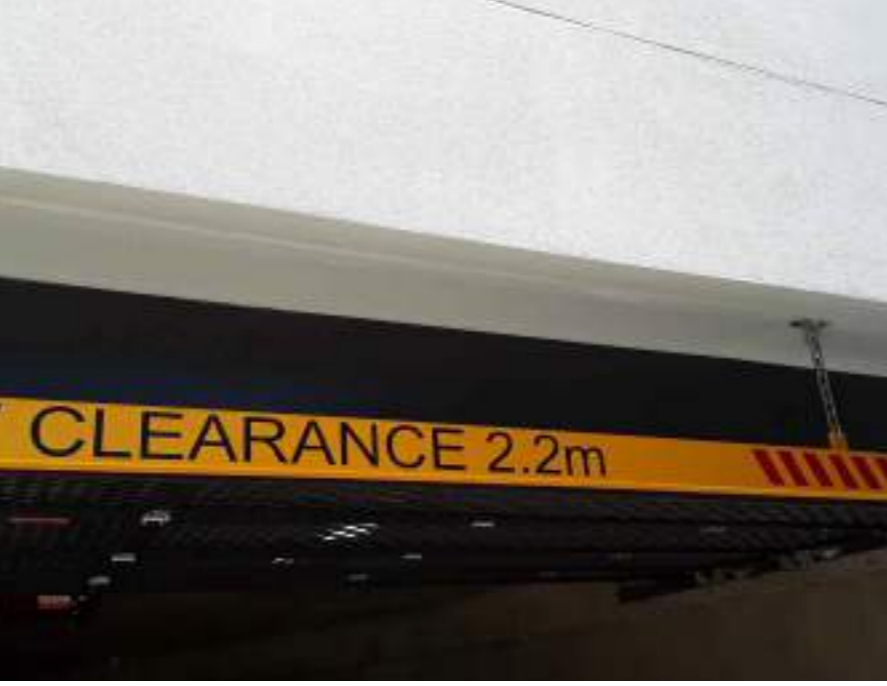
Note clearance of 2.2m required to basement. Exit sign inside basement is under 2100mm high.

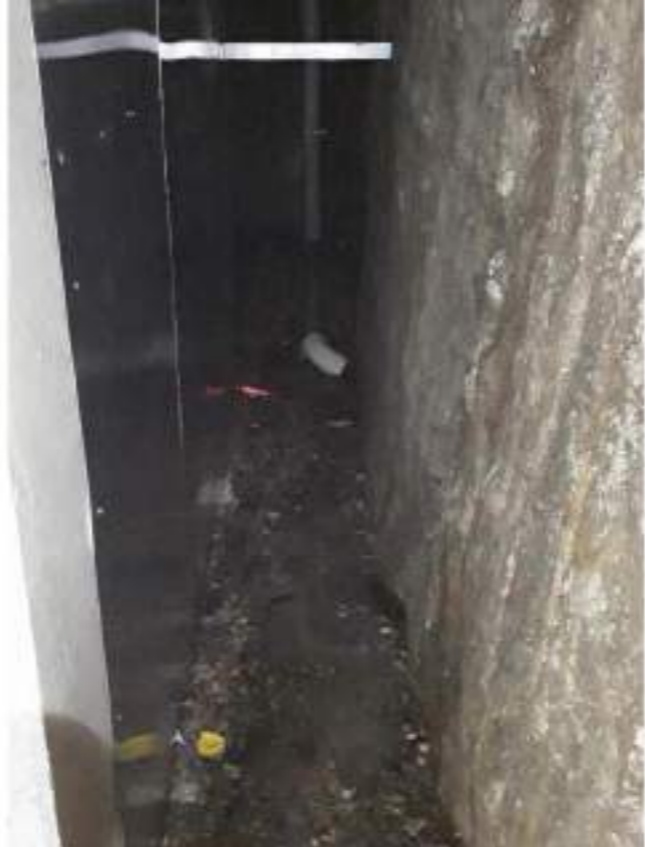
DEFECT NO.	LOCATION	AREA	BREACH	PHOTOGRAPH	DEFECT DESCRIPTION
C 117	Basement 2	North wall	See section 8.4 of this report.

Stagnant water behind parking bay 30.
C 118	Basement 2	North wall	See section 8.4 of this report.  Dish drain not draining as such not fit for purpose.

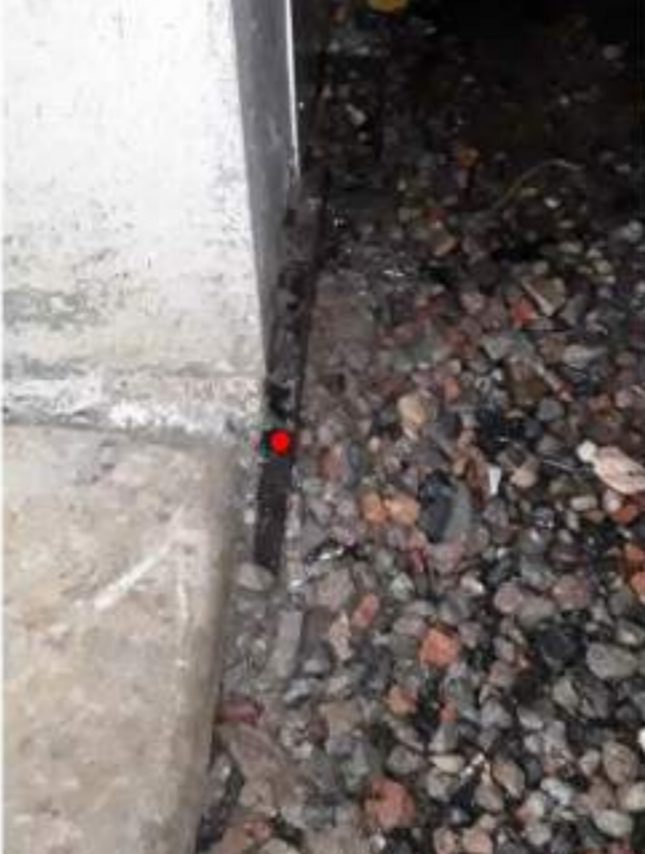
A. Saturated formwork to parking bay 30. B. Water ponding in dish drain.

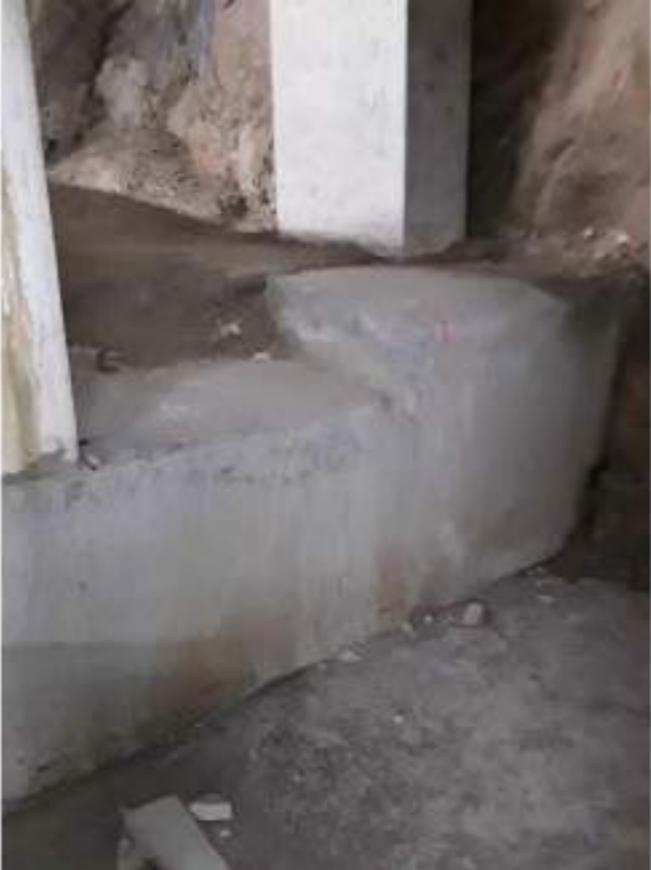
Poor concreting works adjacent to ramp.
C 125	Basement 2	Parking bay 24 (Column)	See section 8.20 of this report

C 124	Basement 2	North of building - adjacent to the ramp	Poor concreting works are adjacent to ramp.	Scabble back and install topping.
C 132	Basement 2	North of building - adjacent to the ramp	Retained formwork in the moist environment.	Remove formwork.
C 133	Basement 2	North of building - adjacent to the ramp	Concrete beam filled with the debris.	Scabble back and install non-shrink grout.
C 134	Basement 2	North of building - adjacent to the ramp	Concreting has not been completed with due care and skill.	Scabble back and install non-shrink grout.
C 137	Basement 2	North of building - adjacent to the ramp	Incomplete concreting.	Scabble back and install non-shrink grout.
C 138	Basement 2	North of building - adjacent to the ramp	Missing concrete.	Scabble back and install non-shrink grout.
C 139	Basement 2	Lift area	Open conduits.	Remove and patch with render.
C 151	Building L - roof	Concrete hob	Rough substrate not compliant with AS4654.2 and manufacturer's requirements.	Scabble back and install non-shrink grout.

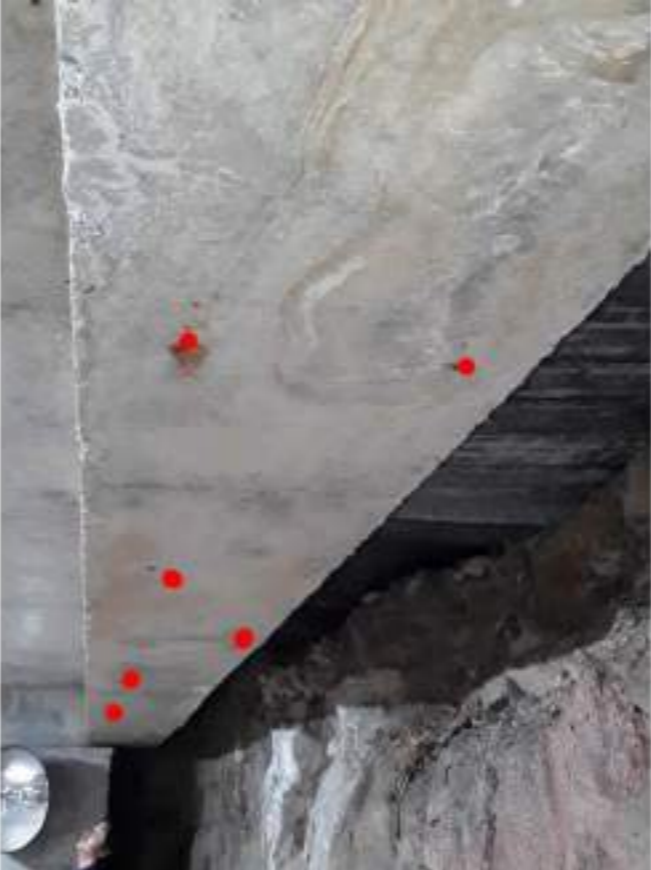
Corroding reinforcement.
C 129	Basement 2	North of building - adjacent to ramp	Structural engineer to inspect.

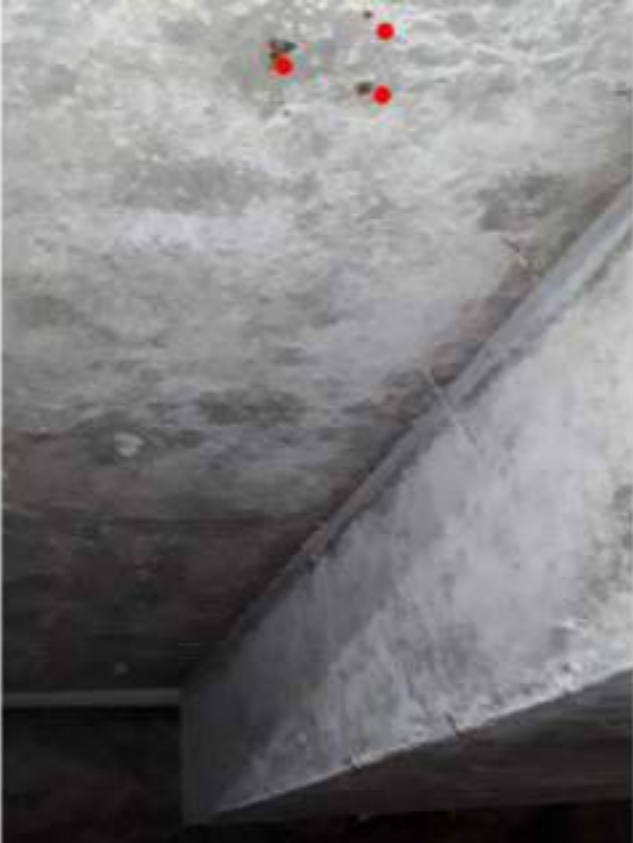
Corroded reinforcements to base of ramp.
C 131	Basement 2	North of building - adjacent to ramp	See section 8.19 of this report. Structural engineer to inspect.

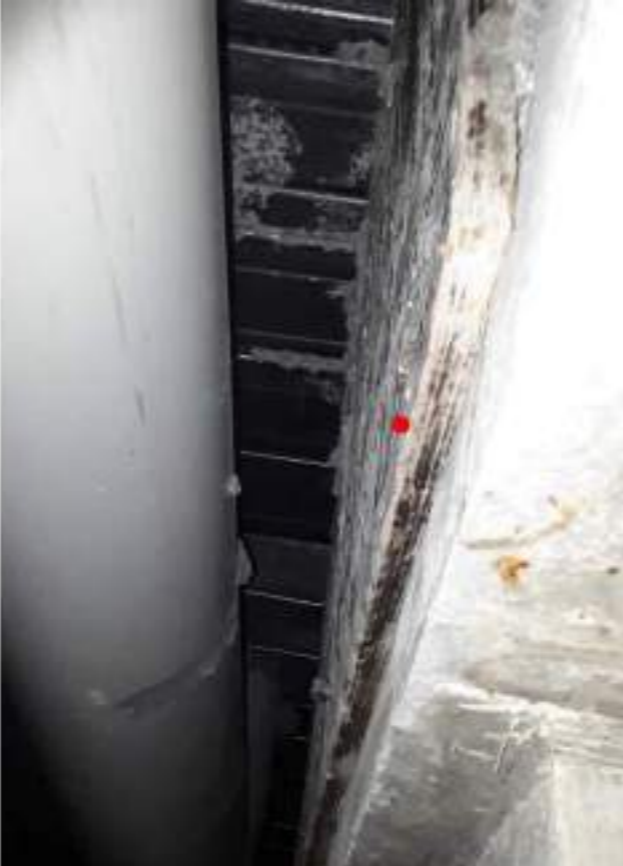
Retained formwork in moist environment. Will attract termites.
C 133	Basement 2	North of building - adjacent to ramp	Works have not been completed with due care and skill.

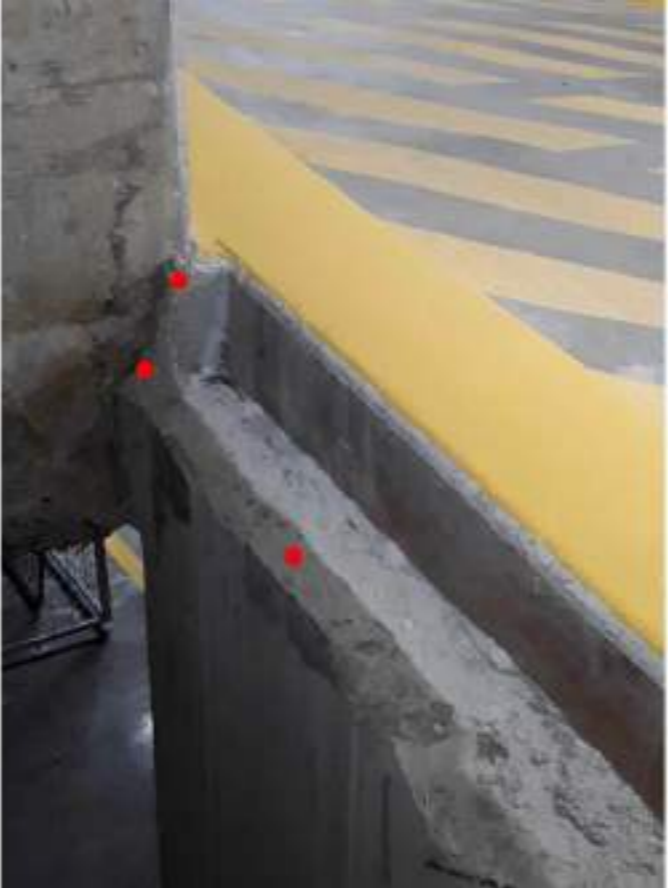
Concreting has not been completed with due care and skill.
C 135	Basement 2	North of building - adjacent to ramp	See section 8.19 of this report.  Structural engineer to inspect.

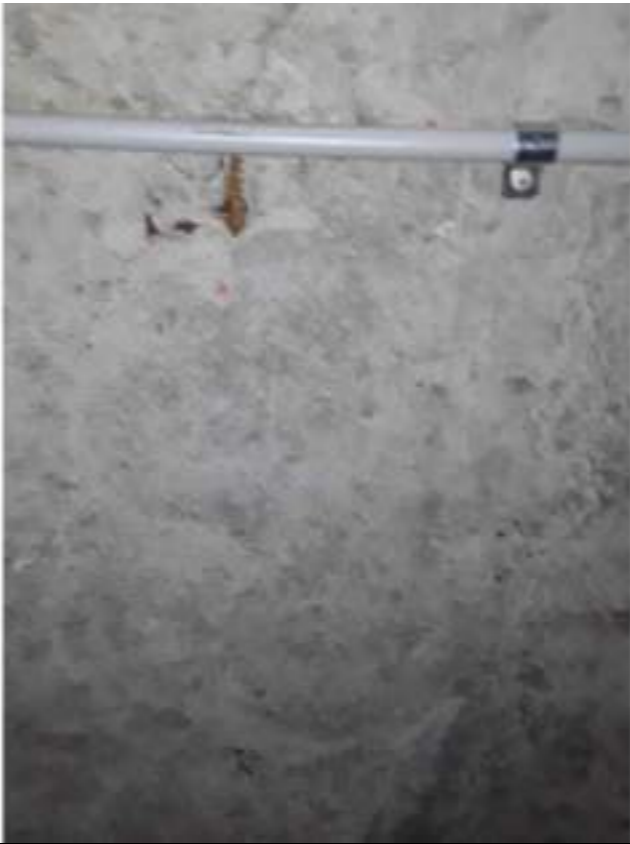
Exposed reinforcement to soffit of concrete ramp.
C 137	Basement 2	North of building - adjacent to ramp	Works have not been completed with due care and skill.

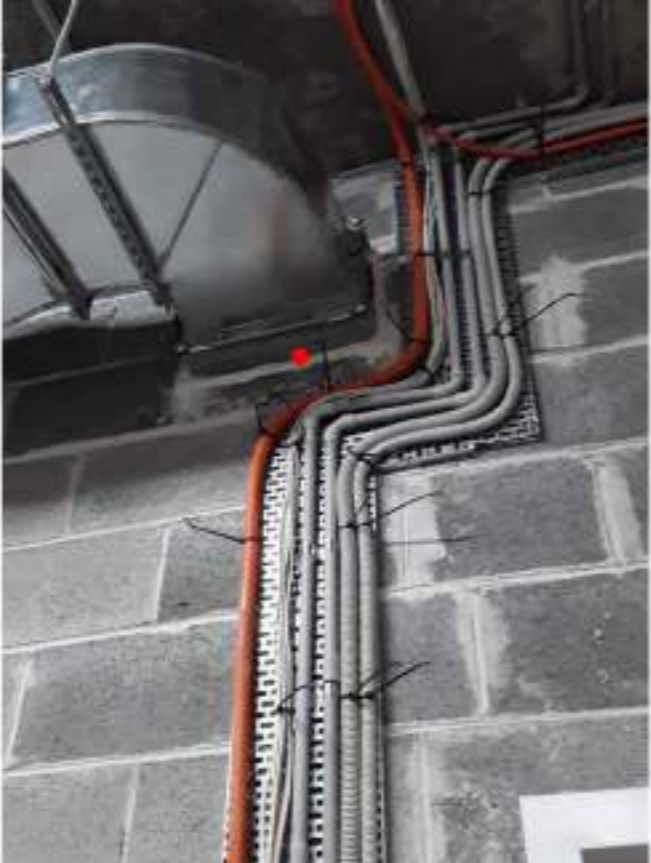
No visible fire damper.
C 143	Building L - Roof	Facade	Note.

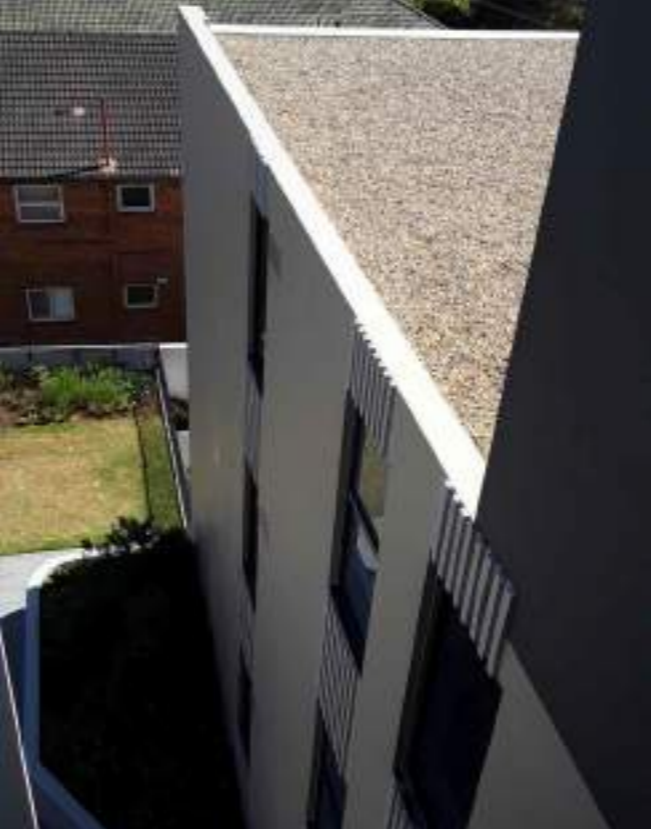
Roof covered with pebbles.

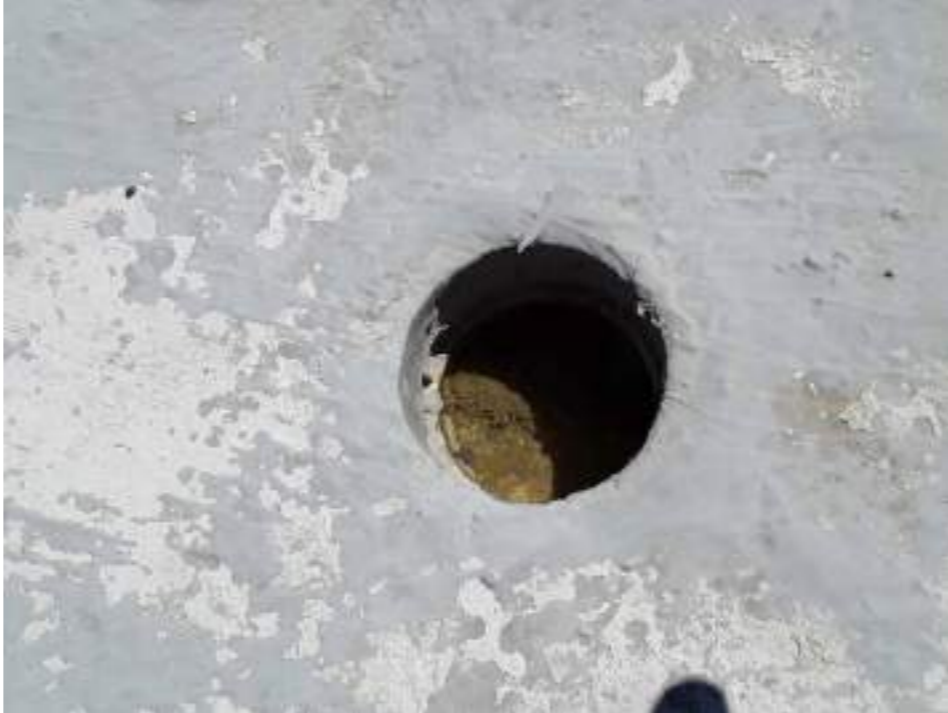
A. Waterproofing not turned down into floor waste. B. Puddle flange has not been provided. C. Drain cover not installed as required by AS4654.2.

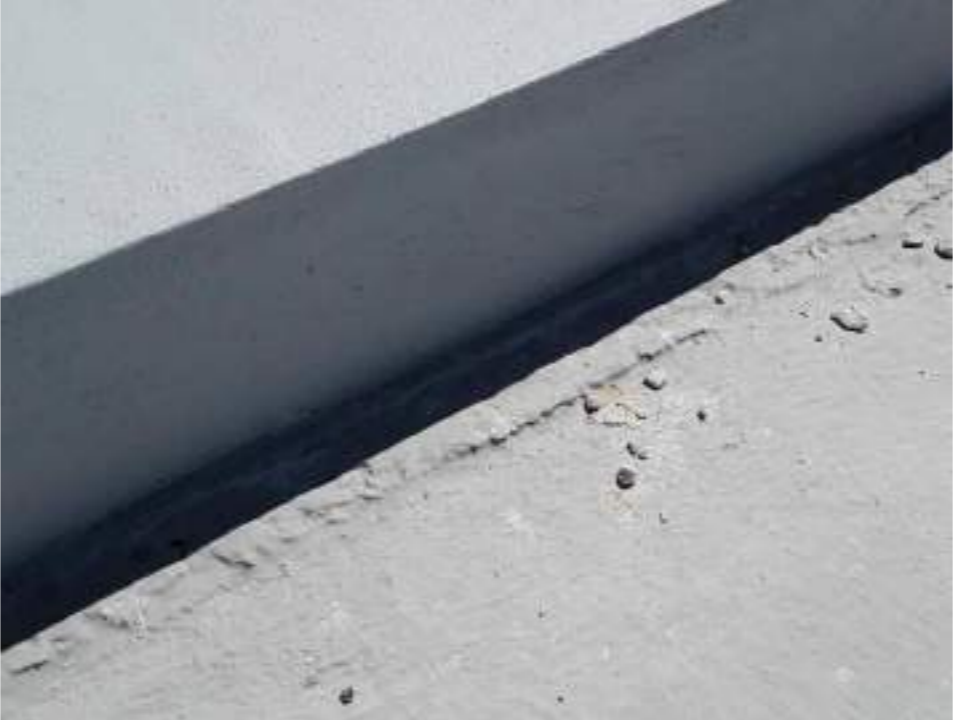
Rough substrate not compliant with AS4654.2 and manufacturers requirements.
C 152	Building L - Roof	Concrete hob	See section 8.11 of this report.

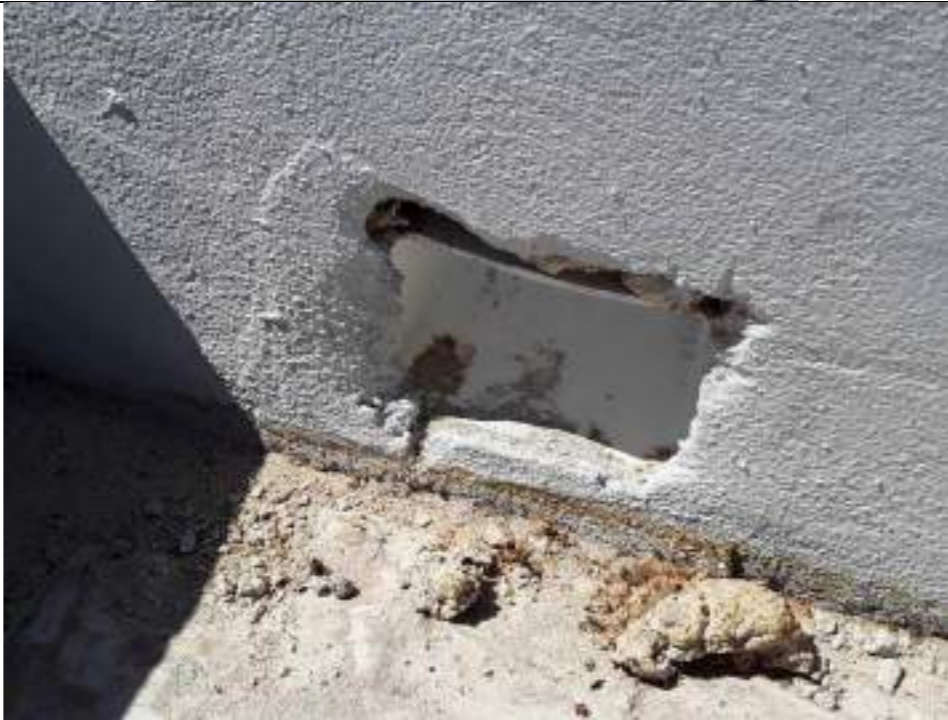
Waterproofing does not turn into overflow.

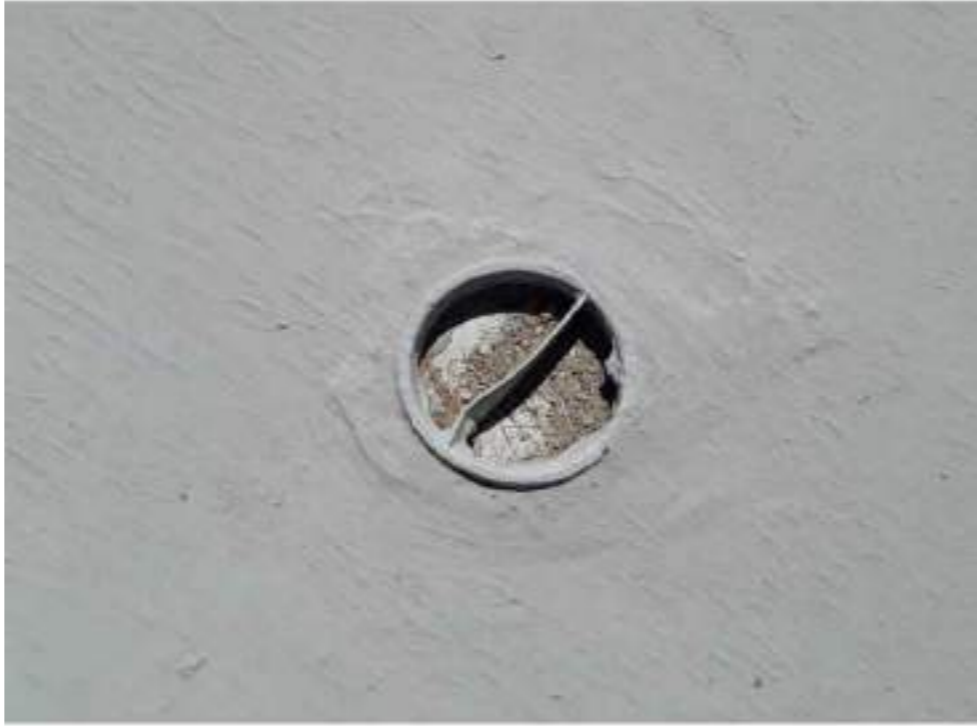
Removal of plug will result in tearing of the waterproof membrane.

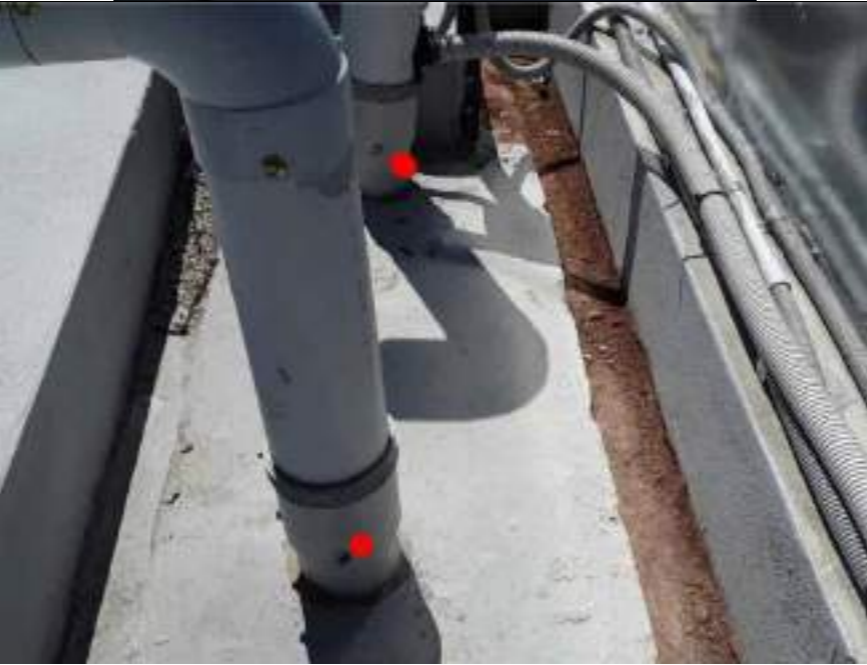
Waterproofing has not been turned up services pipe as required by AS4654.2.

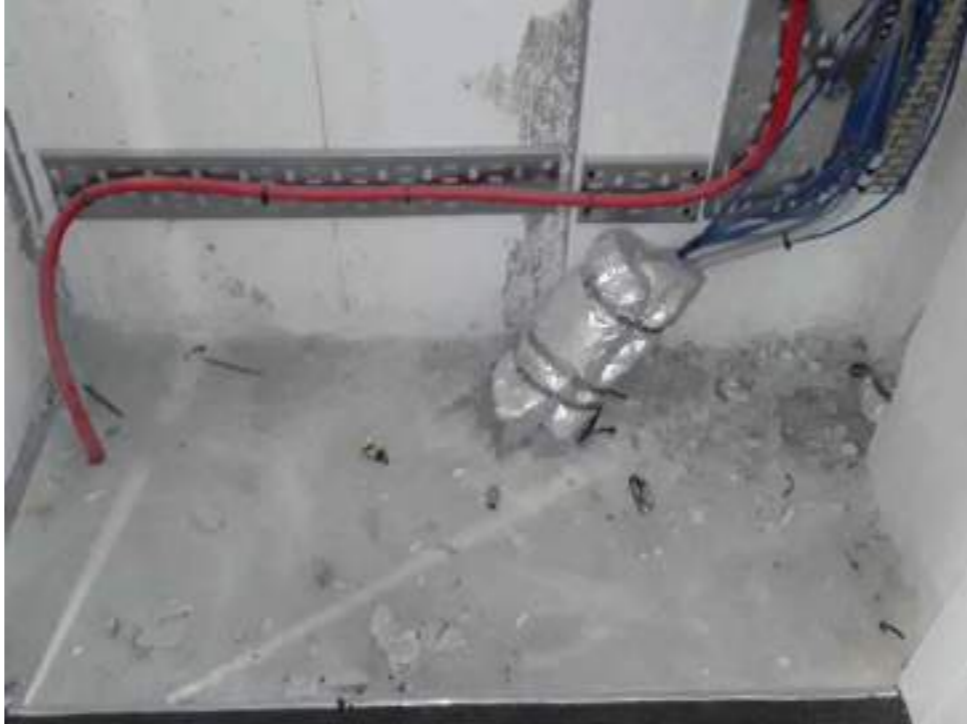
Possible non-compliant fire rating.
C 177	Level G lobby	Service riser	Fire engineer to inspect.

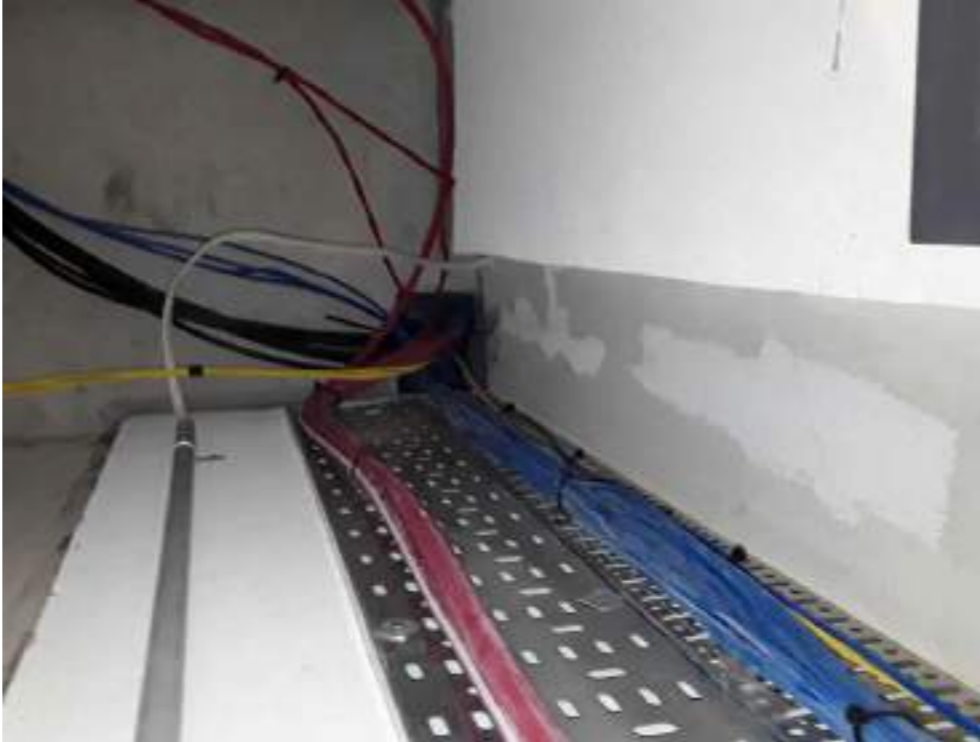
Possible non-compliant fire rating.

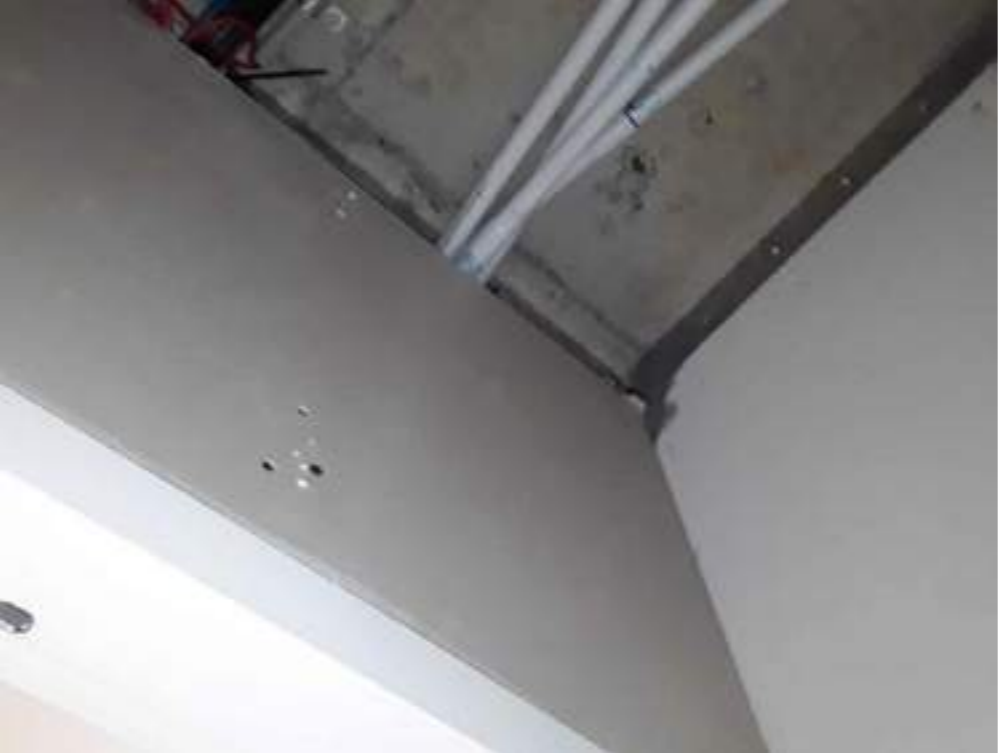
Possible non-compliant fire rating.
C 179	Level G lobby	Service riser	Works have not been completed with due care and skill.

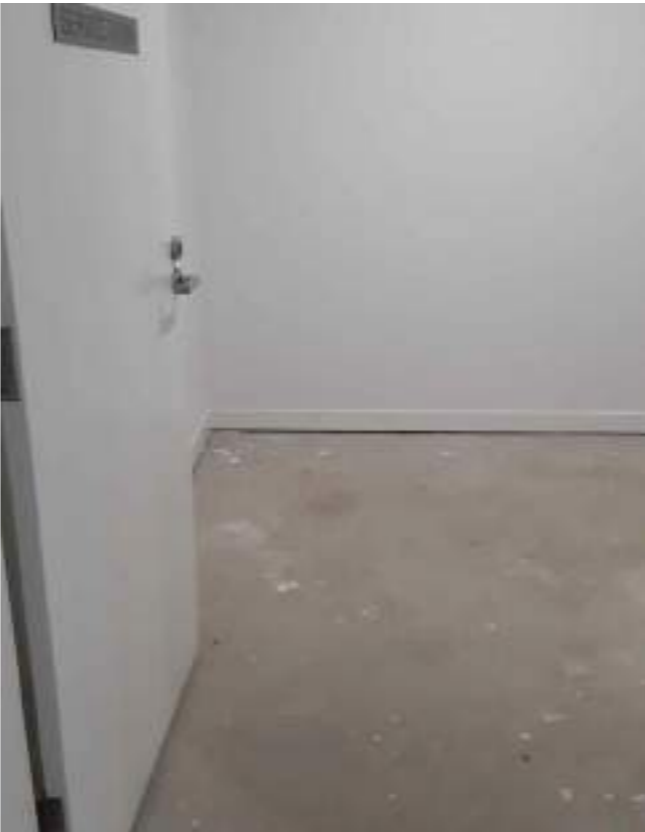
Missing floor finish.

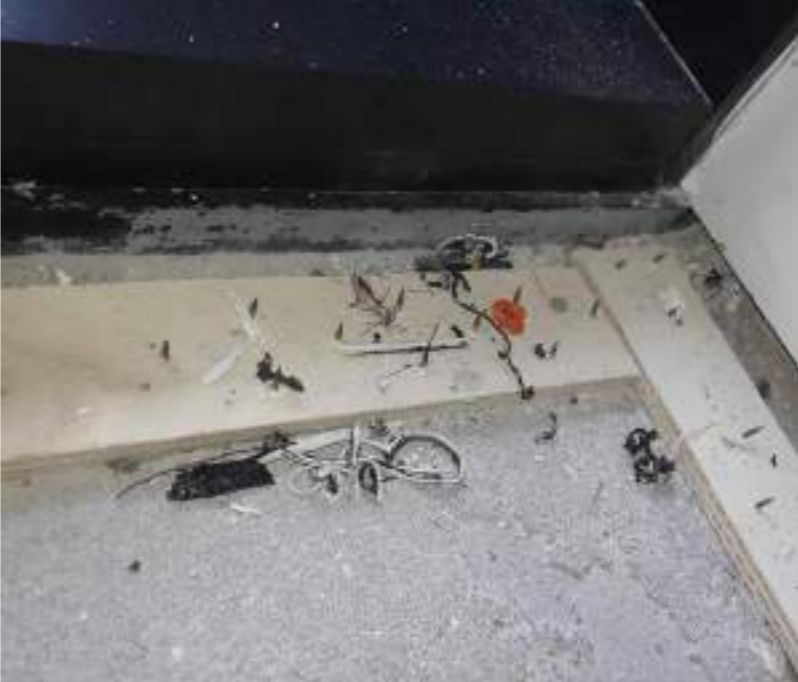
No waterstop.  Aluminium in contact with cement which will cause deterioration.
C 196	Level U4 lobby	Balcony – door threshold	See section 8.3 of this report.

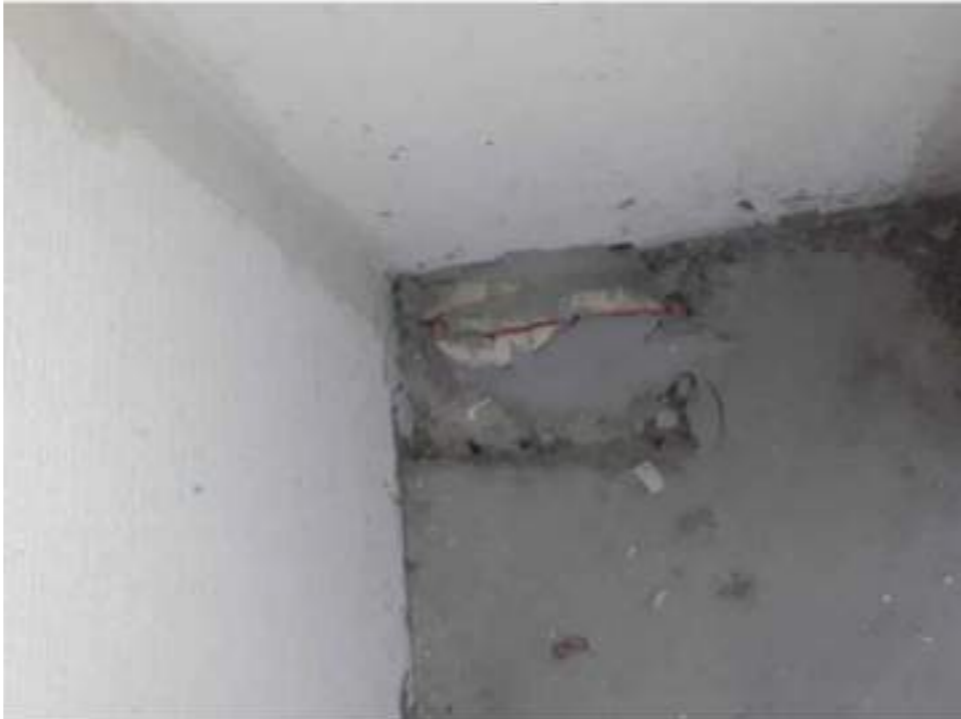
Fire pillow installation.

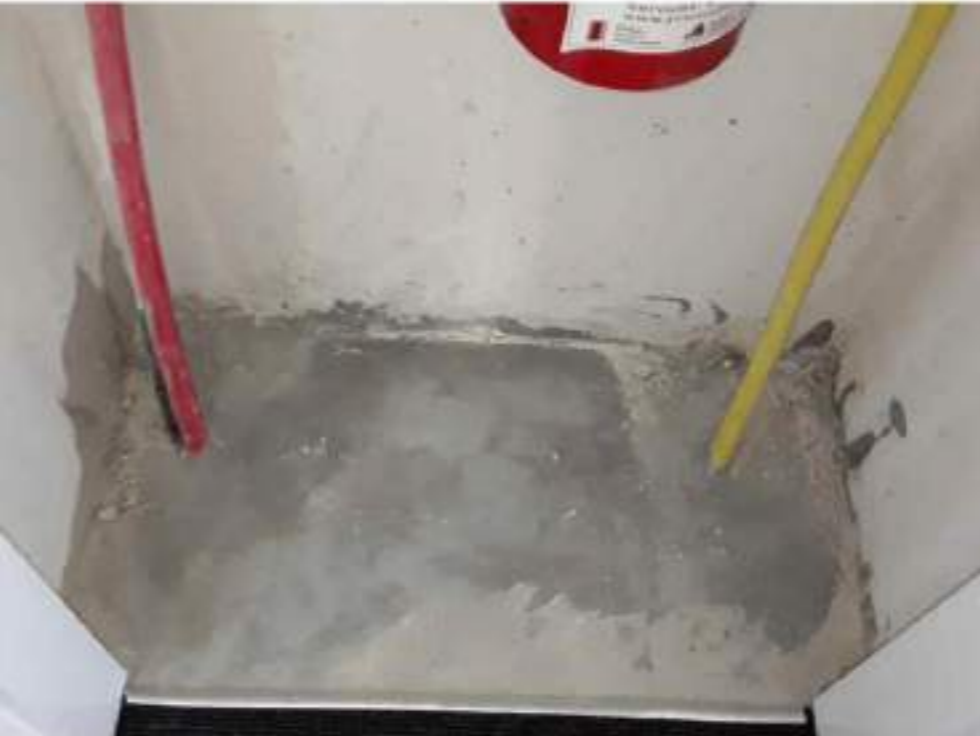
Poly pipes to be inspected by fire engineer.
C 207	Level U4 lobby	Service risers	Fire engineer to inspect.

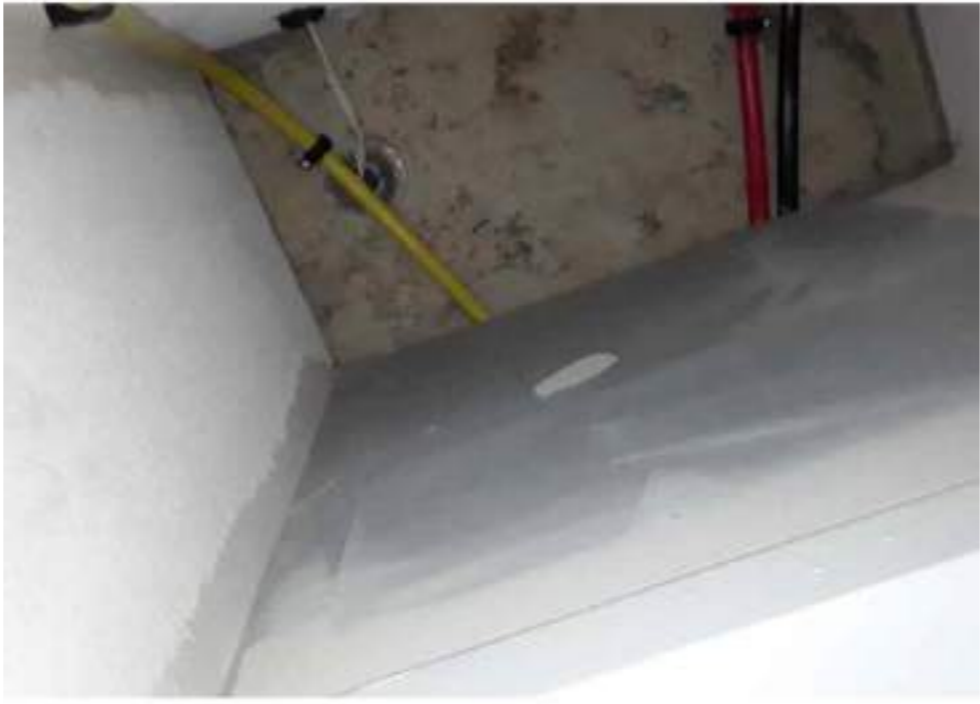
Moisture resistant plaster used to services riser.  Fire consultant to inspect and advise.

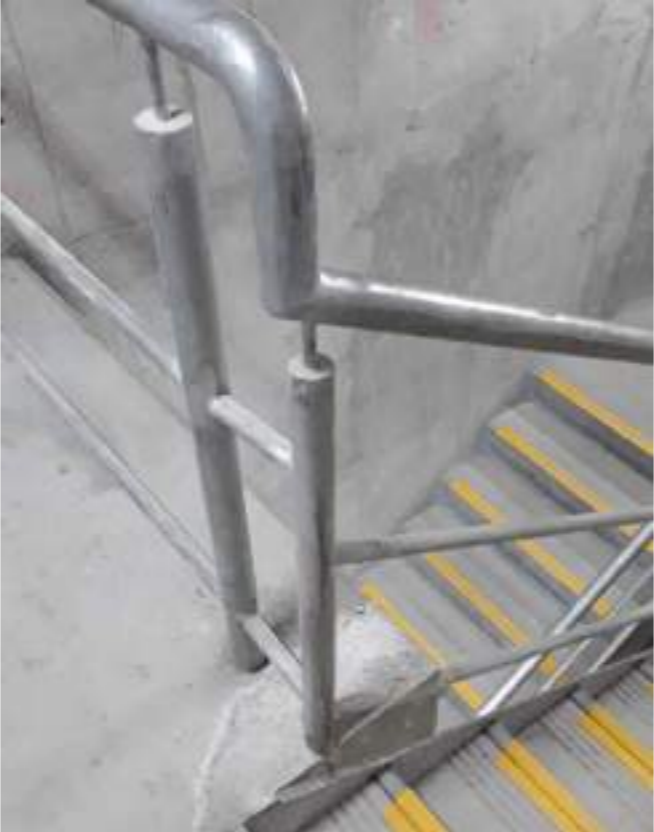
<ul style="list-style-type: none"> <li>A. Handrail not continuous.</li> <li>B. No nosing or compliant non-slip finish.</li> <li>C. Details of paint to be provided to identify if non-compliant and tested to AS4586.</li> </ul>
C 209	Fire stair level U4	Stair nosing	See section 8.15 of this report.

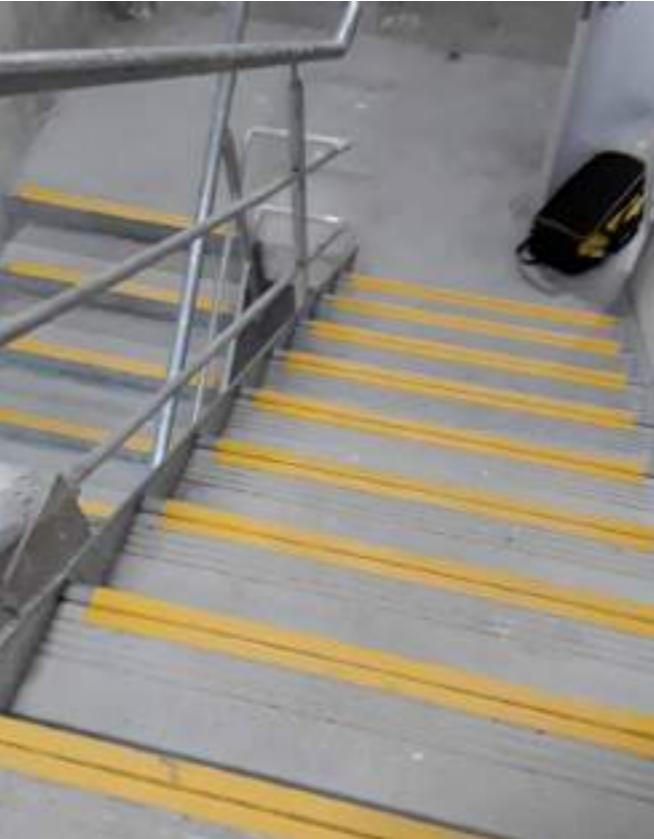
<ul style="list-style-type: none"> <li>A. No nosing or compliant non-slip finish.</li> <li>B. Details of paint to be provided to identify if non-compliant and tested to AS4586.</li> </ul>

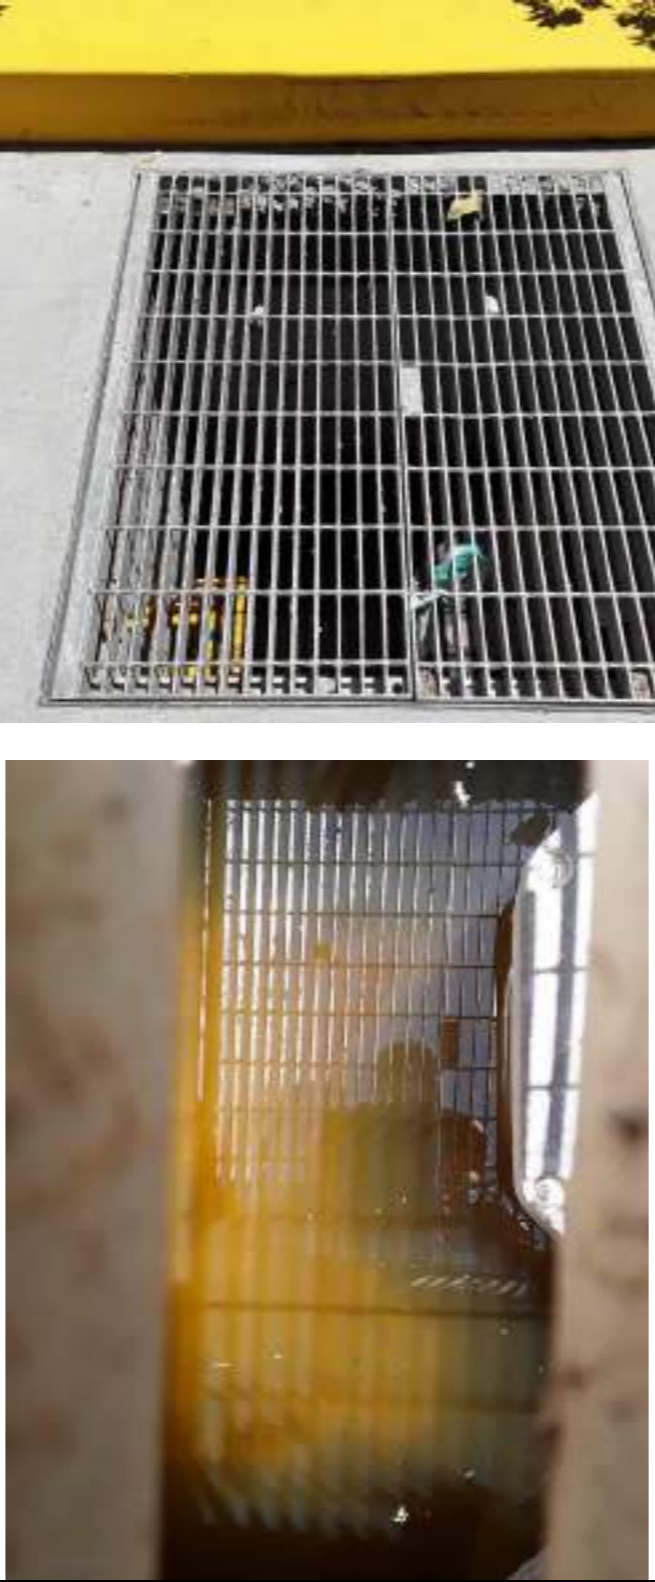
Water ponding in base of driveway pit.

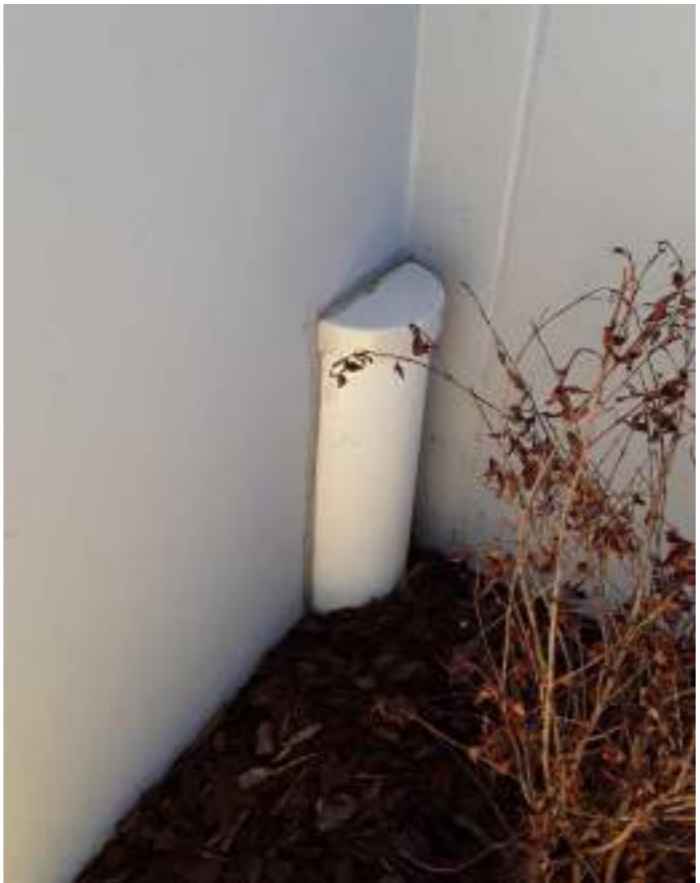
Incomplete pipe in block wall.

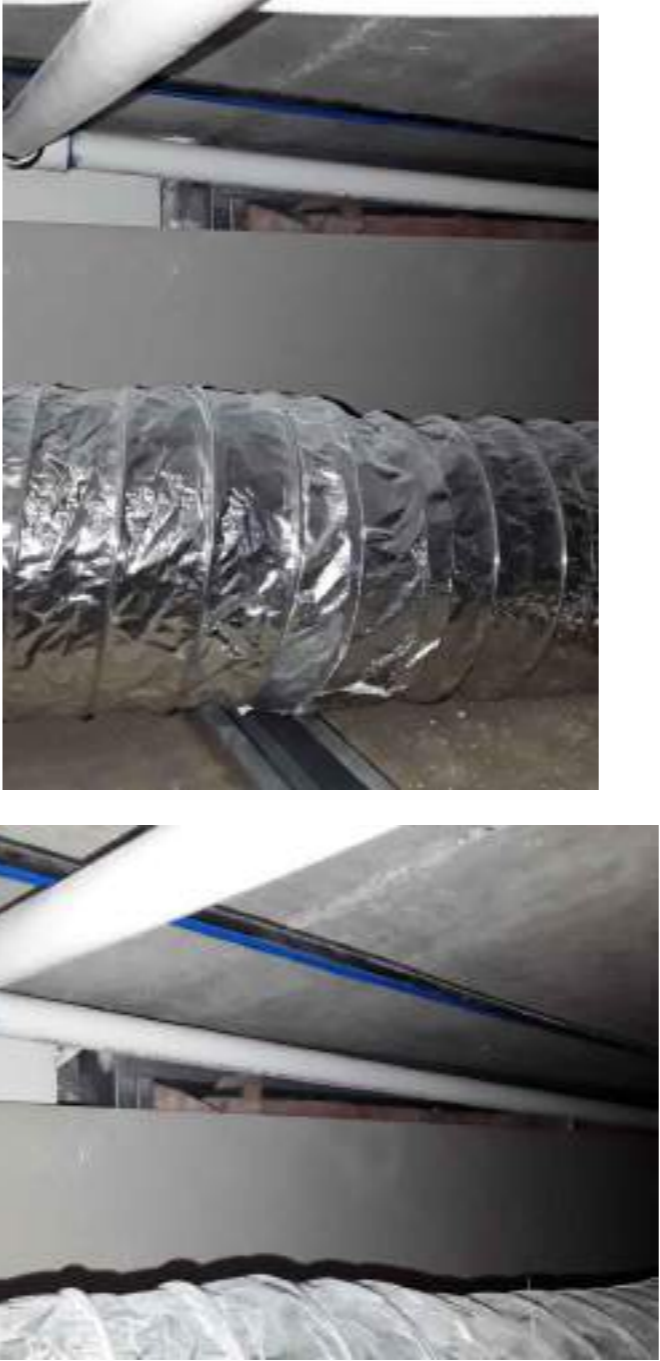
<p>Fire rating between SOC not installed to slab soffit.</p> <p>Fire engineer to inspect and advise.</p>

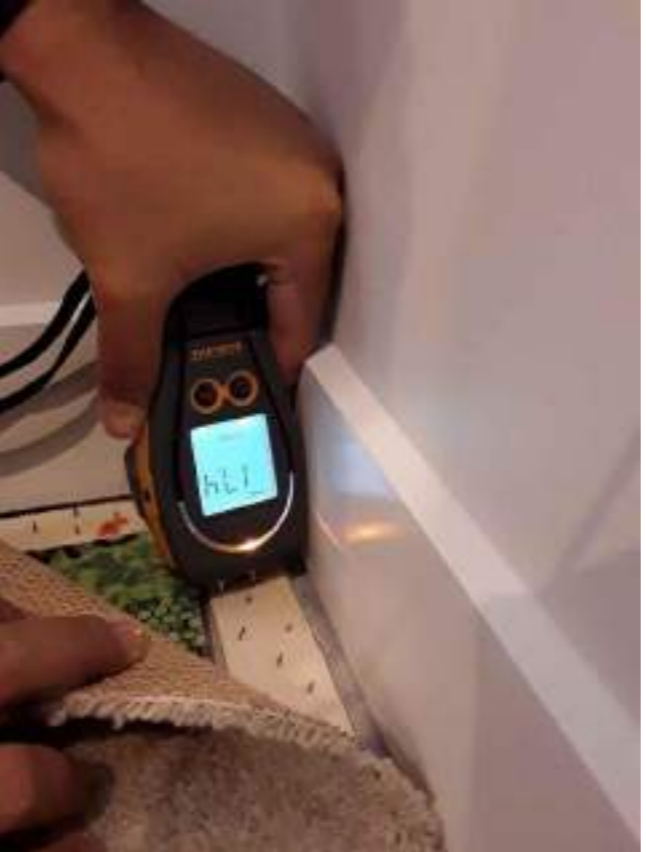
Elevated moisture to base of wall.

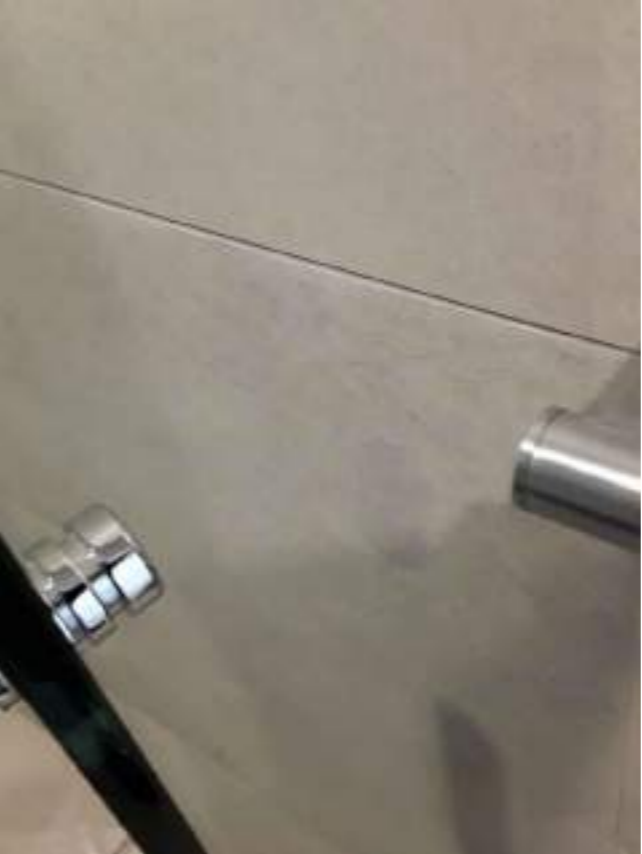
Door can hit tiles. Possible damage to glass door.
U 304.10	Ensuite	Top of door	See section 8.16 of this report.

U G05.13	Ensuite	Vanity (sink)	Void to under-mount sink.	Install sealant.
U 304.9	Ensuite	Shower screen	The door can hit tiles. Possible damage glass door.	Install door stop.
U 306.2	Laundry	Clothes dryer	Instead of shortening the length of the cable, a twist tie has been used to retain the extra length of cable.	Electrician to shorten cable.
U 306.5	Bathroom	Shower screen	Glass not identifiable as safety glass.	Replace with safety glass.
U 306.8	Ensuite	Door striker	Poor painting works below door striker.	Repaint.
U 306.19	Main bedroom balcony	Top of FC cladding	No parapet cap to exposed FC blade wall.	Install Colorbond capping throughout.

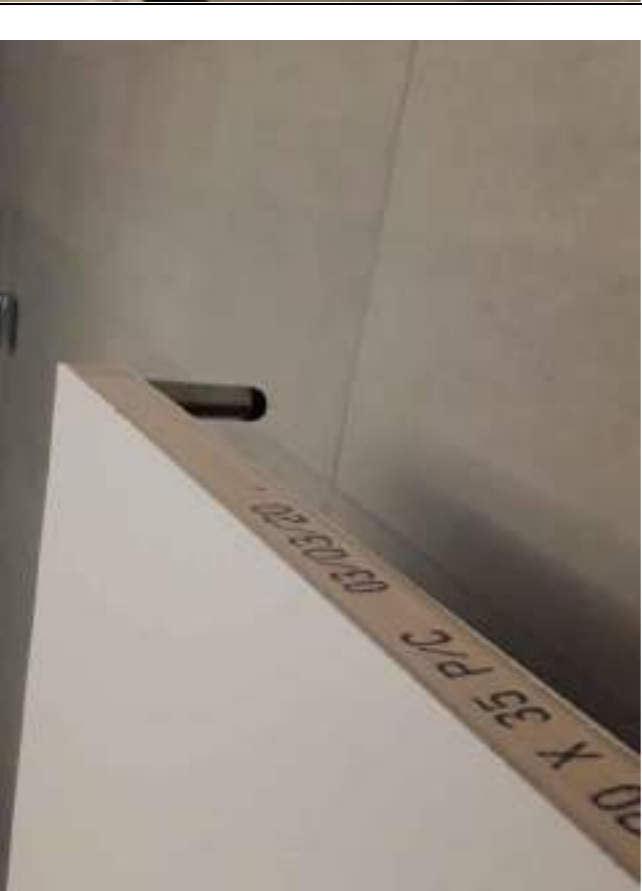
Top of door has not been sealed.

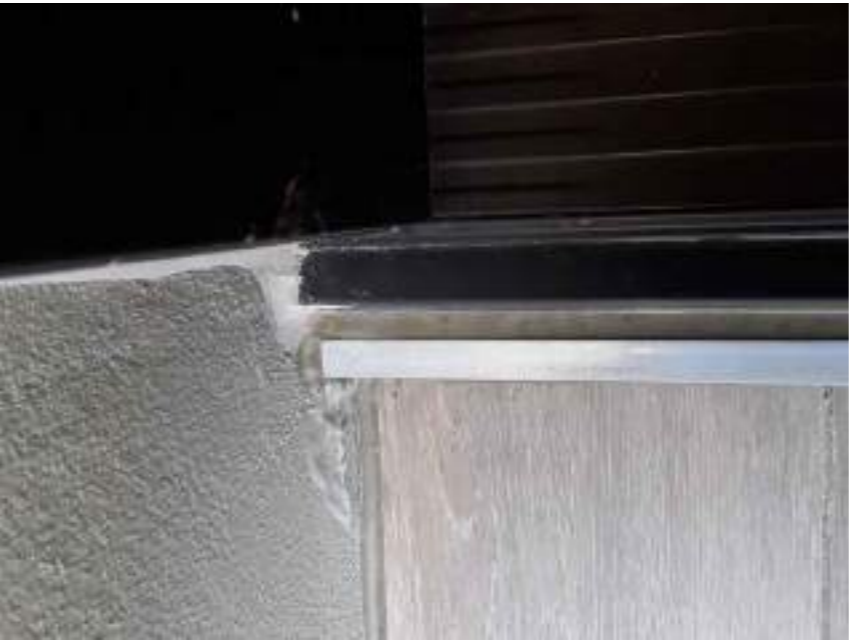
<p>Tile installed proud of subsill not behind as detailed by AS4654.2.</p>
