HOMESAFE INSPECTIONS

COMBINED BUILDING AND PEST INSPECTION

29 Harrison Ave
Bonnet Bay, NSW 2226

31/08/2023

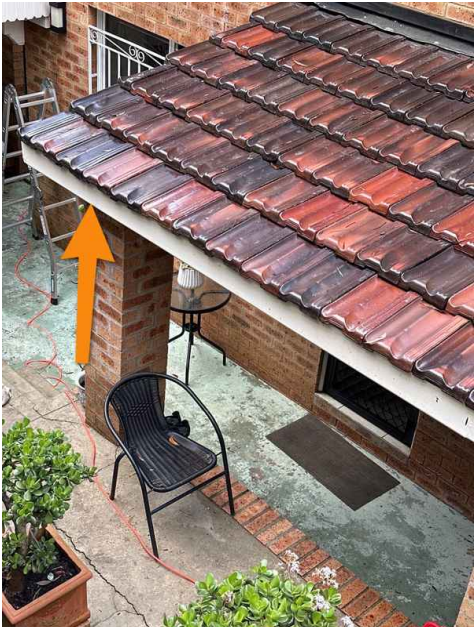
GUTTERS MISSING

A section of the gutter has not been installed/missing on rear patio roof. It is recommended that a qualified roofer be contacted for assessment.

Contact a qualified roofing professional.

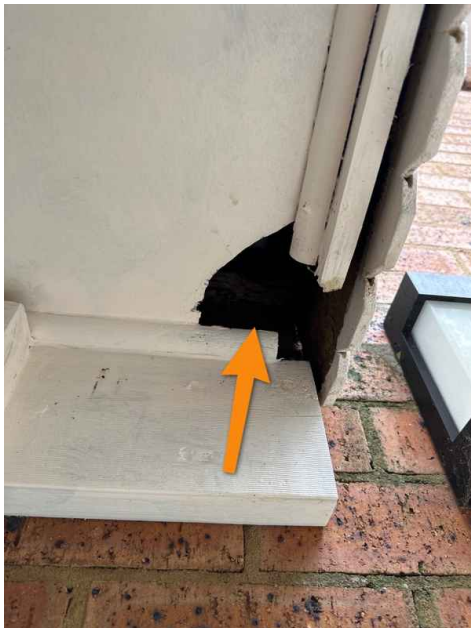
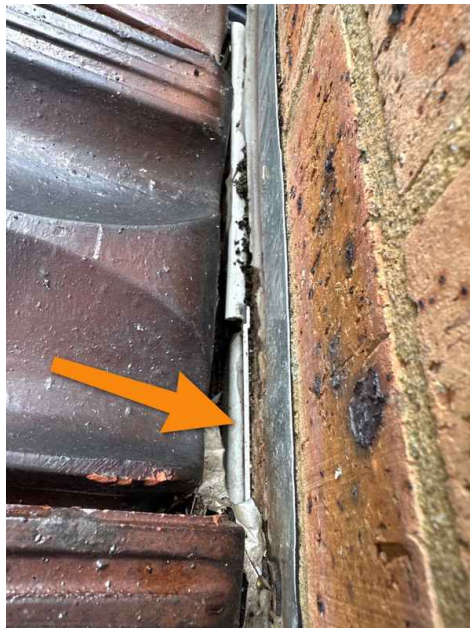
WALL/ROOF JUNCTION LEAK

Evident leak at wall/roof junction. Possible flashing issue

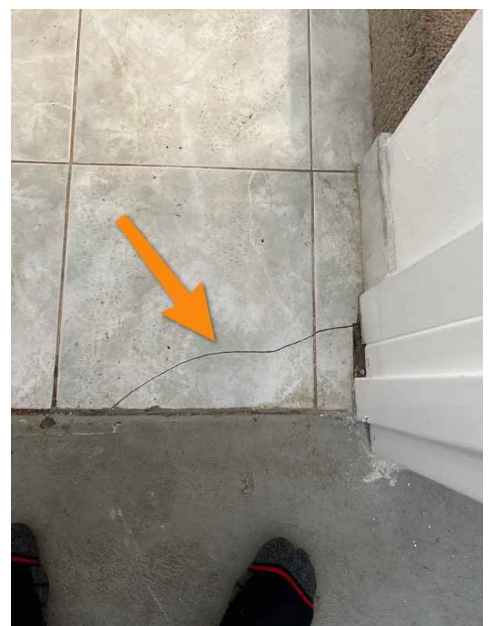
CRACKED TILES

Cracked floor tiles noted

Contact a qualified tile contractor

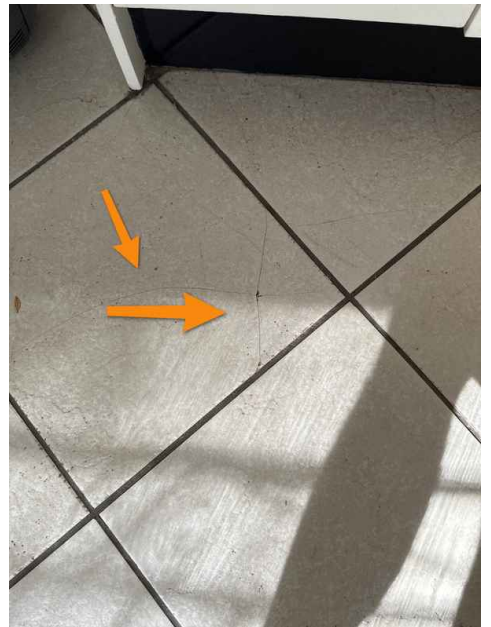
CRACKED TILES

Cracked floor tile/s noted

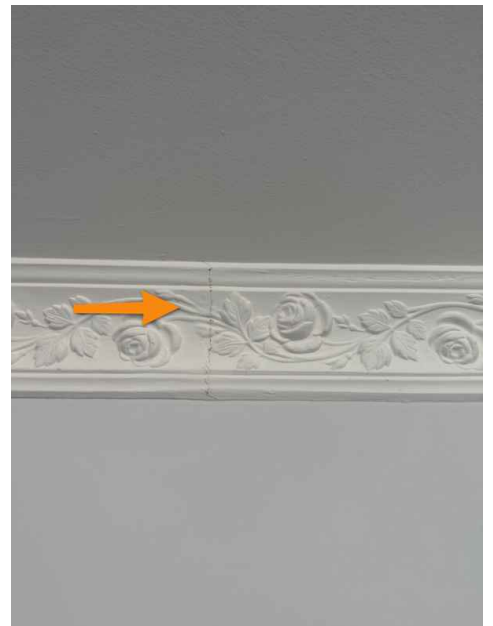
MINOR SETTLEMENT CRACKS

Settlement Cracks Noted. These are typical and generally, patch and paint will suffice, however, we recommend monitor these cracks and if become wider or longer, you will need to contact a structural engineer to assess.

Contact a qualified professional.

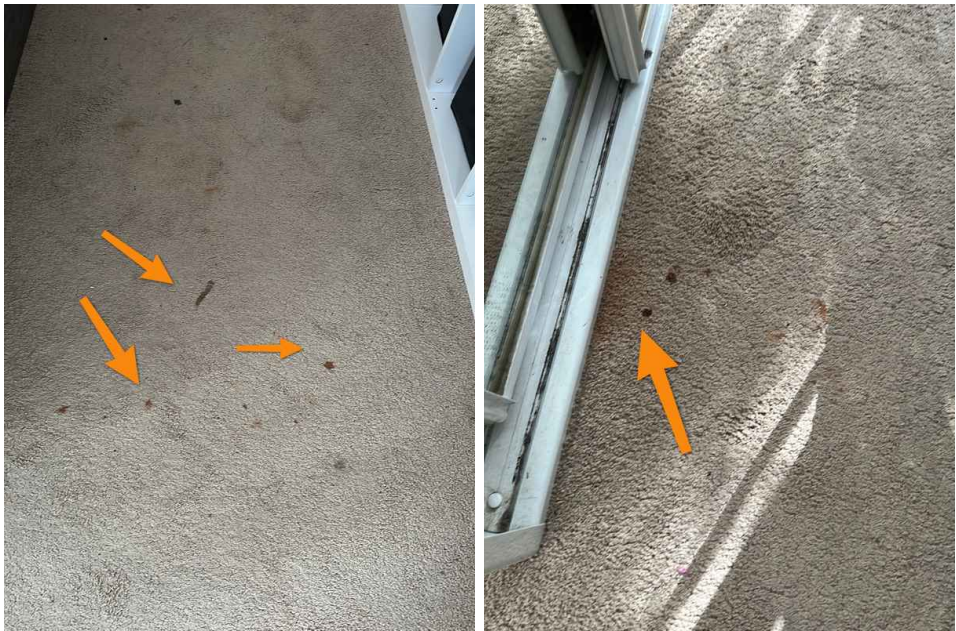
CARPET STAINS

Carpet had areas of staining or discoloration. Recommend a thorough steam clean by a qualified carpet cleaning company

Contact a qualified cleaning service.

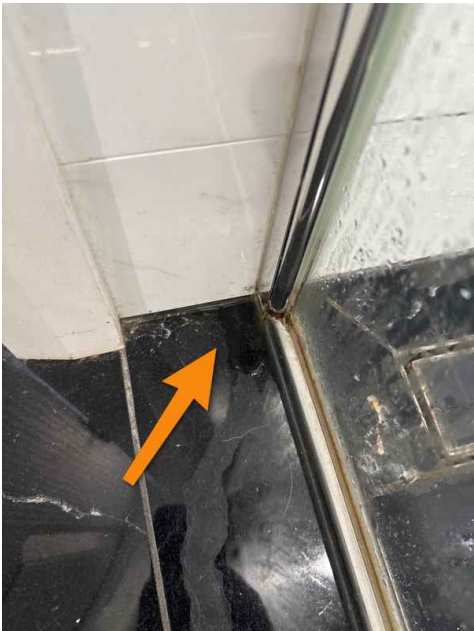
SHOWERSCREEN LEAK

Water is leaking under the shower screen. Recommend adequately resealing floor and wall junctions.

Contact a qualified general contractor.

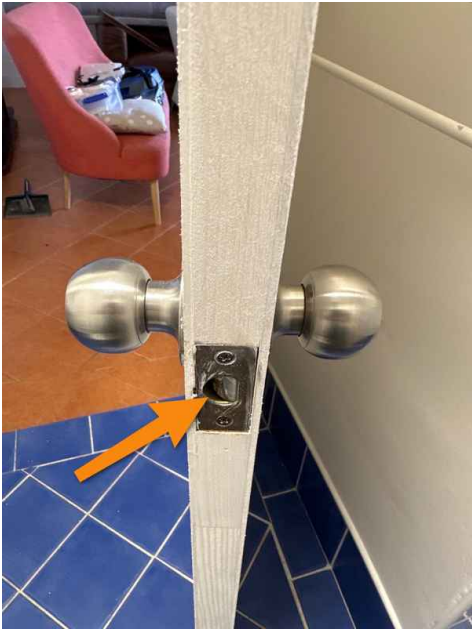
DOOR HARDWARE LOOSE/POSSIBLY DAMAGED

Door lock is loose and/or possibly damaged.

Contact a qualified carpenter.
