## Building Report

63 Buchanan Ave, Bonnet Bay

## **BUILDING & TIMBER PEST INSPECTION REPORT TO AS4349.1 2007 & AS4349.3 2010**

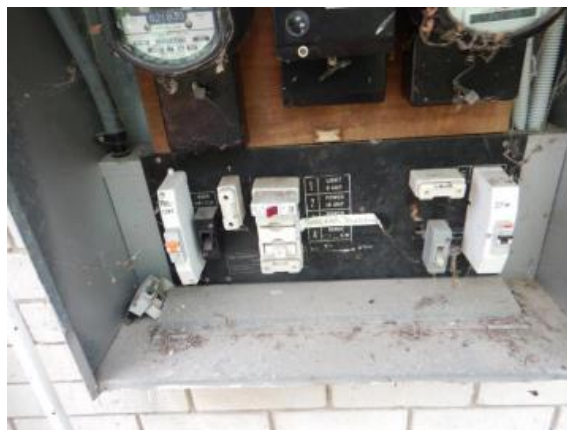
**Electrical Safety Switch:**

- Not present. This is considered a major safety hazard and requires immediate installation. We recommend an electrician be engaged to install a new safety switch and also check all electrical wiring / fittings & fixtures.

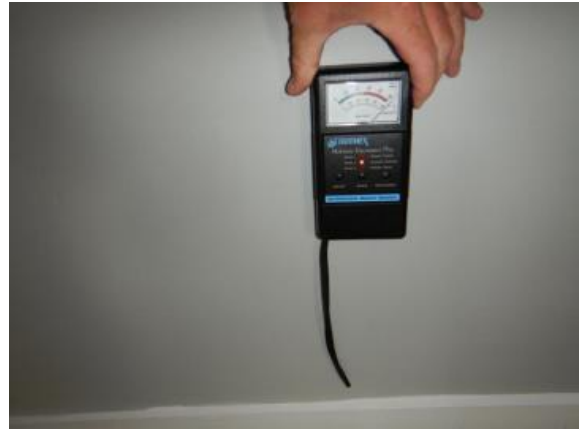
High moisture levels, were detected in the wall at the rear of the ensuite shower. I recommend that a plumber be engaged to conduct a compression check on the combination and pipes and to also check the wetseal.

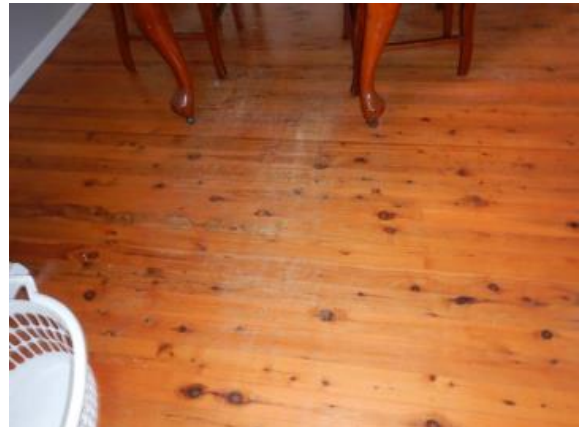
Signs of wear to some polished floor boards requires re-polishing.

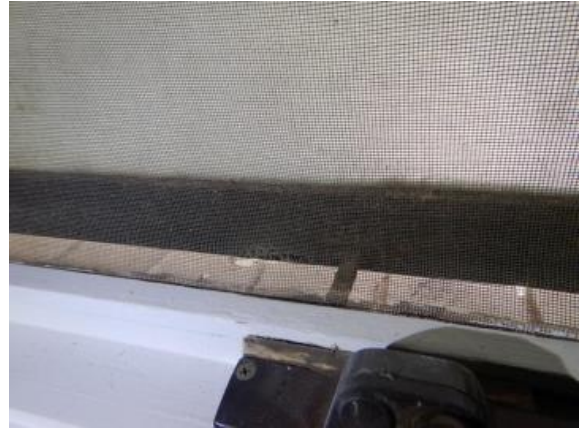
Some gauze requires repair.

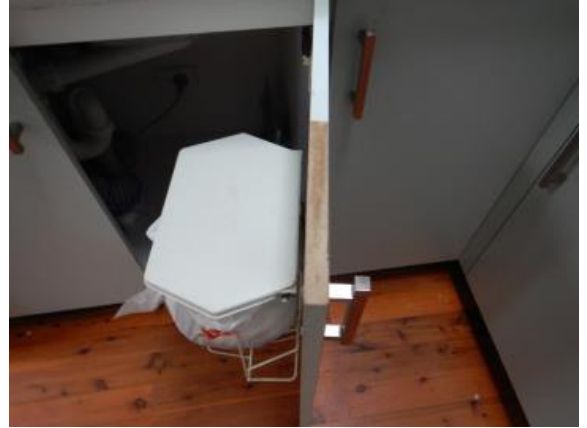
Some edge stripping requires repair.

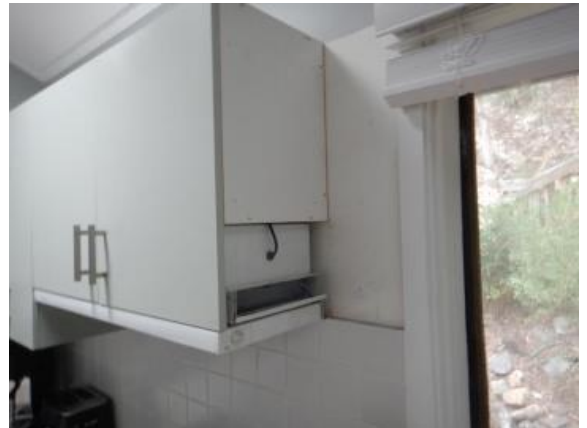
End panel to overhead cupboard is missing and requires replacement.

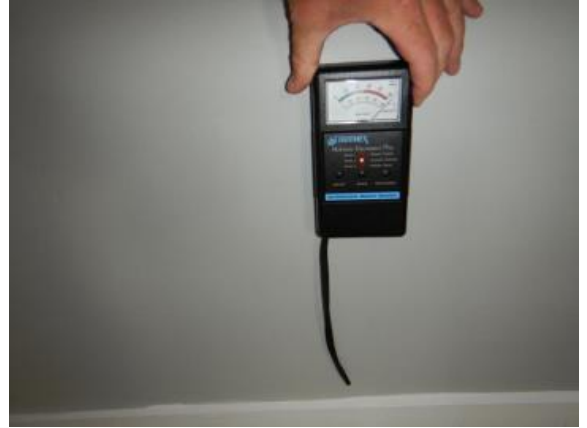
There are signs of high moisture levels in the wall at the rear of the Ensuite shower. I recommend that a plumber be engaged to conduct a compression check on the combination and pipes and to also check the wetseal.

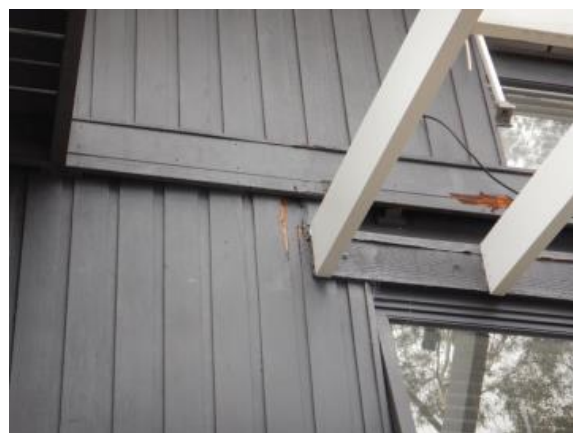
Some external cladding shows signs of damage and require repair / repainting.

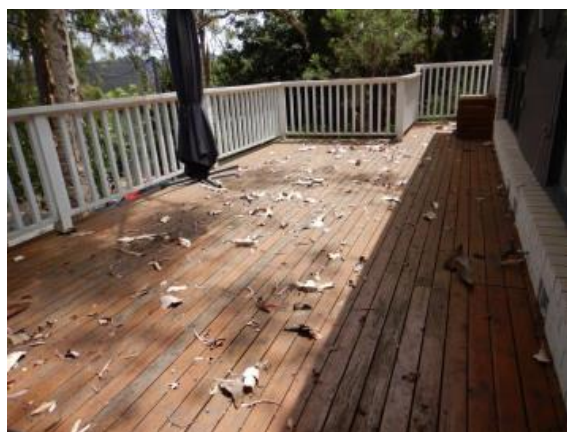
Some decking & framing timbers show signs of weather damage and require repair / refixing / repainting.

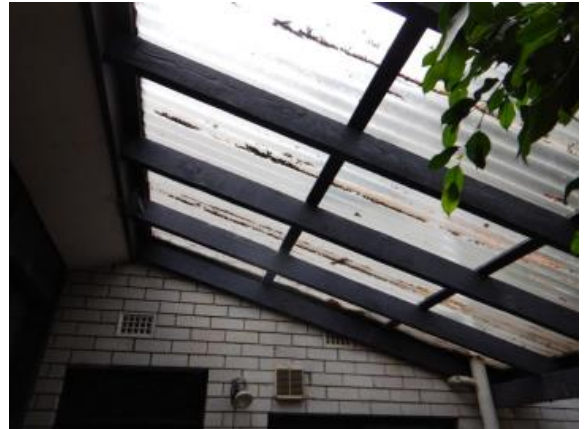
Polycarbonate or similar sheeting is present to some roofing areas and should not be walked on - This is a potential Safety Hazard.

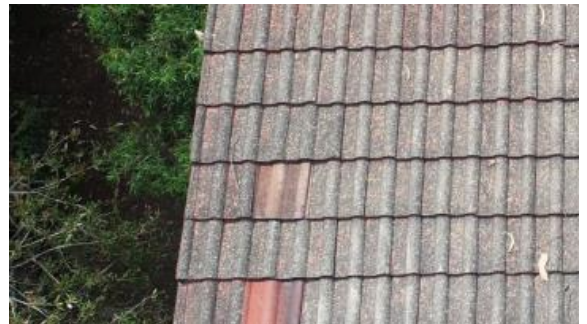
Some tiles have shifted slightly and require re-positioning to avoid any potential leaks.

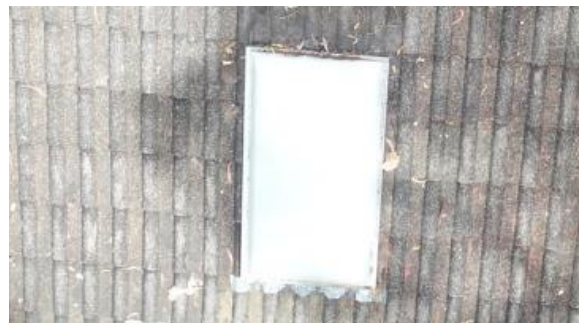
Metal trim surrounding the skylight is showing signs of rust and requires treatment with Killrust or similar.

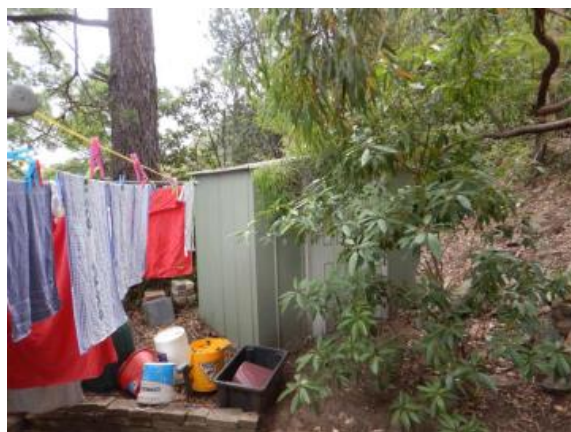
Doors require adjustment.

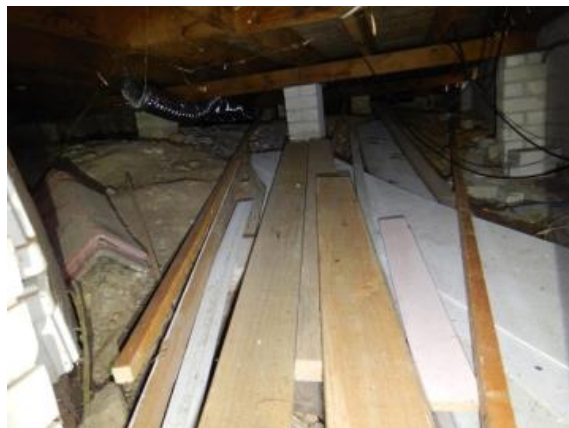
- We recommend the removal of stored timbers from the underfloor as timbers in contact with soil are highly attractive to termite attack.

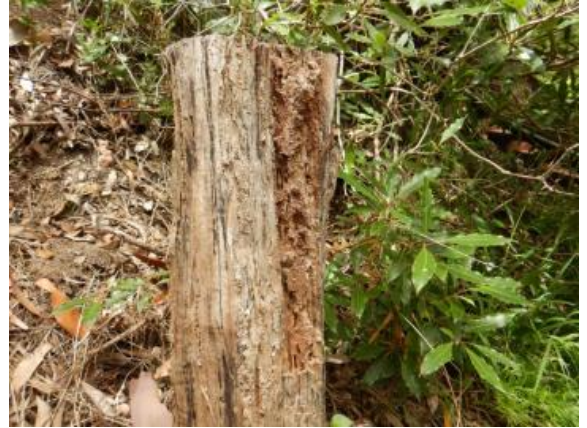
Various tree stumps.

The visible damage to the timbers appears to be moderate to extensive. Further damage probably exists in concealed areas. Please refer to the definitions section of this report - Section 1.2 - Timber Damage.

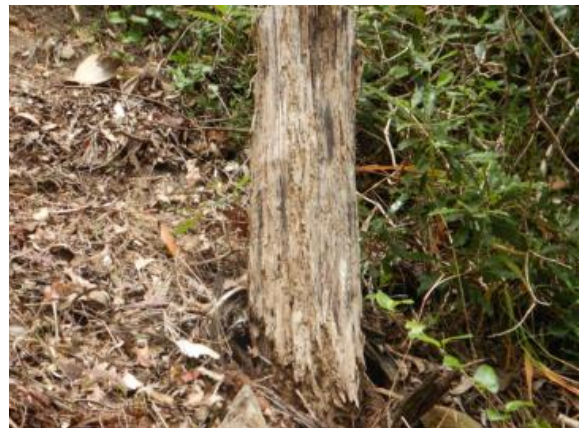
- Tree stumps should be removed as they provide an area for termites to establish a colony.
