RE: Building & Pest Inspection & Report – 12 Honeysuckle St, Jannali

BPI - INSPECTION REPORT

12 Honeysuckle St, Jannali.

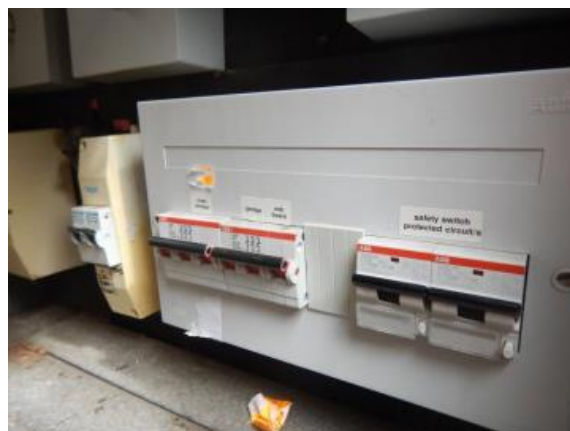
Whilst not an electrician, it appears that an electrical safety switch is present.

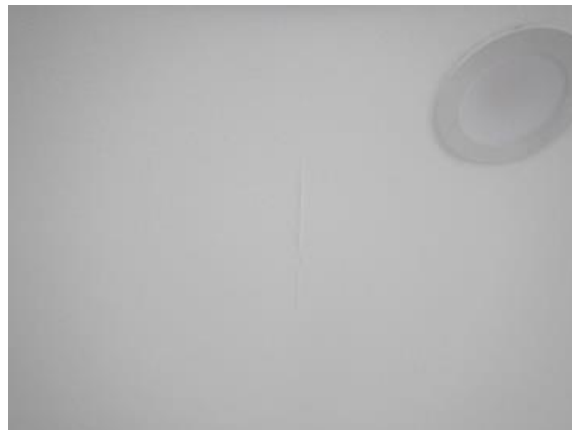
Cracks to some ceiling sheeting.

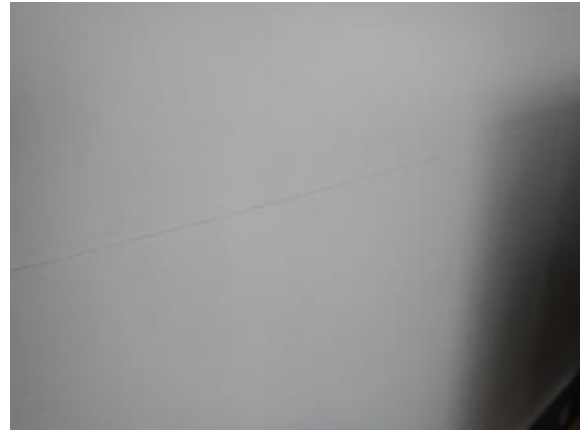
Cracks to some wall sheeting.

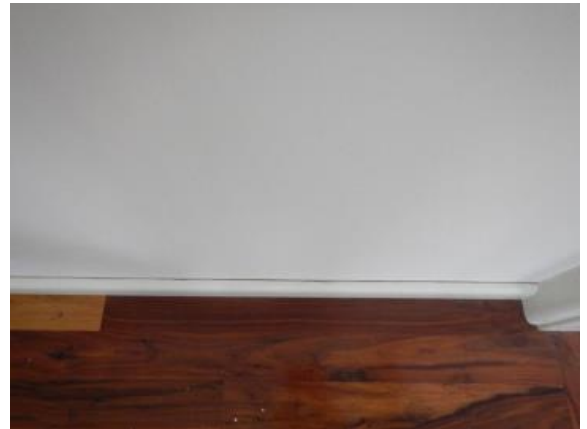
Gaps at some skirting / wall joins require sealing.

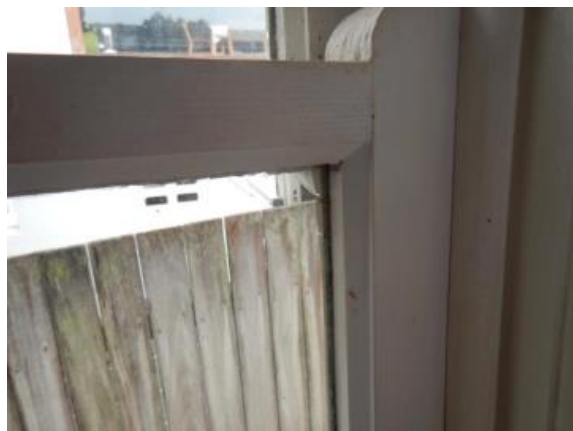
Cracked glass to some windows.

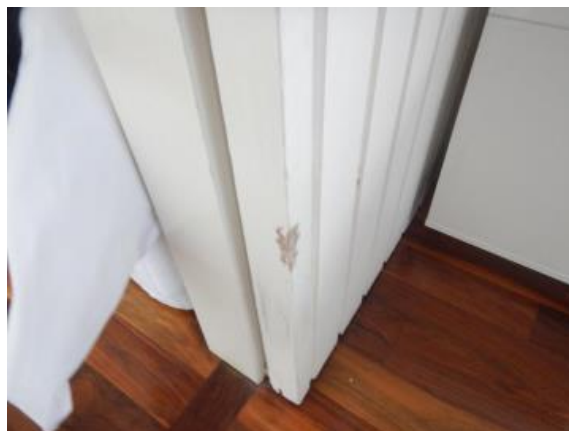
Paintwork to some doors requires touching up / repainting.

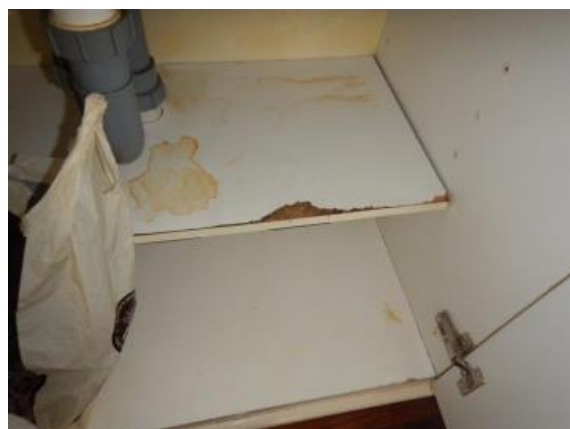
Evidence of water penetration / damage to sink cupboard.

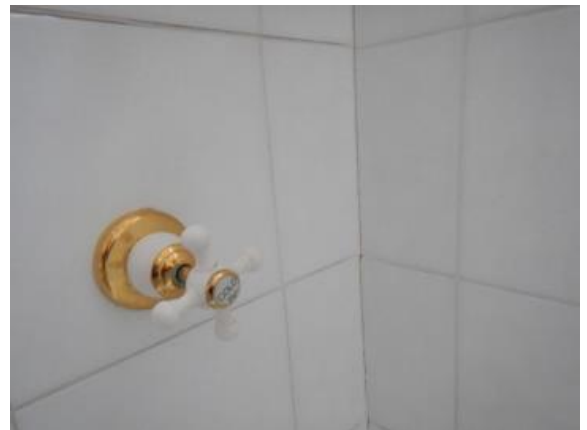
Some wall tiles require regrouting and resealing.

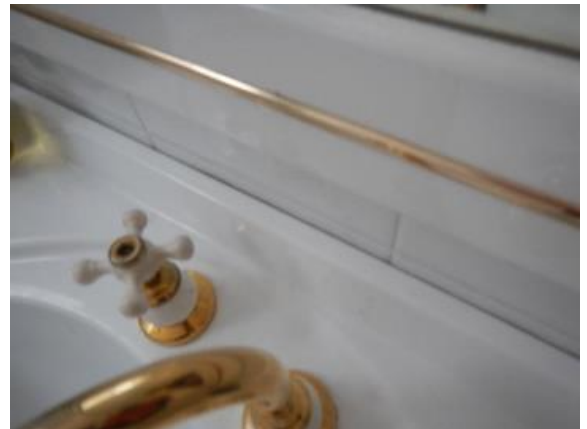
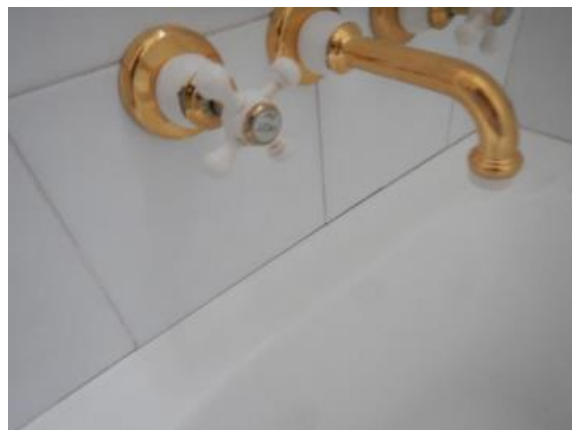
Junctions of Bathroom vanity and wall tiles require resealing with silicone.

Junctions of bath / wall tiles require resealing with silicone.

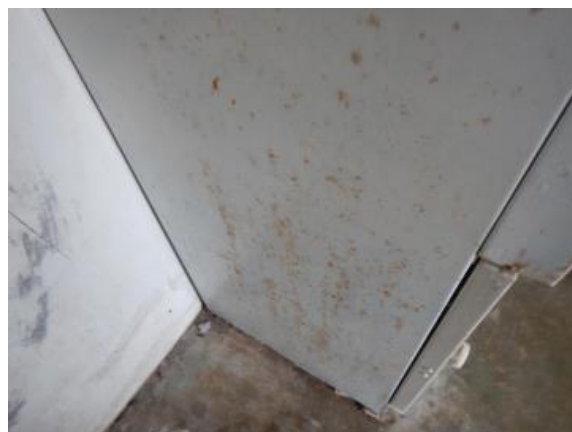
Rust to laundry tub cabinet requires repair / repainting.

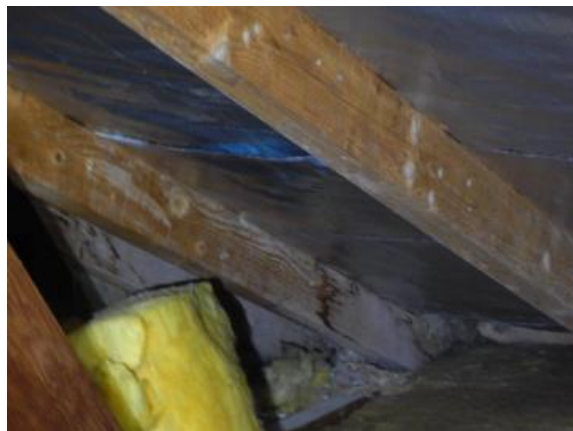
There is evidence of past water penetration within the Roof Void.

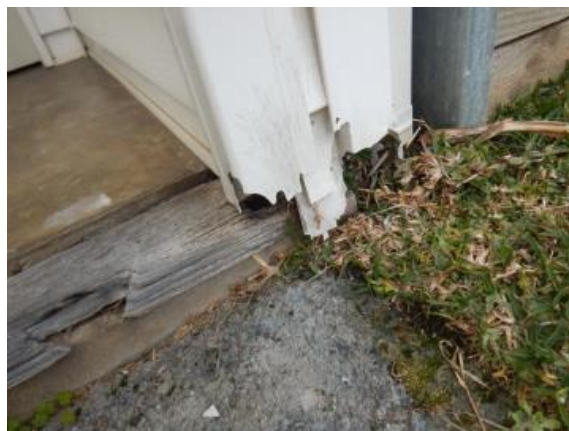
Some external cladding is damaged and requires repair / patching.

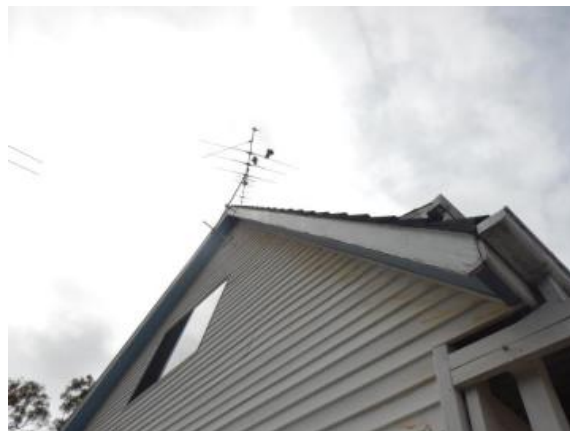
Some fascia timbers show signs of weather damage and require repair / sealing.

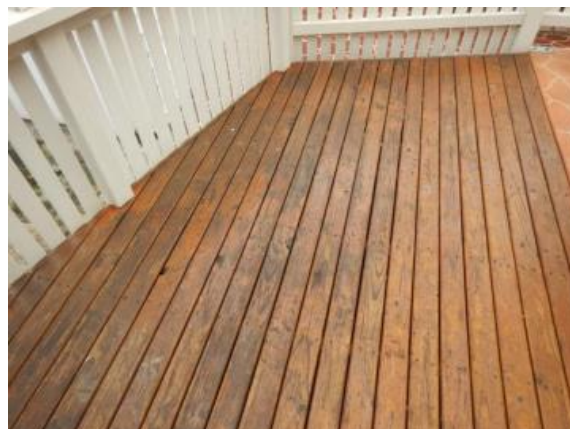
Some verandah decking timbers show signs of weather damage and require repair / refixing / resealing.

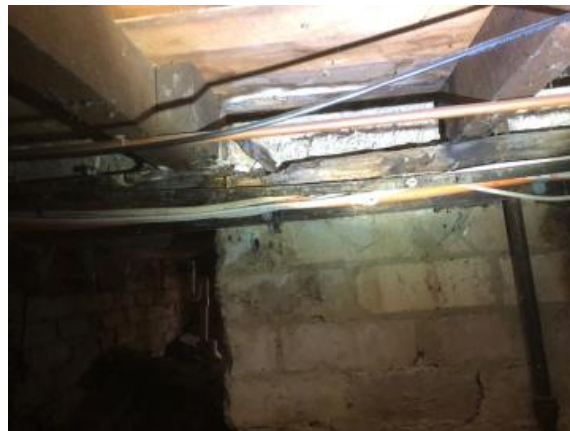
Some flooring shows signs of past water penetration to Bathroom.

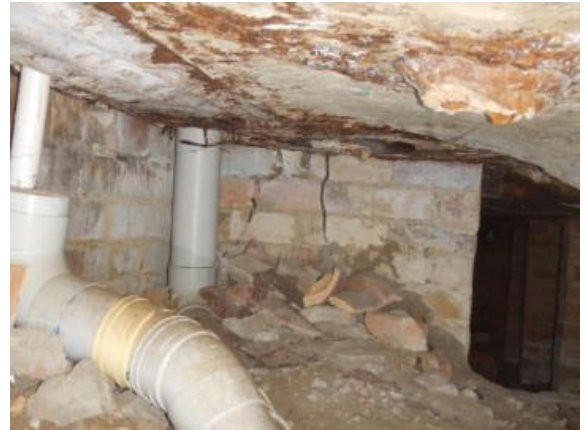
Termite workings have been noticed within the subfloor area.

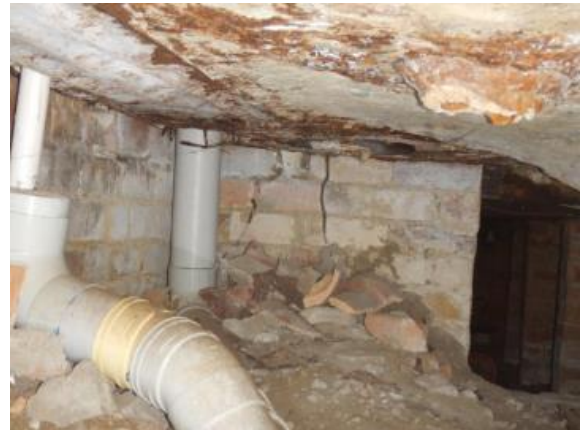
Old formwork sheets are rusted and restricting the inspection of the underside of the slab.

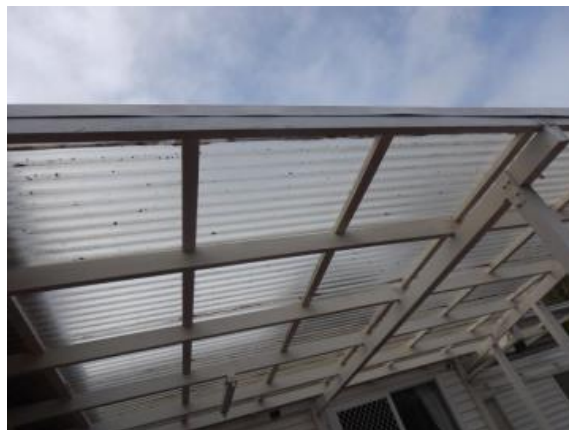
Polycarbonate or similar sheeting is present to some roofing areas and should not be walked on - This is a potential Safety Hazard.

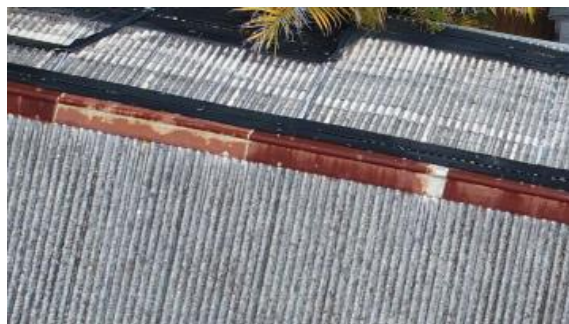
Surface rust to roof flashings to garage requires repair / painting with Killrust or better.

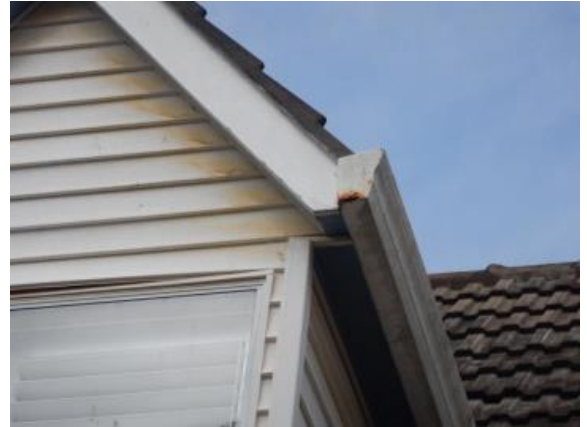
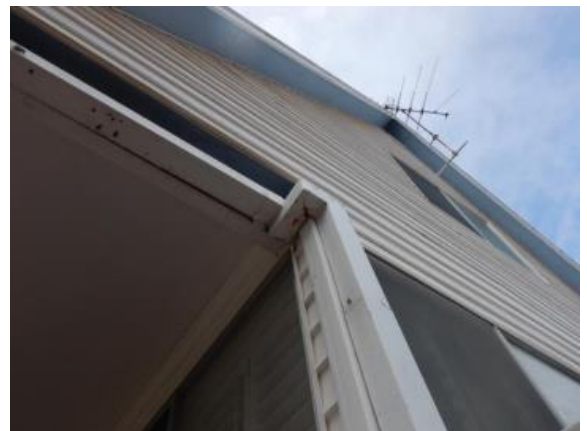
Some sections of guttering are rusted and require repair / painting with Killrust or better / replacement.

Some downpipes are rusted and require repair / painting with Killrust or better / replacement.

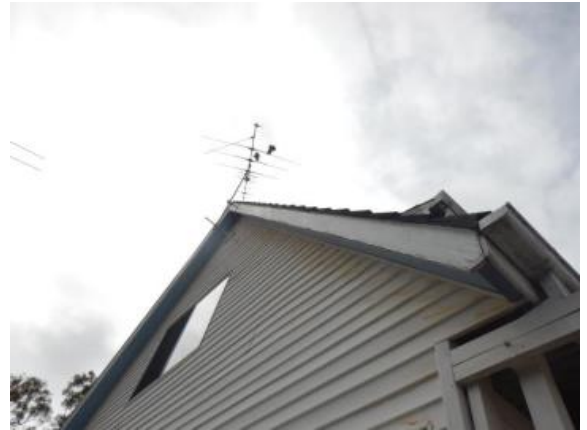
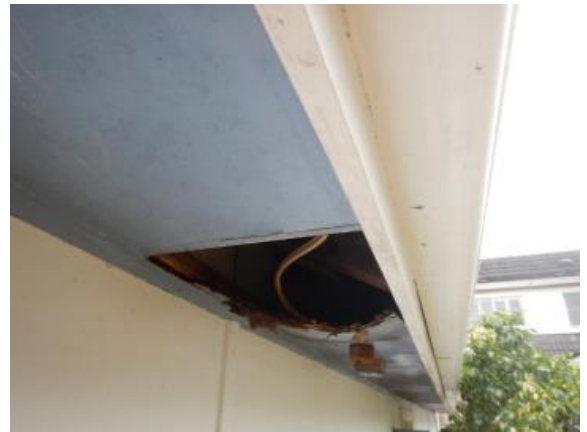
Some fascia / gable timbers show signs of weather damage and require repair / sealing.

Some eave soffit sheeting to the garage shows signs of damage and requires repair / resealing.

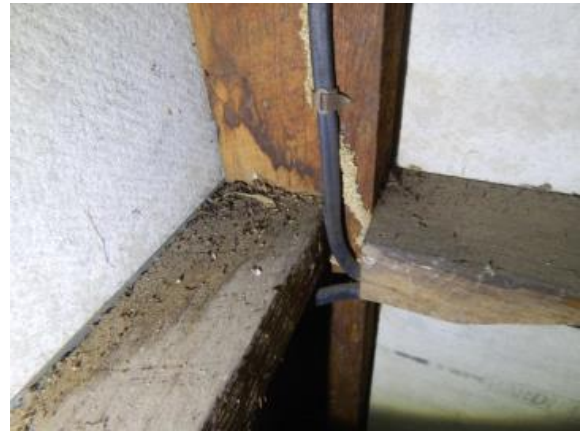
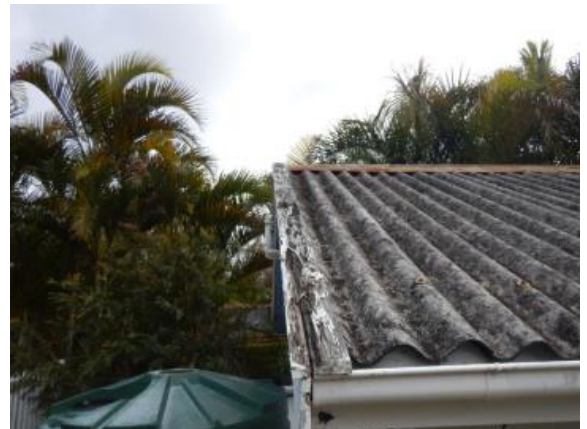
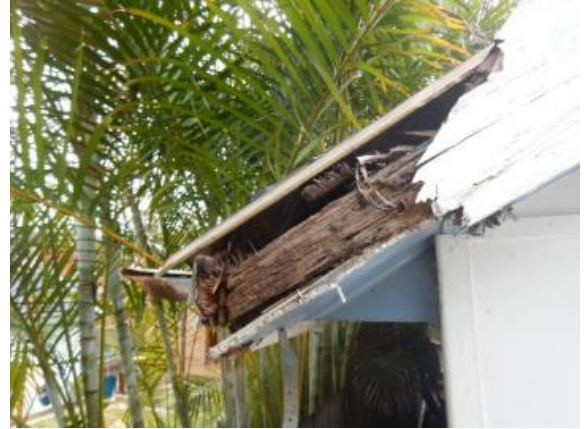
Signs of termite workings within the garage area.

Signs of wet rot to various external timbers to the garage.

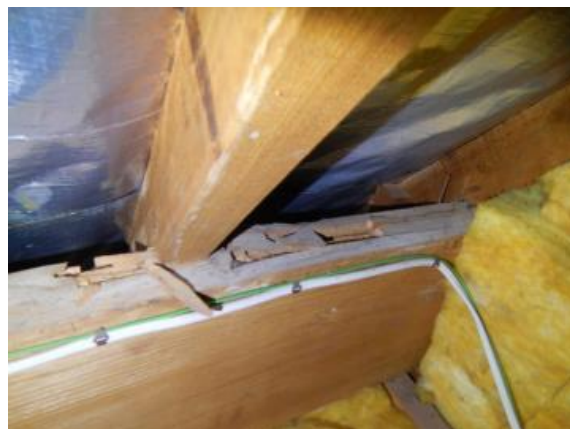
Some framing timbers.

The visible damage to the timbers appears to be moderate. Further damage may exist in concealed areas. Please refer to the definitions section of this report - Section 1.2 - Timber Damage.

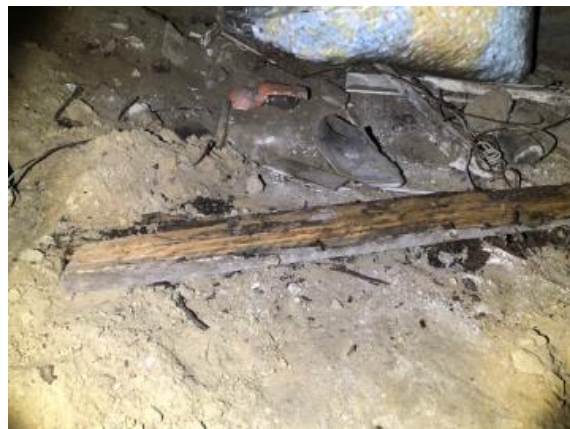
Some loose & stored timber within the subfloor area.

The visible damage to the timbers appears to be moderate to extensive. Further damage probably exists in concealed areas. Please refer to the definitions section of this report - Section 1.2 - Timber Damage.

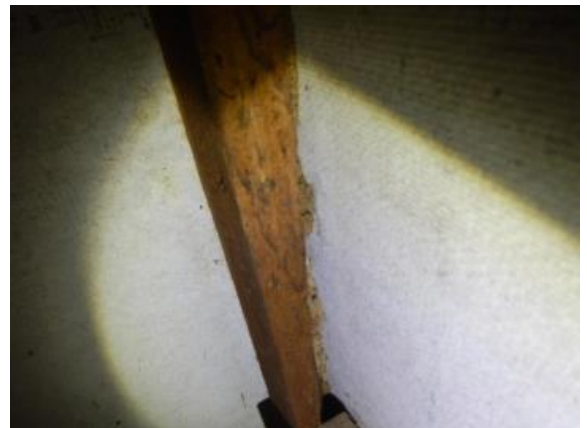
Some framing timbers.

The visible damage to the timbers appears to be moderate to extensive. Further damage probably exists in concealed areas. Please refer to the definitions section of this report - Section 1.2 - Timber Damage.

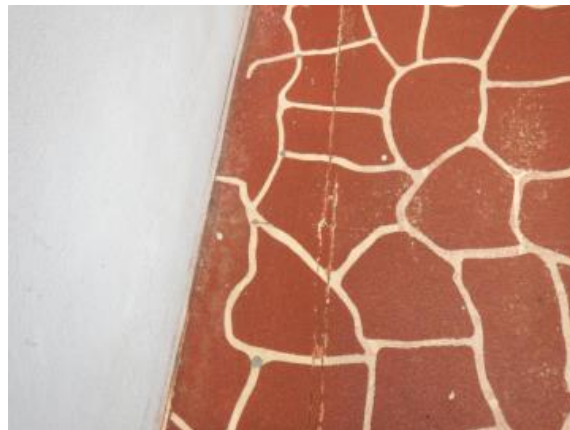
Evidence of drill holes were noted to perimeter concrete areas. Drill holes are an indicator that the area or areas may have been treated by chemical injection in respect to termite control or protection. We strongly recommend any prospective purchaser attempt to verify this information and obtain copies of all relevant documentation.
