# SYDNEY SOUTH BUILDING & PEST INSPECTIONS

**RE: Building & Pest Inspection & Report – 185 - 187 Acacia Rd, Kirrawee**

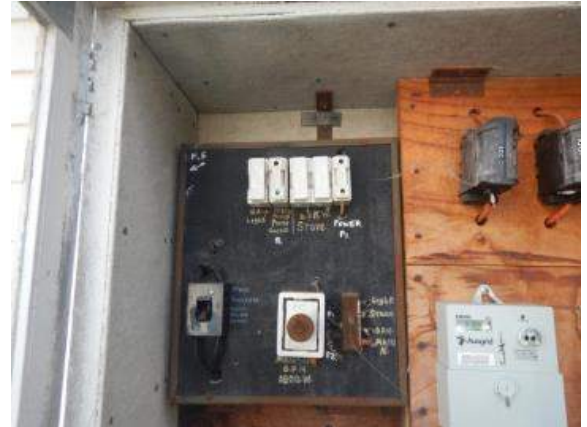
**ELECTRICIAL SAFETY SWITCH:**

Not Present - Installation is required.

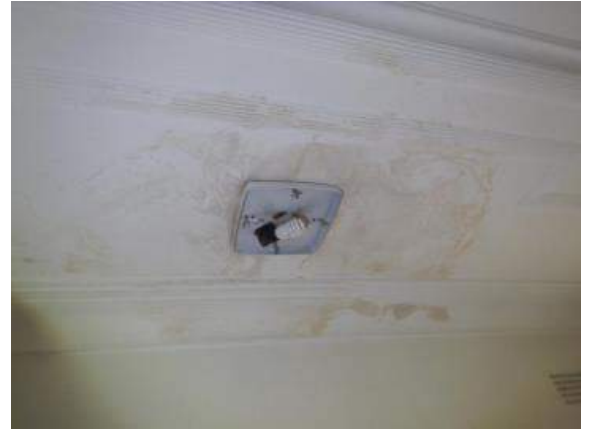
### **Damp Damage**

Signs of water penetration to some ceilings.

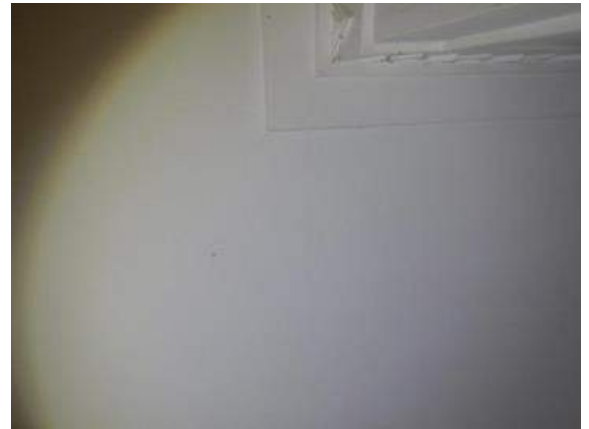
### **Cracking / Defective Lining**

Cracks to some wall sheeting.

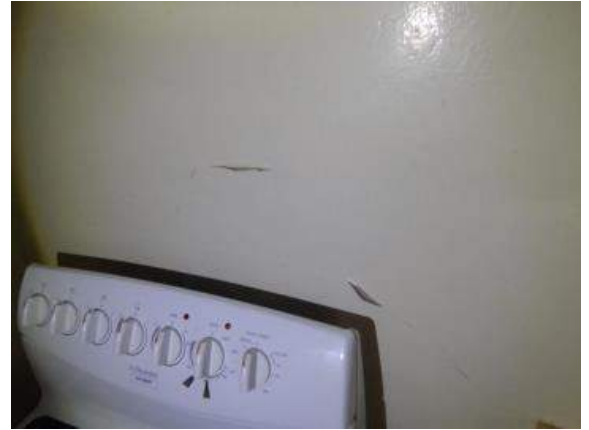
### Paintwork / Finish

Some minor surface damage and paintwork to some walls requires touching up / repainting.

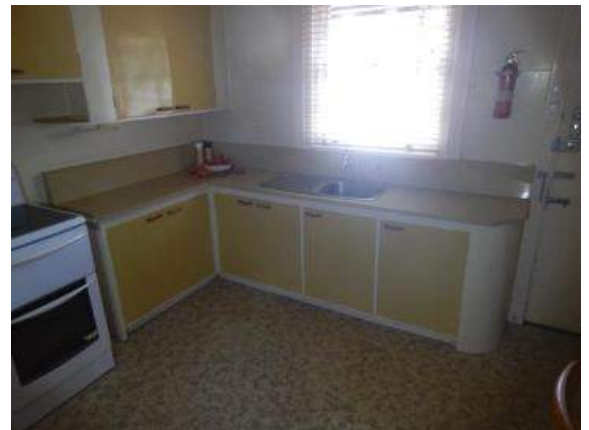
**Overall Condition**

Old but serviceable.

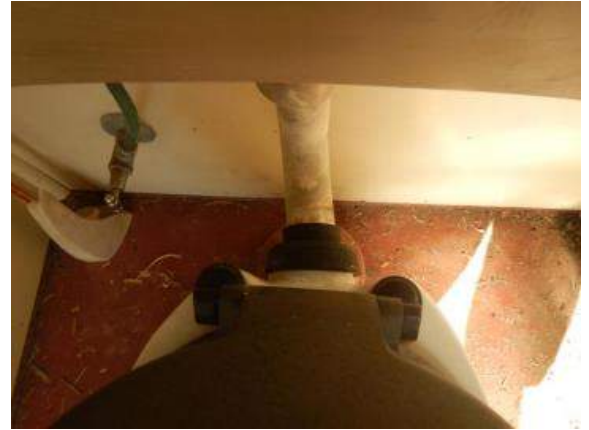
**Leaking**

New 50mm flushpipe rubber required to toilet.

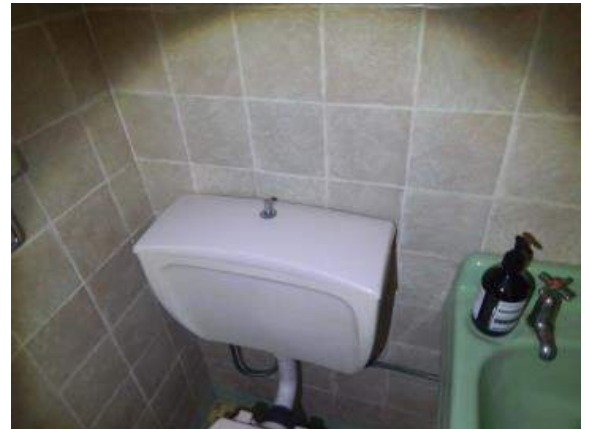
**Other (specify)**

Toilet to bathroom was not operational during the inspection.

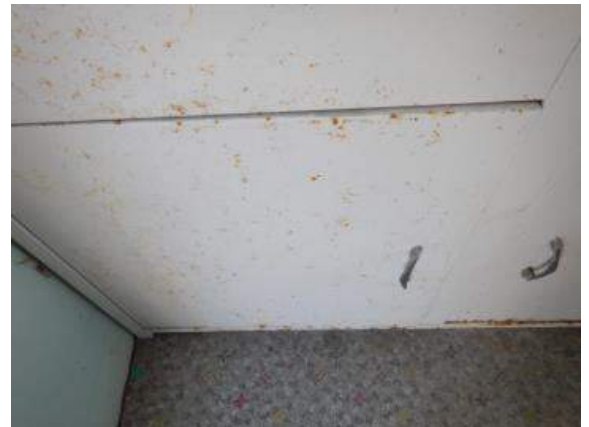
**Damage**

Laundry tub cabinet shows signs of rust and requires repair / painting with Killrust or better.

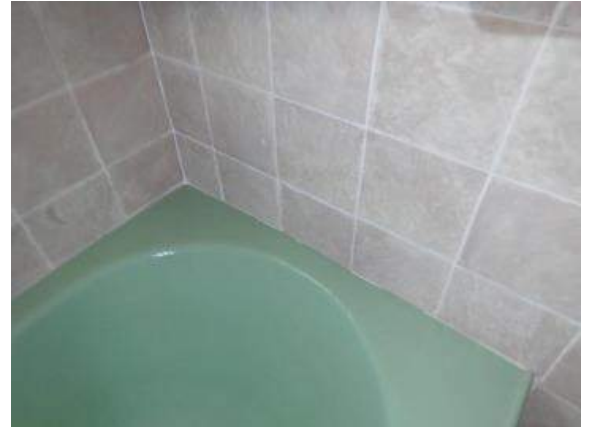
### **Adequately Sealed**

Junctions of bath / wall tiles require resealing with silicone.

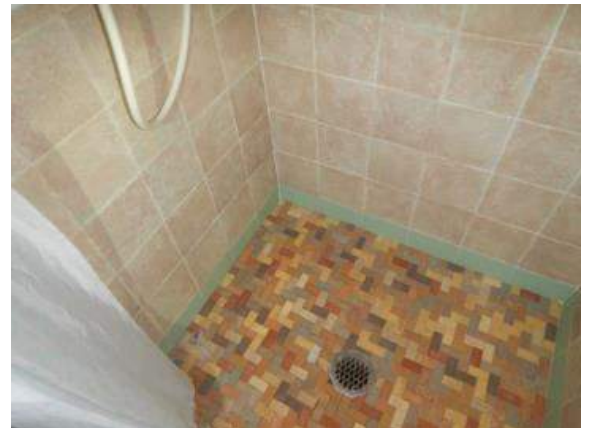
### **Tiles**

Junctions of Bathroom shower floor / wall tile joins require resealing with silicone.

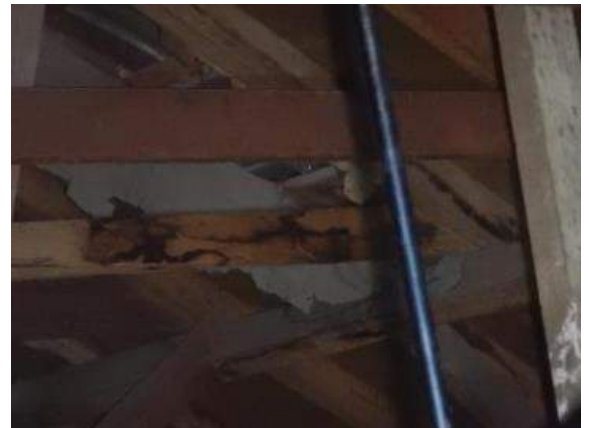
### Roof Space & Framing - Condition

There is evidence of past water penetration within the Roof Void.

Older roof frames do not comply with current wind ratings.

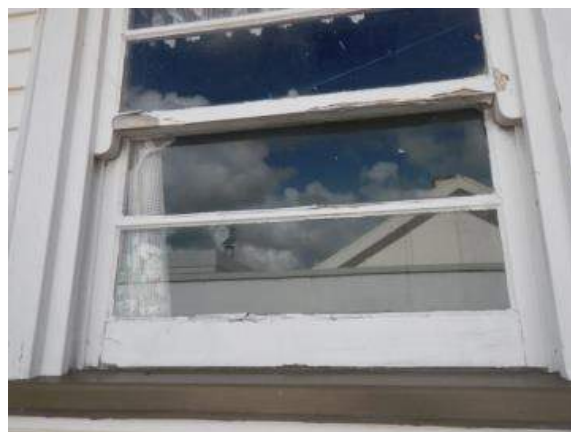
Some frames and sashes show signs of weather damage.

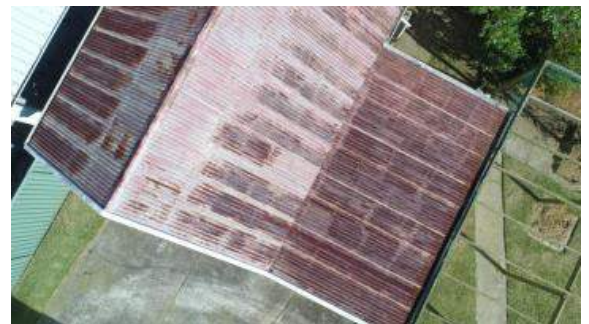
Surface rust requires repair / painting with Killrust or better. Some sections of roof sheeting may require replacement. I recommend a qualified roofer / plumber be engaged to inspect the roof exterior and quote the cost of rectification prior to a purchase decision being made.

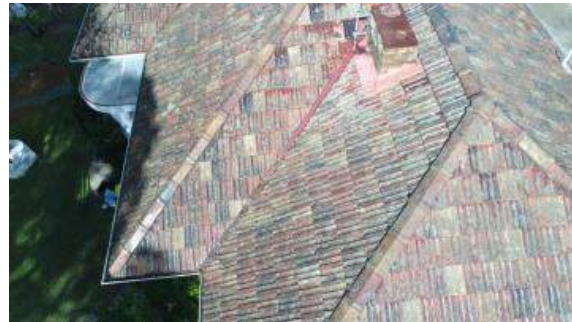
Some sections of valleys are full of debris and require cleaning. Failure to do so may allow water to become blocked and back flow into the roof void causing water damage.

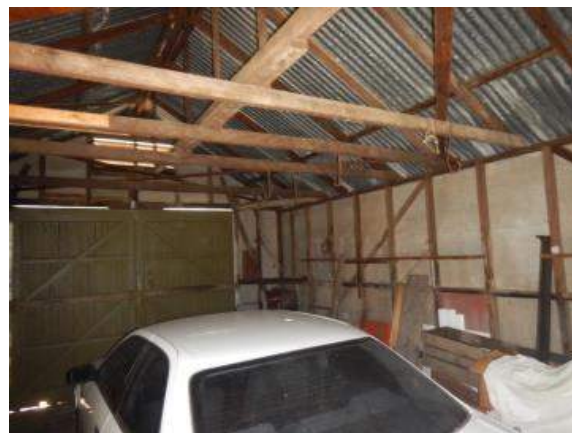
Some wall and floor areas were covered by stored goods and machinery and were inaccessible.

**Further inspection of these areas is strongly recommended once access has been obtained.**

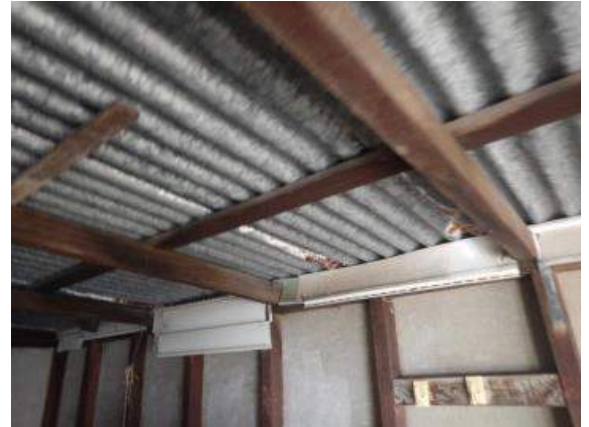
Some roof sheeting and flashings are rusted and require repair / replacement.

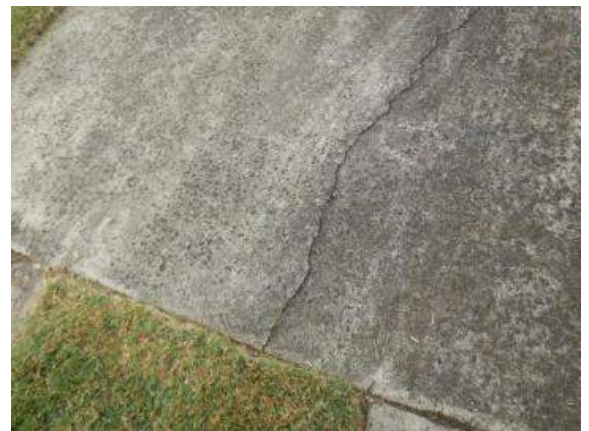
**PATHS & DRIVEWAYS**

Some cracks to concrete slabs.

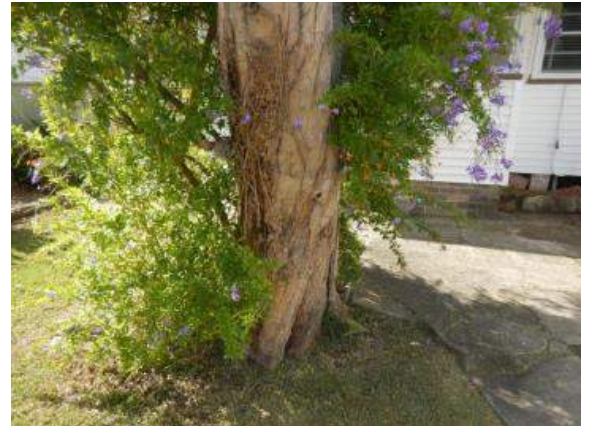
#### Severity

The visible damage to the timbers appears to be moderate. Further damage may exist in concealed areas. Please refer to the definitions section of this report - Section 1.2 - Timber Damage.

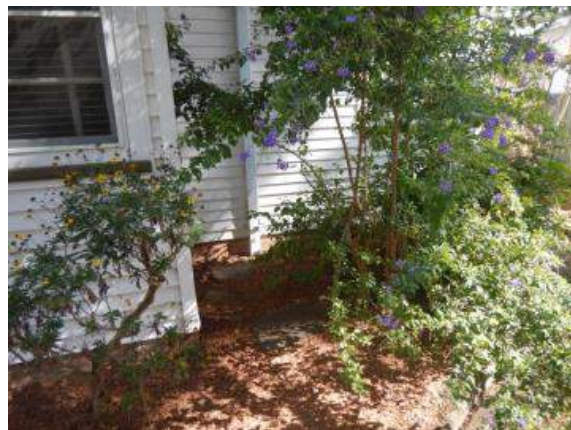
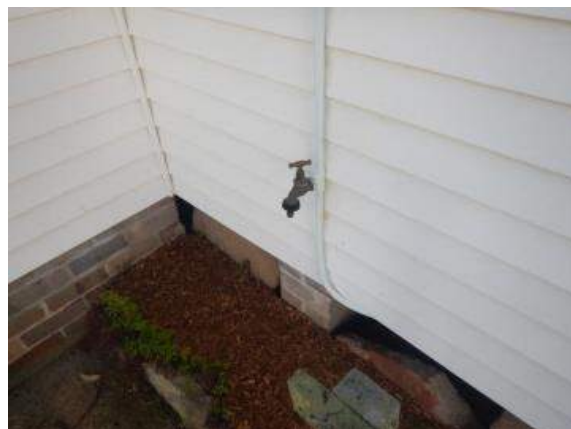
- It is essential that all garden beds and vegetation close to or abutting the external walls of the structure be removed immediately. These can attract / allow concealed termite entry and should be removed.

- Some taps adjacent to the building(s) were not located above a drain or concrete pad. Water discharging on to the soil adjacent to the structure is highly conducive to termite attack. You should have a plumber install drains to all such taps or place a concrete pad beneath the tap so that water is dispersed.
