Visual Timber Pest Inspection and Report in Accordance with AS 4349.3-2010

9 Bandain Avenue, Kareela, NSW 2232

INSPECTOR DETAILS	
Name Of Inspection Firm:	Target Pest Control
Contact Phone:	02 9528 0452
Technician Name:	Anthony Lee
Report Prepared Date:	17/04/2019

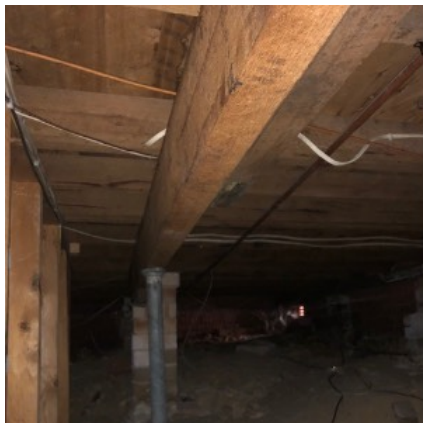
Brick piers with ant caps subfloor

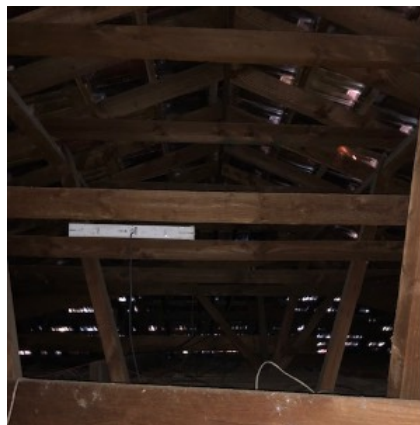
Roof void insulated

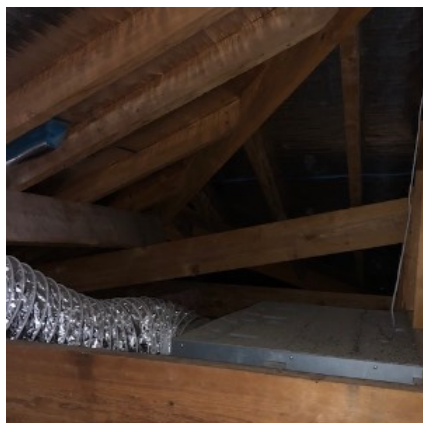
Roof void insulated

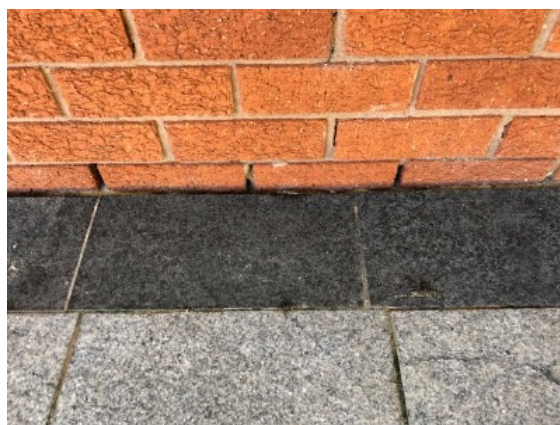
Concrete slab no access to subfloor

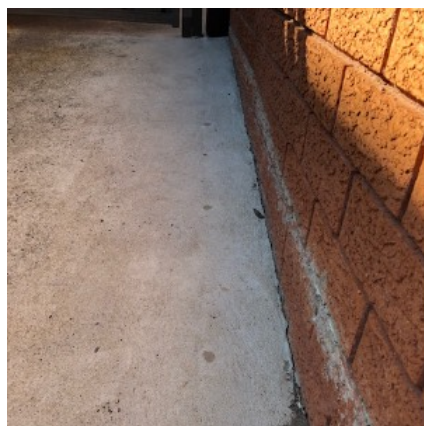
Drill holes found to concrete at side of house

WARNING: If evidence of drill holes in concrete or brickwork or other signs of a possible previous treatment are reported then the treatment was probably carried out because of an active termite attack. Extensive structural damage may exist in concealed areas. You should have an invasive inspection carried out and have a builder determine the full extent of any damage and the estimated cost of repairs as the damage may only be found when wall linings etc are removed.

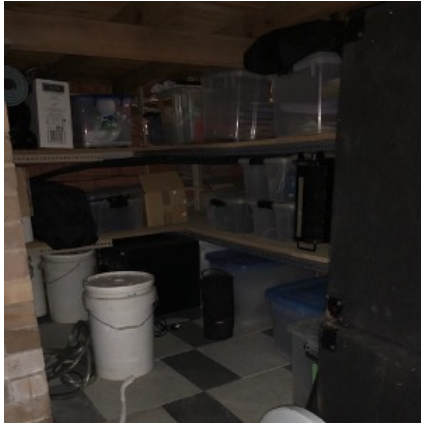
Stored goods to subfloor

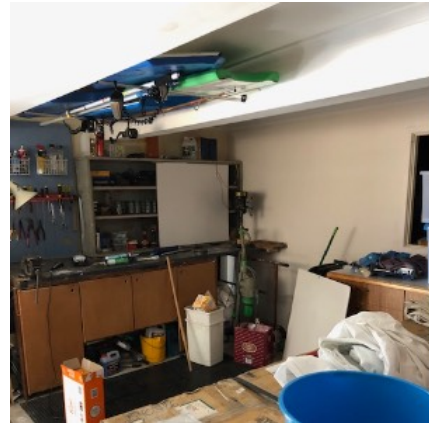
Stored goods to garage

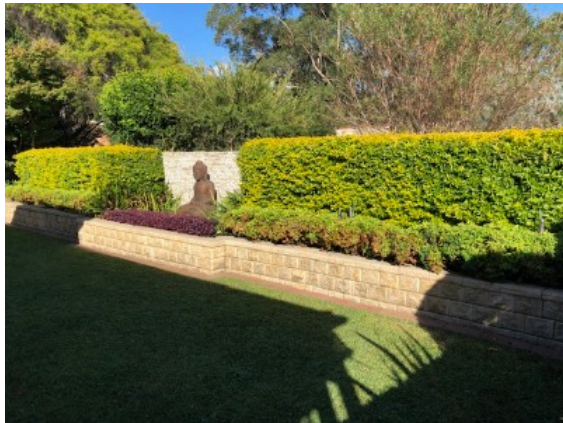
Hedges covering timber fences

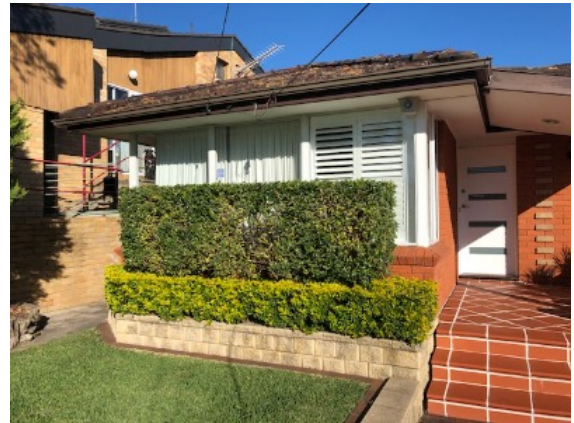
Vegetation to front
