BUILDING CONSULTANCY GROUP

Visual Pre-Purchase Building Inspection Report

CLIENT DETAILS	
Inspection address:	9 Bandain Avenue, Kareela, NSW 2232
Inspection date & time:	Date: 23/04/2019 Arrival time: 8:30AM
Approximate age of this property (Excluding extensions):	35-45 Years (Properties built before 1986 may contain asbestos)
Weather conditions at the time of this inspection:	Fine
Whether building is furnished:	Yes
Building tenancy:	Property Occupied
Persons present at the time of this inspection:	Vendor

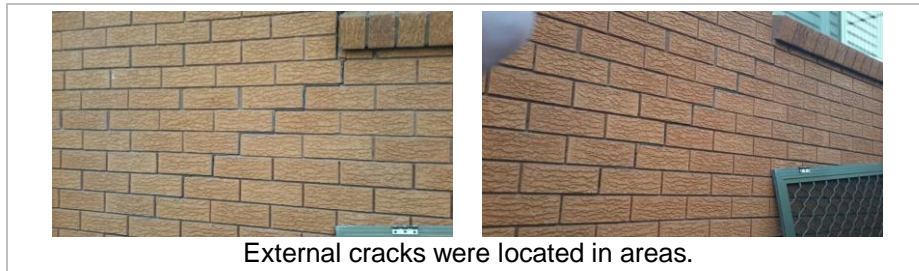
The cracked areas	Photo of crack	Approximate width & length of cracking
To the <u>external</u> brickwork/walls of this inspected dwelling being category "2".	Yes	<u>Exterior:</u> Under 2mm & approximately 2800mm in length.
To the <u>internal</u> walls and ceilings of this inspected dwelling being category "1".	No	<u>Interior:</u> Under 1mm and up to 100mm in length.

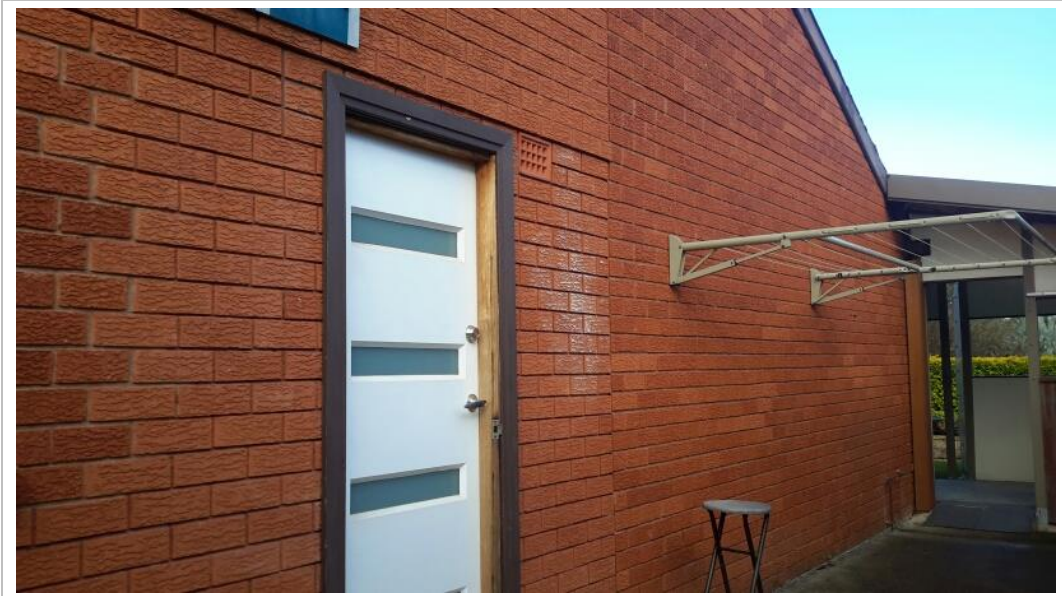
<p>Mortar to this property's exterior brickwork has dislodged/cracked in areas.</p>	<p>Some of this property's lintels are showing signs of rusting and it is recommended that this property's lintels be monitored for any further deterioration.</p>	<p>Damp proofing to the exterior walls is bridged in areas. This can potentially lead to moisture readings to sections of the internal walls throughout this property.</p>

<p>The bedroom 3 window sill brick(s) is dislodging.</p>

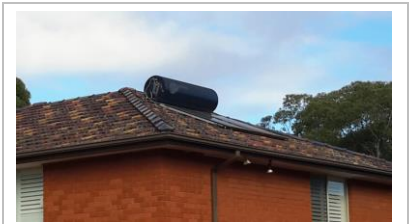
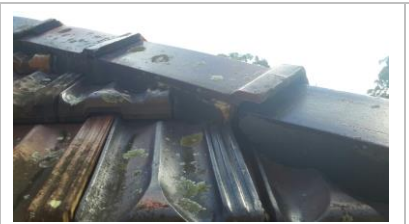
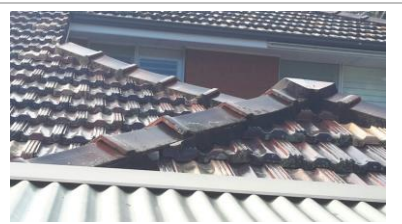
a) **Roof undulation was visibly evident in areas at the time of this inspection.**

<p>This property's hot water solar system appeared to be rusty at the time of this inspection and it is recommended that a licensed Plumber, qualified in hot water solar systems evaluate this utility.</p>	<p>Cracking was visible to the roof bedding and/or pointing areas in sections at the time of this inspection and it is recommended that all damaged areas be repaired by a qualified and licensed Roofer as soon as possible.</p>

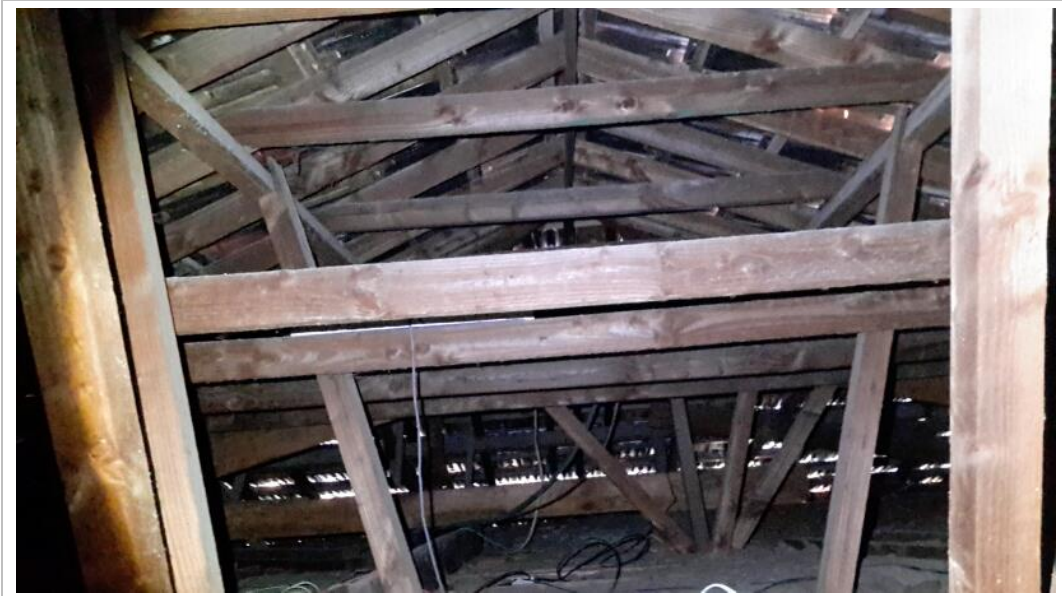
This property's insulation is a form of loose-fill insulation. (It could not be ascertained if this is asbestos and was NOT tested as part of this inspection.)

It appears as though several roof tiles are starting to deteriorate and replacement of all damaged roof tiles is recommended by a qualified and licensed Roofer as soon as possible.

A ceiling joist in the roof space area has been cut at the manhole and it is recommended that this ceiling joist/area be re-supported as soon as possible.

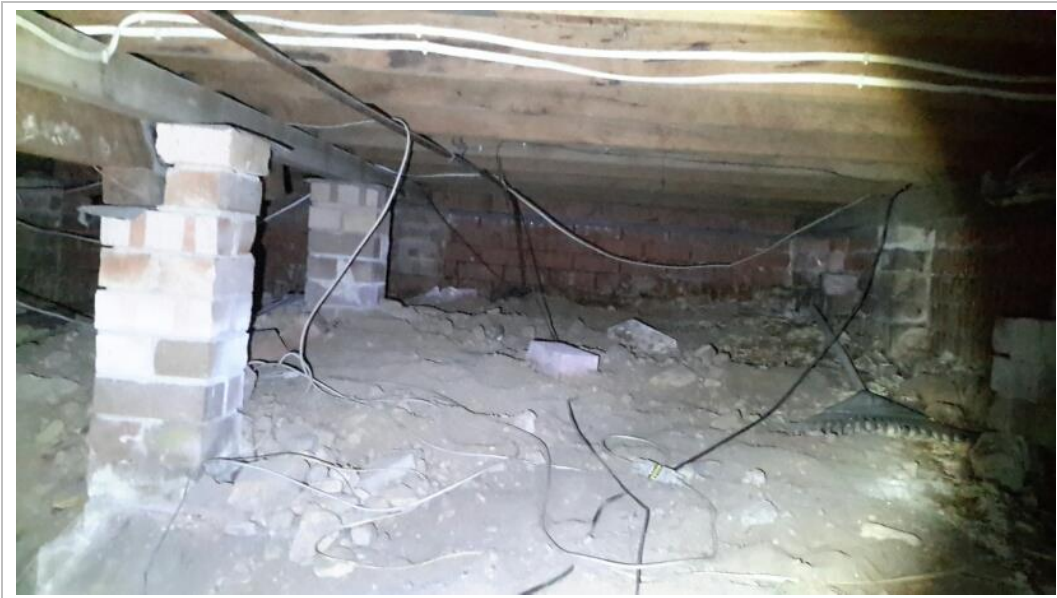
A pier in this property's sub-floor area, near the garage's front left corner is close to eroding soil and an additional support has been added to this area. This is beyond our area of expertise/qualifications and it is recommended that the advice from a qualified and licensed Structural Engineer be sought and inspect this property's sub-floor area/piers.
