# Visual Pre-Purchase Building Inspection Report

To comply with Australian Standard AS4349.1-2007

CLIENT DETAILS	
<b>Client:</b>	Matt Jinks
<b>Contact details:</b>	<b>Ph:</b>
<b>Inspection address:</b>	65 Cremona Road, Como NSW 2226
<b>Inspection date &amp; time:</b>	<b>Date:</b> 19/11/2019 <b>Arrival time:</b> 2:30 PM
<b>Approximate age of this property (Excluding extensions):</b>	30-40 years (Properties built before 1986 may contain asbestos)
<b>Weather conditions at the time of this inspection:</b>	Fine
<b>Whether building is furnished:</b>	Yes
<b>Building tenancy:</b>	Property Occupied
<b>Persons present at the time of this inspection:</b>	Tenant

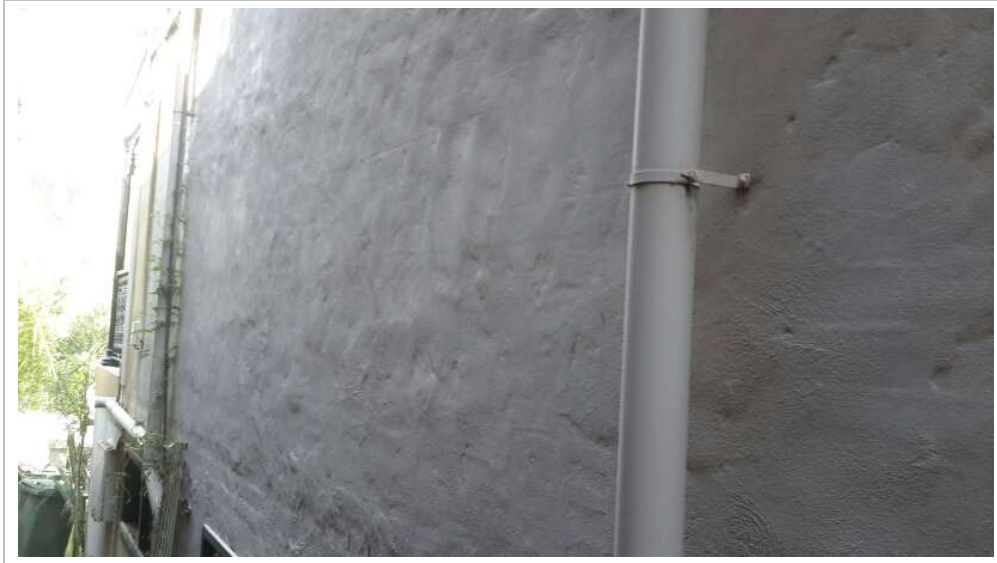
## THE EXTERIOR OF THIS BUILDING

1. The exterior paint work finish: **In poor condition, generally.**
2. Weep holes:
  - a) Are there weep holes to this property: **Weep holes are present.**

3. This property has **aluminium** windows and the units that were not locked at the time of this inspection **are in an average condition, therefore some units may require general adjustments to correct their as intended operation**, easing due to excessive paint use, lock repairs and/or general lubrication.

4. Are flyscreens damaged in areas to the doors and/or windows to this dwelling: **Yes, some flyscreens are missing.**
5. Condition of external exposed door locks: **Are in average condition, generally.**

Paint work is poor to sections of this property's external walls with mould forming in areas.

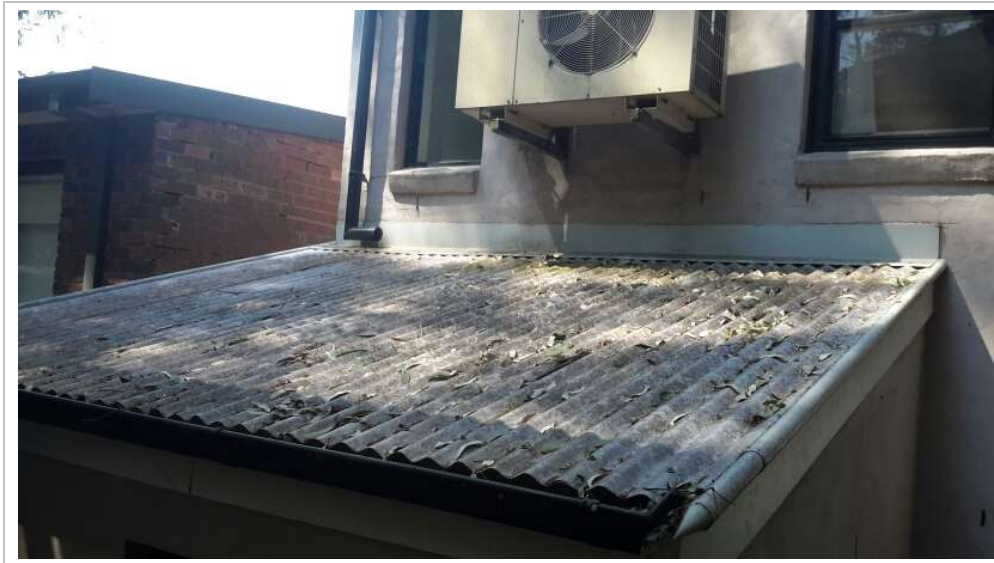
## THE ROOF EXTERIOR OF THIS BUILDING

2. Are gutters & valley gutters rusting: **Yes, this property's gutters are rusting in sections and it is recommended that these areas be monitored for any further deterioration.**

3. Are gutters & downpipes leaking: **No, not at the time of this inspection.**
4. Metal roofing condition: **Is in average condition, generally.**
5. Roof undulation was visibly evident in areas: **No, not at the time of this inspection.**

Sections of flashings at the back of this property require repair work.	Wood decay was evident to some sections of this property's timber fascia's/bargeboards. Maintenance and/or replacement of damaged timbers is required.	The Gutters are full of debris which prevent the gutters and downpipes from operating as intended and need to be cleared on a regular basis.

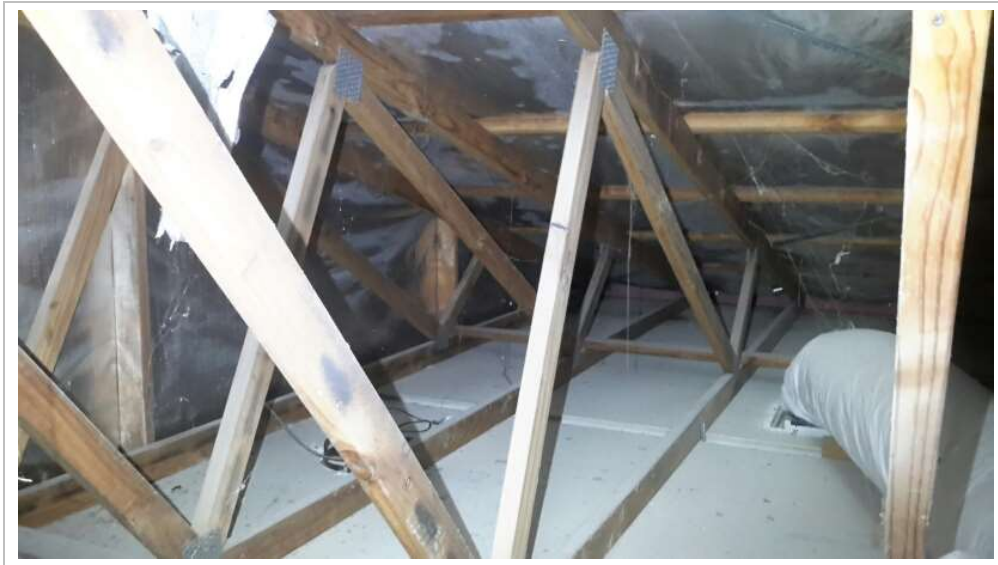
## THE ROOF SPACE OF THIS BUILDING

1. Sarking: **Sarking is ripped or missing in sections throughout this property's roof space area.**  
*(Sarking is a silver foil material under the roof tiles/sheets.)*
2. Insulation: **Yes, insulation has been installed to this property's roof space area.** *(All types of ceiling insulation installation are to comply with the current Australian Standards AS/NZS3000:2007 in relation to Downlights, Exhaust fans, IXL Heater/Fan Light units and Range Hood units.)*
3. Sagging of roof elements: **No, not at the time of this inspection.**
4. Visible damage: **No, not at the time of this inspection.**
5. Roof construction: **Trussed construction.**

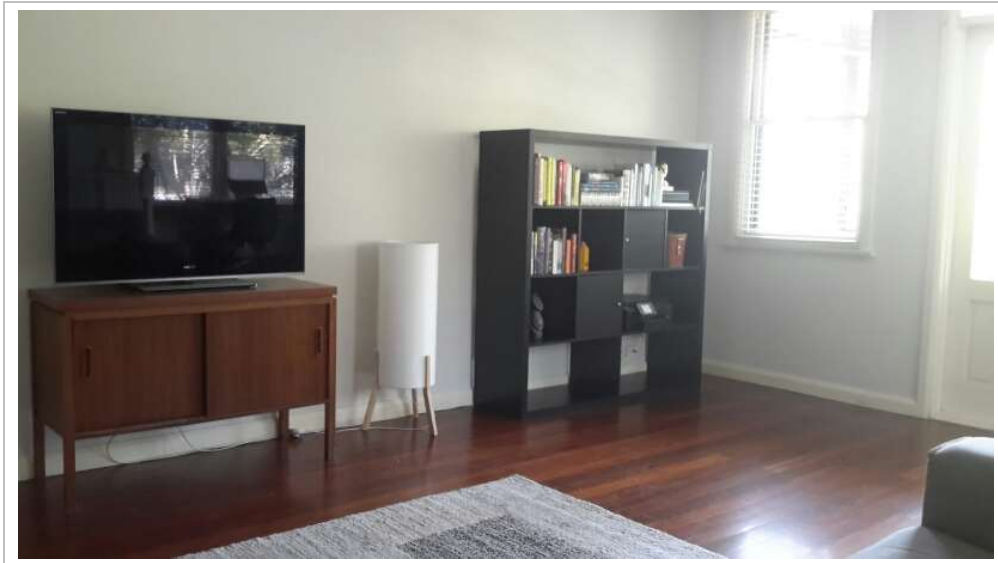
## THE INTERIOR OF THIS BUILDING

1. Painting/wallpaper: The internal paint work/wallpaper is in an **average condition, but poor in some sections.** *(Any other associated marks, indents, holes, scratches, cracks and/or poorly patched areas to some of the walls and ceiling areas internally can be rectified prior to the next time of repainting.)*

2. Flooring is in an **average condition, generally.**
3. **NOTE:** Cornice joint cracking and cornice separation may be visible in some rooms. This is only minor and is normally common settlement only, unless otherwise stated in the body of this report.
