Visual Timber Pest Inspection and Report in Accordance with AS 4349.3-2010

65 Cremona rd, Como NSW 2226

Name Of Inspection Firm:	Target Pest Control
Contact Phone:	02 9528 0452
Technician Name:	Anthony Lee
Report Prepared Date:	20/11/2019

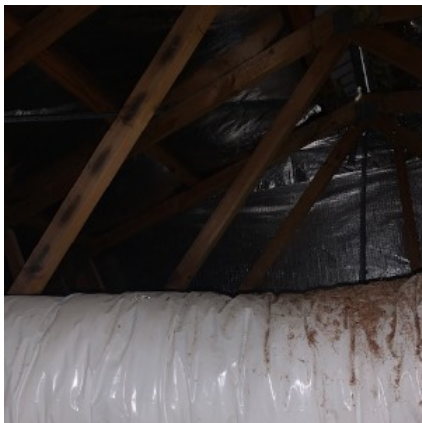
Roof void with insulation and air con ducting

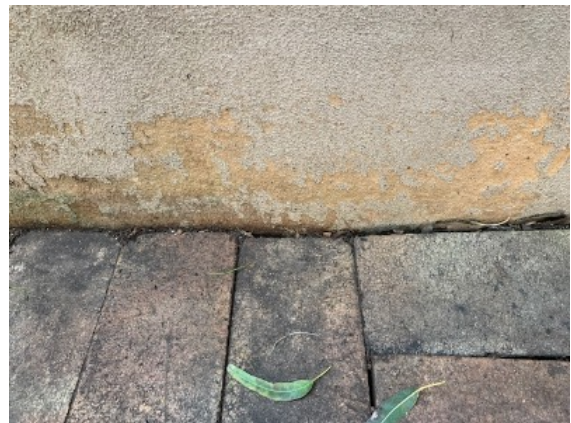
Concrete slab no access to subfloor

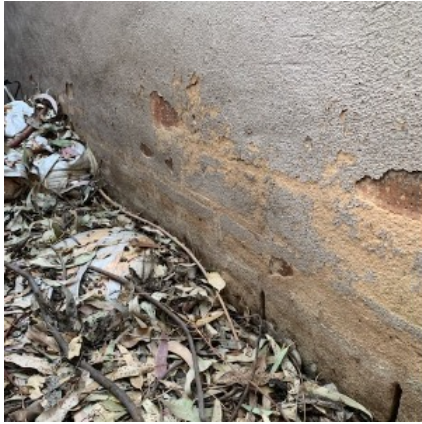
Weep holes covered at rear and side

WEEP HOLES IN EXTERNAL WALLS: It is very important that soil, lawn, concrete paths or pavers do not cover the weep holes. Sometimes they have been covered during the rendering of the brick work. They should be clean and free flowing. Covering the weep holes in part or in whole may allow undetected termite entry.

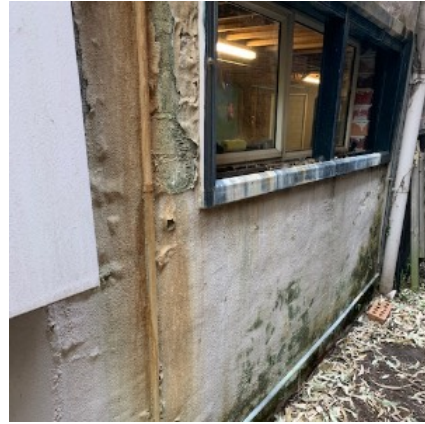
Mould found to side of house

MOULD: Mould on walls and ceilings etc; is an indicator of high moisture or very poor ventilation. If reported You need to have the reason investigated by a builder or a Industry Hygienist as its presence may indicate the presence of a water leak, wood decay or termites behind the wall or ceiling sheeting.

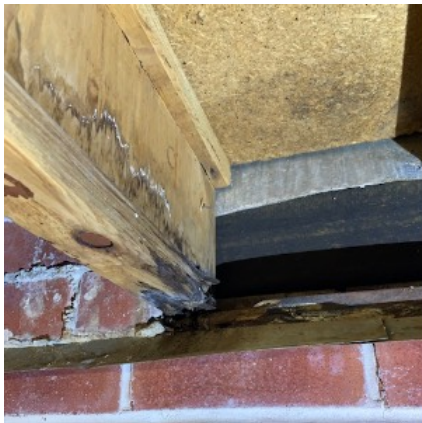
Wood rot found to garage roof timbers

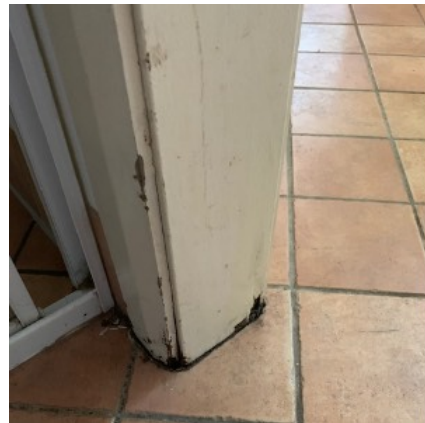
Wood rot found to bathroom door frame

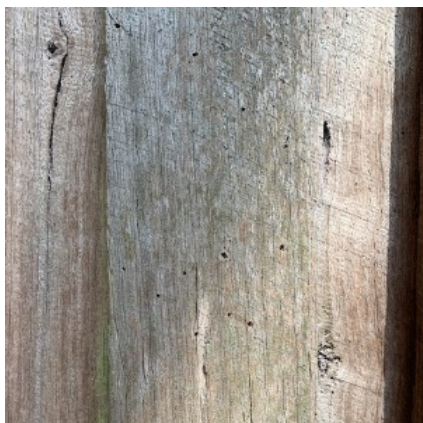
Past borer to fences

BORER RECOMMENDATIONS: Replacement of all susceptible timbers is always preferred since, in the event of selling the property in the future it is probable that an inspector will report the borers as active (see above). A chemical treatment to control and/or protect against Furniture beetle and/or Queensland pine beetle can be considered as a less effective, lower cost option. Before considering this option You should consult with a builder (See Terms & Limitations) to determine if the timbers are structurally sound. Following the initial treatment a further inspection is essential in twelve months' time to determine if further treatment is needed. Treatments over a number of consecutive years may be required.
