Visual Timber Pest Inspection and Report in Accordance with AS 4349.3-2010

35 Second Ave, Jannali NSW 2226

INSPECTOR DETAILS	
Name Of Inspection Firm:	Target Pest Control
Contact Phone:	02 9528 0452
Technician Name:	Anthony Lee
Report Prepared Date:	26/11/2019

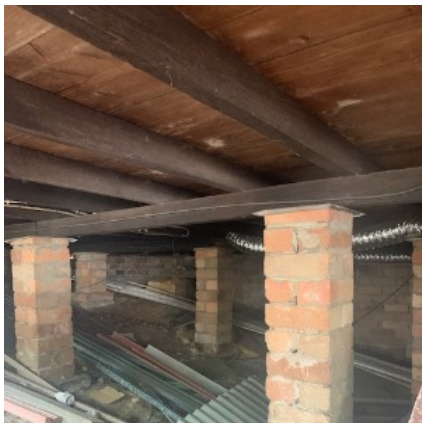
Brick piers with ant caps subfloor

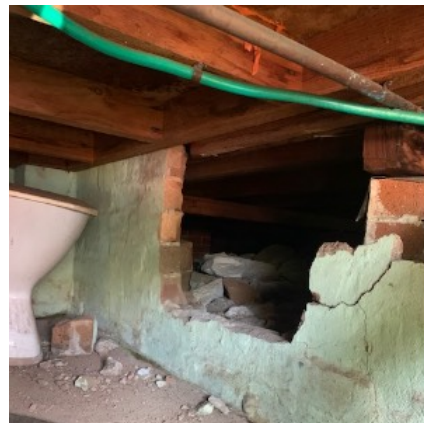
Brick piers with ant caps subfloor

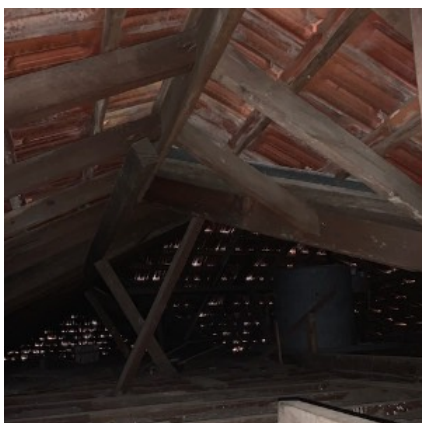
Roof void with insulation

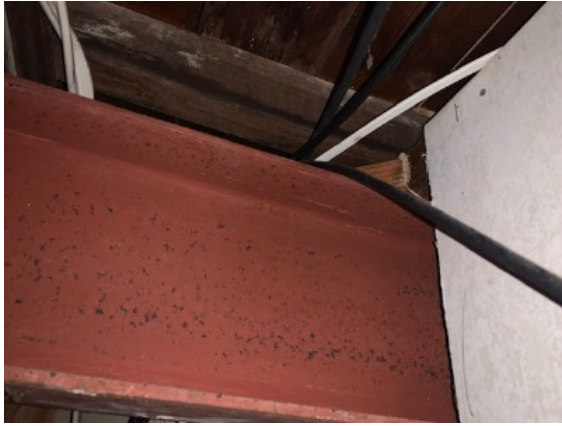
Termite:Termite Evidence Identified
WARNING: SEE SECTION 3, Point 4. Termite Damage VisibleTermite Damage Extent - Moderate
Refer to the advice in Section 3: Invasive Inspection**Borer:**

Past termite to subfloor timbers

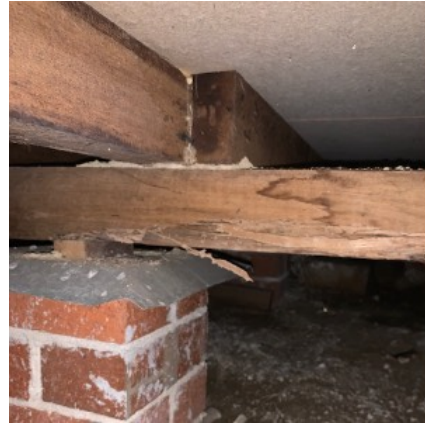
Past termite to subfloor timbers

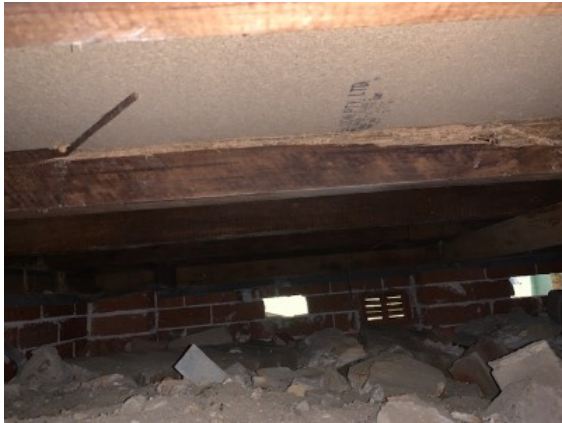
Past termite to subfloor timbers

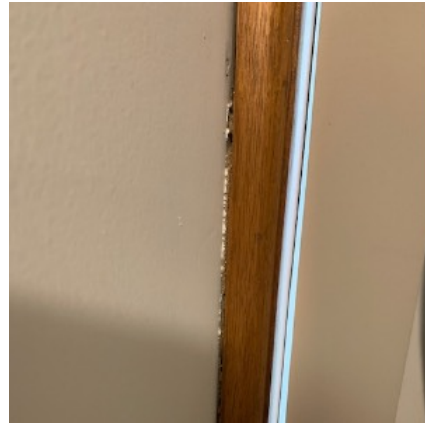
Past termite to window frame

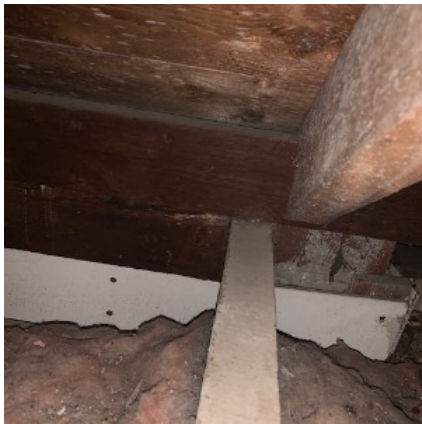
Past termite to roof timbers

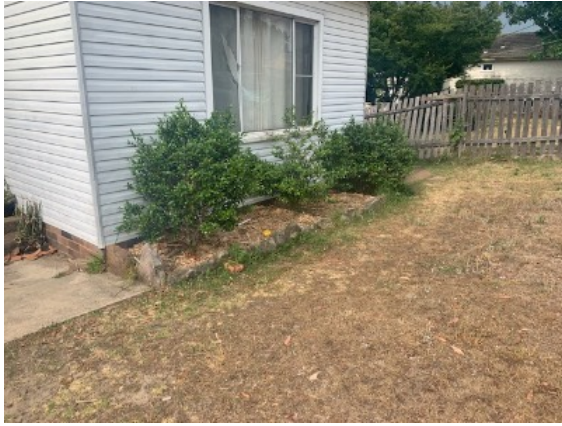
Vegetation to front

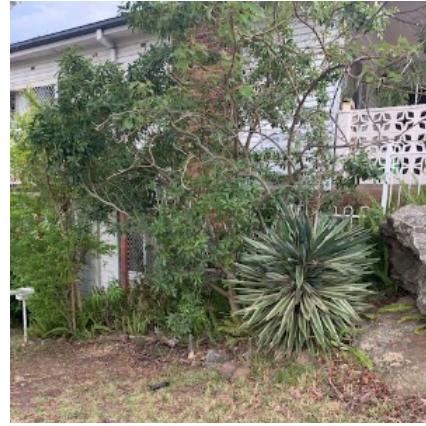
Vegetation to side

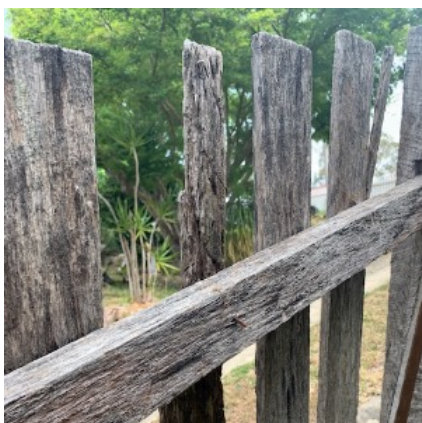
SITE TIMBER PEST ISSUE - Side fence	
Moisture:	No Reading Necessary
Termite:	No Termite Evidence Identified Refer to Important Warnings: Invasive Inspection
Borer:	Borer Identified WARNING: SEE SECTION 3 NOTE ON BORERS AND BORER RECOMMENDATIONS Borer Damage Visible Borer Damage Extent: Moderate to Extensive Borer Species: No Borers Found
Fungal Decay:	No Fungal Decay Identified
Location of Threats Not Limited To:	Borer: Side fences
Is an invasive inspection recommended?	No
Were any major safety hazards related to Timber Pest Activity and/or Damage identified?	No Important Note: Where a Major Safety Hazard is identified above, it must be attended to and rectified to avoid the possibility of personal injury &/or death.

Past borer to fences

BORER RECOMMENDATIONS: Replacement of all susceptible timbers is always preferred since, in the event of selling the property in the future it is probable that an inspector will report the borers as active (see above). A chemical treatment to control and/or protect against Furniture beetle and/or Queensland pine beetle can be considered as a less effective, lower cost option. Before considering this option You should consult with a builder (See Terms & Limitations) to determine if the timbers are structurally sound. Following the initial treatment a further inspection is essential in twelve months' time to determine if further treatment is needed. Treatments over a number of consecutive years may be required.

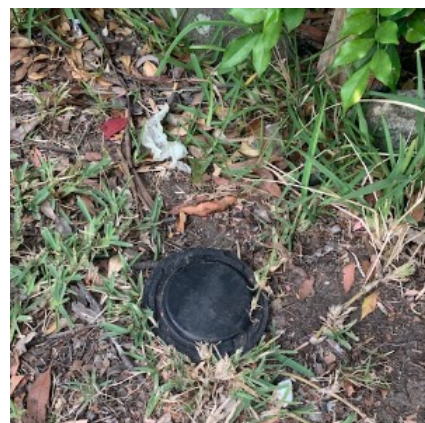
Termite bait station found in garden

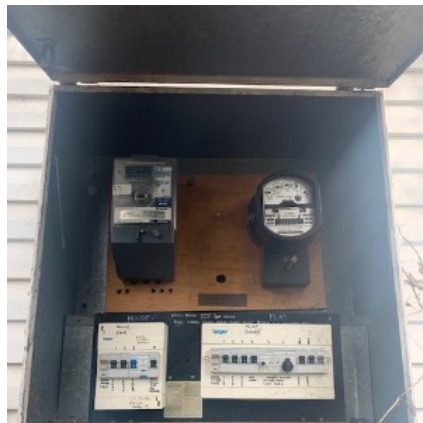
Photo Of Durable Notice

Is there a Termite Management Sticker?	No WARNING: This firm can give no assurances with regard to work that may have been previously performed by other firms. You should obtain copies of all paperwork and make your own inquiries as to the quality of the treatment, when it was carried out and warranty information. In most cases you should arrange for a treatment in accordance with 'Australian Standard 3660' be carried out to reduce the risk of further attack.
Evidence of Previous Treatment:	Bait Stations
Treatment Location:	Perimeter bait station found
Environmental Termite Pressure:	Level of Termite Pressure: Medium Overall Degree of Risk of Timber Pest Infestation: Moderate

Termite Management Recommendation:	Recommended as a termite management system is not installed
Frequency of Further Inspections:	12 months
Other Inspections Recommended:	No
