# Pre-Purchase Building & Pest Inspection Report

16 Kirrawee Avenue, Kirrawee

Date: 16/06/20

Reference: 20057

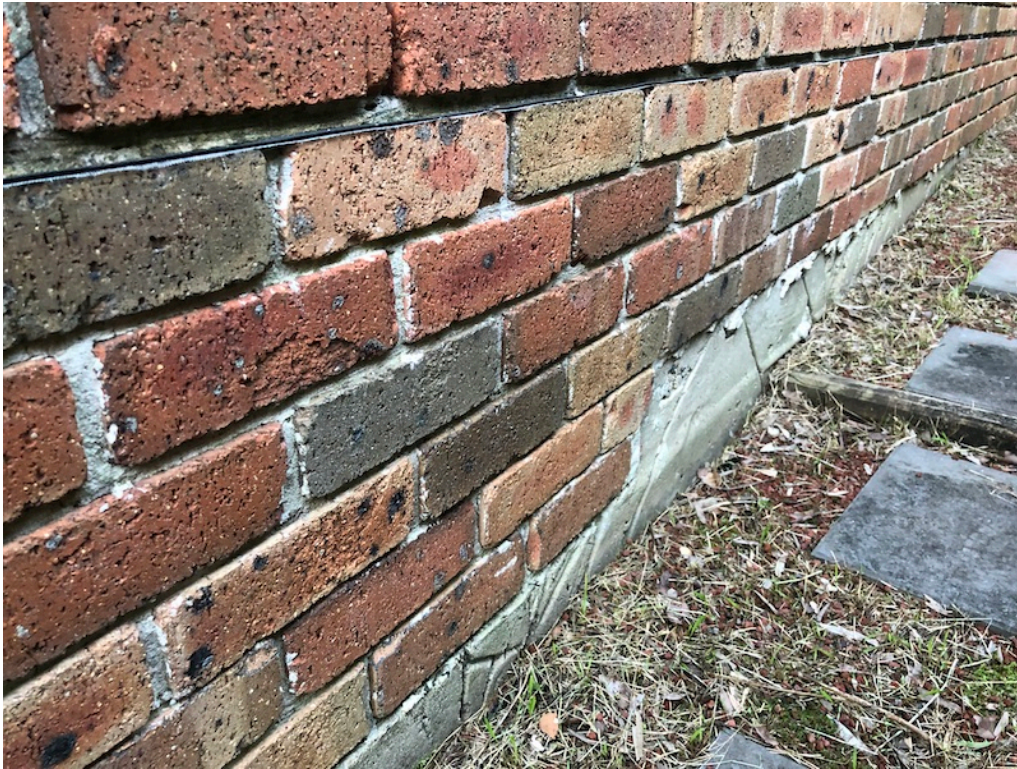
9. Subfloor slab inaccessible

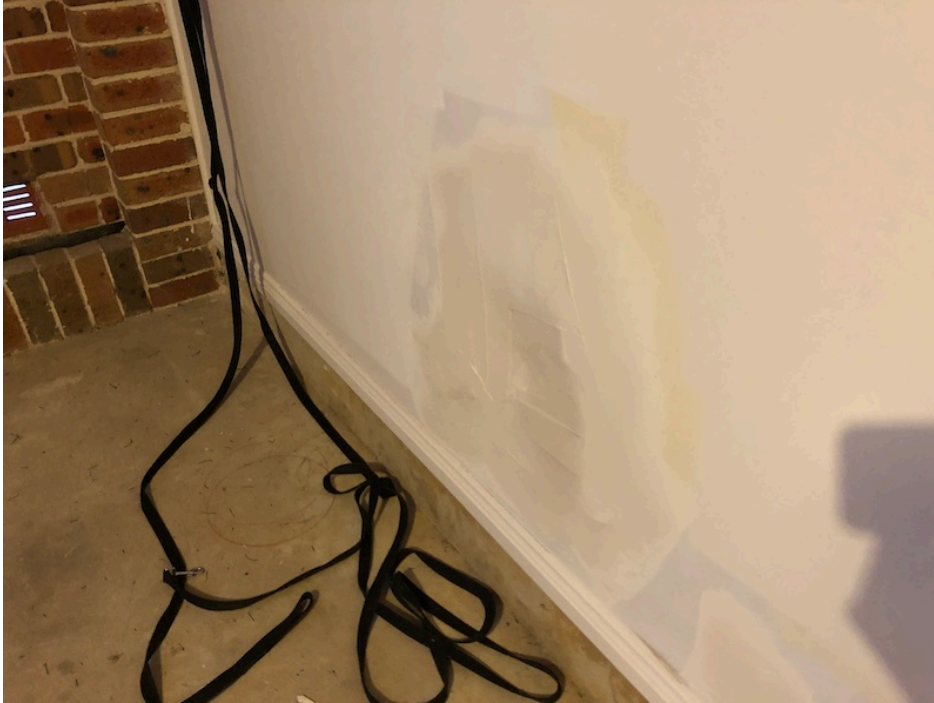
1. Unfinished plaster wall repair in garage from damage. No further deterioration anticipated.

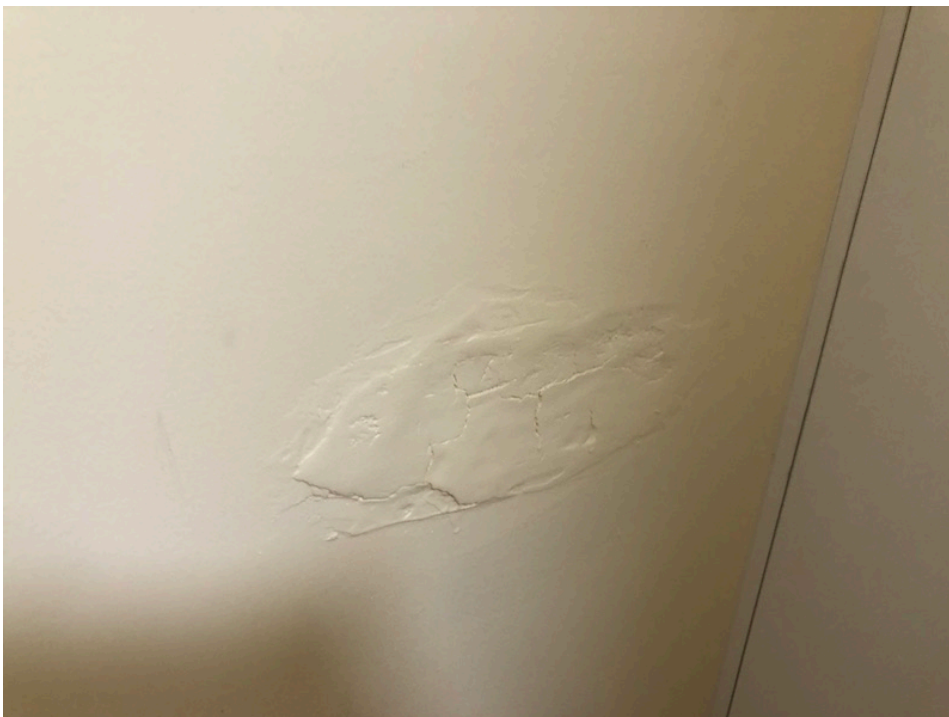
2. Unfinished plaster wall repair in laundry. No further deterioration anticipated.

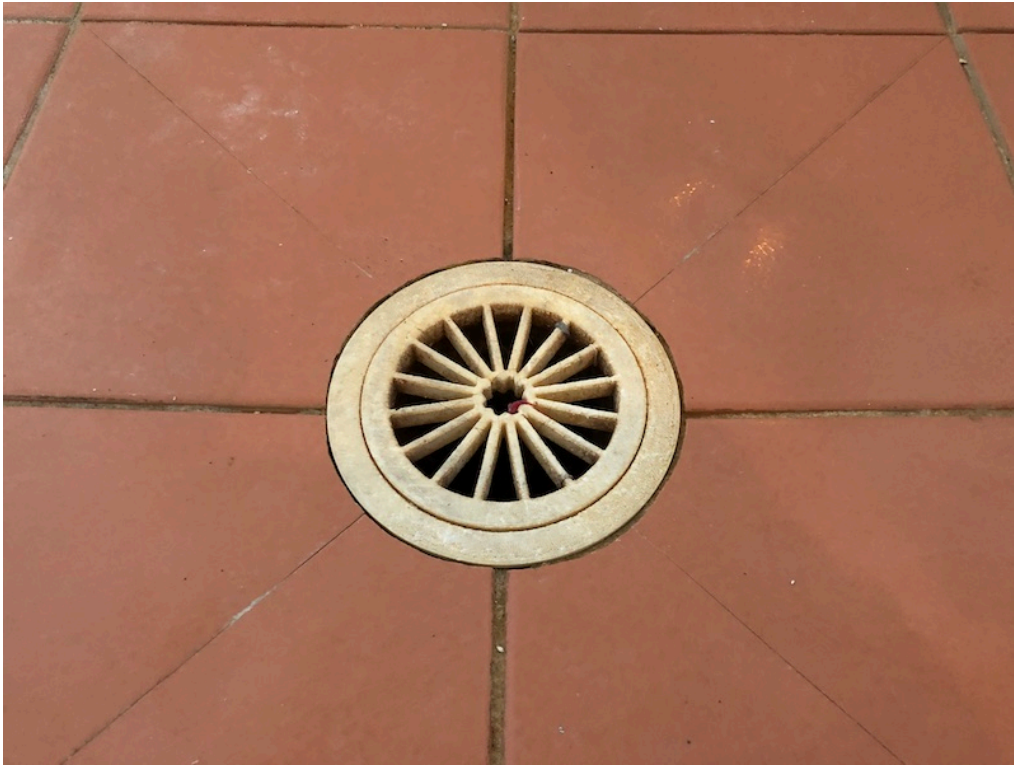
3. Deteriorating grout in floor tiles around shower drain of bathroom. Potential for further deterioration.

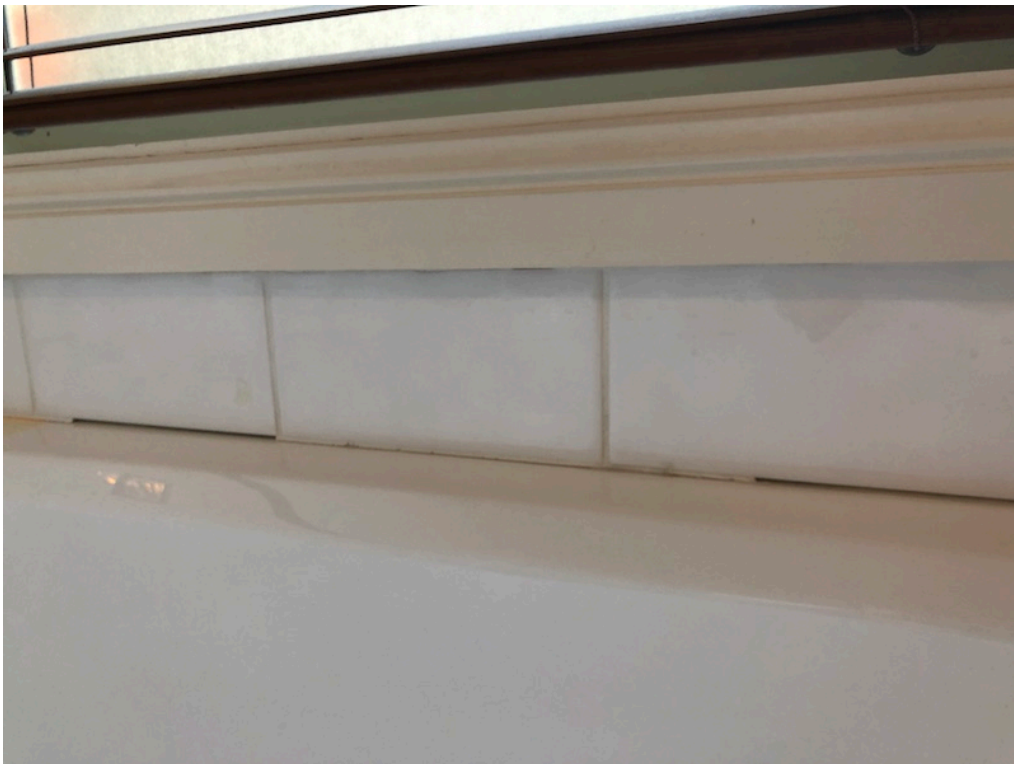
4. Deteriorating grout in wall tile grout above bath in bathroom. Potential for further deterioration.

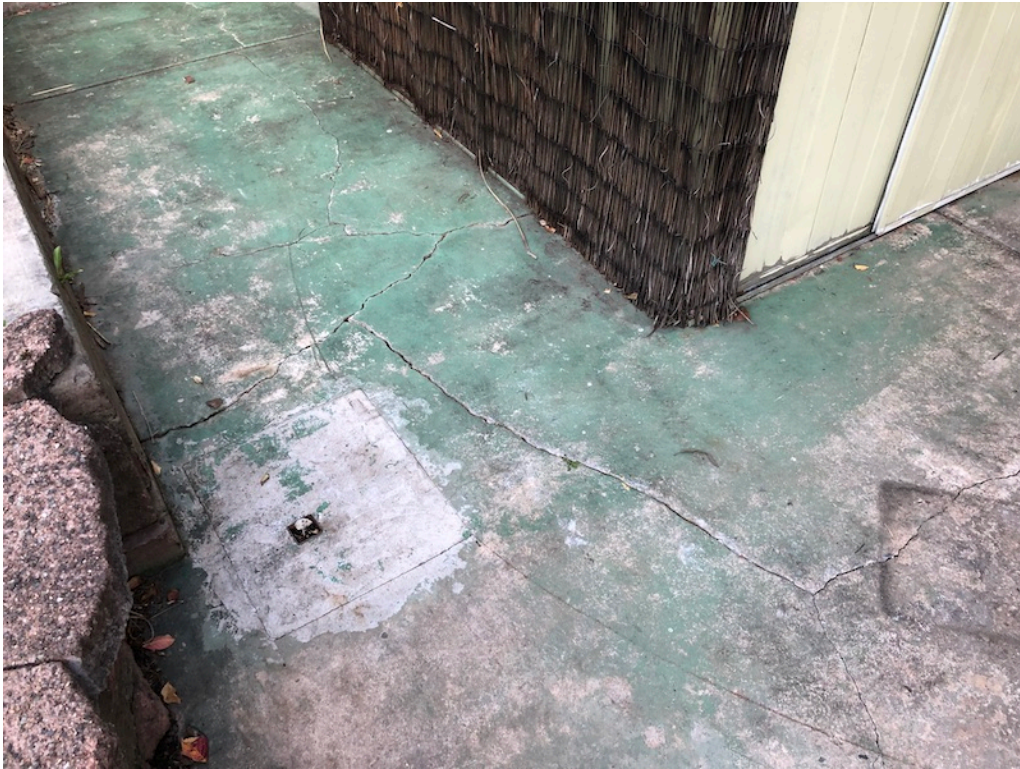
5. Multiple concrete slab cracks to shed slab. Serviceability crack with potential for further cracking.

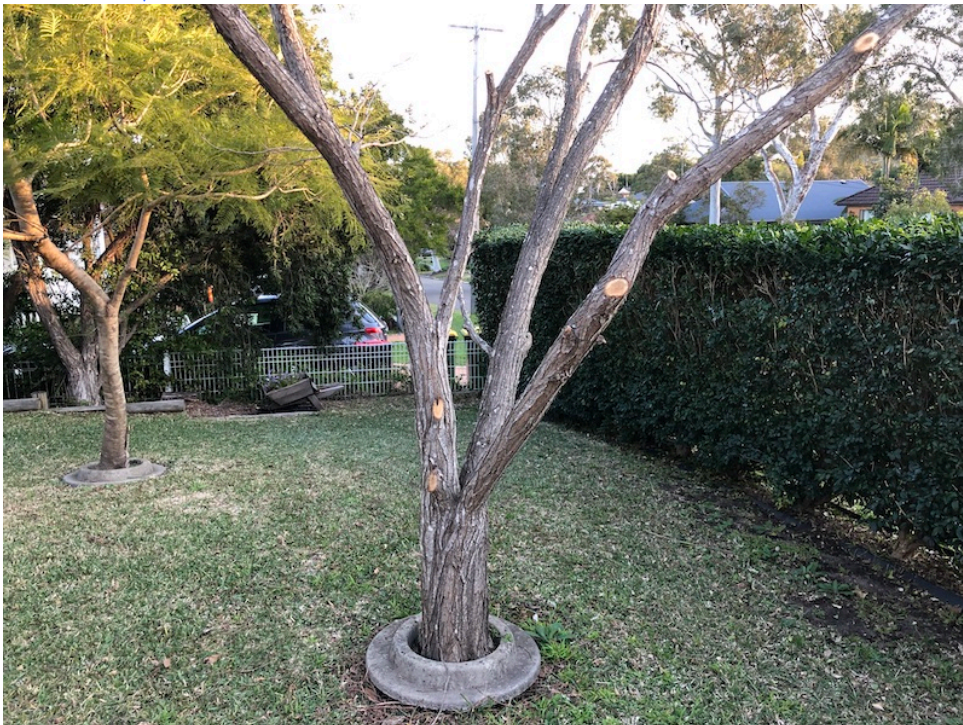
1. Trees on site increases chance of timber pest activity.

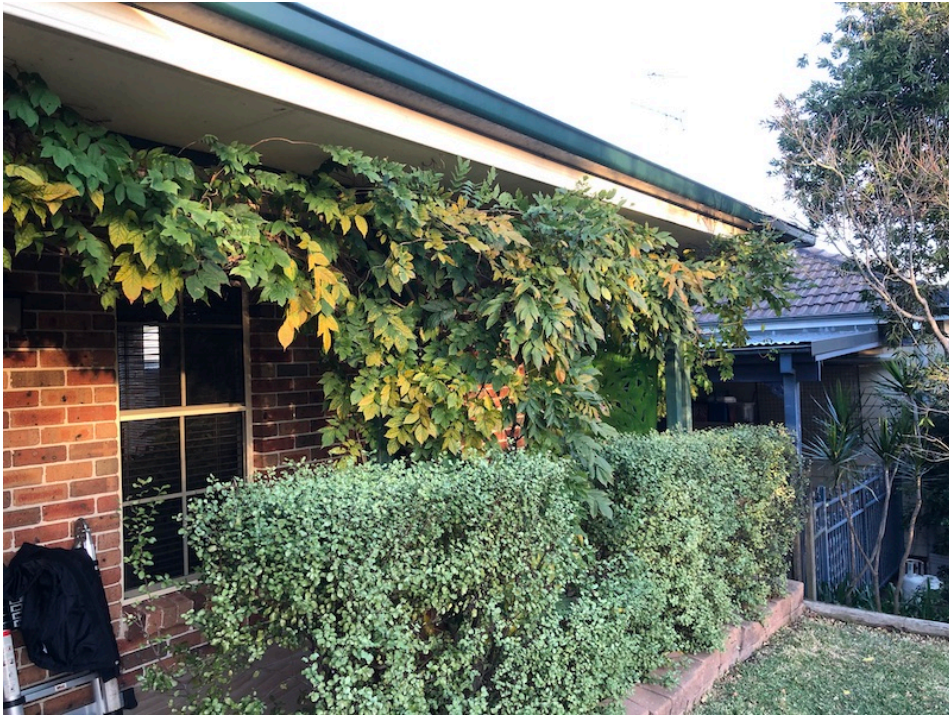
2. Vegetation providing bridge to main structure, increasing chance of timber pest activity.
