Pre-Purchase Building & Pest Inspection Report

63 Oyster Bay Road, Oyster Bay

Date: 03/08/20

Reference: 20084

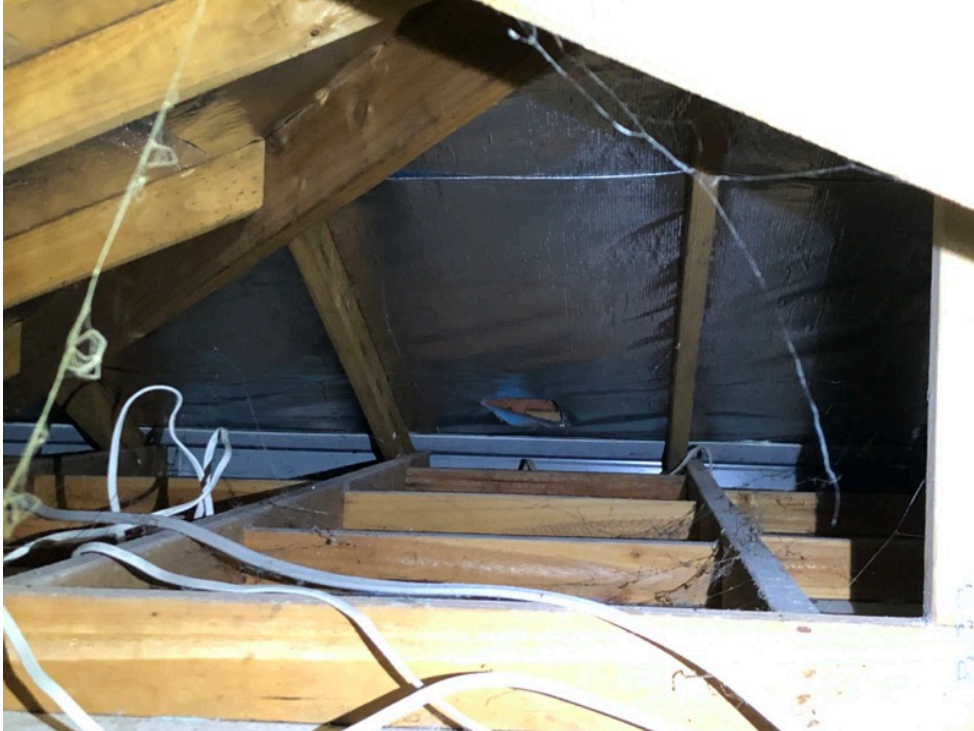
#	Description
1.	Torn sarking in multiple locations in garage roof void. Potential for further deterioration and water ingress.
2.	Deteriorated seal around top of balcony sliding door. Potential for further deterioration.

1. Torn sarking in multiple locations in garage roof void. Potential for further deterioration and water ingress.

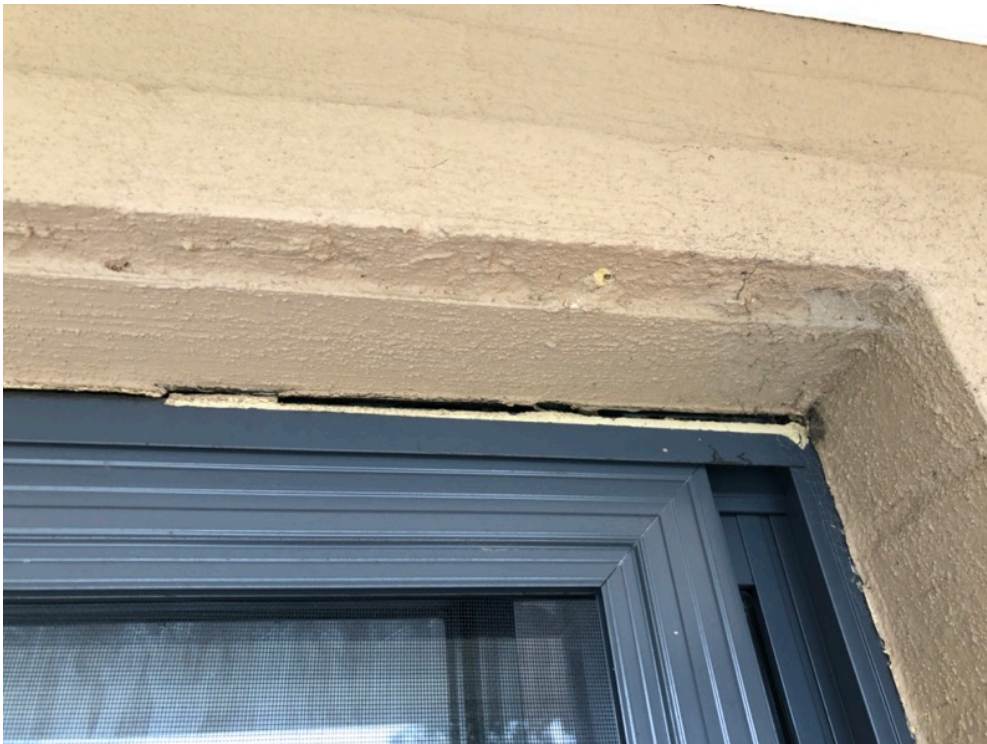
2. Deteriorated seal around top of balcony sliding door. Potential for further deterioration.

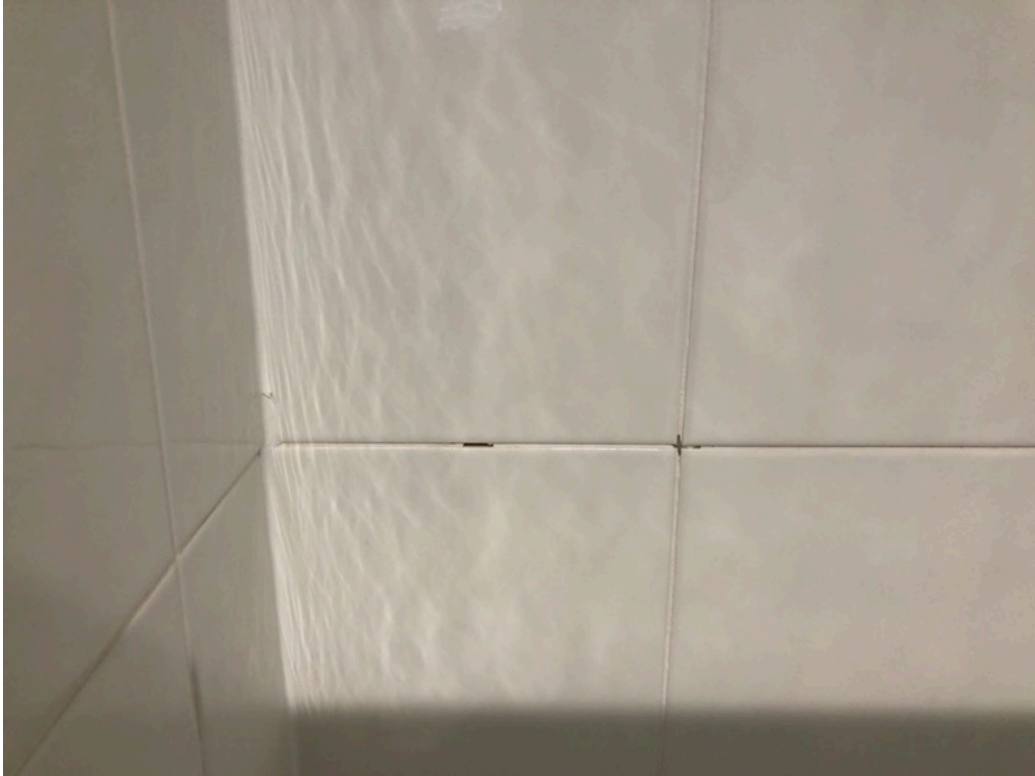
3.	Grout deteriorating to wall tiles in shower of Ensuite. Potential for further deterioration.
4.	Grout deteriorating around shower floor tiles in bathroom upstairs. Potential for further deterioration.

3. Grout deteriorating to wall tiles in shower of Ensuite. Potential for further deterioration.

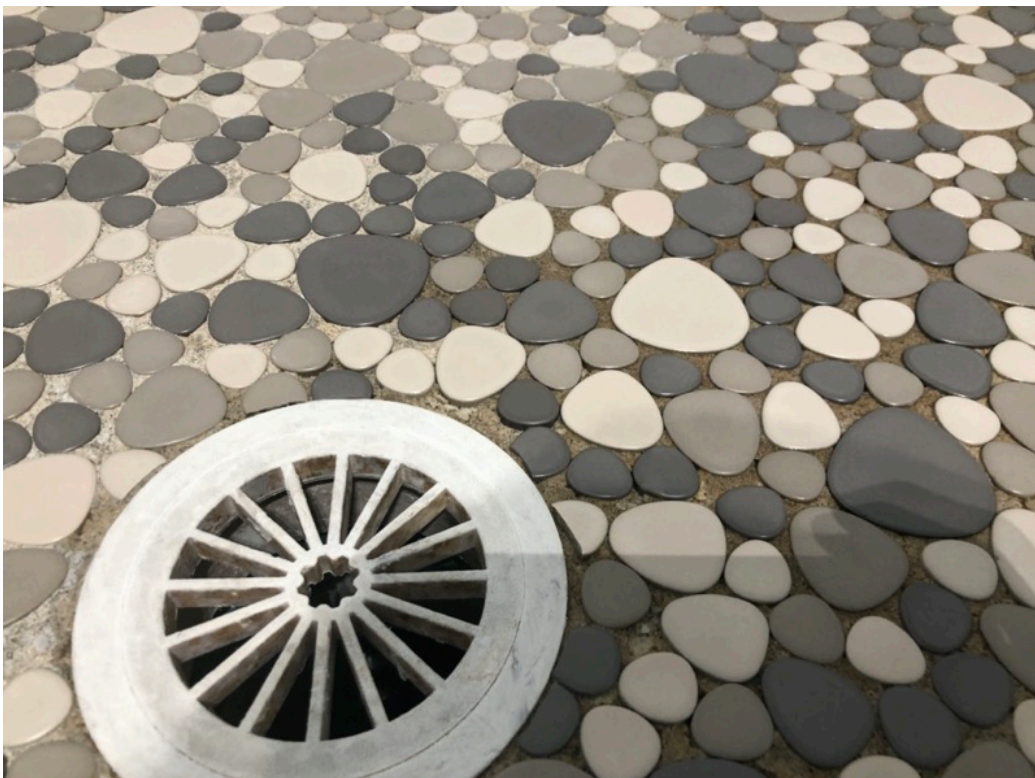
4. Grout deteriorating around shower floor tiles in bathroom upstairs. Potential for further deterioration.

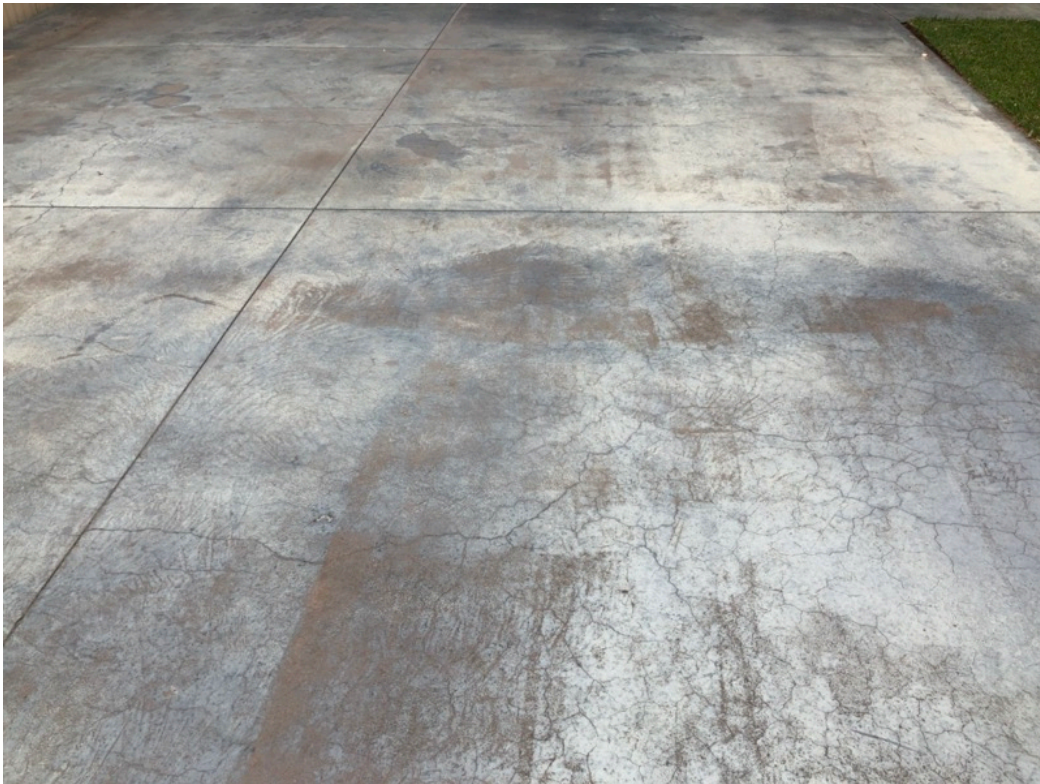
5.	Webbed cracking to concrete driveway slab. Appearance cracks with potential for further cracking.
6.	Garden bed crack near driveway. Serviceability crack with potential for further cracking.

5. Webbed cracking to concrete driveway slab. Appearance cracks with potential for further cracking.

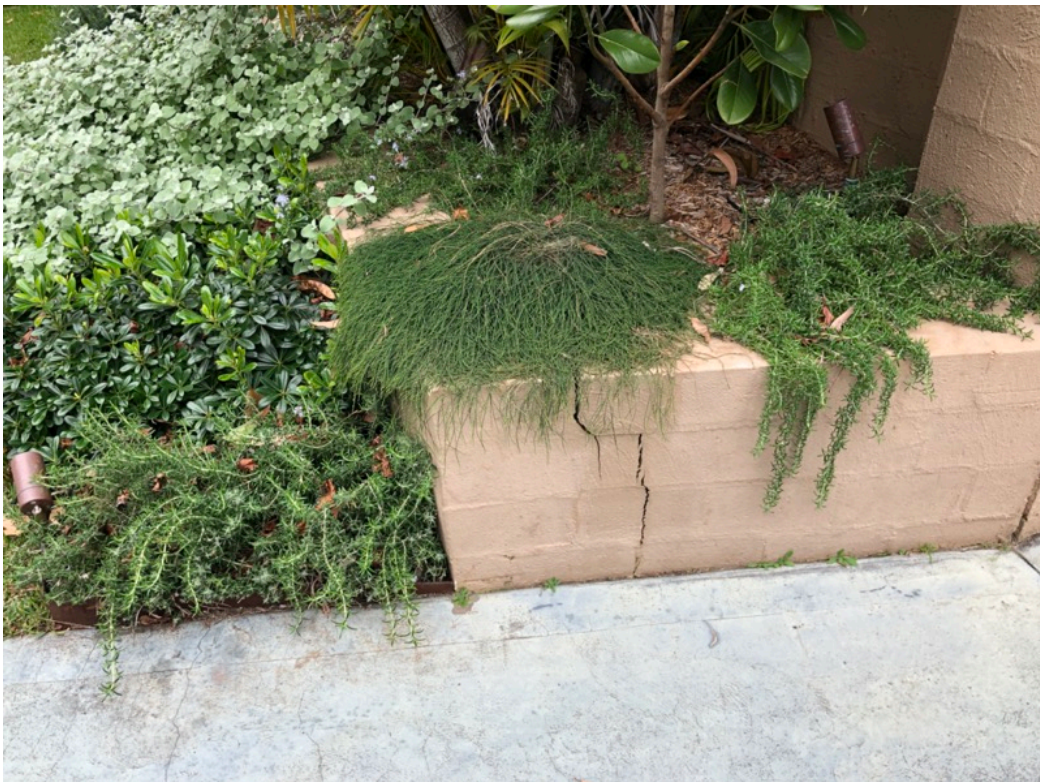
6. Garden bed crack near driveway. Serviceability crack with potential for further cracking.

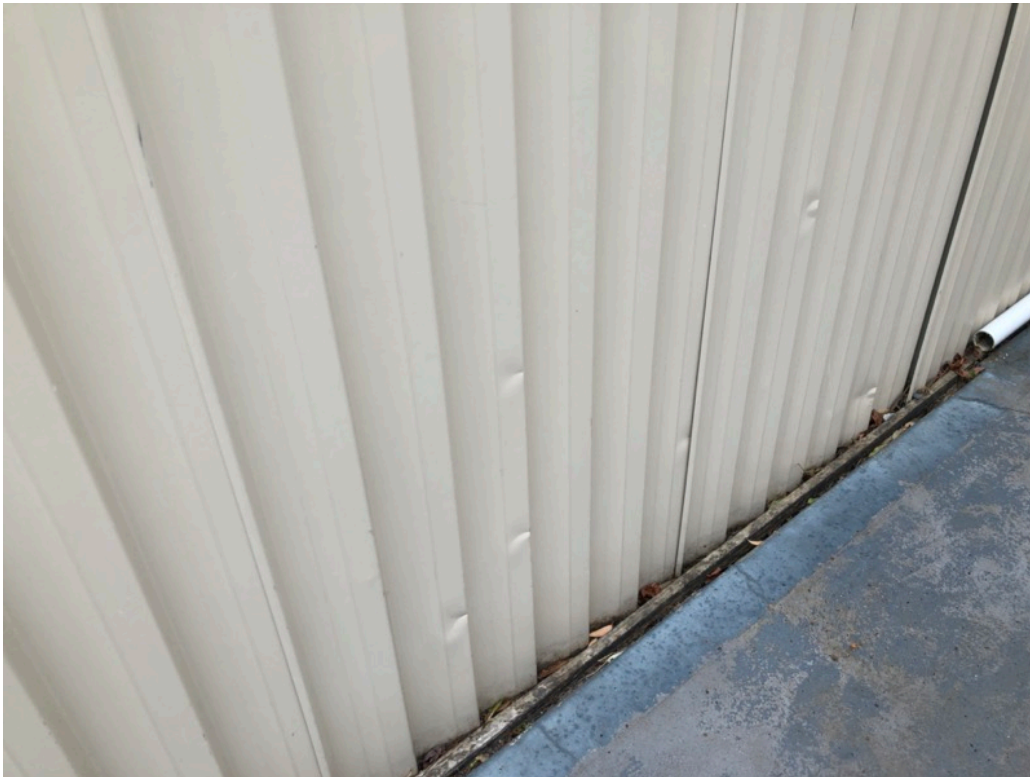
7.	Multiple locations of dents to fence on west side. No further damage anticipated.
8.	Leaning brick retaining wall on east side. Serviceability defect with potential for further deterioration.

7. Multiple locations of dents to fence on west side. No further damage anticipated.

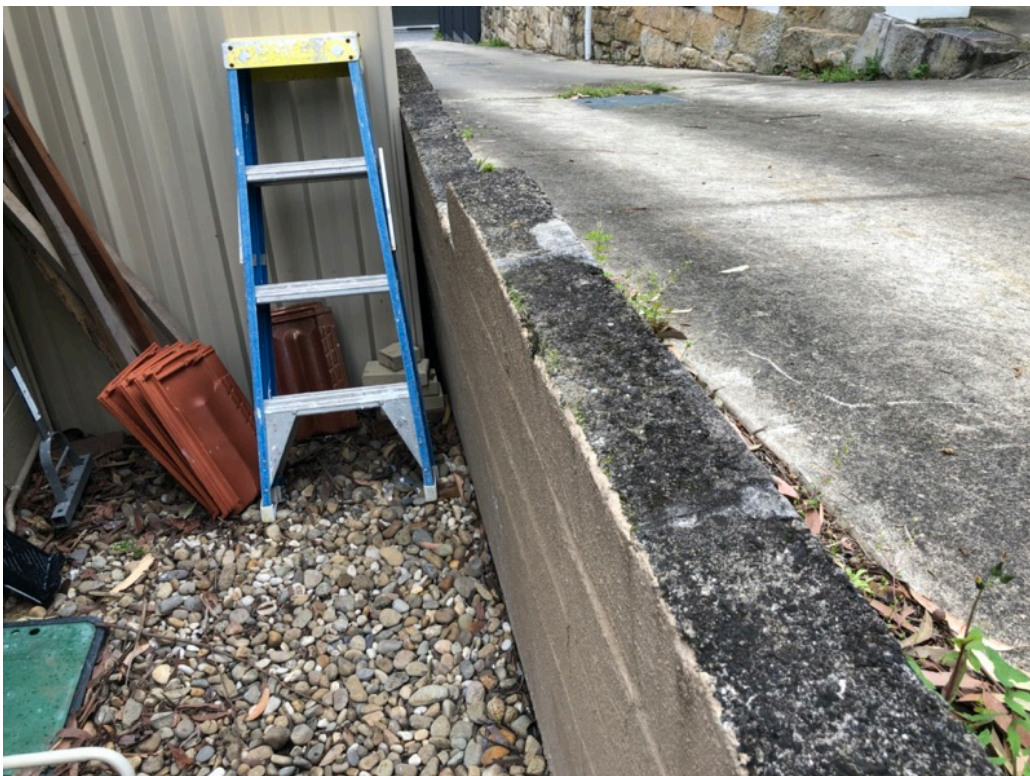
8. Leaning brick retaining wall on east side. Serviceability defect with potential for further deterioration.

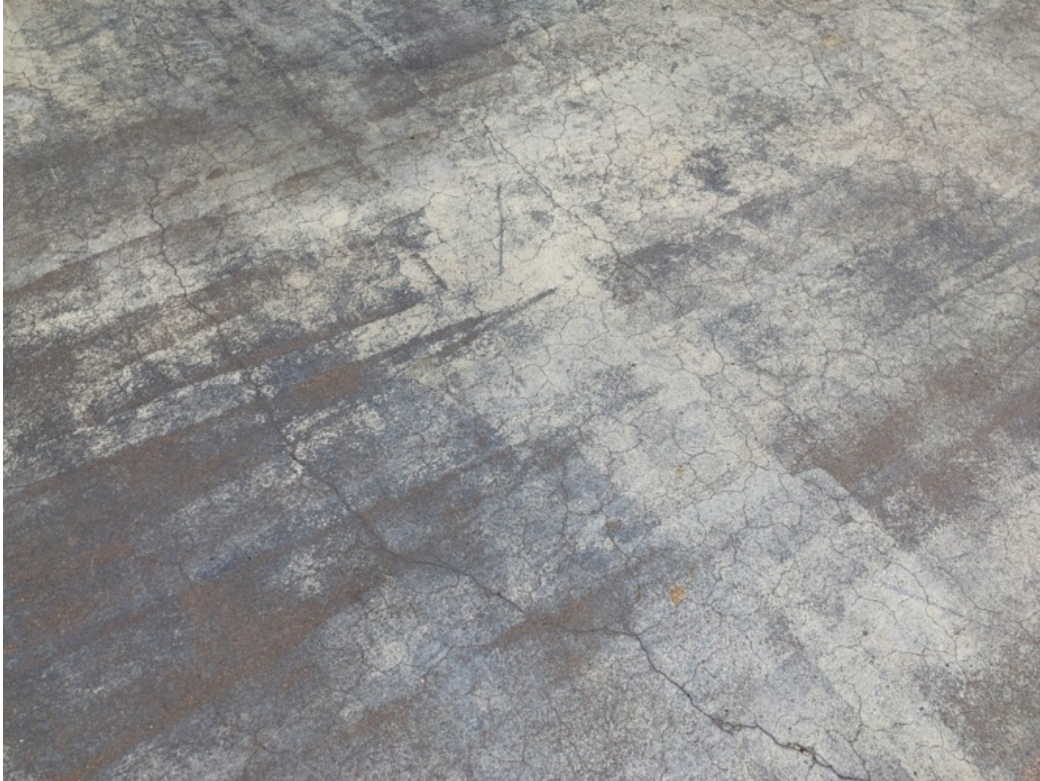
9.	Webbed path cracking throughout back yard area. Appearance cracks with potential for further cracking.
10.	Brick windowsill crack below window on west side. Appearance crack with potential for further cracking.

9. Webbed path cracking throughout back yard area. Appearance cracks with potential for further cracking.

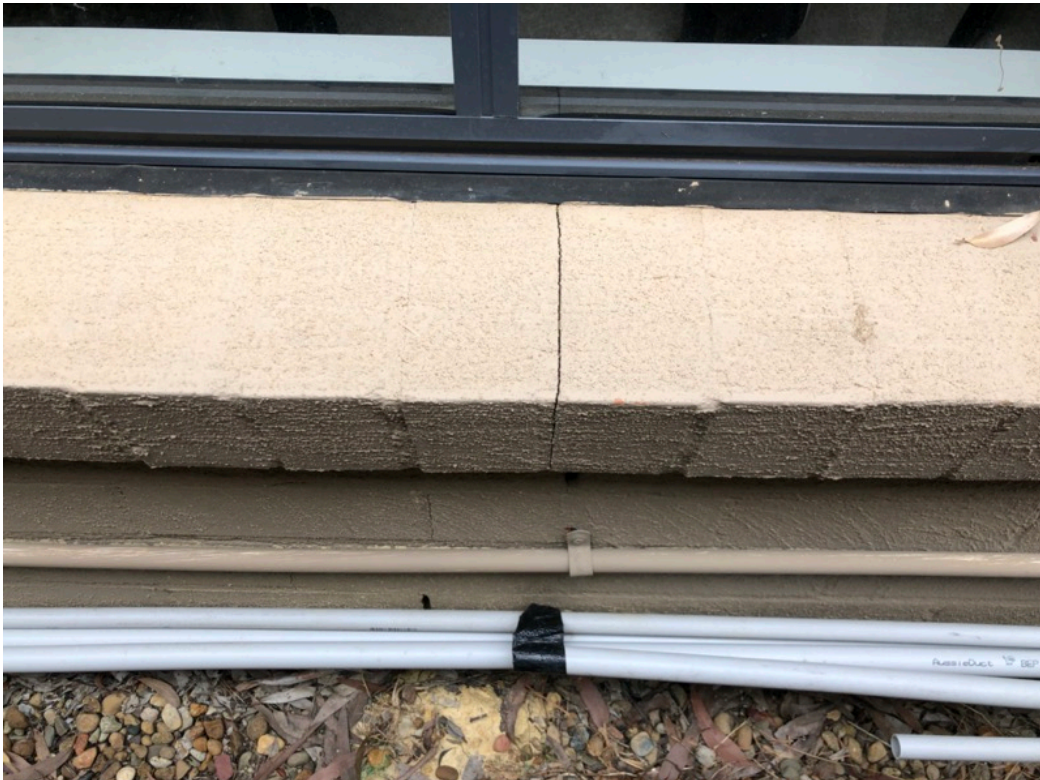
10. Brick window sill crack below window on west side. Appearance crack with potential for further cracking.

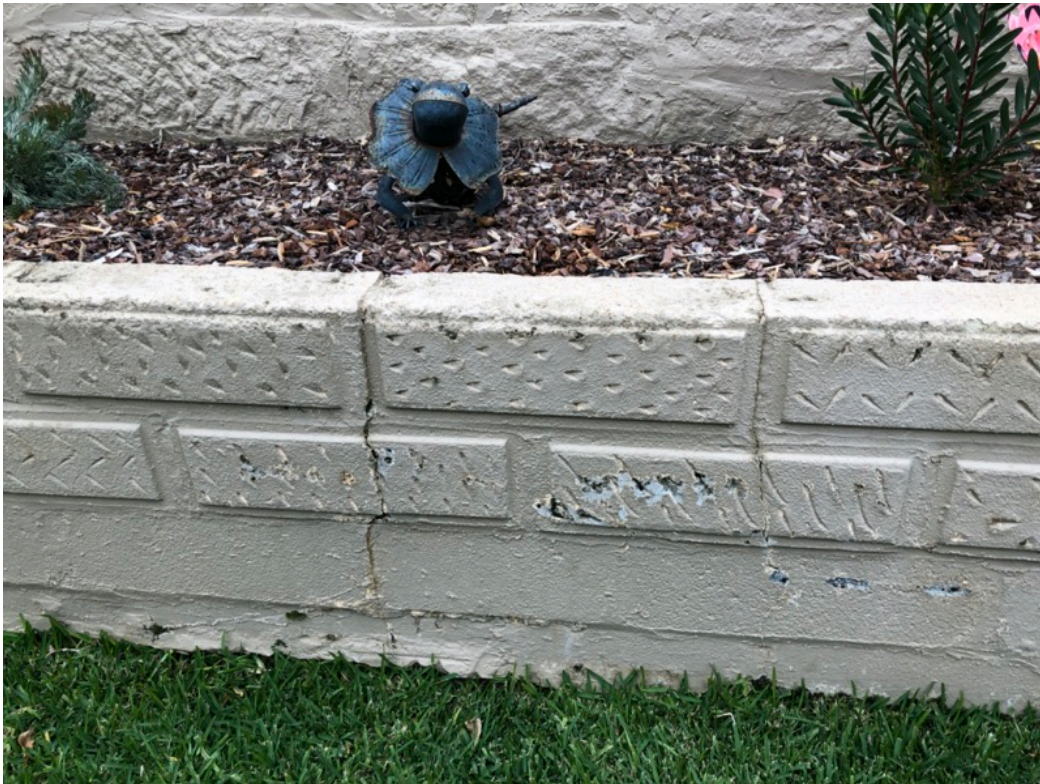
11.	Garden bed crack near back yard steps. Appearance crack with potential for further cracking.

11. Garden bed crack near back yard steps. Appearance crack with potential for further cracking.

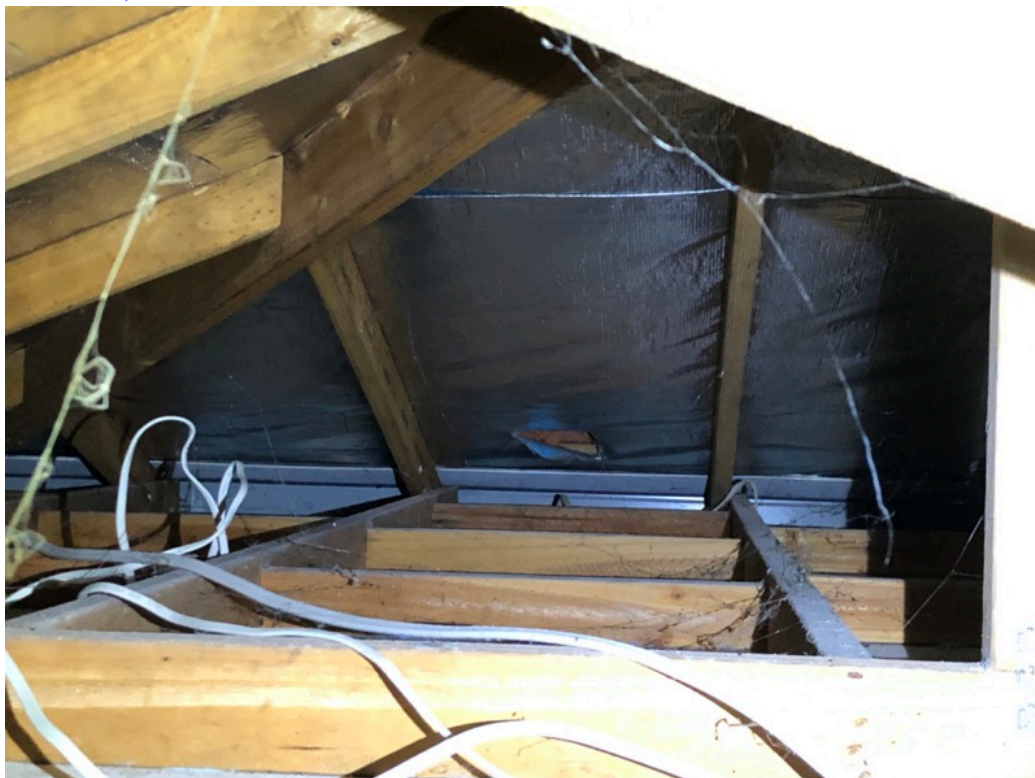
1. Torn sarking in roof void increases chance of water ingress. Moisture increases chance of timber pest activity.

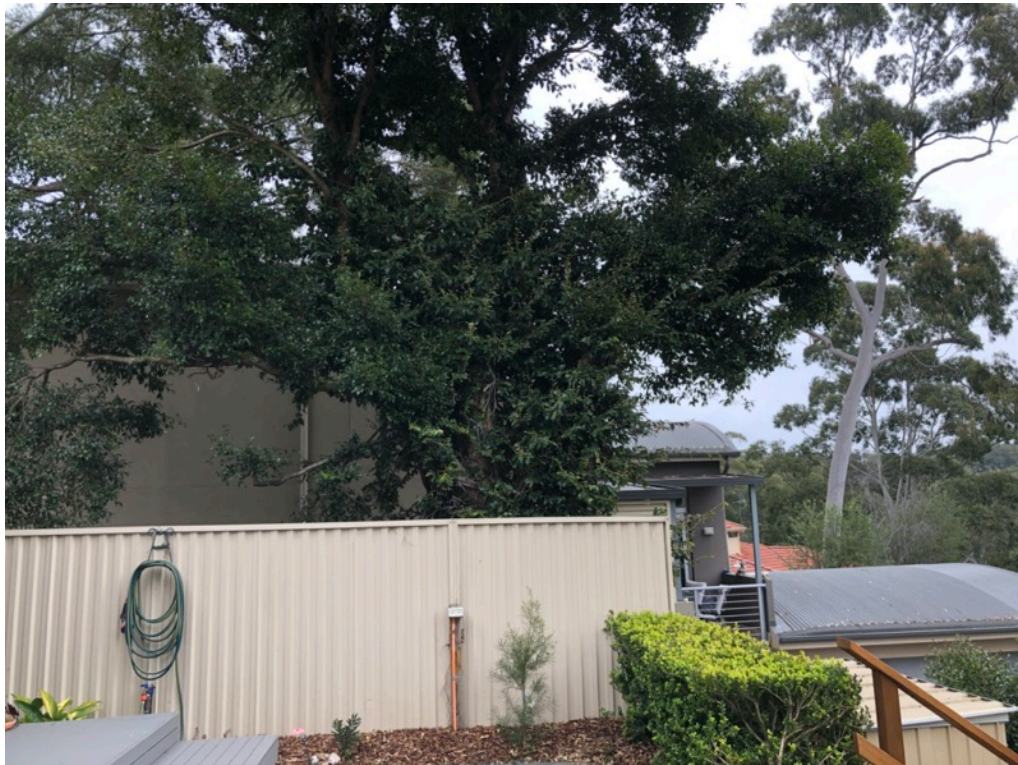
2. Trees nearby increases chance of timber pest activity.
