Pre-Purchase Building & Pest Inspection Report

12 Como Road, Oyster Bay

Date: 07/08/20

Reference: 20086

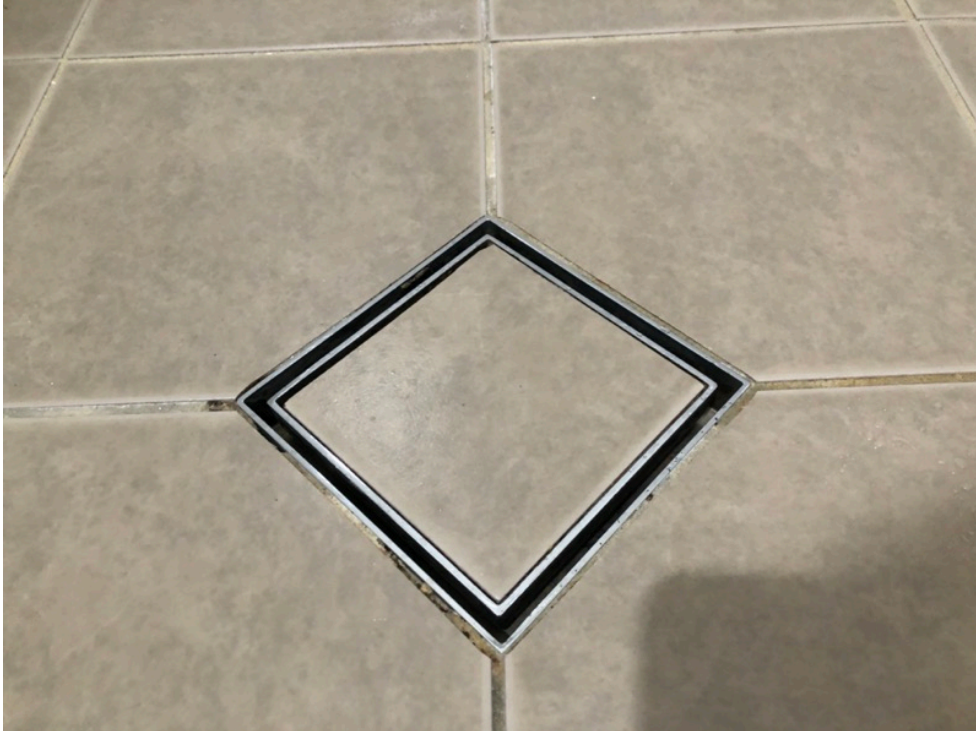
1. Grout deteriorating around drain in shower floor tiles in bathroom. Potential for further deterioration.

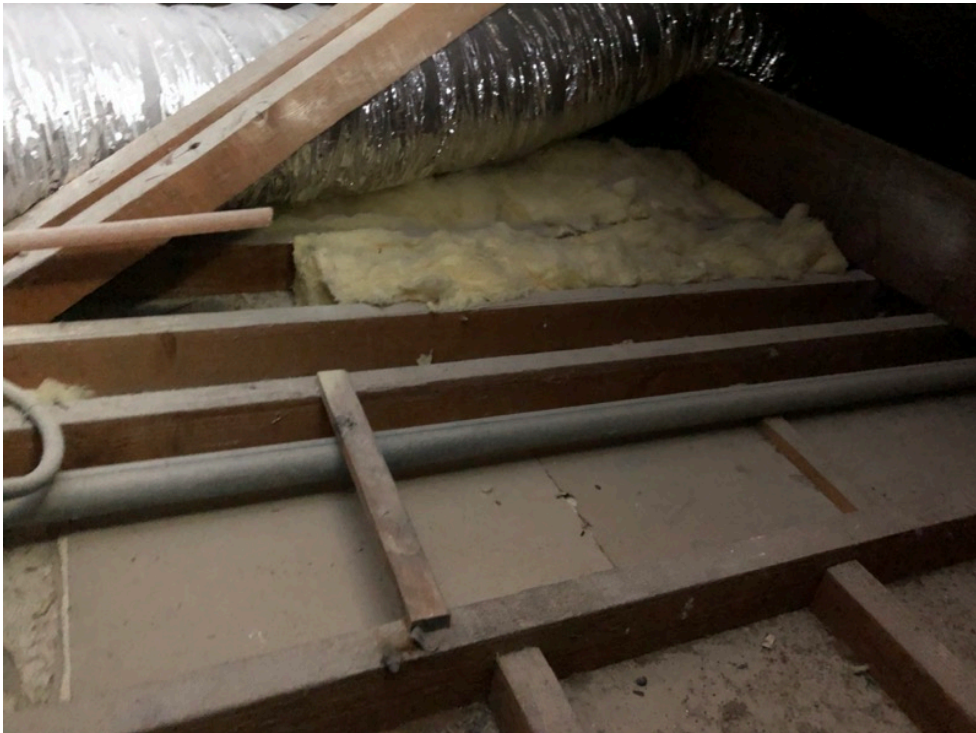
2. Missing pieces of insulation in roof void. No further loss of operation anticipated.

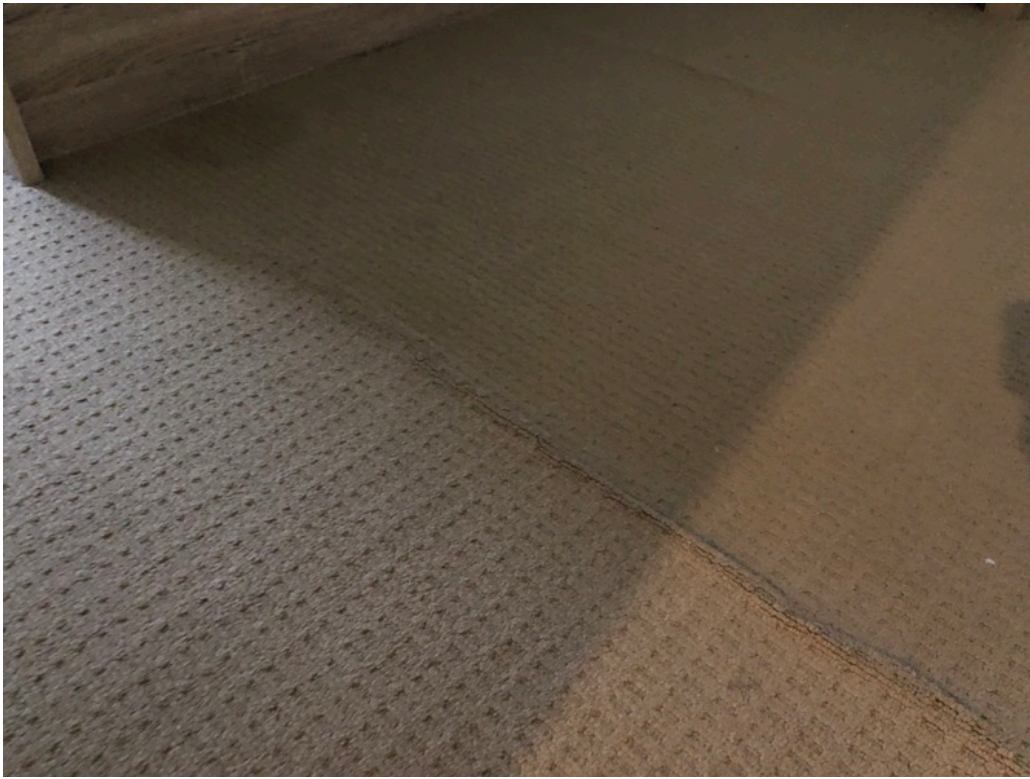
3. Loose carpet in middle of Bedroom 3. Potential for further deterioration.

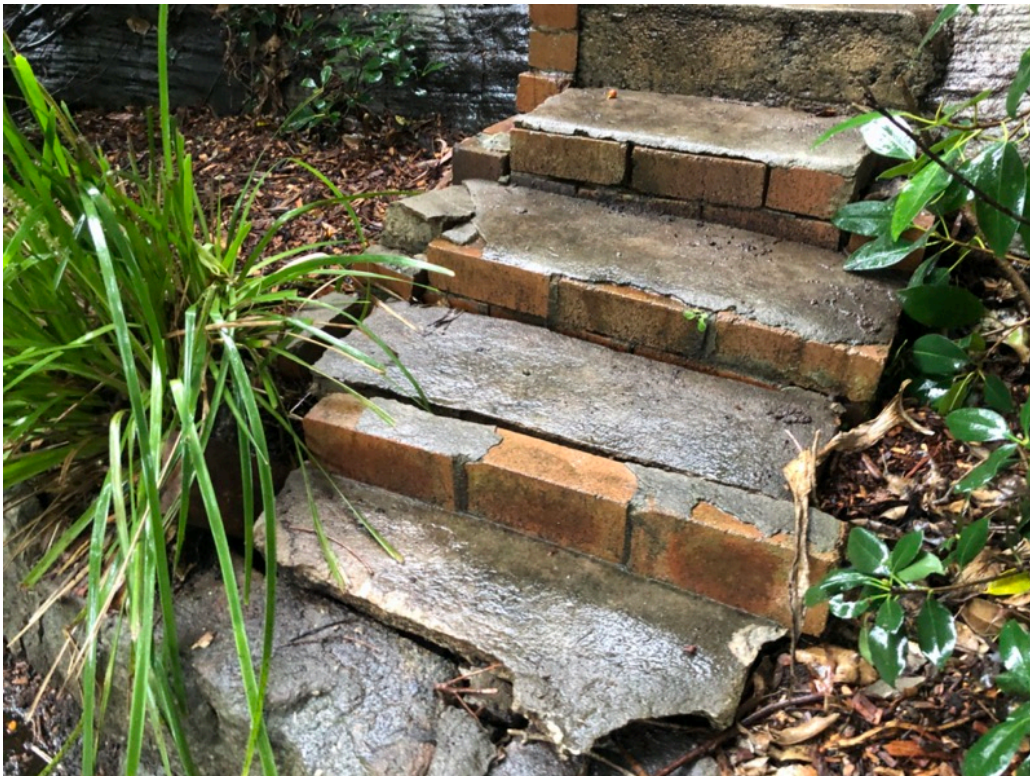
4. Loose concrete / brick step in backyard behind pool area. No further deterioration anticipated.

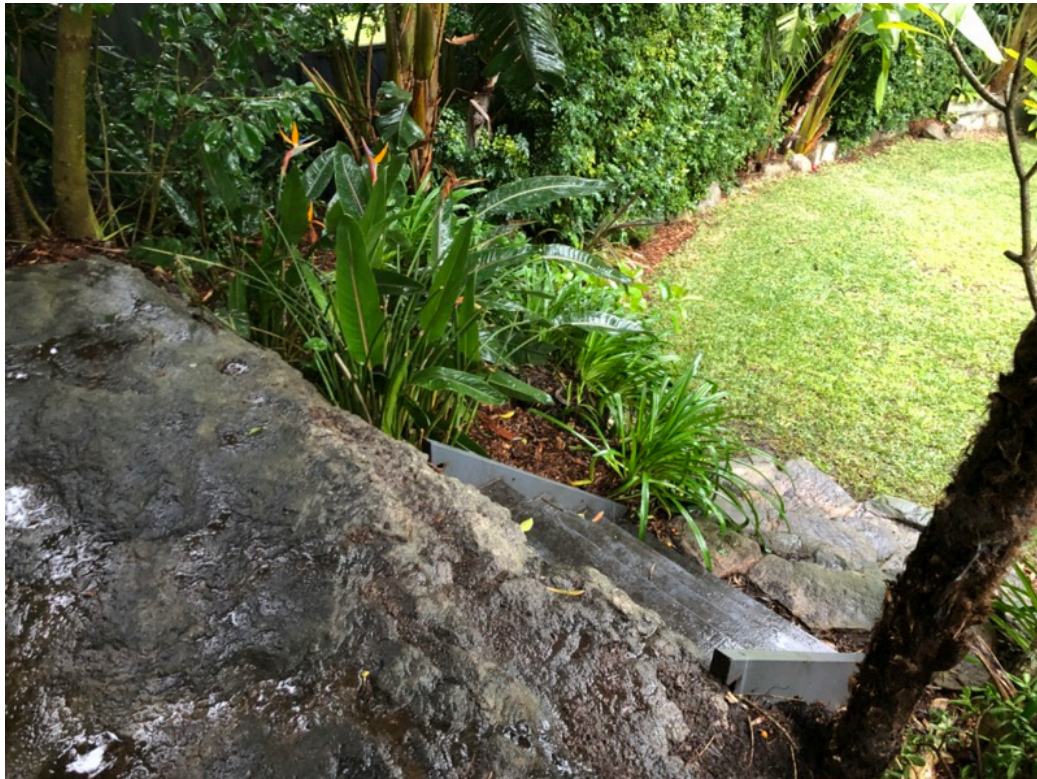
5. Fall hazard due to no handrail on backyard steps behind pool. Potential for injury.

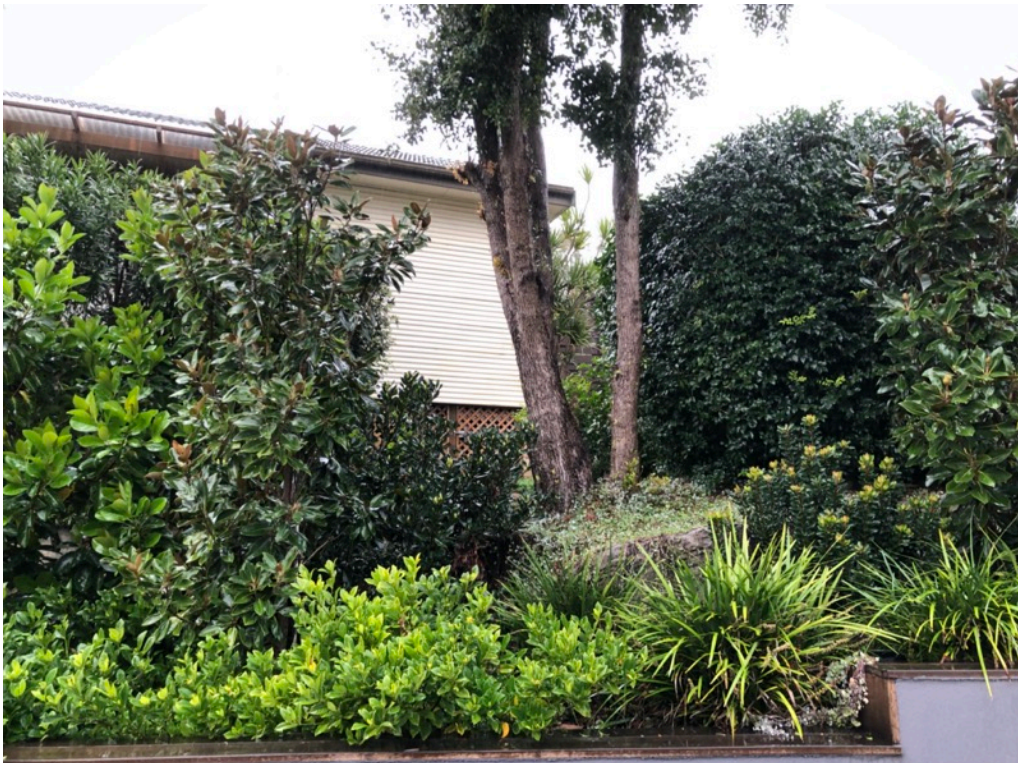
1. Trees on site increases chance of timber pest activity.

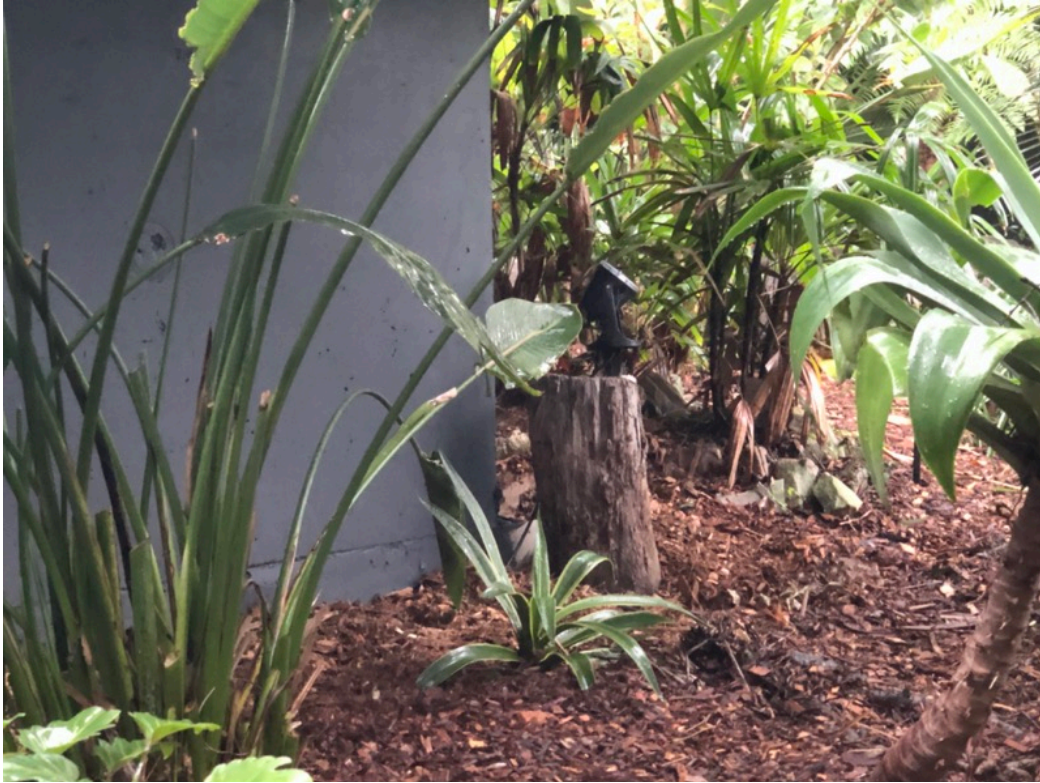
2. Stump on site increases chance of timber pest activity.
