Pre-Purchase Building & Pest Inspection Report

13 Jarrah Close, Alford's Point

Date: 05/10/20

Reference: 20013

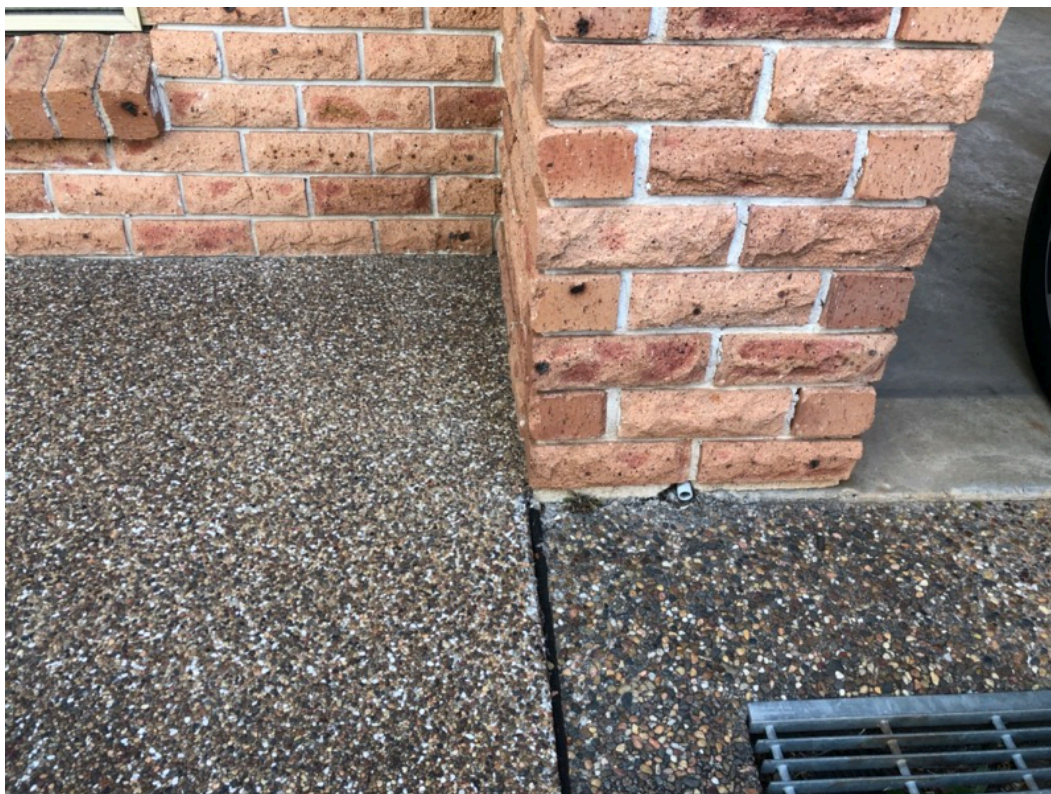
15. Subfloor – Concrete slab inaccessible

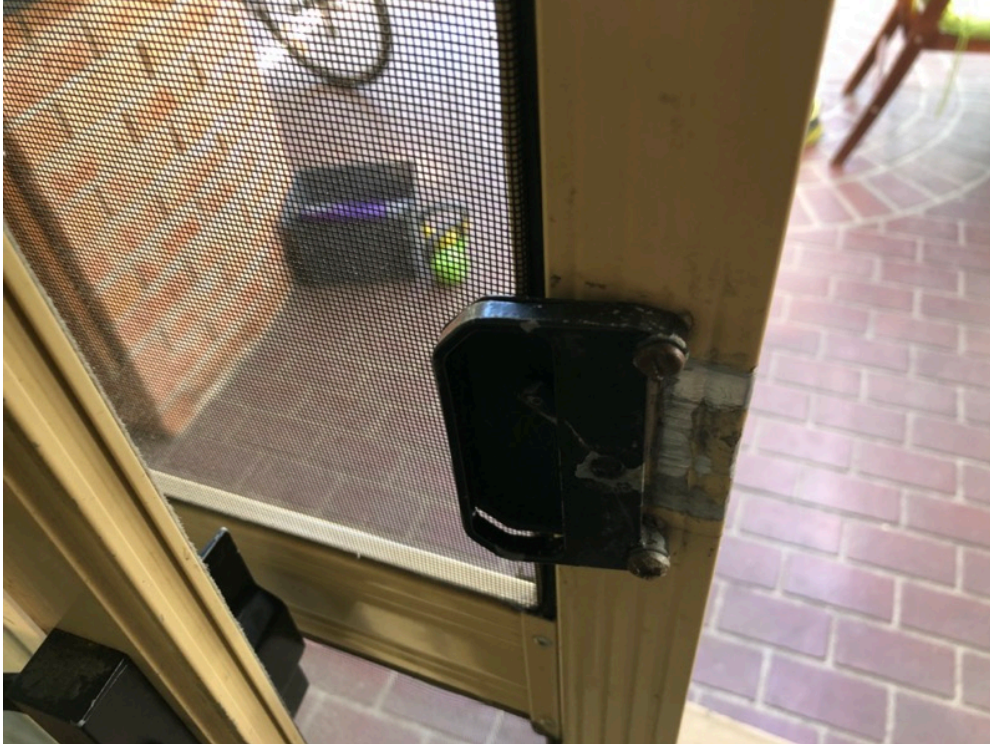
1. Loose handle on sliding door fly screen in dining room. No further deterioration anticipated.

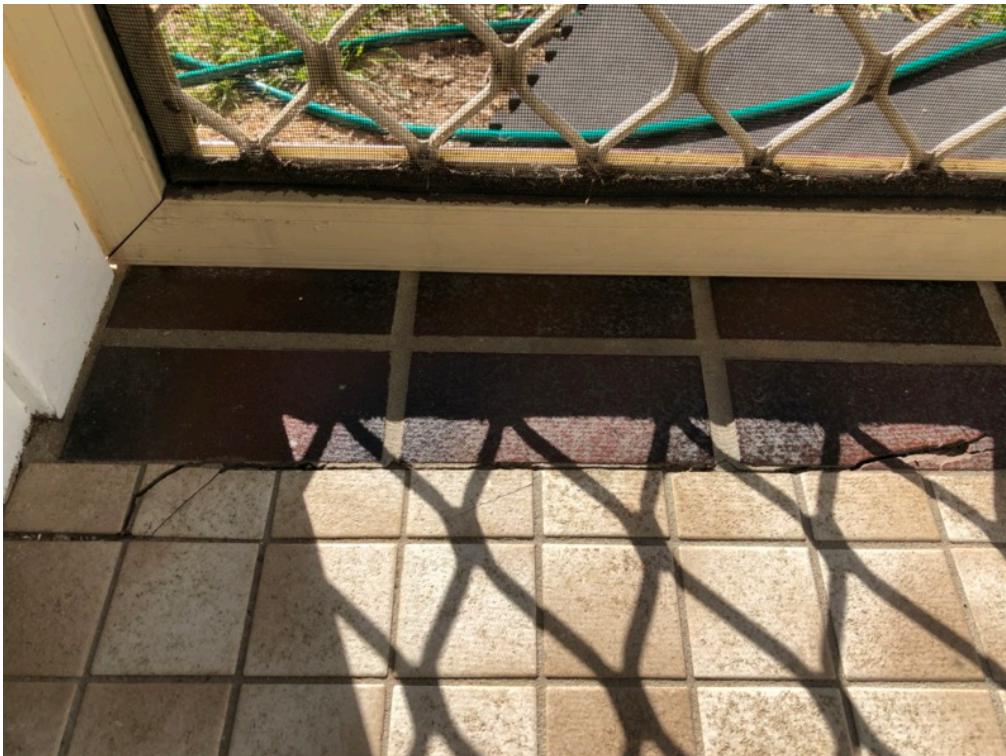
2. Multiple cracked tiles in laundry near back step. Potential for further cracking.

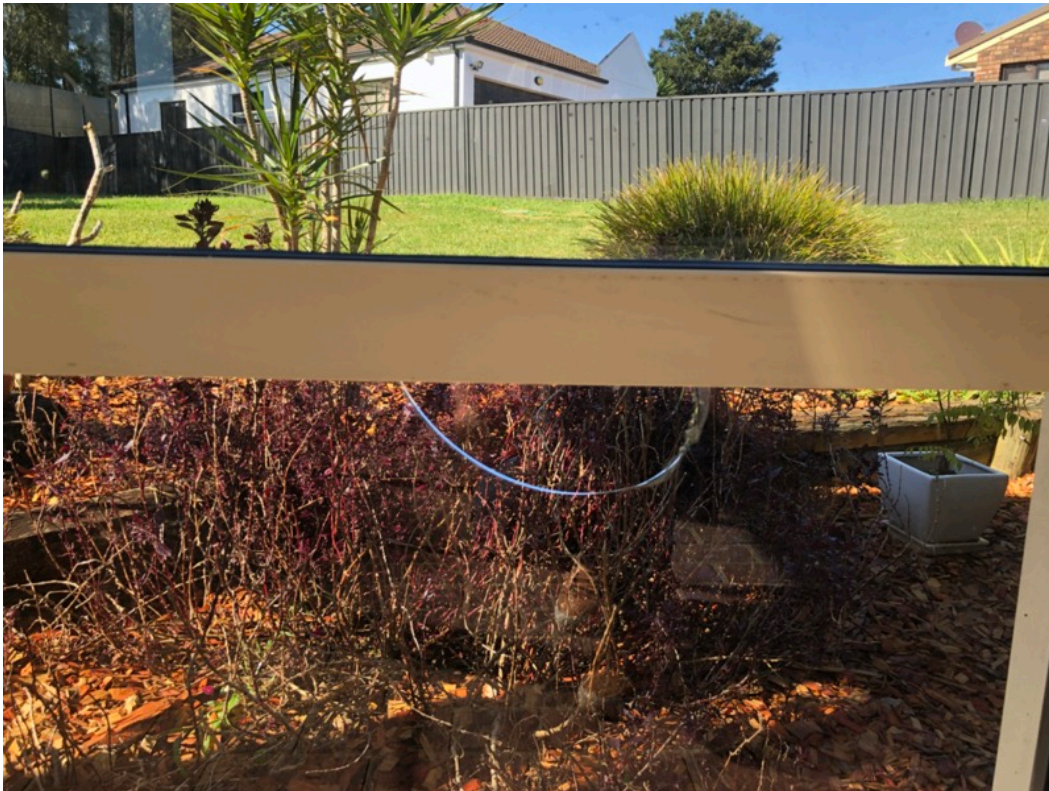
3. Cracked window pane on patio near South East corner. No further damage anticipated.

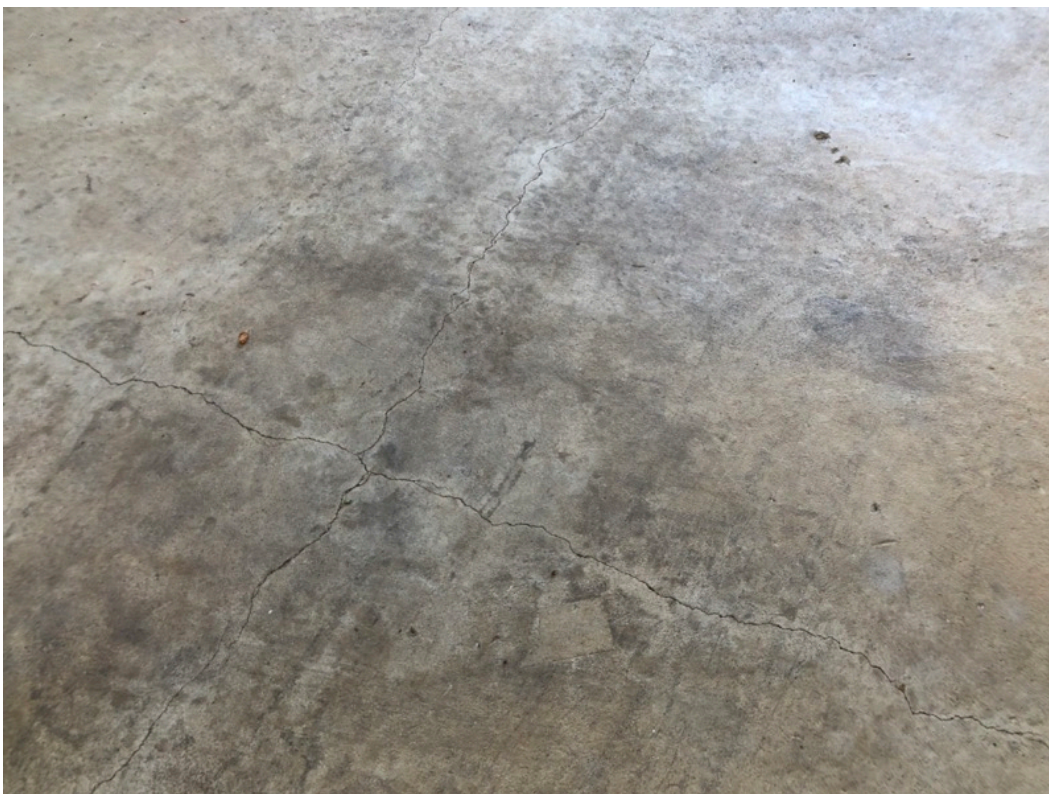
4. Multiple concrete webbed cracks to garage floor slab. Appearance cracks with potential for further cracking.

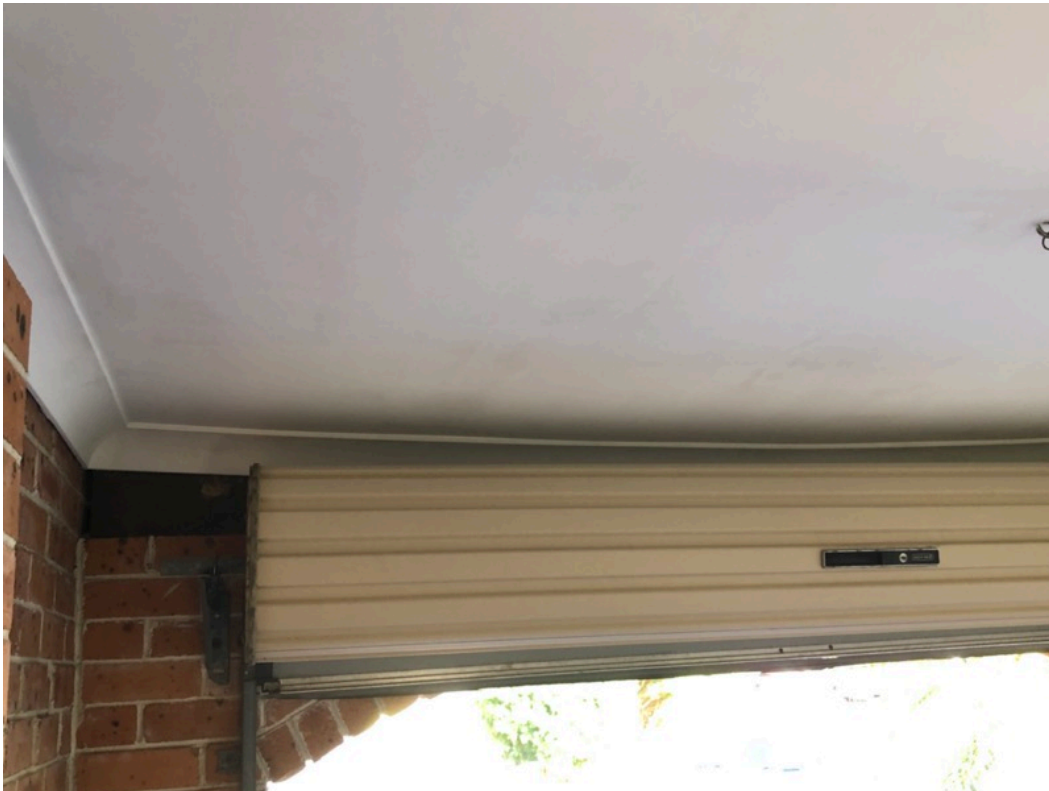
5. Sagging plaster cornice above roller door in garage. Inspected roof void and no visible damage. Potential for further deterioration.

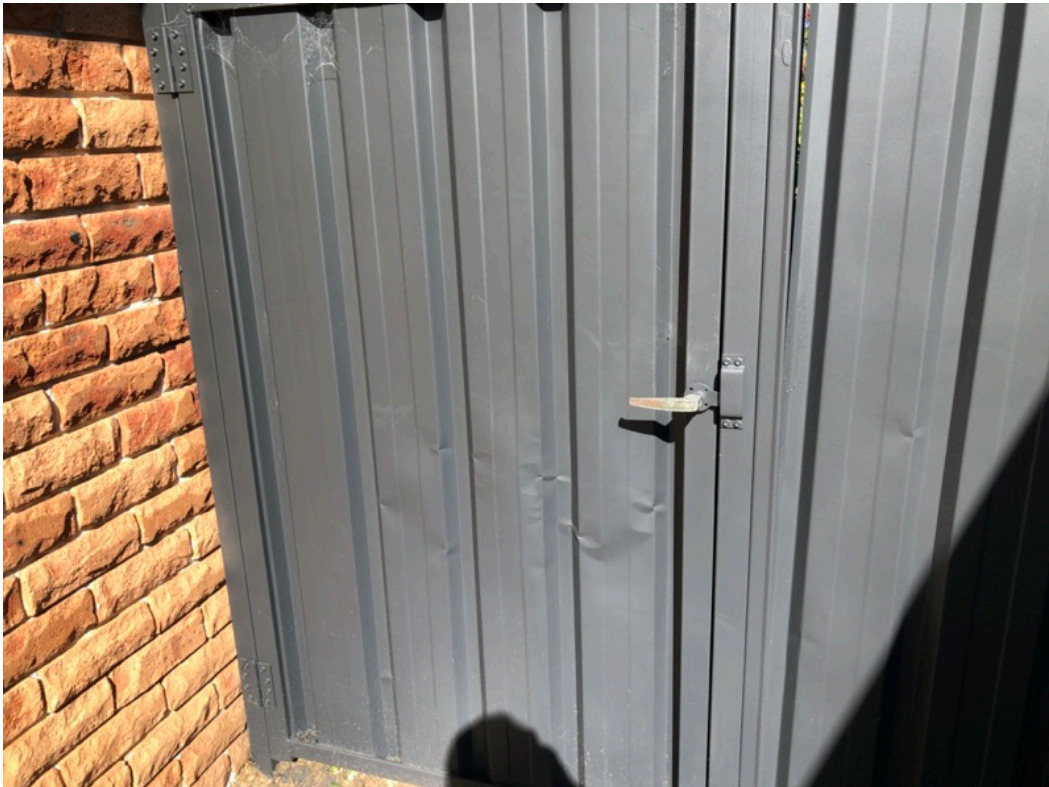
6. Dents to side gate on north side. No further damage anticipated.

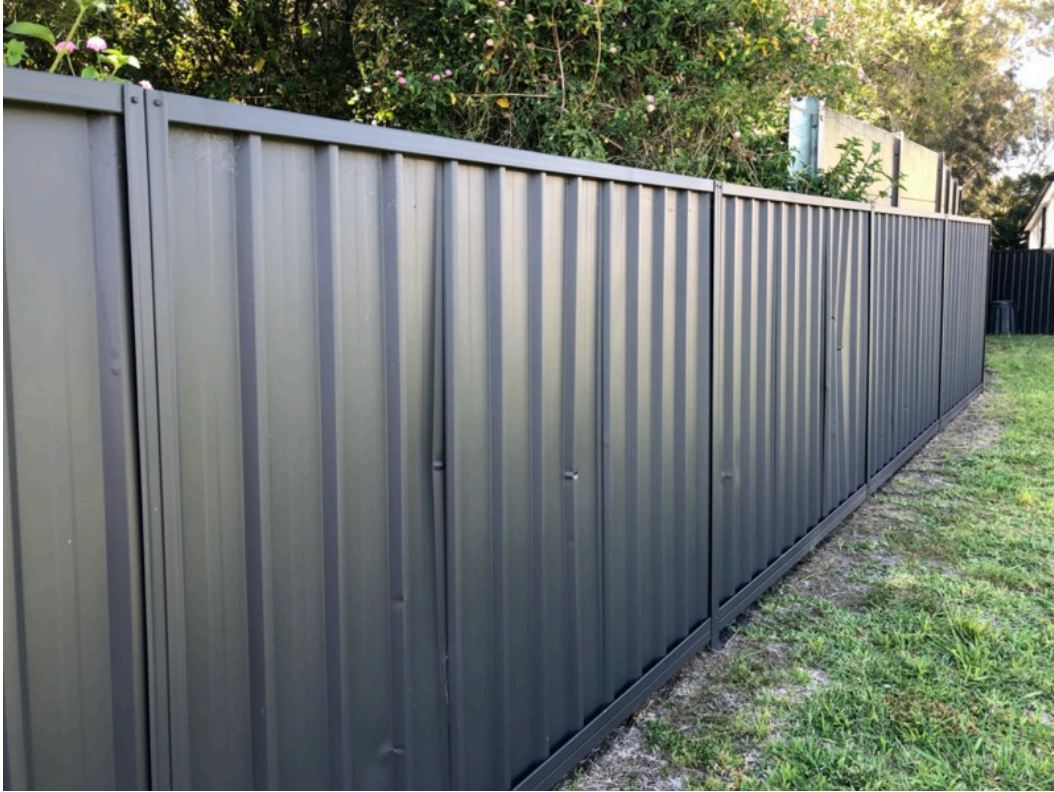
7. Dents to multiple fence panels along East side. No further damage anticipated.

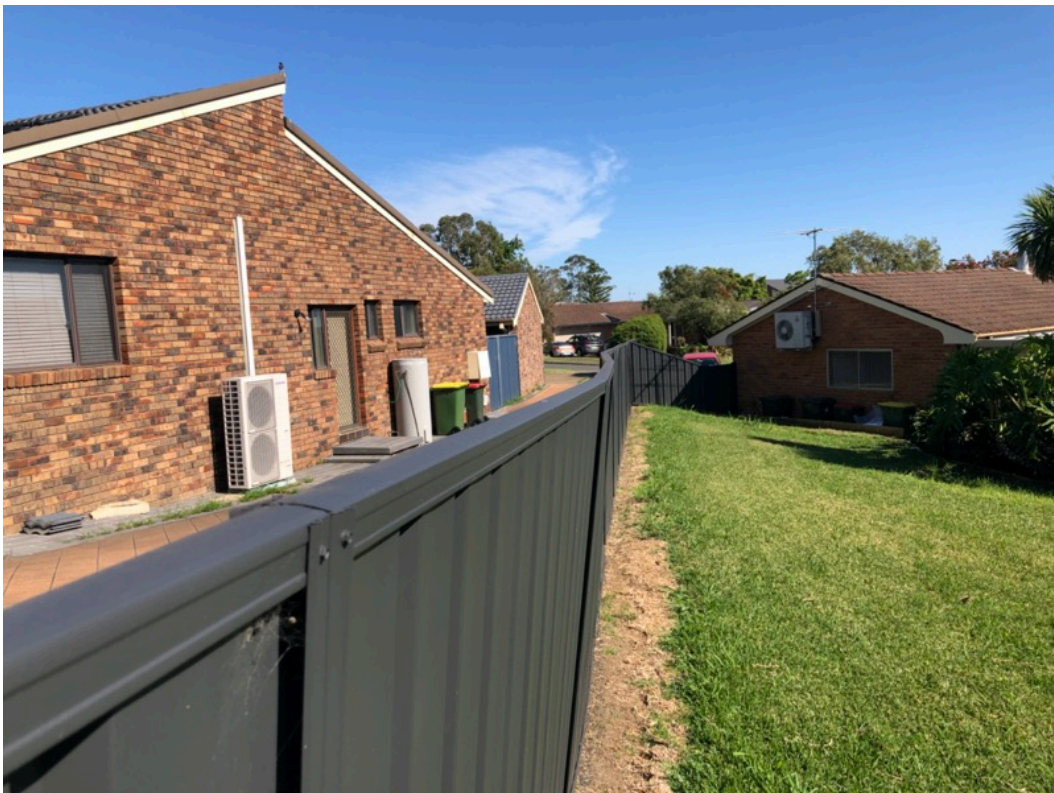
8. Fence leaning in middle of South side. Potential for further deterioration.

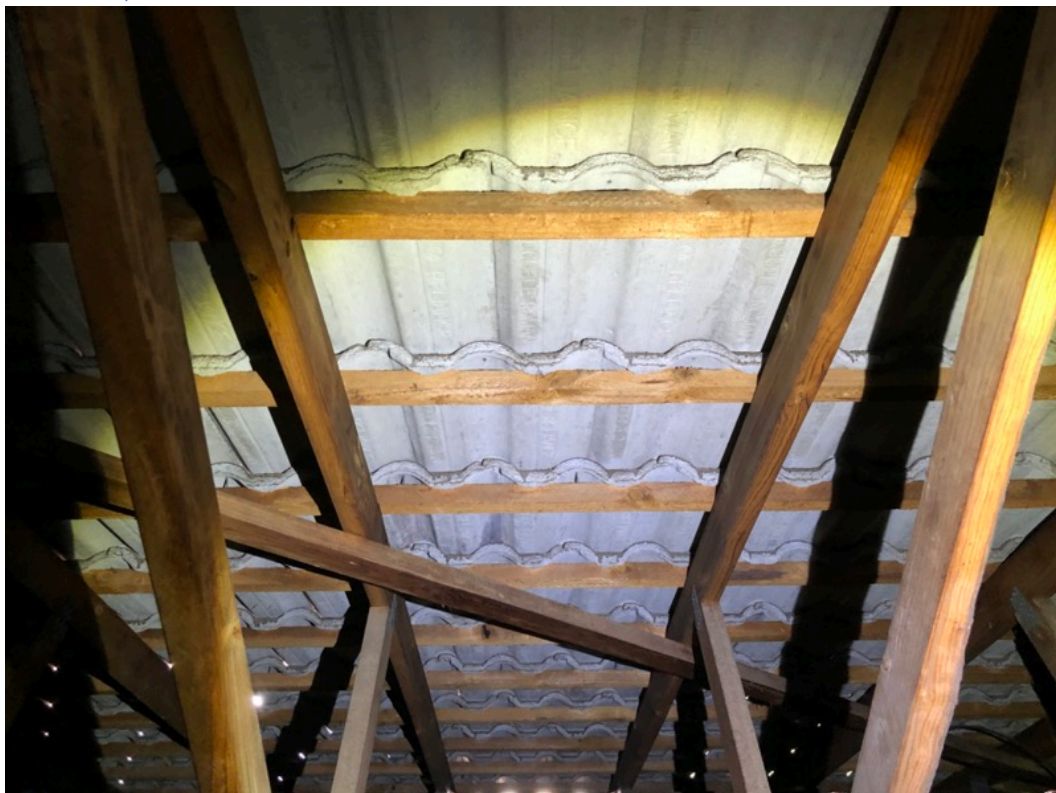
1. No sarking installed in roof void. If tiles become broken, then water ingress can occur. Moisture increases chance of timber pest activity.

- No (as detailed in point 8)** treatment of Timber Pest Attack is required.
- Yes, (as detailed in point 9)** removal of Conditions Conducive to Timber Pest Attack is necessary.
- Due to the susceptibility of the property to sustaining Timber Pest Attack the next inspection is recommended in **12 months**.
