Pre-Purchase Building & Pest Inspection Report

3 Armentieres Avenue, Milperra

Date: 06/04/21

Reference: 21031

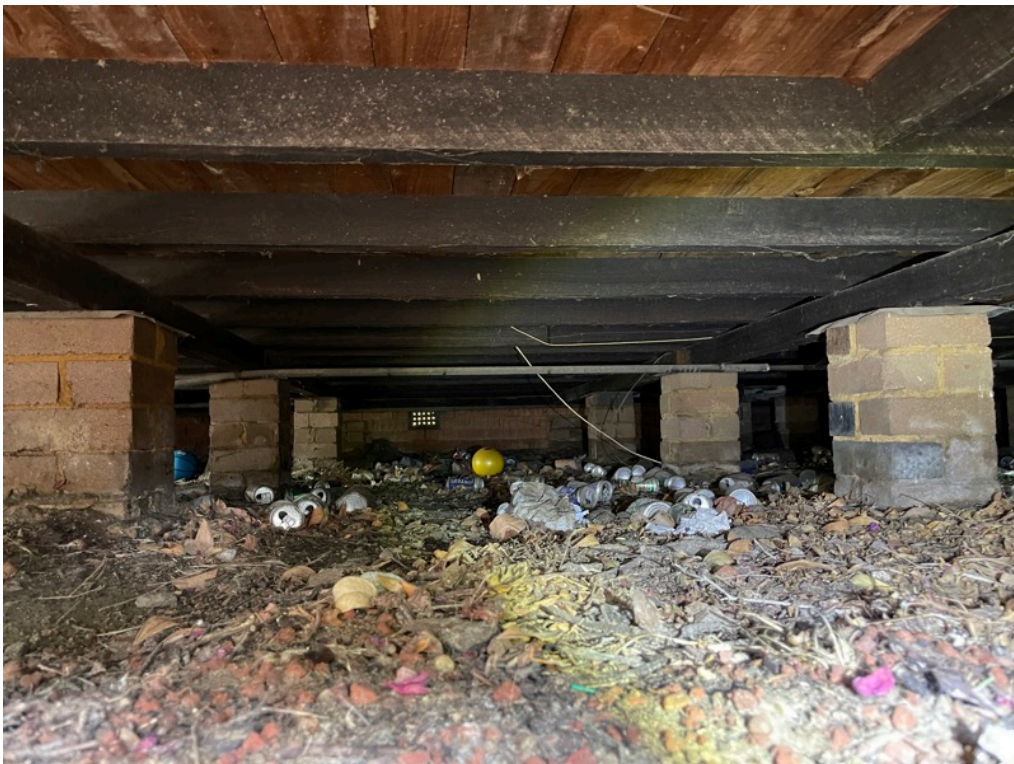
15. Subfloor with restricted access on South side

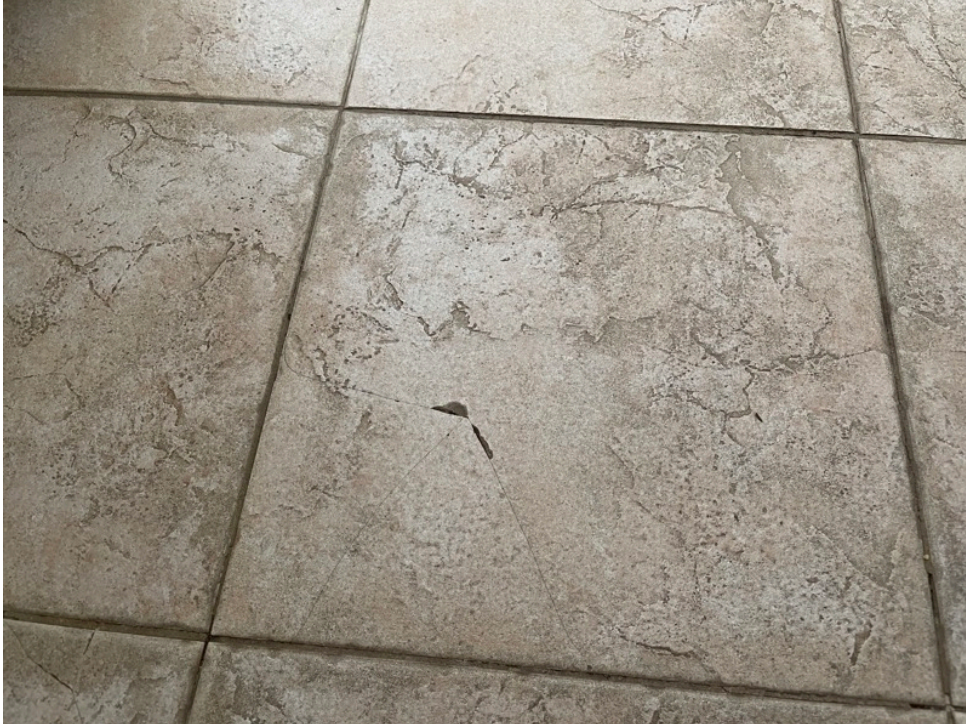
1. Cracked floor tile in kitchen. No further damage anticipated.

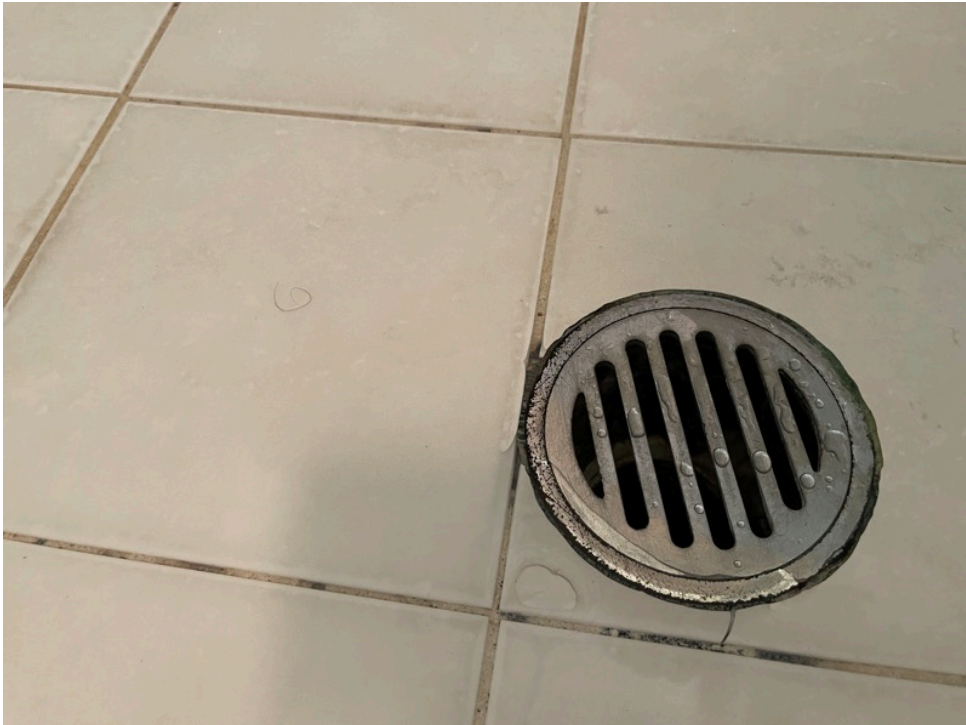
2. Deteriorating grout in floor tiles around shower drain in bathroom. Potential for further deterioration.

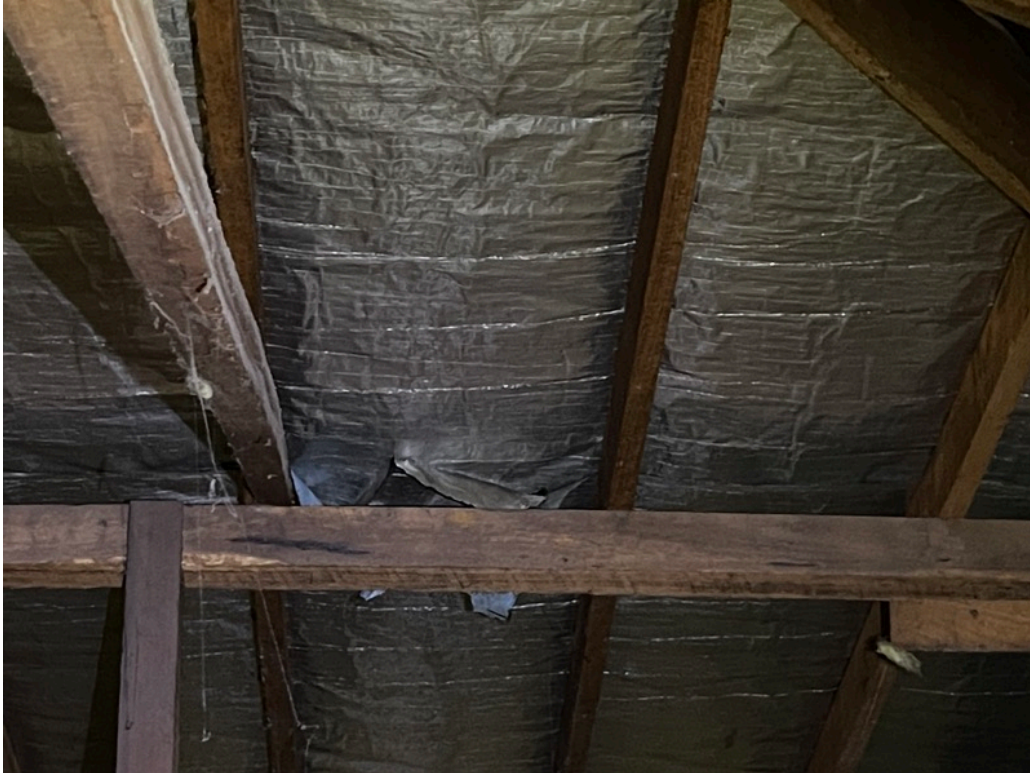
3. Torn sarking in multiple locations in roof void. Potential for water ingress if nearby tiles become broken.

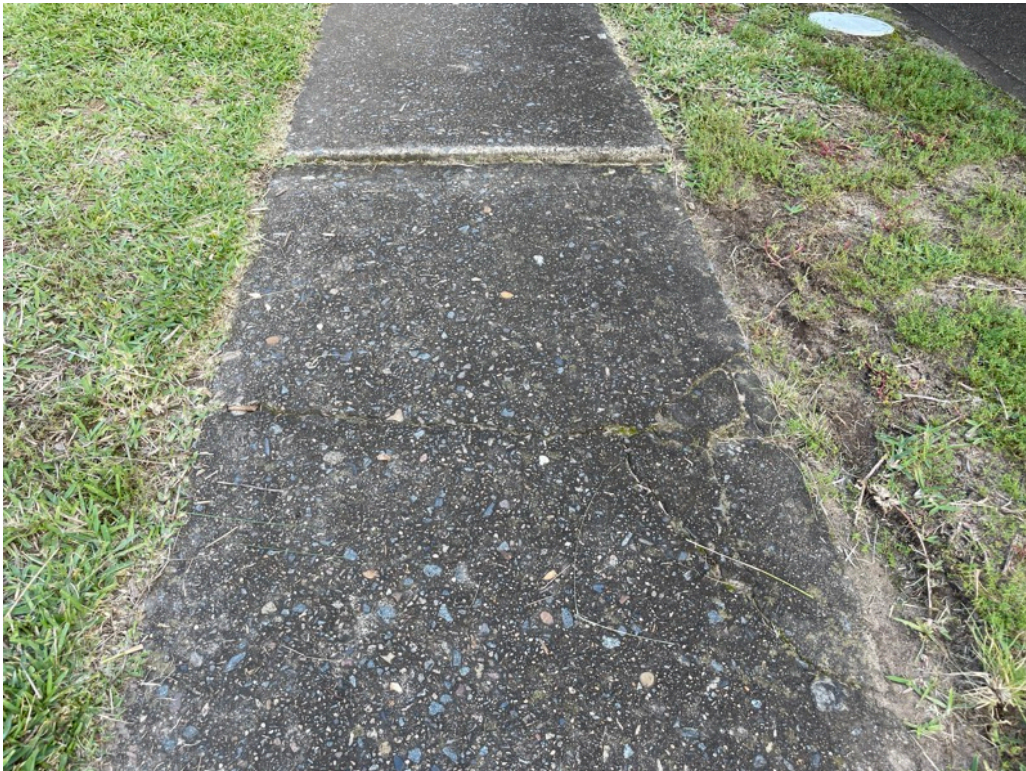
4. Concrete driveway slab crack and subsidence. Serviceability crack with no further cracking anticipated.

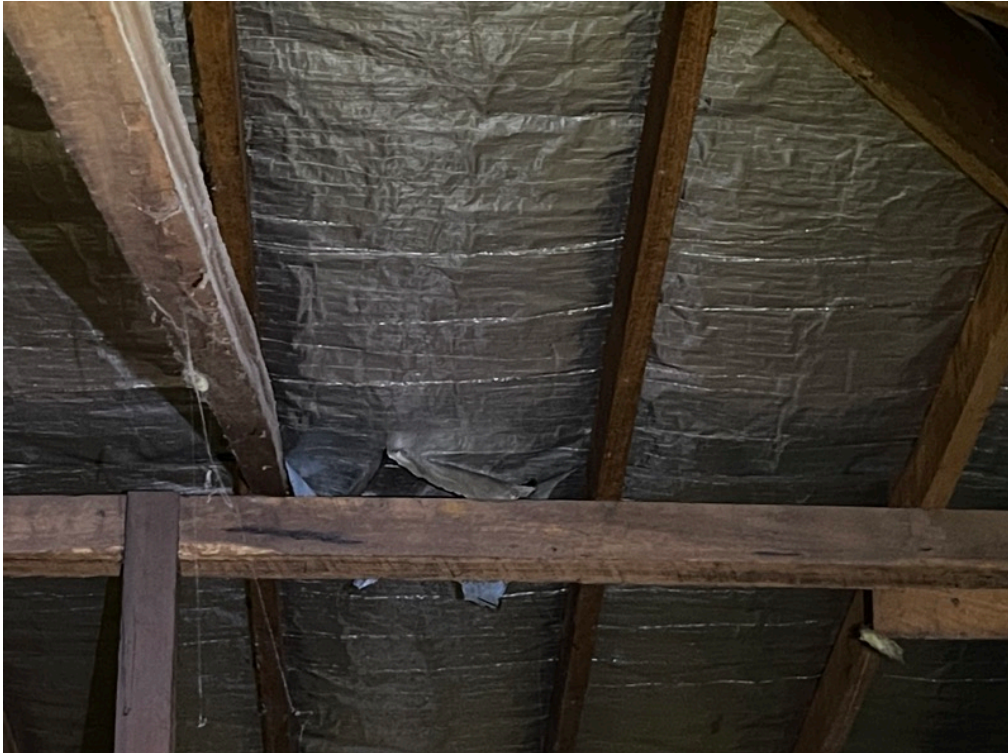
1. Torn sarking in roof void. Potential for water ingress if nearby tiles become broken. Moisture increases chance of timber pest activity.

1. **No (as detailed in point 8)** treatment of Timber Pest Attack is required.
2. **Yes, (as detailed in point 9)** removal of Conditions Conducive to Timber Pest Attack is necessary.
3. Due to the susceptibility of the property to sustaining Timber Pest Attack the next inspection is recommended in **12 months**.

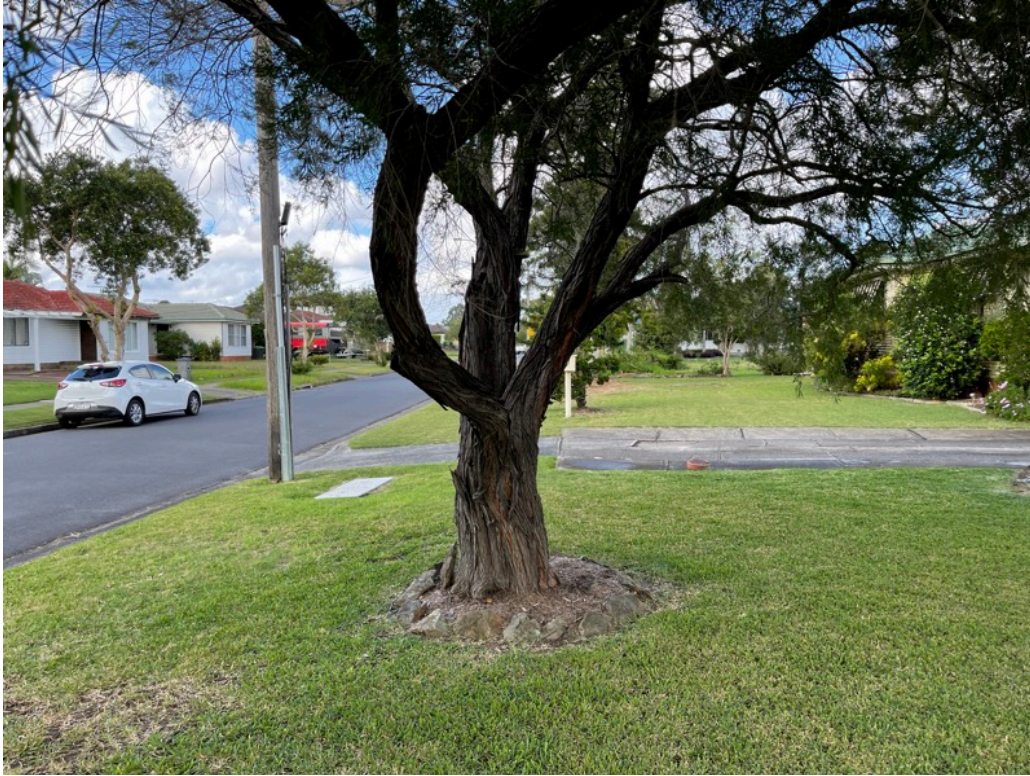
2. Trees pm site increases chance of timber pest activity.
