Building Report

15a Warrigal St, Jannali

BUILDING & TIMBER PEST INSPECTION REPORT TO AS4349.1 2007 & AS4349.3 2010

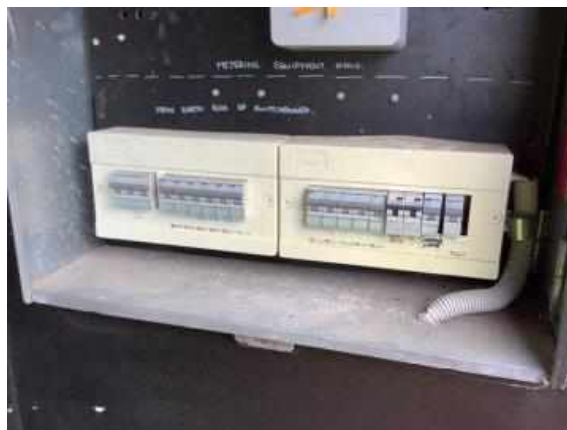
Electrical Safety Switch:

- Whilst not an electrician, an electrical safety switch is present to the building.

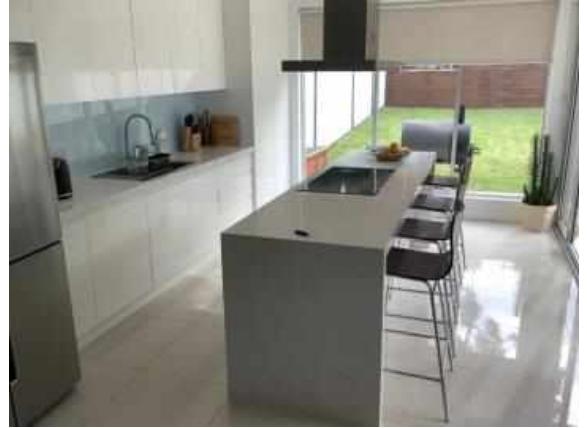
All kitchen electrical appliances and wiring need to be checked by a qualified electrician. The checking of any electrical item is outside the scope of this report. It is recommended that a licensed electrician be consulted for further advice.

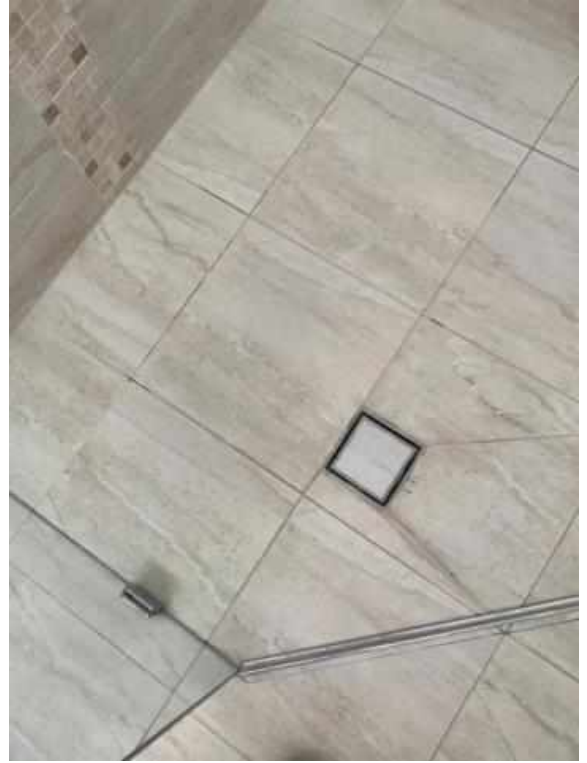
Grout and sealant

Some floor tiles require regrouting and resealing to Bathroom shower.

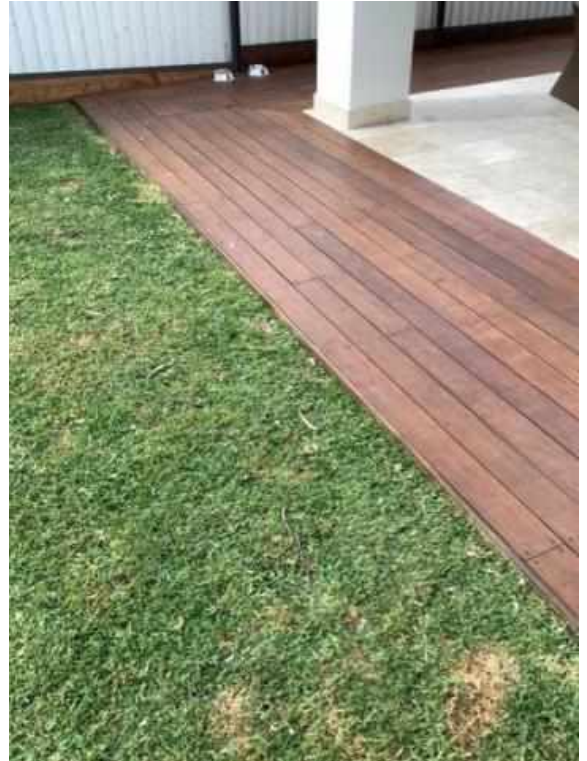
There is insufficient crawl space below decking timbers due to the method of construction. See Section 2.0 - Reasonable Access.

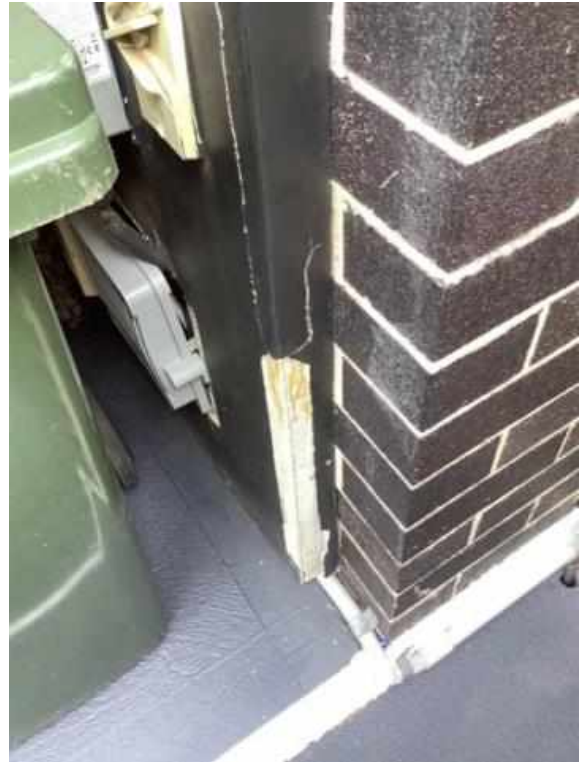
EXTERNAL CLADDING

Some external cladding shows signs of weather damage.

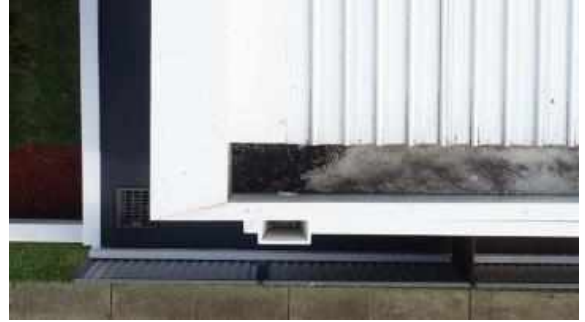
GUTTERS / DOWNPIPES

Some sections of gutter require cleaning.

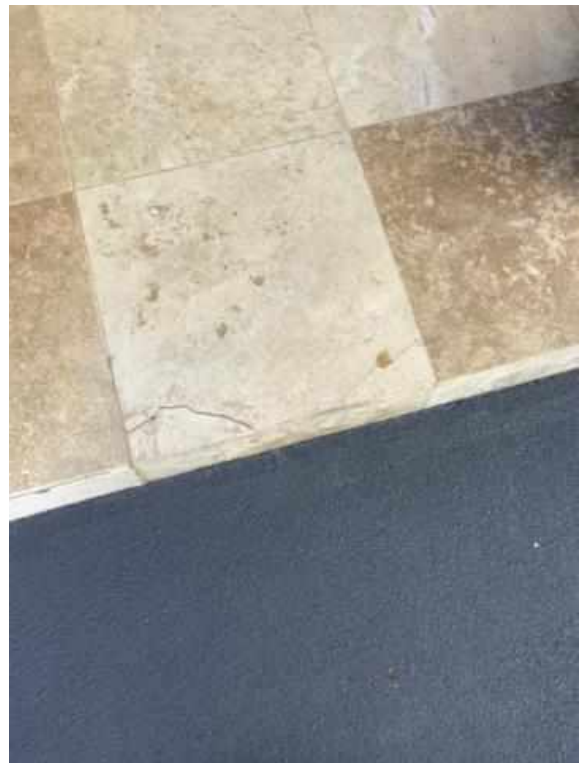
PATHS

Some cracks to entry area tiles.

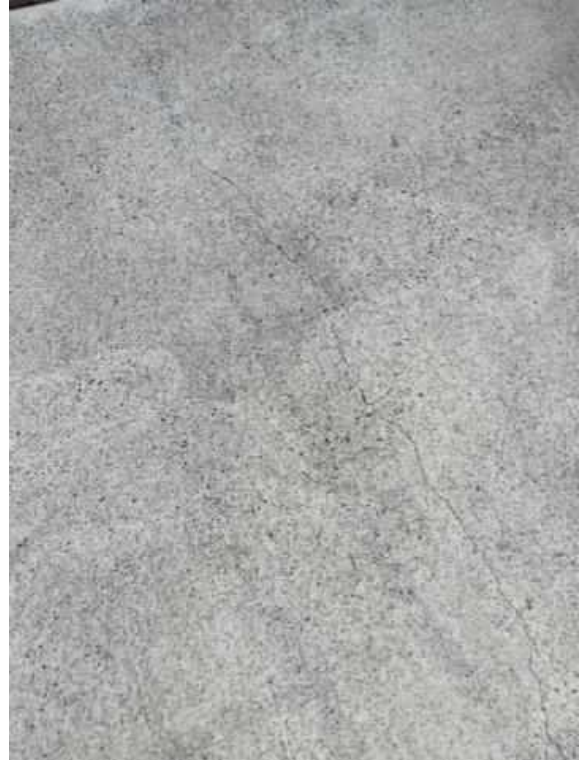
DRIVEWAYS

Some surface cracks to concrete driveway slabs.

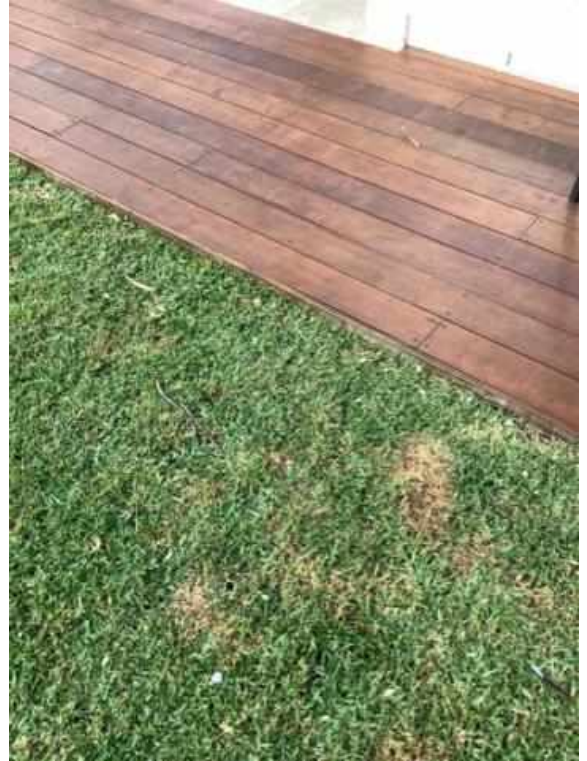
- Some external timbers are in contact with soil. This may allow or have allowed concealed termite entry. The situation should be modified so that timber to soil contact does not occur.
