Building Report

9 Withybrook Pl, Sylvania

BUILDING & TIMBER PEST INSPECTION REPORT TO AS4349.1 2007 & AS4349.3 2010

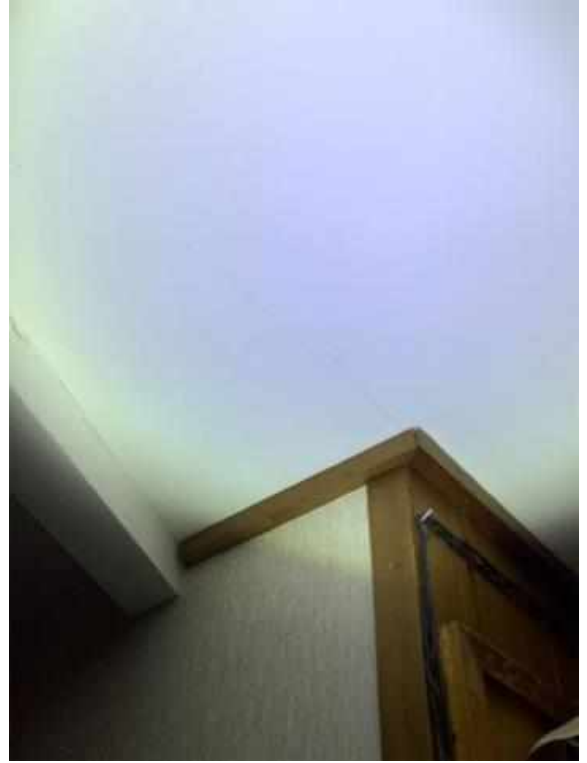
Cracking / Sagging / Defective Lining

Cracks to some ceiling sheeting.

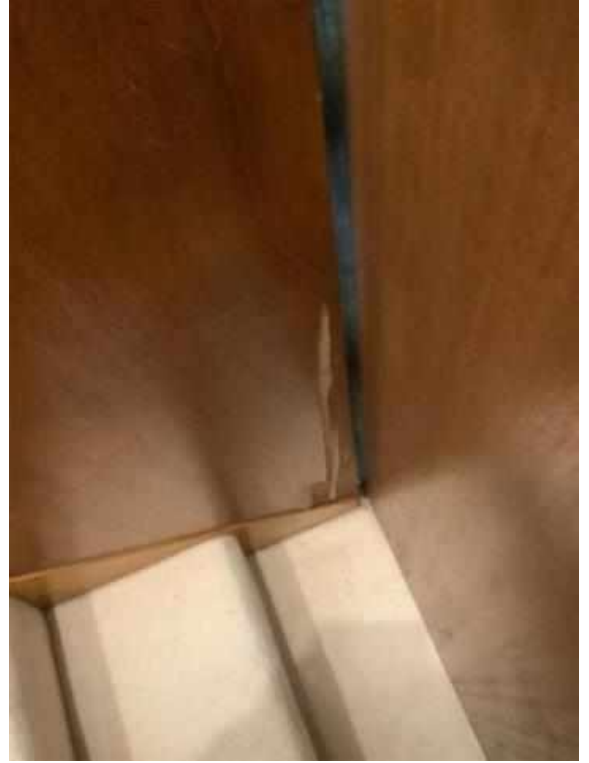
Cracking / Defective Lining

Damage to timber wall panels.

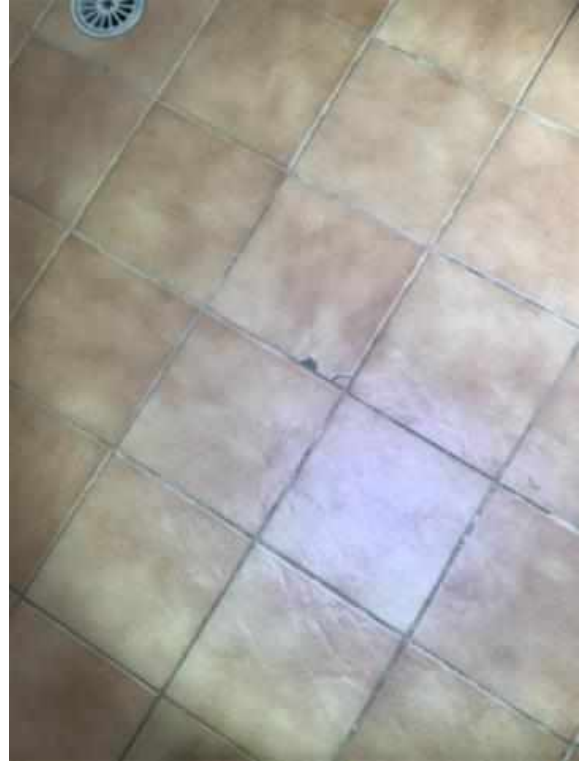
TILED AREAS**Drummy / Cracked / Loose**

Percussion chips to some floor tiles.

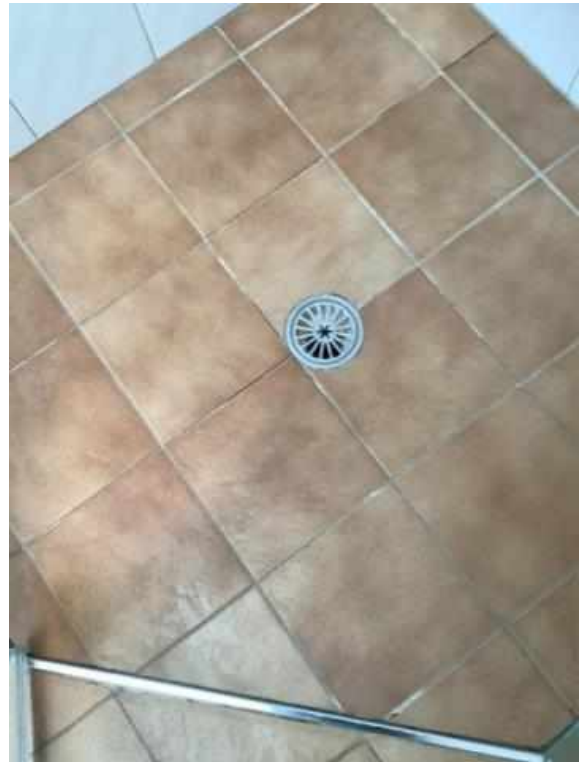
Grout and sealant

Some floor tiles require regrouting and resealing to Shower.

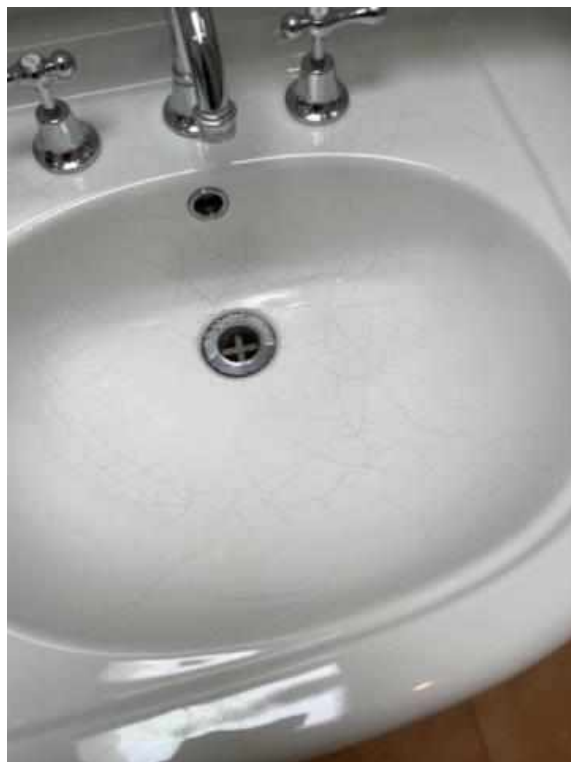
Enamel cracksanity basin require repair.

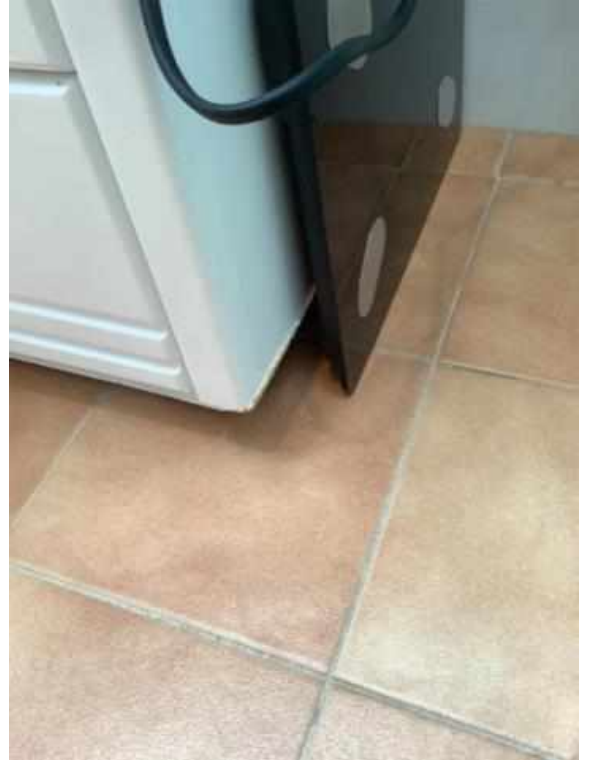
Signs of past water damage to vanity cabinet.

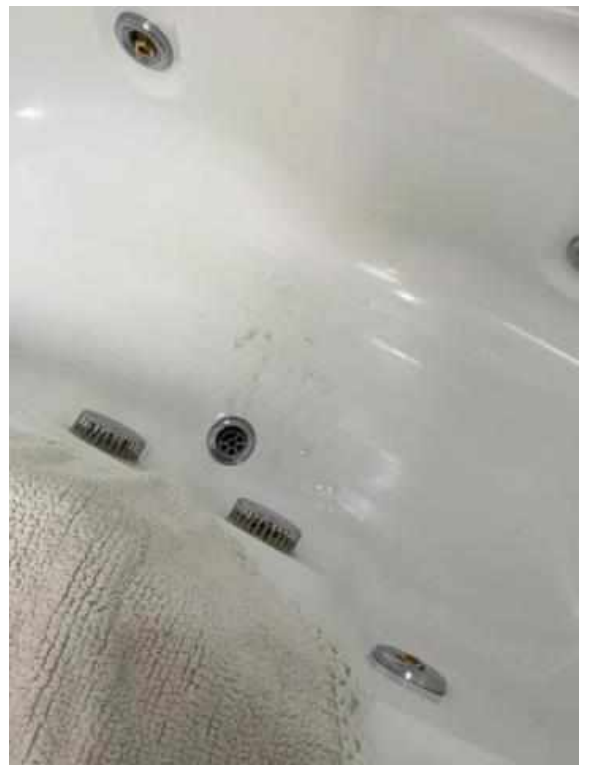
Enamel scratches/ wear to bath require repair.

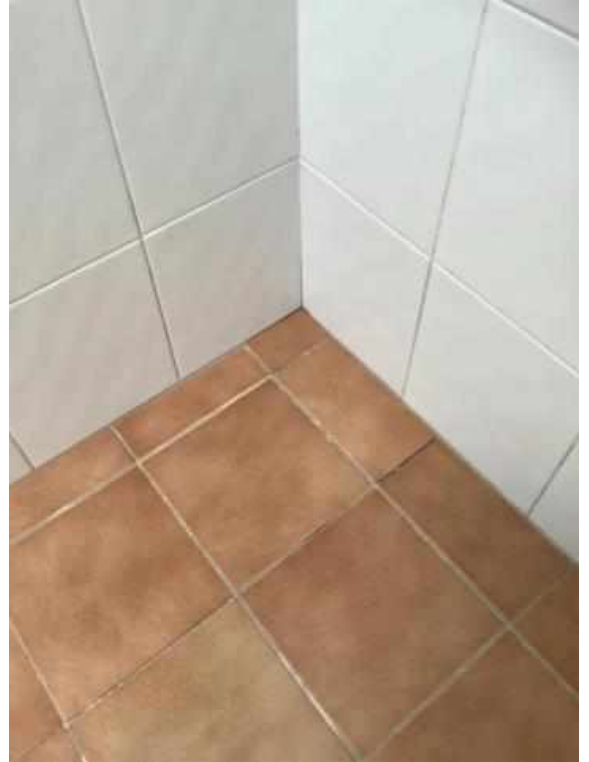
Other (specify)

Junctions of shower floor and wall tiles require resealing with silicone.

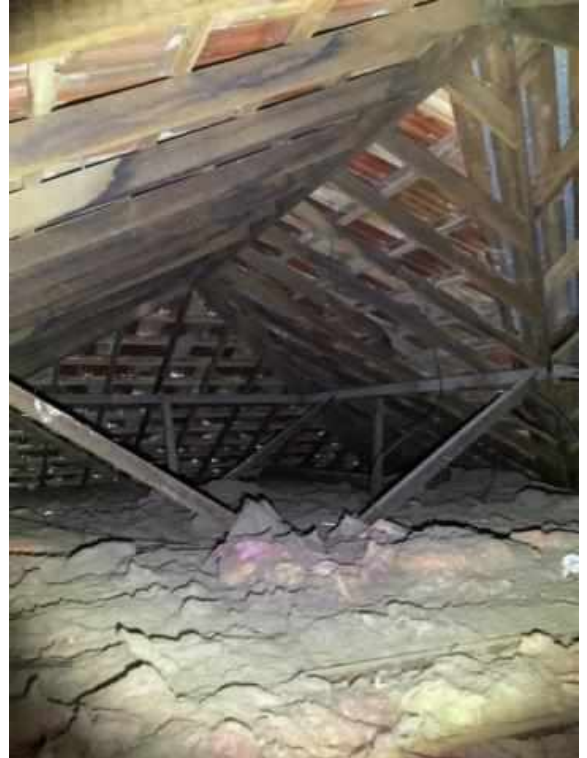
Roof Space & Framing - Condition

Older roof frames do not comply with current wind ratings. This roof is in satisfactory/ typical condition for the age/ construction date.

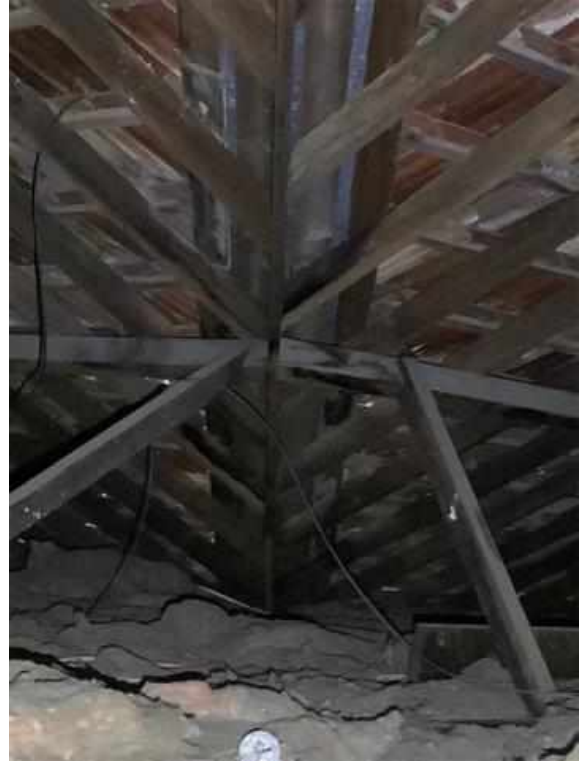
Signs of past water penetration was found in roof void
I recommend a roof tiler or roofing plumber be engaged
to find cause of leak and repair.

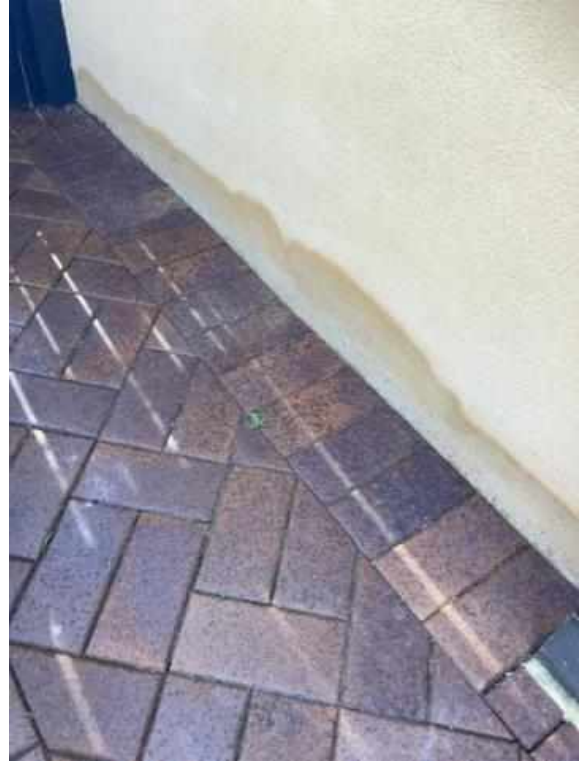
Damp

Signs of water penetration to render.

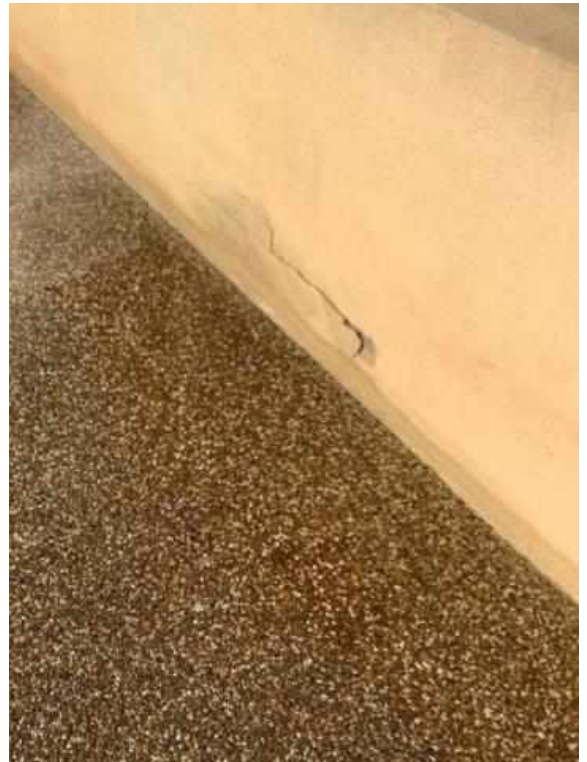
Other (specify)

Cracks/ damage to render requires repair repainting.

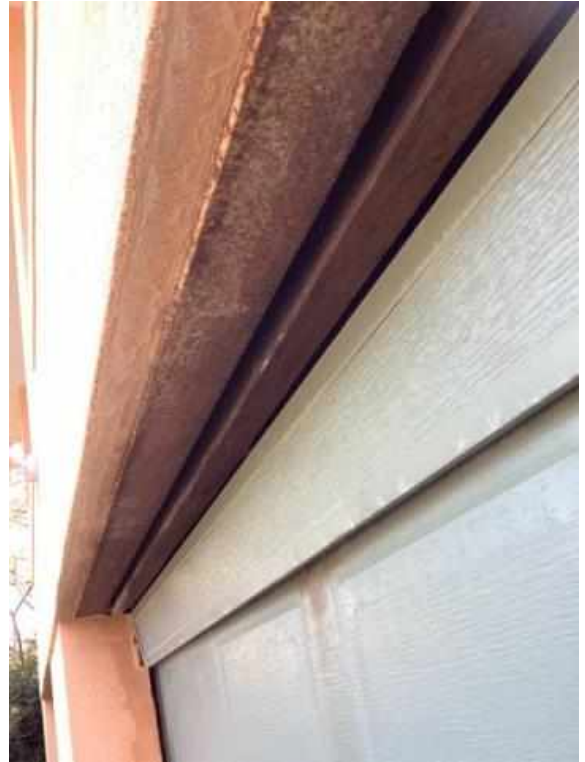
STEEL LINTELS

Rust to some lintels requires repair / repainting with Killrust or equivalent.

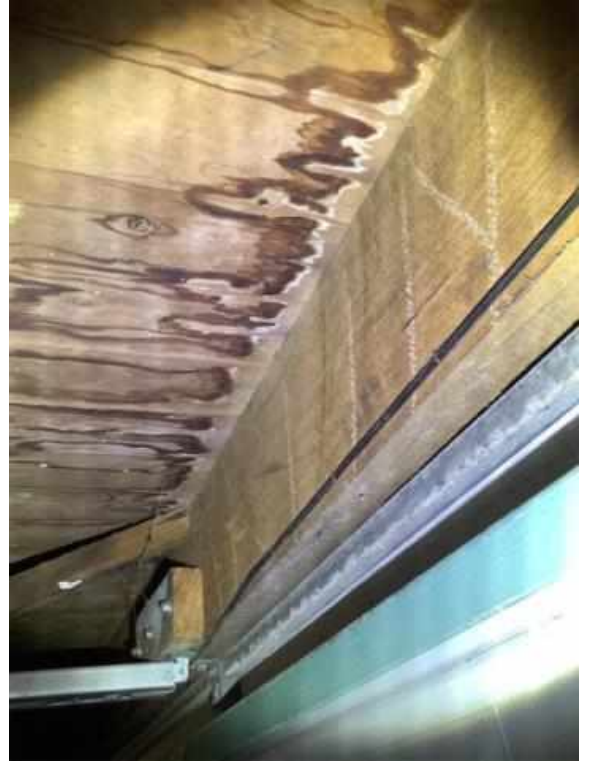
Timber Floors

Signs of past water penetration to some timber floor boards.

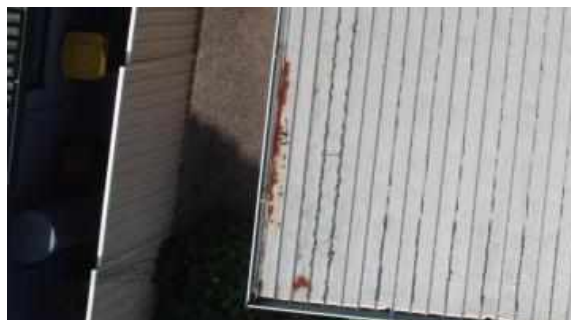
SHEET ROOFING

Surface rust requires repair / repainting with Killrust or equivalent.

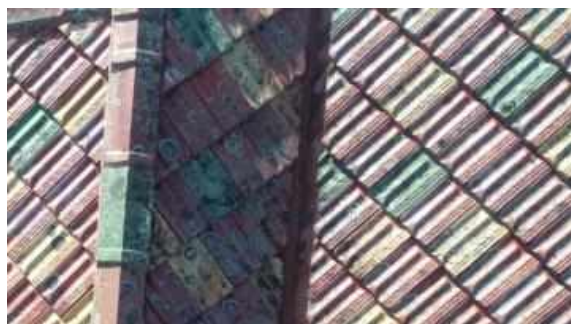
VALLEYS

Surface rust to some valley flashings requires repair / painting with Killrust or equivalent.

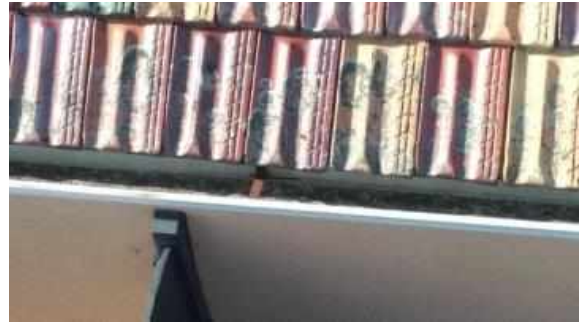
GUTTERS / DOWNPIPES

Rust to some gutter brackets requires repair / painting with Killrust or equivalent.

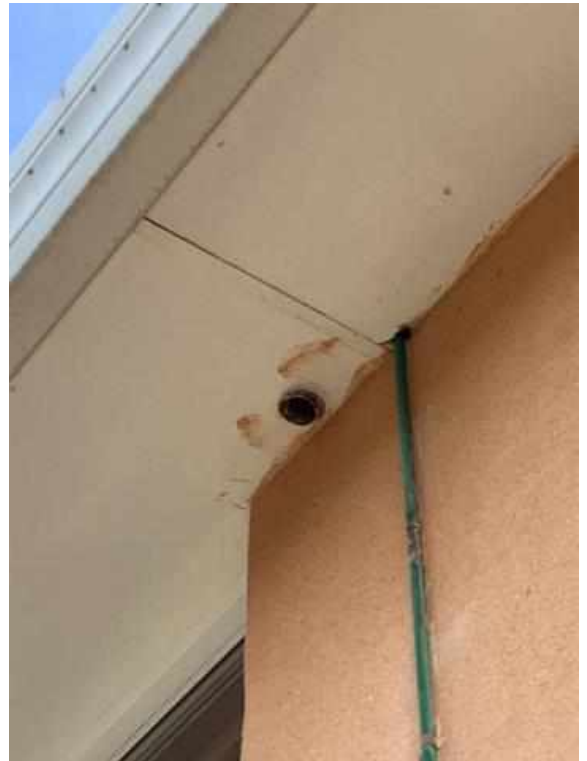
EAVES / FASCIAS / BARGES

Paintwork to eaves requires a touch up.

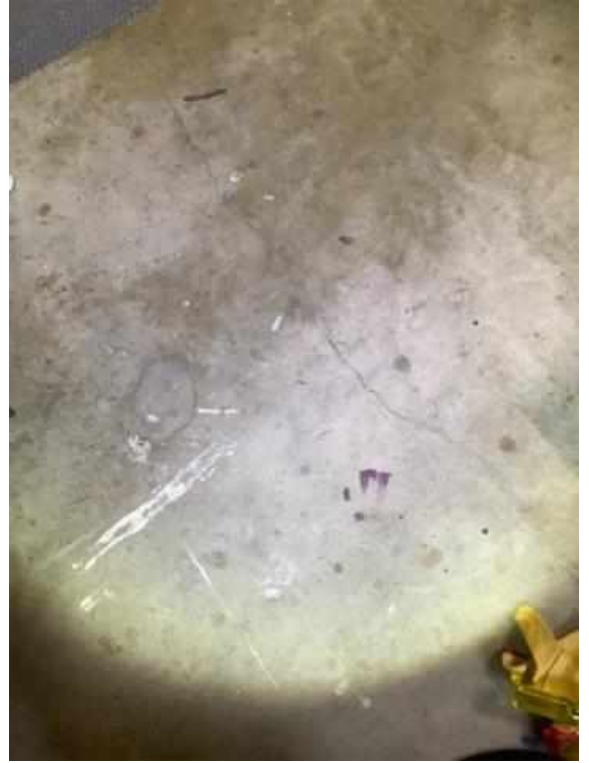
Some surface cracks to slab.

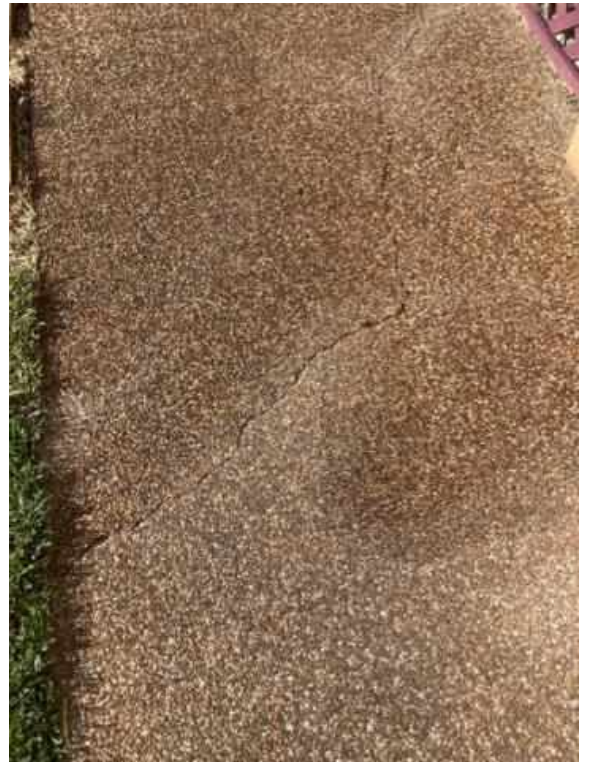
PATHS

Some cracks to concrete paths.

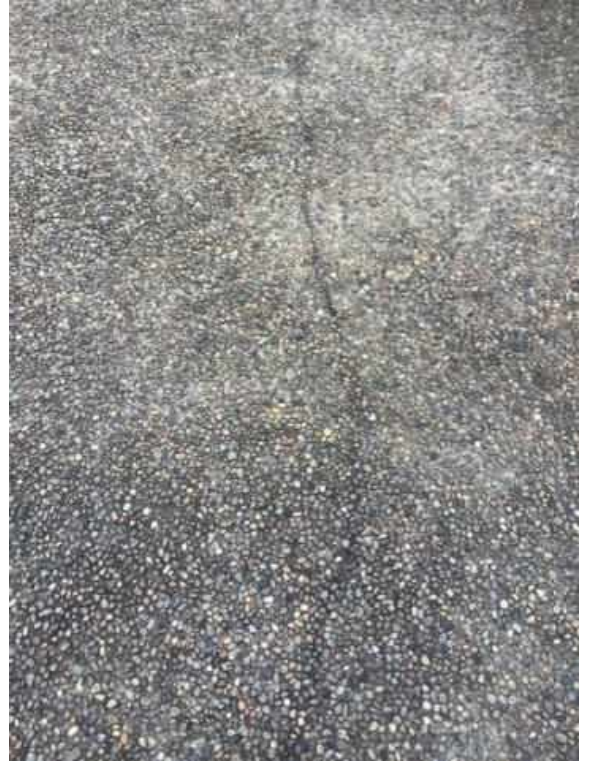
DRIVEWAYS

Some surface cracks to driveway slabs.

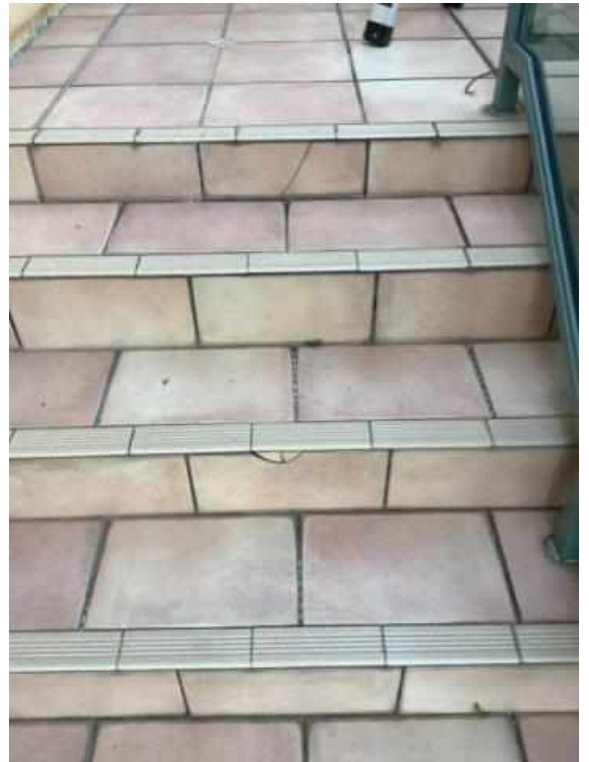
STEPS

Cracks to some tiles to front steps.

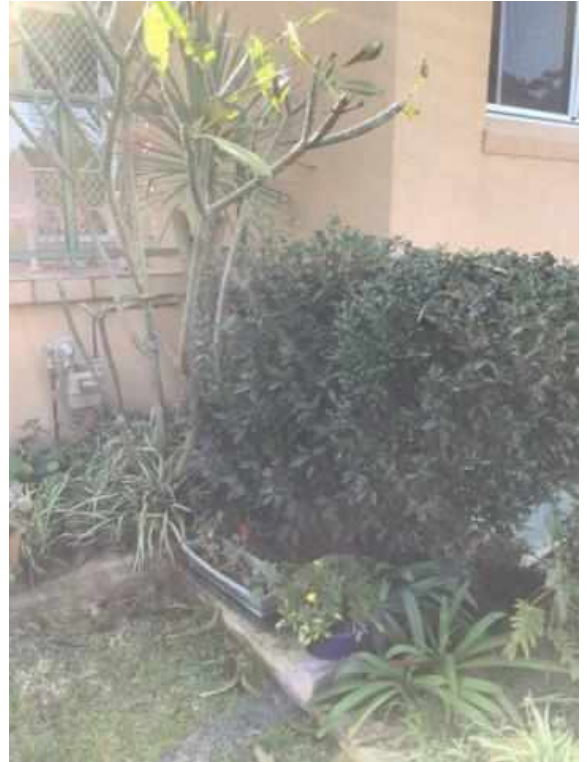
- Remove garden beds and vegetation close to or abutting the external walls of the structure. These can attract / allow concealed termite entry and should be removed.
