Building Report

52 Jacana Gr, Heathcote

BUILDING & TIMBER PEST INSPECTION REPORT TO AS4349.1 2007 & AS4349.3 2010

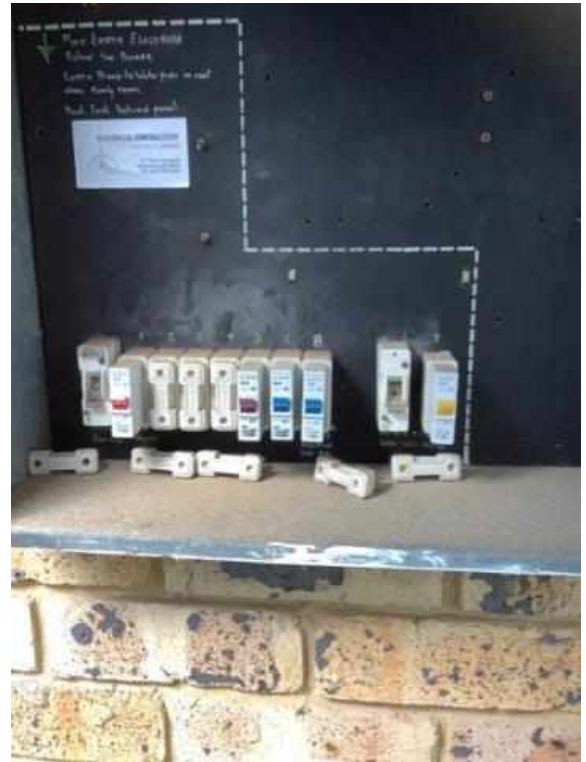
Note: Porcelain fuses have been identified to the switchboard. We recommend an electrician be engaged to remove the fuses and upgrade as required.

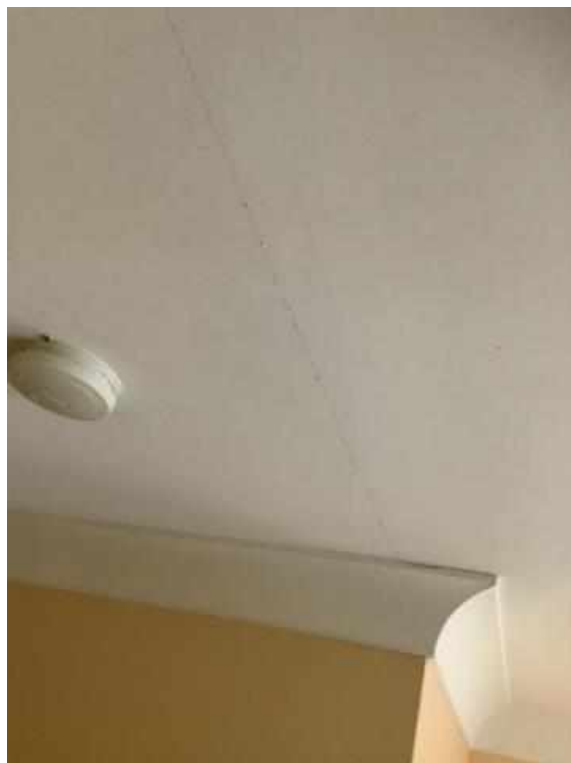
Cracks to some ceiling sheeting.

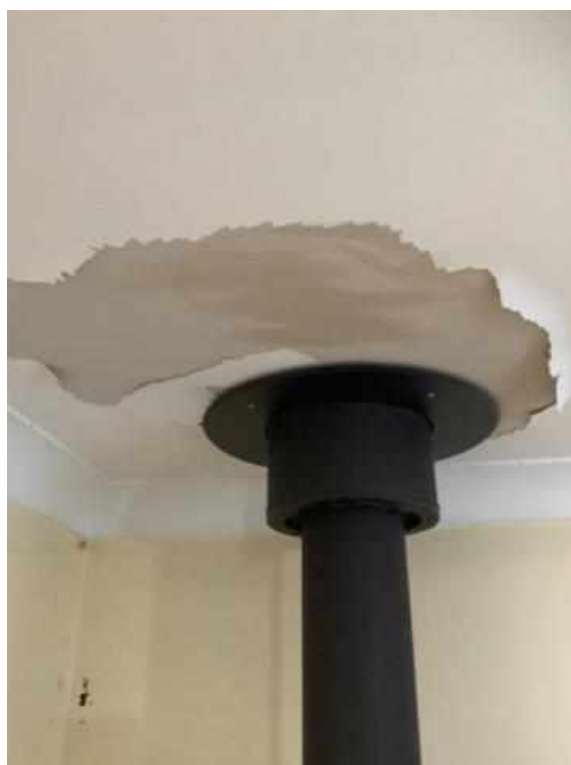
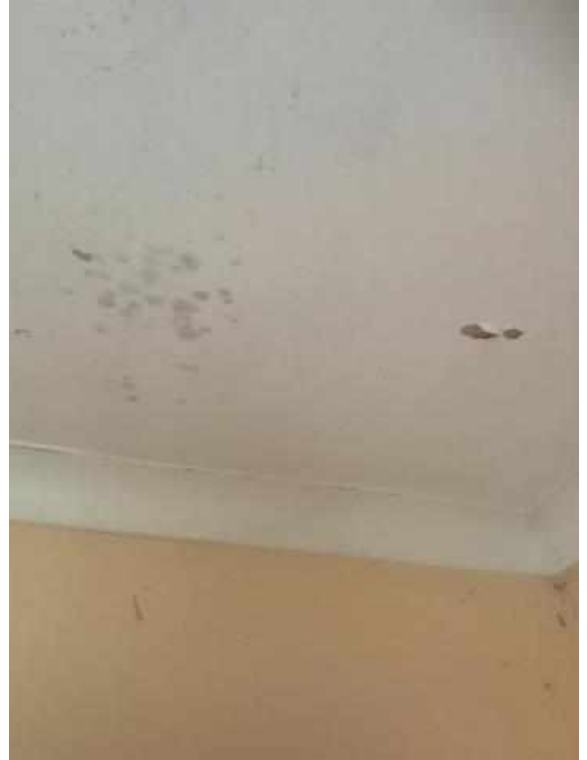
Signs of past water penetration to some ceilings.

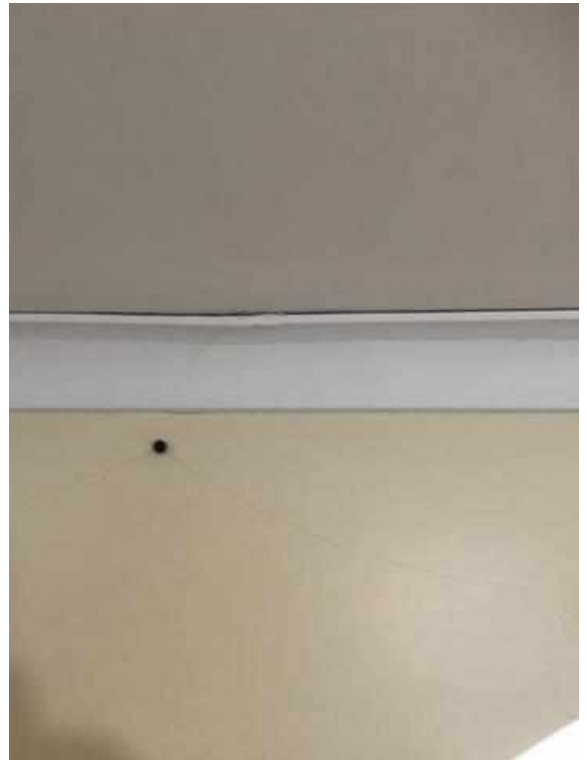
Gaps to some cornice / ceiling junctions require filling.

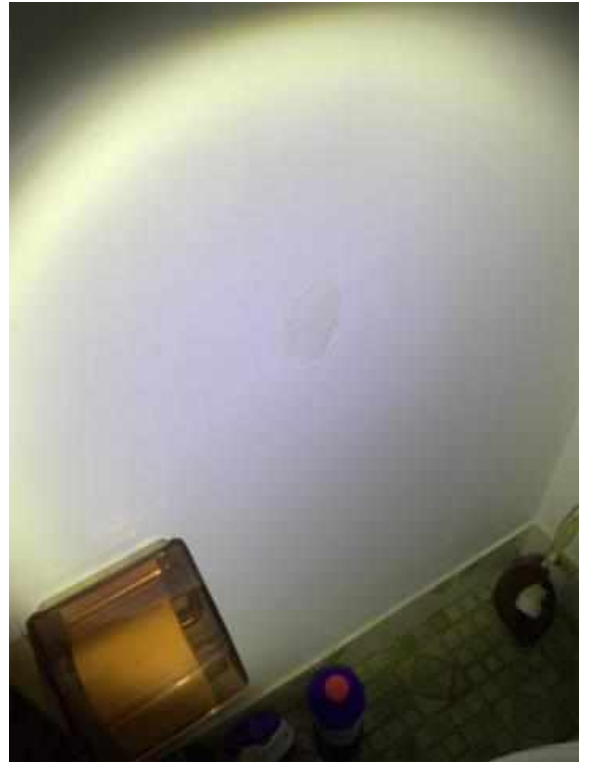
Signs of past patching to some walls.

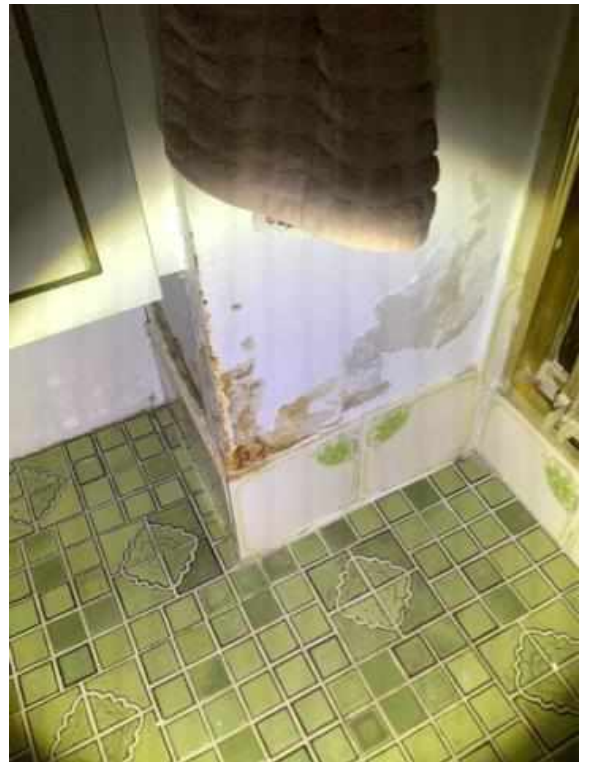
Signs of water penetration to Ensuite walls adjacent to shower.

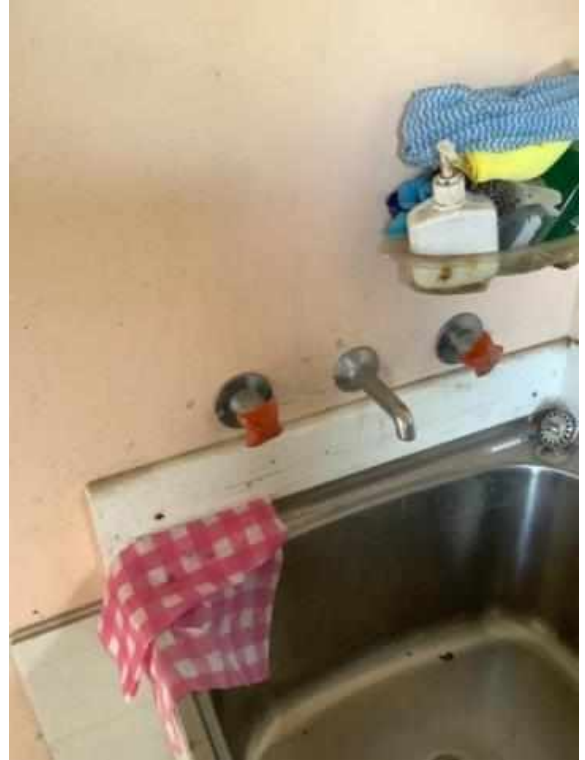
Signs of past water penetration to Laundry.

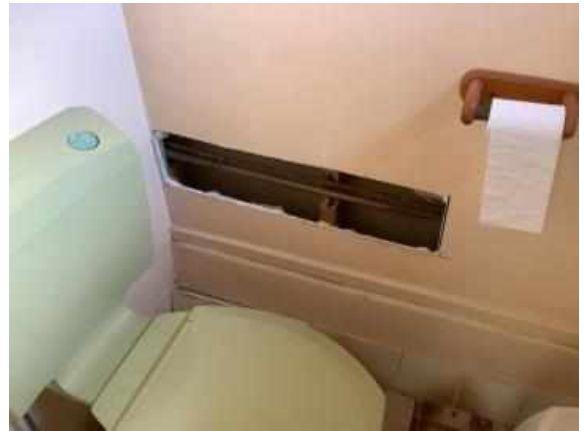
Wall sheeting to laundry toilet requires repair.

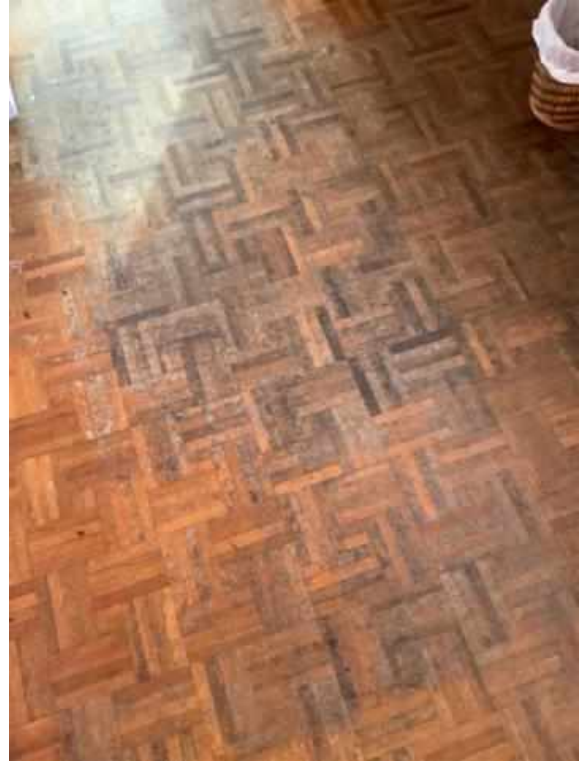
Some parquetry flooring is showing signs of wear are requires sanding and polishing.

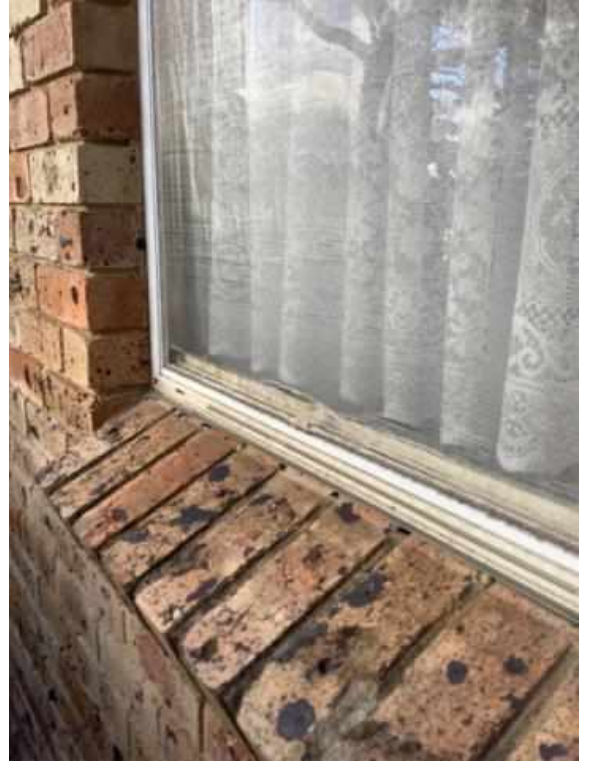
Some gauze requires repair.

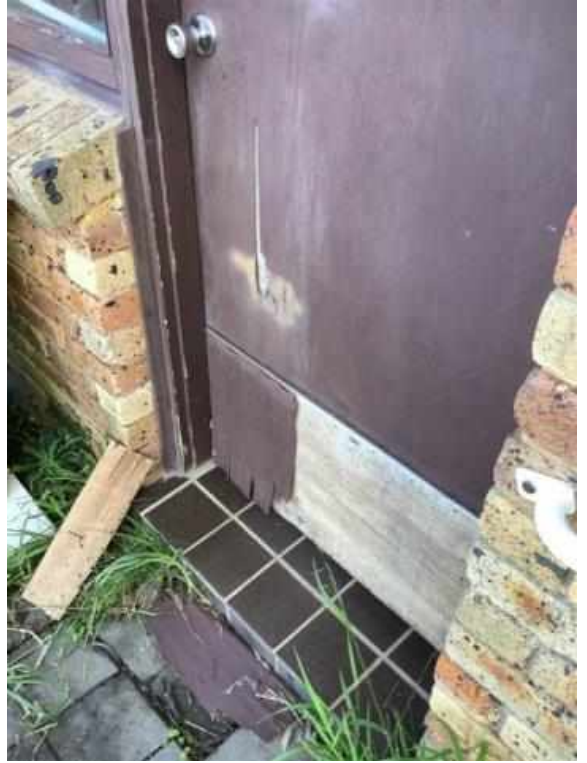
Weather damage to some external doors requires repair / repainting.

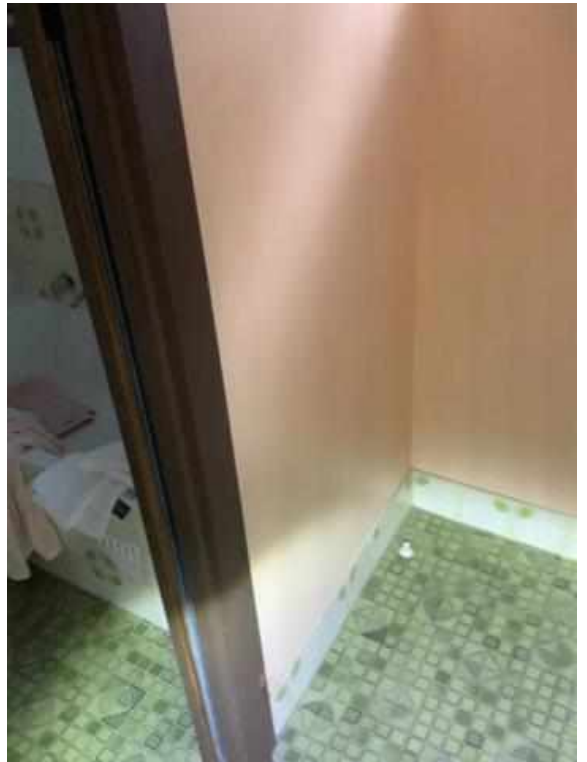
Toilet and bathroom doors are missing and requires replacement.

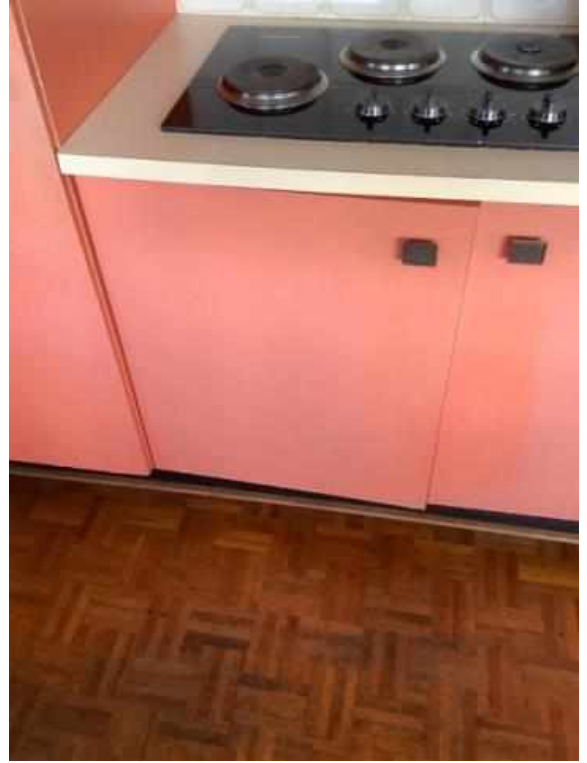
Surface wear to some laminate.

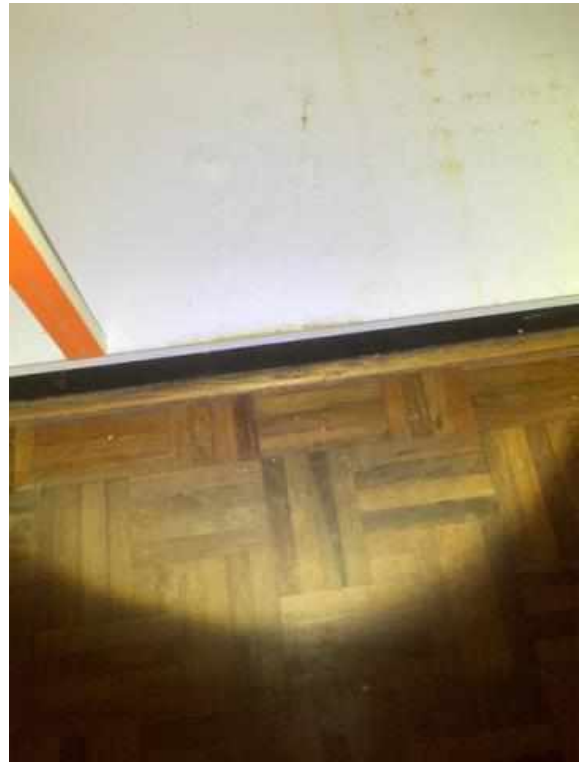
Signs of past water penetration to sink cupboard.

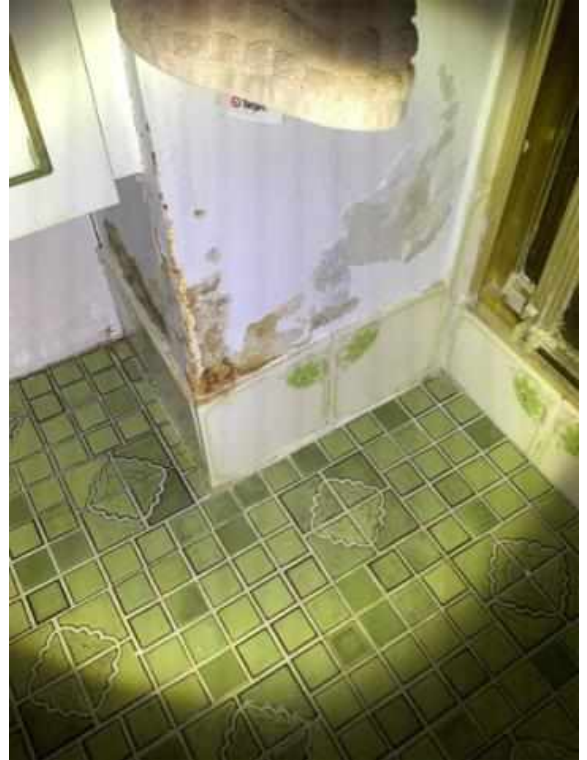
There are signs of high moisture levels in the wall at the rear of the bathroom shower. I recommend that a plumber be engaged to conduct a compression check on the combination and pipes and to also check the wetseal.

Signs of high moisture levels in wall at rear of shower.

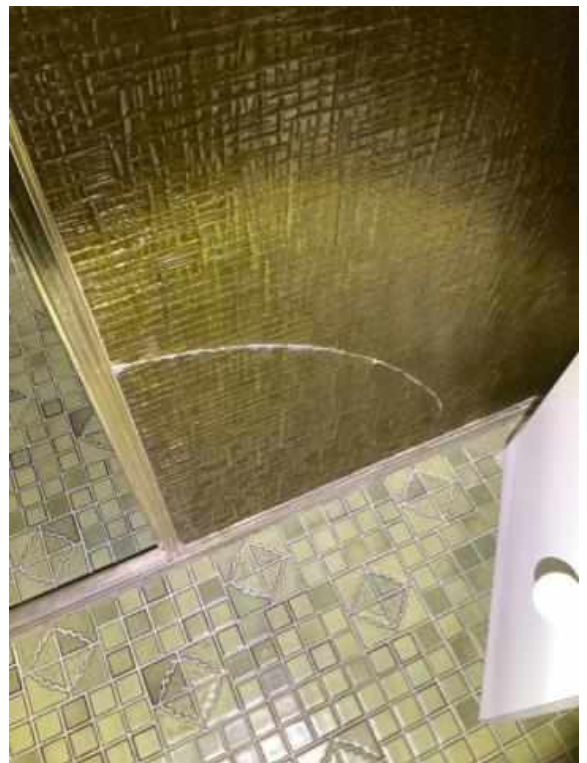
Cracks to slider panels.

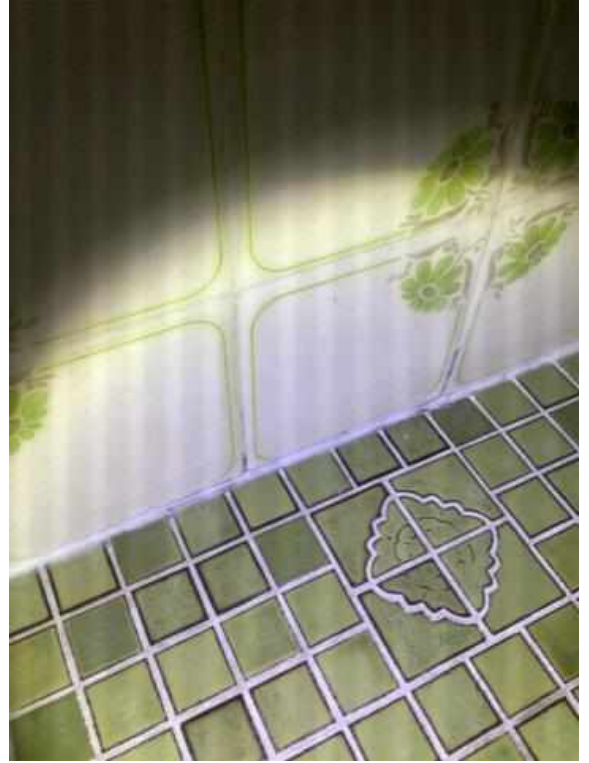
Cracks to shower wall tiles.

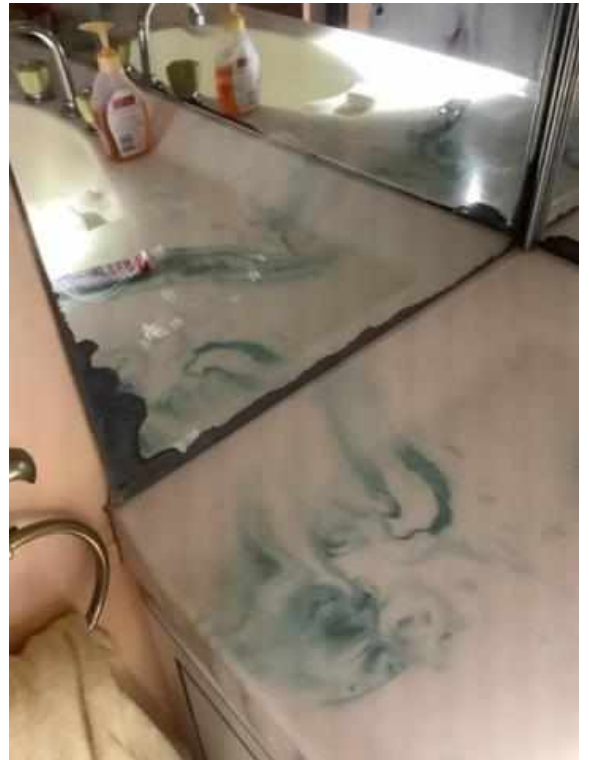
The bathroom mirror edges are blemished / stained.

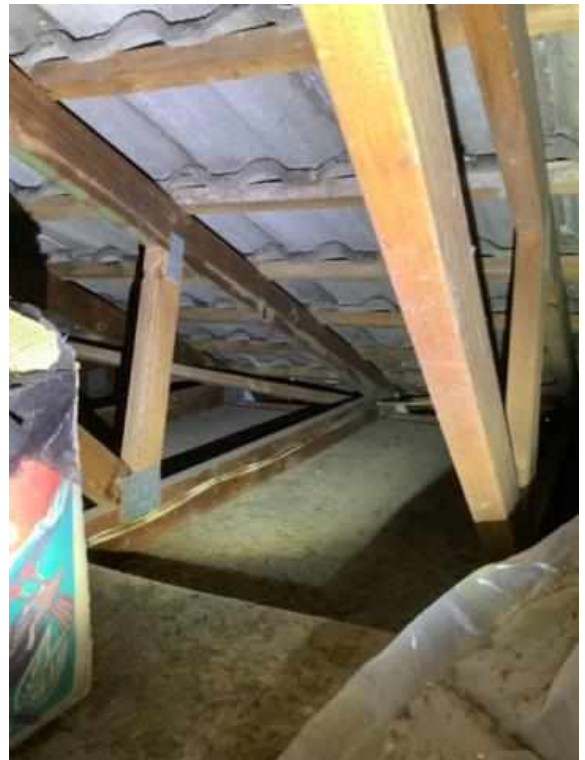
Signs of past water penetration was found in roof void

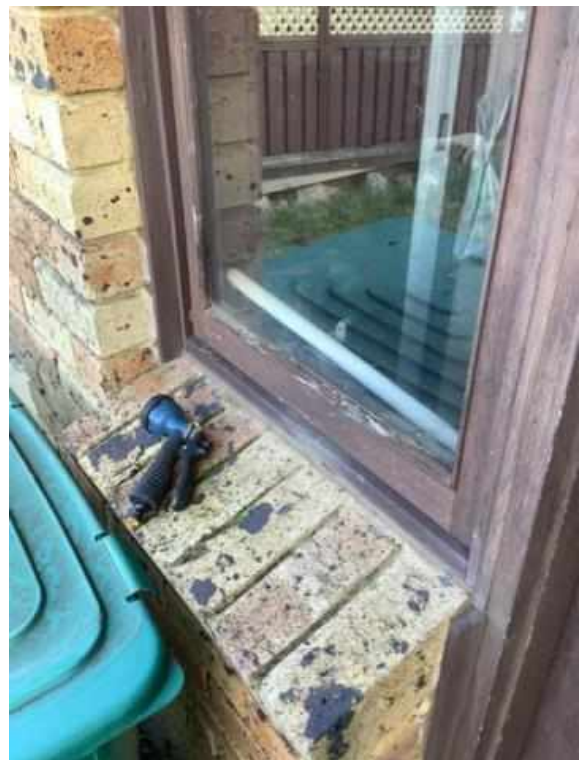
Some frames and sashes show signs of weather damage and require repair / repainting.

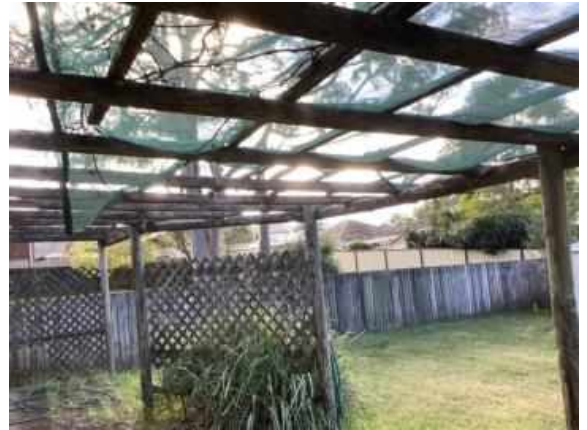
Some pergola timbers show signs of weather damage and require repair / replacement.

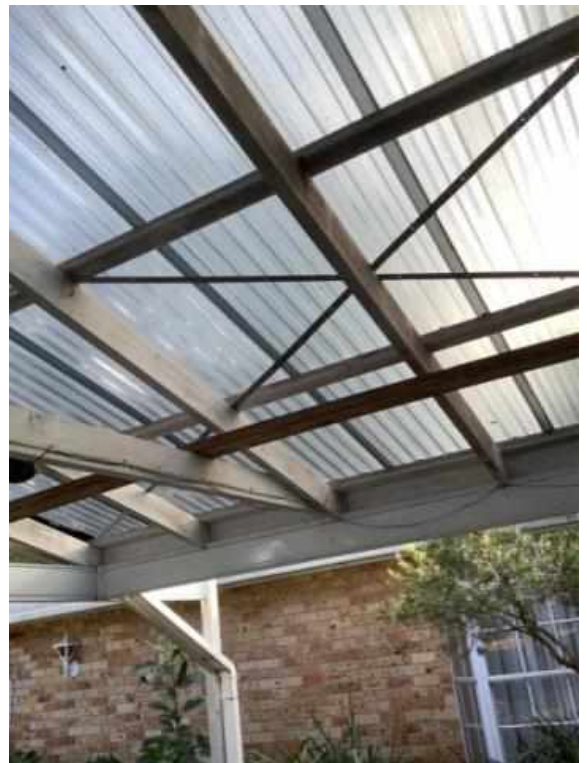
Polycarbonate or similar sheeting is present to some roofing areas and should not be walked on - This is a potential Safety Hazard.

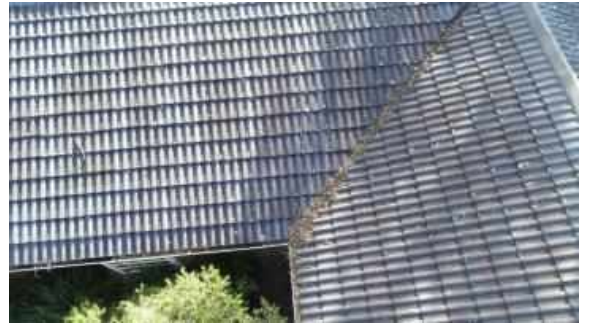
Some valleys require cleaning.

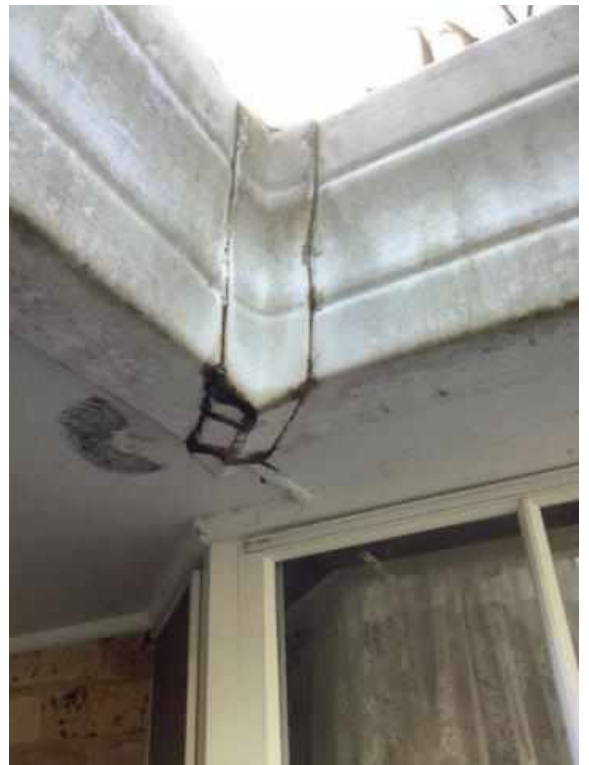
Some gutter and downpipe joins require resealing.

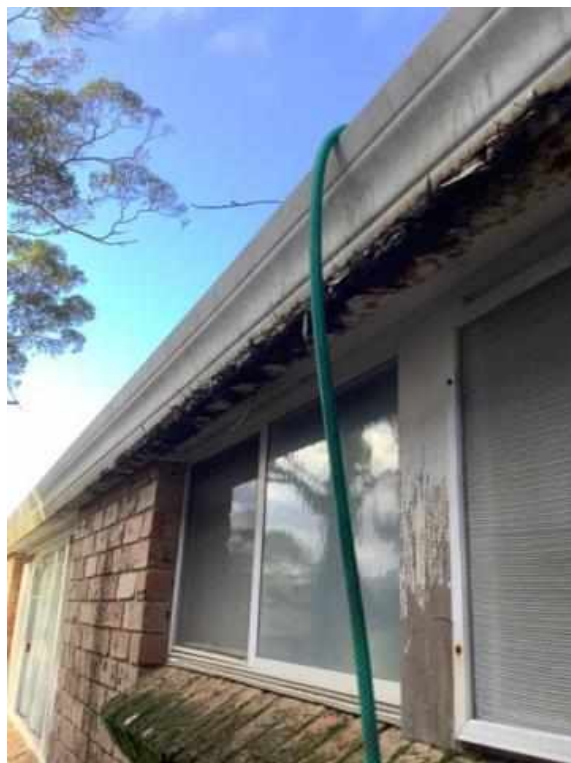
Some gutters are rusted and require repair / replacement.

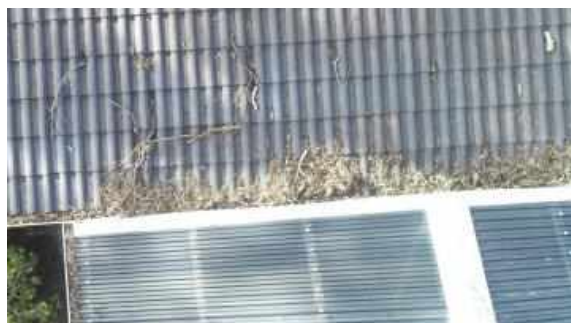
Some sections of gutter require cleaning.

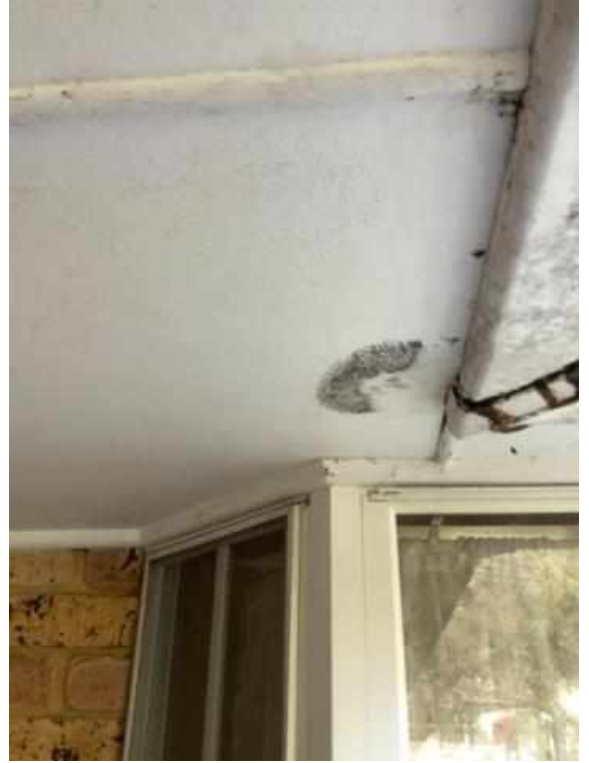
Weather damage to eaves requires repair repainting.

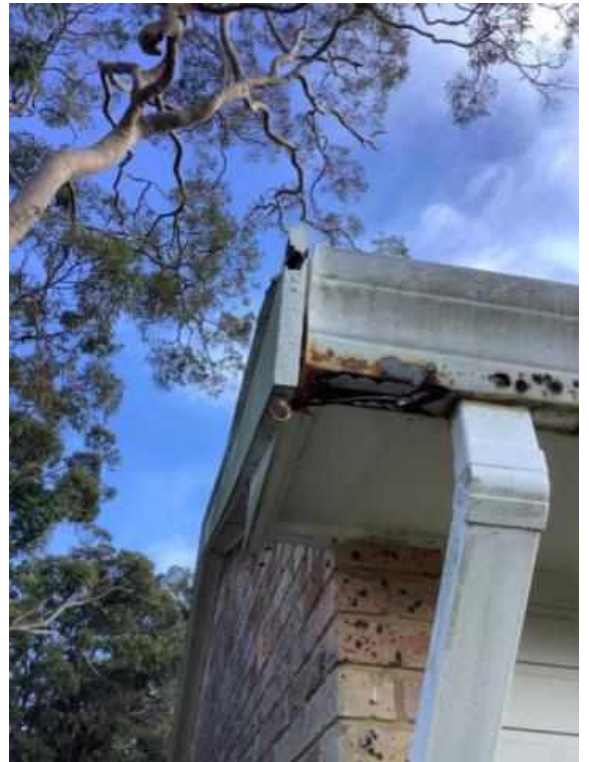
Some fascia / barge timbers show signs of weather damage and require repair / replacement.

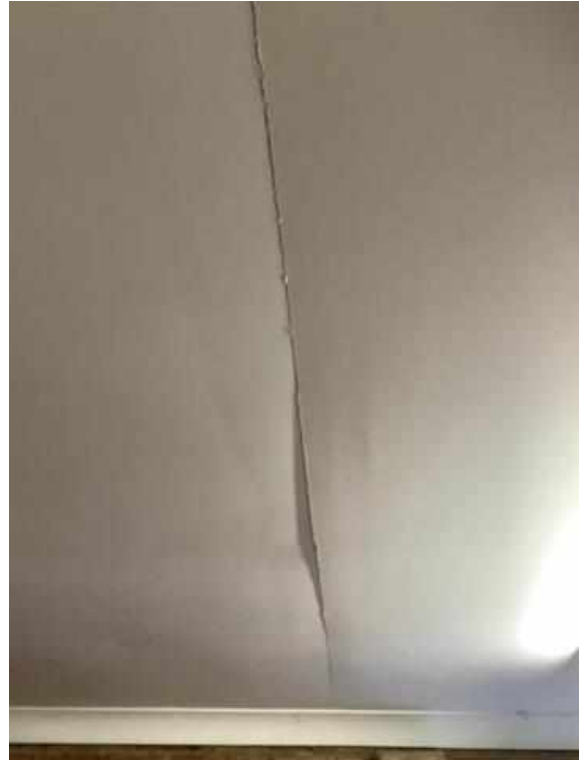
Cracking to ceiling sheeting.

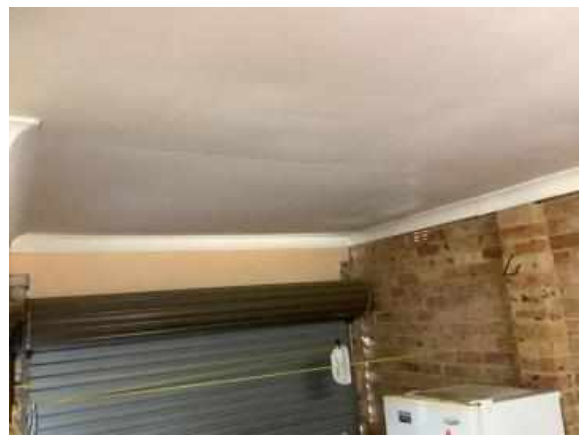
Undulations/ sagging to some ceiling sheeting in garage.

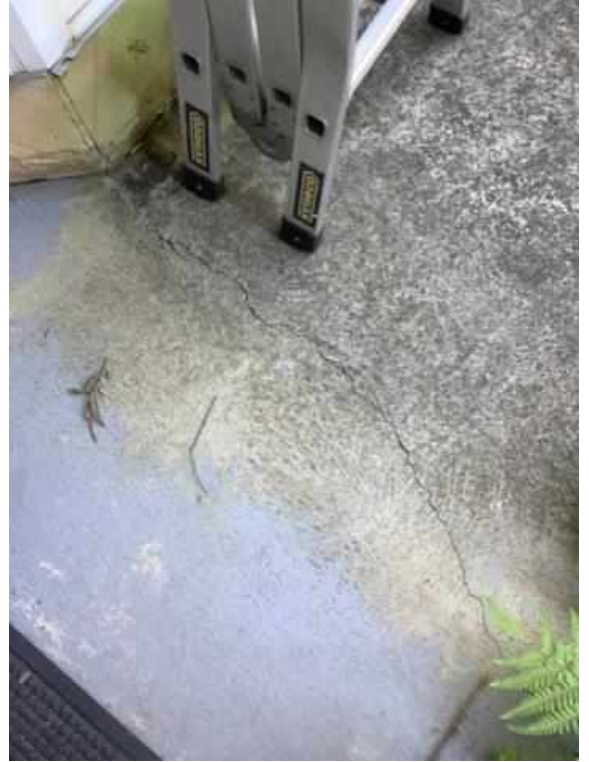
Some cracks to concrete paths.

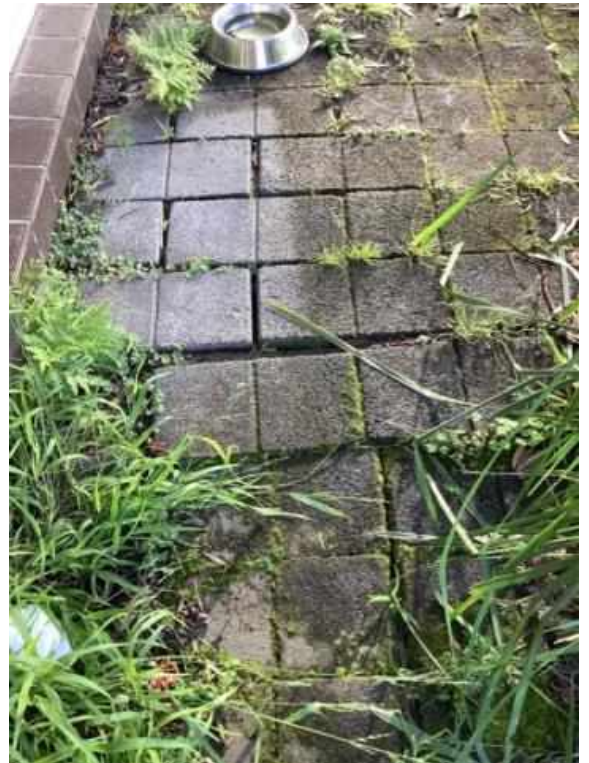
Some pavers require relaying.

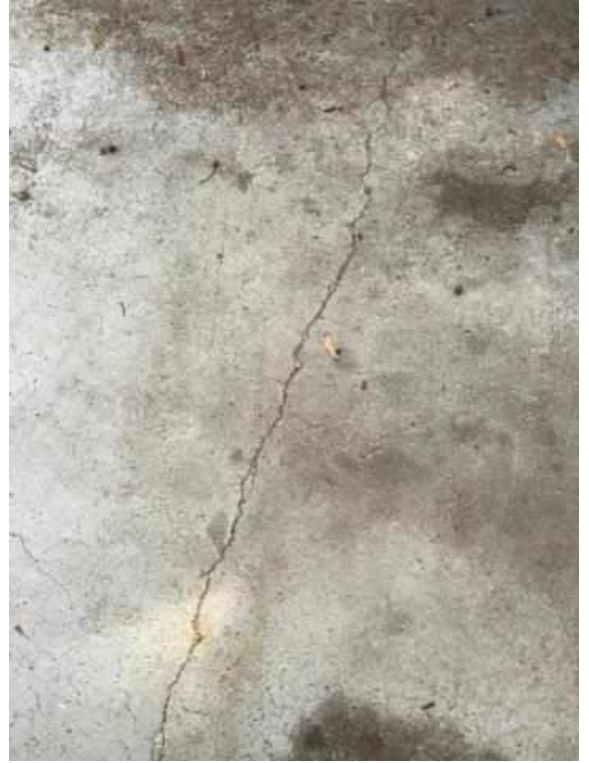
Some surface cracks to driveway slabs.

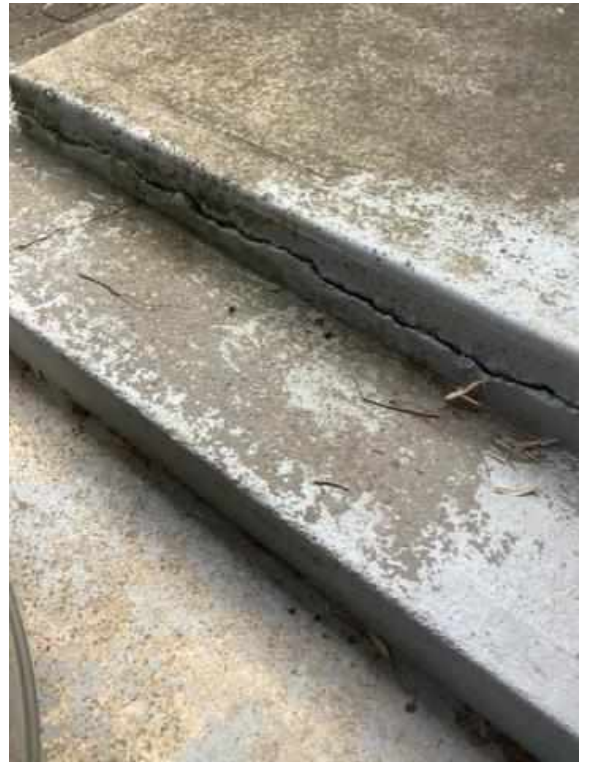
Cracking to front steps.

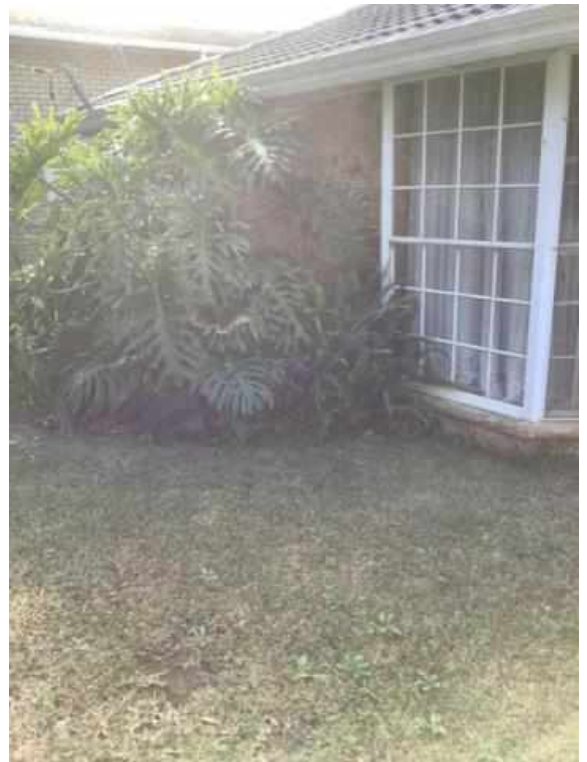
- Remove garden beds and vegetation close to or abutting the external walls of the structure. These can attract / allow concealed termite entry and should be removed.

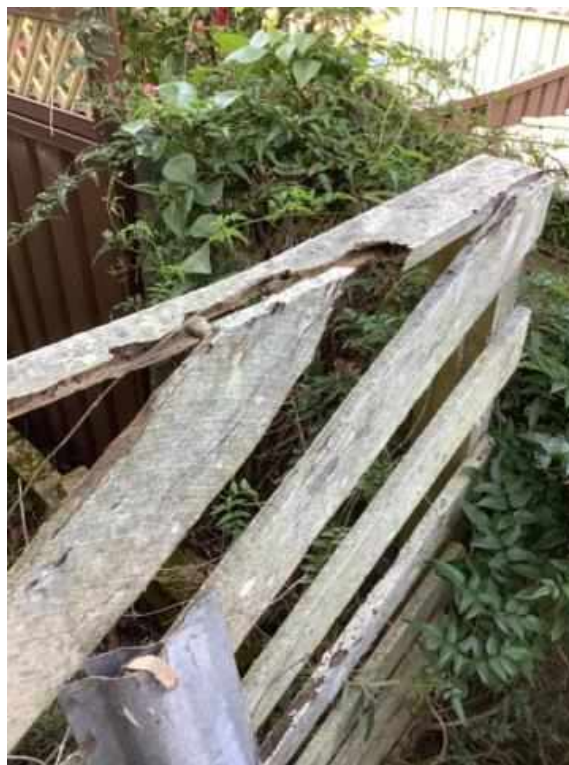
The visible damage to the timbers appears to be moderate to extensive. Further damage probably exists in concealed areas. Please refer to the definitions section of this report - Section 1.2 - Timber Damage.
