Building Report

96 Prince Edward Park Rd, Woronora

BUILDING & TIMBER PEST INSPECTION REPORT TO AS4349.1 2007 & AS4349.3 2010

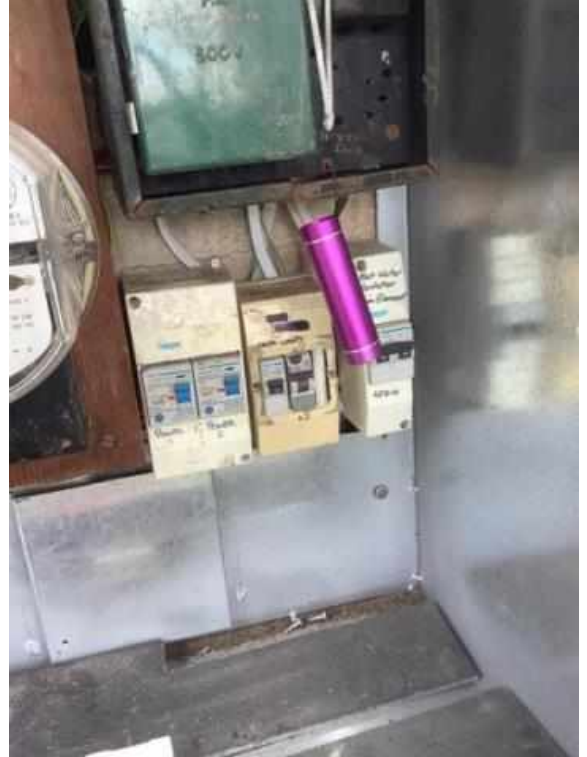
Note: Porcelain fuses have been identified to the switchboard. We recommend an electrician be engaged to remove the fuses and upgrade as required.

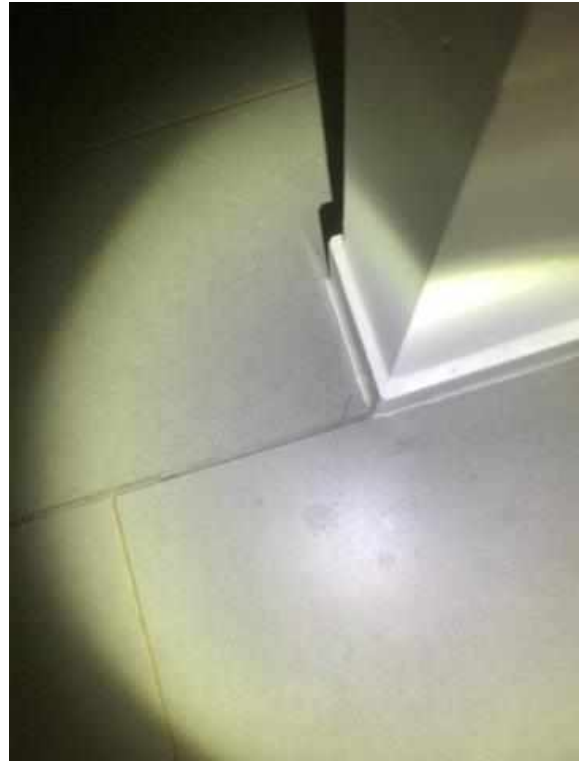
TILED AREAS**Drummy / Cracked / Loose**

Cracks to some floor tiles to Laundry.

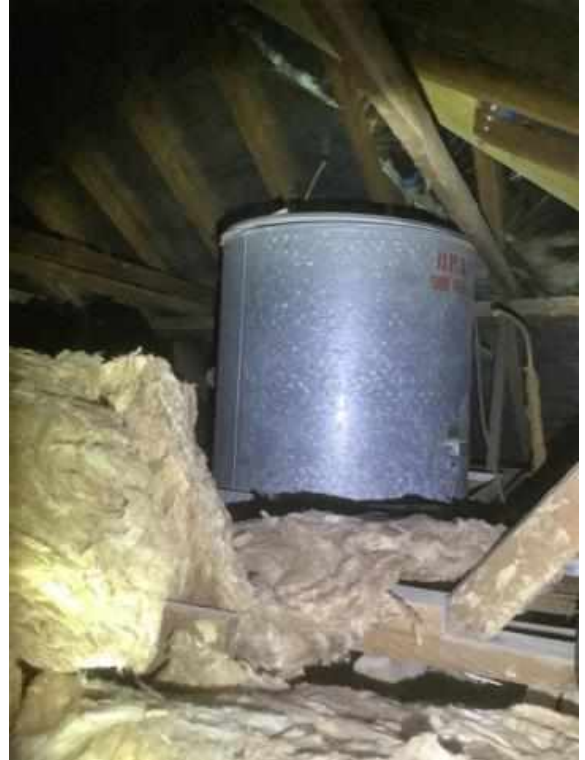
Roof Space & Framing - Condition

Evidence of termite damage to various framing timbers (rafters). Refer to the attached Timber Pest Inspection Report.

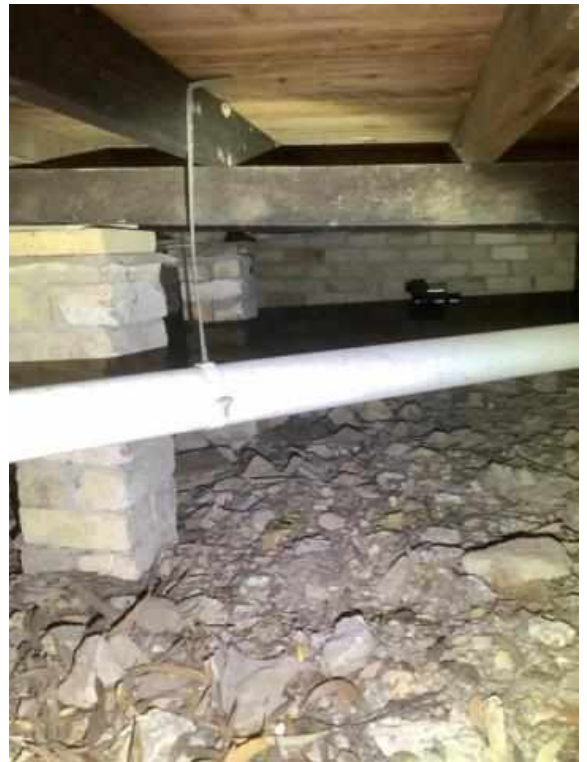
Piers / Stumps / Posts - Condition

Some piers show signs of subsidence / movement.

- Some piers show signs of subsidence / movement. We recommend that a re-stumping specialist be engaged to assess these piers and determine a scope of work required to rectify / replace.

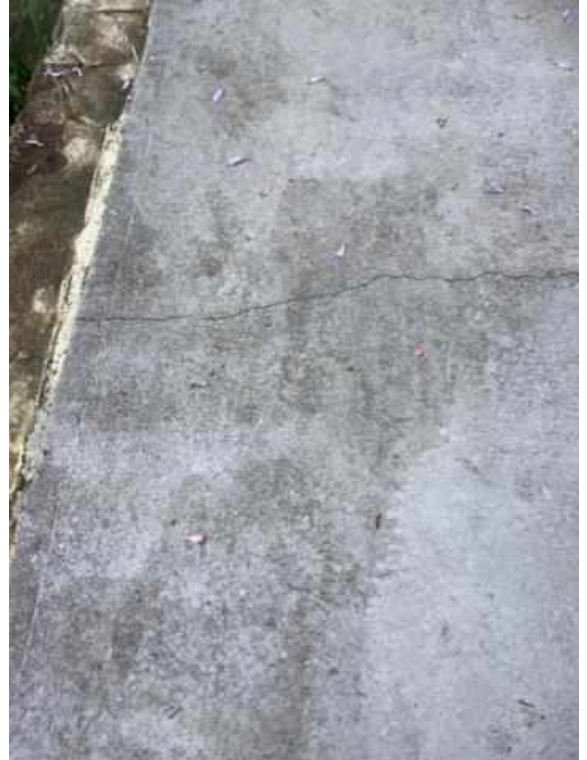
PATHS

Some surface cracks to concrete paths.

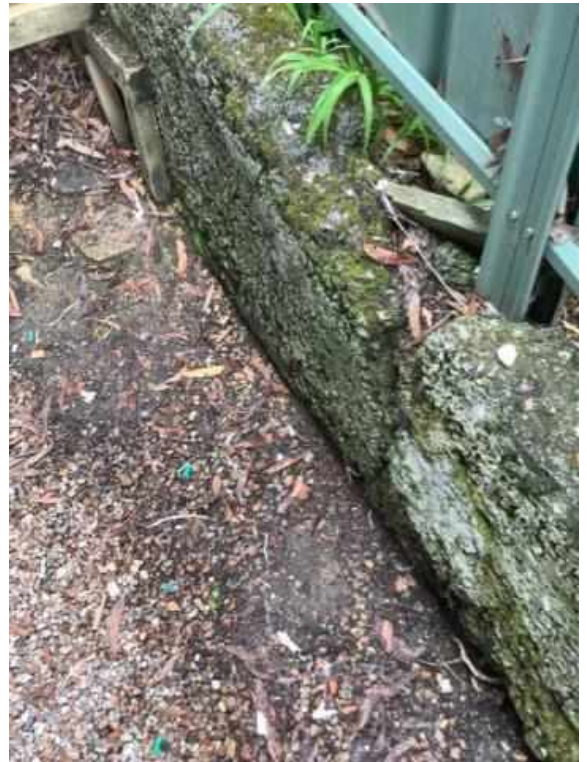
SMALL RETAINING WALLS

Cracks damage to brick/block retaining walls require repair or replacement.

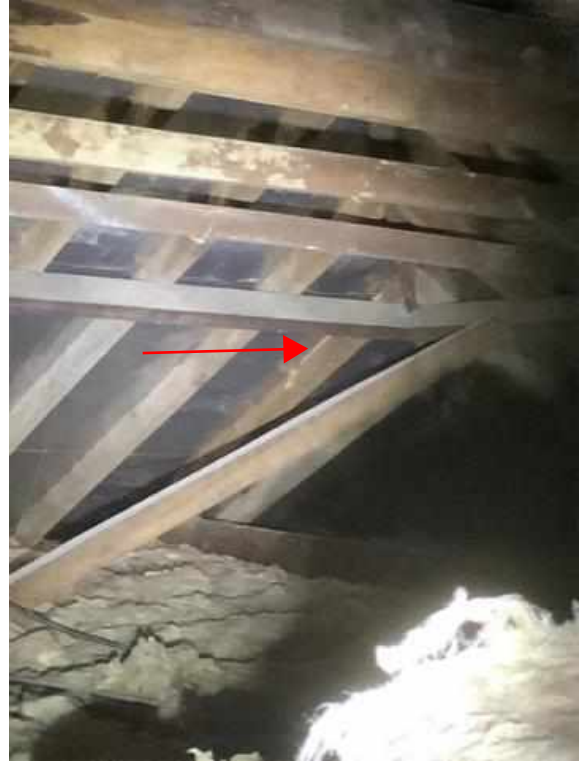
Affected Timbers / Areas:

Some roof framing timbers.

Severity

The visible damage to the timbers appears to be moderate. Further damage may exist in concealed areas. Please refer to the definitions section of this report - Section 1.2 - Timber Damage.

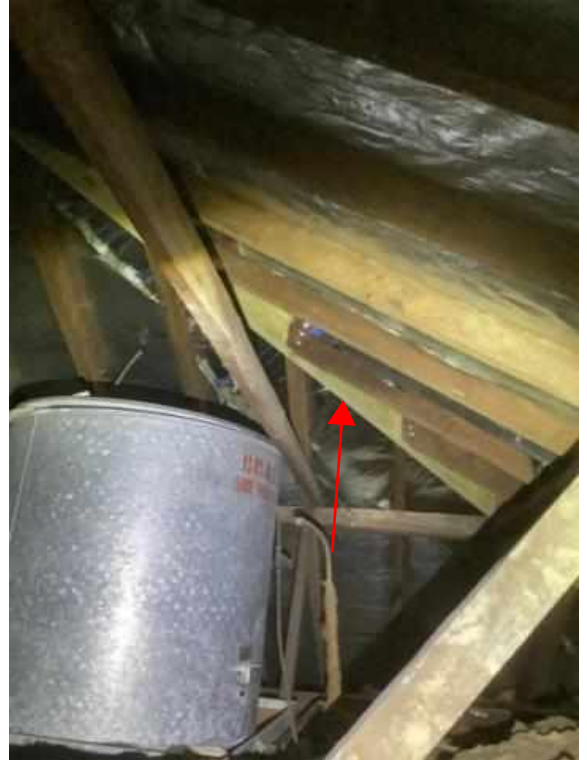
Affected timbers / Areas:

Hip rafter timber.

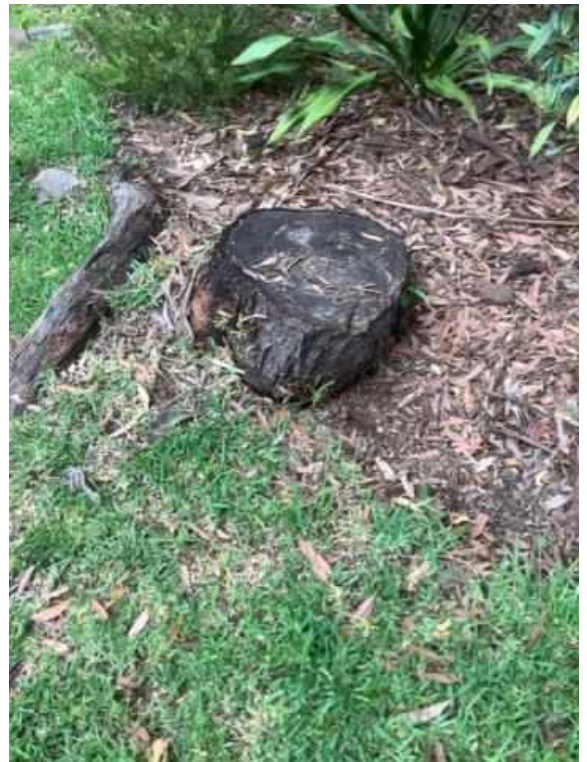
- Tree stumps should be removed as they provide an area for termites to establish a colony.
