Building Report

87 Ingrid Rd, Karelia

BUILDING & TIMBER PEST INSPECTION REPORT TO AS4349.1 2007 & AS4349.3 2010

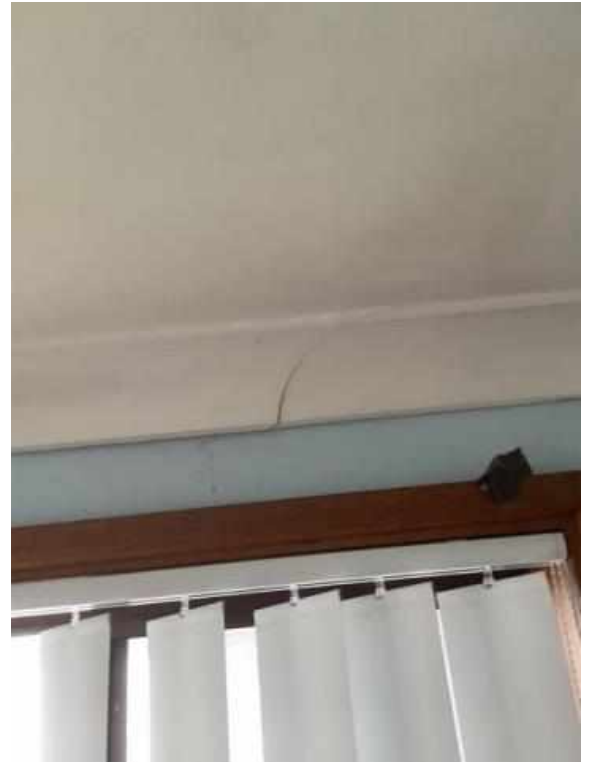
Cracks to some cornices.

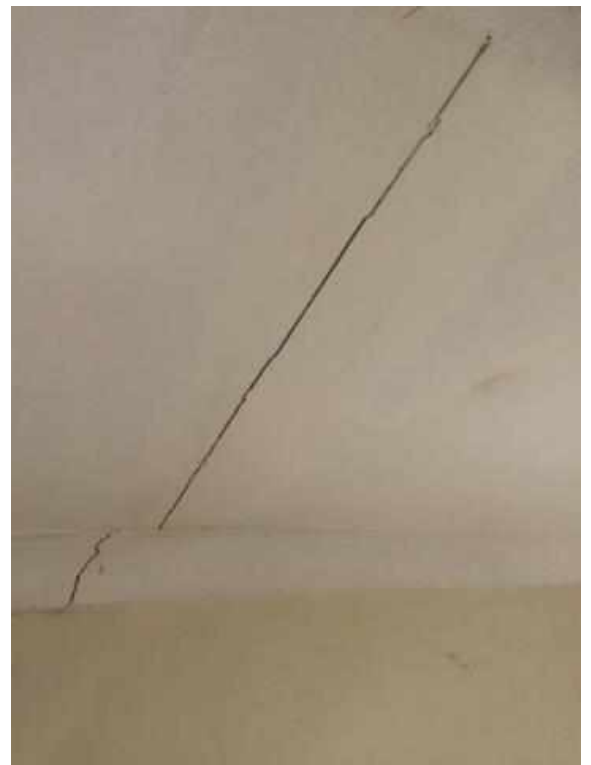
Cracks to some ceiling sheeting.

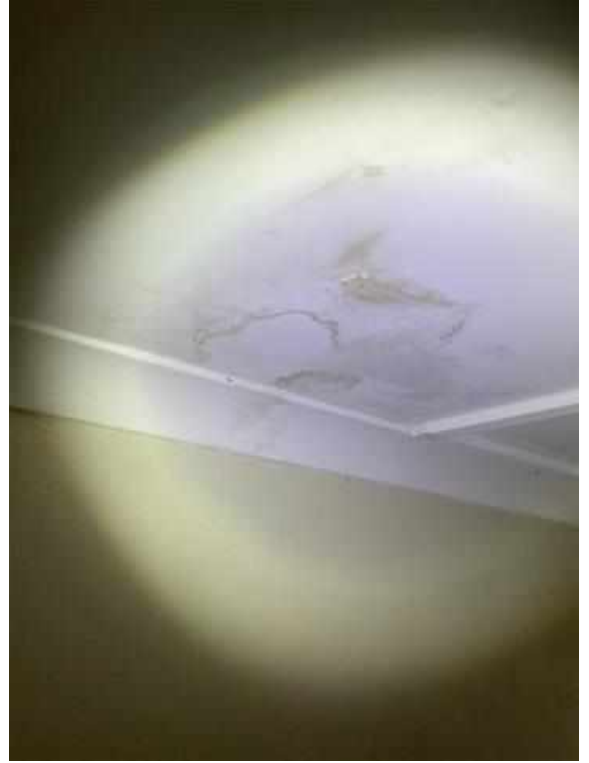
Signs of past water penetration to some ceilings, this area is below the bathroom shower.

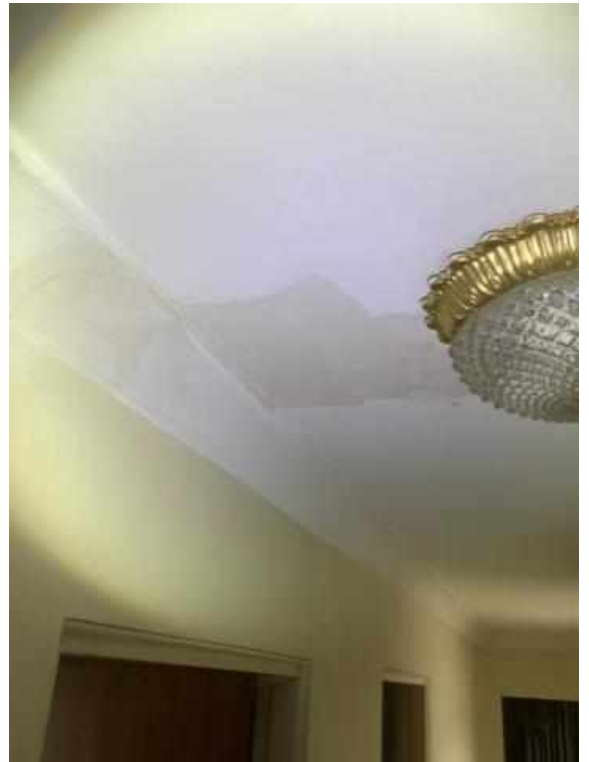
Signs of past repair patching to ceiling sheets requires repair repainting.

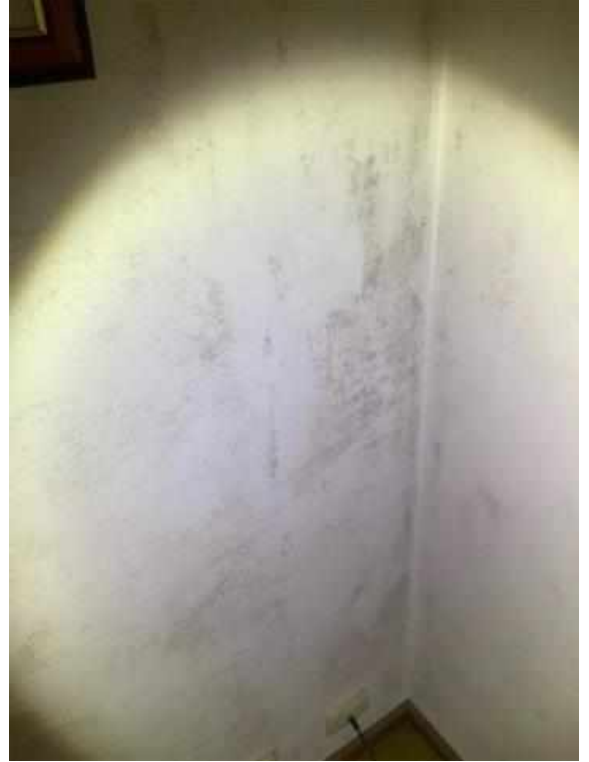
Signs of past water penetration to some walls.

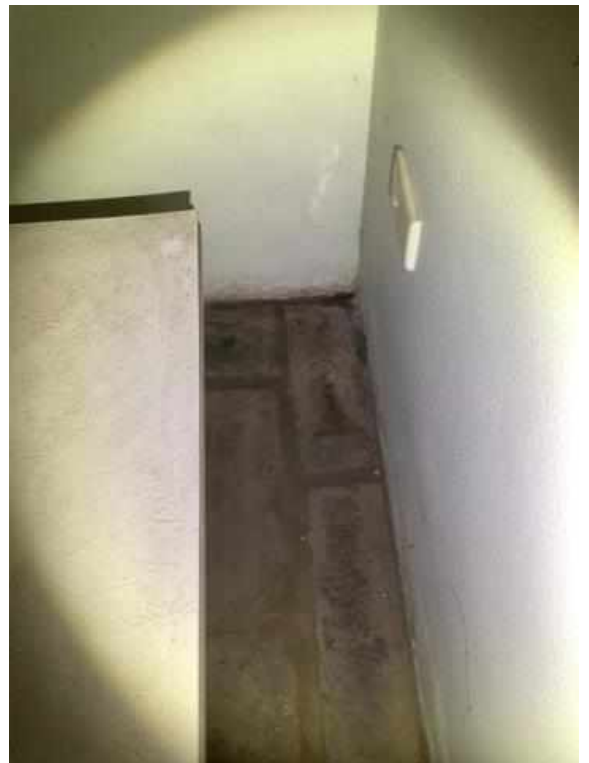
Signs of past water penetration to some walls.

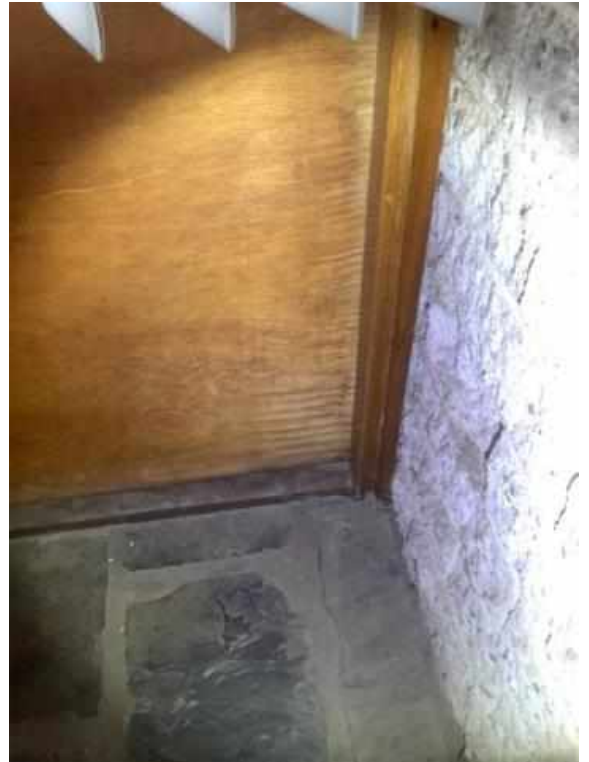
Signs of past water penetration to some walls.

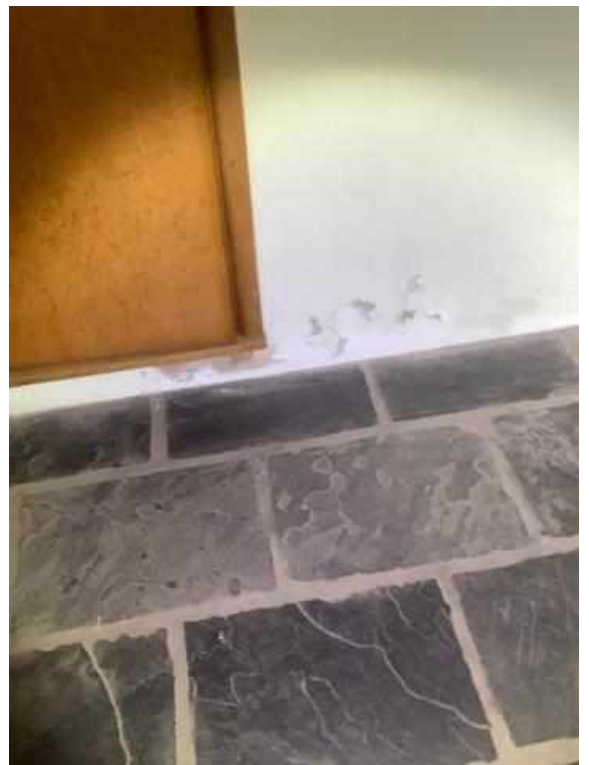
Signs of past water penetration to some walls.

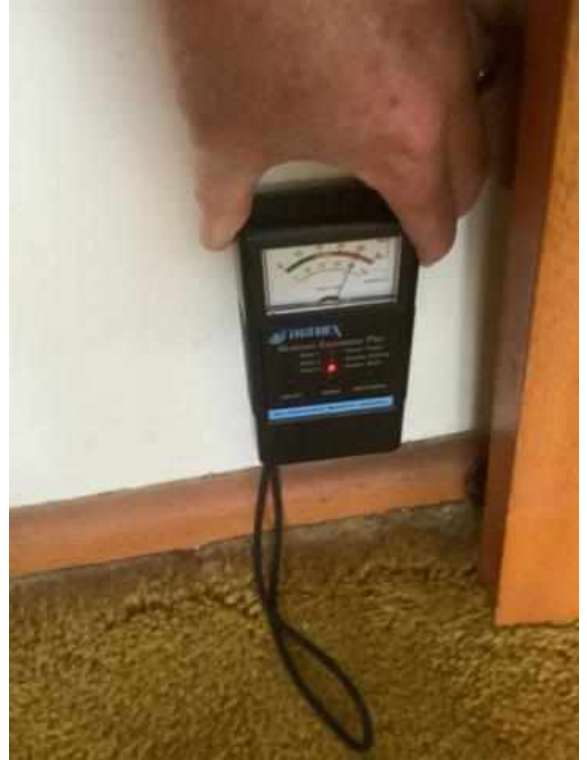
High moisture levels were detected in the wall at the rear of the bathroom shower. I recommend that a plumber be engaged to conduct a compression check on the combination and pipes and to also check the wetseal.

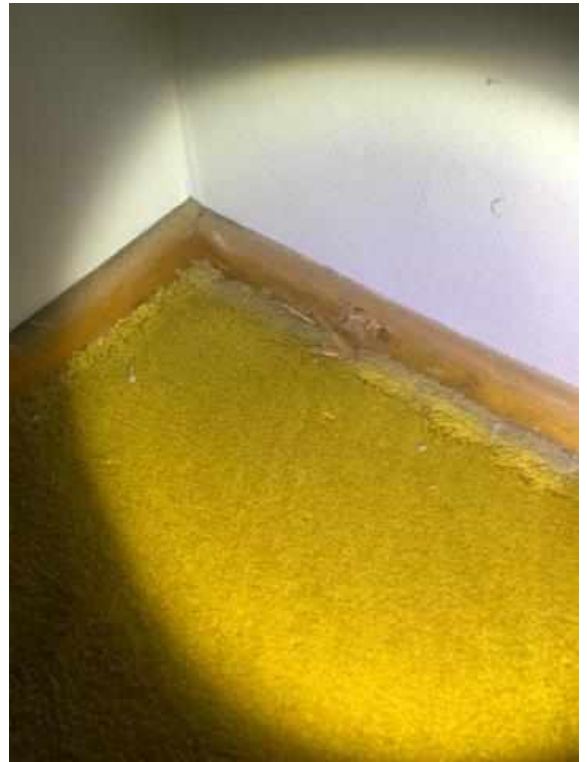
Evidence of termite damage to various internal skirtings and architraves throughout the building. Some of this damaged timber requires repair / replacement. We recommend a builder be engaged to determine a scope of work to rectify this problem. Refer to the attached Timber Pest Inspection Report.

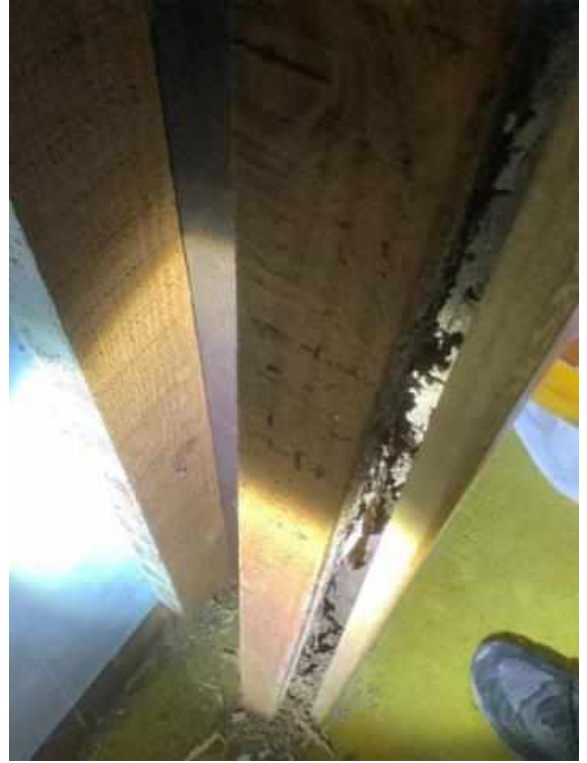
Evidence of termite damage to some wall framing timbers to bedroom 3. Some of this damaged timber requires repair / replacement. We strongly recommend a builder / carpenter be engaged to conduct an invasive inspection to determine the full extent of damage and to determine a scope of work to rectify the damage. Refer to the attached Timber Pest Inspection Report.

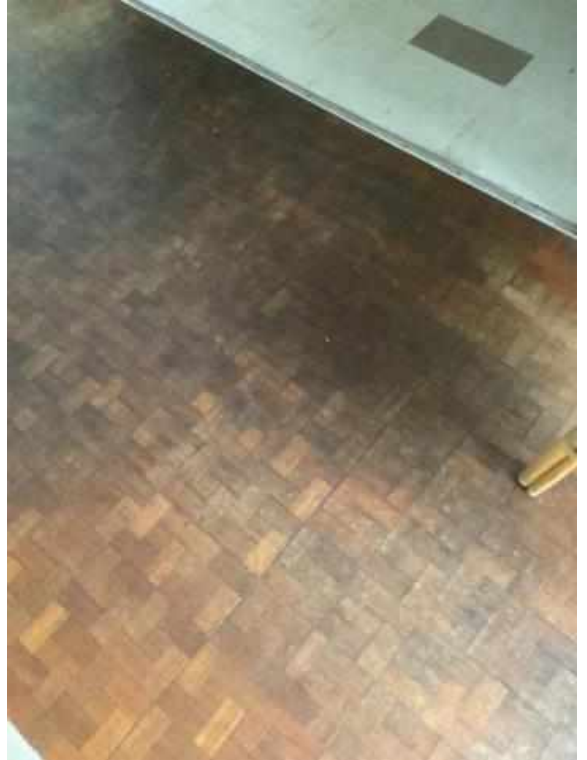
Some sections of polished floors show signs of wear and are recommended to be re-polished.

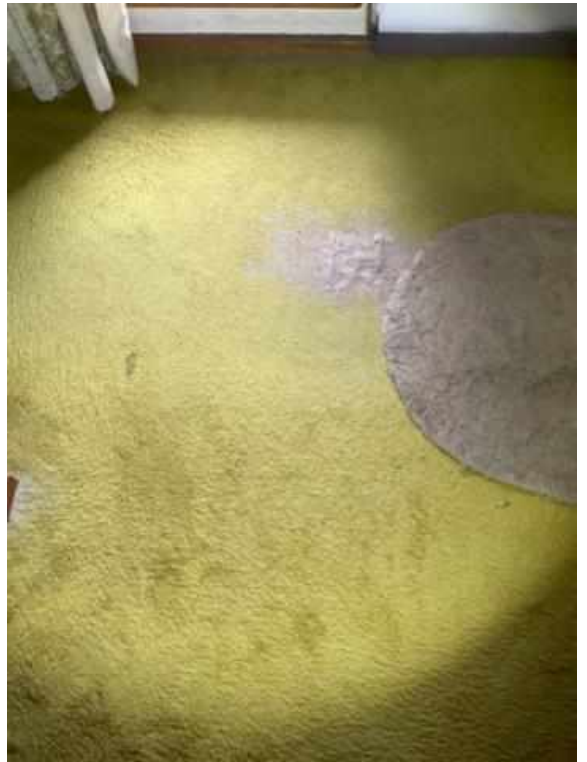
Some floor coverings to various rooms are in a poor condition and are recommended to be replaced.

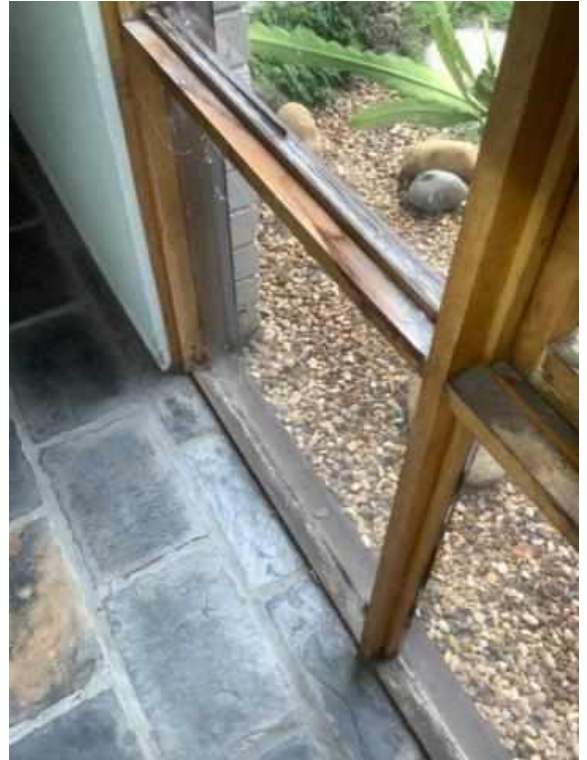
Some frames and sashes show signs of weather damage and require repair / repainting.

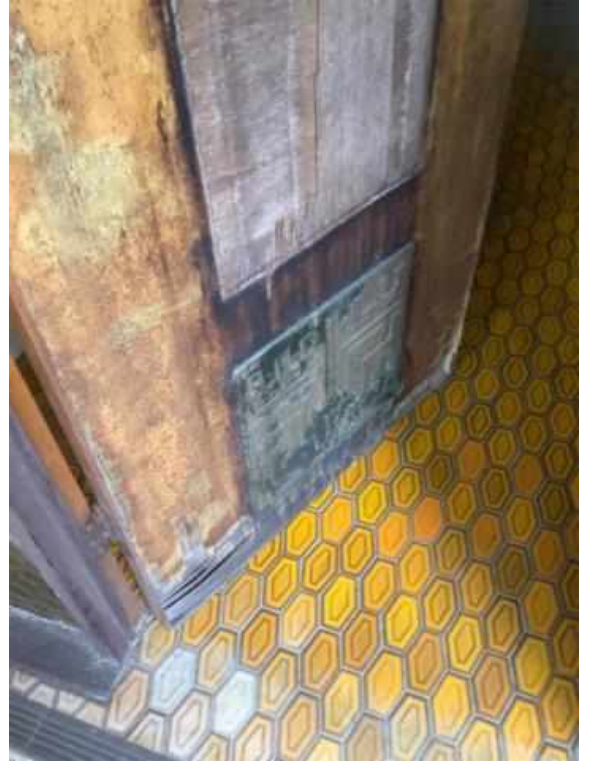
Front door shows signs of weather damage and requires repair / repainting.

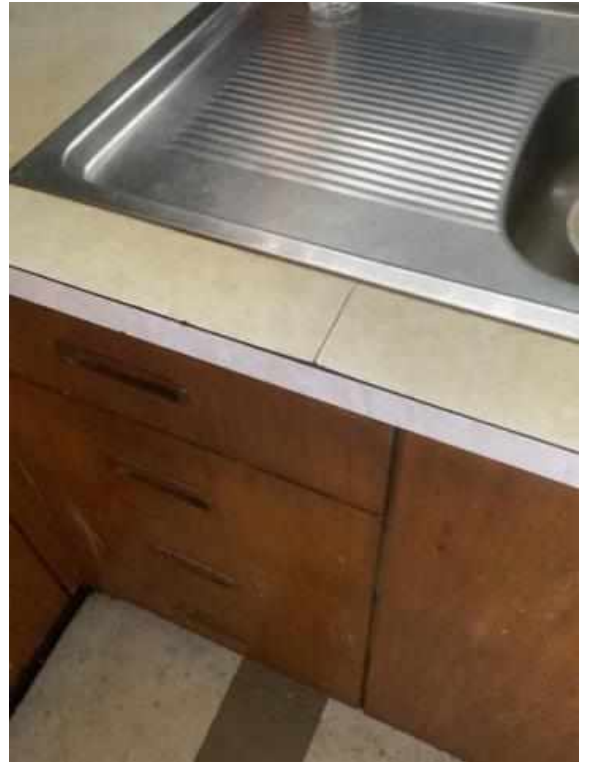
Some laminate shows signs of lifting.

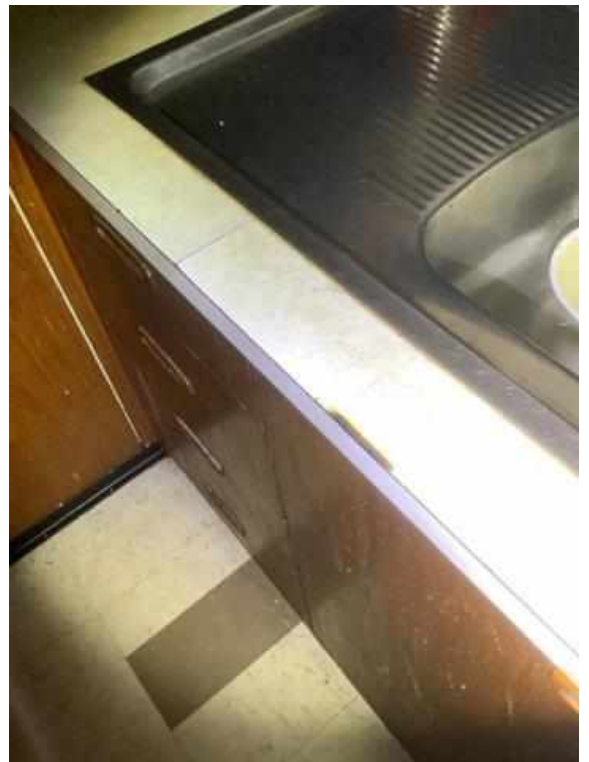
Surface damage to some laminate.

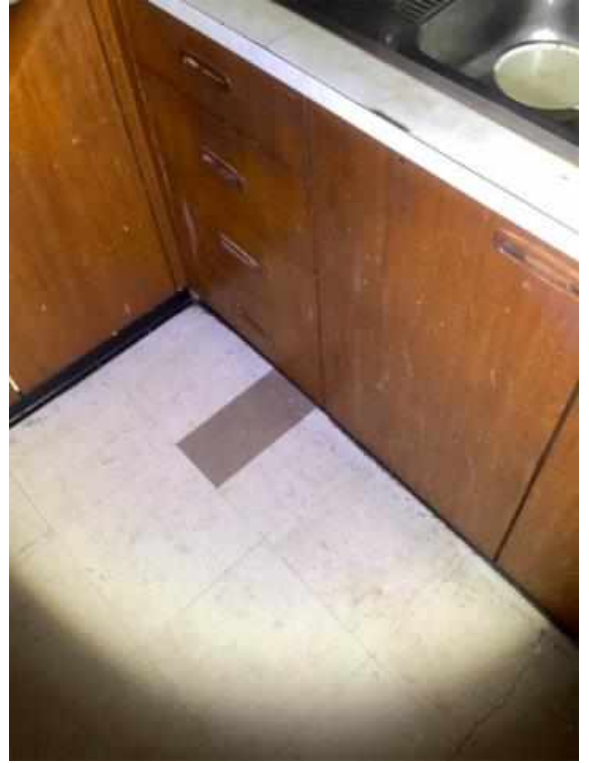
Some doors and drawers require repair.

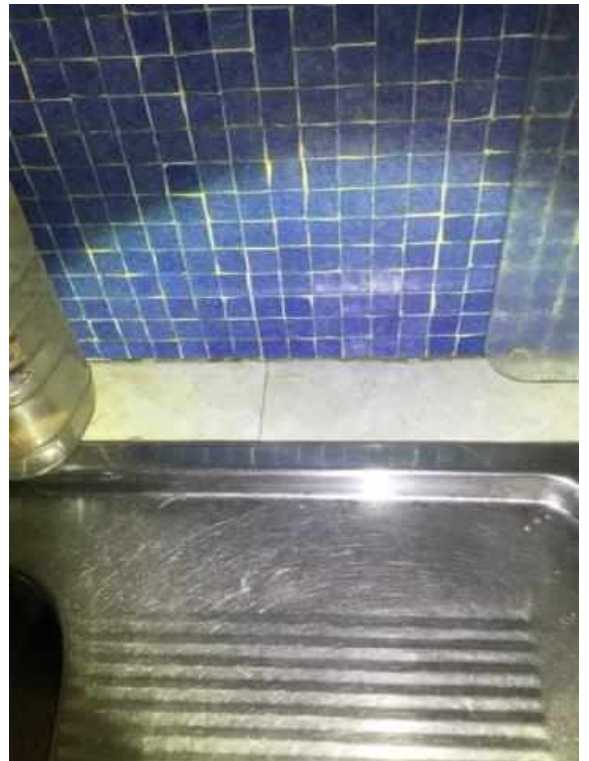
Junctions of bench tops and splashback tiles require resealing with silicone.

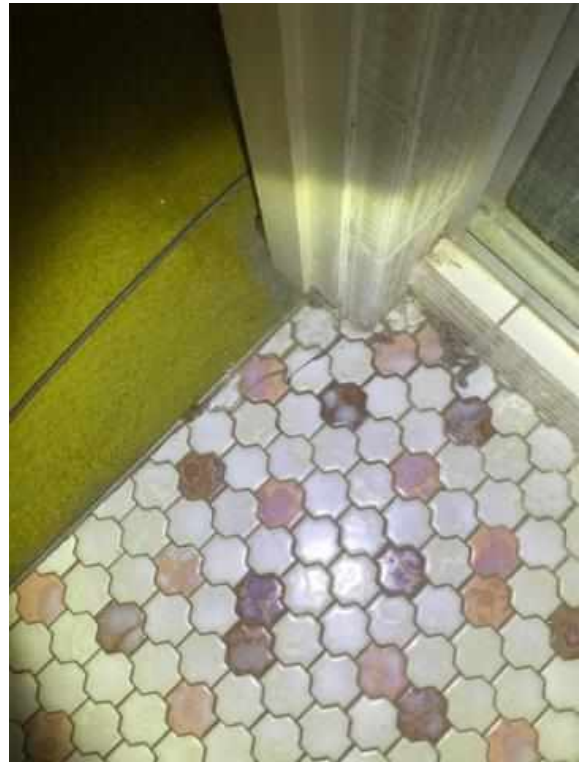
Cracks to some floor tiles to Bathroom.

Drummy floor tiles to some areas.

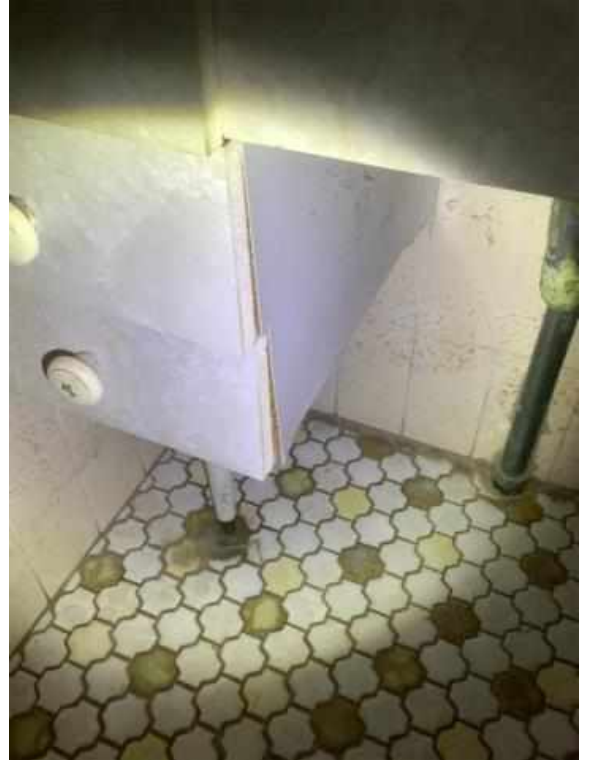
Laminate is peeling from the vanity cupboard.

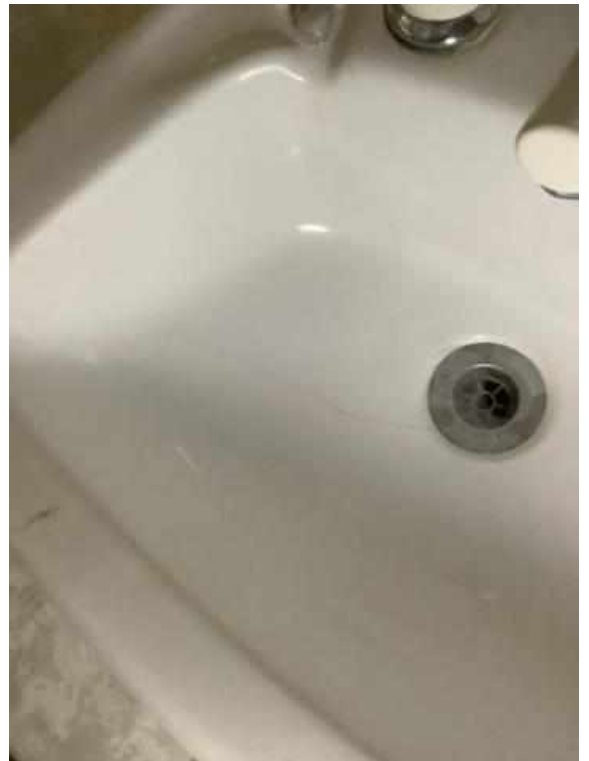
Cracking to hand basin requires repair/ replacement.

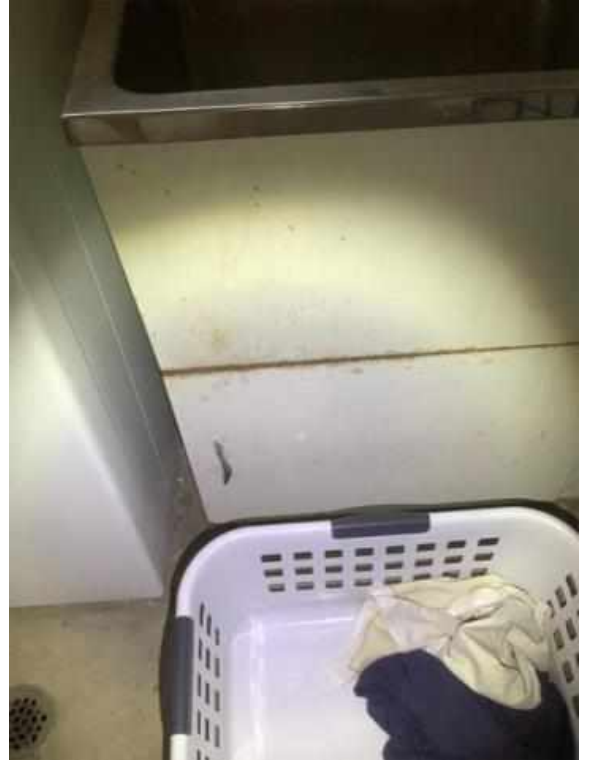
Rust to laundry tub cabinet requires repair / repainting.

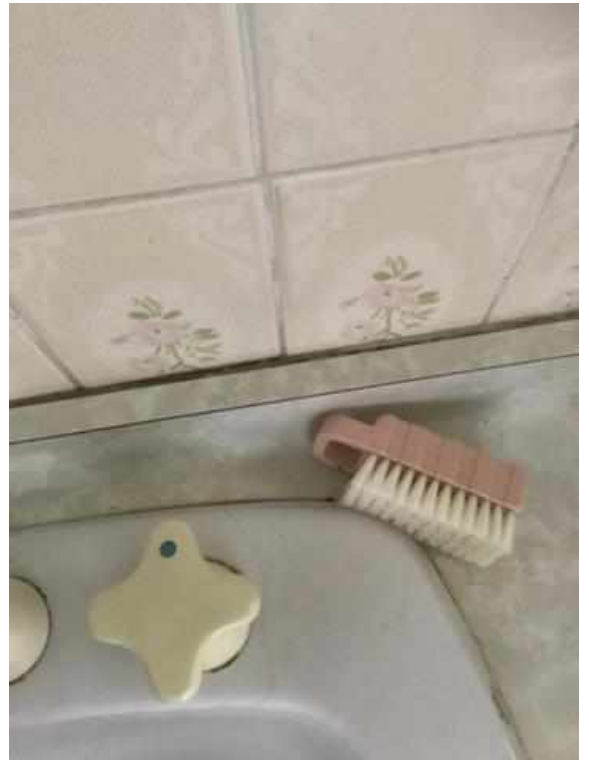
Junctions of vanity and wall tiles require resealing with silicone.

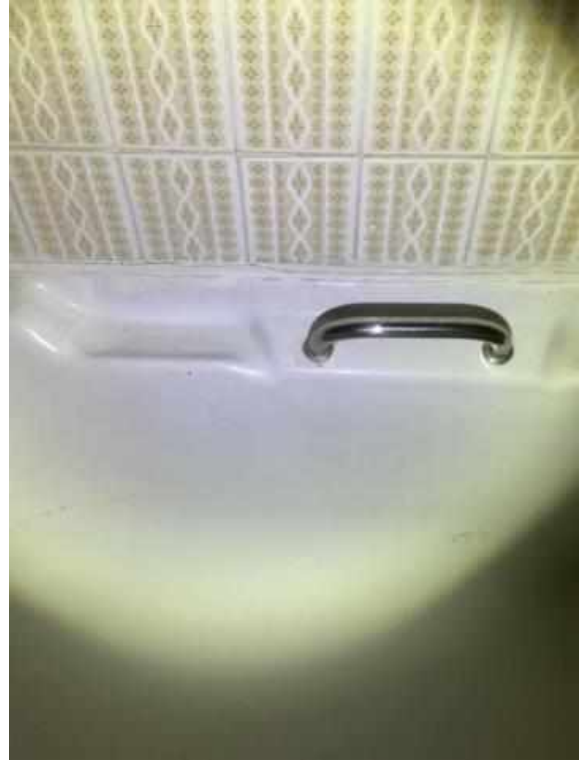
Junctions of bath and wall tiles require resealing with silicone.

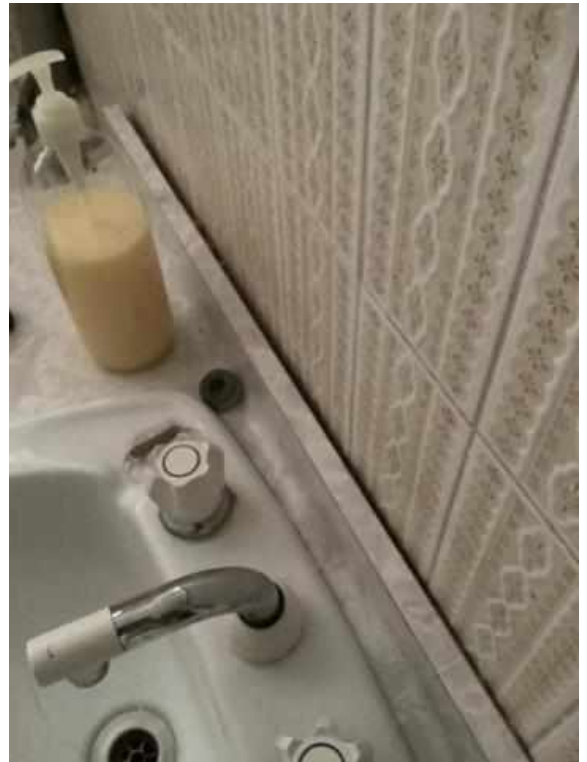
Junctions of vanity and wall tiles require resealing with silicone.

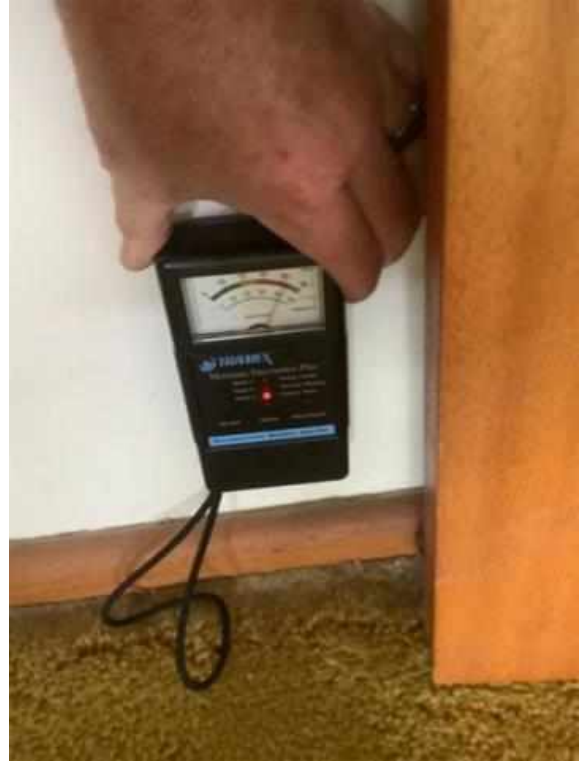
There are signs of high moisture levels in the wall at the rear of the bathroom shower. I recommend that a plumber be engaged to conduct a compression check on the combination and pipes and to also check the wetseal.

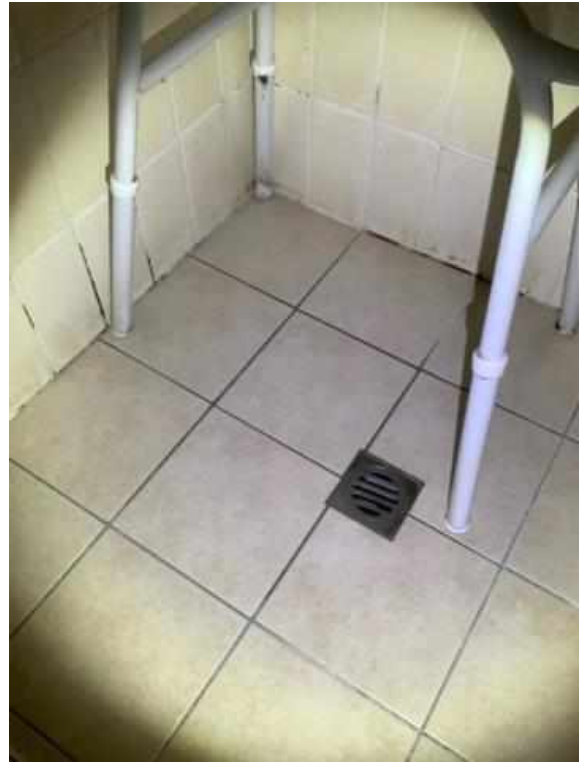
Junctions of shower floor and wall tiles require resealing with silicone.

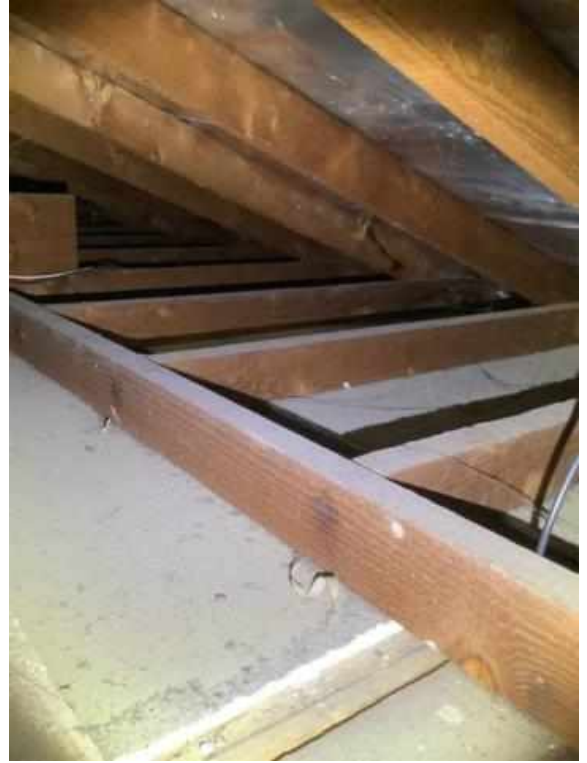
Signs of past water penetration was found in roof void
I recommend a roof tiler or roofing plumber be engaged
to find cause of leak and repair.

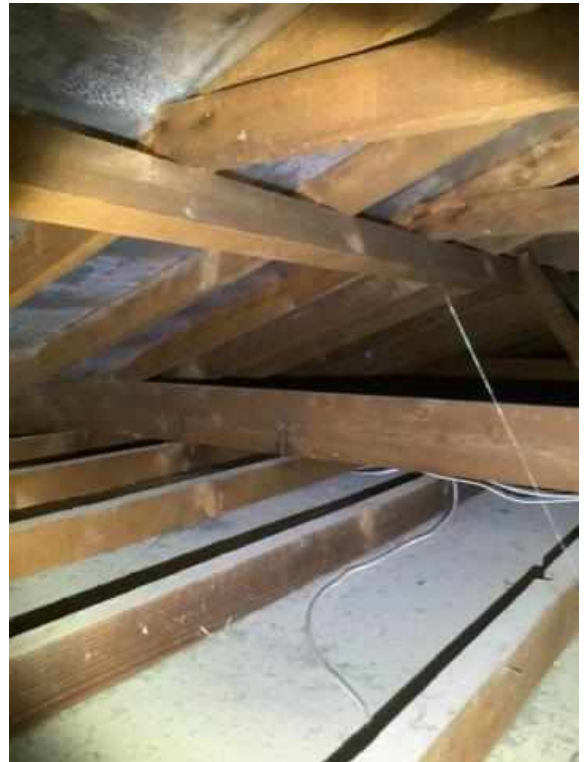
Evidence of termite damage to various framing timbers.
Some of this damaged timber requires repair /
replacement. We recommend a builder be engaged to
determine a scope of work to rectify this damage. Refer
to the attached Timber Pest Inspection Report.

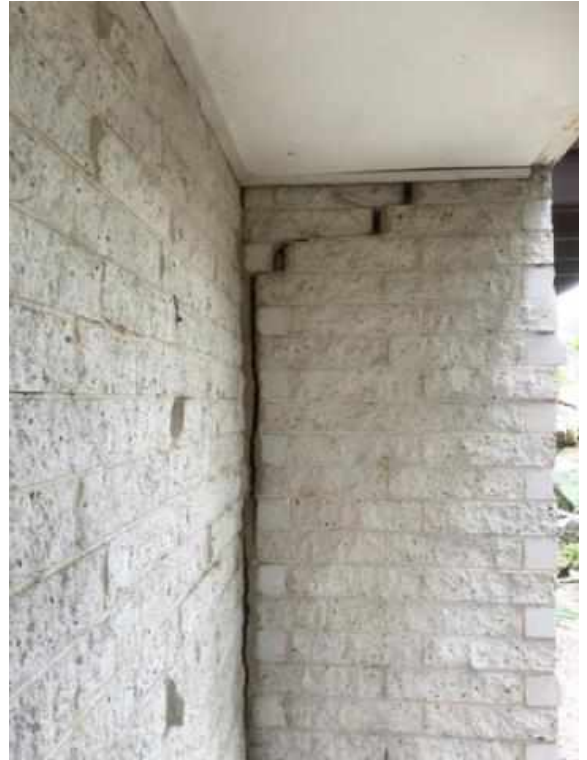
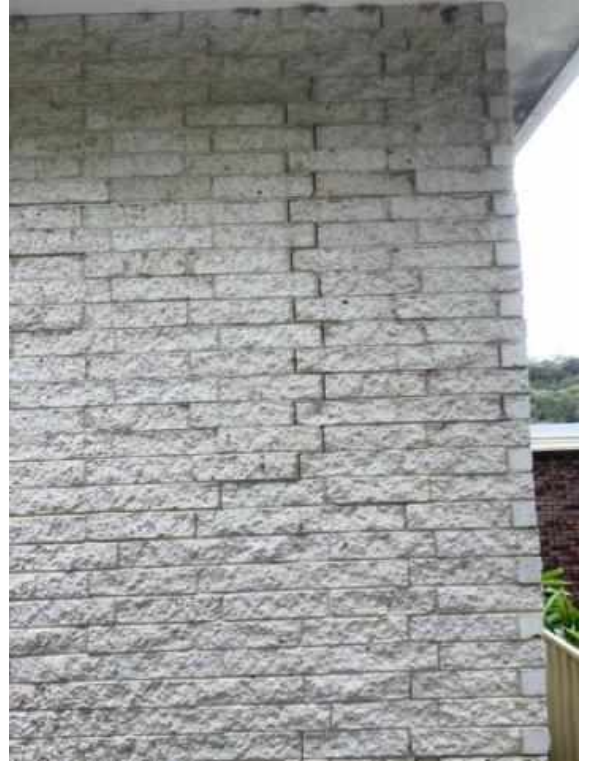
Cracks to the brickwork indicate that some settlement or subsidence / soil heave has taken place. We strongly recommend that this settlement / subsidence be referred to at appropriate Structural / Geotechnical Engineer for investigation.

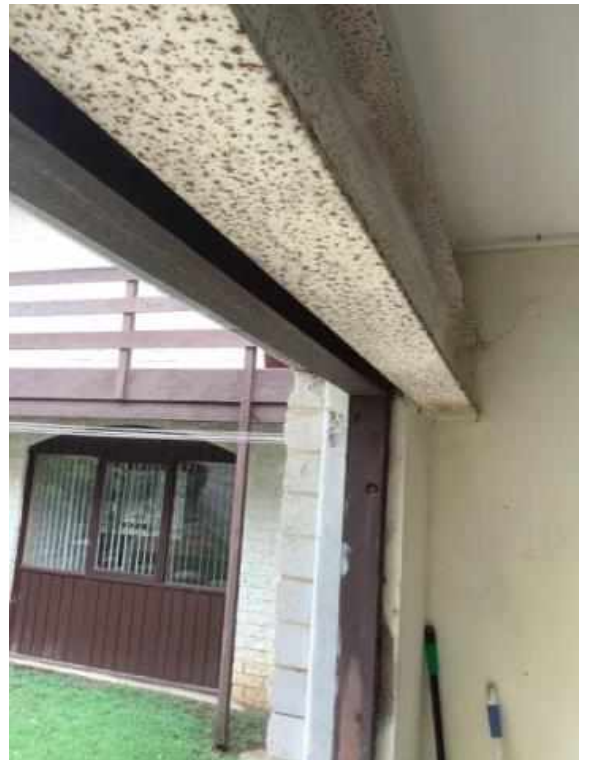
Rust spots to some lintels requires repair / repainting with Killrust or equivalent.

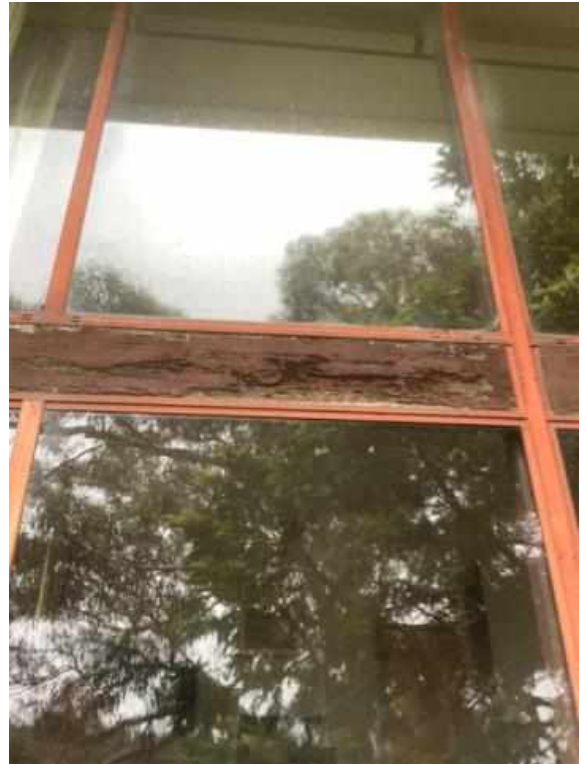
Some frames show signs of weather damage.

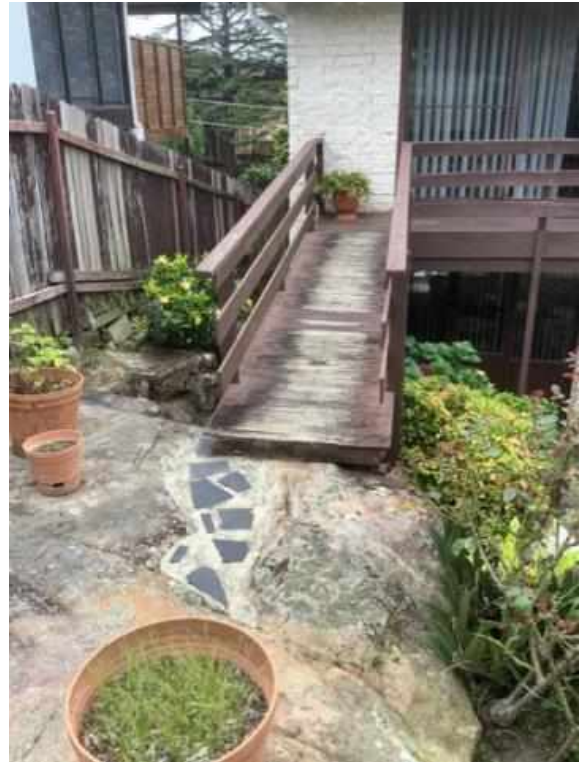
Some decking & framing timbers show signs of weather damage and require repair / replacement.

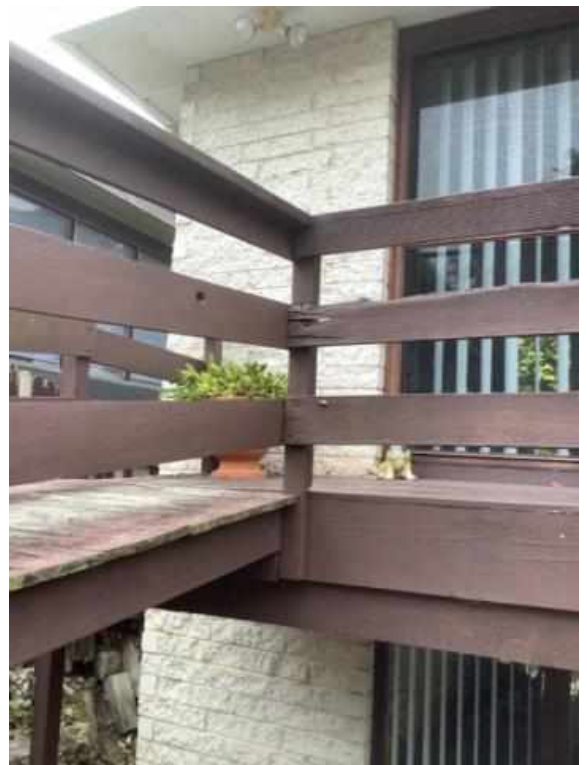
Some balustrade timbers show signs of weather damage.

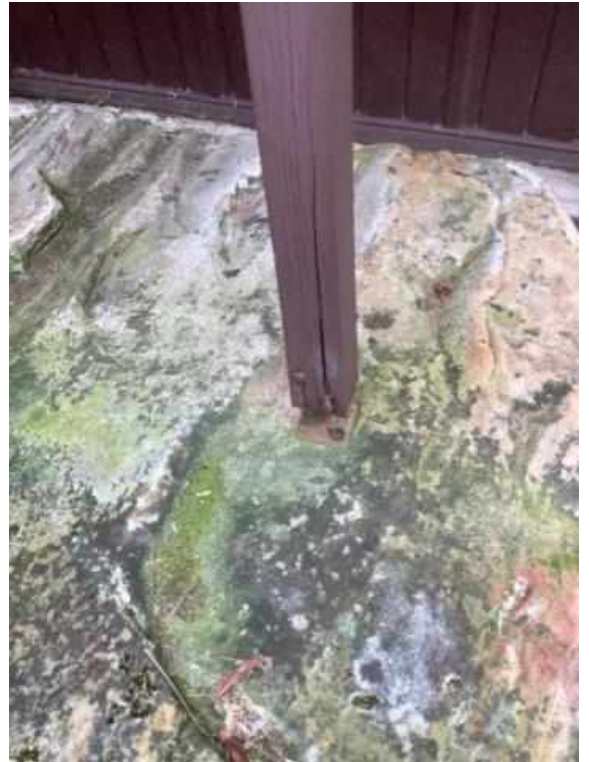
Decking posts are splitting and require repair/ replacement.

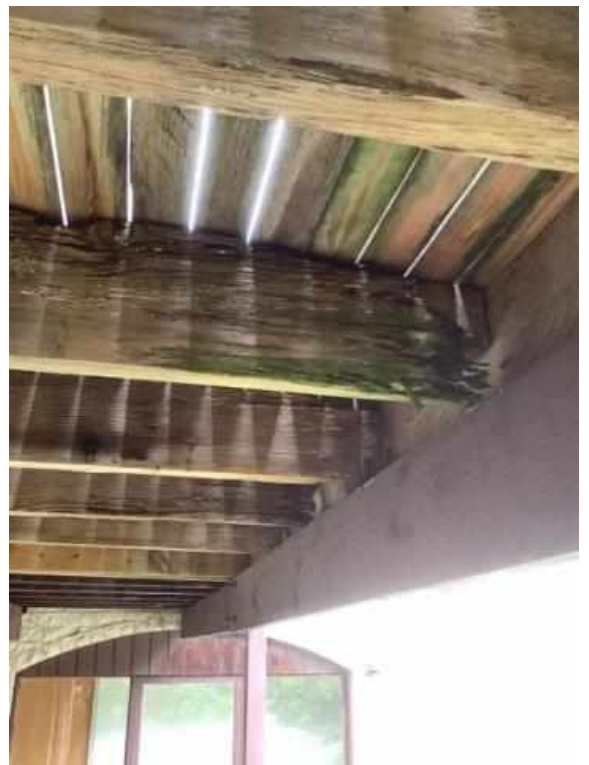
Some decking & framing timbers show signs of weather damage.

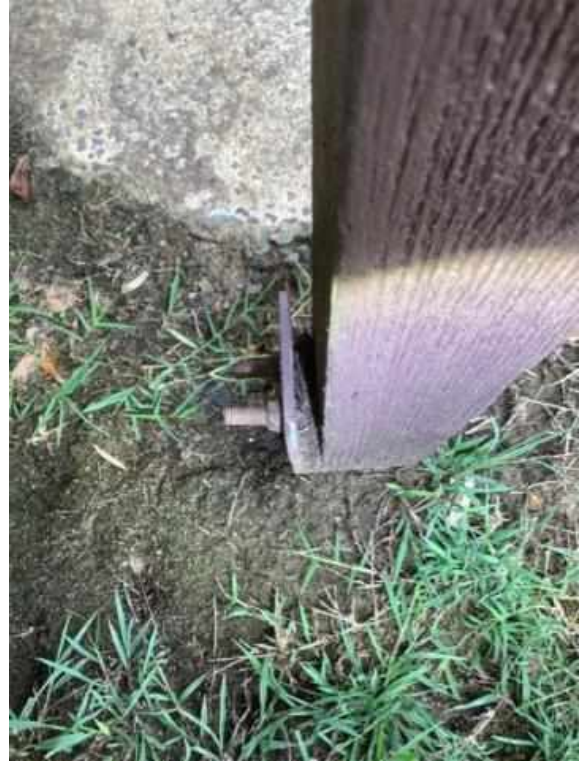
Decking post bolts have rusted through, new fixing should be fitted immediately.

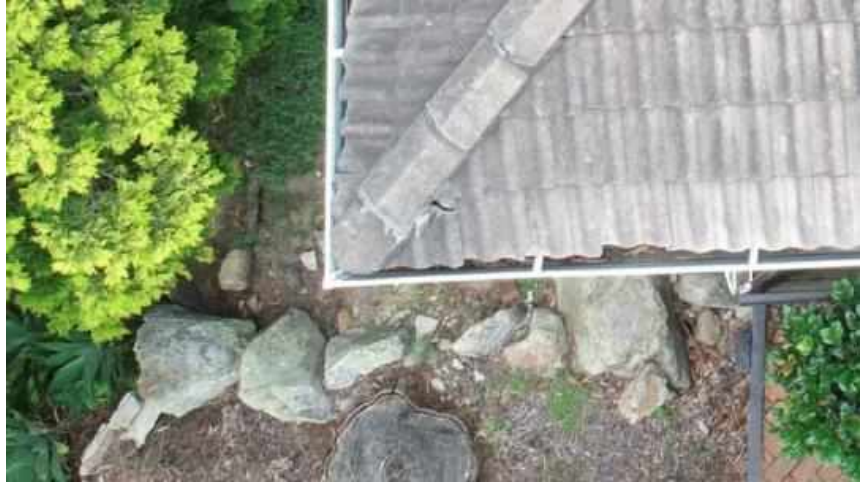
Cracked roof tiles require repair / replacement.

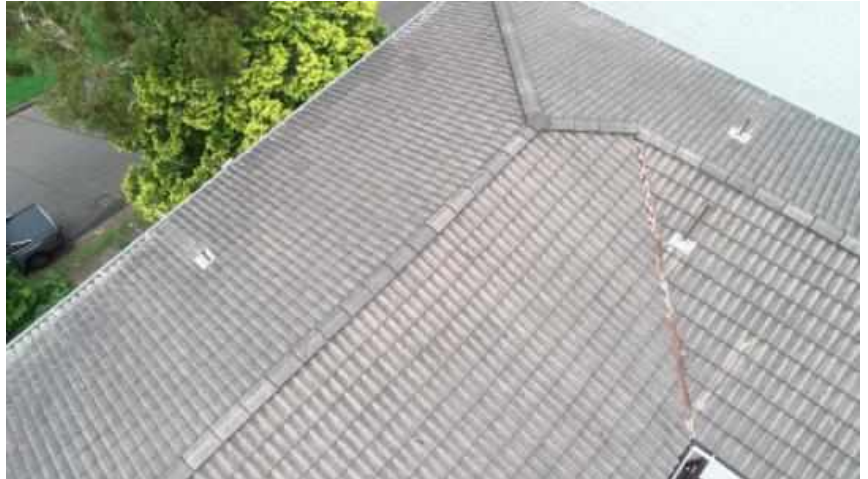
Surface rust to some valley flashings requires repair / painting with Killrust or equivalent.

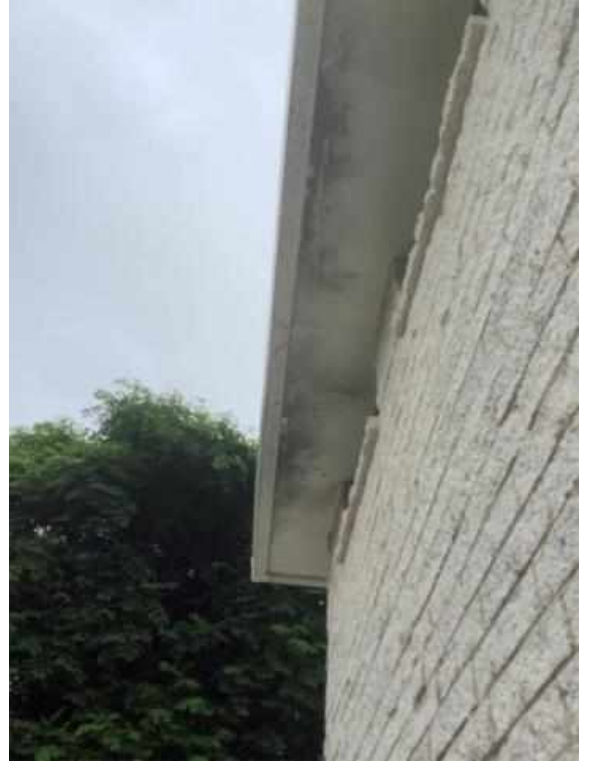
Weather damage to eaves requires repair repainting.

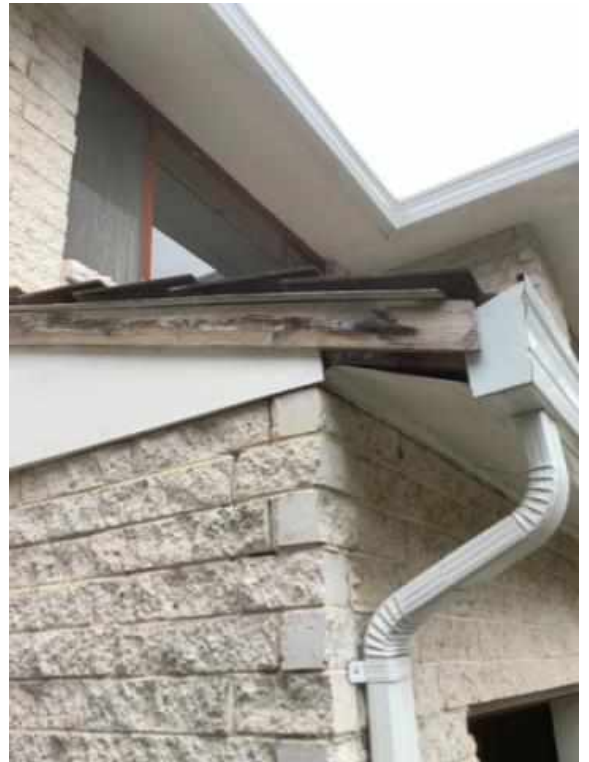
Some fascia / barge timbers show signs of weather damage and require repair / repainting.

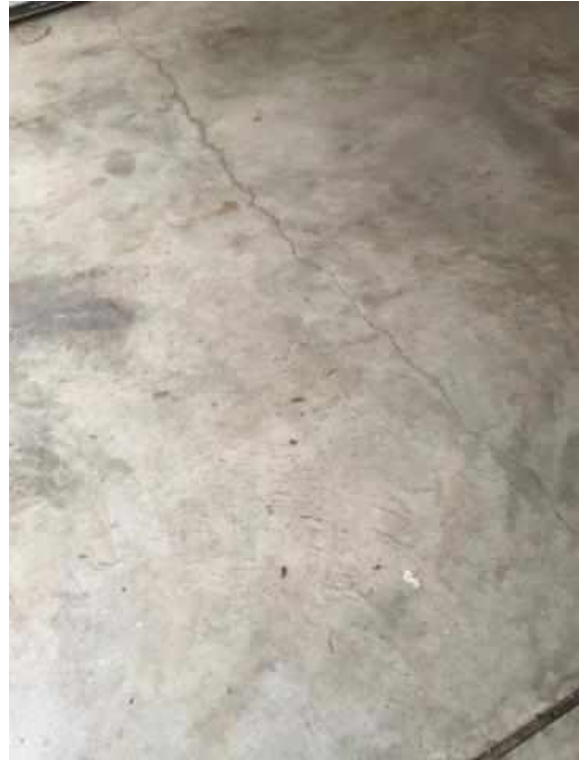
Some surface cracks to slab.

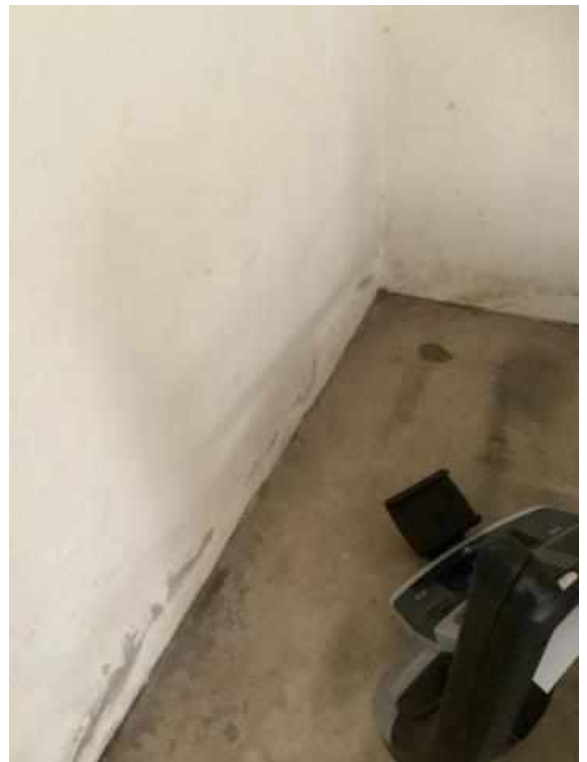
Signs of past water penetration through walls.

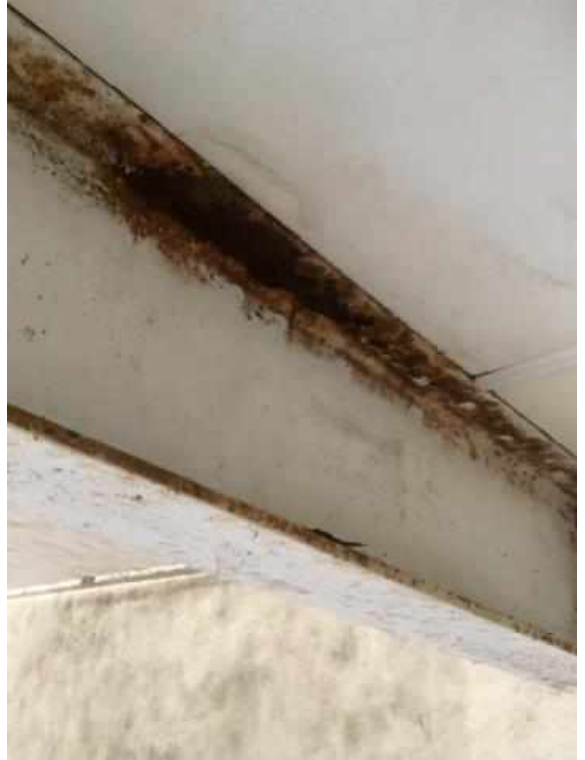
Steel beam to the garage area is rusted, this should be assessed by a structural engineer to assess its structural integrity.

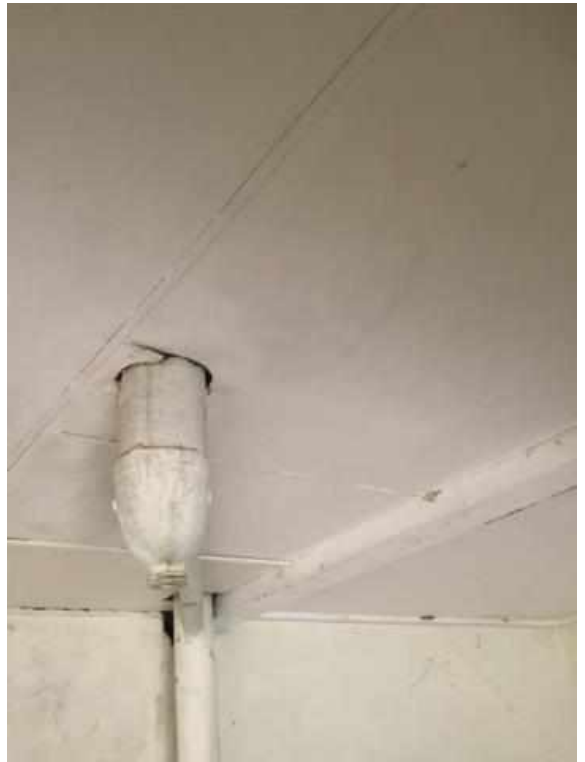
Signs of past water penetration to the ceiling, this area is below the ensuite shower.

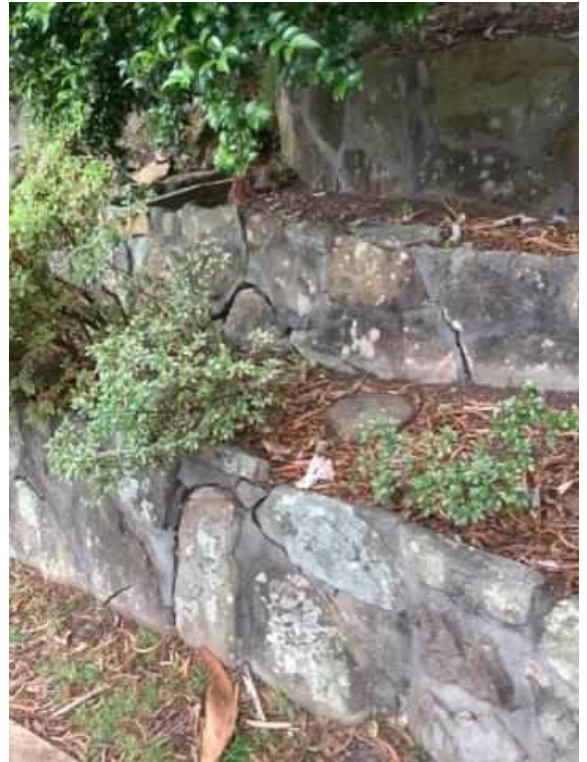
Cracks damage to some garden retaining walls require repair or replacement.

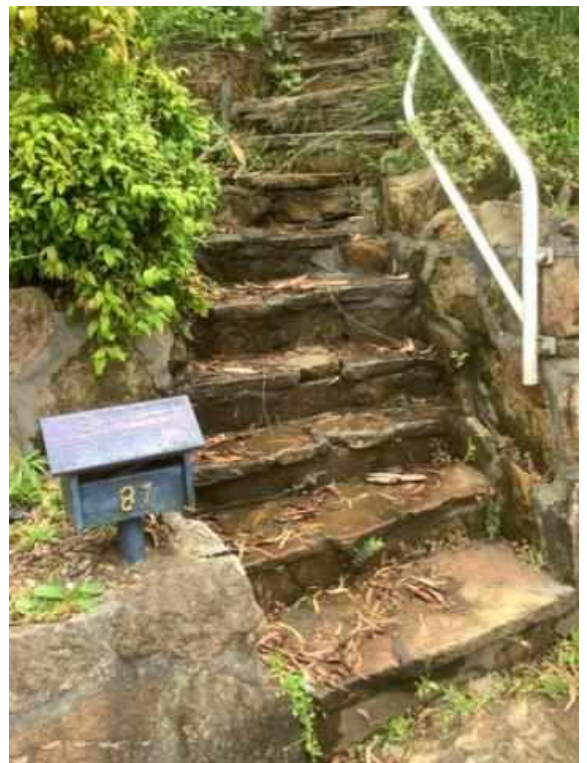
Step heights and size vary and could be a trip hazard.
