Building Report

87 Ingrid Rd, Karelia

BUILDING & TIMBER PEST INSPECTION REPORT TO AS4349.1 2007 & AS4349.3 2010

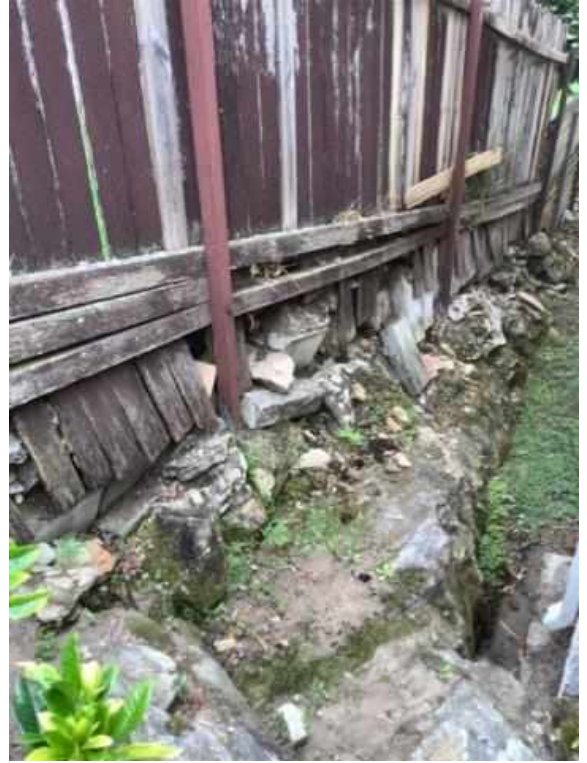
Some fencing requires repair / refixing.

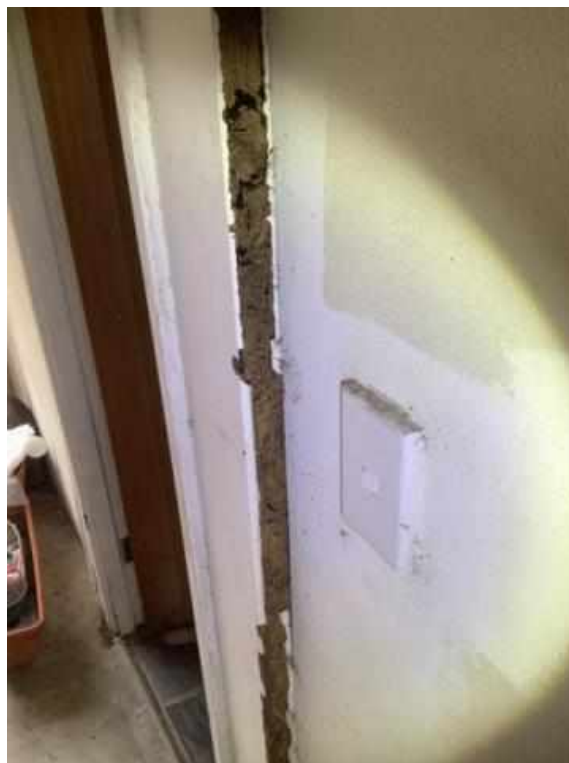
The visible damage to the timbers appears to be moderate to extensive. Further damage probably exists in concealed areas. Please refer to the definitions section of this report - Section 1.2 - Timber Damage.

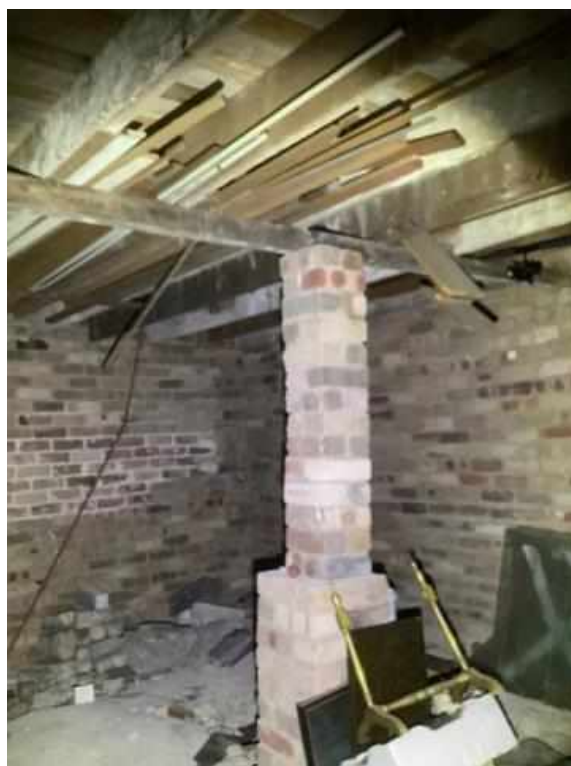
- We note the lack of ant capping or deficiencies in the fitment of ant capping. The purpose of ant capping is to reduce the risk of concealed termite attack. Ant capping should be repaired or installed where possible.

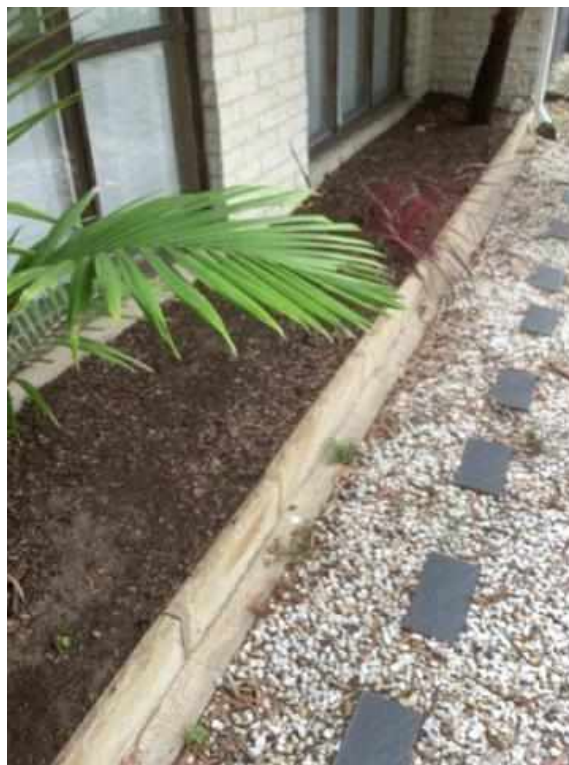
- Remove garden beds and vegetation close to or abutting the external walls of the structure. These can attract / allow concealed termite entry and should be removed.
