Building Report

15B Warrigal St, Jannali

BUILDING & TIMBER PEST INSPECTION REPORT TO AS4349.1 2007 & AS4349.3 2010

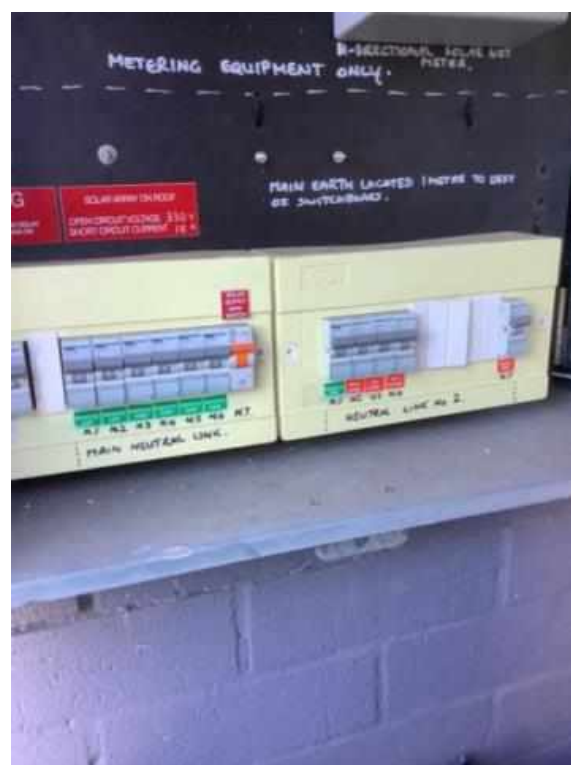
- Whilst not an electrician, an electrical safety switch is present to the building.

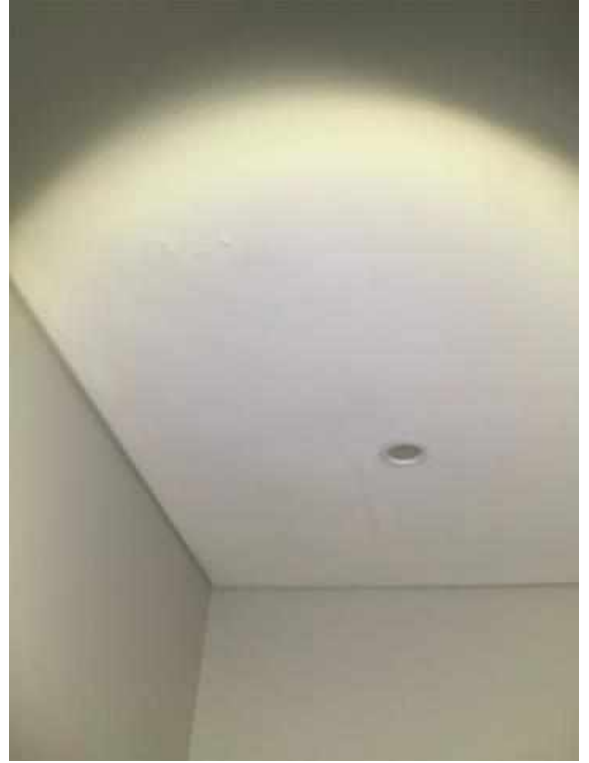
Signs of past water penetration to Office.

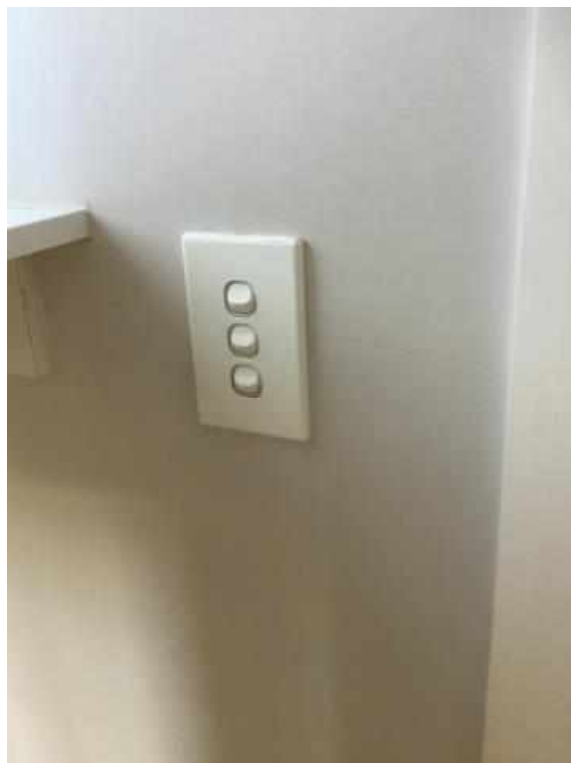
Cracks to some sheet joins.

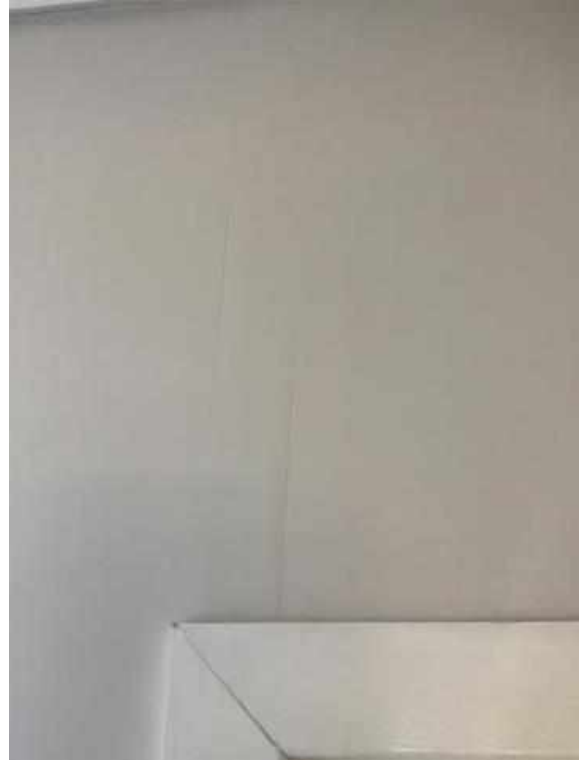
Taped join to plasterboard is bubbling in the WIR,
rectification is required.

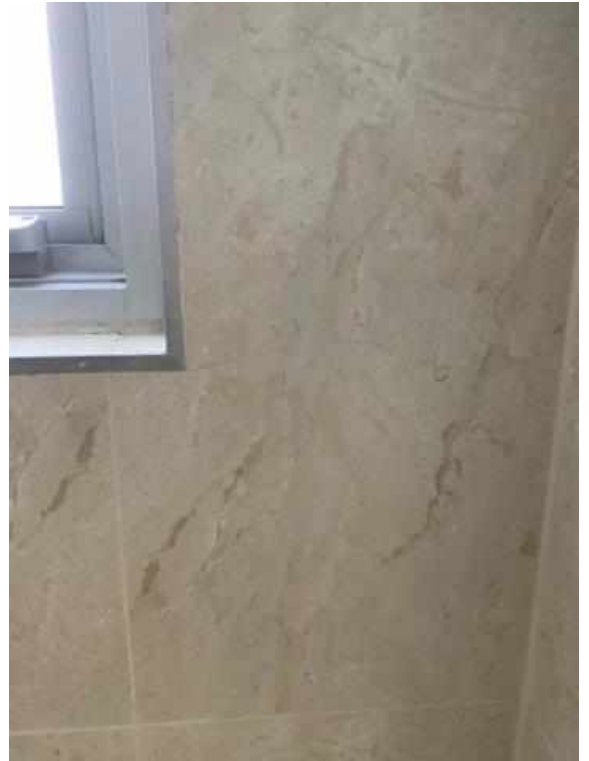
Cracks to some wall tiles to Ensuite shower.

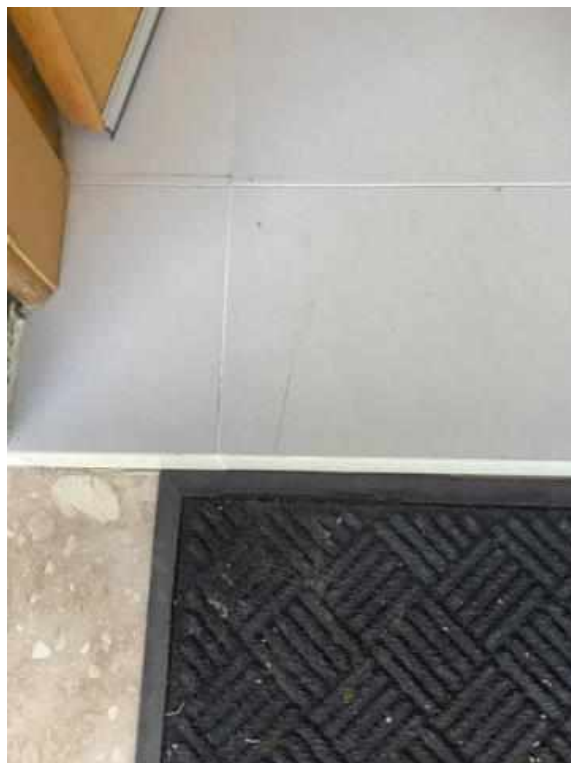
Cracks to some floor tiles to Front door threshold.

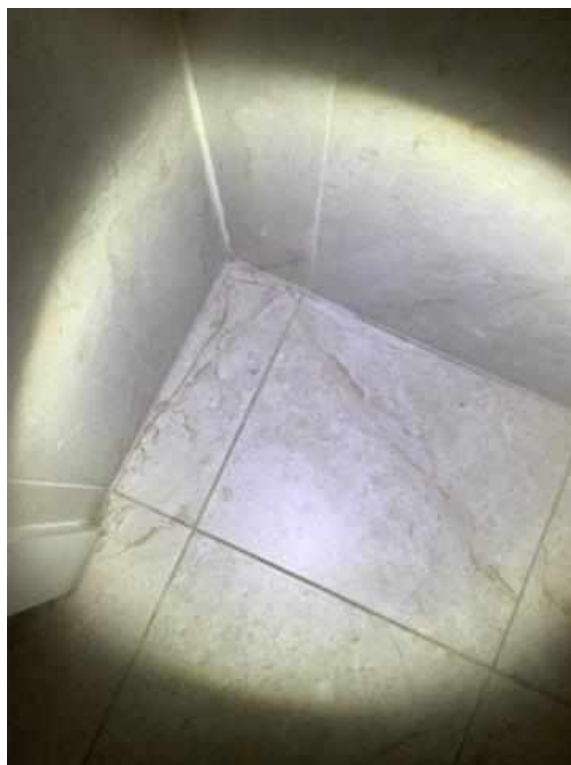
Cracks to some floor tiles to WC.

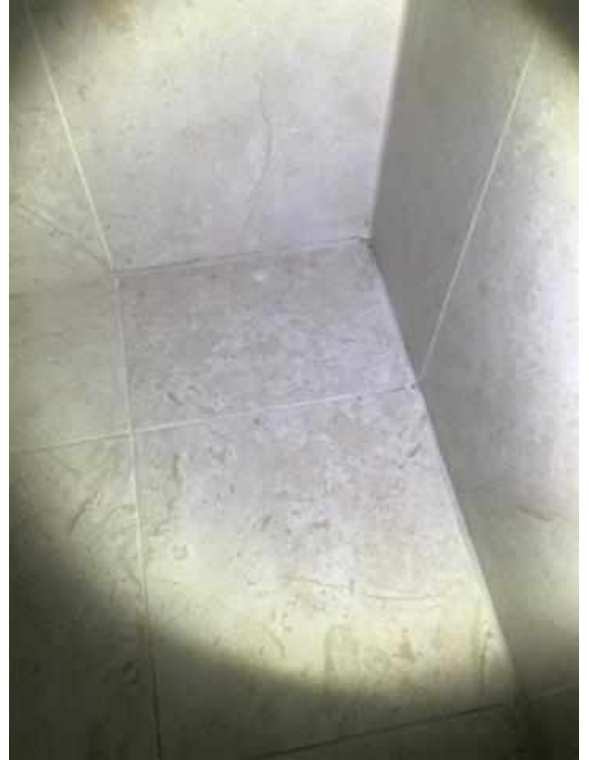
Junctions of shower floor and wall tiles require resealing with silicone to Ensuite.

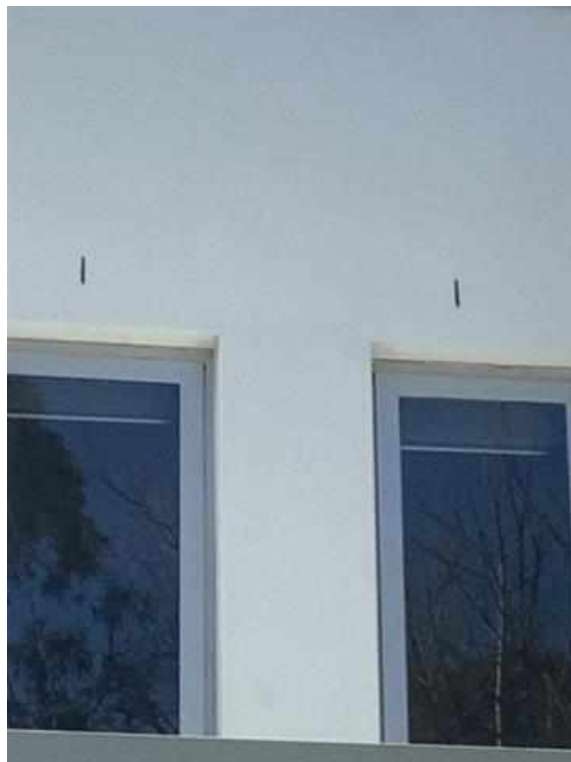
Cracks to fibrous cement sheeting to some areas.

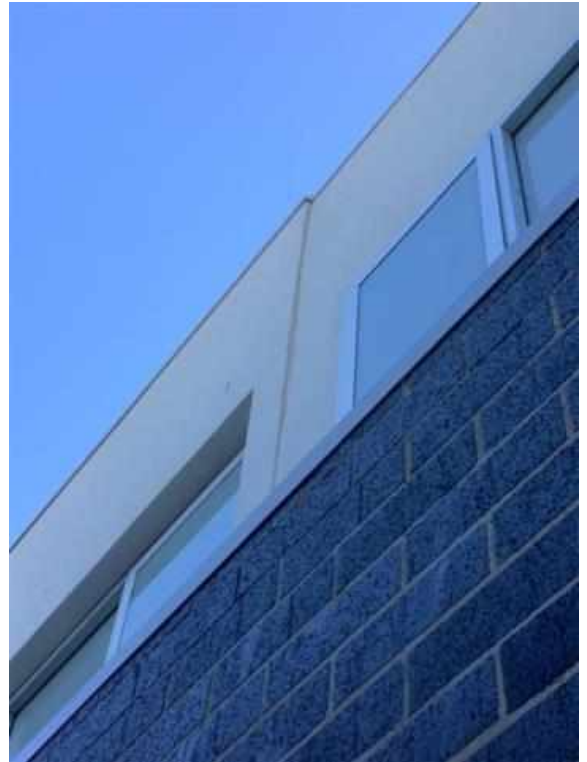
Alignment of wall cladding either side of the expansion joint is out, rectification may be required.

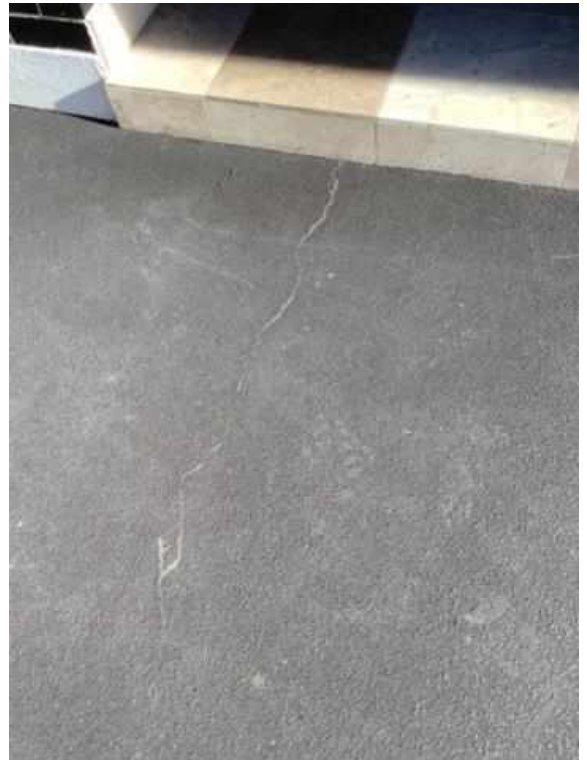
Some cracks to concrete paths.

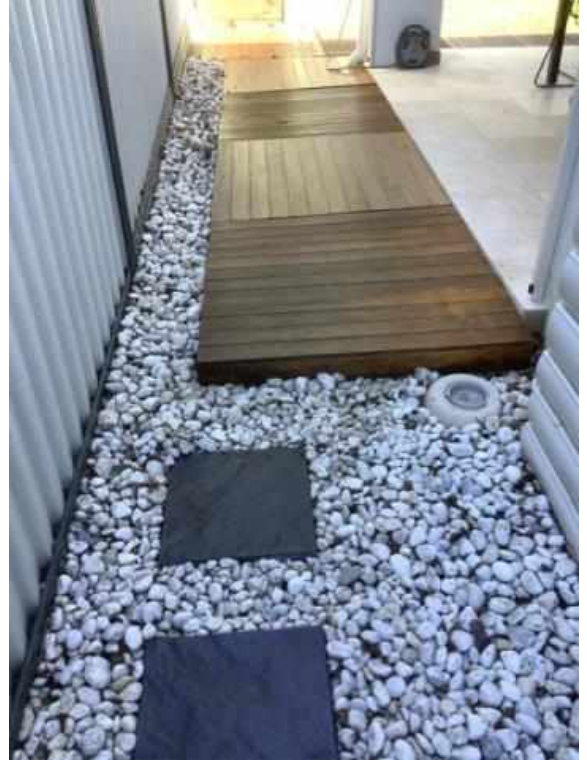
- Some external timbers are in contact with soil. This may allow or have allowed concealed termite entry. The situation should be modified so that timber to soil contact does not occur.

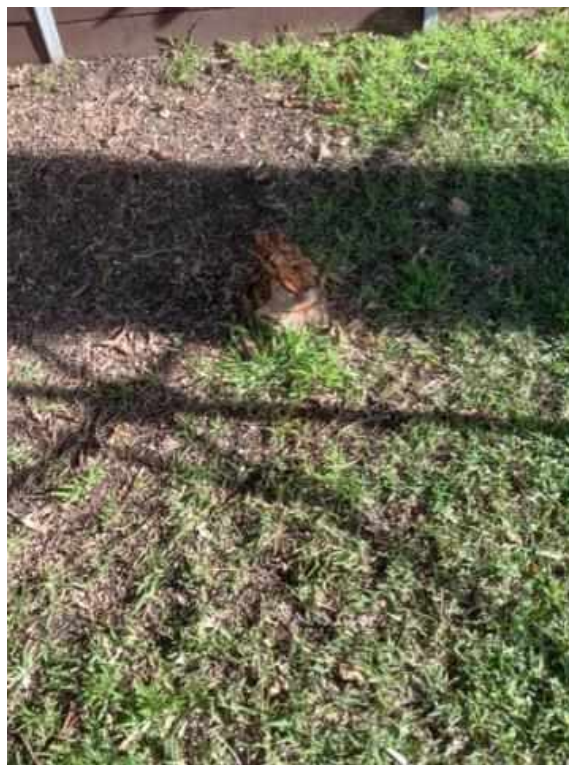
- Tree stumps should be removed as they provide an area for termites to establish a colony.
