COMBINED BUILDING AND PEST INSPECTION

11 Leichhardt Cres
Sylvania, NSW 2224

03/08/2023

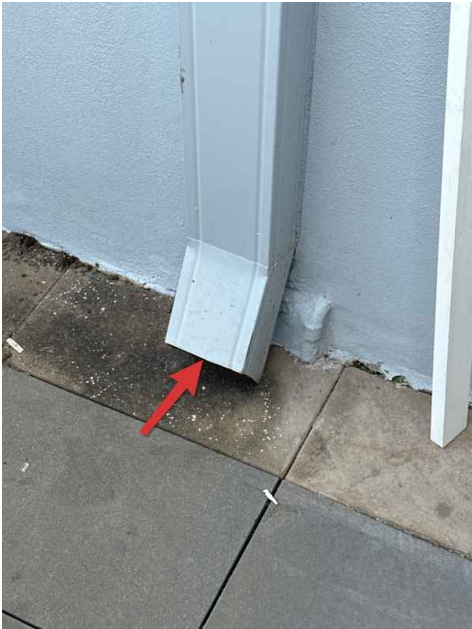
Down pipe/s not connected to storm water discharge - Down pipes not connected to storm water have the potential to cause differential settlement to the footings, cause rising damp.

Contact a qualified plumbing contractor.

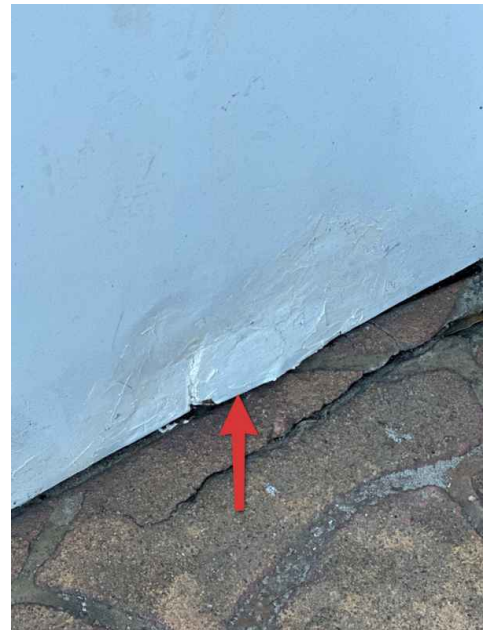
AGE/DETERIORATION

Age/deterioration noted to door.

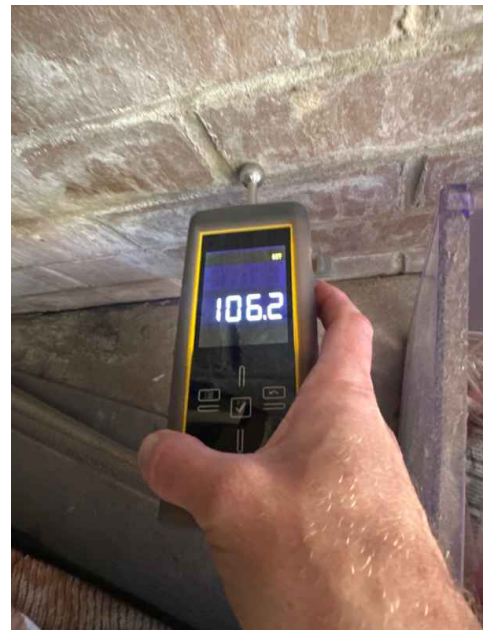
4.4.1 Internal Wall

HIGH MOISTURE- MASONRY - BELOW GROUND LEVEL

Wall is below ground level. High moisture levels obtained. Contact a licensed drainage plumber for further advice and recommendations

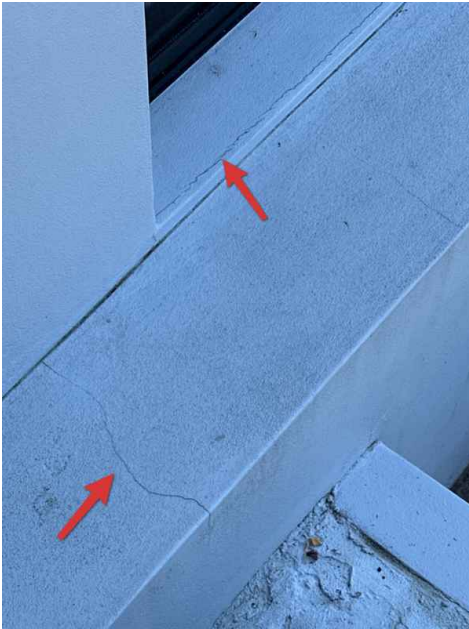
MINOR RENDER CRACKS

Minor render cracks noted. Patch and paint will suffice.

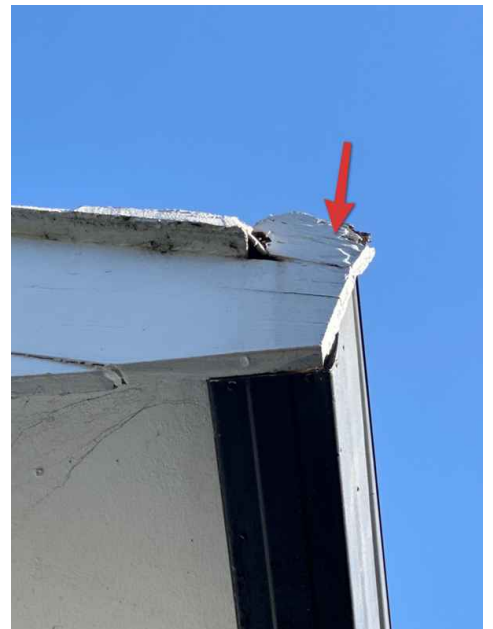
5.7.1 Eaves & Fascia

FASCIA - ROTTED

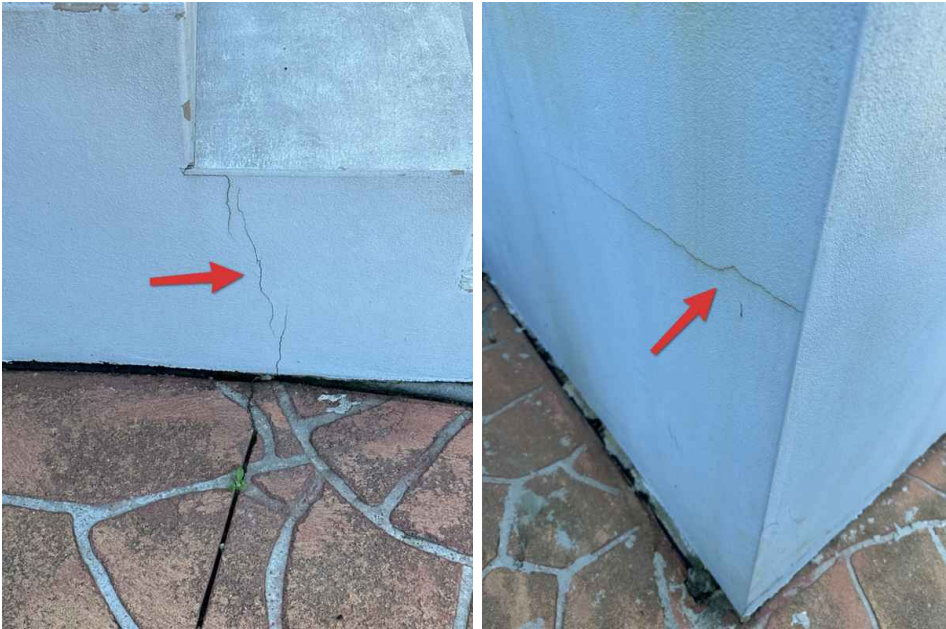
5.9.1 Stairs

MINOR CRACKS

Minor cracks noted to side of stairs. Patch and paint will suffice.

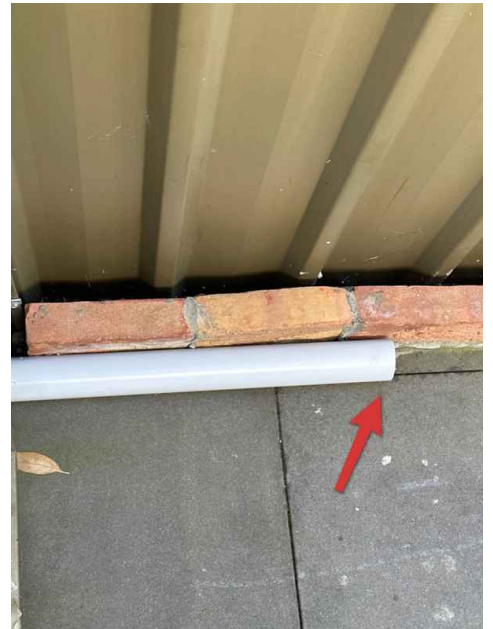
5.10.1 Pergola

DOWNPIPES NOT CONNECTED

Down pipe/s not connected to stormwater discharge - Downpipes not connected to stormwater have the potential to cause differential settlement to the footings and cause rising damp.

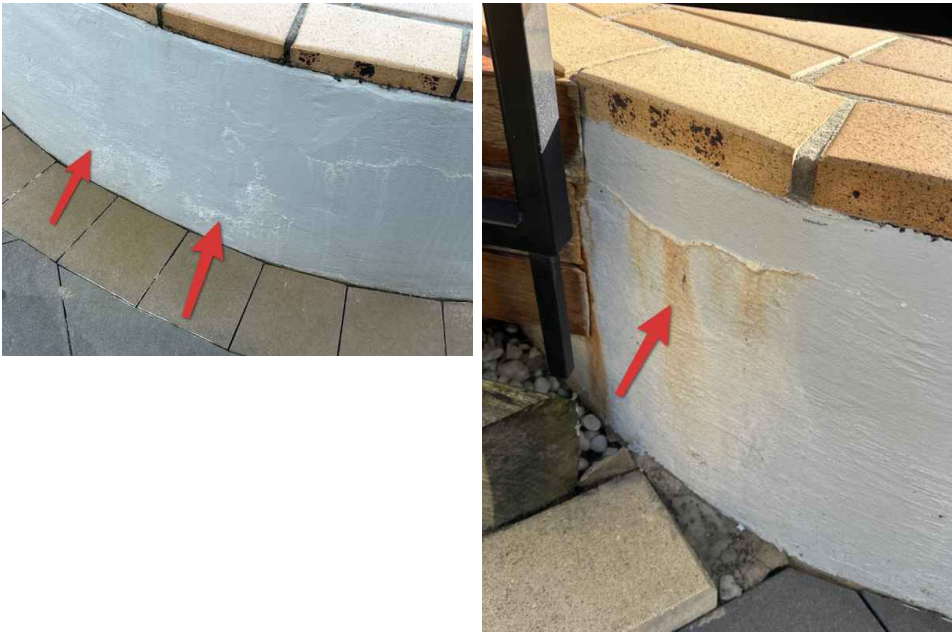
Salt residue/damp damage evident on retaining wall base. Inadequate drainage installed behind retaining wall.

Recommendation
Contact a qualified landscaping contractor

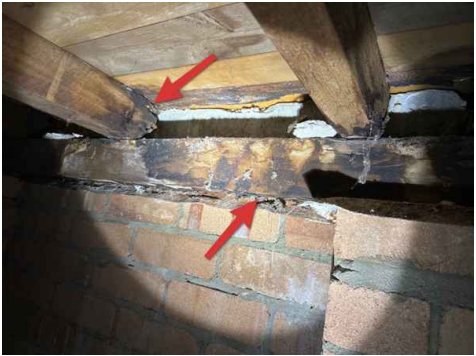
6.3.1 Subfloor

MINOR WOOD ROT

Minor wood rot noted to a timber joist and bearer. This was dry at the time of inspection and was likely the result of a previous bathroom leaking prior to a renovation

Contact a qualified professional.

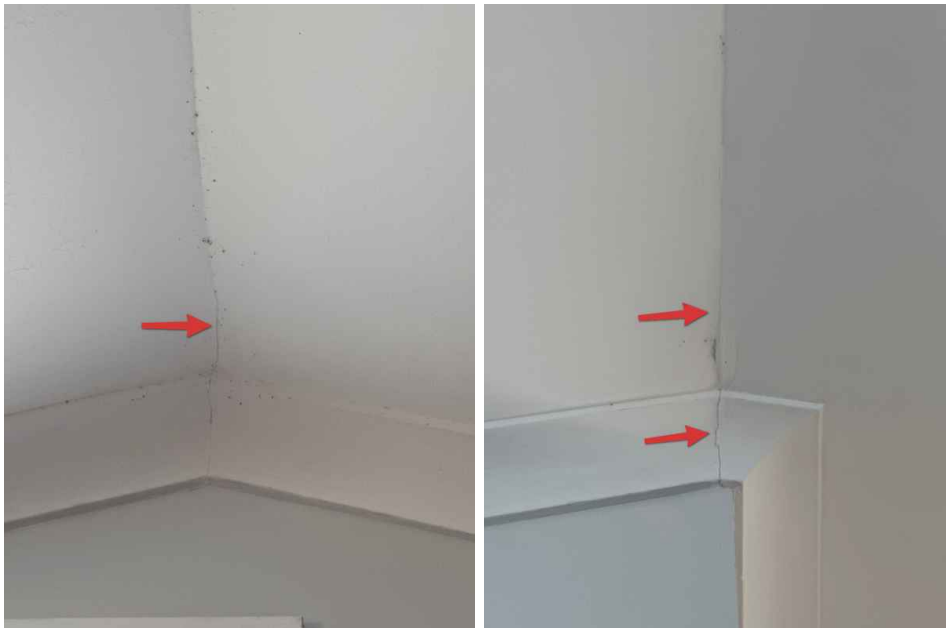
Ceiling sheet joins cracks evident. This is likely due to thermal expansion

Contact a qualified professional.

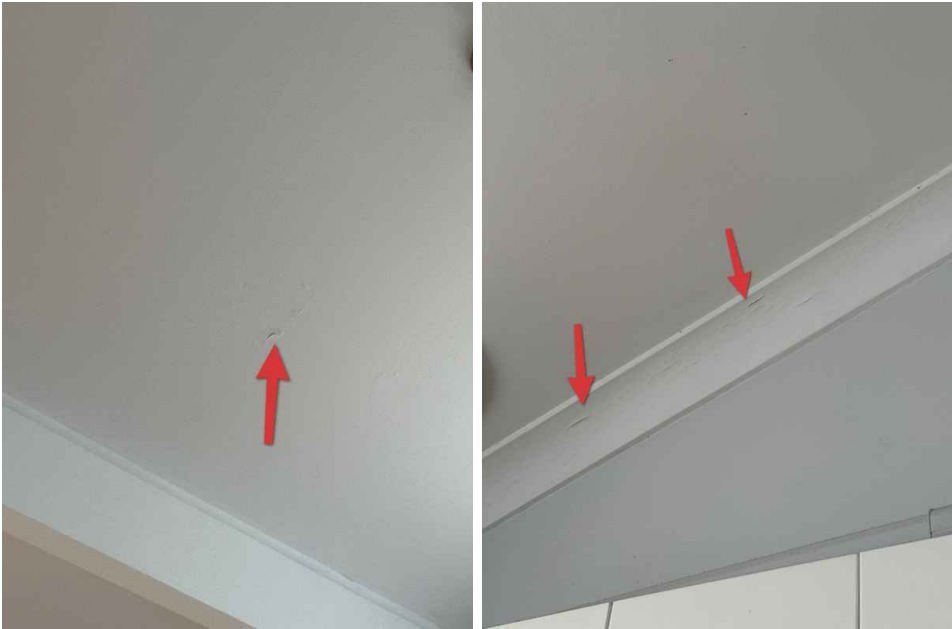
7.5.2 Ceilings

MINOR PAINT DETERIORATION

Minor Paint deterioration noted to ceilings in sections of house.

Contact a qualified professional.

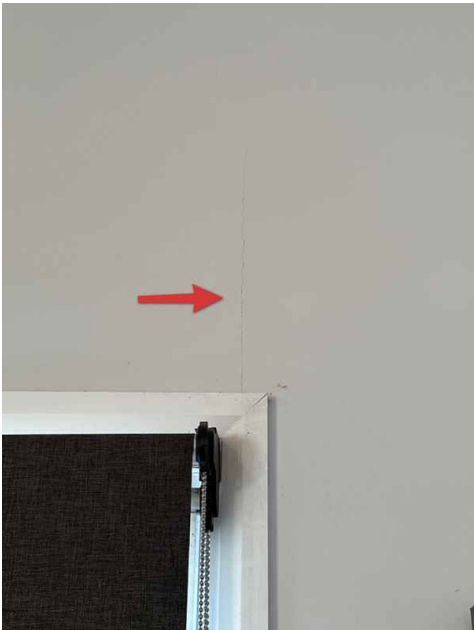
9.4.1 Walls

SHEET JOIN CRACKS

Sheet join cracks noted. This is probably due to thermal expansion. Patch and paint will suffice

Contact a qualified professional.

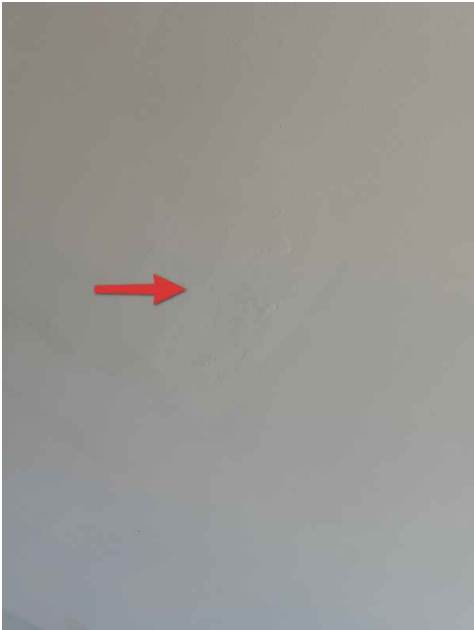
10.5.1 Ceilings

Sub standard patching noted to the ceiling lining.

Contact a qualified Gyprock and plaster service

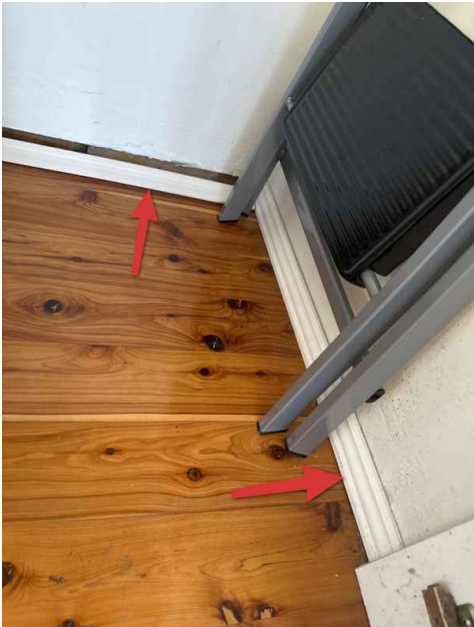
Skirting hasn't been fixed to the wall and is loose. Contact a qualified carpenter for finishes.

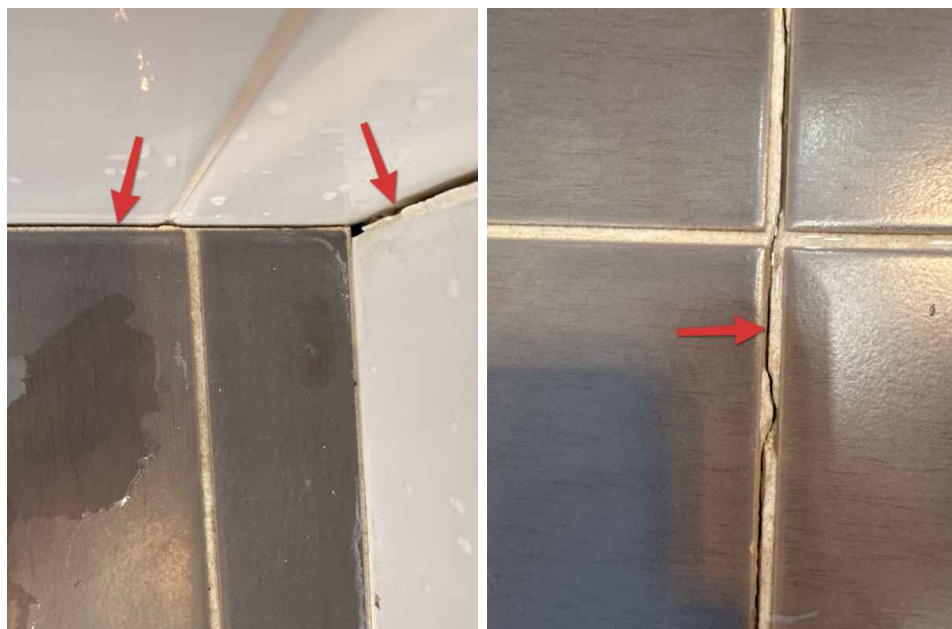
TILE GROUT DETERIORATION

Tile grout deterioration. Re-grout / seal the shower tiles and screen junctions. A qualified plumber should be engaged for advice and recommendations.

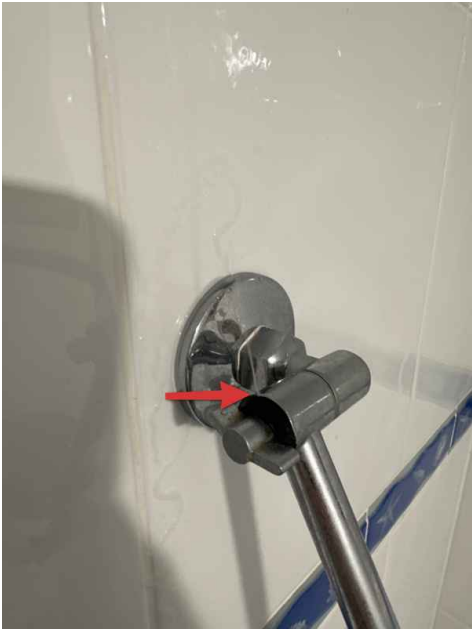
19.9.2 Shower & Bath

LEAKING SHOWER HEAD

Contact a qualified professional.
