Strata Inspection Report

Prepared for:	Calyssa Manolaros
Matter of:	Manolaros Sale
C/-	Sanders Property Agents Andrew Mills / Daneke Wright
Address:	30/63-69 President Avenue Caringbah
Lot No:	30
Strata Plan No:	17885
Date of Inspection:	1 Aug 2023

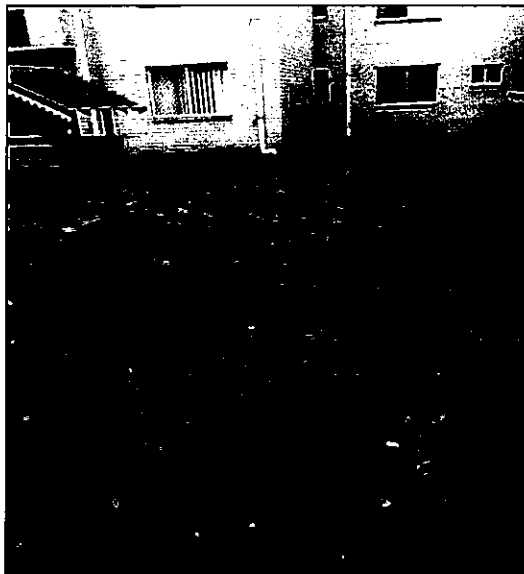
Last point is for BWC – the quote includes the re-turfing of the area. See Priority 1 Scope (page 4) of quote – last point. "Reinstall soil and turf". This was not done. The soil is extremely soft, and has dropped approximately 4 inches over the work area, and is now being covered with weeds. See photos below."

Drop in soil.

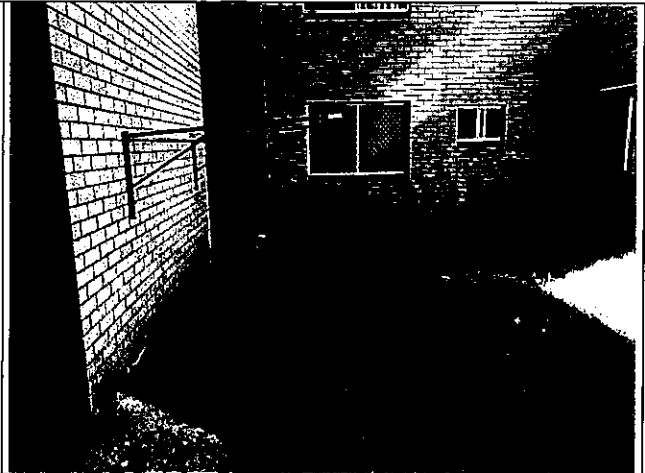
Photograph No 2 – General view of the central courtyard looking south but closer to the northern external wall. The bare patch of earth to the left is the approximate location of the joint to the podium slab.

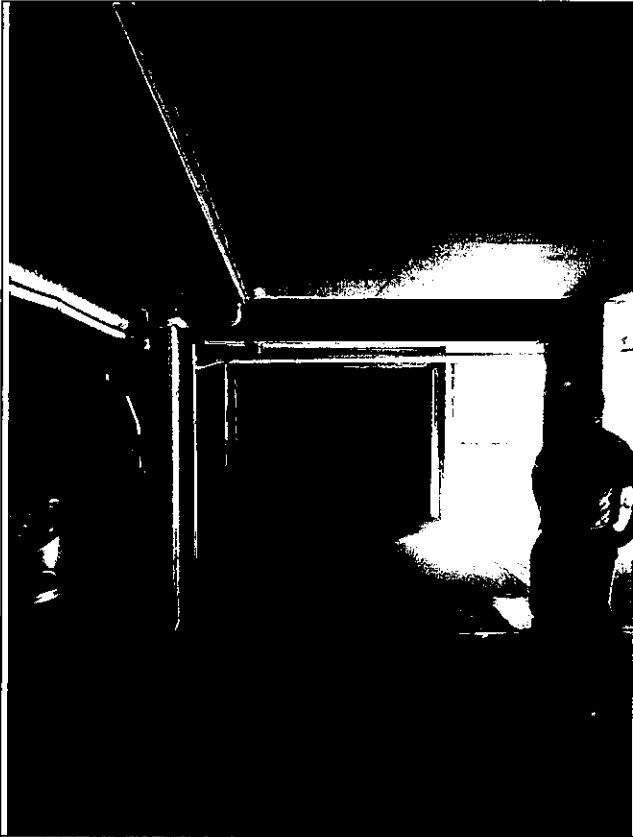
Photograph No 11 – View of the metal catch tray beneath the joint looking north with the visible dampness and soluble salt staining to the slab soffit

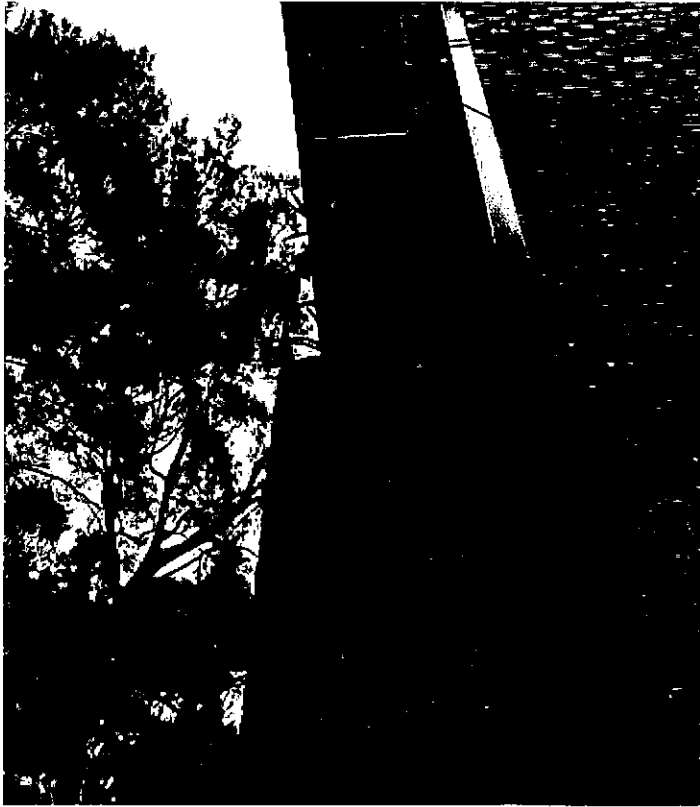
Photograph 1

Sample photographs of the balcony balustrade separation from the building wall.

The separation is generally less than 5mm.

We recommend they can simply be monitored and reported to Strata Management if there is noticeable change in the separation.

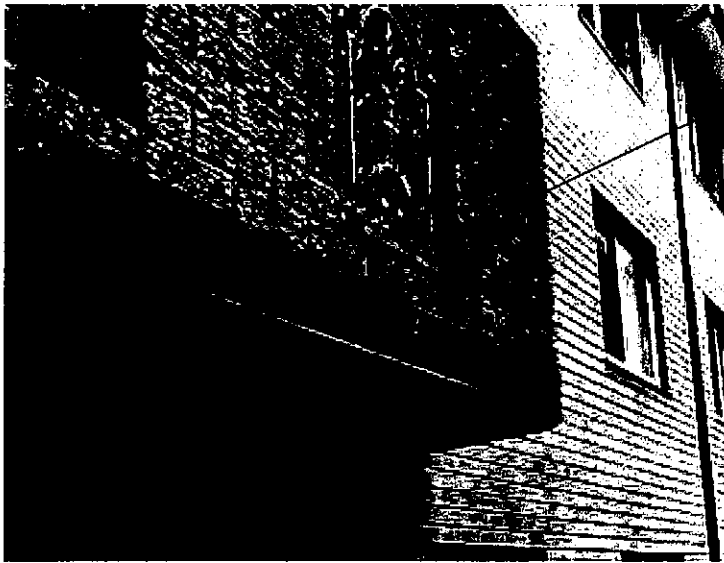
Photograph 3

We observed evidence of cracking render to the recently painted balcony slab edges.

The cracking of the rendered balcony slab edges generally suggests potential concrete spalling behind (corrosion to the steel reinforcement).

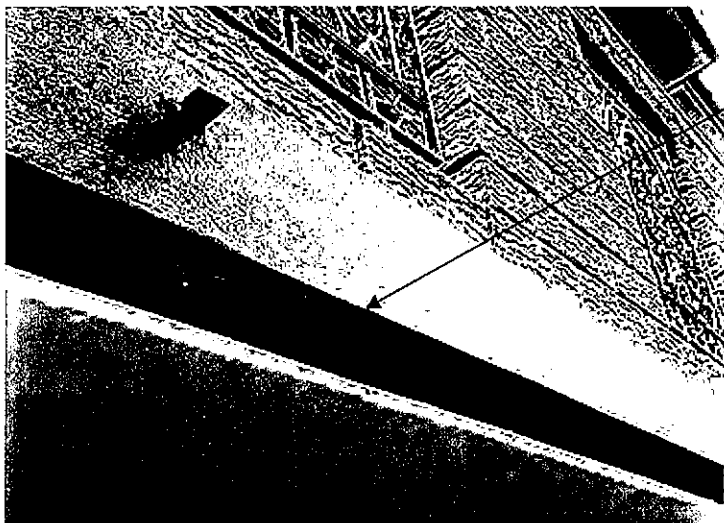
Photograph 4

Evidence of cracking to the rendered balcony slab edges.

Most balconies display some degrees of cracking to the balcony slab edges which suggest potential concrete spalling (corroded reinforcement behind).

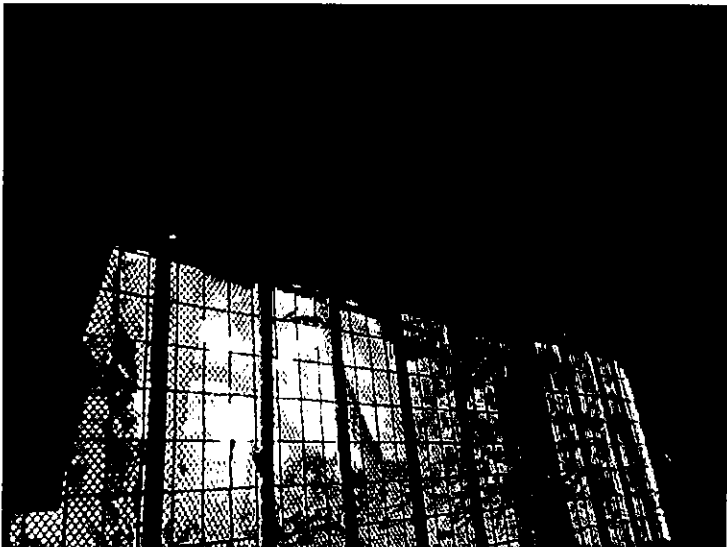
Photograph 7

We observed evidence of cracked and delaminated concrete above ventilation opening.

This is evidence of concrete spalling caused by corrosion of steel reinforcement.

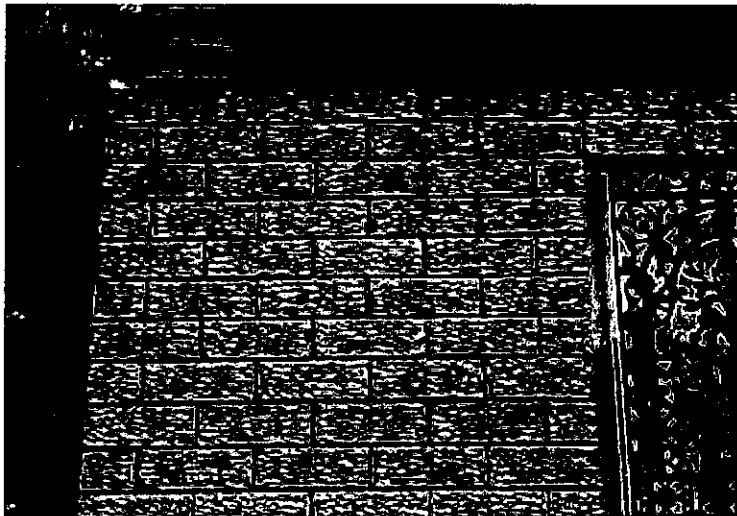
Photograph 12

Missing coping tiles on to the brick balustrade on an isolated 1st floor balcony on the south-eastern elevation.

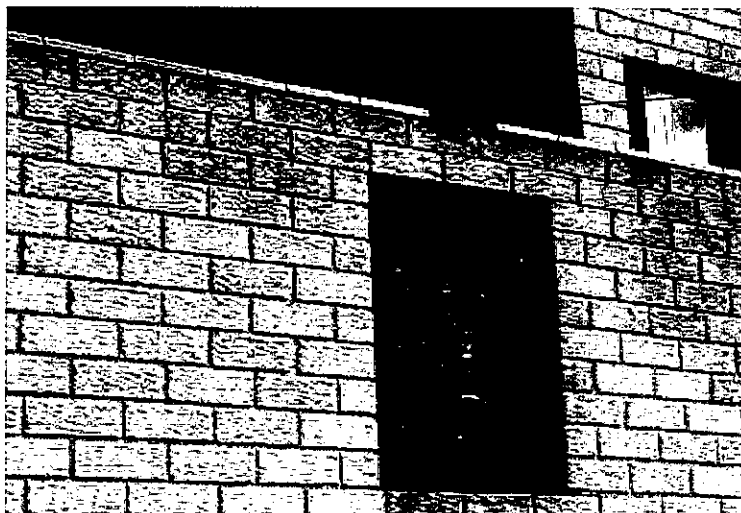
Photograph 13

Missing coping tiles on to the brick balustrade on an isolated 1st floor balcony on the south-eastern elevation.

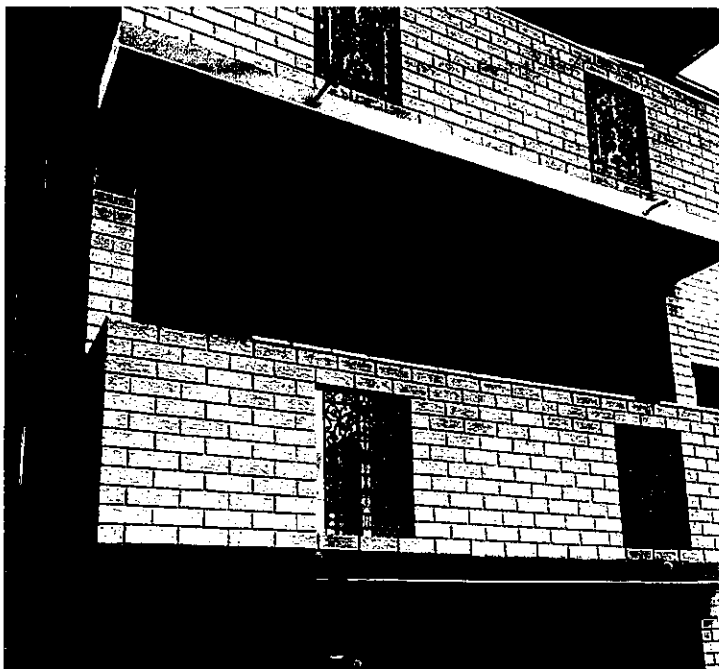
Photograph 18

The decorative grilles in the balustrade walls throughout the complex have near horizontal elements which may facilitate climbing.
