## **BUILDING & PEST REPORT**

<b>REPORT NUMBER:</b>	<b>2308053</b>
<b>VENDOR:</b>	<b>MARTIN</b>
<b>REFERRED BY:</b>	<b>Please note that this report can only be relied upon by the person named on the front of this report.</b>
<b>REFERENCE NUMBER:</b>	<b>Should you proceed with purchase of subject property and want legal protection you can purchase a copy of this report by contacting our office within 30 days of date on report.</b>
<b>PROPERTY INSPECTED:</b>	<b>43 YAMBA ROAD COMO NSW 2226</b>
<b>INSPECTION DATE:</b>	<b>4<sup>th</sup> SEPTEMBER 2023</b>

## Pre-Purchase Building Inspection Report

43 Yamba Rd, Como NSW 2226

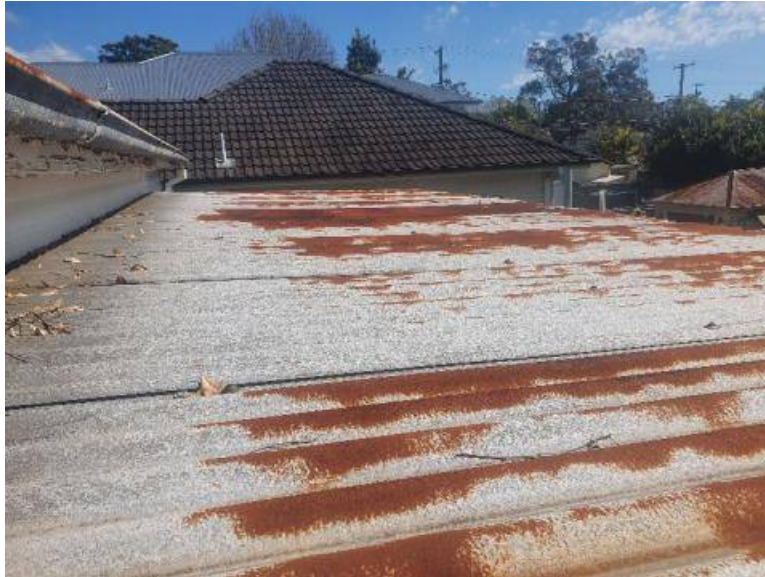
The overall condition of the roof coverings is fair. The External Roof System should be regularly inspected for damage and defects which may allow rain water penetration. The metal roofing is rusting and requires replacement.

Visible deflection was noted to the roof line. For more detail see section under "Roof System Internal".

A licensed Roofing Contractor should be called to make a further evaluation and repairs or rectification as needed.

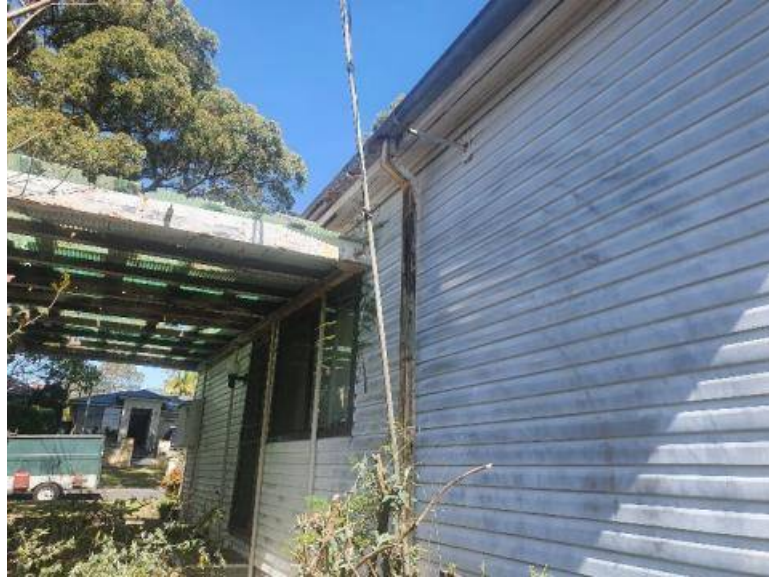
Some downpipes do not appear to be connected to a stormwater dispersal system. This should be rectified. The gutters and downpipes rusted and should be repaired or replaced as necessary.

A licensed Roof Plumber should be called to make a further evaluation and repairs or rectification as needed.

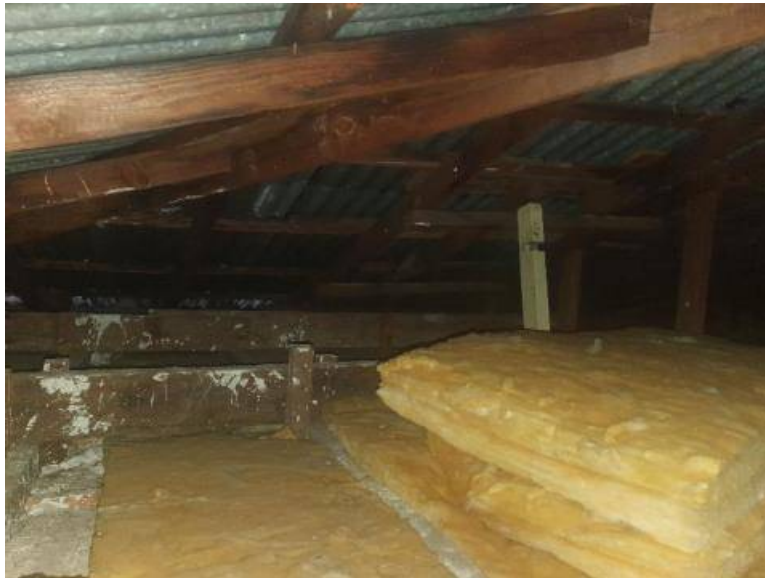
The cut and pitched roof timbers do not appear to provide adequate support. Additional support is required above the areas listed below in the form of: Struts: Purlins: Collar ties: The areas where additional supports are required are to the; Rear section: Front section: Mid section:

A licensed Building Contractor should be called to make a further evaluation and repairs or rectification as needed.

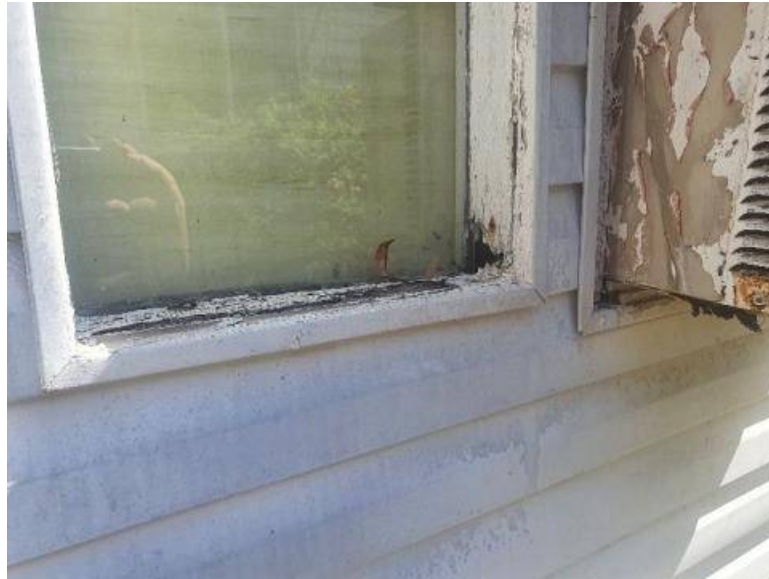
The condition of the exterior of the windows is generally poor. Paint is peeling off the window frames and maintenance is required. Putty in windows has deteriorated and requires attention. Severe wet rot decay is present to the window frames. Maintenance and/or repairs will be required.

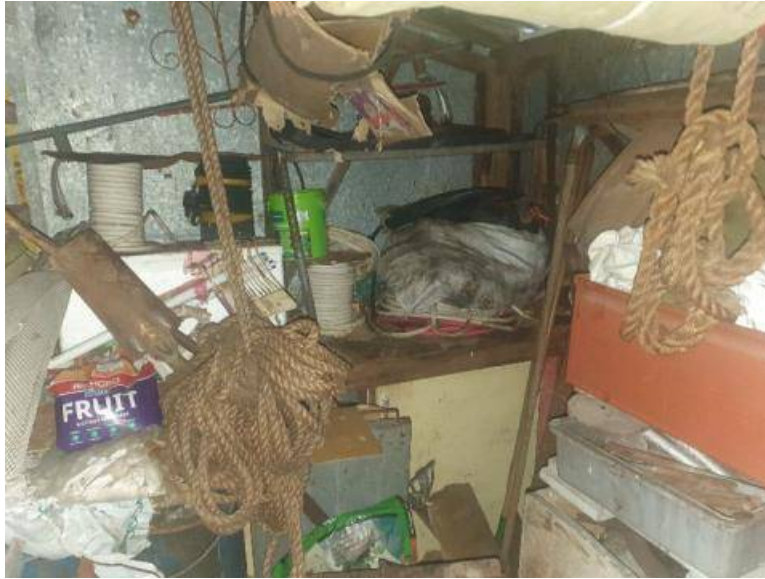
Inspection within some areas was restricted by stored items.

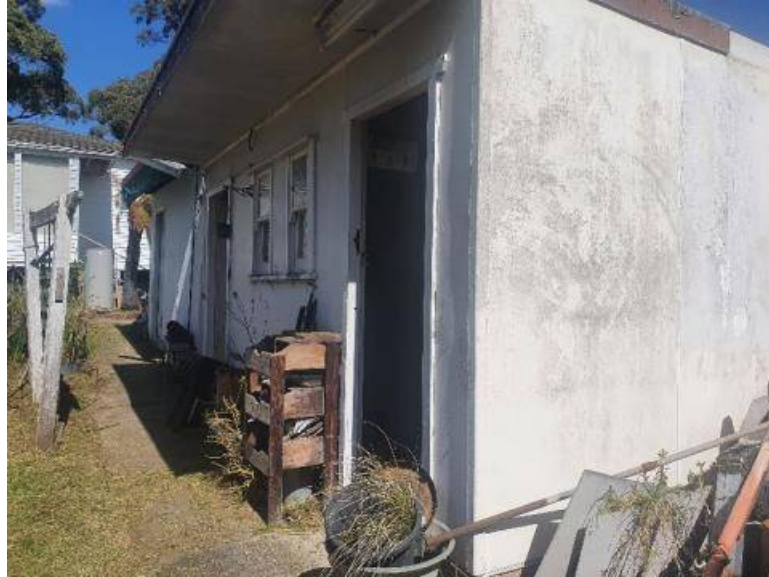
### Outbuilding B:

The overall condition of the roof coverings is poor. The External Roof System should be regularly inspected for damage and defects which may allow rain water penetration.

The metal roofing is rusting and requires replacement.

A licensed Roofing Contractor should be called to make a further evaluation and repairs or rectification as needed.

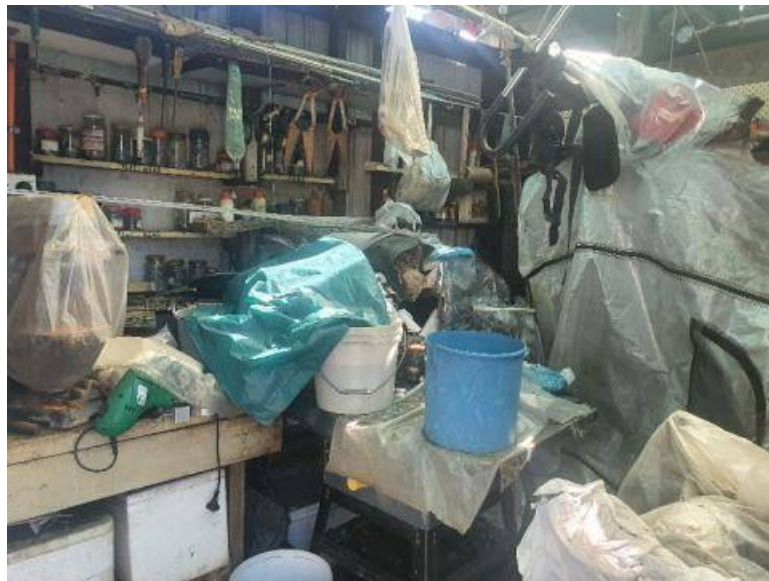
Outbuilding C:

Inspection within some areas was restricted by stored items.

The structure is generally in poor condition.

The overall condition of the roof coverings is poor. The External Roof System should be regularly inspected for damage and defects which may allow rain water penetration.

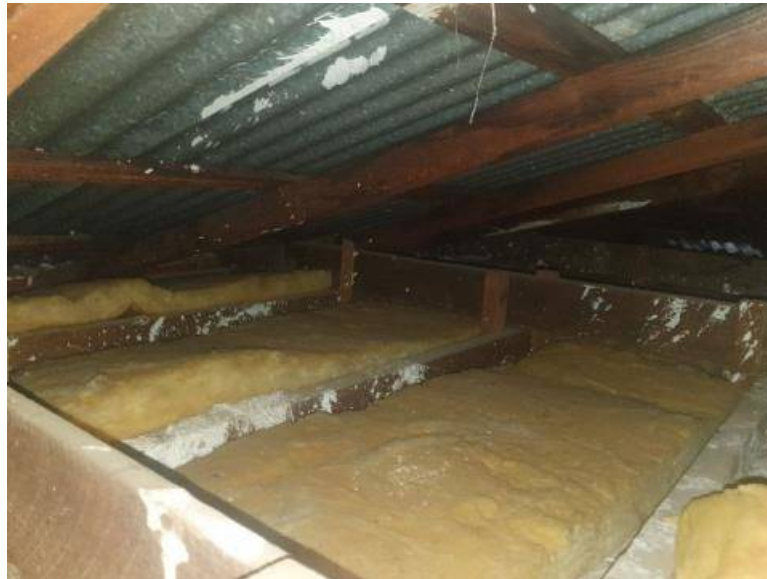
Clearance within sections of the roof was too low to allow body access. This allows only a limited visual inspection from a distance to be carried out. Roofing timbers above the area(s) listed below were not accessed. Due to the significant access restrictions, we strongly recommend another entry point be installed to allow access to the currently inaccessible sections of the roof void.

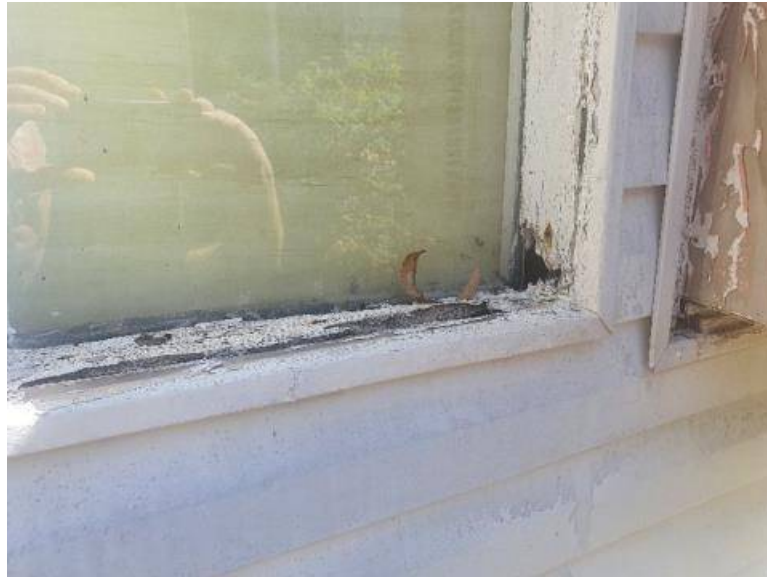
**Yes - Fungal Decay (wood rot) was noted to the following timbers/areas.**

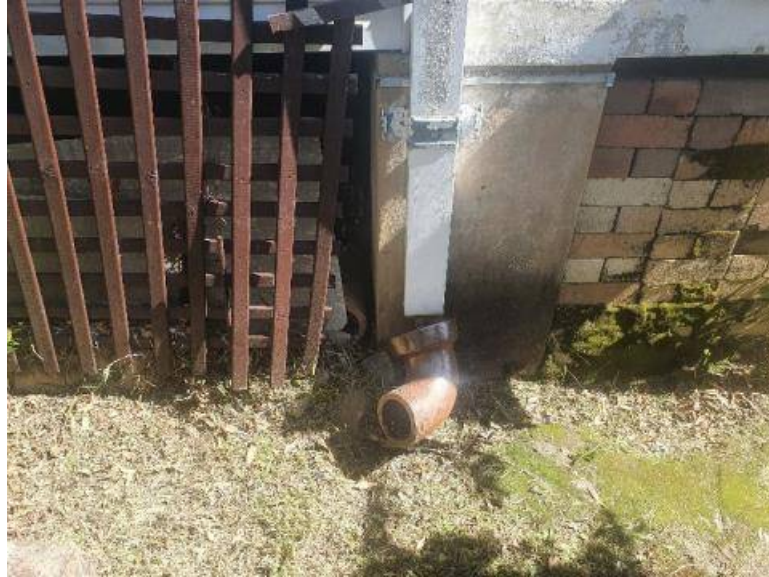
Some gutters and/or downpipes appear to discharge rainwater directly adjacent to the foundations of the structure. These should be connected to a stormwater dispersal system.

Untreated landscaping timbers should be removed or replaced with a treated timber or non timber alternative. If replaced with timber, ensure appropriate durability rating for external use.

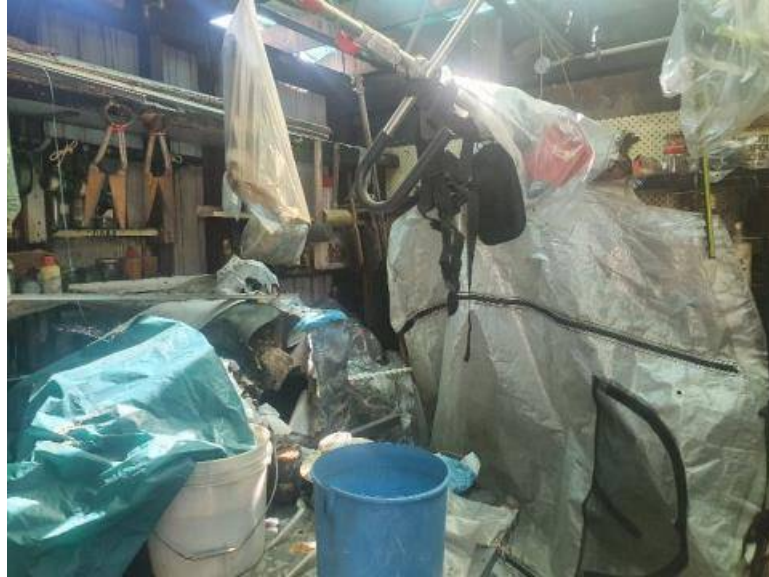
Inspection within some areas was severely restricted by stored items.
