HOMESAFE INSPECTIONS

COMBINED BUILDING AND PEST INSPECTION

215 Oyster Bay Rd
Oyster Bay, NSW 2225

04/10/2023

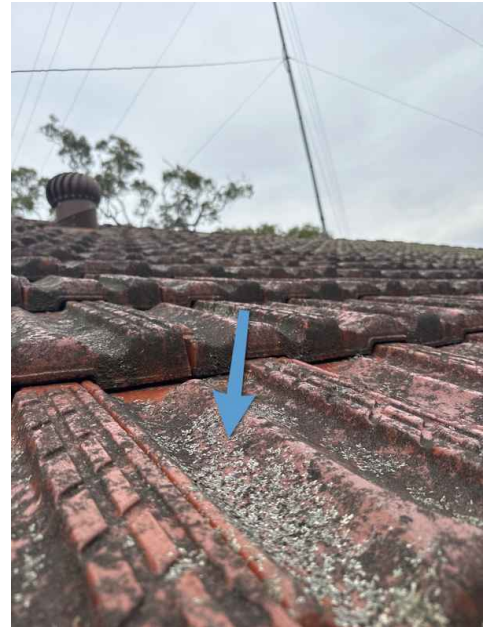
Moss has built upon the tiles over time. It is preferable to have removed/cleaned to prevent deterioration.

Contact a qualified roofing professional.

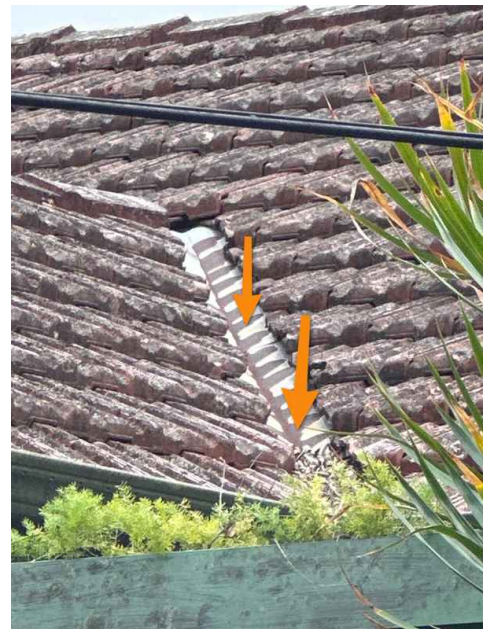
3.1.2 Coverings

ROOF VALLEY RUST

Roof valleys are rusted. Contact a qualified roofer for replacement as this could result in roof leaks if not fixed.

Contact a qualified professional.

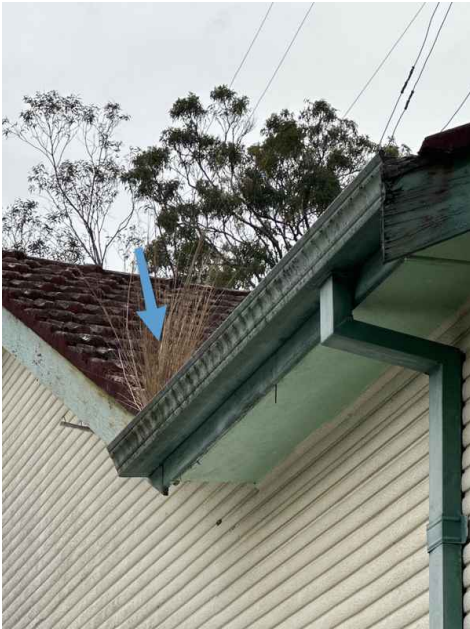
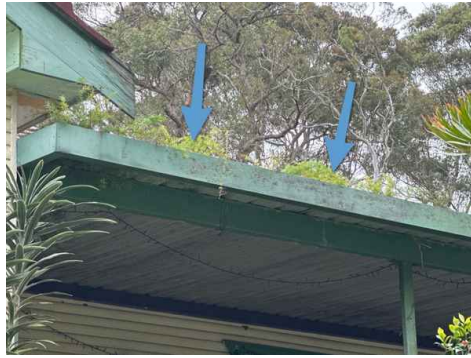
3.2.1 Gutters

Debris has accumulated in the gutters. Recommend cleaning to facilitate water flow.

Contact a qualified roofing professional.

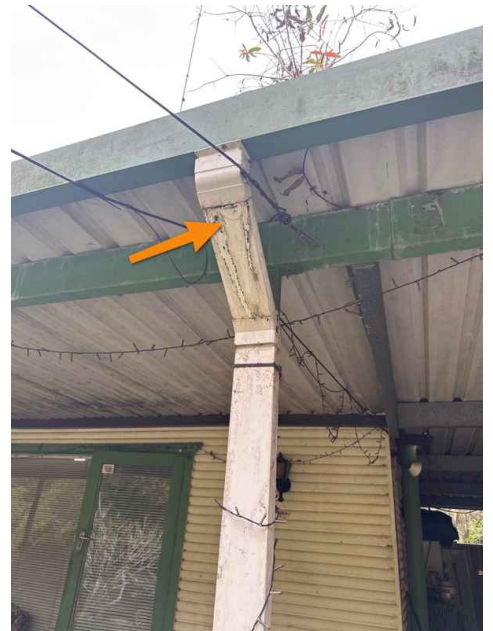
3.3.1 Downpipes

LEAKING

Evidence of leaking down pipe joins.

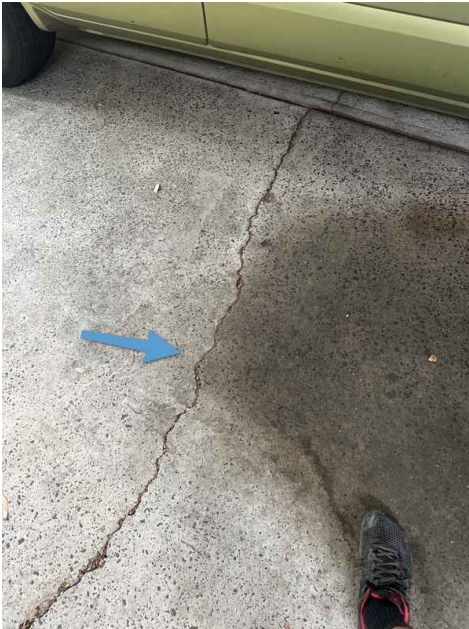
CRACKS - MINOR

Typical cracking to concrete in garage.

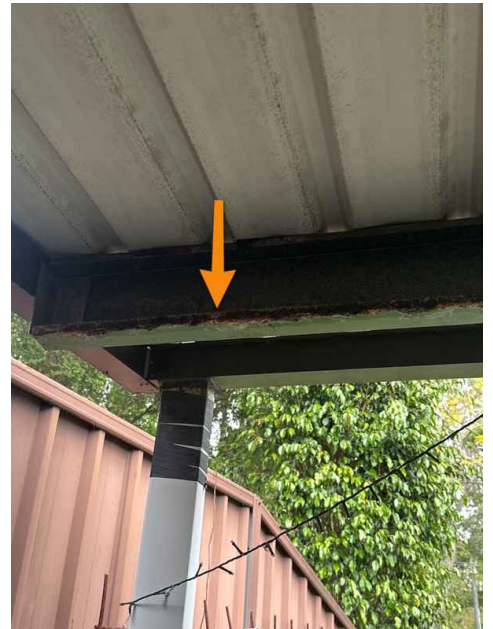
4.4.1 Internal Wall

RUST - SUPPORT BEAMS

Surface rust noted to support beams. Further deterioration likely.

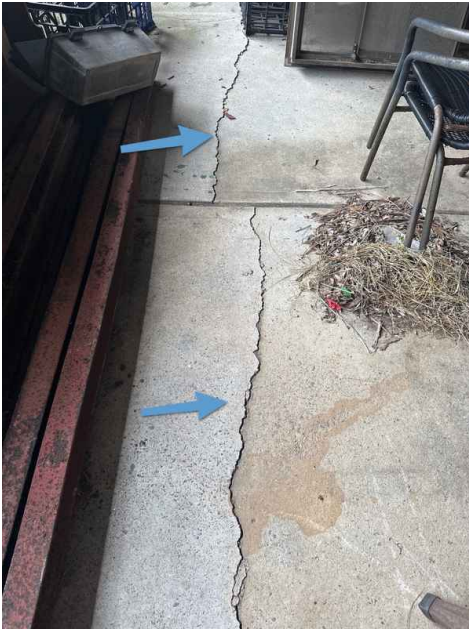
CRACKS - MINOR

Typical cracking to concrete in garage.

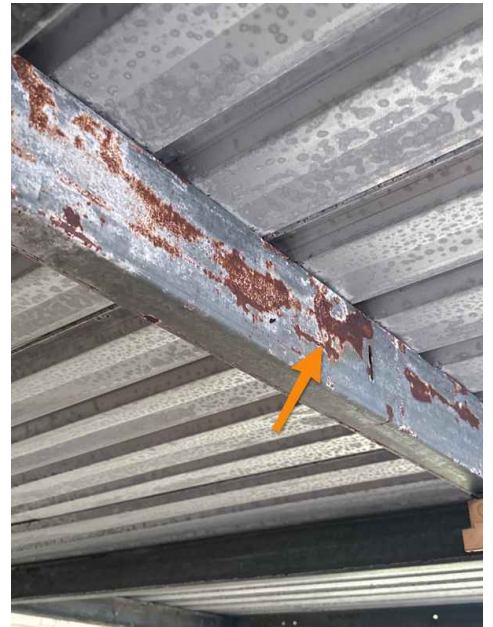
5.4.1 Internal Wall

RUST - SUPPORT BEAMS

Surface Rust noted to support beams. Further deterioration likely.

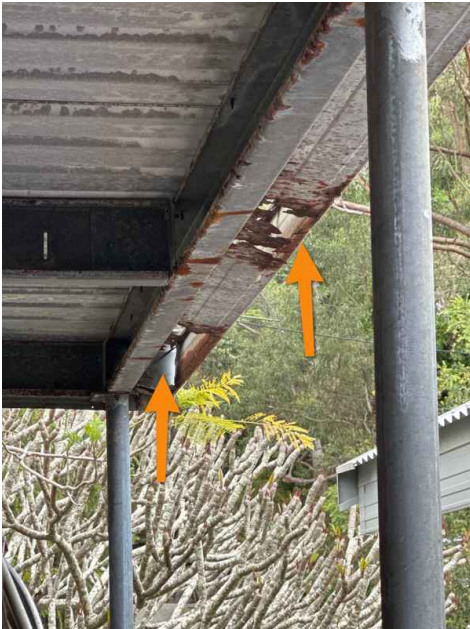
5.7.1 Roof & Gutter

RUST PENETRATION

Gutter rust/penetrations - The gutter has excessive rust where leaking will occur.

Contact a qualified roofing professional.

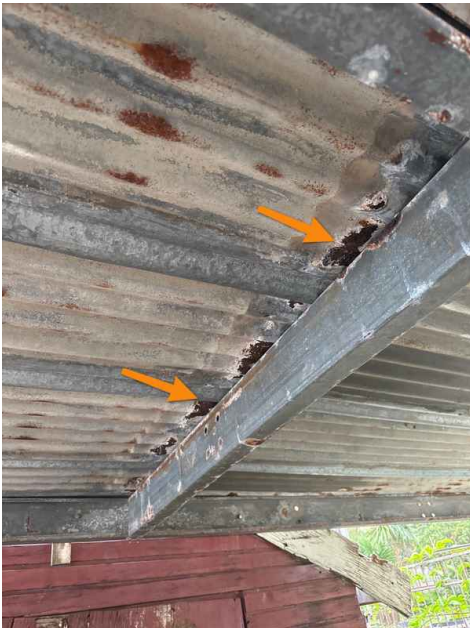
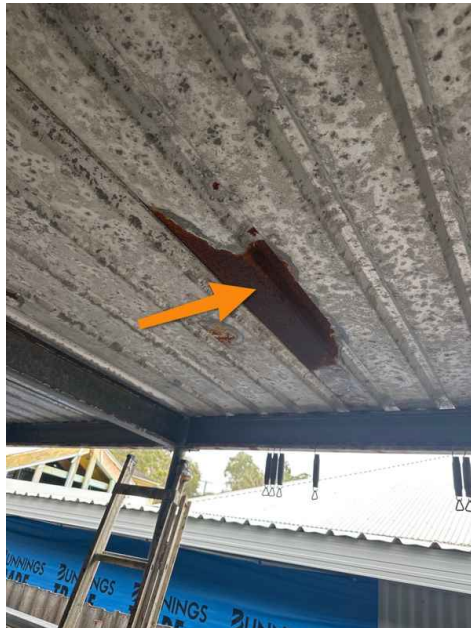
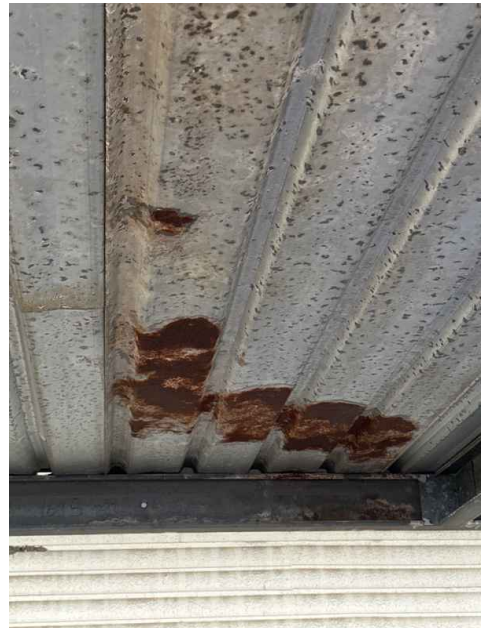
5.7.2 Roof & Gutter

ROOF RUST

Metal roof is rusting and requires or replacement as the may lead to water ingress into the roof cavity.

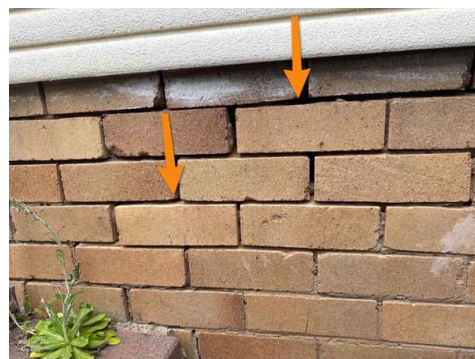
MORTAR DETERIORATION

Mortar deterioration noted.

Contact a qualified masonry professional.

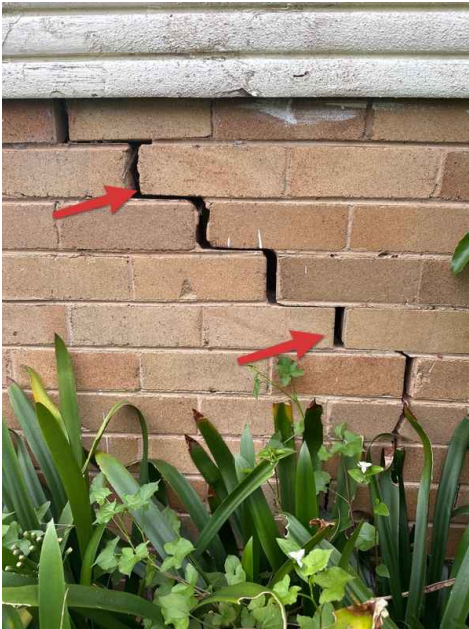
6.2.2 External

CRACKING - MAJOR

Moderate to major cracking was observed at one or more points on the exterior. This can be the result of poor original compaction of soil at the time of construction or excess moisture in the underlying soil. Recommend consulting with a structural engineer and/or soil expert.

Contact a qualified structural engineer.

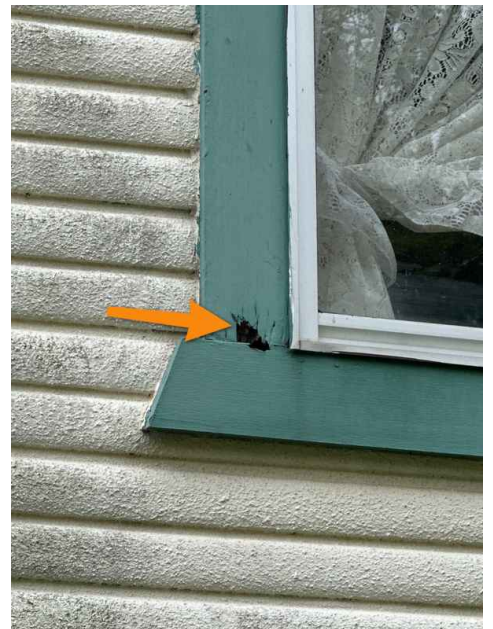
6.6.1 Exterior Windows

TIMBER FUNGAL DECAY

Timber fungal decay is evident in sections of the window framework
- Some areas should be replaced.

Contact a qualified window repair/installation contractor.

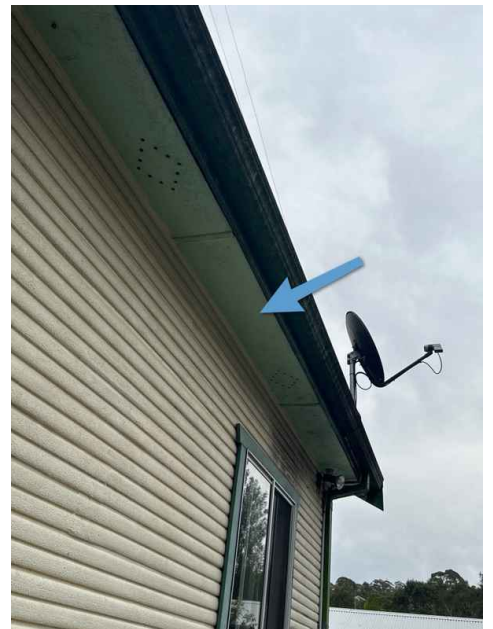
Fibrous Cement Sheeting installed for eave lining. We recommend an ASBESTOS test be conducted by a licensed inspector.

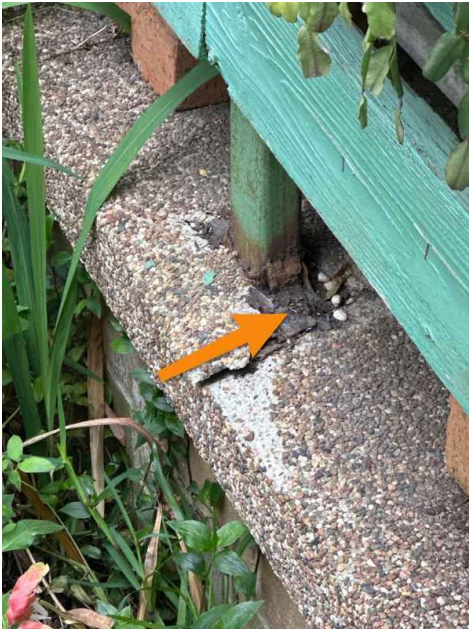
6.10.1 Pergola

SURFACE RUST

Surface rust noted to posts. Monitor and if rust worsens replace. This is also causing cracking to concrete to veranda.

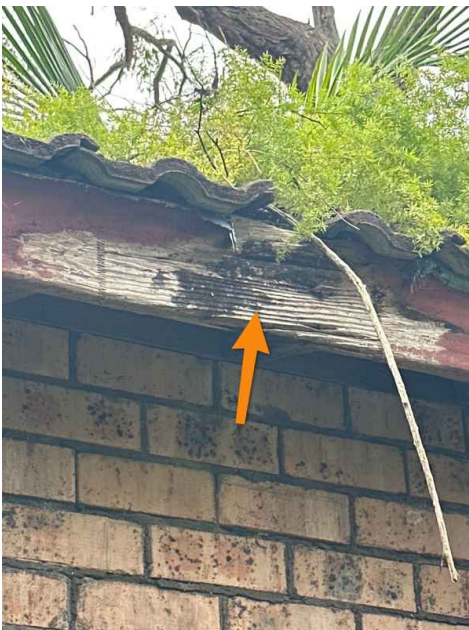
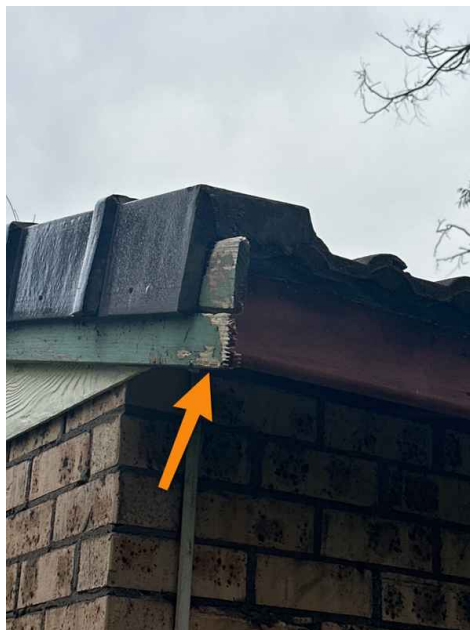
6.10.2 Pergola

FASCIA ROT

Fascia rot noted. Further deterioration likely.

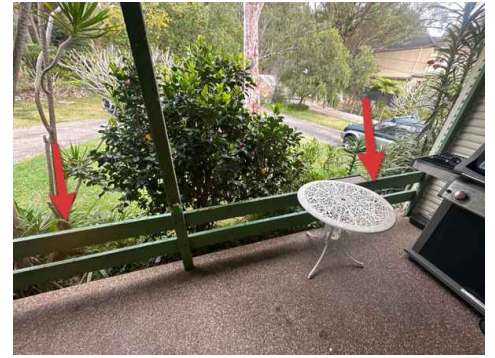
6.12.1 Verandah

BALUSTRADE HEIGHT

Contact a qualified professional.

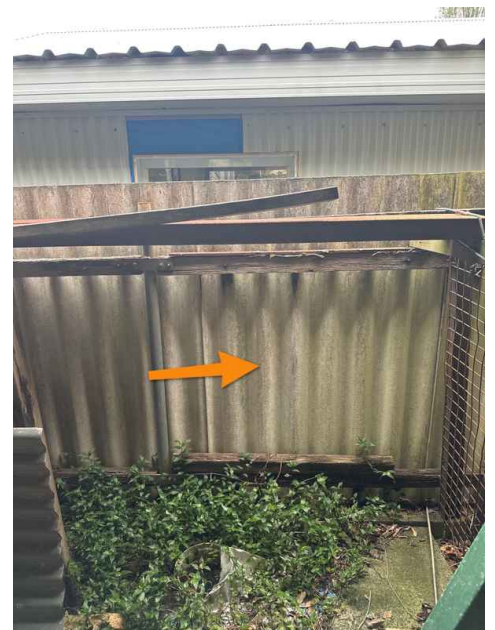
The sections are fibrous cement sheeting. Note: We recommend an asbestos inspection be conducted by a licensed asbestos inspector prior to a decision to purchase. Considered a health and safety defect

Contact a qualified professional.

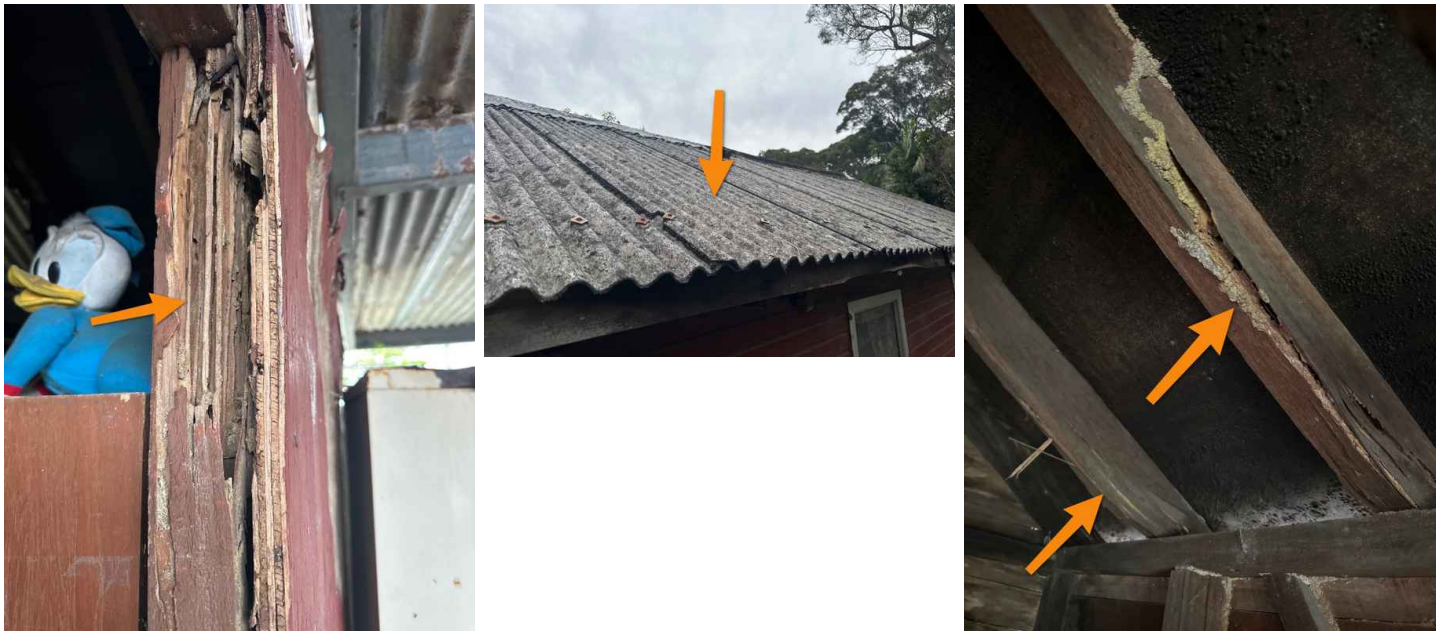
6.16.1 Shed

POOR CONDITION / TIMBER PEST ATTACK / ASBESTOS ROOF

The shed is considered in poor condition and also has termite damage. Asbestos roof also noted. repairs/replacement should be considered.

Contact a qualified carpenter.

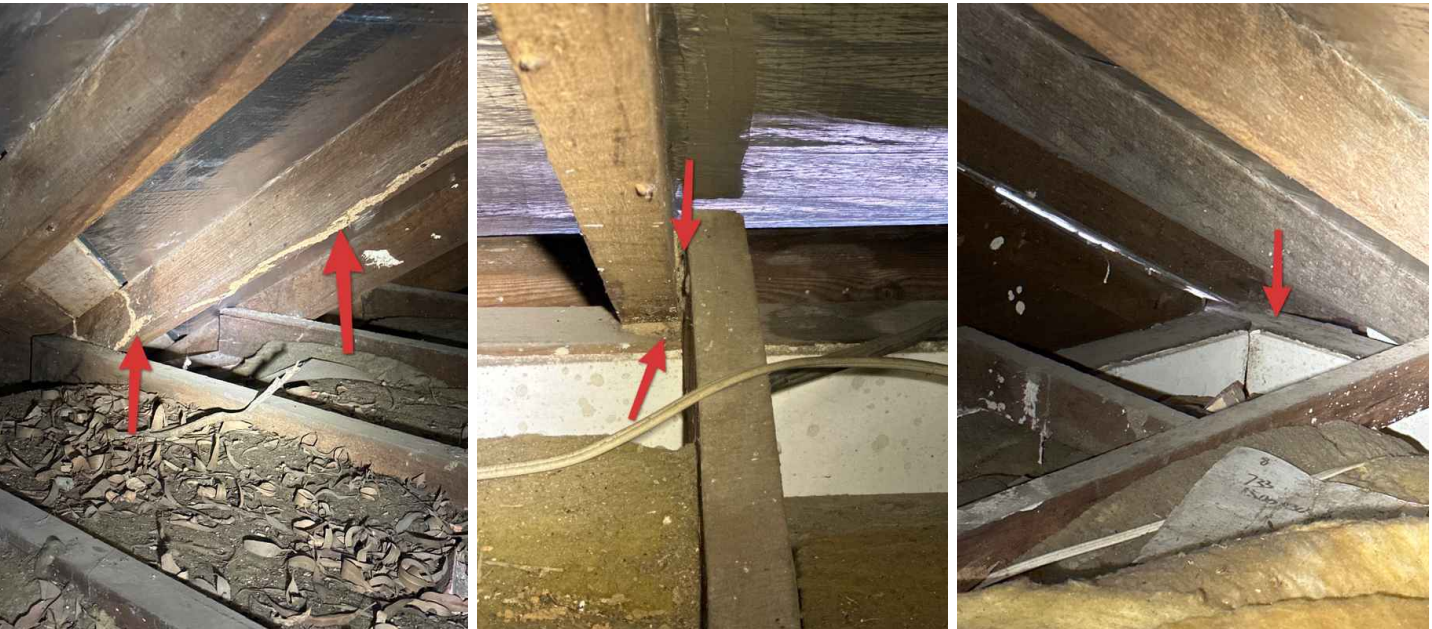
Timber Pest Attack Noted. Termite mudding noted to 2 top plates, 2 rafters and 1 ridge Timbers. Timber damage visible to 1 top plate and 1 rafter. It is recommended a qualified carpenter is contacted to replace the damaged Timbers and a qualified timber pest specialist is contact for a treatment to be done on the house.

Contact a qualified carpenter.

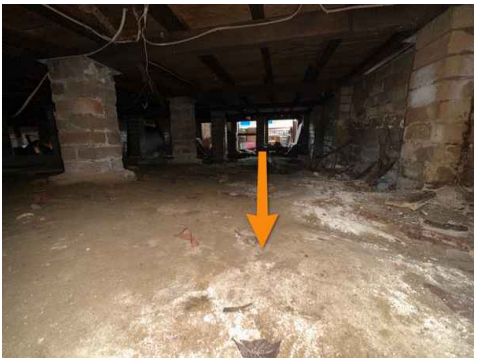
7.3.1 Subfloor

DAMP

Damp soil noted at the time of inspection. Likely due to recent rainfall and negative grading/ inadequate drainage systems

Contact a qualified landscaping contractor

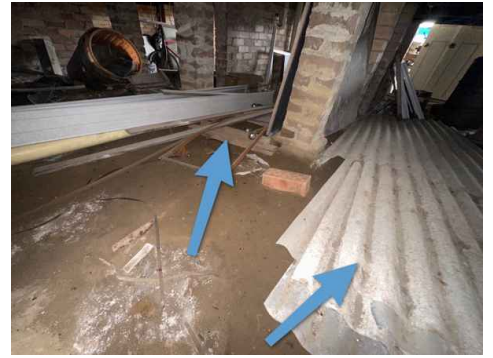
7.3.2 Subfloor

DEBRIS

There was debris and other material in the subfloor, we recommend cleaning these to aid with ventilation and reduce the likely hood of rodents and pests.

Contact a qualified professional.

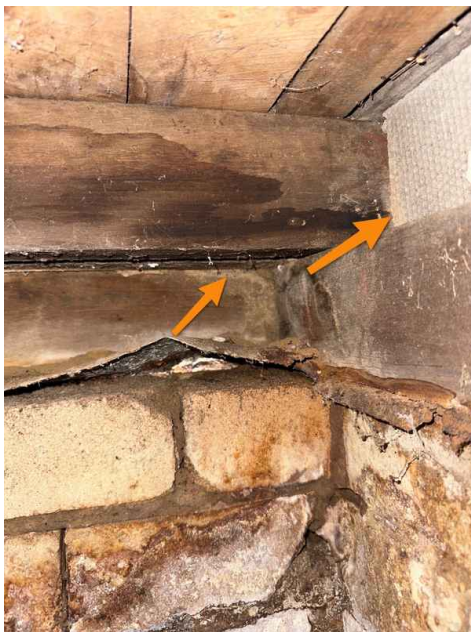
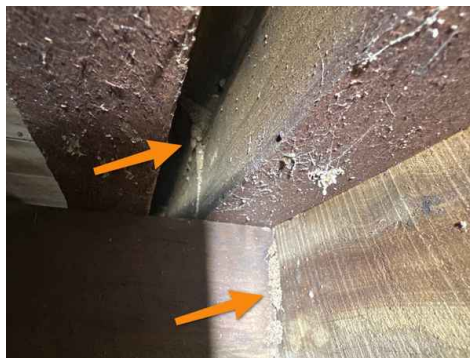
7.3.3 Subfloor

TIMBER PEST ATTACK

Timber pest attack noted. Termite mudding noted to 4 joists, 2 bearers and 2 bottom plates. No timber damage visible. It is recommended a qualified timber pest specialist is contacted for a treatment to be done on the house.

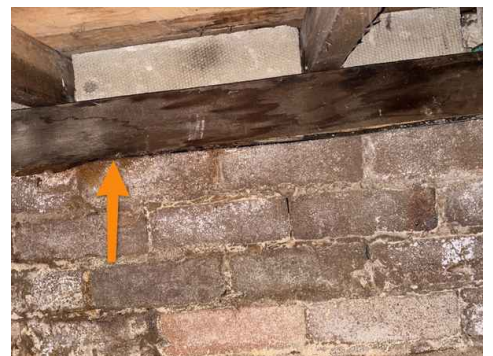
7.4.1 Piers & Foundation Walls

RUSTED ANT CAPPINGS

Rusted ant capping noted. Ant capping is not designed to prevent termite entry but to force the termites to show themselves by means of mud packing. Rusted, missing or defective ant capping will allow the termites to enter the building undetected. This should be repaired. Contact a licensed bricklayer for further advice

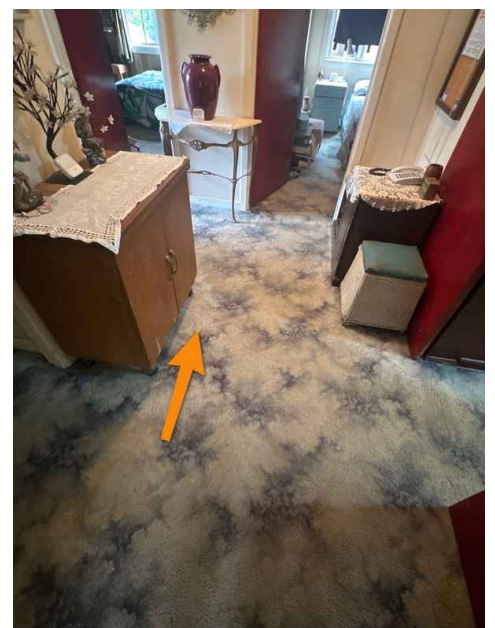
Unevenness visible in the floor - Recommendations: A qualified carpenter should be engaged for advice and recommendations re-leveling.

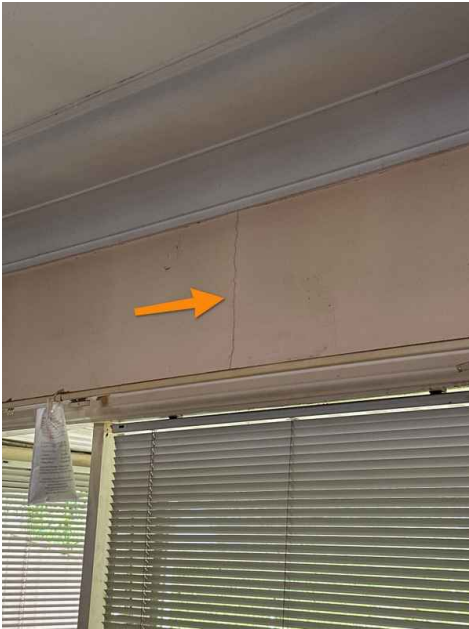
9.4.1 Walls

MINOR SETTLEMENT
CRACKS

Settlement Cracks Noted. These are generally typical. Patch and paint may suffice. These cracks should be monitored and if they widen it is recommended that a structural engineer be contacted for assessment

Contact a qualified professional.

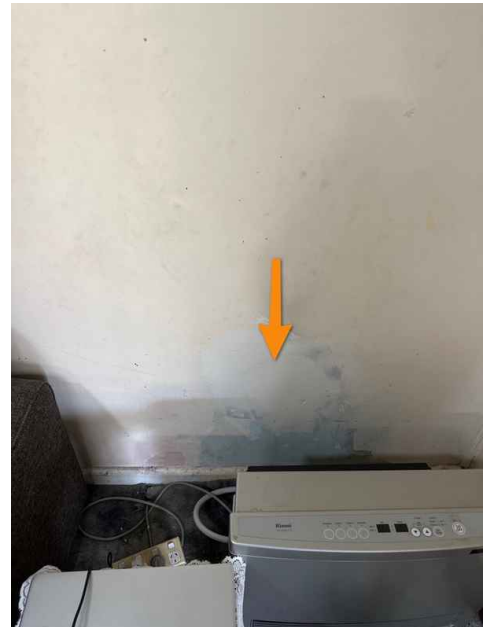
9.4.2 Walls

POOR PATCHING

Sub-standard plasterboard patching observed at the time of inspection. Recommend re-patching.

Contact a qualified professional.

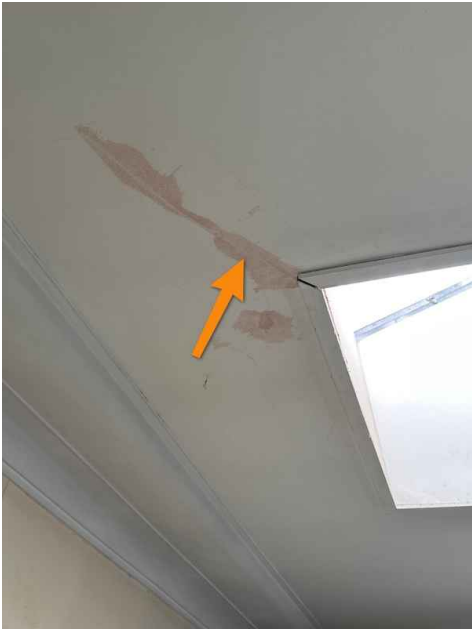
9.5.1 Ceilings

MINOR SETTLEMENT CRACKS

Settlement Cracks Noted. These are typical and generally, patch and paint will suffice, however, we recommend monitor these cracks and if become wider or longer, you will need to contact a structural engineer to assess.

Contact a qualified professional.

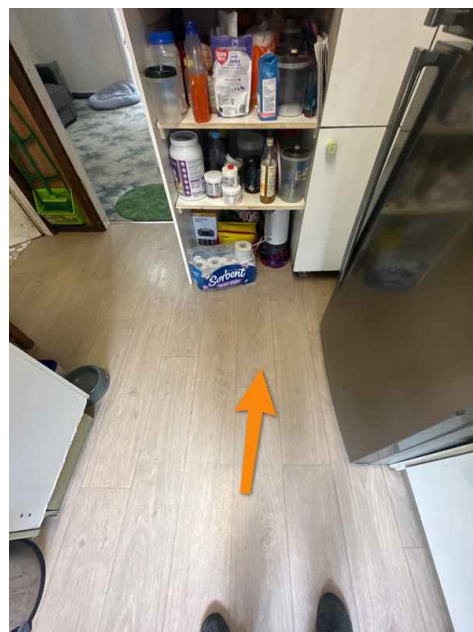
Unevenness visible in the floor - Recommendations: A qualified carpenter should be engaged for advice and recommendations re-leveling.

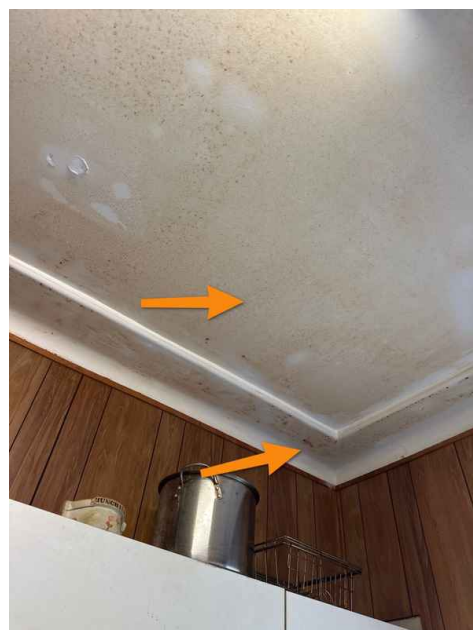
10.5.1 Ceilings

POSSIBLE MOLD

There are possible signs of fungi growth on ceiling. It is unknown if this is a safety hazard. Recommend a qualified mold inspector evaluate.

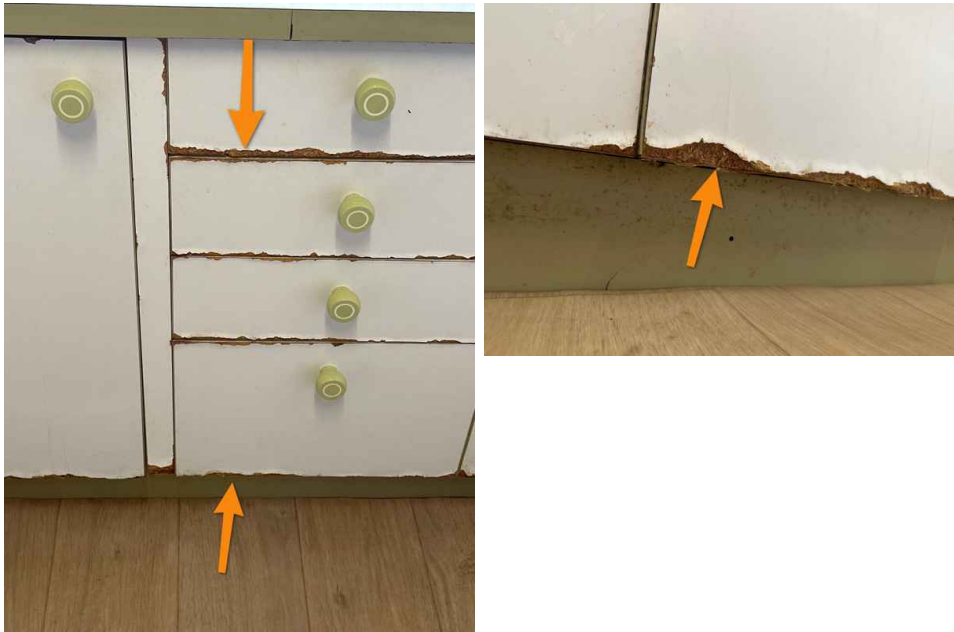
10.7.1 Sink, Cabinetry & Benchtops

MOISTURE DAMAGE TO CABINETS

Moisture Damage was noted to the cabinets, contact a joinery company for repairs

Recommendation
Contact a qualified cabinet contractor.

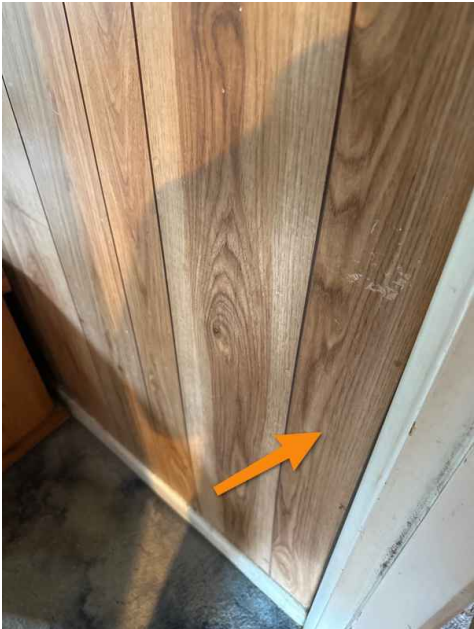
13.4.1 Walls

Wall panel is bulging / loose. More fixings / glue is recommended.
