HOMESAFE INSPECTIONS

COMBINED BUILDING AND PEST INSPECTION

6 Argyle Pl
Kareela, NSW 2232

24/10/2023

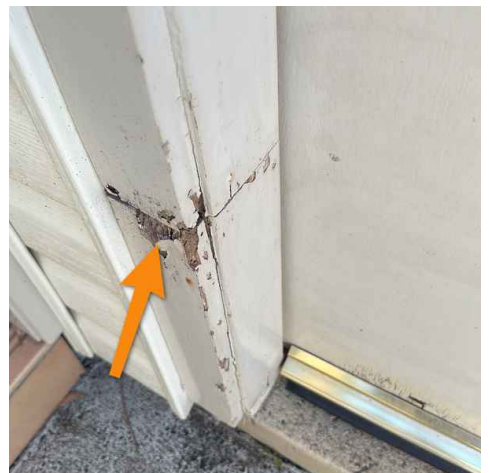
4.1.1 Doors

ROT TO FRAME

Rot observed to the door frame. This is likely due to its exposure to the elements. Replacement recommended

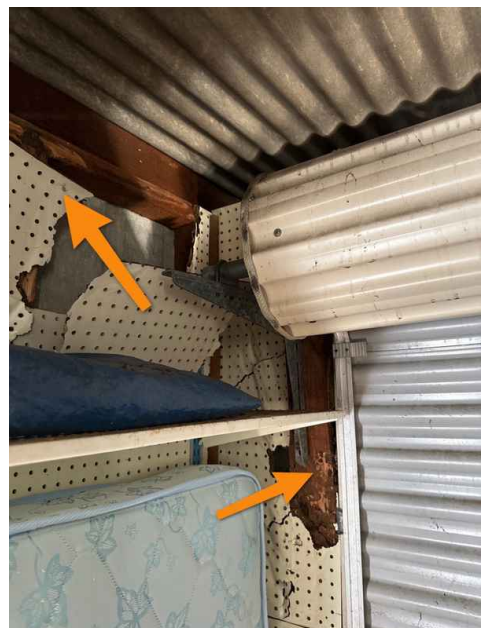
4.4.1 Internal Wall

TIMBER PEST ATTACK

Old termite damage and mudding noted. It is recommended that a timber pest management system be implemented to prevent further attacks.

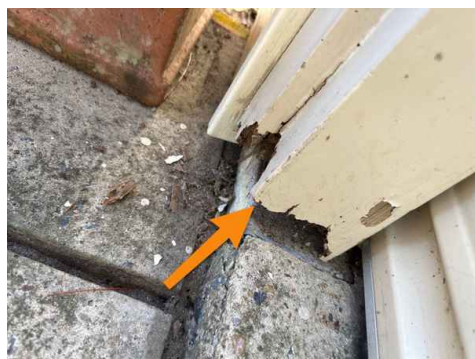
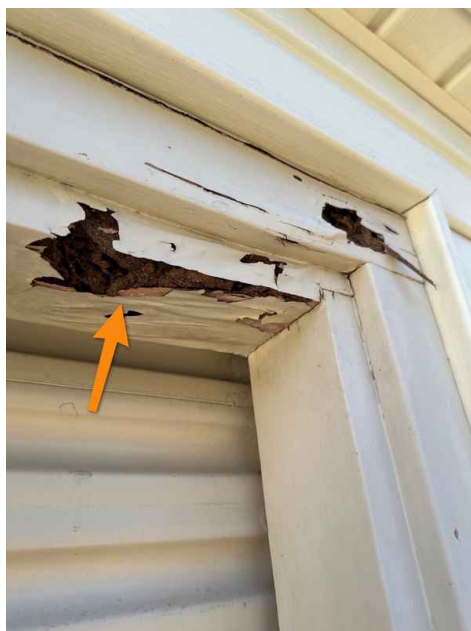
4.5.1 Garage Door

Old termite damage and mudding noted. It is recommended that a timber pest management system be implemented to prevent further attack.

Garage roller door frame bottom left

Garage roller door frame top right

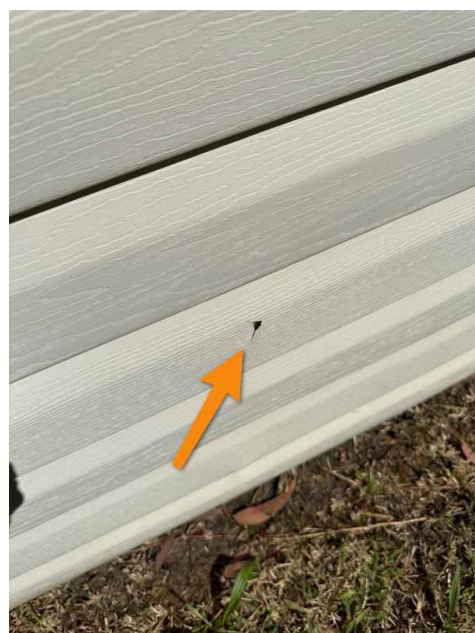
4.6.1 External Wall Cladding

IMPACT DAMAGE

Impact damage noted to the exterior.

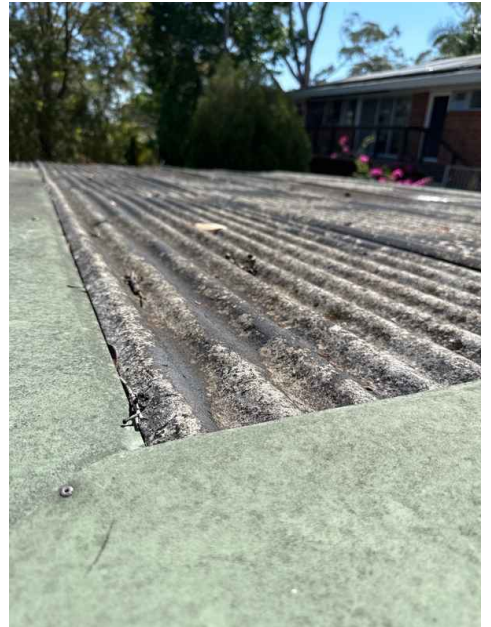
4.7.1 Roof & Gutter

ASBESTOS

Likely Asbestos roof sheeting has been installed. It is recommended that an asbestos test be done

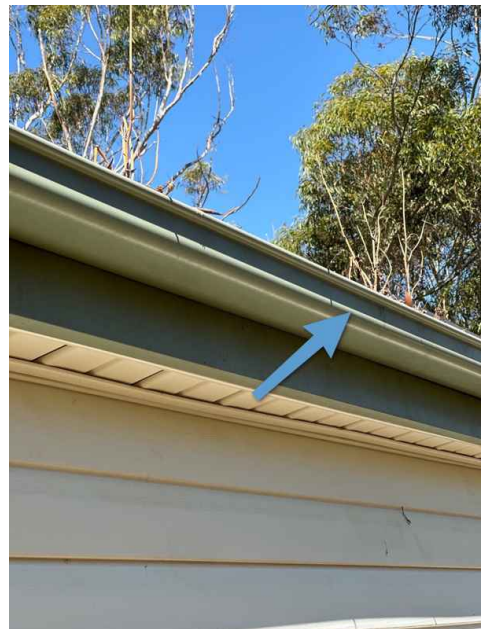
4.7.2 Roof & Gutter

DEBRIS IN GUTTERS

Debris in gutters noted. These require regular clearing

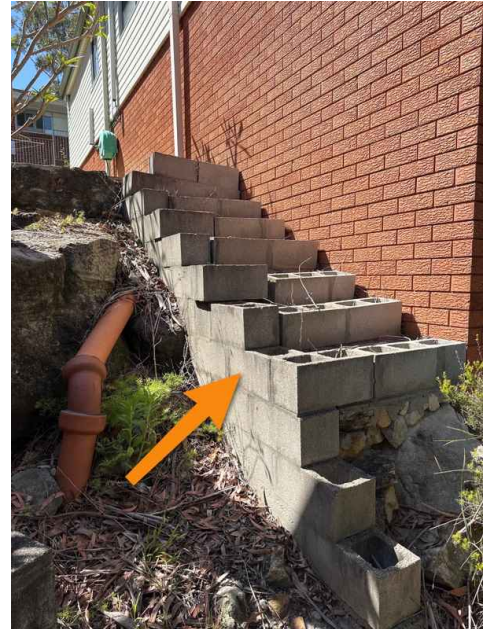
Incomplete works noted.

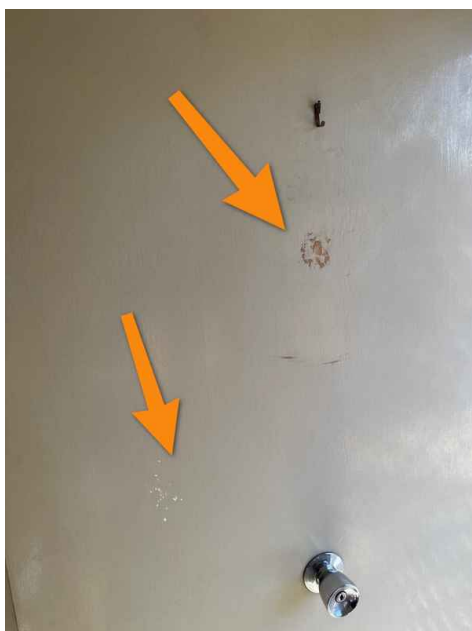
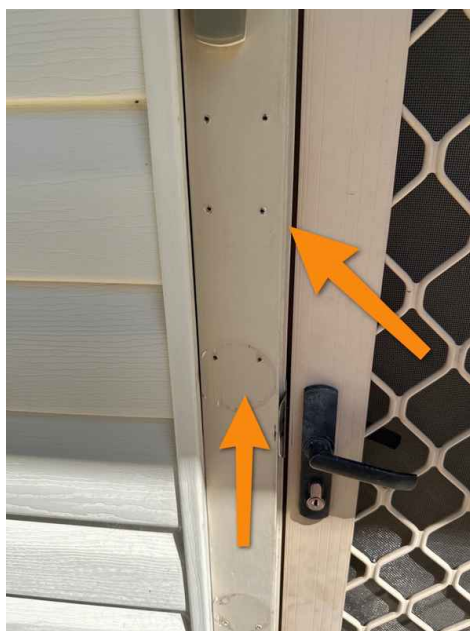
5.5.1 Exterior Doors

PAINT/REFINISH NEEDED

Door finish is worn. Recommend refinish and/or paint to maximize service life.

Contact a qualified door repair/installation contractor.

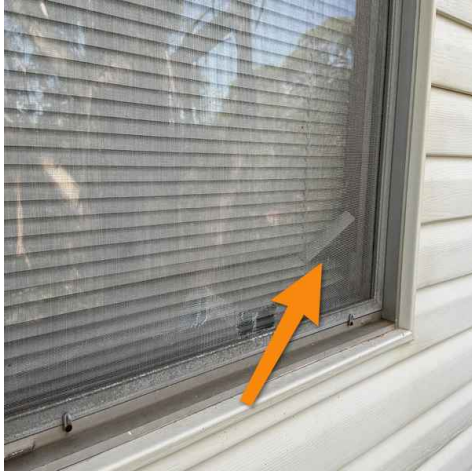
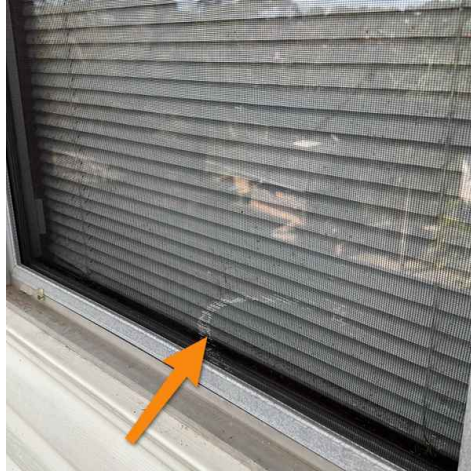
5.6.1 Exterior Windows

FLYSCREEN DAMAGE

Damage was observed to the fly screens. Replace as required.

Contact a qualified window repair/installation contractor.

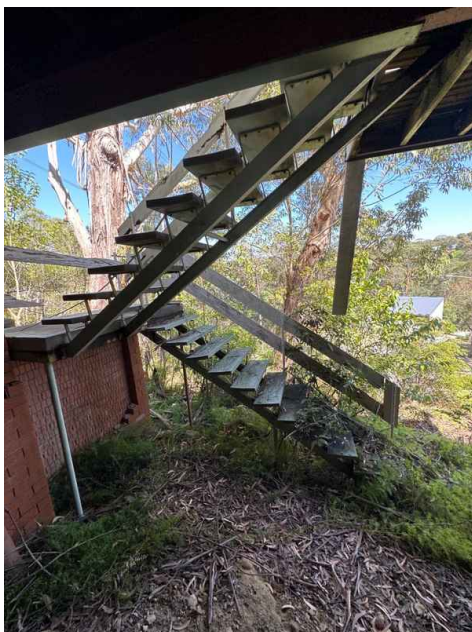
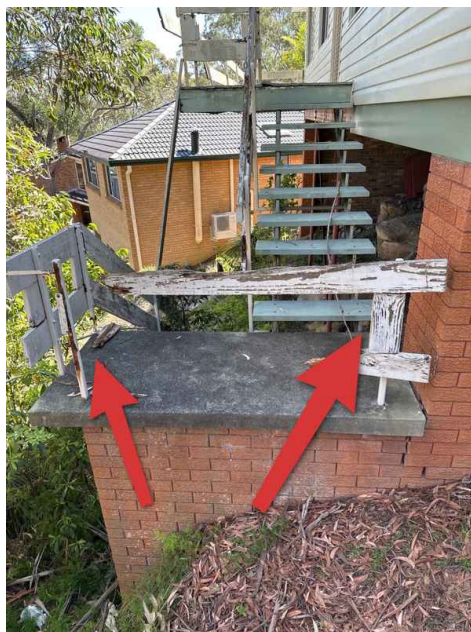
5.9.1 Stairs

STAIRS - DETERIORATED

One or more sections of the exterior stairs are deteriorated. These stairs are a safety hazard and require immediate repairs/replacement.

Major Defect/Safety Hazard

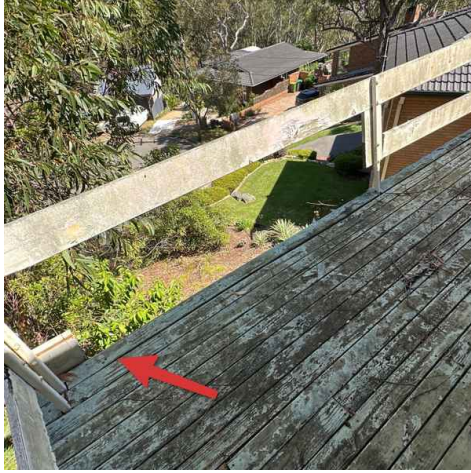
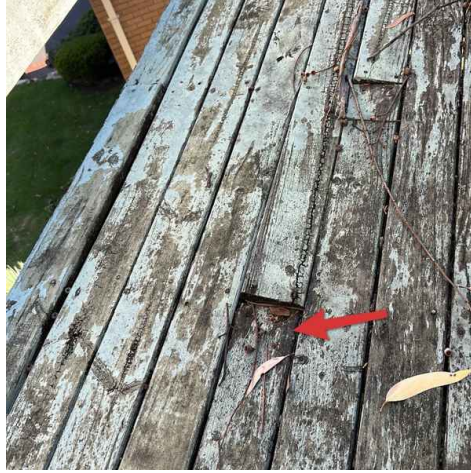
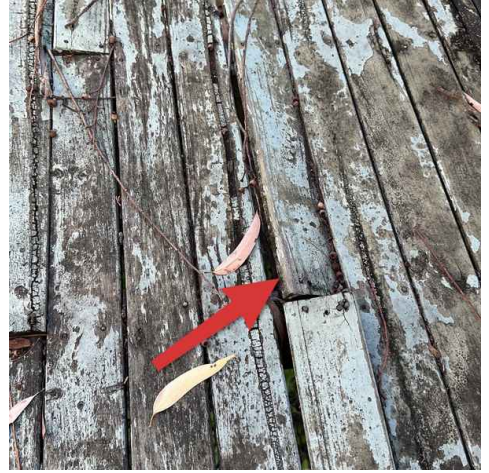
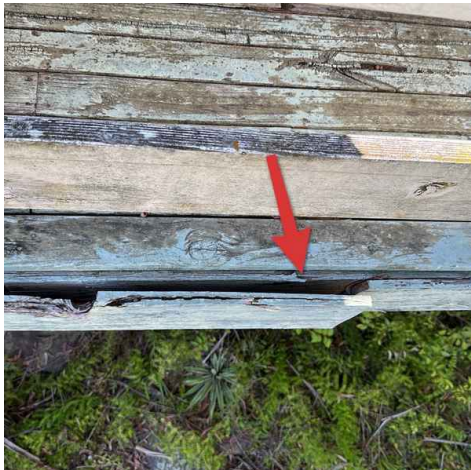
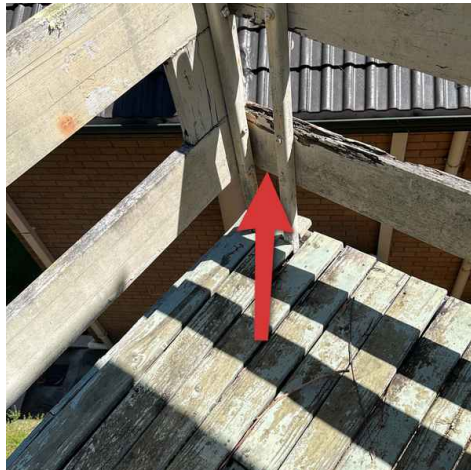
5.12.1 Verandah

ROT

Rot to entire verandah and balustrades noted. Balustrades gaps are wider than 125mm. Immediate rectification works required. Currently not safe to walk on until works completed.

**Major Defect/Safety Hazard**

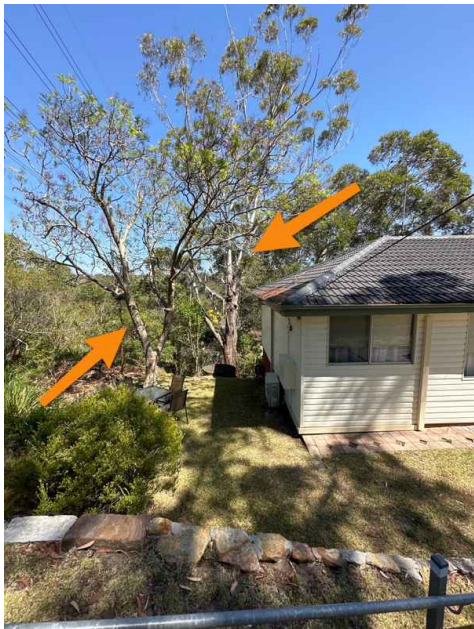
Trees observed overhanging the roof. This can cause damage to the roof and prevent proper drainage. Recommend a qualified tree service trim to allow for proper drainage.

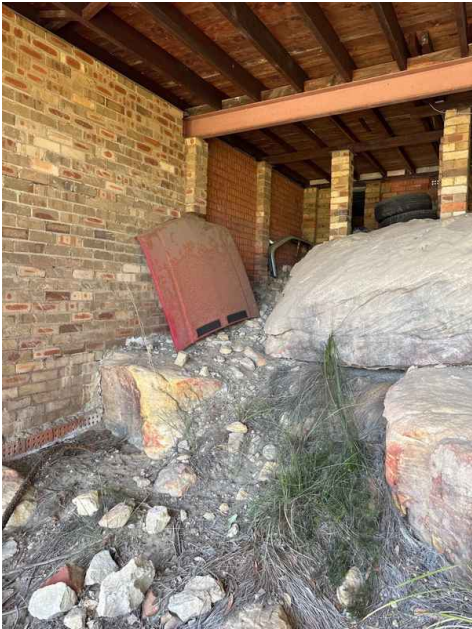
6.3.1 Subfloor

DEBRIS

There was debris and other material in the subfloor, we recommend cleaning these to aid with ventilation and reduce the likely hood of rodents and pests.

Contact a qualified professional.

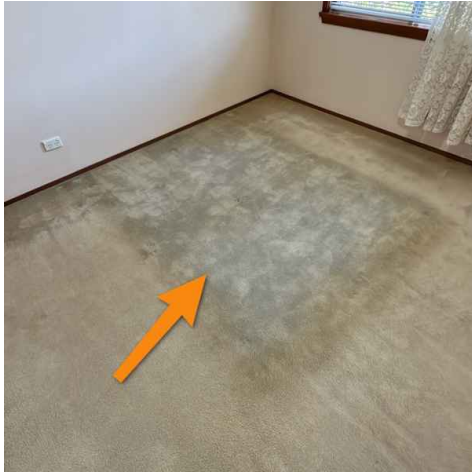
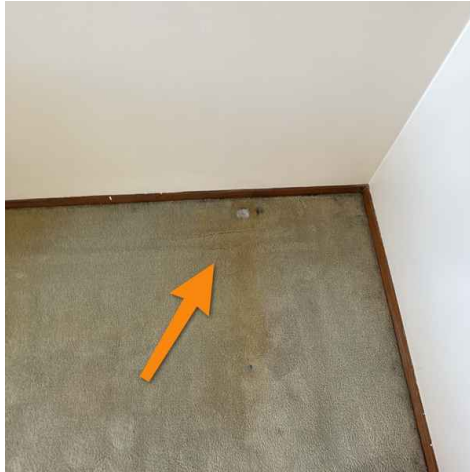
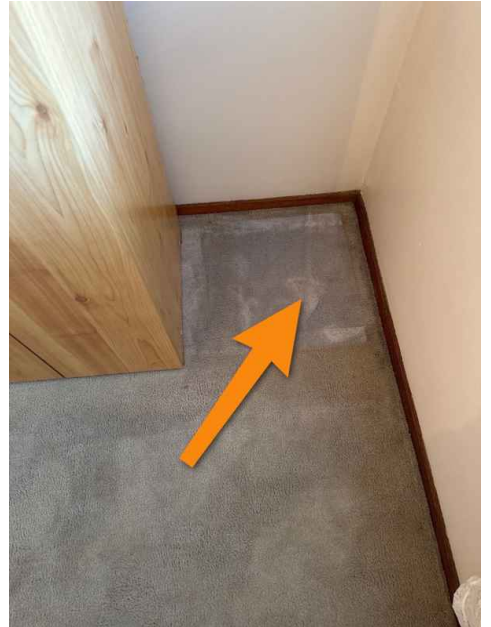
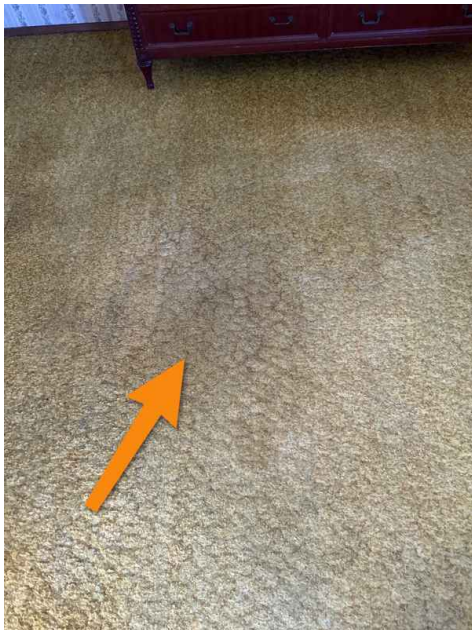
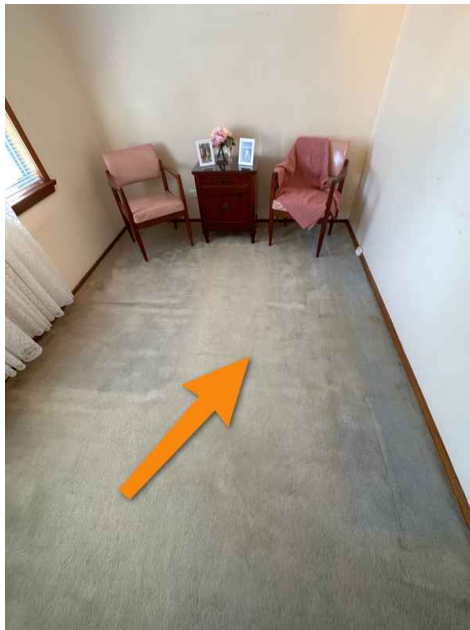
CARPET STAINS

Carpet had areas of staining or discoloration throughout. Recommend a thorough steam clean by a qualified carpet cleaning company

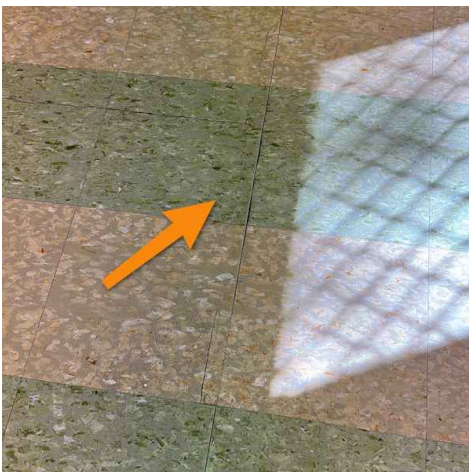
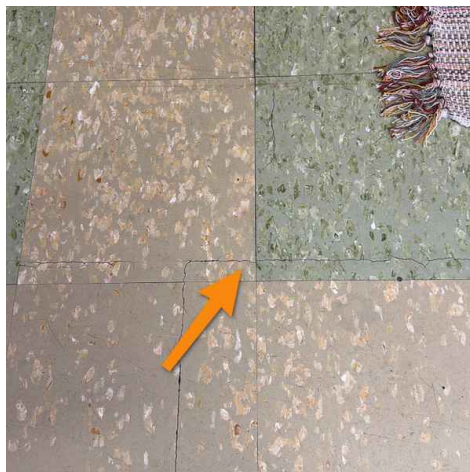
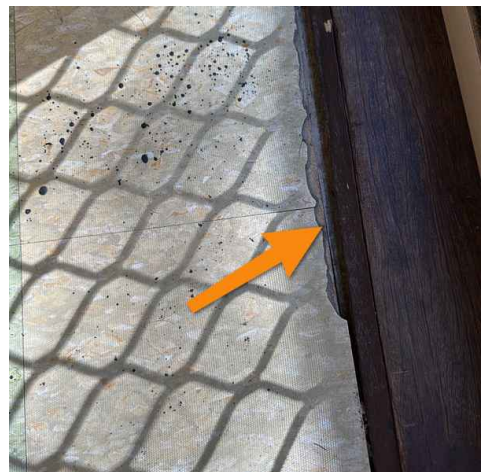
LINO FLOOR DETERIORATION

The lino floor has begun to lift throughout the property. It is recommended that a qualified Lino flooring specialist be contacted for repairs.

Contact a qualified professional.

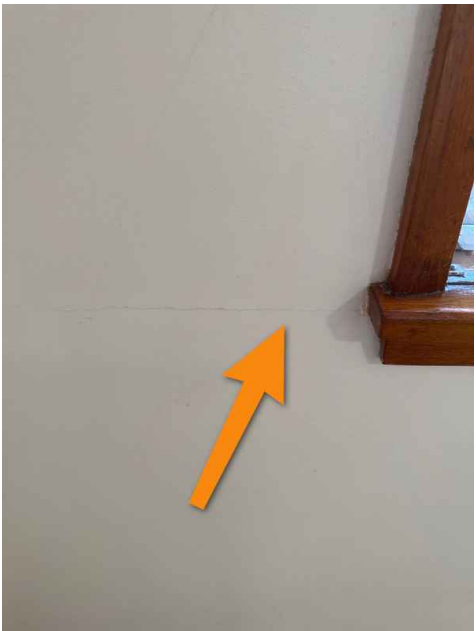
SHEET JOIN CRACKS

Sheet join cracks noted. This is probably due to thermal expansion.
Patch and paint will suffice

Recommendation
Contact a qualified professional.

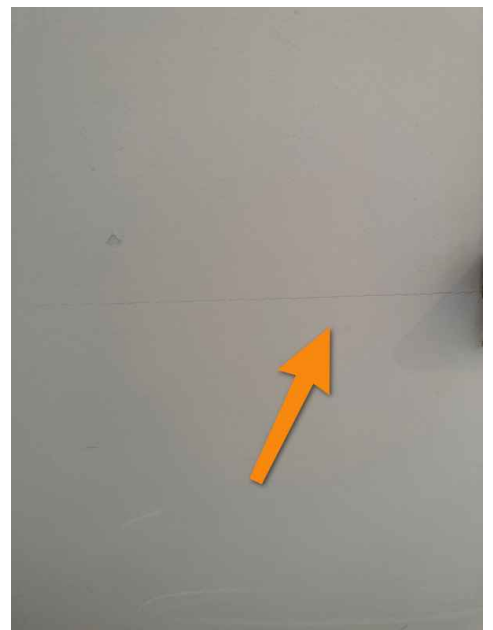
SHEET JOIN CRACKS

Sheet join cracks noted. This is probably due to thermal expansion. Patch and paint will suffice

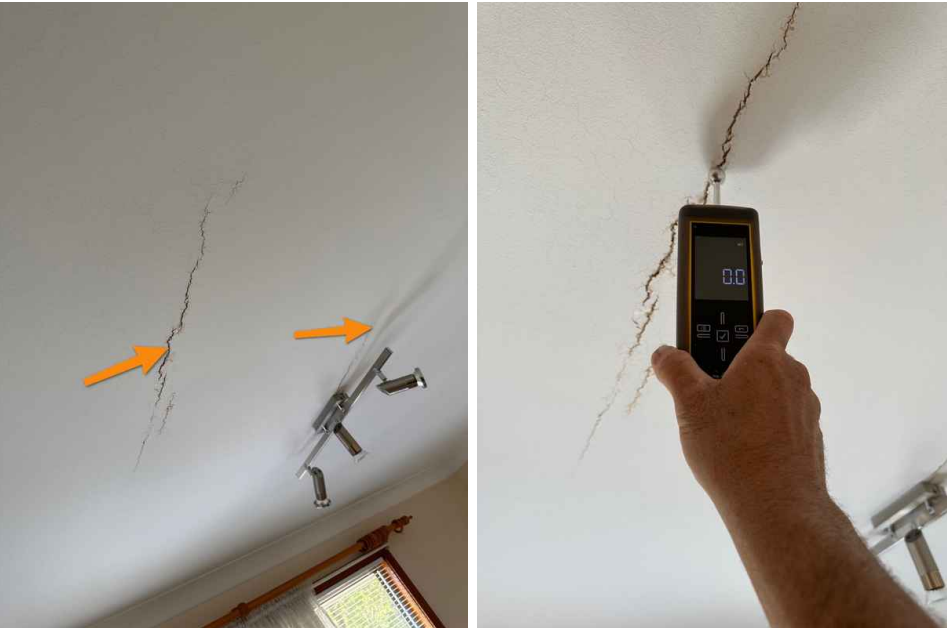
14.5.1 Ceilings

SAGGING

Ceiling sagging - Requires immediate repairs to prevent further collapse

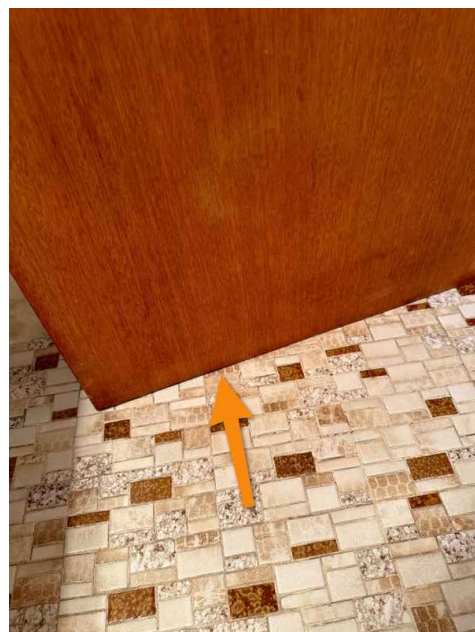
15.1.2 Doors

BINDING DOOR

Contact a qualified carpenter.

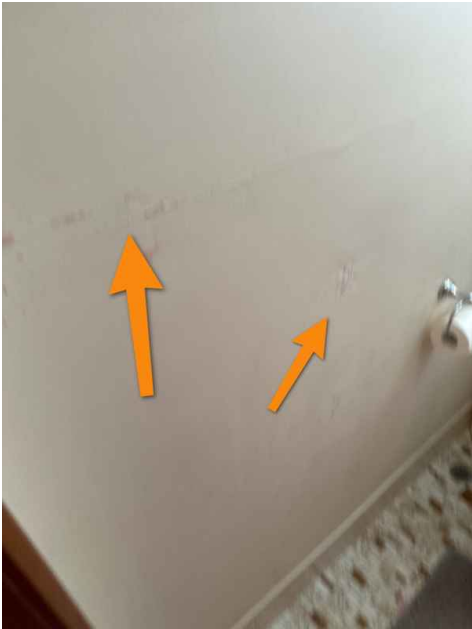
15.3.1 Walls

INCOMPLETE PATCH

Incomplete patching noted to the walls. It is recommended that these be sanded and painted.

Contact a qualified professional.

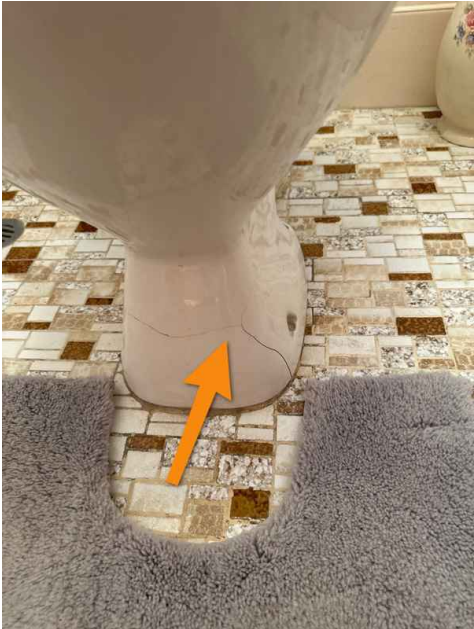
15.7.1 Toilet

DAMAGE

Damage to toilet noted. Recommend contacting a plumber for replacement

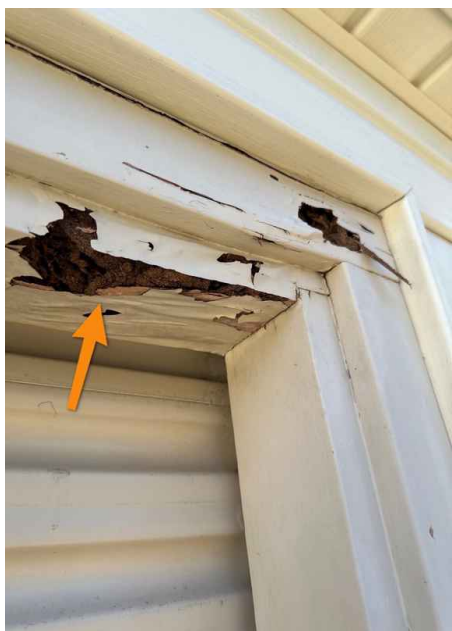
Garage roller door frame top right

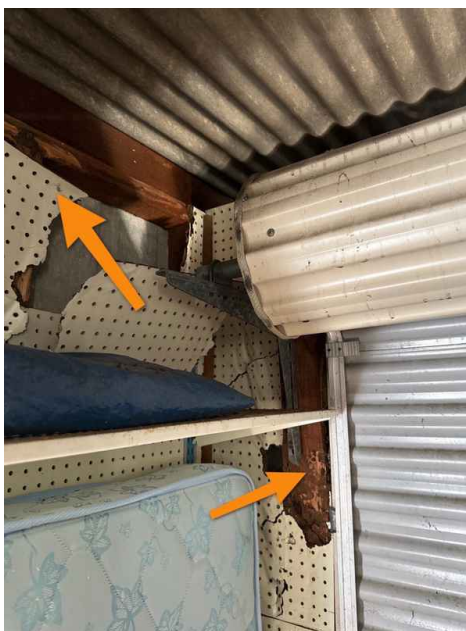
Garage door frame and adjacent wall

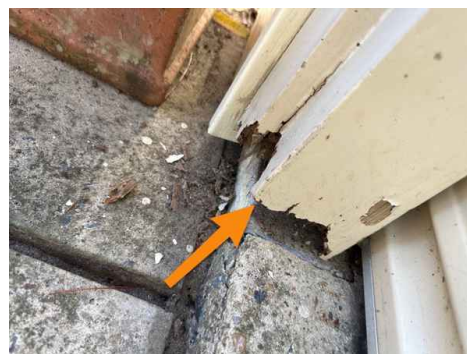
Garage roller door frame bottom left
