COMBINED BUILDING AND PEST INSPECTION

4 Sixth Ave
Loftus, NSW 2232

19/10/2023

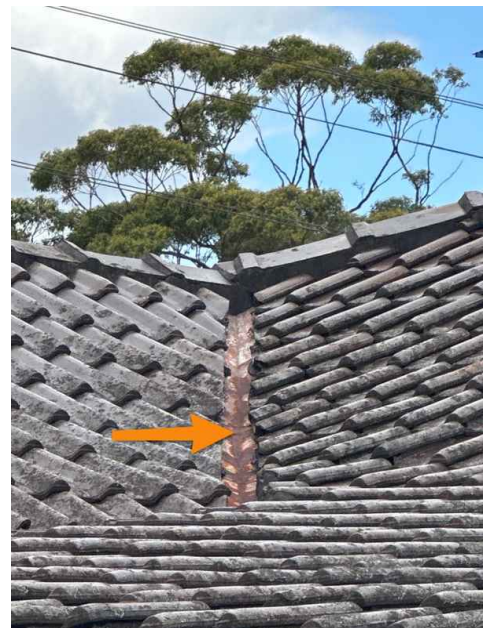
ROOF VALLEY RUST

Roof valleys are rusted. Contact a qualified roofer for replacement as this could result in roof leaks if not fixed.

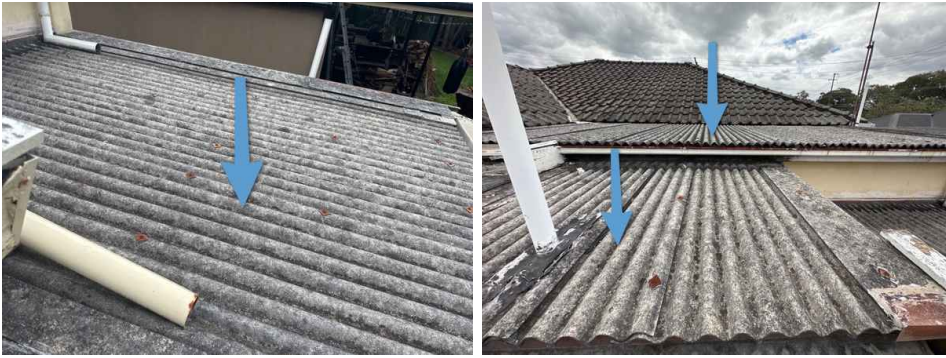
3.1.2 Coverings

ASBESTOS ROOF LINING

Asbestos roof lining noted. An asbestos test is recommended to confirm

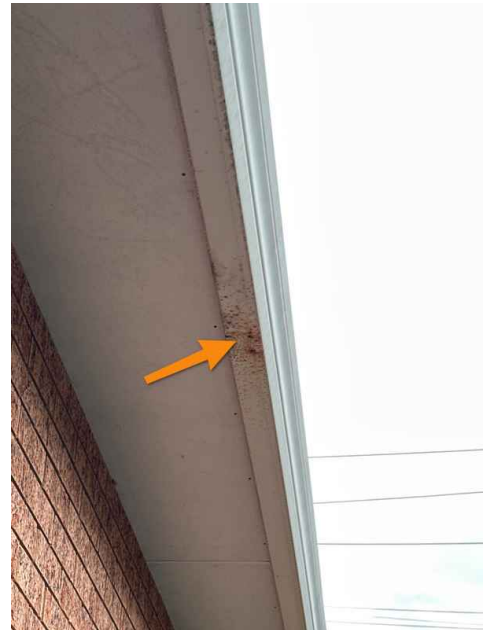
3.2.1 Gutters

RUST SURFACE

Gutter surface rust in sections - the rust is yet to penetrate and repairs/sealing may be an option.

Contact a qualified roofing professional.

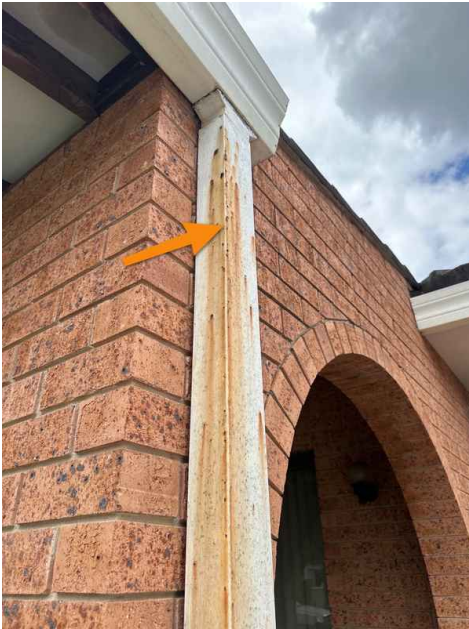
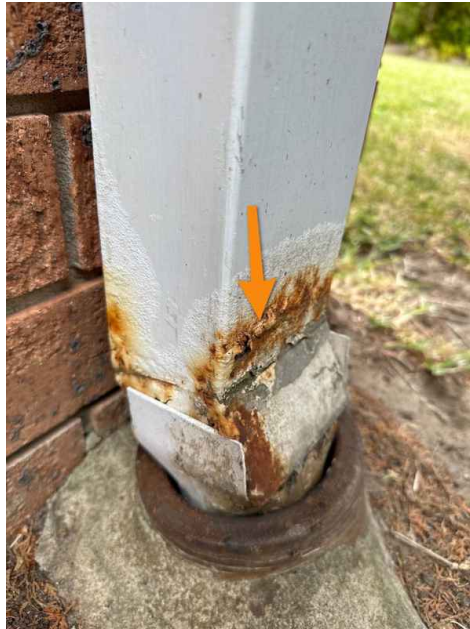
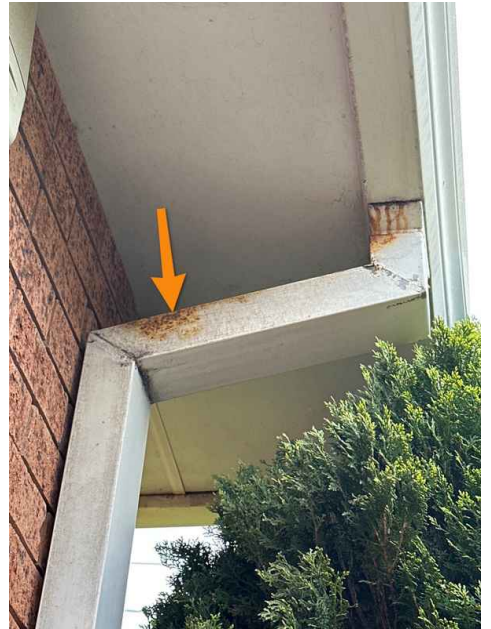
3.3.1 Downpipes

RUST

Surface rust or penetrations. Over time, this has the potential to cause differential settlement to the footings, causing rising damp.

Contact a qualified plumbing contractor.

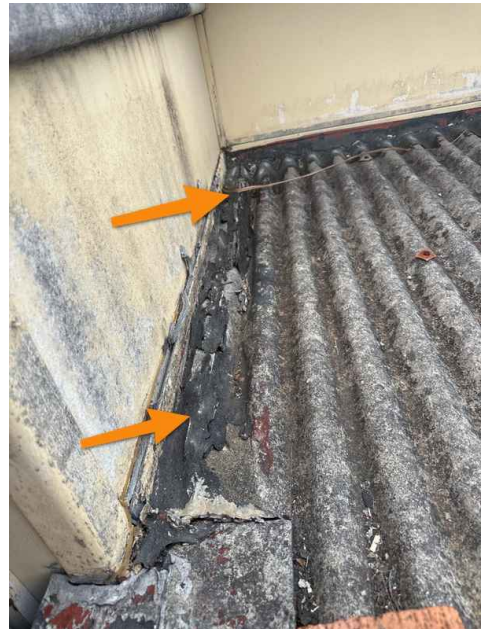
3.4.1 Flashings

CORRODED - SEVERE

Roof flashing showed signs of severe corrosion, which can lead to moisture intrusion and/or mold. Recommend a qualified roofing contractor evaluate and repair.

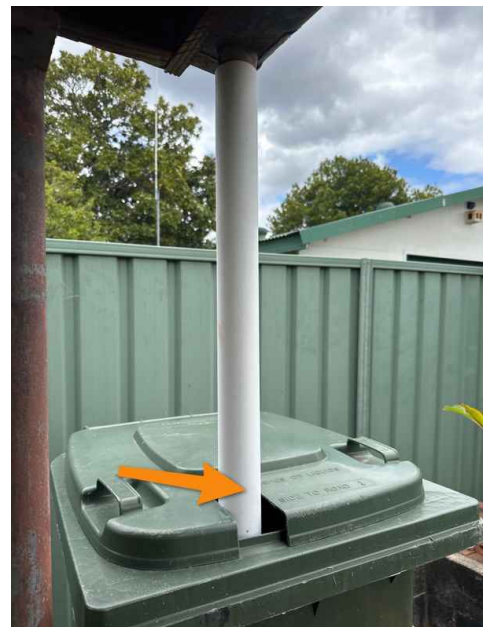
Down pipe/s not connected to storm water discharge - Down pipes not connected to storm water have the potential to cause differential settlement to the footings, cause rising damp and is also conducive to termite infestation.

Contact a qualified plumbing contractor.

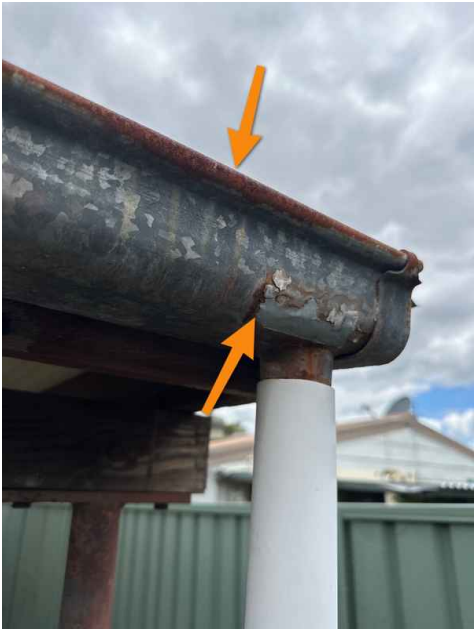
4.7.2 Roof & Gutter

GUTTER RUST

Surface rust or penetrations. Over time, this has the potential to cause differential settlement to the footings, causing rising damp and is also conducive to termites.

Contact a qualified plumbing contractor.

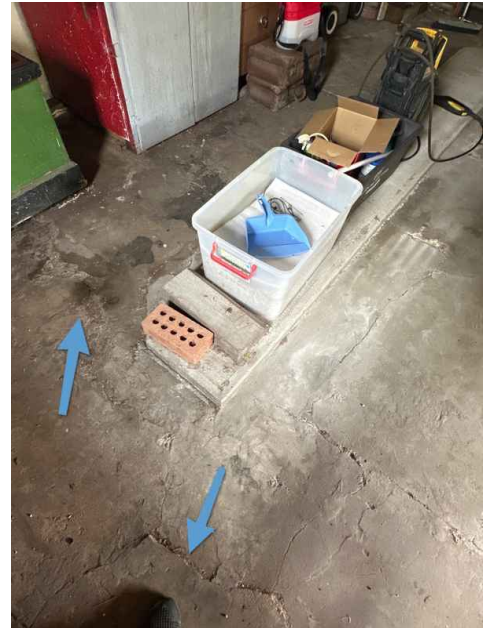
CRACKS - MINOR

Typical cracking to concrete in garage.

Contact a qualified professional.

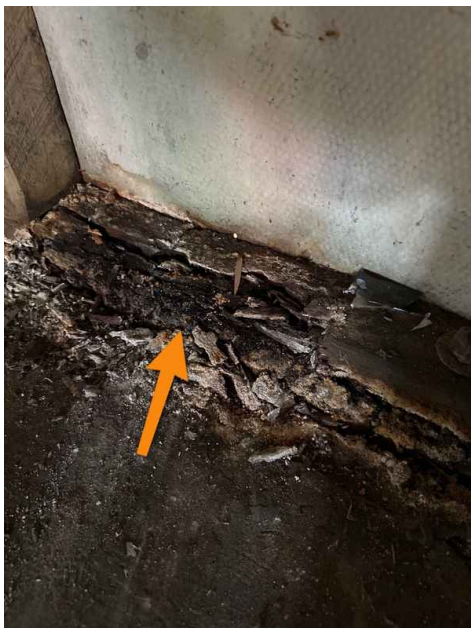
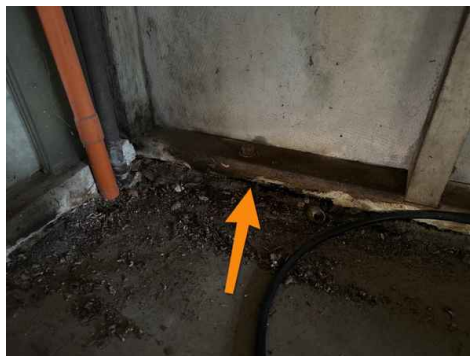
5.4.1 Internal Wall

TIMBER ROT

Timber rot noted to garage framework. It is recommended damaged areas are replaced. Contact a qualified carpenter for repairs.

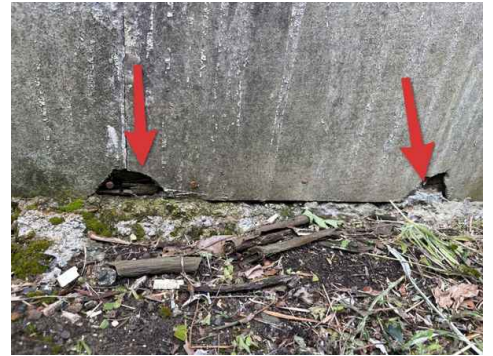
5.6.1 External Wall Cladding

ASBESTOS / IMPACT DAMAGE

External wall lining is likely asbestos. Impact damage also noted. This is a safety issue. An asbestos test is recommended to confirm

Contact a qualified professional.

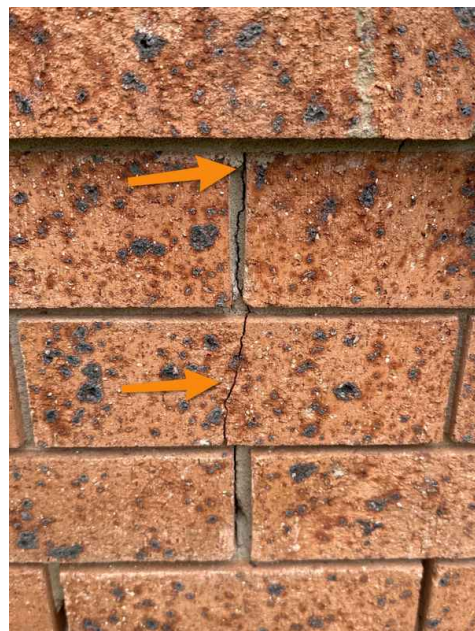
Minor Defect/Recommendations**CRACKING - MINOR**

There appears to have been some settlement in the building which has caused some cracking to the walls. These cracks are categorized as 0 to 2mm which is minor and typical for a building of this type and age. This can also cause some doors to bind or be out of square. In the inspector's opinion these cracks are due to settlement, usually due to ground movement and subsequent movement to building materials can be expected. Any cracks should be monitored and if cracks increase in size, further investigation should be carried out by a structural engineer.

Contact a qualified carpenter.

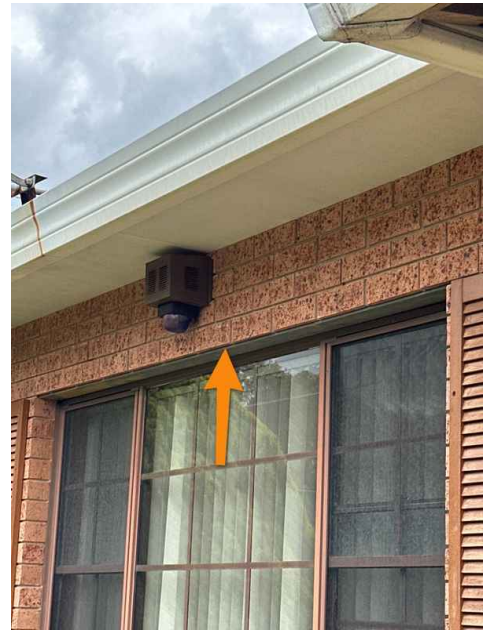
6.6.1 Exterior Windows

LINTEL SAGGING

Lintel sagging in sections. This may cause cracking in wall linings above the window

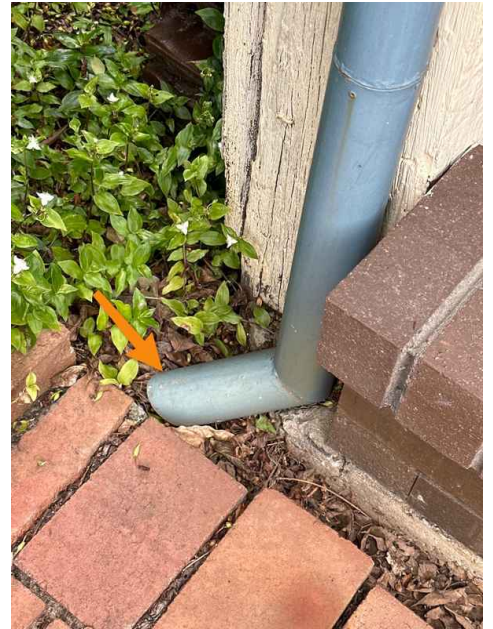
6.10.1 Pergola

DOWNPIPES NOT CONNECTED

Down pipe/s not connected to stormwater discharge - Downpipes not connected to stormwater have the potential to cause differential settlement to the footings and cause rising damp.

Contact a qualified plumbing contractor.

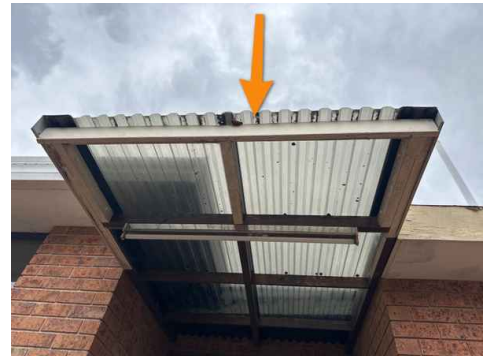
6.10.2 Pergola

NO GUTTER

No gutter installed. It is recommended a qualified roof plumber is contacted for installation of gutter.

Contact a qualified professional.

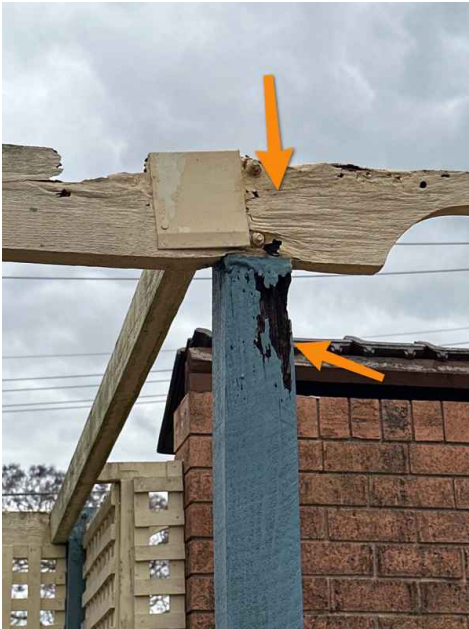
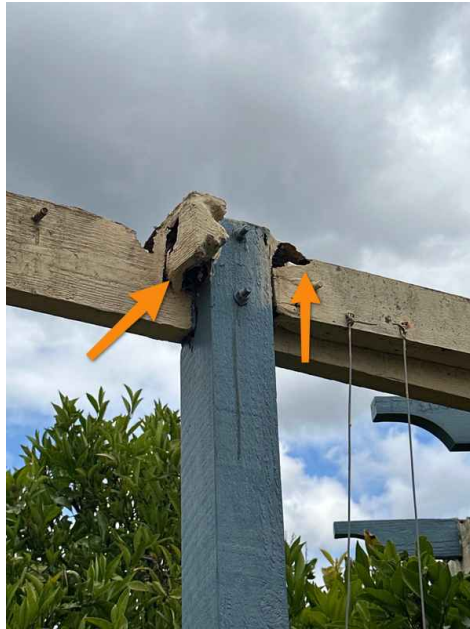
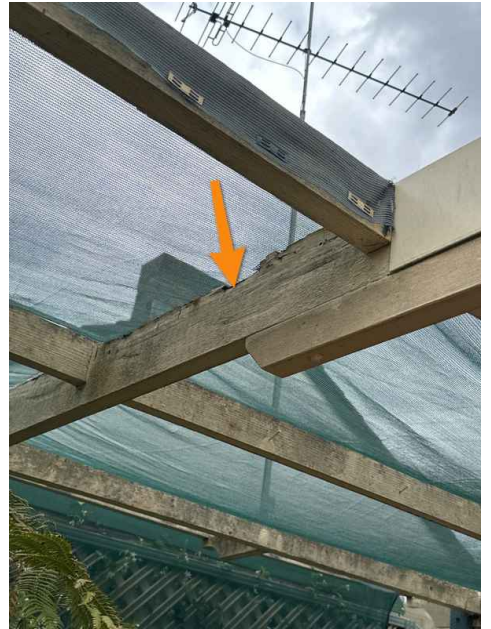
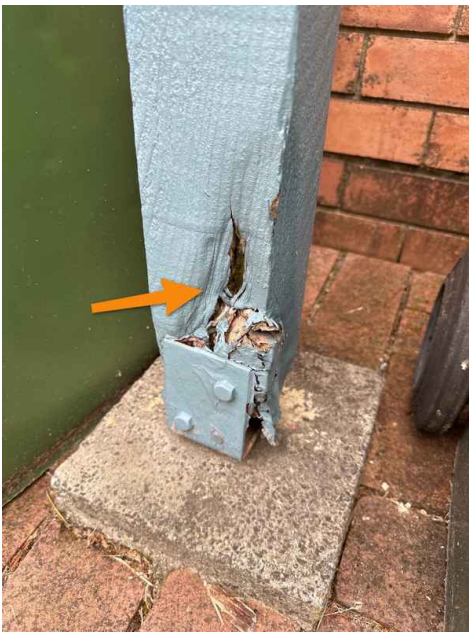
6.10.3 Pergola

TIMBER FRAME ROT

Timber fungal decay in the framework / timber posts is visible. It is recommended pergola is replaced.

Contact a qualified carpenter.

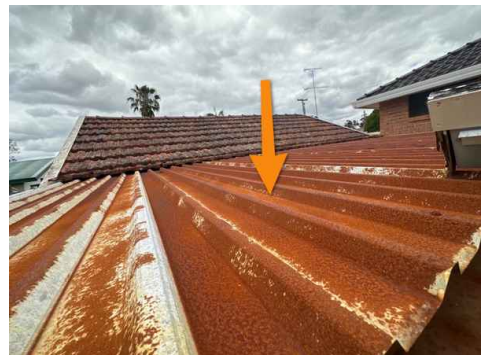
6.10.4 Pergola

ROOF RUST

Roof rust noted. Further deterioration likely. Contact a qualified roofer for repairs.

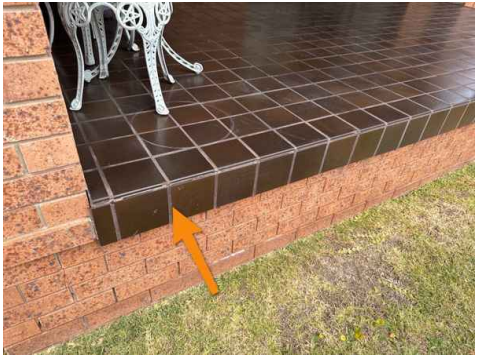
6.12.1 Verandah

DRUMMY TILES

Drummy tiles noted. Further deterioration likely.

Recommendation
Contact a qualified tile contractor

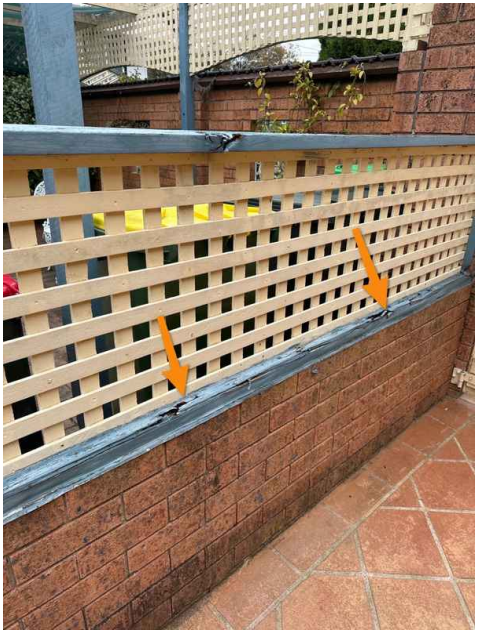
TIMBER ROT

Timber rot noted to decorative Timbers to fence.

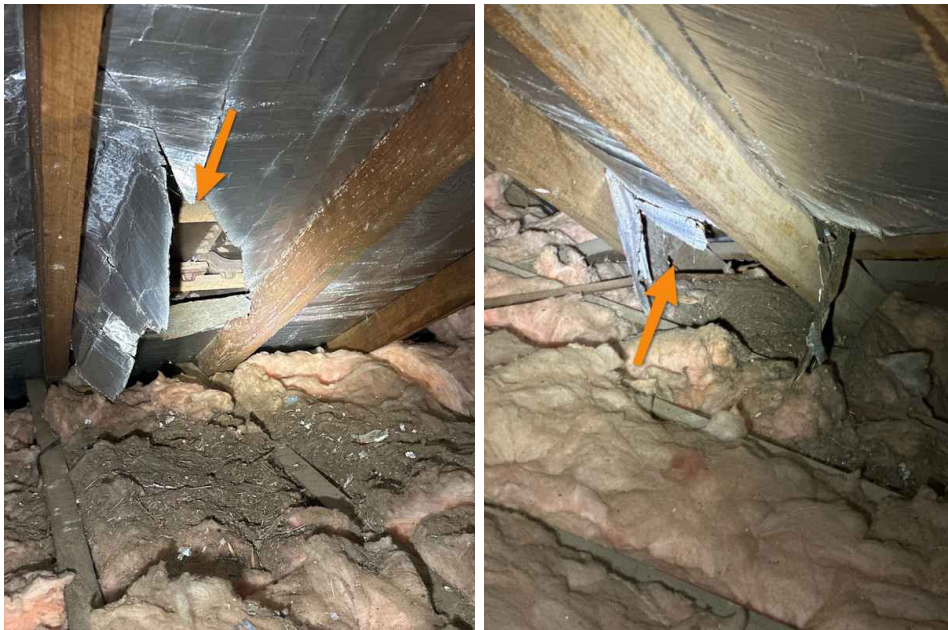
SARKING DETERIORATION

Sarking deteriorated/ damaged / aged in areas

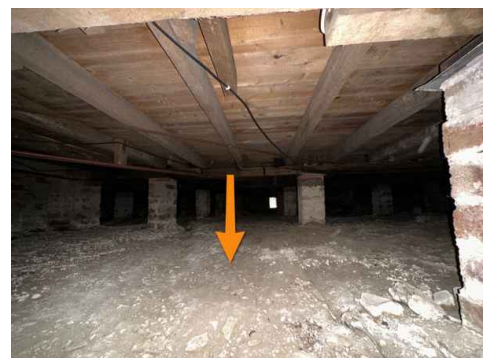
7.3.1 Subfloor

DAMP

Damp soil noted at the time of inspection. Likely due to recent rainfall and negative grading/ inadequate drainage systems

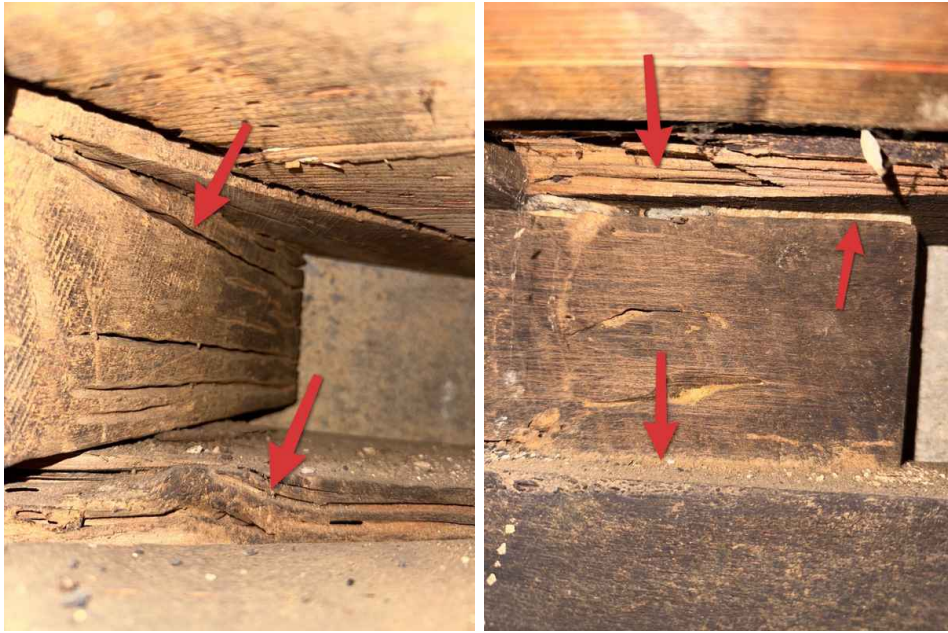
7.3.2 Subfloor

TIMBER PEST ATTACK

Timber pest attack noted. Termite mudding and Timber damage noted to 2 joist, 1 bearer and 1 bottom plate. It is recommended a qualified carpenter is contacted for repairs and a qualified timber pest specialist is contacted for a treatment to be done on the house.

Contact a qualified professional.

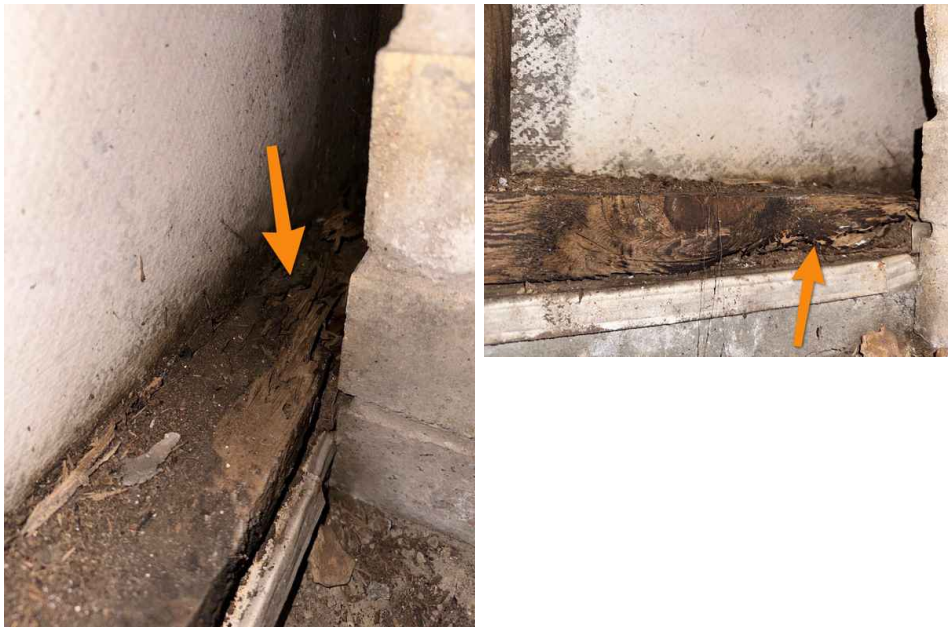
7.3.3 Subfloor

TIMBER ROT - BOTTOM PLATE

Timber rot noted to a bottom plate to the laundry wall which is visible from the subfloor. It is recommended a qualified carpenter is contacted for repairs.

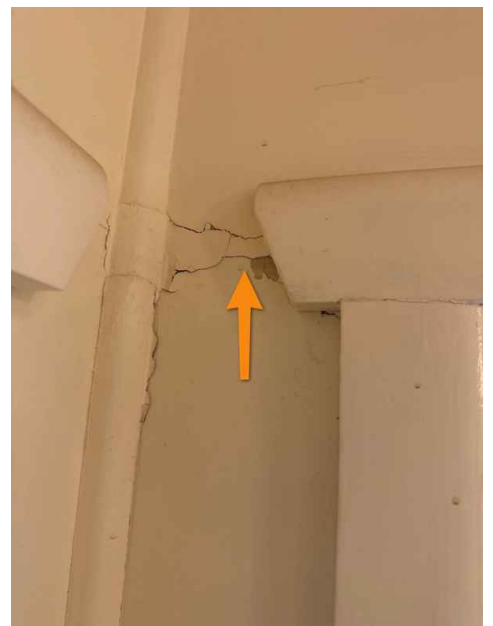
MINOR SETTLEMENT CRACKS

Settlement Cracks Noted. These are generally typical. Patch and paint may suffice. These cracks should be monitored and if they widen it is recommended that a structural engineer be contacted for assessment

Contact a qualified professional.

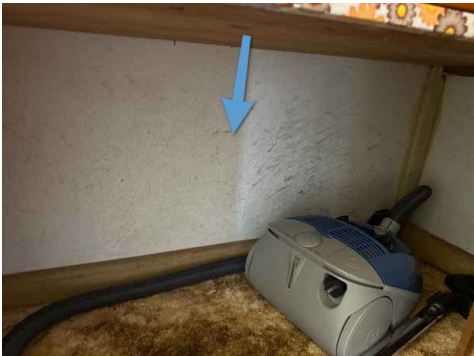
8.8.1 Linen closets/ Wardrobes/ Storage areas

POSSIBLE ASBESTOS LINING

Possible asbestos lining inside of linen cupboard. An asbestos test is recommended to confirm.

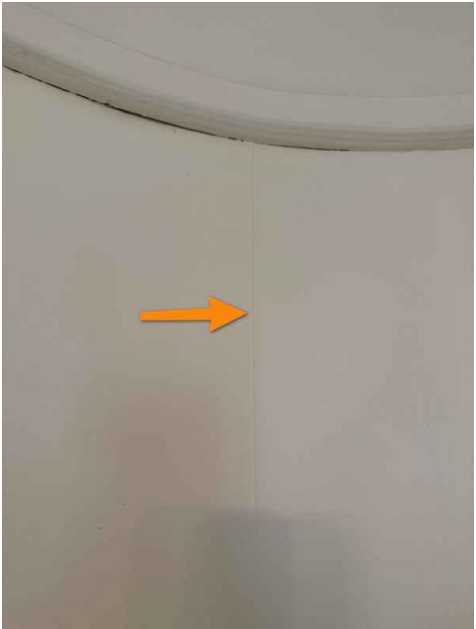
9.4.1 Walls

SHEET JOIN CRACKS

Sheet join cracks noted. This is probably due to thermal expansion. Patch and paint will suffice

Recommendation
Contact a qualified professional.

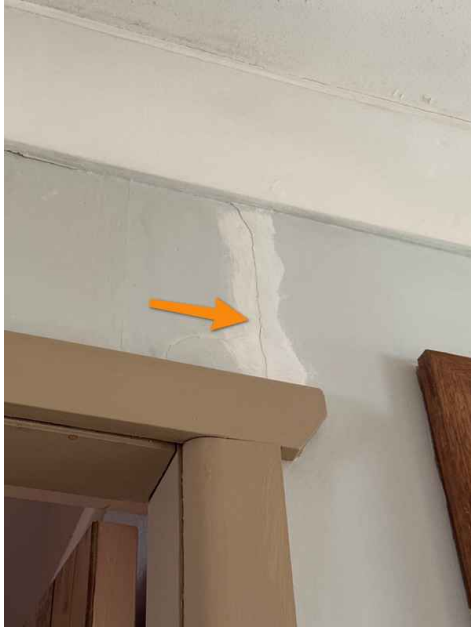
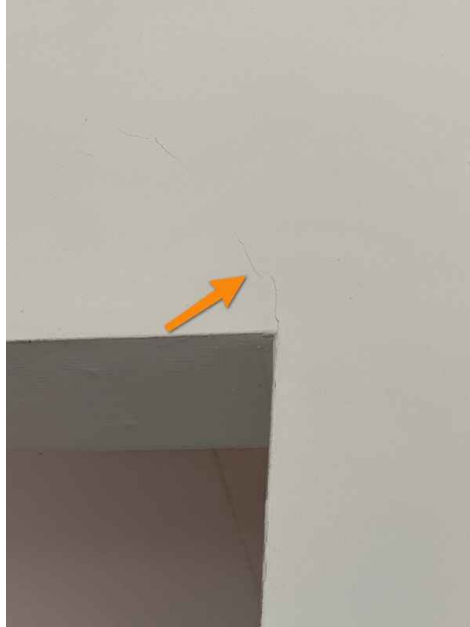
10.4.1 Walls

MINOR SETTLEMENT CRACKS

Settlement Cracks Noted. These are generally typical. Patch and paint may suffice. These cracks should be monitored and if they widen it is recommended that a structural engineer be contacted for assessment

Contact a qualified professional.

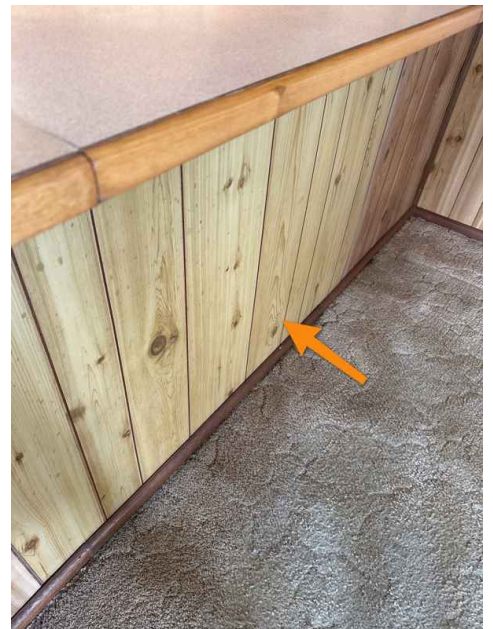
10.4.2 Walls

WALL BULGE

Minor wall bulge noted. This is probably due to stud alignment. Further investigation required.

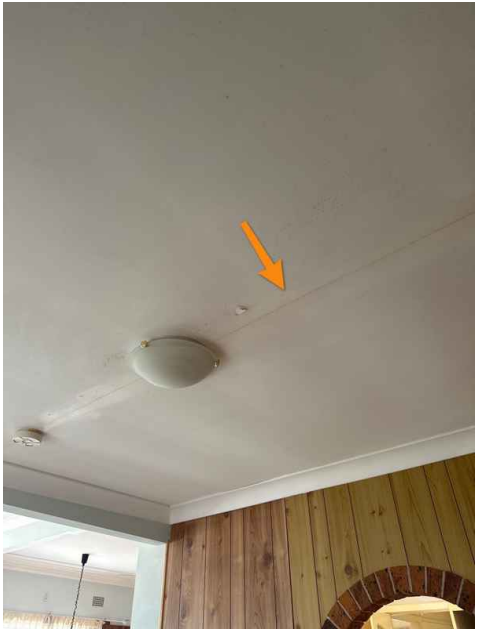
10.5.1 Ceilings

SHEET JOINS

Ceiling sheet joins cracks evident. This is likely due to thermal expansion

Recommendation
Contact a qualified professional.

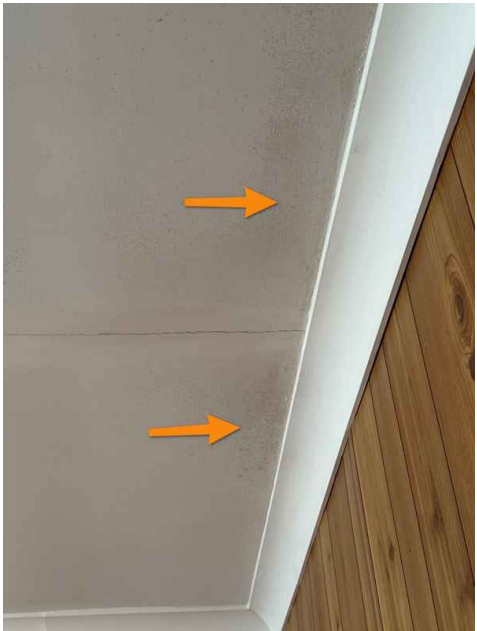
10.5.2 Ceilings
POSSIBLE MOLD

There are possible signs of fungi growth on ceiling. It is unknown if this is a safety hazard. Recommend a qualified mold inspector evaluate.

Recommendation
Contact a qualified mold inspection professional.

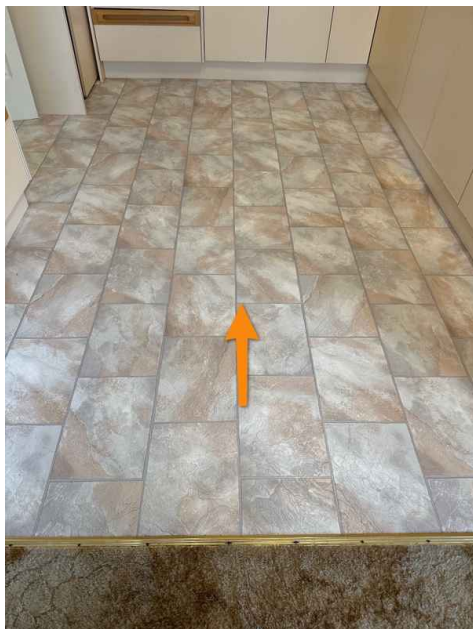
Minor Unevenness visible in the floor - Recommendations: A qualified carpenter should be engaged for advice and recommendations re-leveling.

Contact a qualified carpenter.

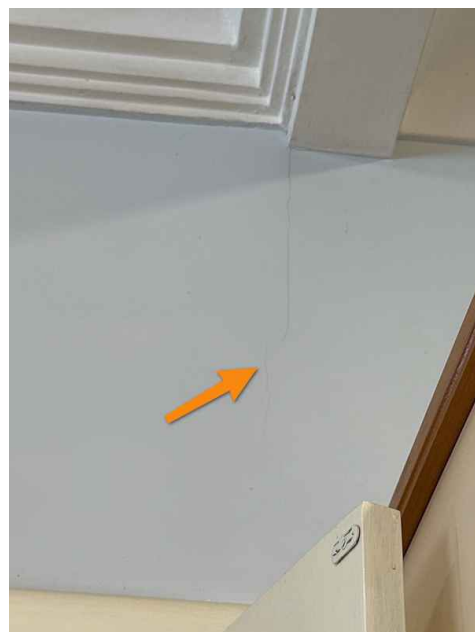
12.4.1 Walls

MINOR SETTLEMENT CRACKS

Contact a qualified professional.

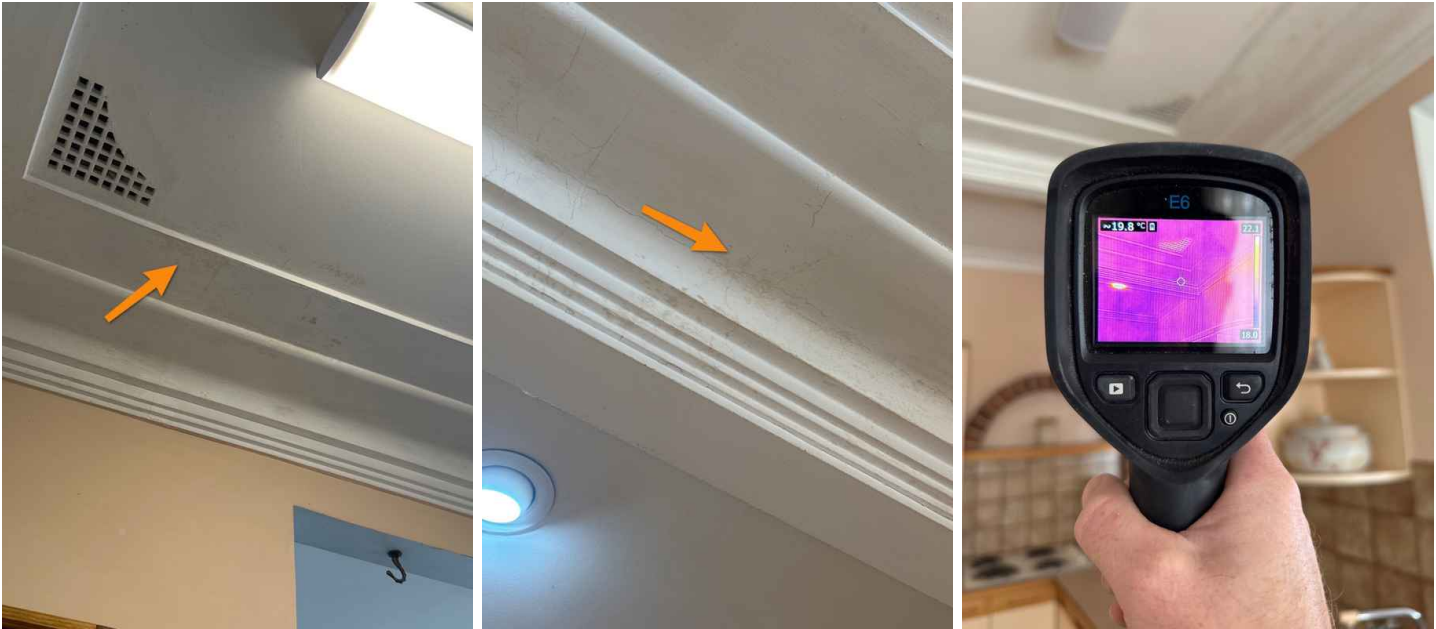
12.5.1 Ceilings

STAINS - DRY

Contact a qualified professional.

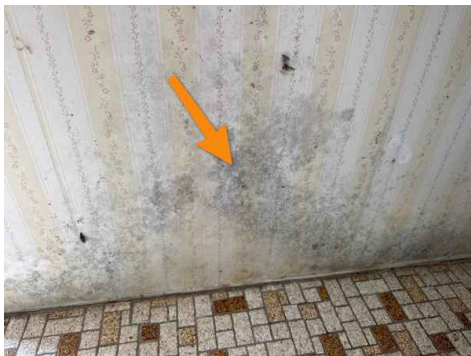
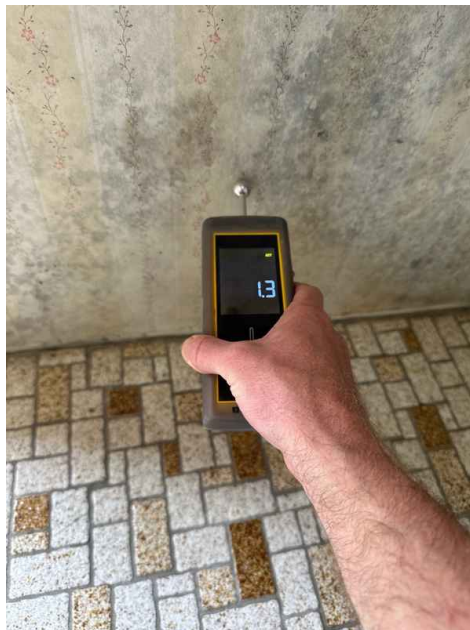
13.4.2 Walls

POSSIBLE MOULD

Possible mould noted. Low moisture readings detected.

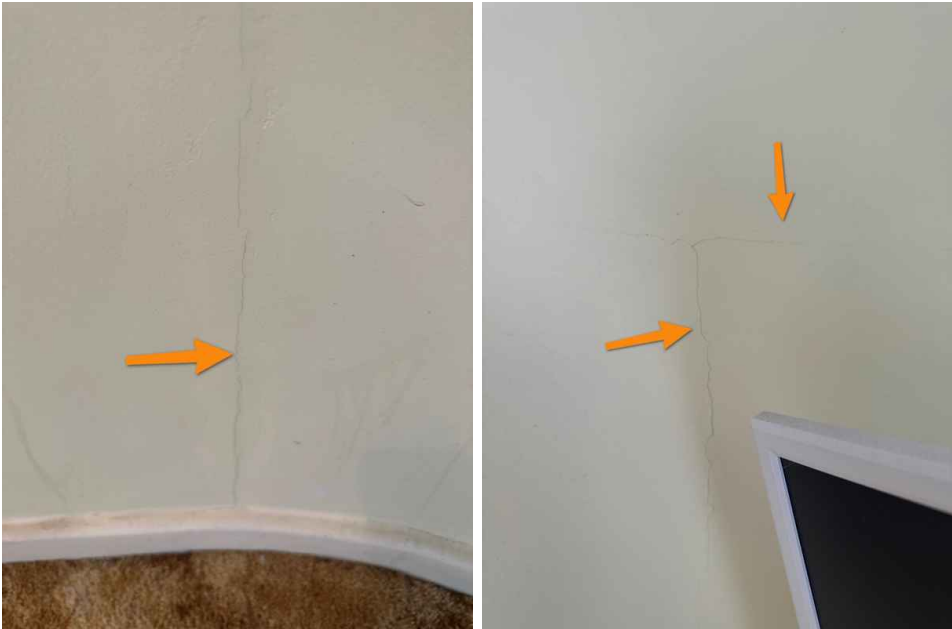
14.4.1 Walls

SHEET JOIN CRACKS

Contact a qualified professional.

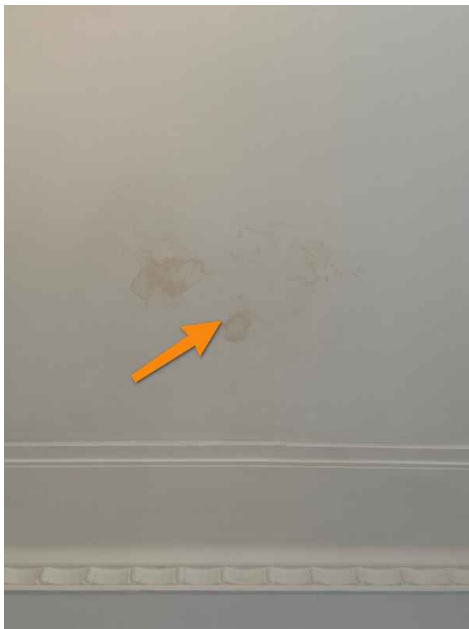
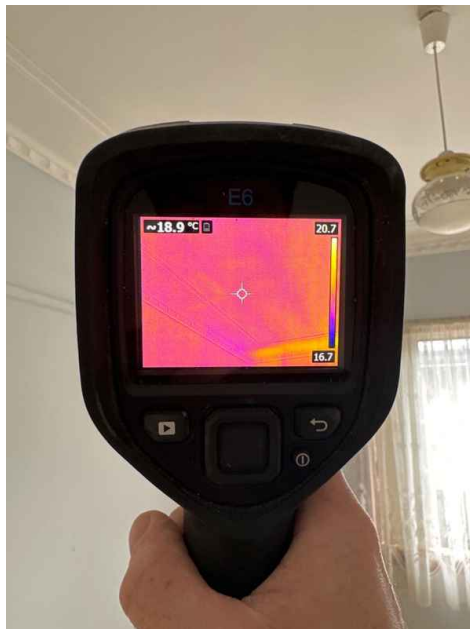
15.5.1 Ceilings

STAINS - DRY

Contact a qualified professional.

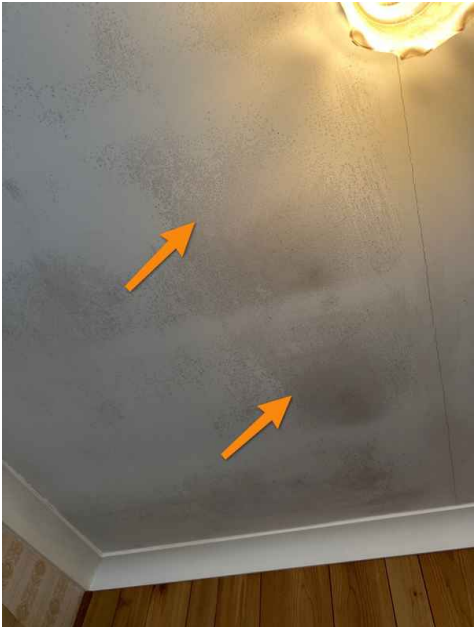
16.5.2 Ceilings

POSSIBLE MOULD

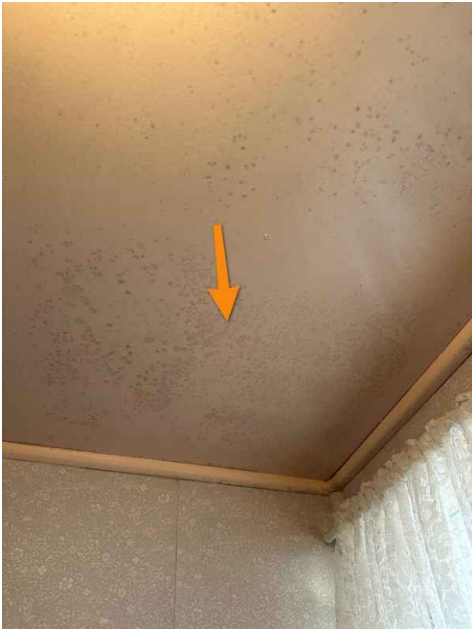
18.5.1 Ceiling

POSSIBLE MOLD

Contact a qualified mold inspection professional.

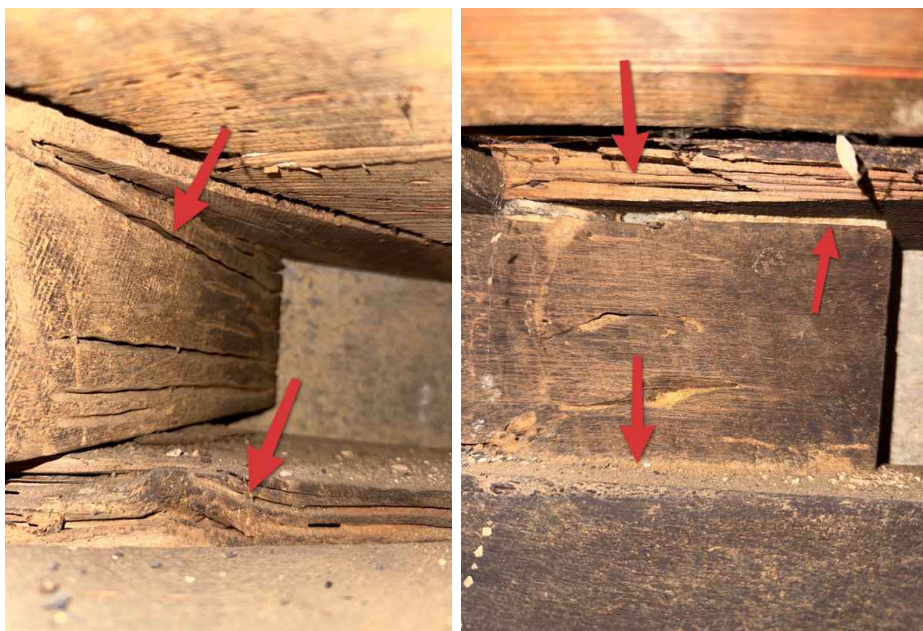
Termite damage and/or workings were found mainly in but not limited to**Subfloor**

Termite damage/workings are not confined to these areas and further damage may also be located in concealed areas.

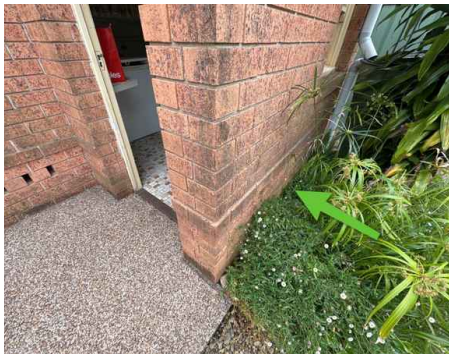
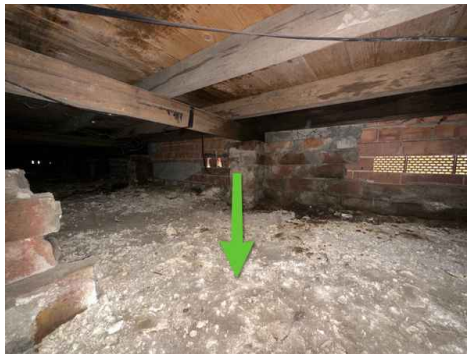
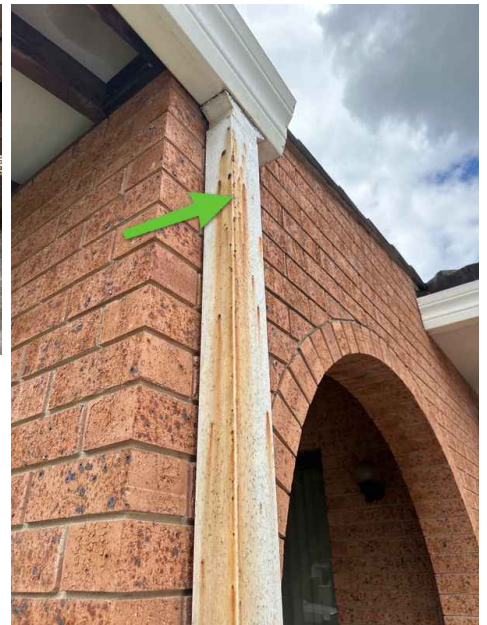
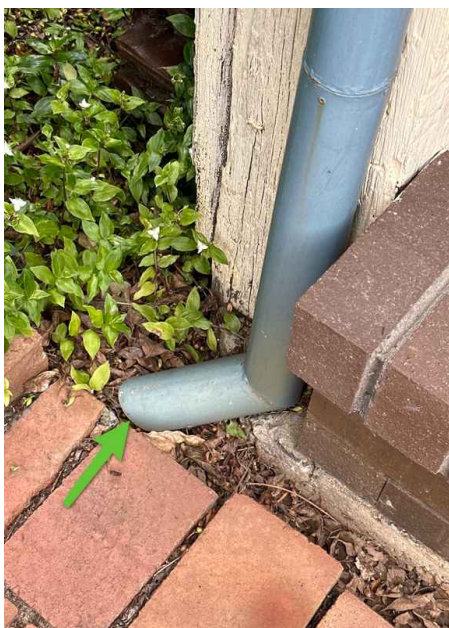
D/P Connection, Damp Subfloor Soil, Slab Edge, Mulch & Garden Beds Next to House, Timber Sleepers, Timber Debris, D/P Leak

Conducive conditions are areas that promote termite activity. The above areas are recommended that repairs be completed to help minimise the risk of termite attacks.
