FOURTEENTH REPORT - STORM AND WATER DAMAGE CLAIM

TABLE 1 – 68-70 ETON & 51-53 MERTON STREET, SUTHERLAND

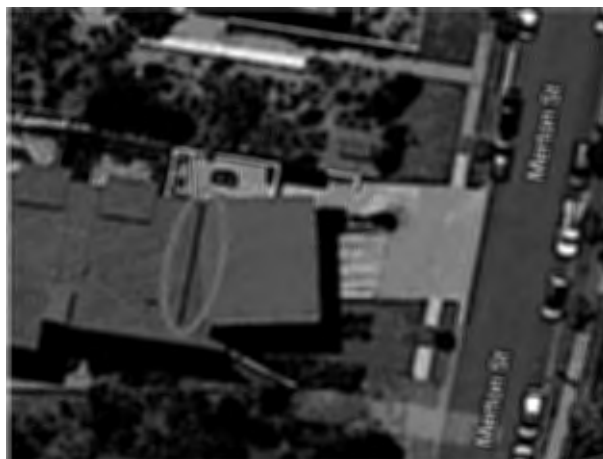
The eastern wall of Unit 501 (located on the top floor) has been affected by water penetration via the junction of the lower eastern roof.

Gain access to the lower roof and install a new apron flashing in accordance with the following:

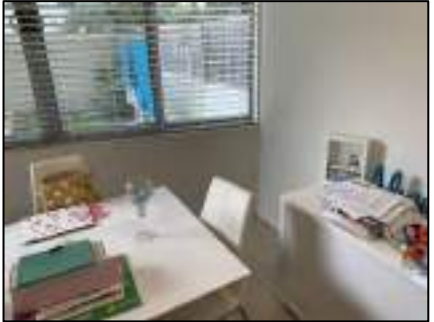
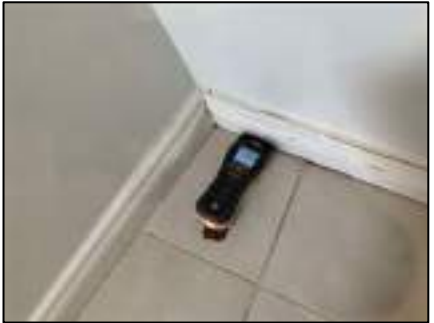
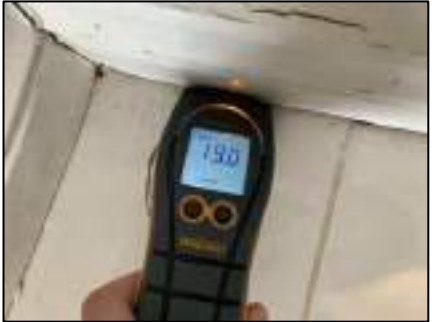
ITEM	LOCATION	DESCRIPTION	PHOTOGRAPH(S)
1.0	UNIT 103 (68 ETON)		
1.1	Living Room	<p>Advised by the resident of water penetration emanating through the east-facing bay windows and walls during periods of significant rainfall.</p> <p>The timber skirting boards along the south-eastern corner of the room are visibly moisture damaged. Elevated moisture meter readings were recorded in the south-eastern corner of the room.</p>

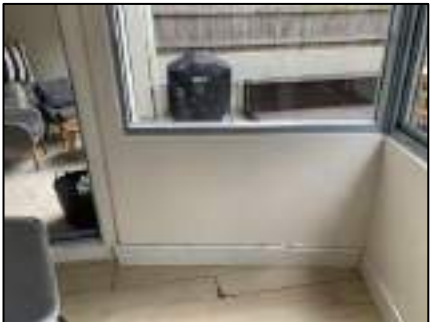
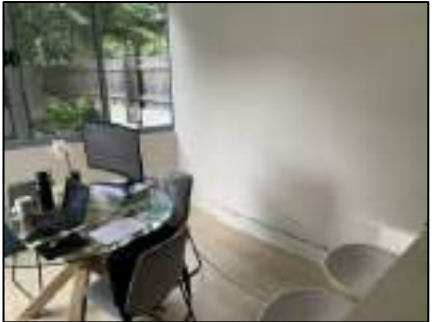
ITEM	LOCATION	DESCRIPTION	PHOTOGRAPH(S)
1.2	Balcony	<p>Insufficient falls (2mm/m) recorded on the tiled terrace surface at the junction of the protruding bay windows.</p> <p>The protruding bay window area appears to be enclosed with roof sheeting utilised as wall cladding.</p>	   
2.0	UNIT 105 (68 ETON)		
2.1	Living Room	<p>Evidence of water penetration in the form of moisture damaged timber skirting boards along the walls beneath the protruding bay windows.</p> <p>Low level moisture meter readings were recorded beneath the bay windows along the base of the protruding walls & skirting boards.</p>

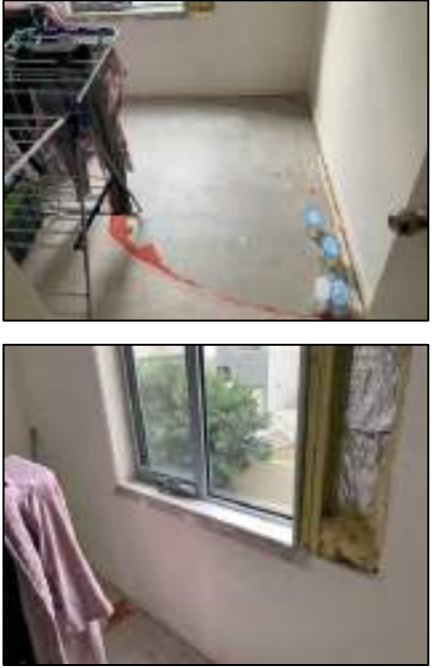
3.0	UNIT 106 (68 ETON)		
3.1	Bedroom 2	<p>Advised by the resident of water penetration entering the bedroom through the eastern wall. It is understood that the water penetration has been a one-off occurrence during the significant 'East Coast Low' in February 2020.</p> <p>Previous investigative works have been undertaken by <i>Network Construction Services</i>, namely through the removal of wall/ceiling sheeting surrounding the eastern window and carpet throughout the entire room.</p>

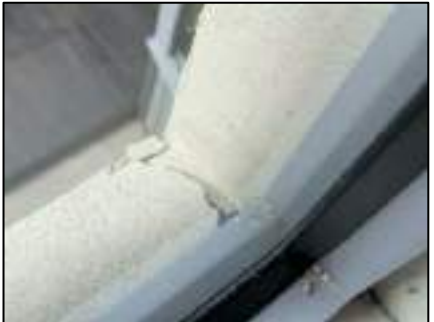
ITEM	LOCATION	DESCRIPTION	PHOTOGRAPH(S)
		<p>The steel universal beam (UB) within the ceiling cavity appears to be supporting the <i>bondek</i> formed concrete floor slab. The UB has been surfaced with a vermiculate protective fire rated coating.</p> <p>The vermiculite protective coating appears to be generally deteriorated and moisture damaged.</p> <p>Approximately 1.0mm wide cracking to the external sill reveal on the east facing window.</p>

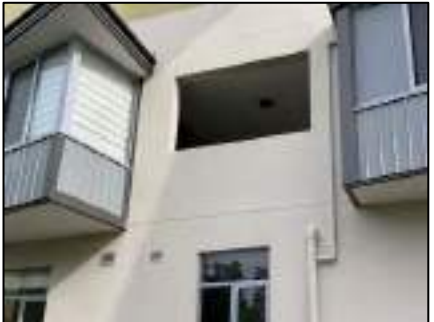
9.2	Facade	<p>The affected area is located beneath an enclosed balcony. The balcony appears to be drained via the plumbing pipework along the eastern façade.</p> <p>Air conditioning vents are evident adjacent to the southern side of the east facing window.</p> <p>We note that the balustrades of the enclosed balcony are clad with fibre cement cladding.</p>

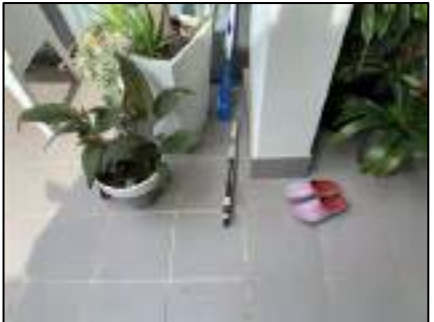
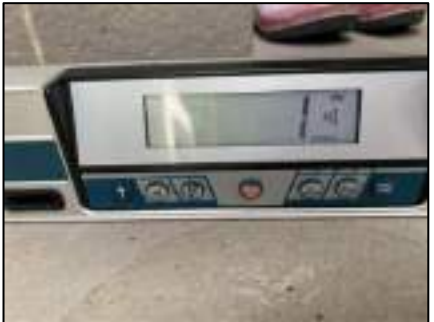
ITEM	LOCATION	DESCRIPTION	PHOTOGRAPH(S)
4.2	Terrace	<p>Cracked and delaminated tiling on the eastern side of the terrace, adjacent to the hardwood timber deck.</p> <p>Isolated cracked and displaced grout throughout the tile joints.</p> <p>Insufficient falls (1mm/m) recorded at the junction between the floor tiling and metal cladding enclosing the bay windows.</p>

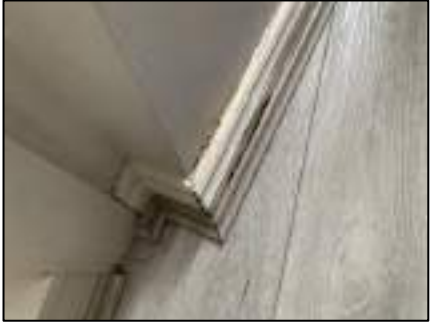
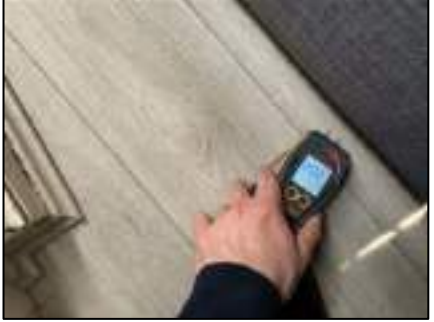
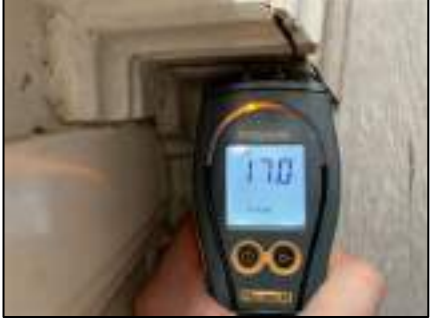
ITEM	LOCATION	DESCRIPTION	PHOTOGRAPH(S)
6.0	UNIT 109 (68 ETON)		
6.1	Living Room	<p>Evidence of water penetration in the form of rotting and moisture damaged timber skirting boards along the perimeter bay window walls.</p> <p>Elevated moisture meter readings were recorded in same.</p>

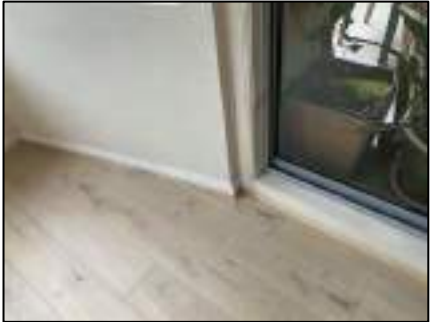
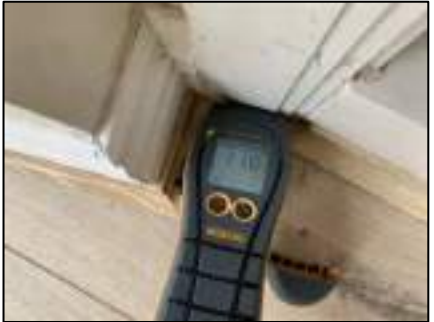
7.0	UNIT 110 (68 ETON)		
7.1	Living Room	<p>Evidence of water penetration in the form of moisture damaged timber flooring and skirting boards along the northern and western protruding bay window walls.</p> <p>Evidence of water penetration in the form of moisture damaged flooring and skirting boards adjacent to the balcony sliding door assembly.</p> <p>Low level moisture meter readings were recorded in same.</p>

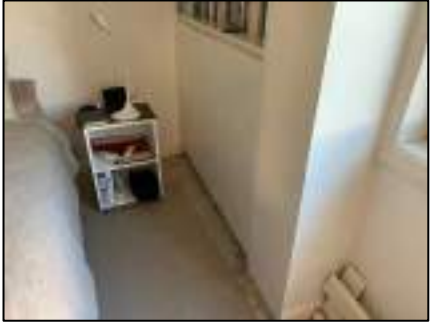
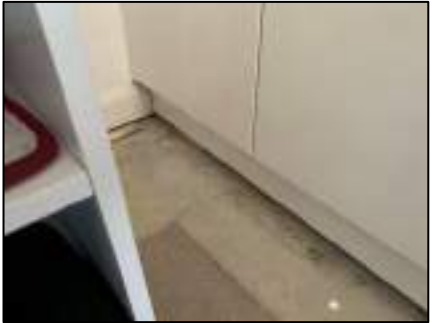
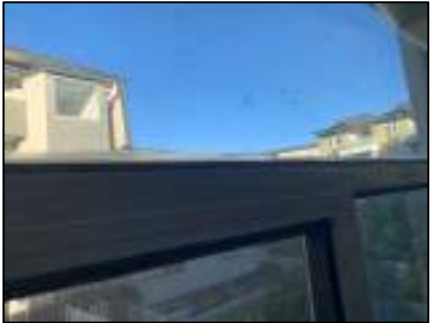
ITEM	LOCATION	DESCRIPTION	PHOTOGRAPH(S)
8.0	UNIT 201 (68 ETON)		
8.1	Second Bedroom	<p>Advised by the resident of water penetration occurring along the base of the eastern wall (opposing the protruding roof of the ground floor unit below). The resident advised that the water penetration occurred during the significant 'east coast low' storm during February 2020.</p> <p>The carpet and underlay throughout the north-eastern corner of the room have been removed due to extensive water penetration damage.</p> <p>The resident advised that previous works have been undertaken, namely through the installation of a significant amount of silicone throughout the east facing window.</p>

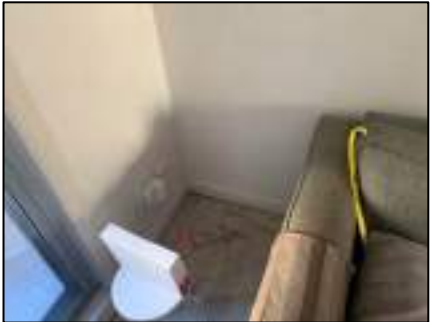
8.2	Living Room	<p>Advised by the resident of water penetration occurring through the base of the eastern wall adjacent to the balcony sliding door.</p> <p>The resident advised that previous investigations have been undertaken by <i>Network Construction Services</i>, involving the flood testing of the balcony. We understand that the flood testing on the balcony did not elicit any internal water penetration.</p> <p>The carpet and timber smooth edges throughout the south-eastern corner of the room have been removed due to extensive water penetration damage.</p>

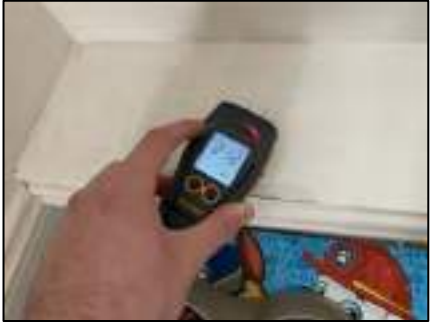
ITEM	LOCATION	DESCRIPTION	PHOTOGRAPH(S)
		<p>Evidence of water penetration in the form of moisture damaged skirting boards and carpet in the south-eastern corner of the room.</p> <p>Elevated moisture meter readings were recorded from the base of the southern wall and timber skirting boards.</p>

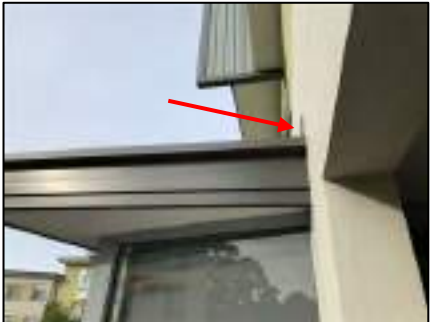
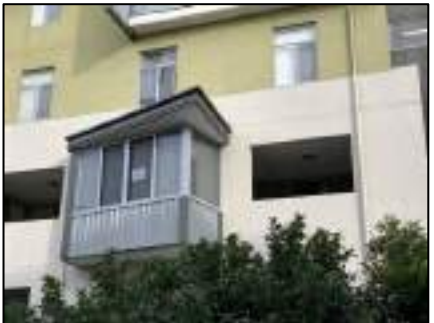
9.2	Balcony/ Facade	A pressure sealed apron flashing is located at the junction of the roof and the façade.

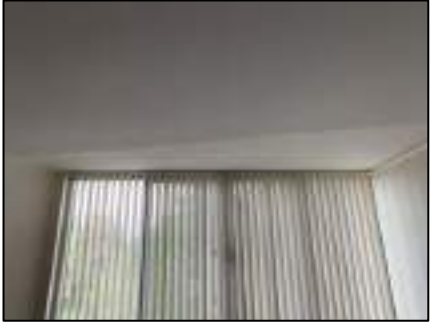
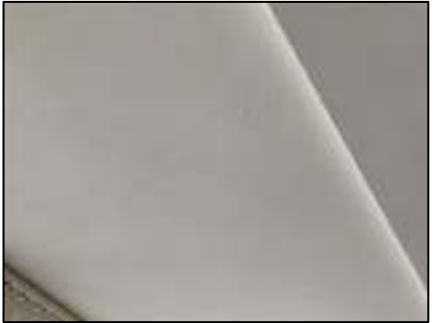
ITEM	LOCATION	DESCRIPTION	PHOTOGRAPH(S)
10.0	UNIT 204 (68 ETON)		
10.1	Living Room	Evidence of water penetration in the form of blistering and moisture stained paintwork on the ceiling, located beneath the junction between the bay window roof and western façade.

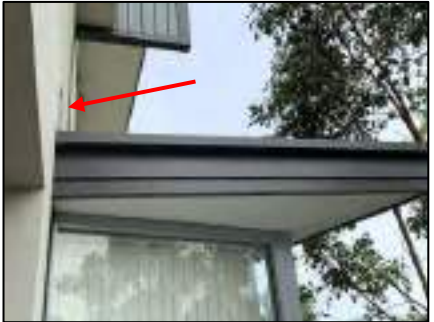
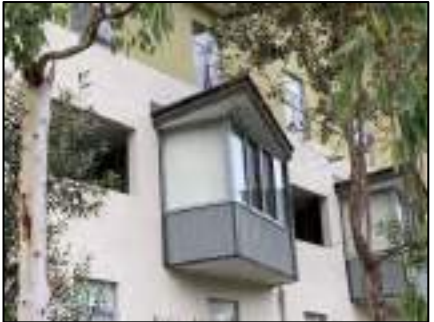
4.2	Balcony/ Façade	A pressure sealed apron flashing is located at the junction of the roof and the façade.

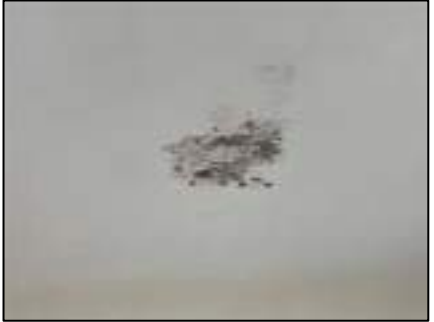
ITEM	LOCATION	DESCRIPTION	PHOTOGRAPH(S)
11.1	UNIT 501 (70 ETON)		
11.1	Entry Foyer	<p>Evidence of water penetration in the form of blistering and mould stained paintwork on the ceiling within the common entry foyer.</p> <p>Advised by the resident that water penetrates through the downlight and fire system penetrations.</p>

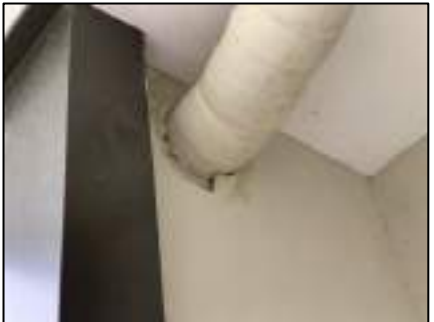
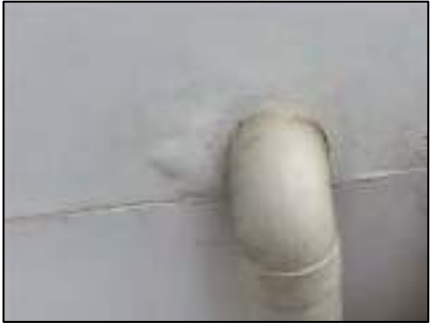
11.2	Balcony	<p>Water penetration is evident through the stormwater downpipe penetration in the south-eastern corner of the balcony soffit.</p> <p>Evidence of water penetration in the form of blistering paintwork and moisture staining at the location of the northern downpipe penetration. The downpipe appears to be servicing the box gutter of the rooftop above.</p>

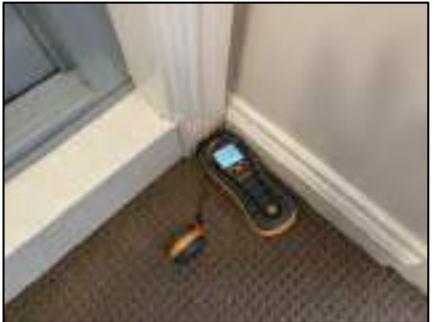
12.0	UNIT 102 (51 MERTON)		
12.1	Second Bedroom	<p>Advised by the resident of previous water penetration occurring through the base of the western wall, beneath the fixed pane window.</p> <p>Elevated moisture meter readings were recorded from the carpet and skirting boards throughout the south-western corner of the room.</p> <p>The room is located adjacent to the external tiled terrace area.</p>

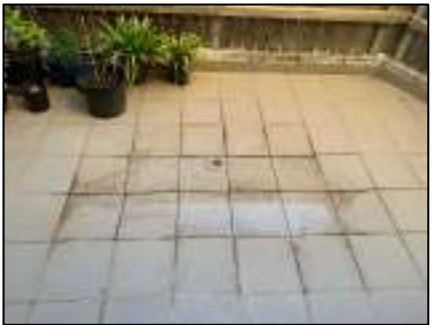
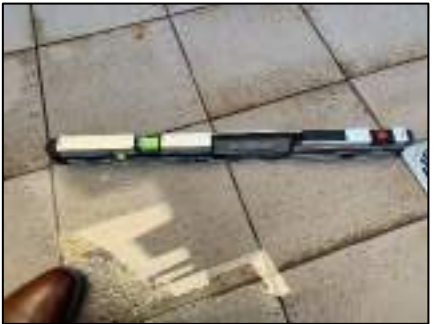
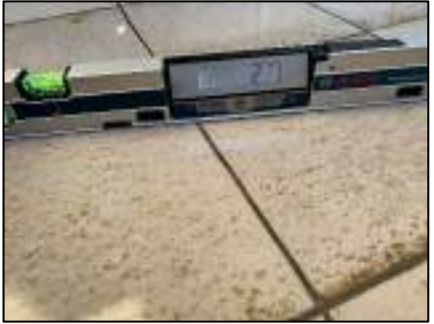
12.2	Terrace	<p>Widespread delaminating and drummy tiling throughout the entire terrace area.</p> <p>Previous works have been undertaken, evidently through the caulking of joints between the uplifted tiling.</p> <p>There does not appear to be any provision of perimeter or central expansion joints in the tiling to accommodate thermal expansion.</p> <p>Undrained water on the balcony tiles. Insufficient falls (2mm/m) away from the central drainage outlet.</p>

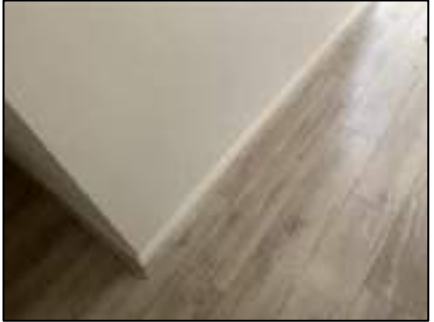
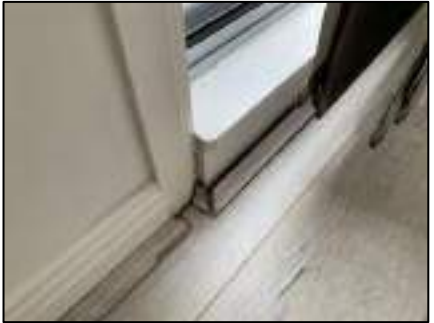
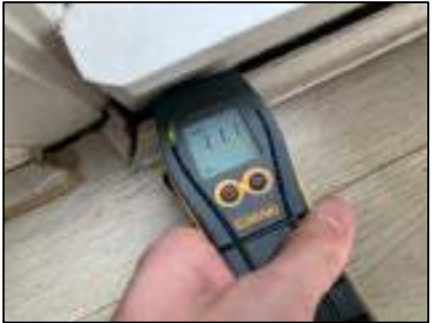
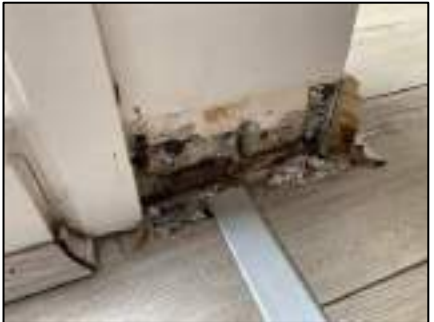
ITEM	LOCATION	DESCRIPTION	PHOTOGRAPH(S)
14.0	UNIT 303 (51 MERTON)		
14.1	Living Room	<p>Advised by the resident of previous water penetration emanating from the eastern balcony during significant rainfall.</p> <p>Evidence of water penetration in the form of moisture damaged timber flooring and skirting boards along the walls adjacent to the balcony.</p> <p>Low level moisture meter readings were recorded from the moisture damaged sections of the flooring and skirting boards.</p> <p>Significant corrosion and moisture damage to steel wall framing adjacent to the balcony area</p>

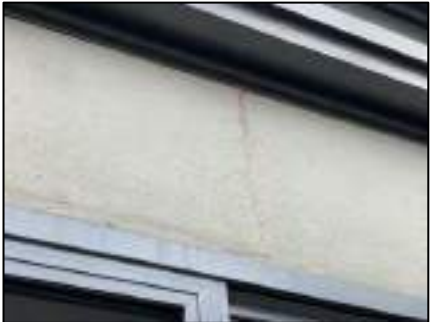
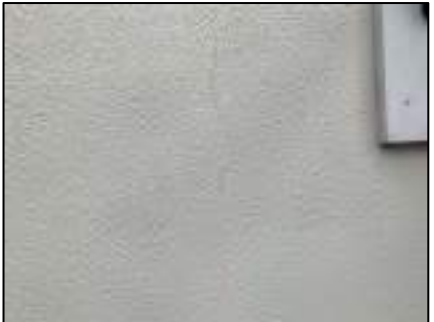
ITEM	LOCATION	DESCRIPTION	PHOTOGRAPH(S)
		Isolated cracking and separation along the joints in the fibre-cement 'blue board' façade sheeting. The façade coating membrane applied to same is consequently tearing in these locations.

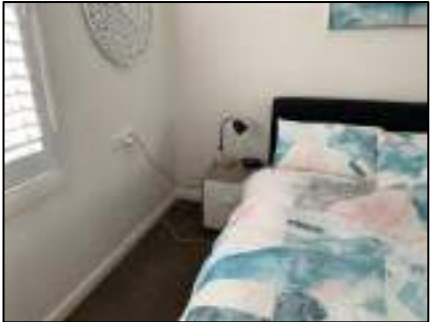
15.0	UNIT 501 (53 MERTON)		
15.1	Bedroom 1	<p>Advised by the resident of previous water penetration emanating from the eastern bedroom wall.</p> <p>It is understood that the water penetration was a one-off occurrence, during the significant 'east coast low' storm in February 2020.</p>

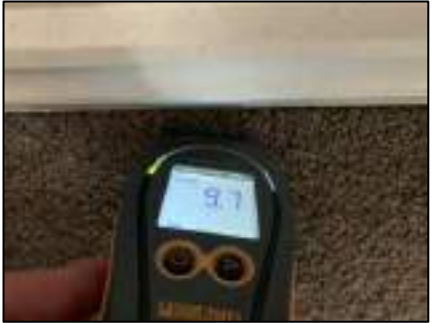
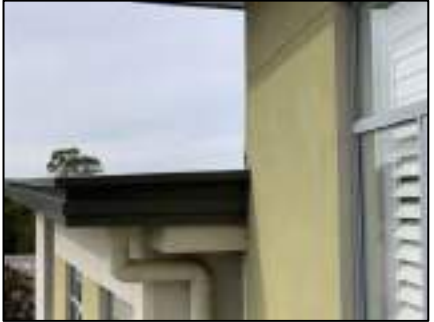
ITEM	LOCATION	DESCRIPTION	PHOTOGRAPH(S)
		<p>Low moisture meter readings were recorded from the base of the eastern walls and carpet.</p> <p>The external roof appears to step down on the eastern wall of the bedroom. No access was available to the rooftop to assess the detailing of same.</p>

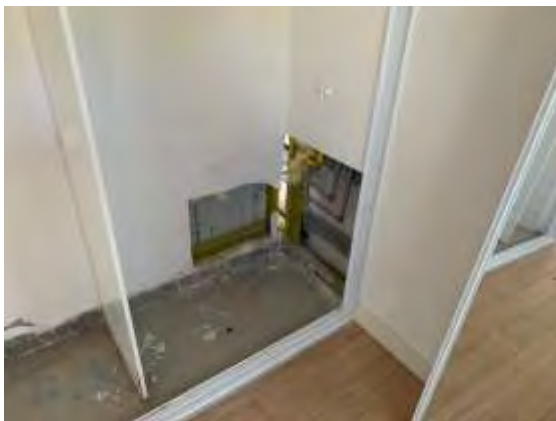
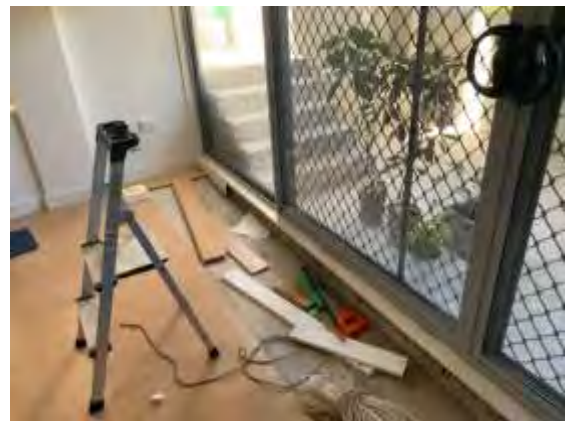
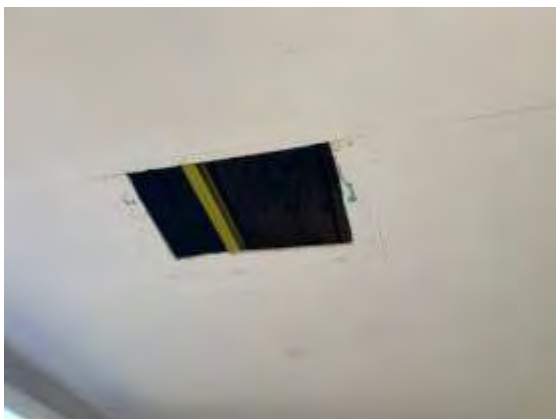
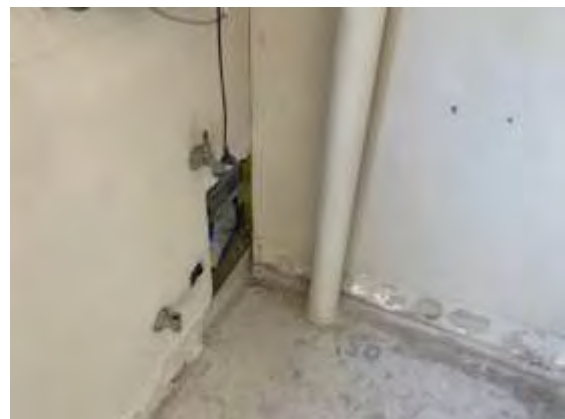
- The unit has been vacant since the storm event that occurred in February 2020.
- It is our understanding that work has commenced in order to investigate the source of the water penetration. This work has been undertaken by *Network Construction Services*.
- The lower balcony tiles and membrane had been demolished at the time of the inspection.
- Various openings have been installed in the facades and finishes as part of the investigation works.

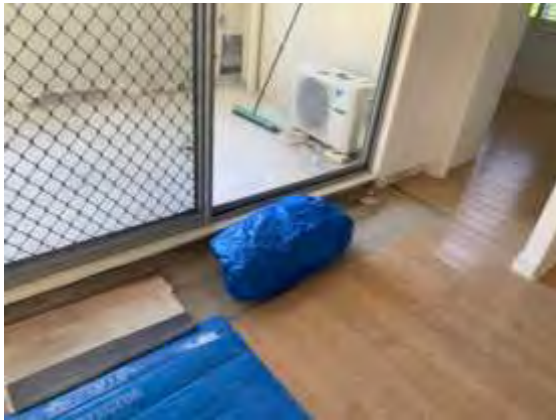
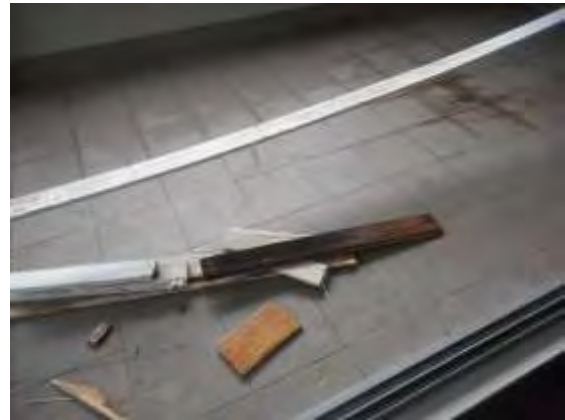
- Evidence of widespread water penetration damage into the living area of Unit 101.
- Two balconies and a planter box are located surrounding the living areas of Unit 101. The upper balcony and planter box are situated on the northern side of the apartment and the lower balcony faces east to *Merton Street*.

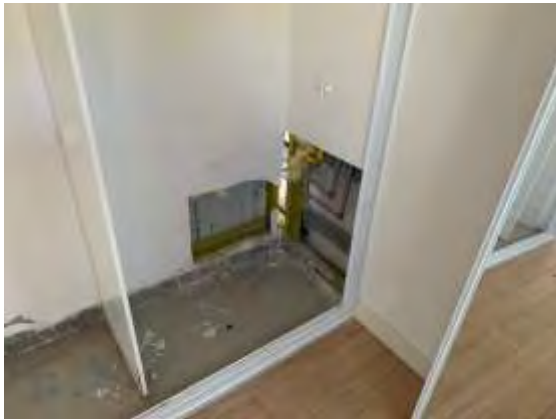
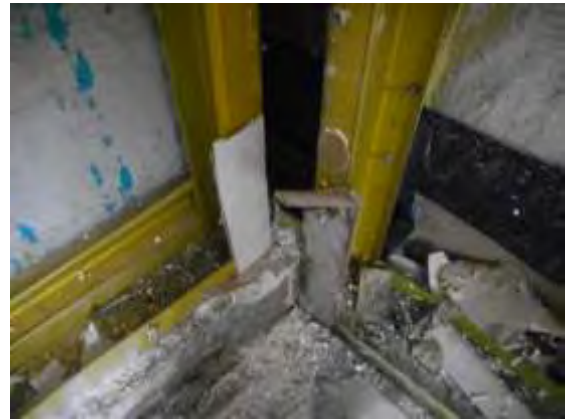
- Evidence of water penetration damage into the main bedroom of Unit 101. The northern wall of the bedroom abuts the southern end of the lower balcony.

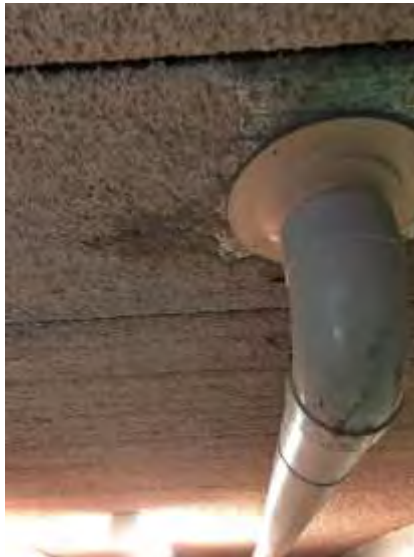
- We have been advised by *Network Construction Services* that the upper balcony has been flood tested and is contributing to the water penetration. Water penetration is also occurring into the storeroom located below.

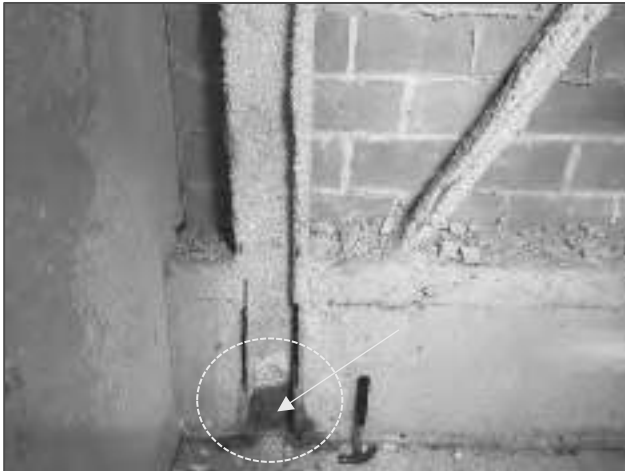
The steel column exhibiting evidence of corrosion is situated within the stairwell, in proximity to axis AL and A3. A visual examination reveals structural corrosion at the base of the column, particularly in the vicinity of the footing, where steel surface delamination is evident. In contrast, the upper portion of the column displays only minor instances of superficial corrosion. It is worth noting that the bottom of the column is in a constant moist condition. Vermiculite also absorbs water and disintegrates.

Photograph 1 – identified column in T1

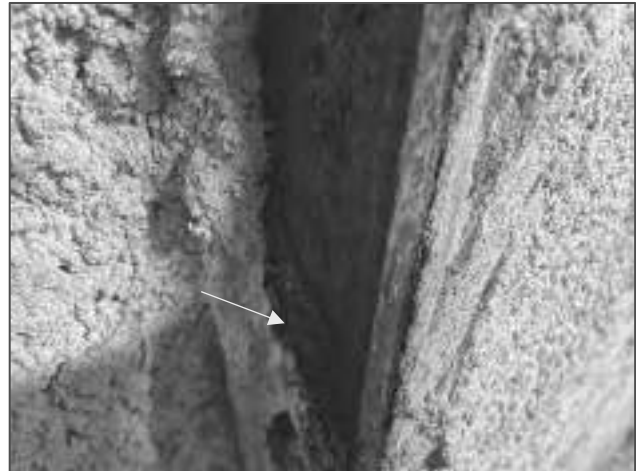
Photograph 2 – corrosion present at the base of the column

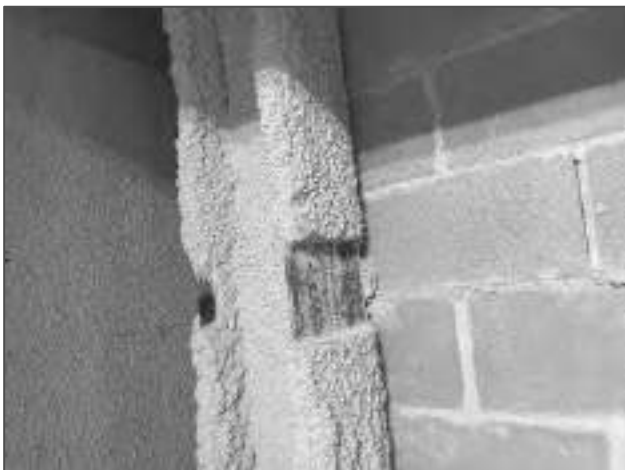
Photograph 3 –minor surface corrosion to the upper area

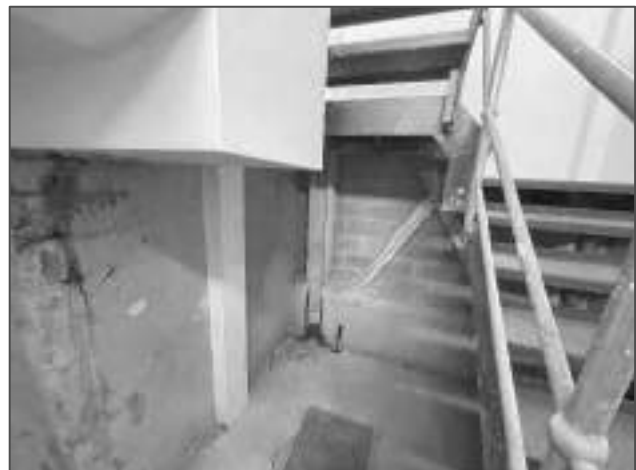
Photograph 4 – general view of the corroded column

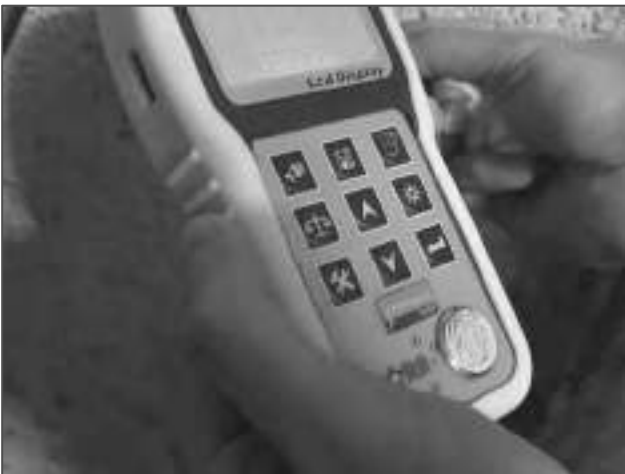
Upon removing the flaking rust, and all loose material, from the lower section and subjecting it to impact with a hammer, a solid sound was emitted, accompanied by a consistent vibration. These outcomes collectively suggest that the column is in a robust and stable condition. The results from multiple ultrasound readings consistently indicated that the flange thickness has not undergone substantial reduction from its intended measurement, despite the present evidence of superficial corrosion. This phenomenon could potentially be attributed to the fact that the discrepancy error of the initial thickness of the steel falls within the higher range of the spectrum, typically varying from -0.5mm to 0.5mm, and the corrosion is mostly causing delamination of the coating layer.

Photograph 8 – UTG reading of the flange thickness on the lower part, 1st reading.

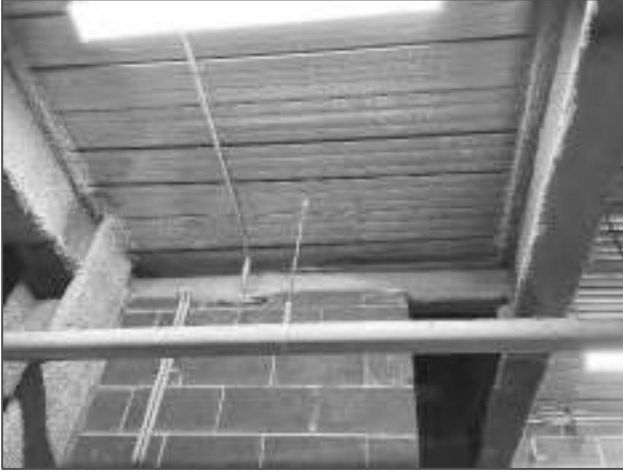
The steel beam T2 with evidence of severe corrosion is located within the stair well near axis B4 and AD. Water stain, and general organic growth, was observed to be present to surrounding building materials, such as blockwork and mortars. Water infiltration from the exterior, originating at the top of the steel element, is evident across the entire beam length.

Photograph 12 – view of the beam from the outside

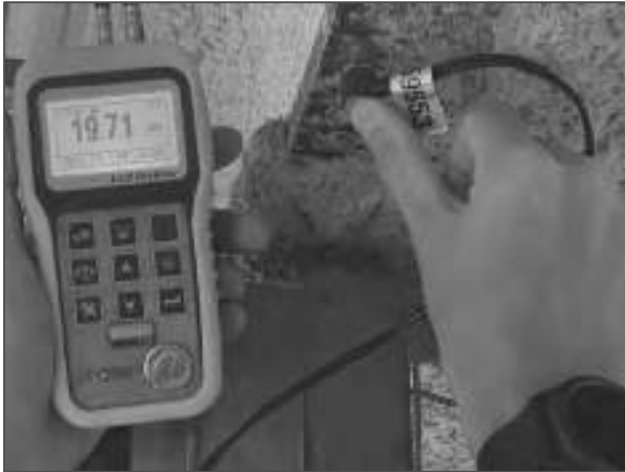
Photograph 18 – UTG reading, T4

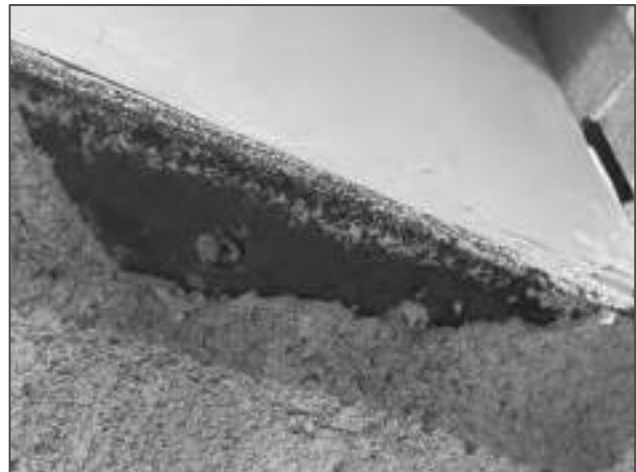
Photograph 21 – presence of surface corrosion on T5

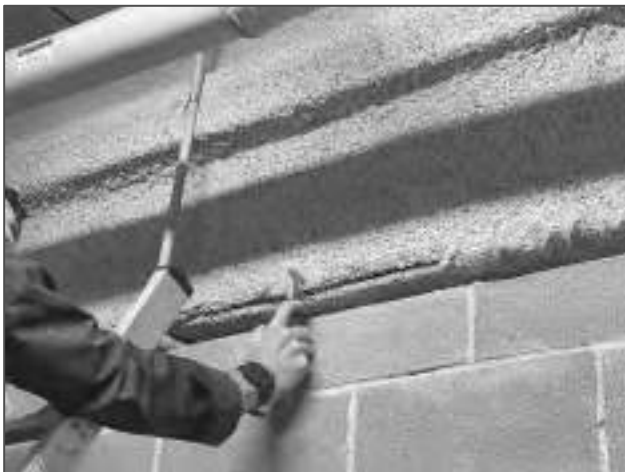
Photograph 22 – calibrator measurement, T3

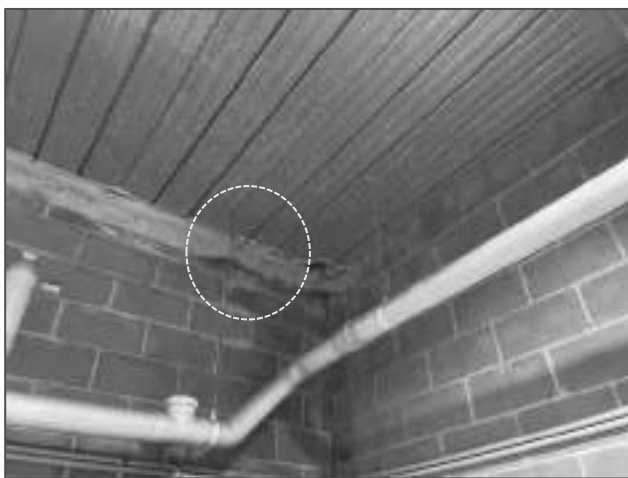
Photograph 24 – T6 before removal of the vermiculite coating

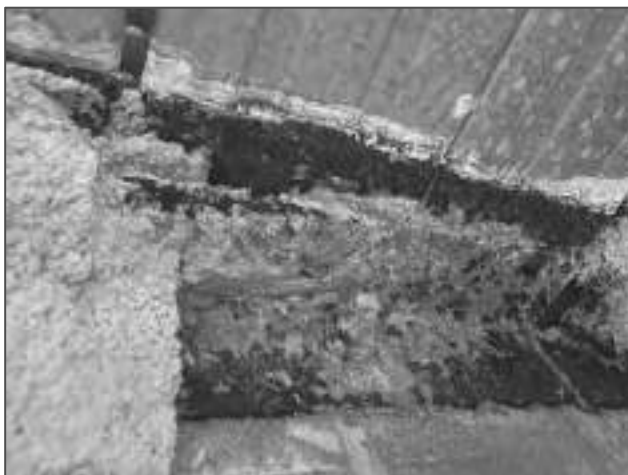
Photograph 26 – widespread surface corrosion

- 1) Clean back the corrosion and assess the condition of the slab steel formwork sheet.
- 2) Ironbridge to examine the shear capacity of the slab in the event that the material is no longer present.
- 3) Rectification of all problems related to water ingress and associated waterproofing deficiencies.

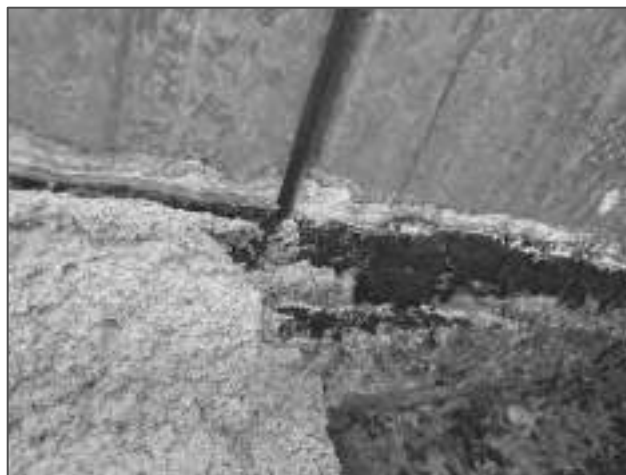
Photograph 27 – white oxide residue on the surface of the slab formwork-sheet system.

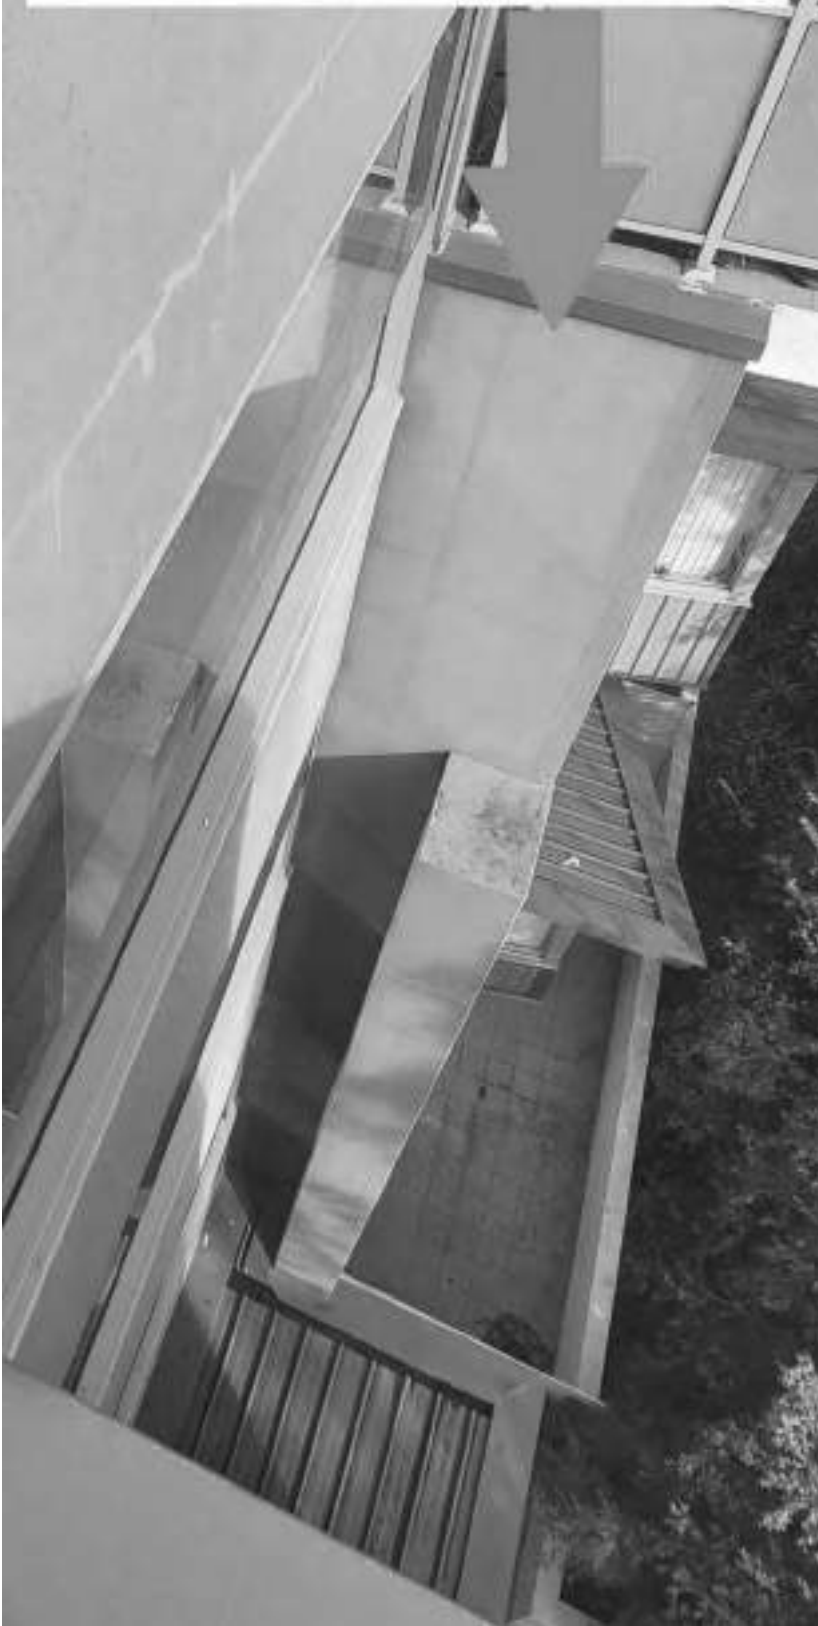
Perpendicular south wall with significant cracking also requires repairs, jointing work, elastomeric coating system
