**THE OWNERS - STRATA PLAN NO. 85881 | 68-70 ETON STREET & 51-53 MERTON STREET,
SUTHERLAND NSW 2232 | BUILDING DEFECTS**

BUILDING INSPECTION REPORT 100838 - REV D.2

68 Eton Street Sutherland New
South Wales 2232
Report Date: 6th October 2023

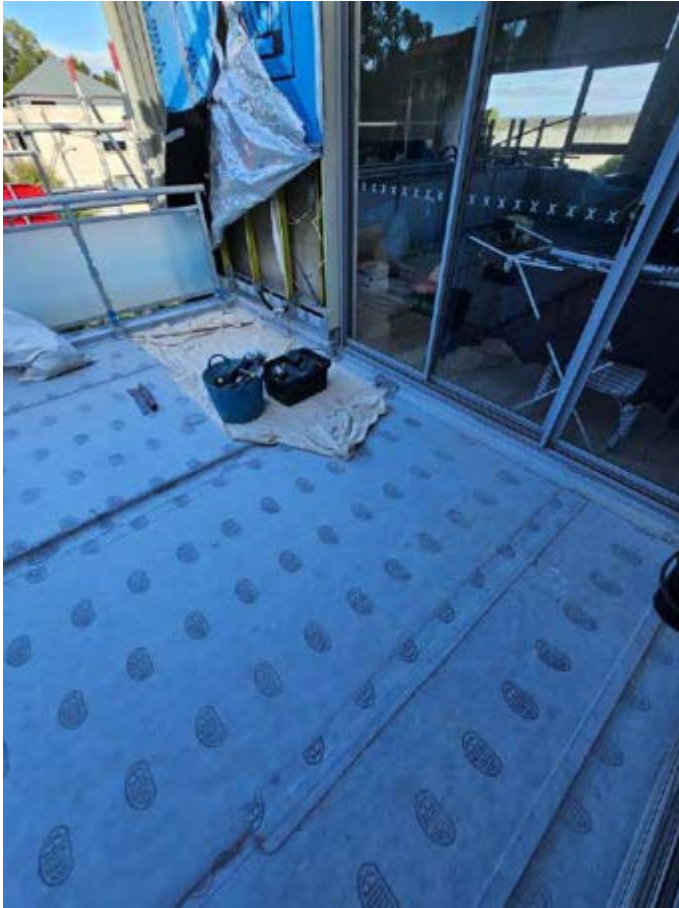
PHOTO 1

All waterproofing has been installed. Waterproofing continues into all wall cavities with the wall sarking to over flash and cavity flashing to dress out over the skirting tiles.

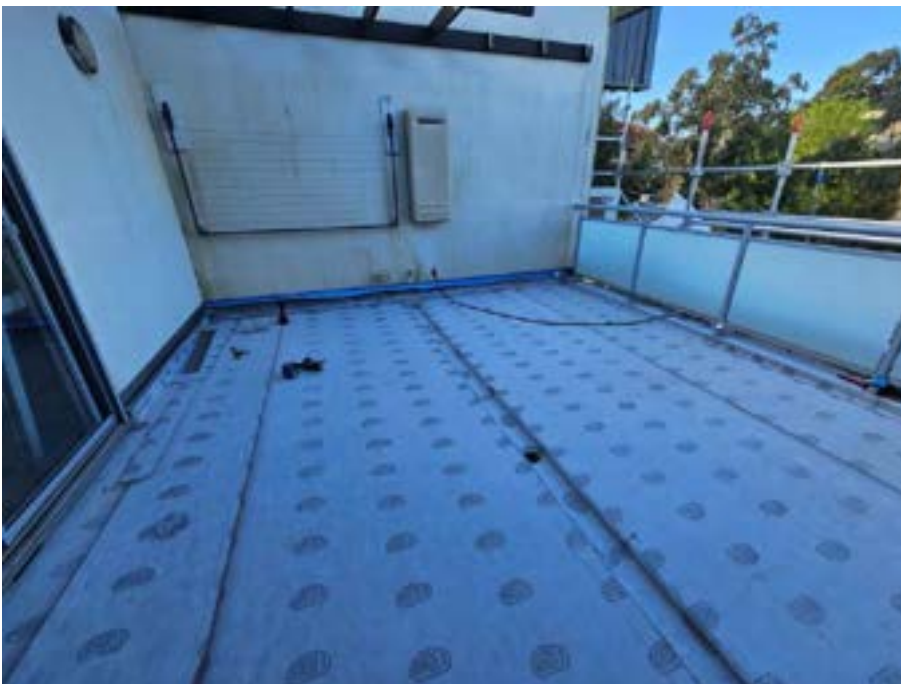
PHOTO 2

All waterproofing has been installed. Waterproofing continues into all wall cavities with the wall sarking to over flash and cavity flashing to dress out over the skirting tiles.

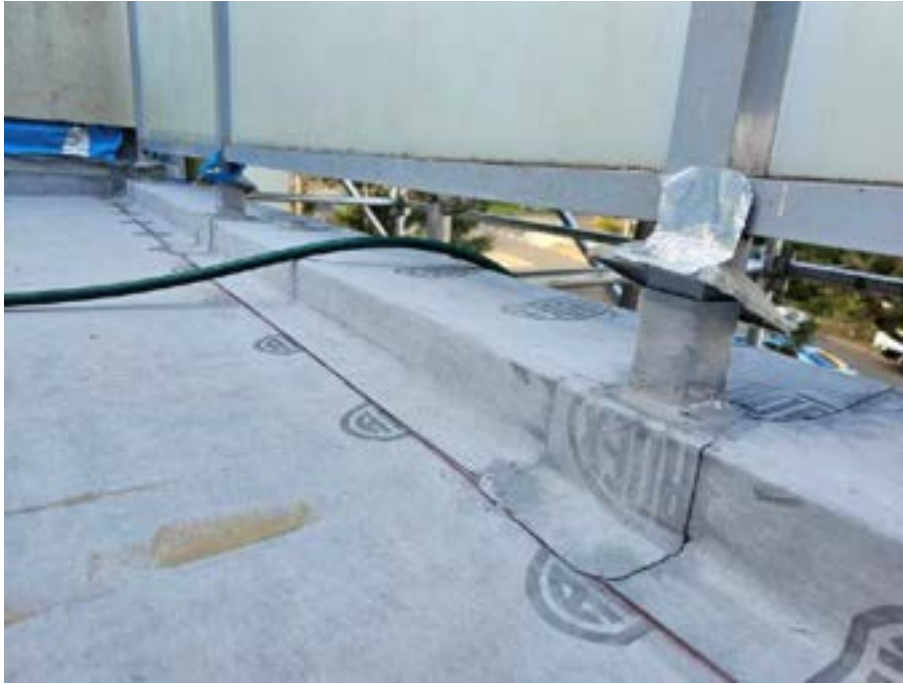
PHOTO 3

All waterproofing has been installed. Waterproofing continues into all wall cavities with the wall sarking to over flash and cavity flashing to dress out over the skirting tiles.

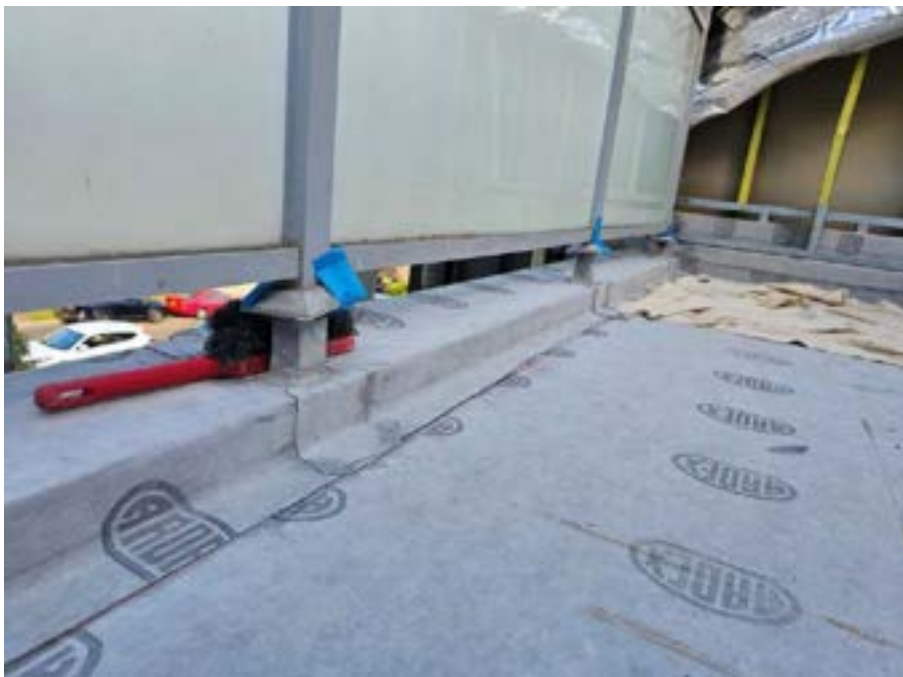
PHOTO 4

All waterproofing has been installed. Waterproofing continues into all wall cavities with the wall sarking to over flash and cavity flashing to dress out over the skirting tiles.

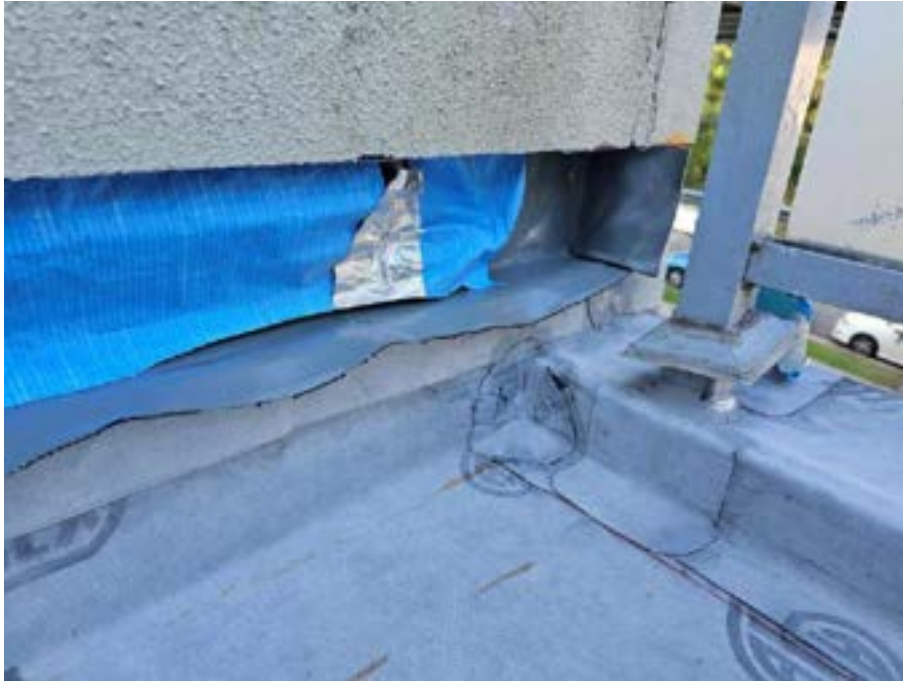
PHOTO 5

All waterproofing has been installed. Waterproofing continues into all wall cavities with the wall sarking to over flash and cavity flashing to dress out over the skirting tiles.

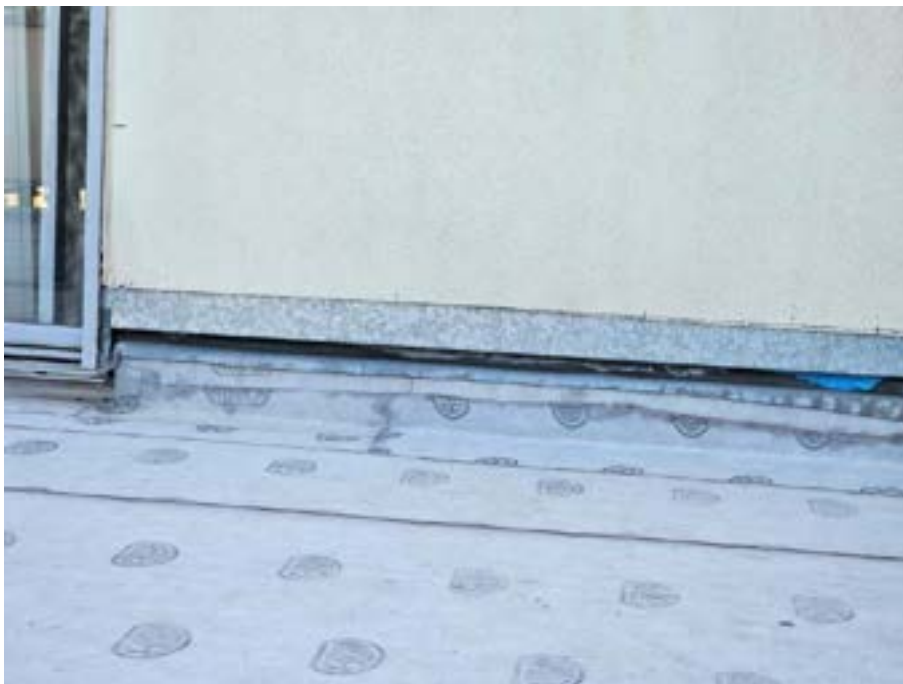
PHOTO 6

All waterproofing has been installed. Waterproofing continues into all wall cavities with the wall sarking to over flash and cavity flashing to dress out over the skirting tiles.

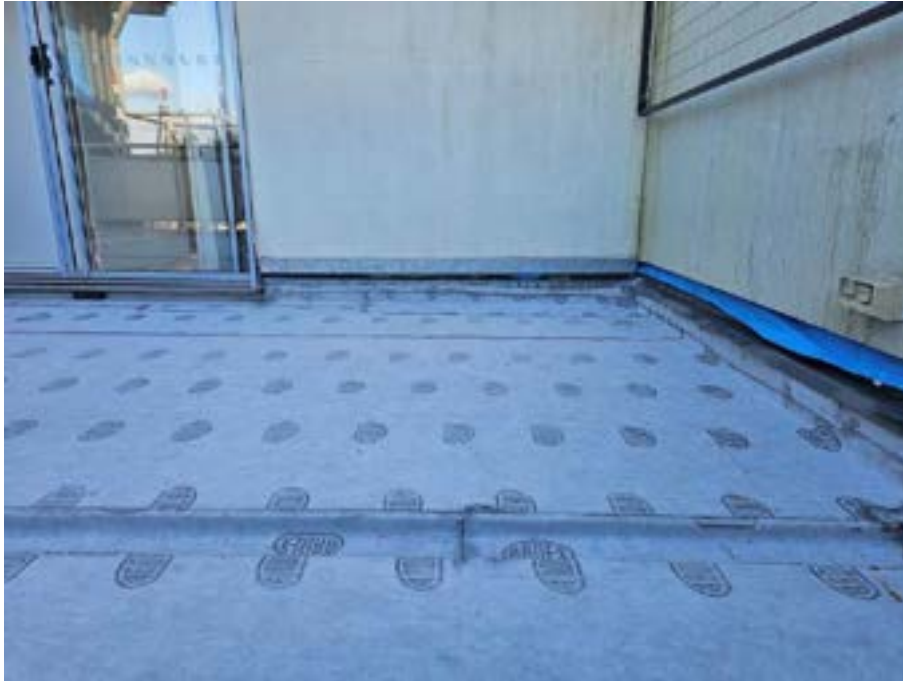
PHOTO 7

All waterproofing has been installed. Waterproofing continues into all wall cavities with the wall sarking to over flash and cavity flashing to dress out over the skirting tiles.

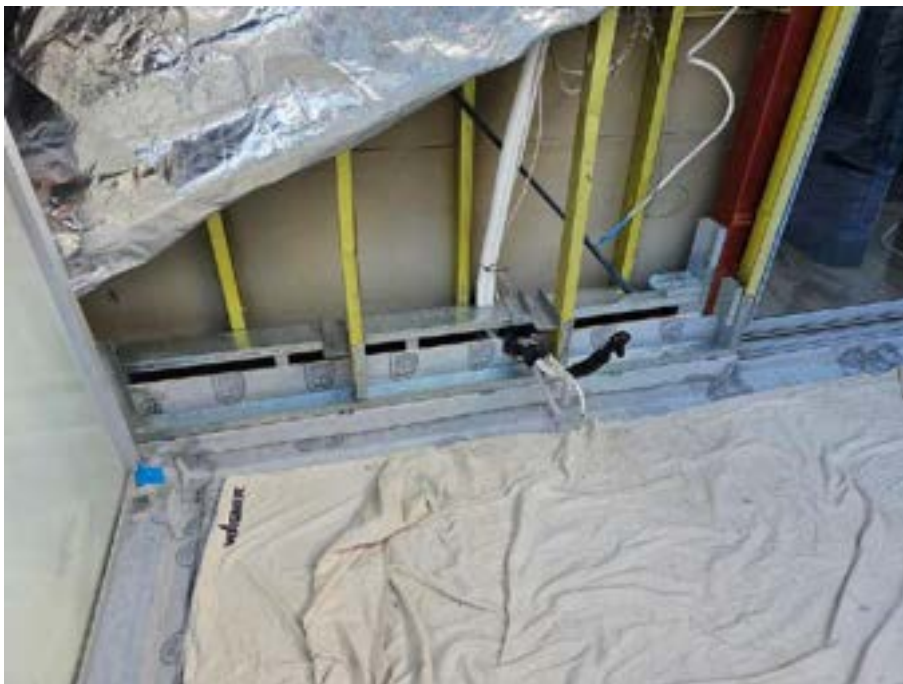
PHOTO 8

All waterproofing has been installed. Waterproofing continues into all wall cavities with the wall sarking to over flash and cavity flashing to dress out over the skirting tiles.

Falls to drainage can be observed within the placement of the balcony screen. A central channel drain has been installed with falls to the central drainage point.

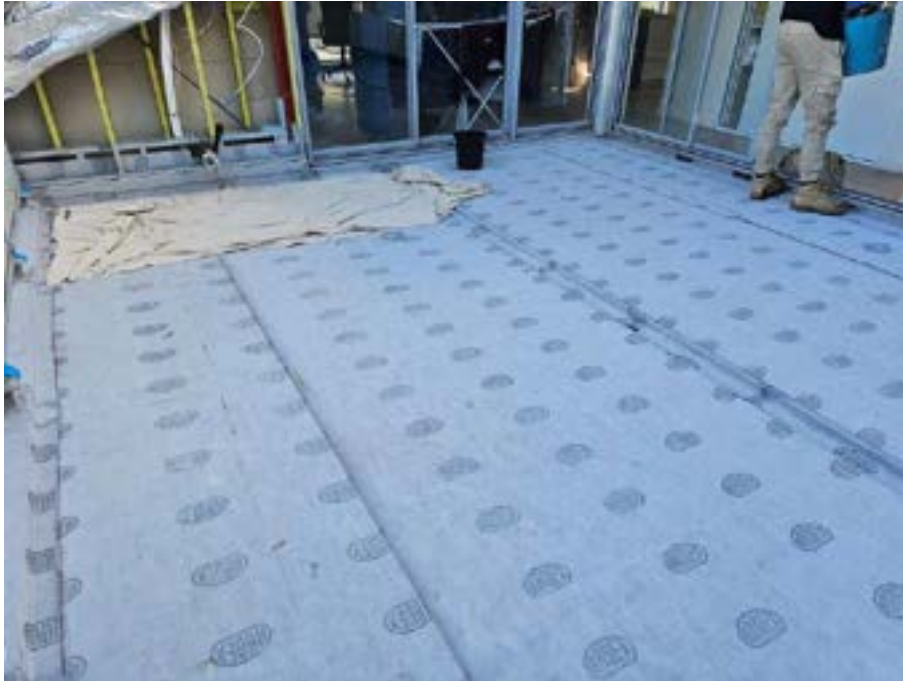
PHOTO 9

Falls to drainage can be observed within the placement of the balcony screen. A central channel drain has been installed with falls to the central drainage point.

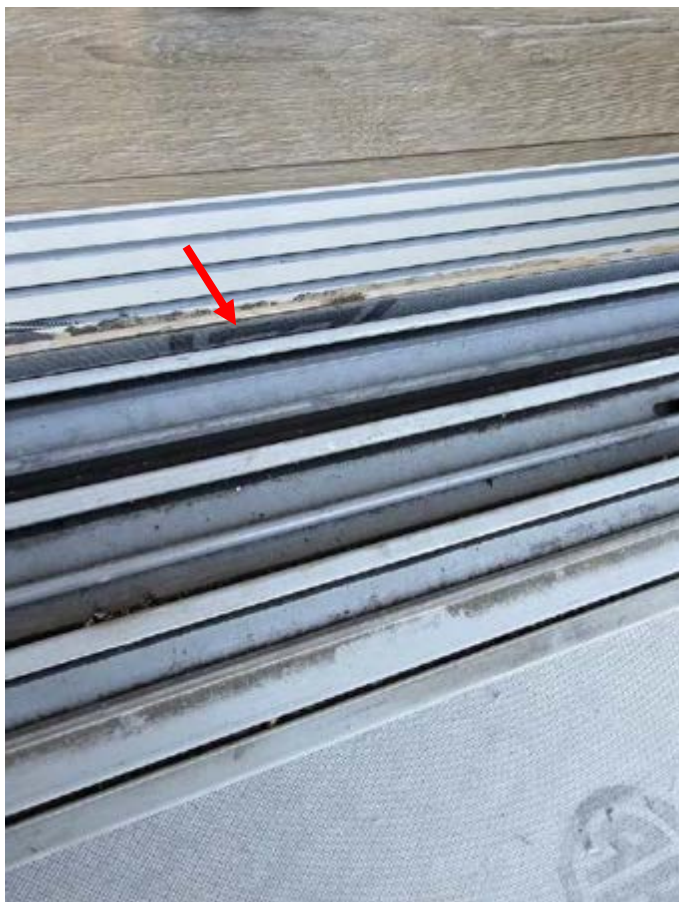
PHOTO 10

Waterproofing upturn evident at the water stop angles behind the balcony doors to the hallway.

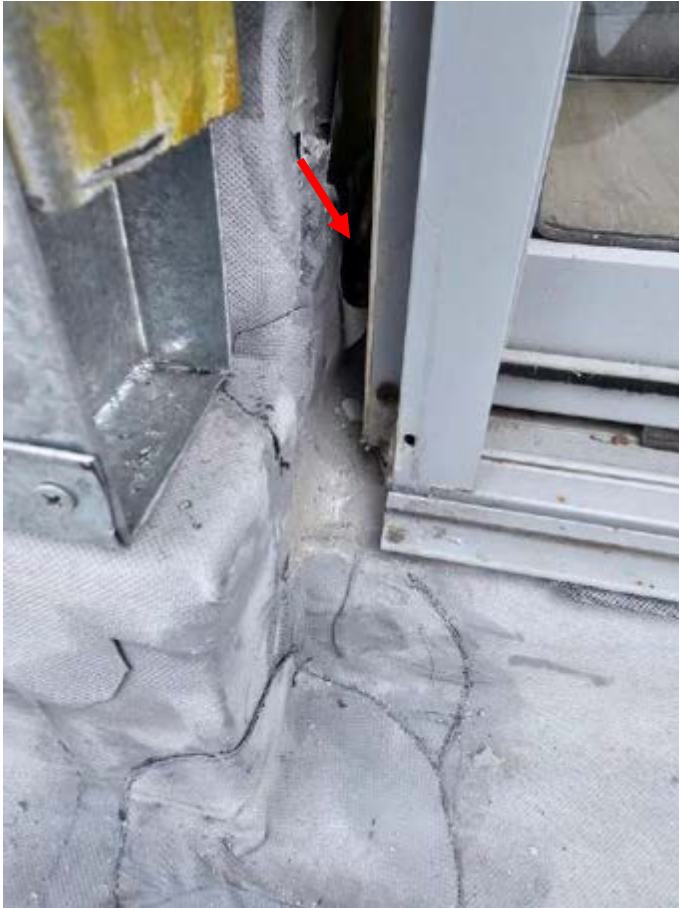
PHOTO 11

Waterproofing upturn evident at the water stop angles behind the balcony doors to the living room.

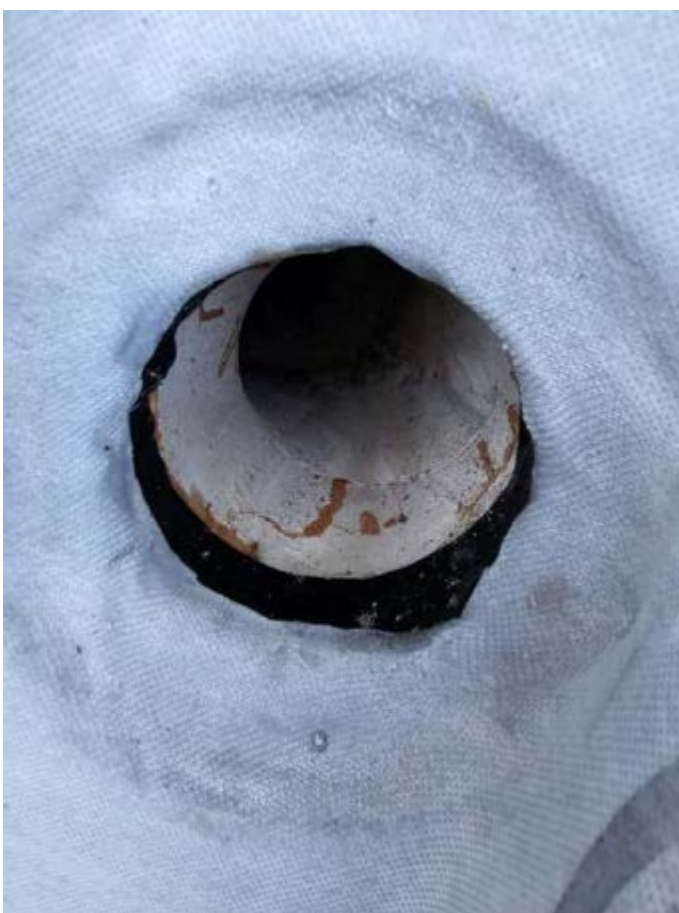
PHOTO 12

Waterproofing termination downturn into the central drainage point on the balcony.

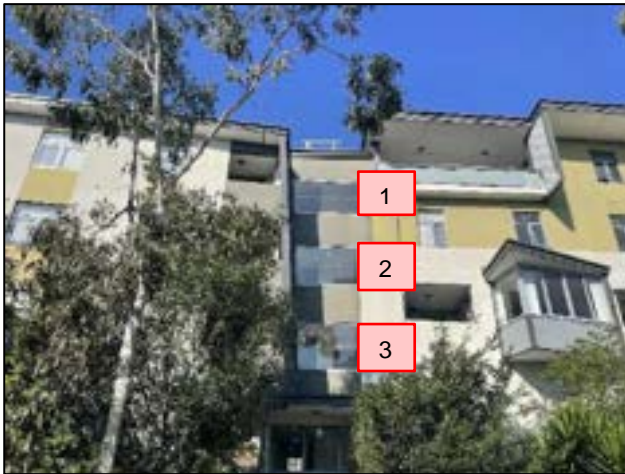
Non-destructive material testing with a glass heat-treatment indicator revealed that the glazing is annealed glass.

Photograph 1 – glazing on the west facade from Eton St

ID	Remedial actions
U1	Replace with Grade A safety glass
U2	Replace with Grade A safety glass
U3	Replace with Grade A safety glass
U4	Replace with Grade A safety glass
U5	Replace with Grade A safety glass
U6	Replace with Grade A safety glass
U7	Apply safety film
U8	Apply safety film
U9	Apply safety film
U10	Replace with Grade A safety glass
U11	Replace with Grade A safety glass

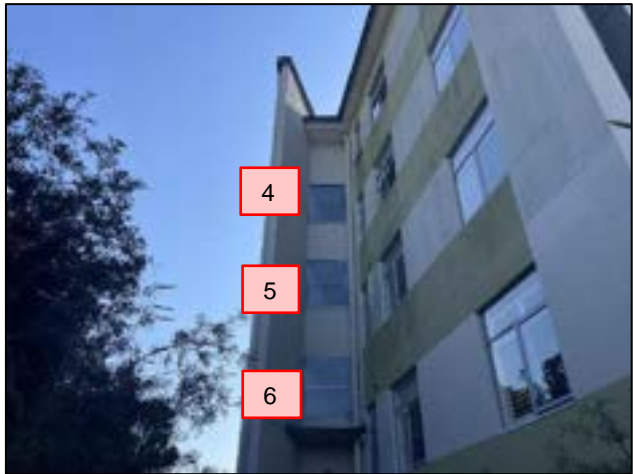
Photograph 2 – glazing on the east facade from Merton St

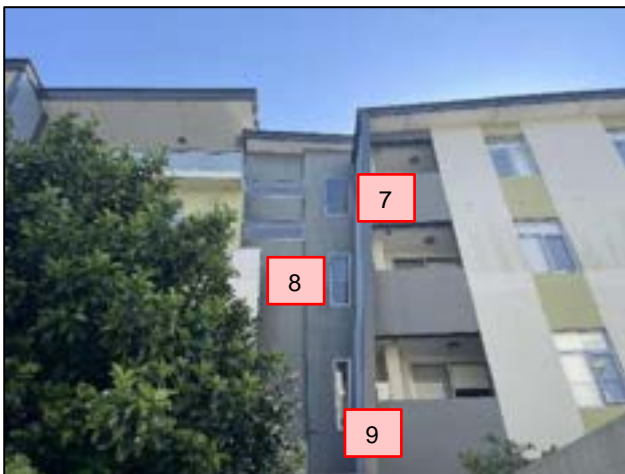
Photograph 3 – glazing on the east facade from courtyard

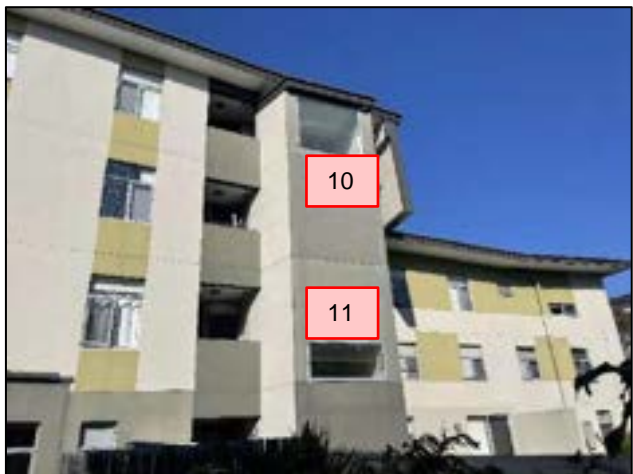
Photograph 4 – glazing on the west facade from courtyard

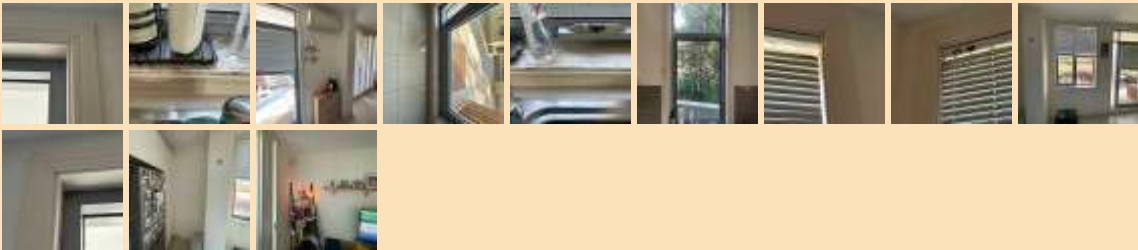
Description:
Kitchen window possible water damage from repaired tap - Observed to be in fair condition with partial signs of water penetration and fabric failure.

Resolution:
Monitor condition of building element (over proceeding 3 months) and where condition changes, consult with Remedial Engineer to review and provide design advice (where applicable) to rectify any water barrier systems, structural issues and undertake repairs to finishes as required.

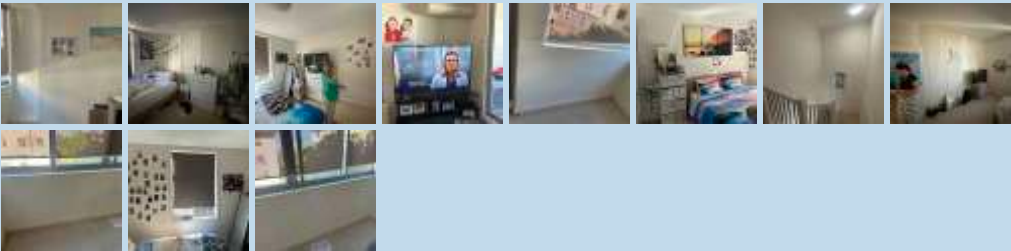
Description:
Observed to be in good condition. Minor non-structural deterioration.

Resolution:
Monitor condition of building element (over proceeding 6 months) and complete general cleaning and maintenance to finishes (where applicable).
