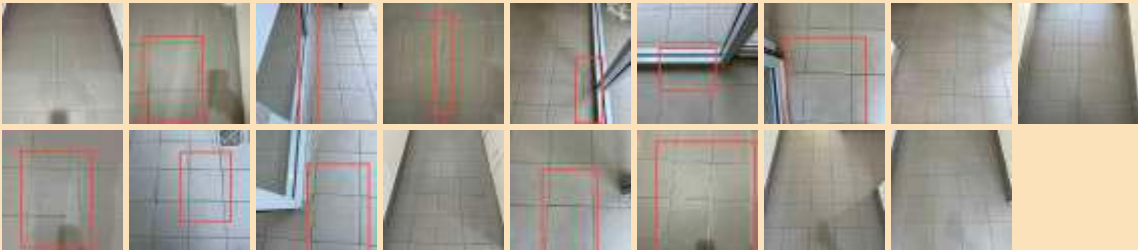
**Location:**  
Level 1 Lobby

**Description:**  
Main Entrance - Cracked tiles internal near entry door/window, externally neat drain. In general, grout is in poor condition both internally and externally.  
Observed to be in fair condition with partial signs of water penetration and fabric failure.

**Resolution:**  
Monitor condition of building element (over proceeding 3 months) and where condition changes, consult with Remedial Engineer to review and provide design advice (where applicable) to rectify any water barrier systems, structural issues and undertake repairs to finishes as required.

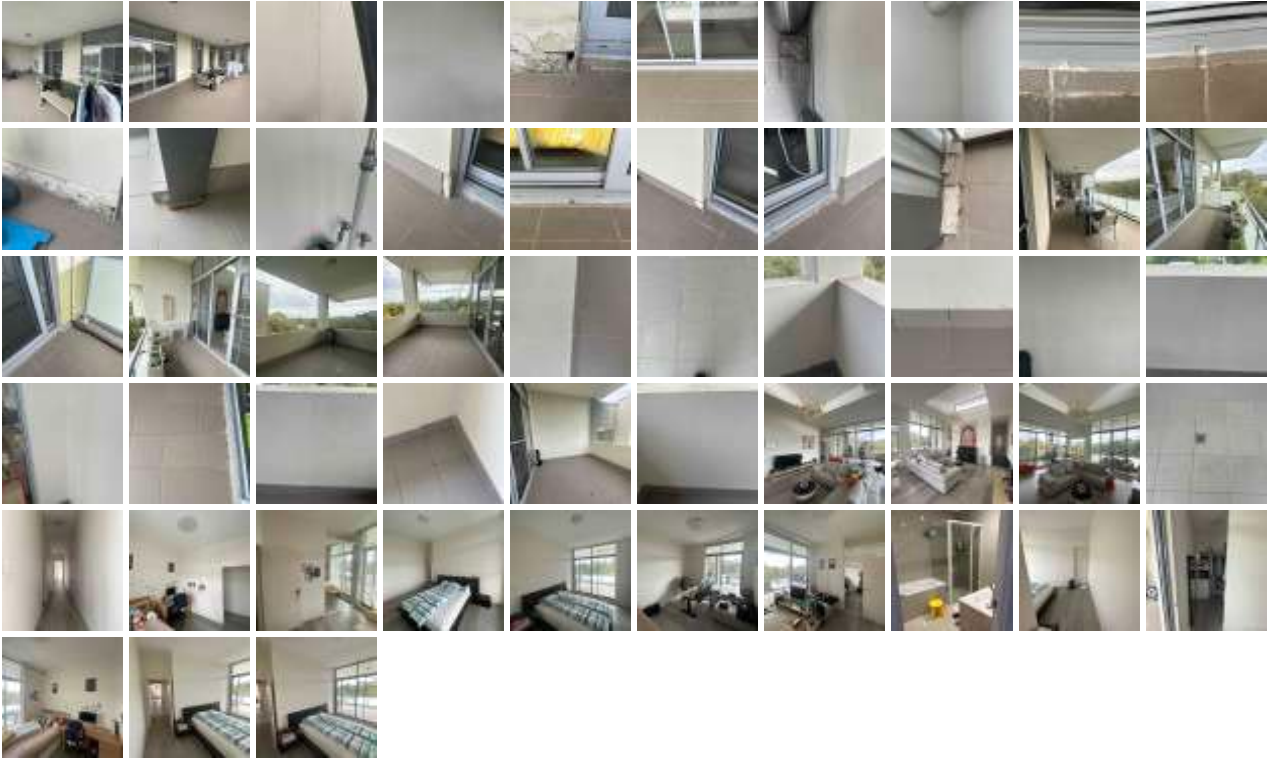
| General Structure | 502/70 Eton St | FAIL |

| <b>Poor</b><br><a href="#">ID:</a><br><a href="#">D-02972</a><br><a href="#">🔗</a> | <b>Description:</b><br>Observed to be in poor condition with significant signs of deterioration and structural failure<br><br><b>Resolution:</b><br>Consult with Structural Engineer to review and provide design advice (where applicable), rectify any structural issues, undertake repairs to finishes and repaint. |

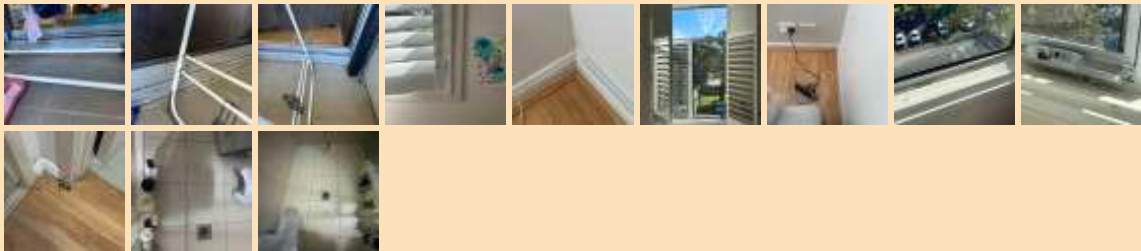
**Description:**  
Upstairs Shower - Shower Leaking.  
Observed to be in fair condition with partial signs of deterioration and potential structural failure

**Resolution:**  
Consult with Structural Engineer to review and provide design advice (where applicable), rectify any structural issues, undertake repairs to finishes and repaint.
