Building Report

93 The Grand Pde Sutherland

BUILDING & TIMBER PEST INSPECTION REPORT TO AS4349.1 2007 & AS4349.3 2010

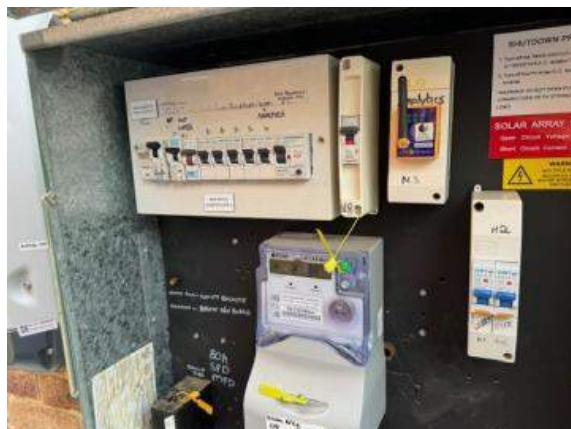
Whilst not an electrician, an electrical safety switch looks to be present to the building.

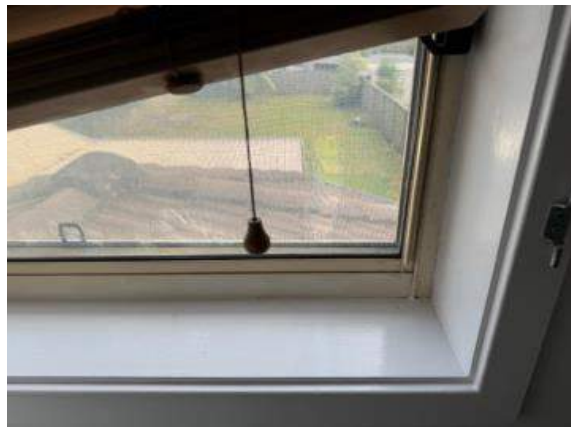
Some gauze requires repair.

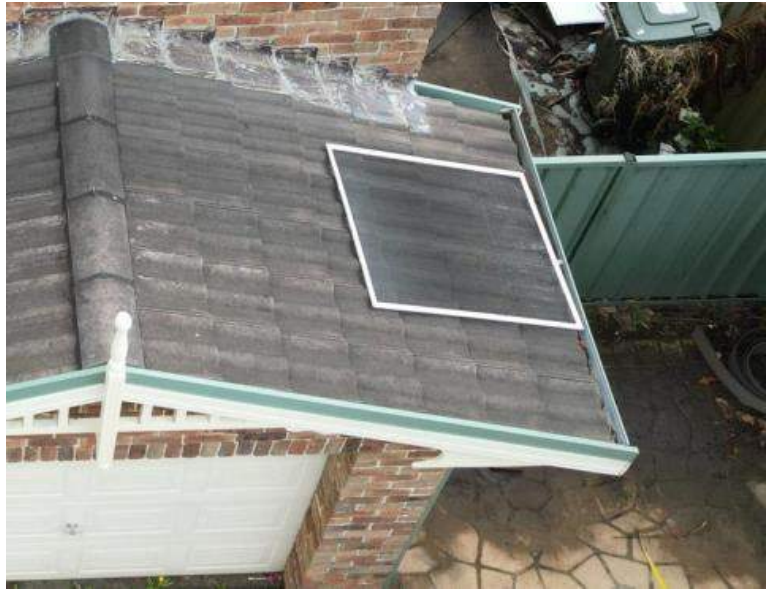
Insect screen has fallen from window frame onto the roof and requires re-fitting.

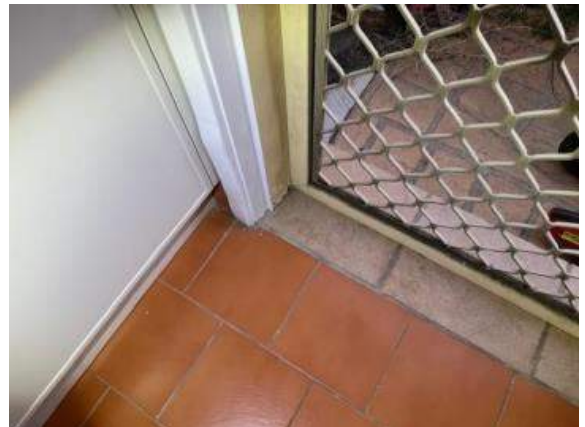
Weather damage to some timber door frames requires repair / repainting.

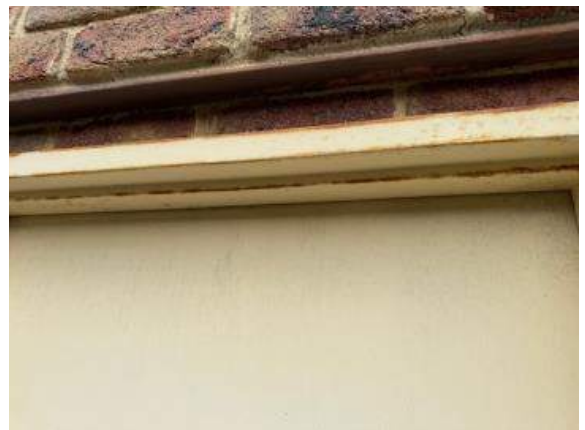
Rust to some steel door frames requires repair / repainting.

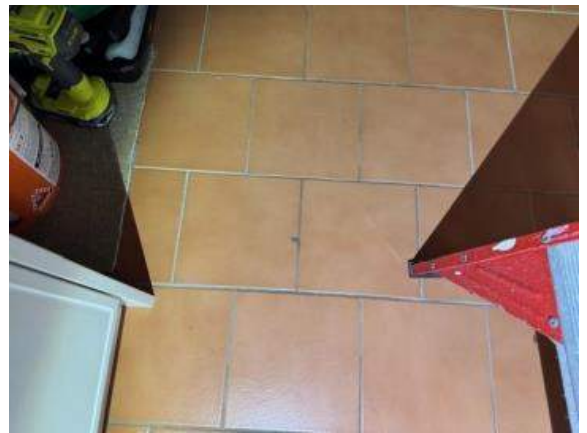
Percussion chips to some floor tiles.

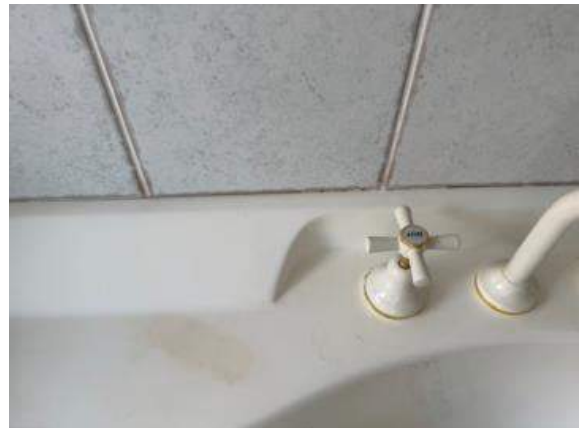
Junctions of vanity and wall tiles require resealing with silicone.

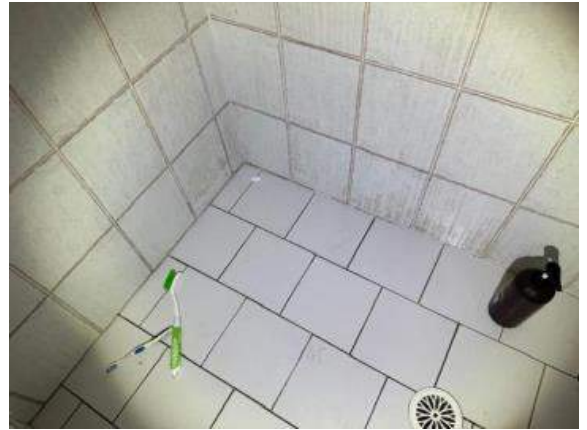
Junctions of shower floor and wall tiles require resealing with silicone.

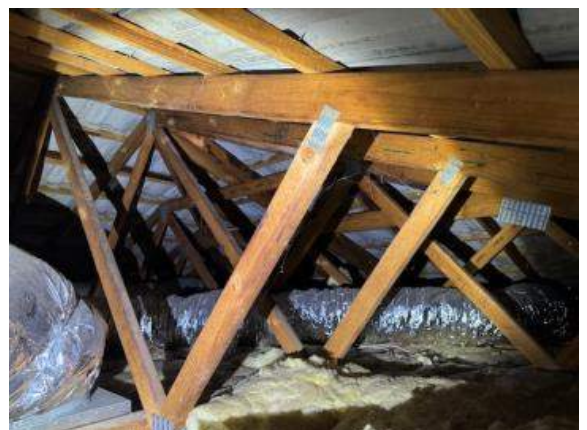
Satisfactory.

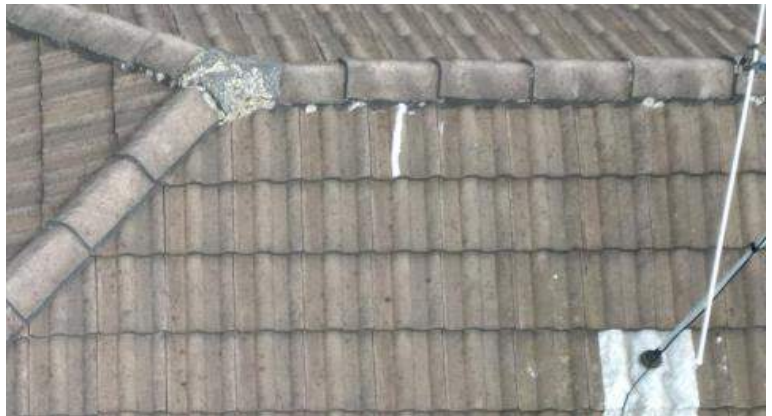
Some roof tiles have been repaired / sealed.

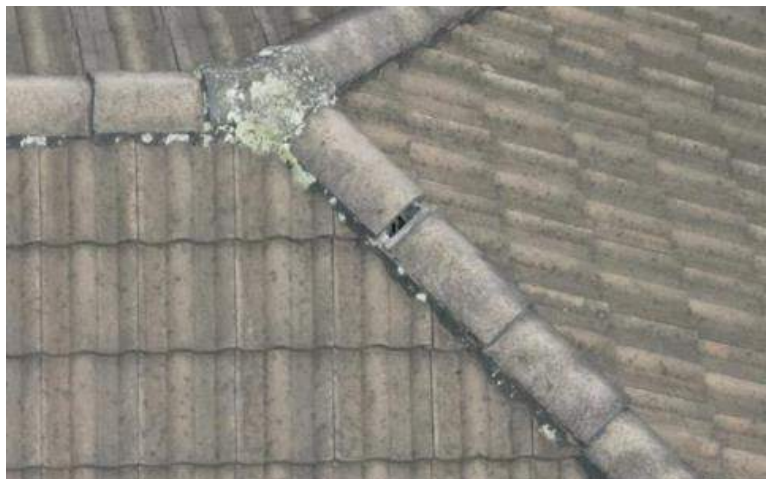
Gap in the hip capping tiles to be repaired/ sealed.

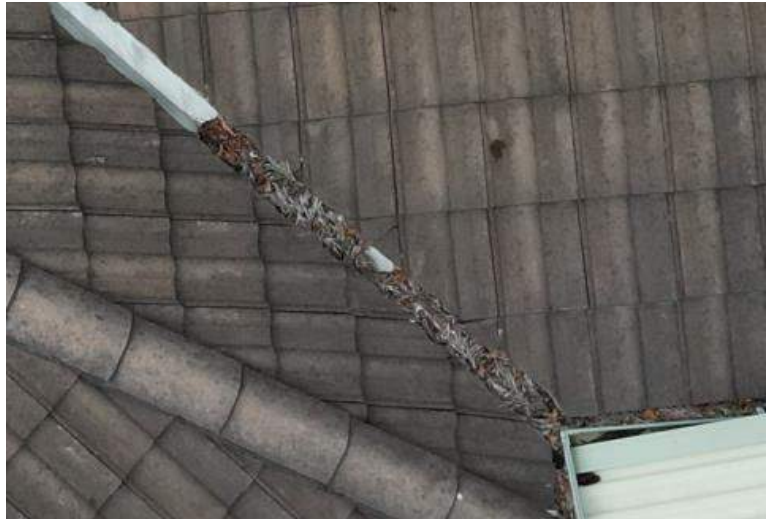
Cracked roof tiles require repair / replacement.

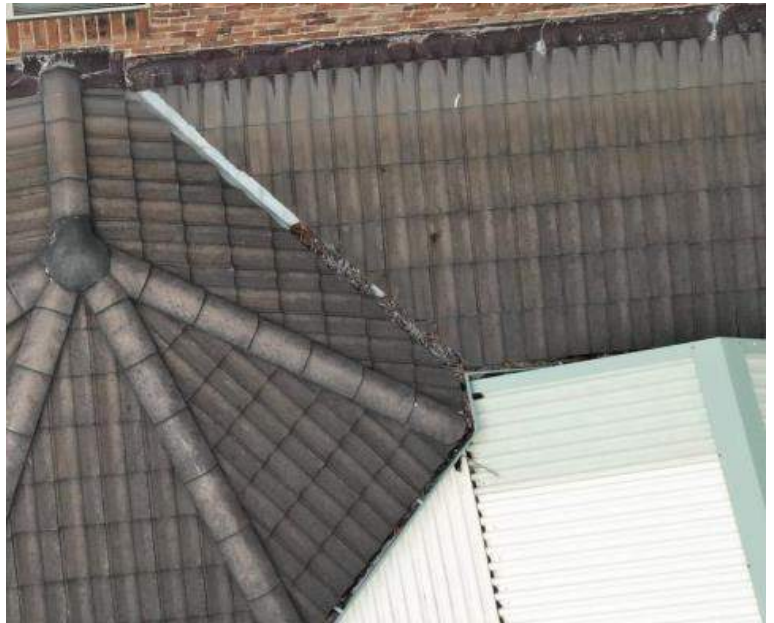
Some valleys require cleaning.

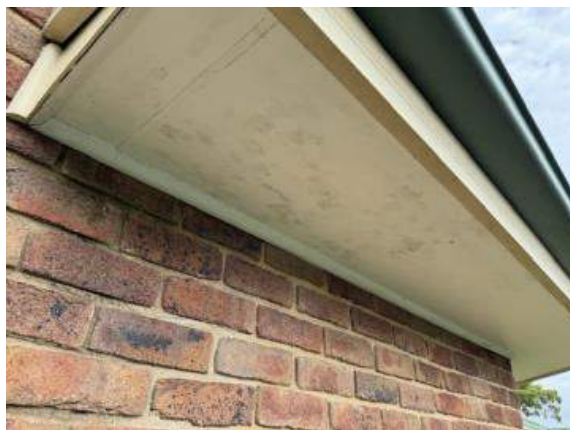
Weather damage to eaves requires repair repainting.

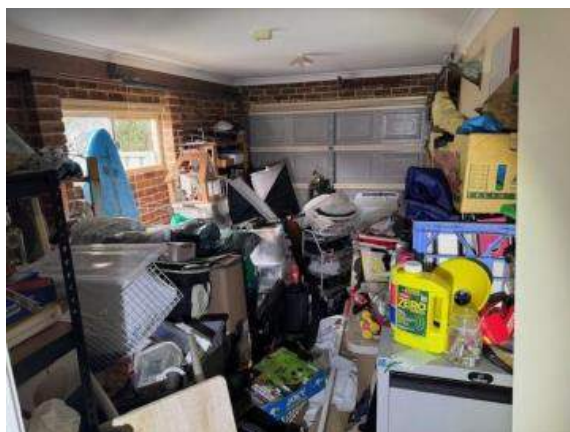
Some wall and floor areas were covered by excessive stored goods and were inaccessible.

Further inspection of these areas is strongly recommended once access has been obtained.

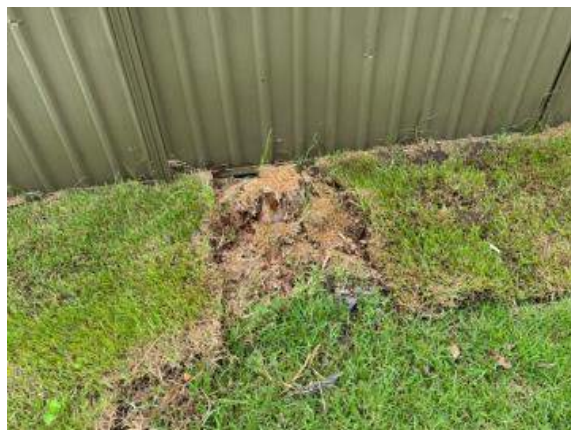
- Tree stumps should be removed as they provide an area for termites to establish a colony.

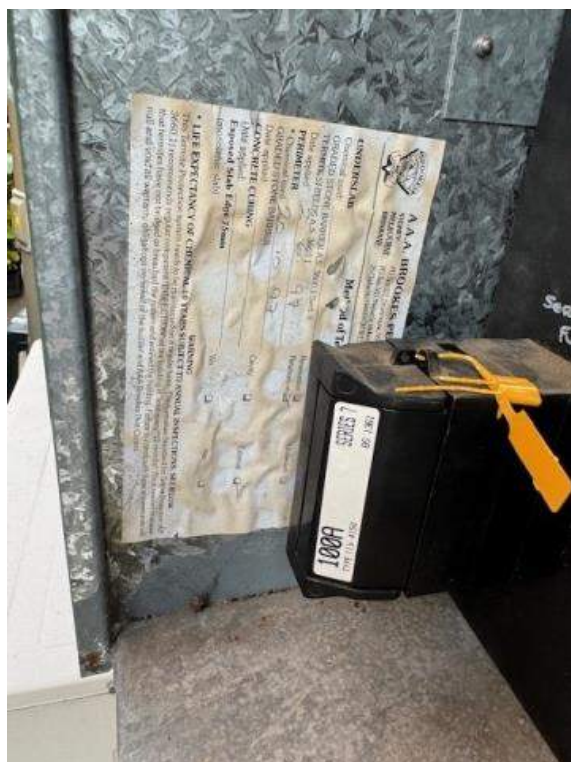
A treatment notice appears to be present however, we are unable to determine the type of treatment carried out as the notice was unreadable.
