## Building Report

4 Barana Pl Kareela

# BUILDING & PEST INSPECTION

## **BUILDING & TIMBER PEST INSPECTION REPORT TO AS4349.1 2007 & AS4349.3 2010**

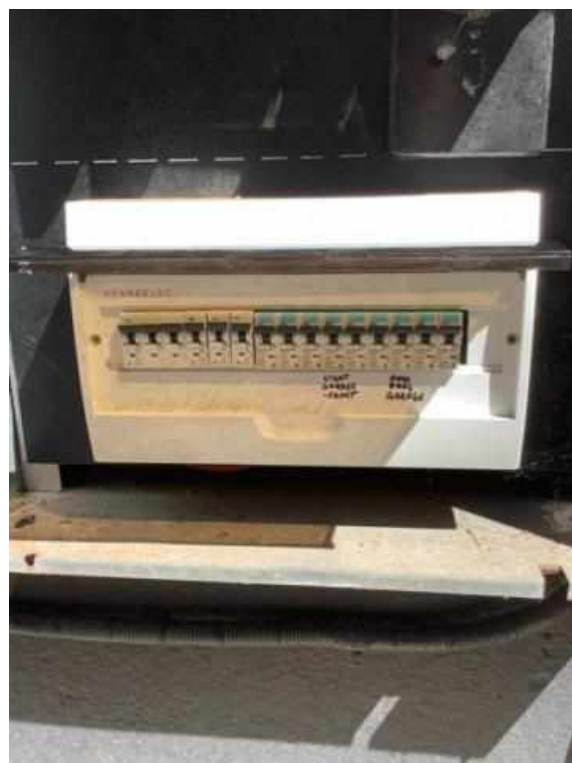
## ELECTRICAL SAFETY SWITCH

Whilst not an electrician, an electrical safety switch looks to be present to the building.

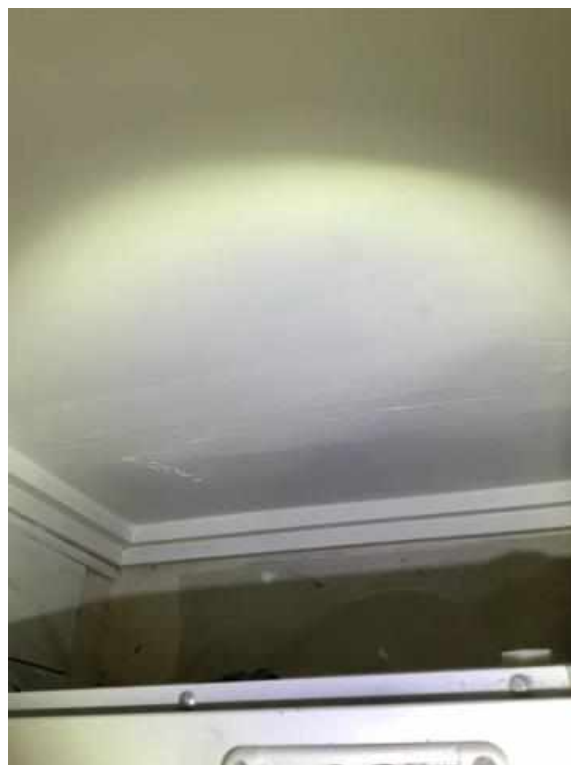
### OTHER (SPECIFY)

Signs of past repair patching to ceiling sheets requires repair repainting.

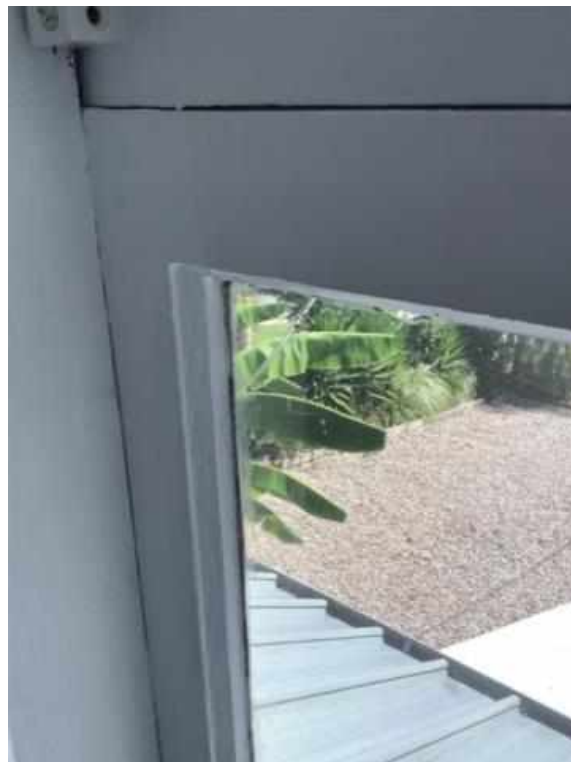
### BROKEN GLASS

Cracked glass to some windows.

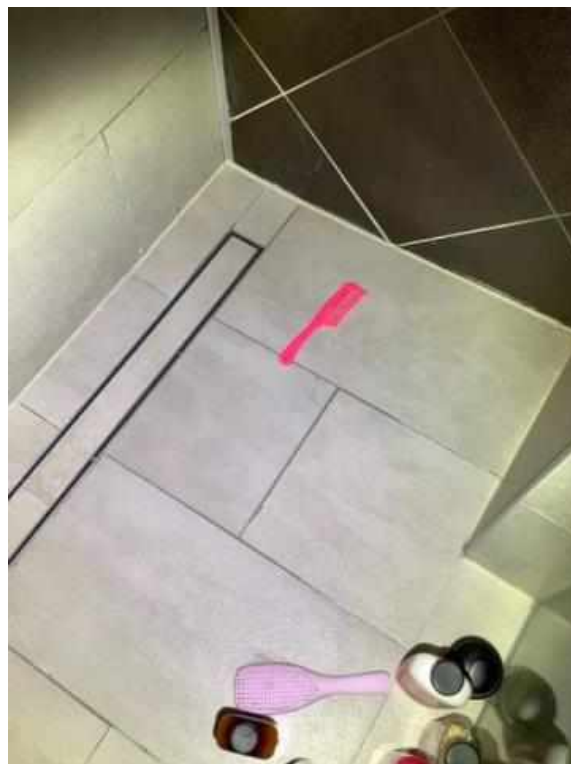
**DRUMMY / CRACKED / LOOSE**

Cracks to some floor tiles to Ensuite shower.

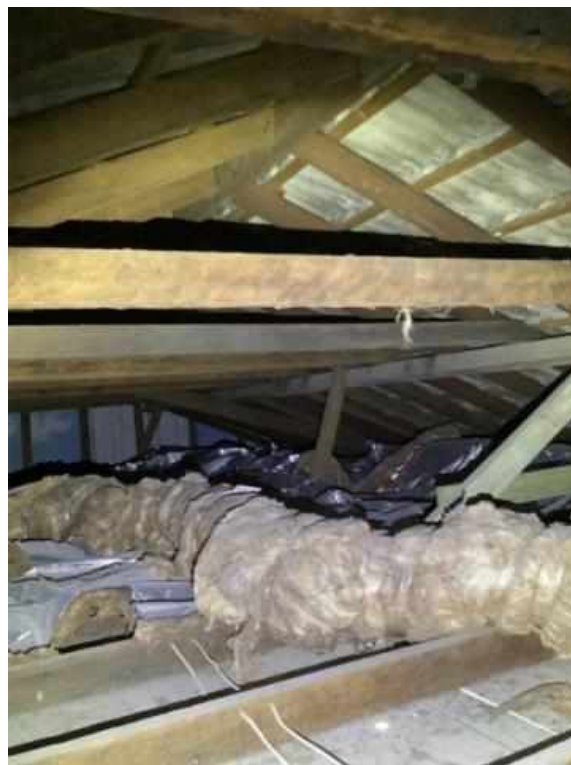
**ROOF SPACE & FRAMING - CONDITION**

Satisfactory.

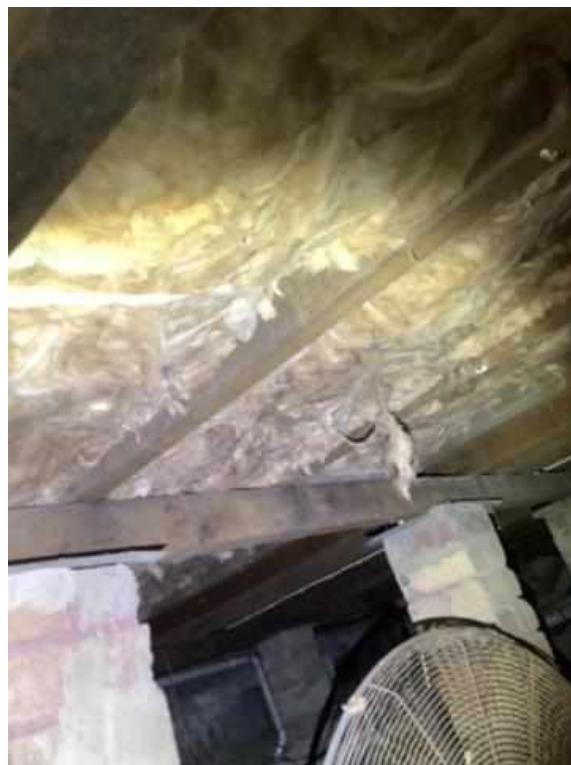
Stored goods are present in this area and restricted inspection.

**Further inspection of these areas is strongly recommended once access has been obtained.**

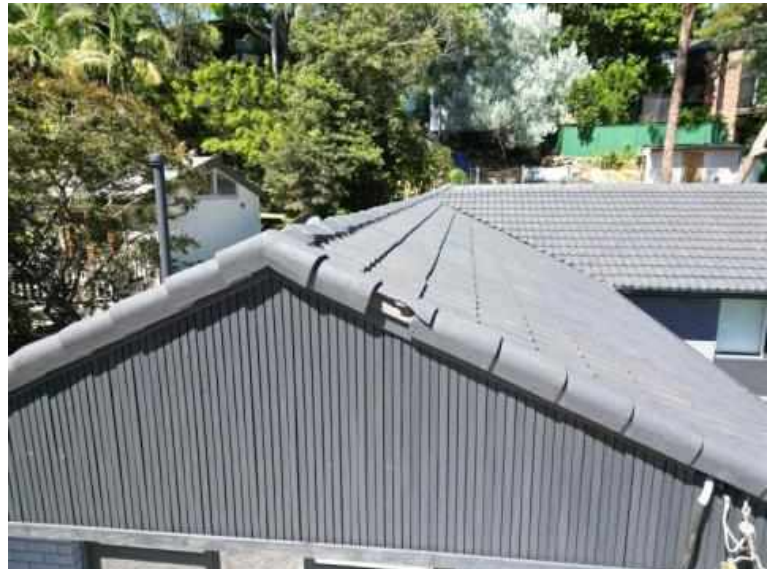
#### ROOF TILES

Gable capping tile is cracked and requires replacement.

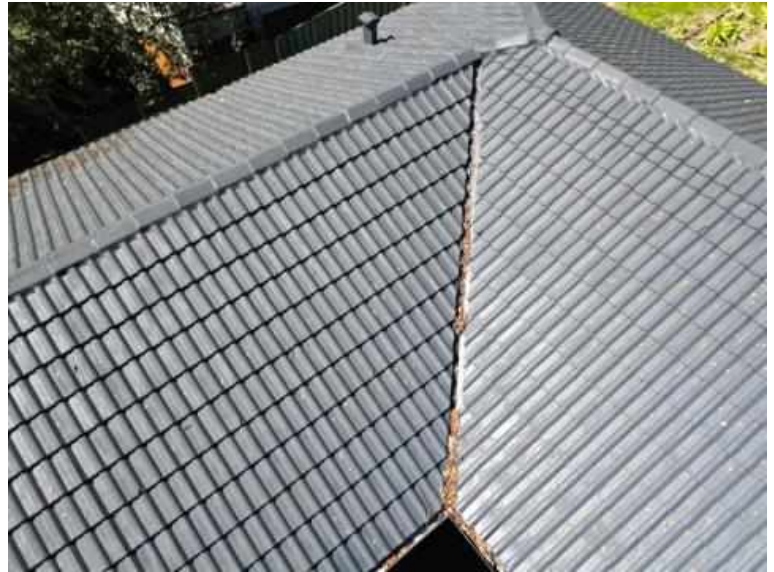
#### VALLEYS

Some valleys require cleaning.

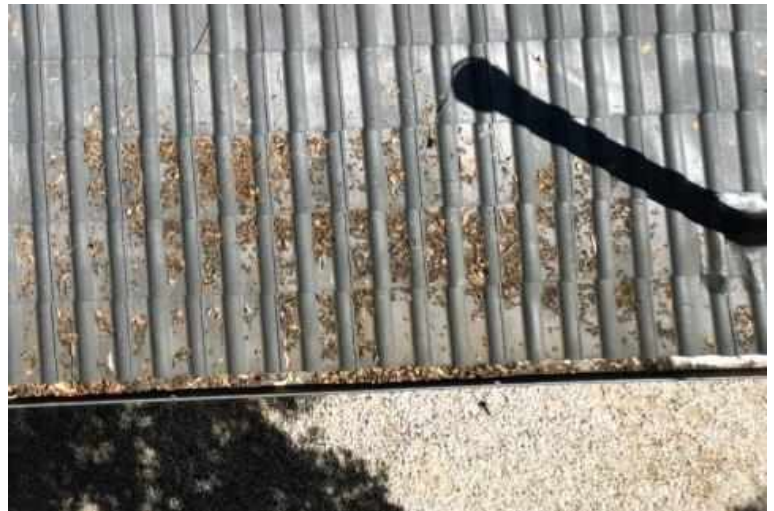
## GUTTERS / DOWNPIPES

Some sections of gutter require cleaning.

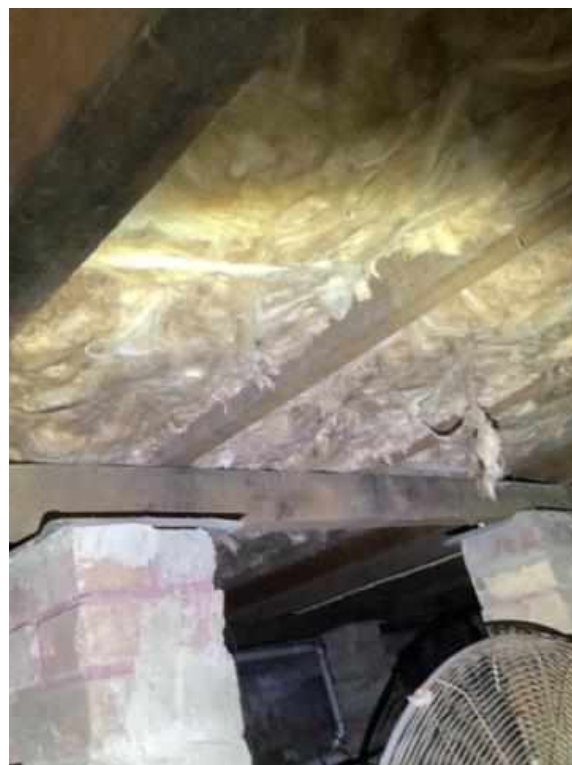
Insulation has been installed between some floor joists, the inspection of the flooring and parts of the joists in these areas was not possible. Some defects may exist but could not be identified.

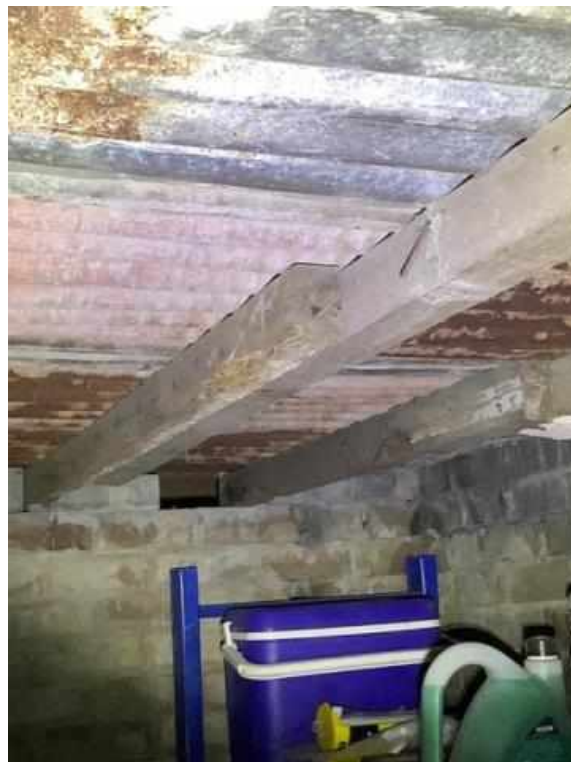
#### AFFECTED TIMBERS / AREAS

Old formwork timbers.

The visible damage to the timbers appears to be moderate. Further damage may exist in concealed areas. Please refer to the definitions section of this report - Section 1.2 - Timber Damage.
