STRUCTURAL REPORT

87 Ingrid Road. Kareela

Cracks in Front of Dwelling at the Wing Wall

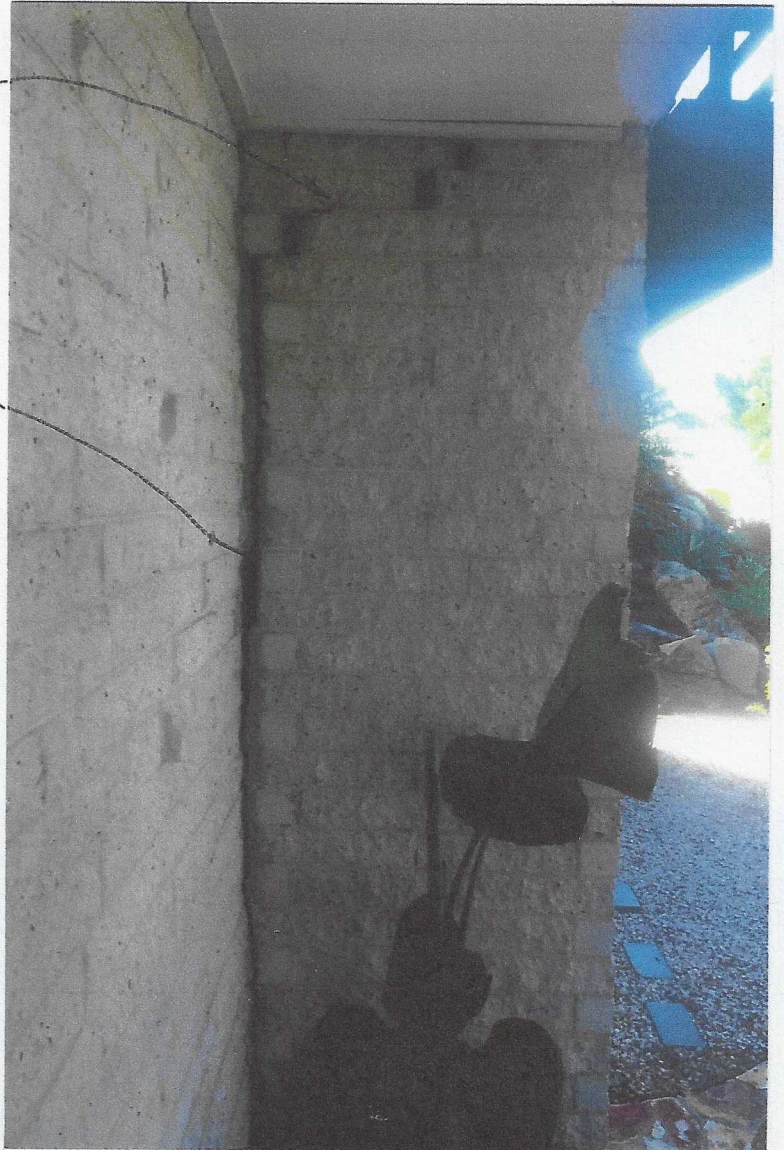
PHOTO 1

The inspection revealed that there has been no further enlargement of these cracks since my inspection on the 13th December 2021 (refer to the attached photo No.1). It was also observed that there are no signs of cracking externally above 1st floor level and at ground level (refer to the attached photos Nos. 2 and 3)

It is apparent that there has been no further settlement of the brick wing wall since the 13th Dec 2021. It is likely that the wall has settled onto firm foundation material, probably rock.

NO FURTHER ENLARGEMENT
OF THESE CRACKS SINCE
13th DEC. 2021

It is recommended that the cracks, as shown in Photo No.1, be filled with a non shrinkable cement mortar as soon as possible. It is anticipated that there will be no further enlargement of these cracks after they have been filled. However, in the unlikely event that cracks show signs opening following the filling, a structural engineer shall be notified regarding what action should be taken.

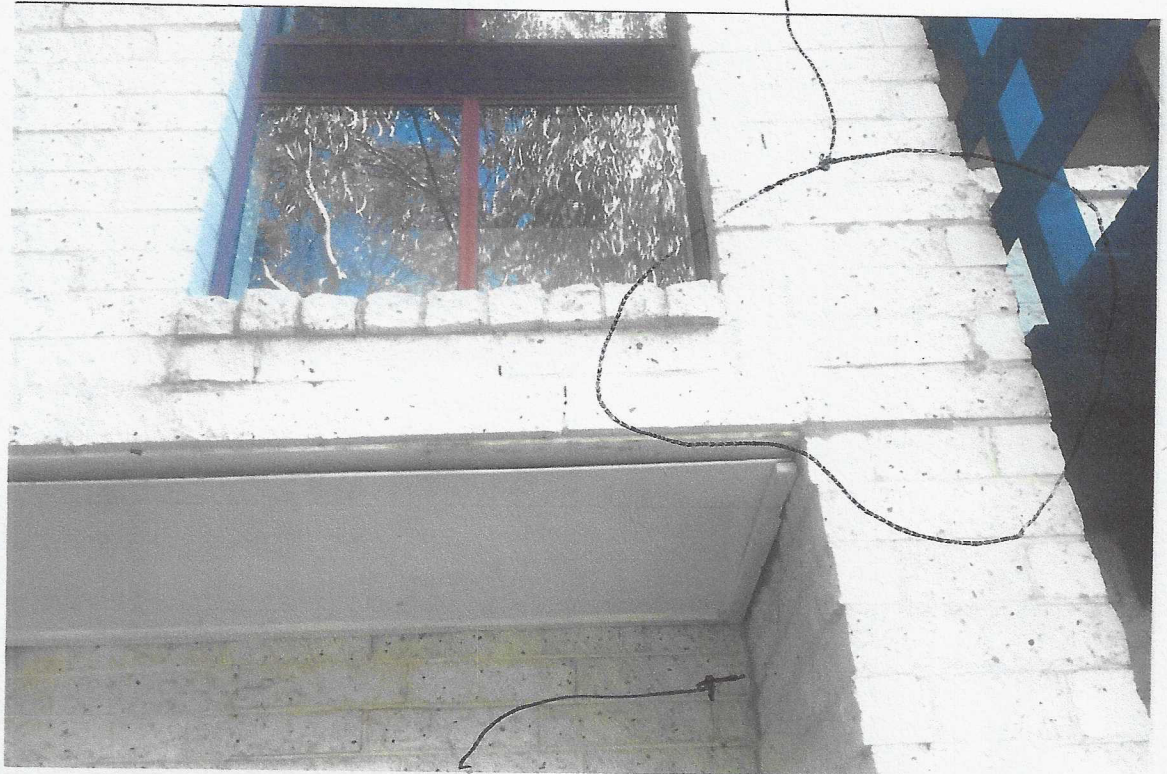
PHOTO 2

NO CRACKS

VISABLE CRACKS
(SEE PHOTO 1)

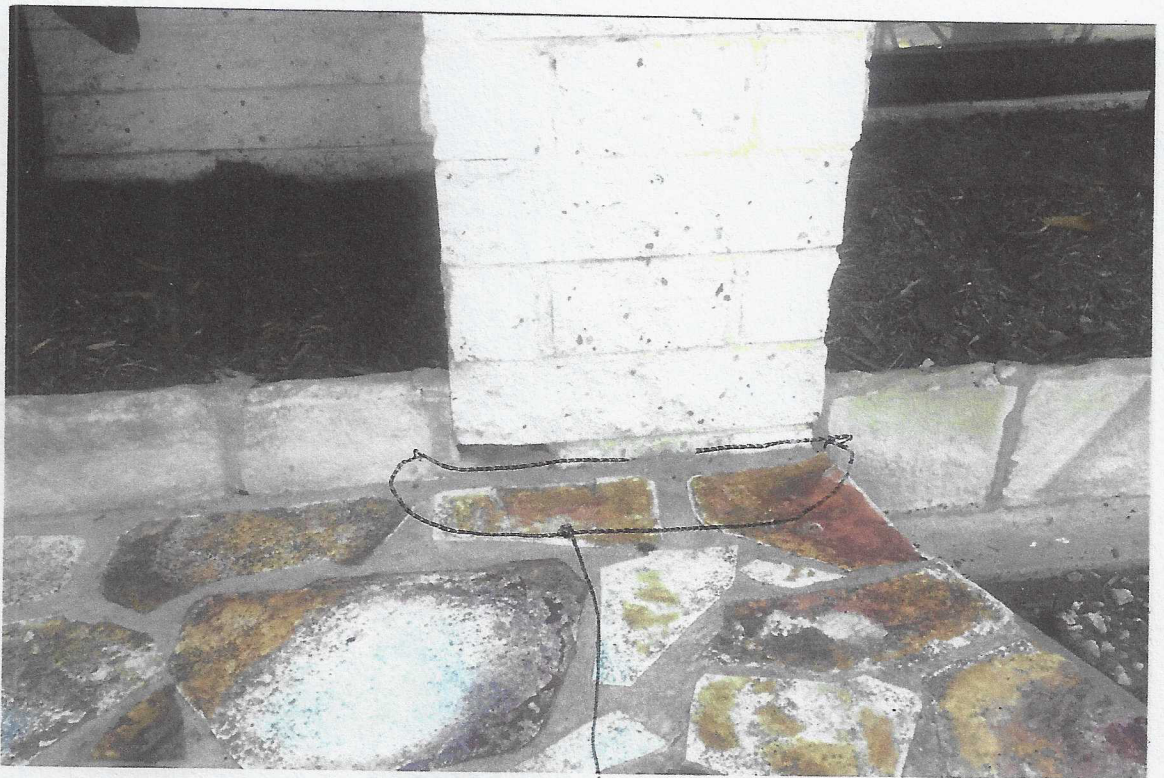
PHOTO 3

NO CRACKS
