HOMESAFE INSPECTIONS

## BUILDING & PEST INSPECTION

87 Ingrid Rd  
Kareela, NSW 2232

15/03/2024

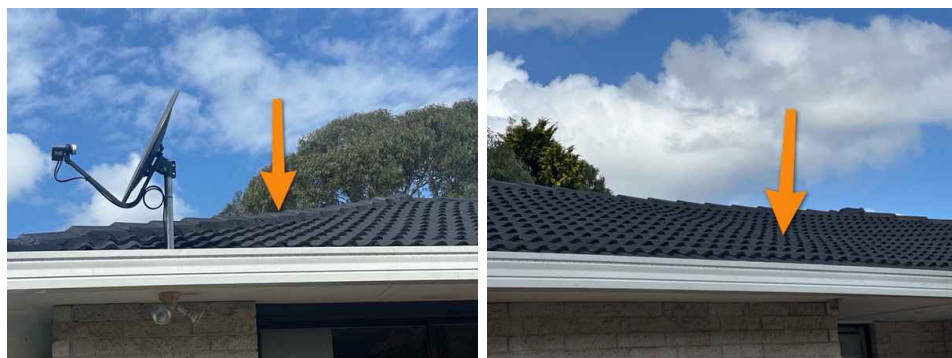
Sagging noted to a section of roof lining. Some adjustments may be required in the roof void.

Contact a qualified professional.

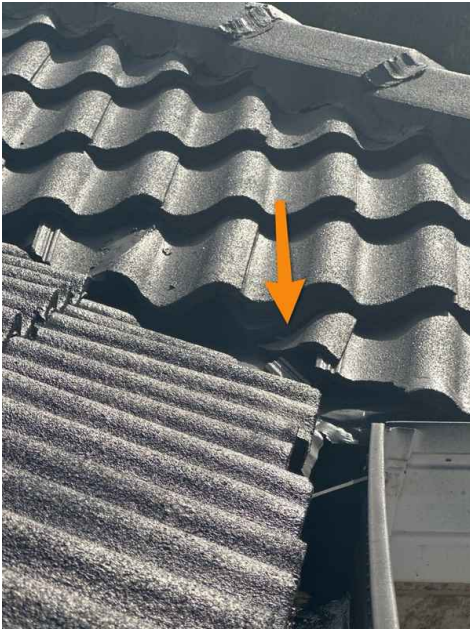
## 3.1.2 Coverings

**TILES CRACKED - MINOR**

The roof had cracked/broken tiles.

Contact a qualified roofing professional.

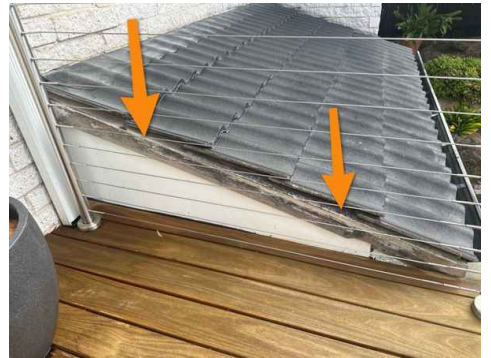
### 3.1.3 Coverings

#### **MORTAR MISSING**

Mortar is missing to a section of the roof. Contact a qualified roofer for finishes.

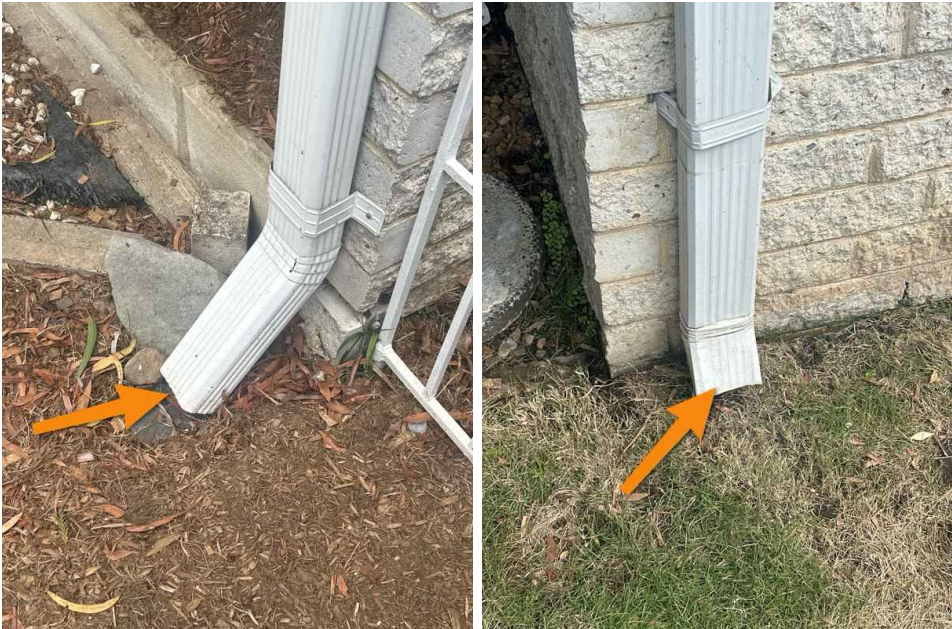
### 3.3.1 Downpipes

#### **NOT CONNECTED**

Down pipe/s not connected to storm water discharge - Down pipes not connected to storm water have the potential to cause differential settlement to the footings, cause rising damp.

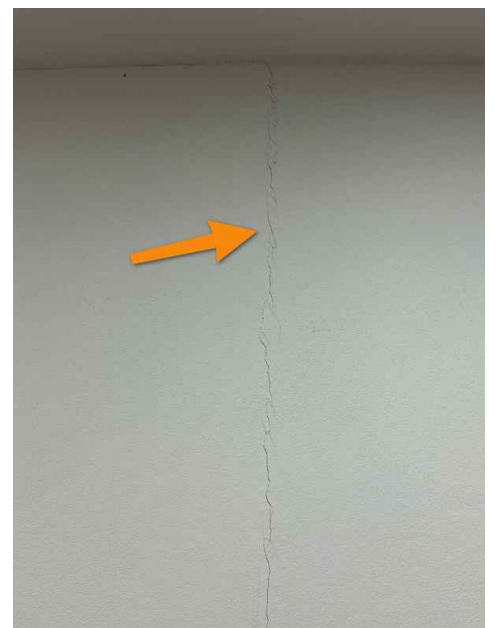
### SETTLEMENT CRACKS

Settlement Cracks Noted. These are typical and generally, patch and paint will suffice, however Monitoring these cracks advised for 12 months and if become wider or longer, you will need to contact a structural engineer to assess.

Contact a qualified professional.

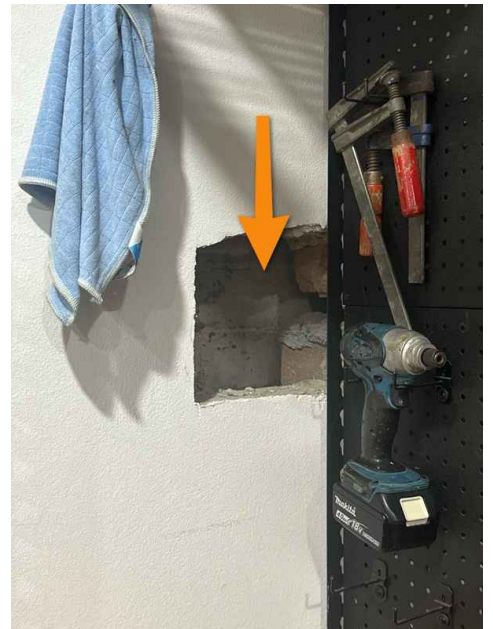
## 4.4.2 Internal Wall

**BRICKS MISSING / DAMAGED**

Bricks missing / damage noted. Contact a qualified brick layer for repairs.

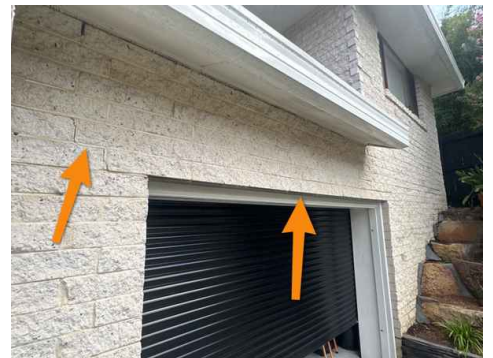
## 4.5.1 Garage Door

**LINTEL SAGGING**

Garage door lintel is sagging. This is causing cracking to the brick work. A bigger lintel might need to be installed to support the brick work. Contact a qualified brick layer for repairs.

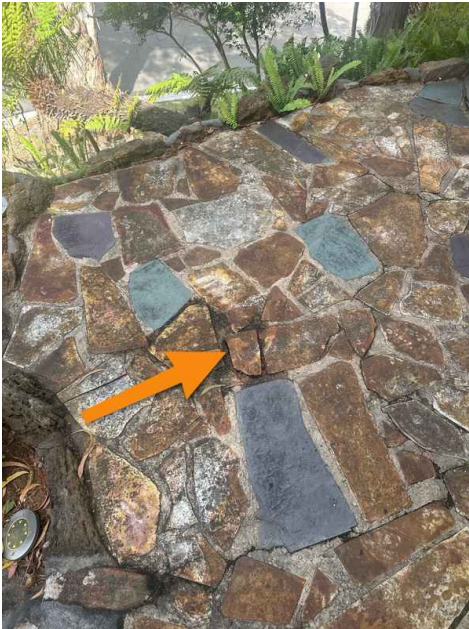
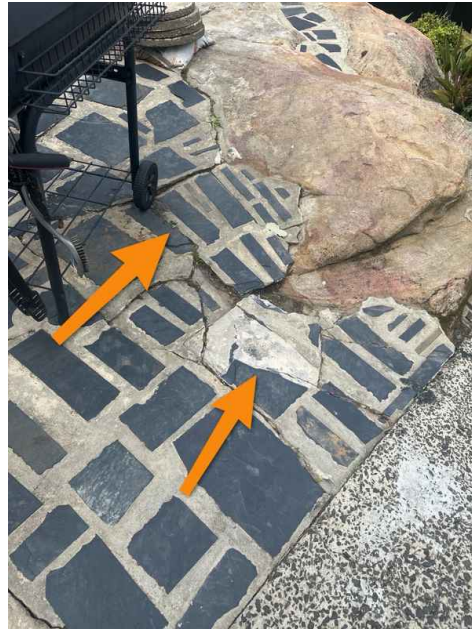
**CRACKED AND DAMAGED / LOOSE TILES**

Cracked and damage / loose noted to tiles

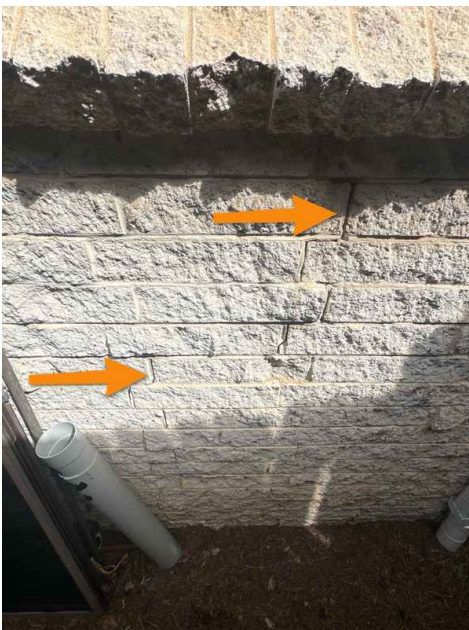
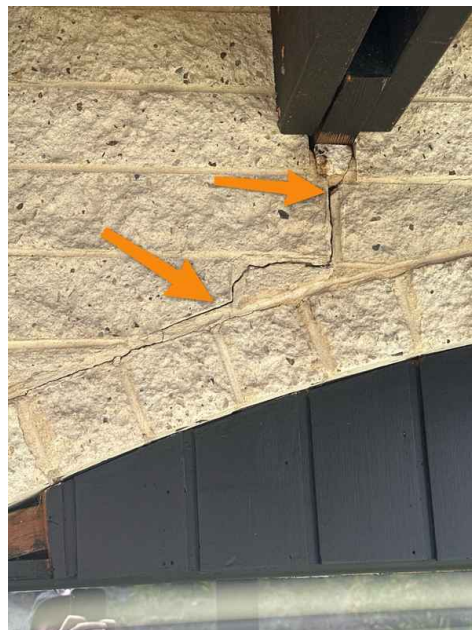
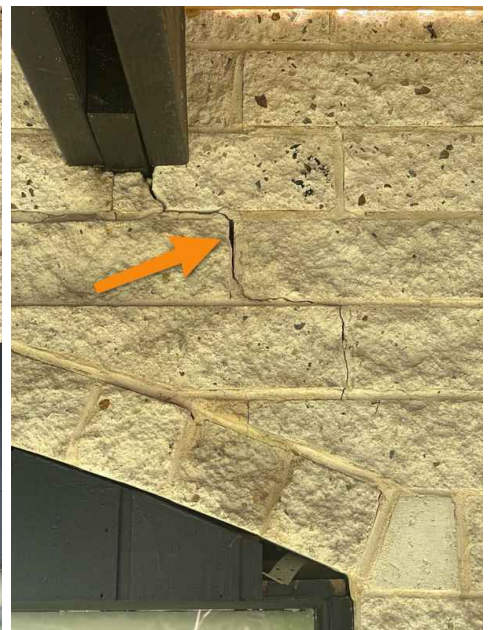
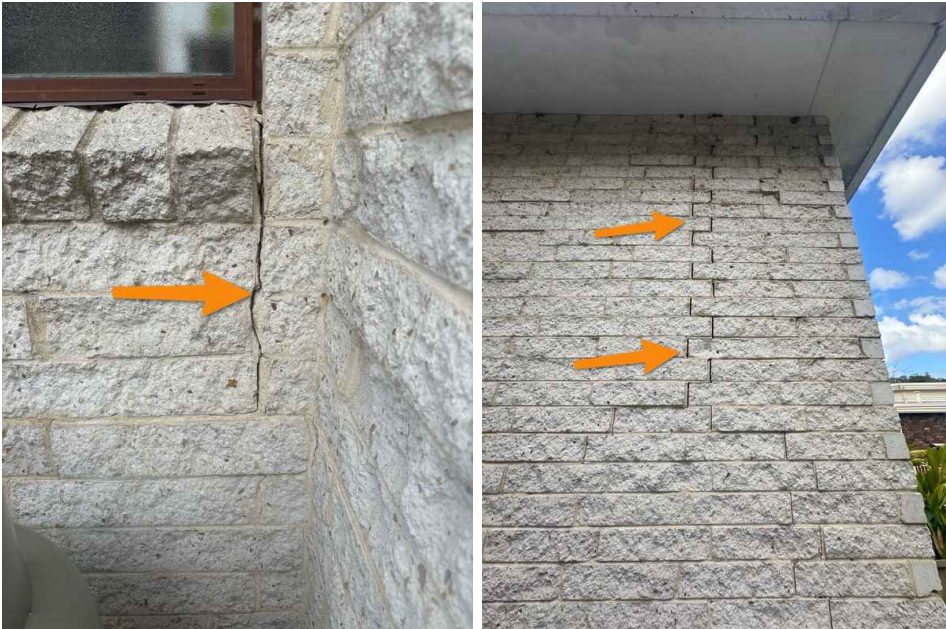
## 5.2.1 External

**CRACKING - MINOR**

There appears to have been some settlement in the building which has caused some cracking to the walls. These cracks are categorized as 0 to 2mm which is minor and typical for a building of this type and age. This can also cause some doors to bind or be out of square. In the inspector's opinion these cracks are due to settlement, usually due to ground movement and subsequent movement to building materials can be expected. Any cracks should be monitored and if cracks increase in size, further investigation should be carried out by a structural engineer.

Contact a qualified carpenter.

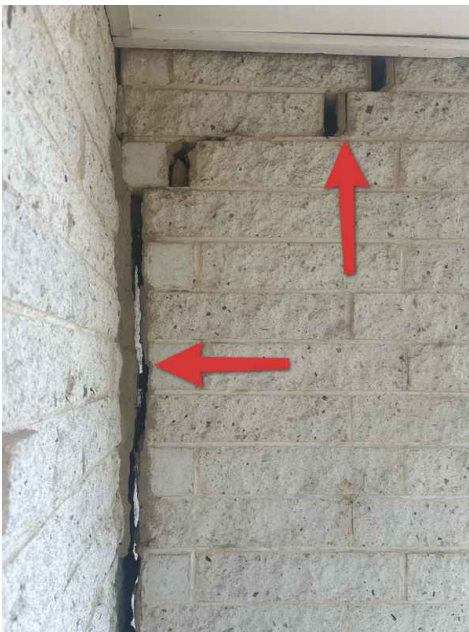
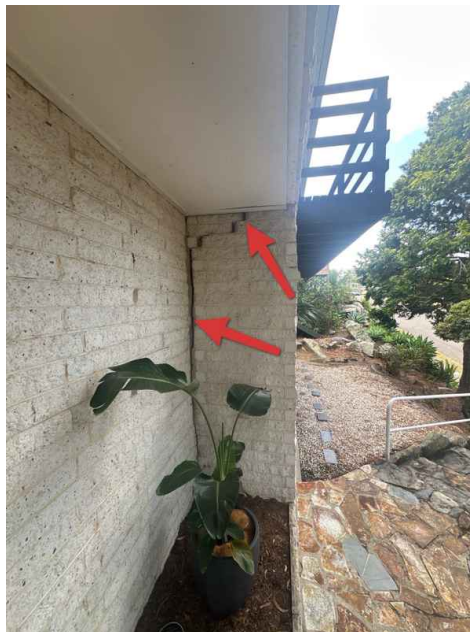
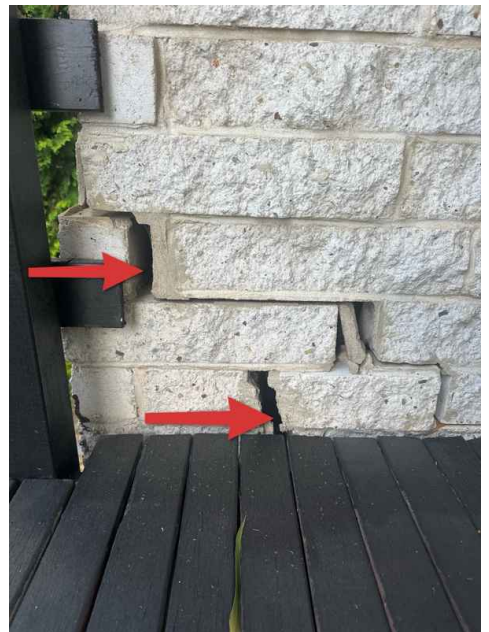
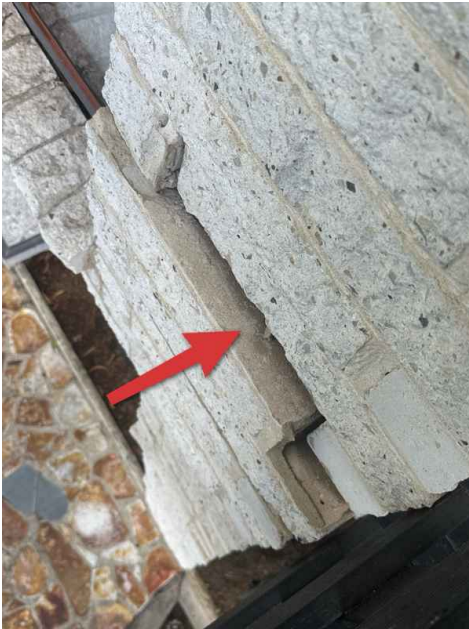
## 5.2.2 External

**CRACKING - MAJOR**

Moderate to major cracking was observed at one or more points on the exterior. This can be the result of poor original compaction of soil at the time of construction or excess moisture in the underlying soil. Recommend consulting with a structural engineer and/or soil expert.

Contact a qualified structural engineer.

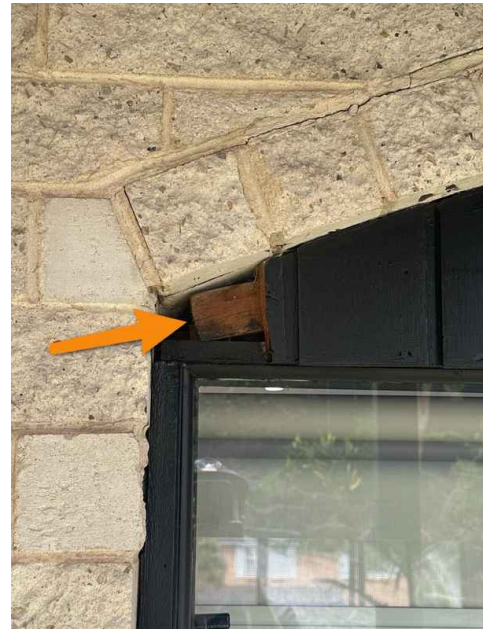
## 5.2.3 External

**CLADDING MISSING**

Paneling/cladding missing

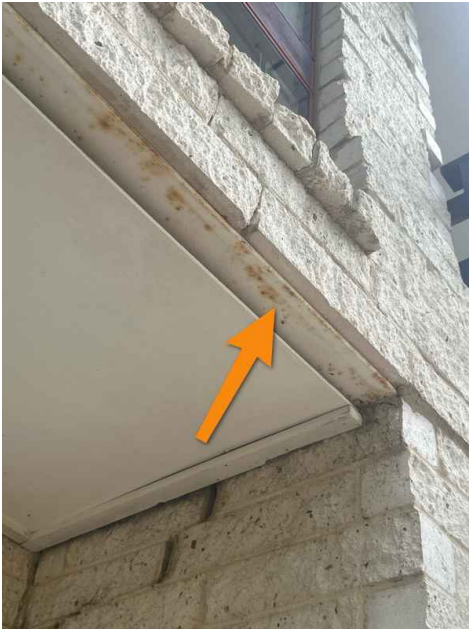
## 5.2.4 External

**LINTEL RUSTING**

Minor surface rust noted to support lintel. If rust continues this can cause cracking to brick work.

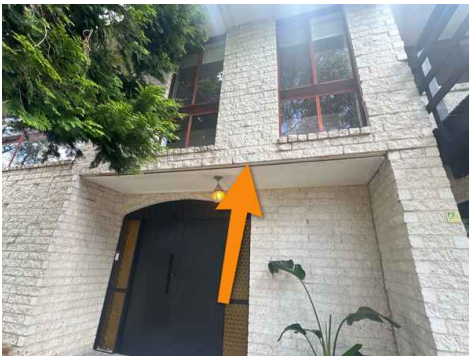
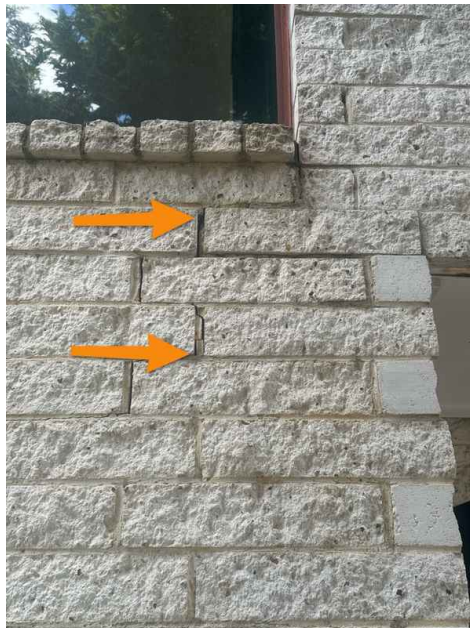
### 5.2.5 External

#### LINTEL SAGGING

Support Lintel sagging in sections. This is causing cracking in wall linings / brick work. Contact a qualified brick layer for repairs as a bigger lintel might need to be installed.

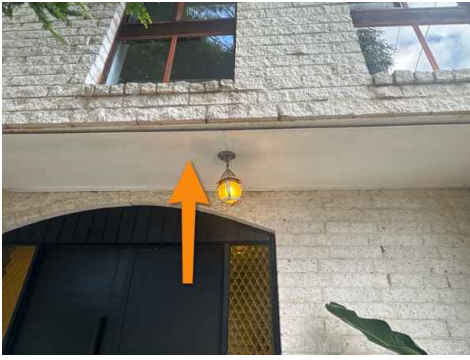
### 5.3.1 Entry

#### CEILING SAGGING

Minor Ceiling sagging or uneven. Contact a qualified carpenter for repairs as more fixings might need to be installed.

Contact a qualified professional.

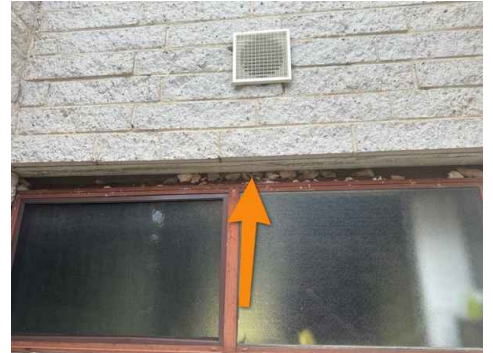
## 5.5.1 Exterior Windows

**GAPS**

Gaps between the window frame and wall cladding evident. It is recommended these be filled with silicone or covered with trims.

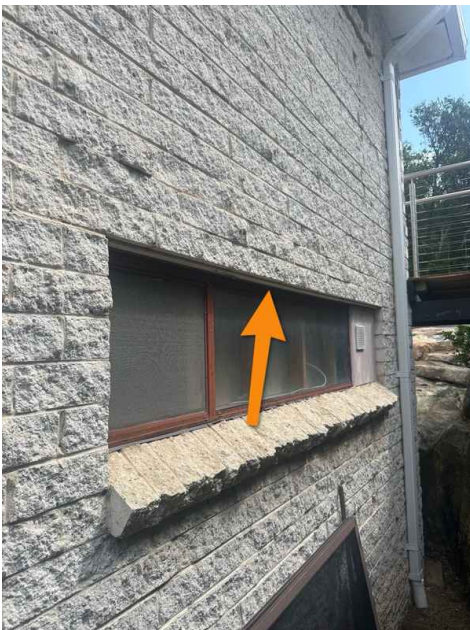
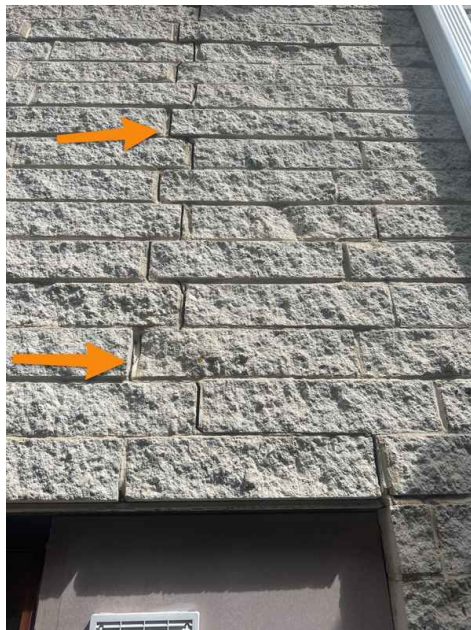
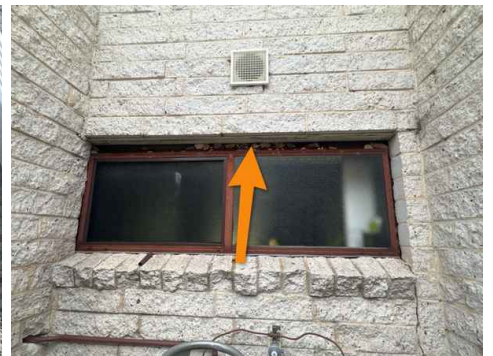
## 5.5.2 Exterior Windows

**LINTEL SAGGING**

Lintel sagging in sections. This is causing cracking in wall linings / brick work. above the window

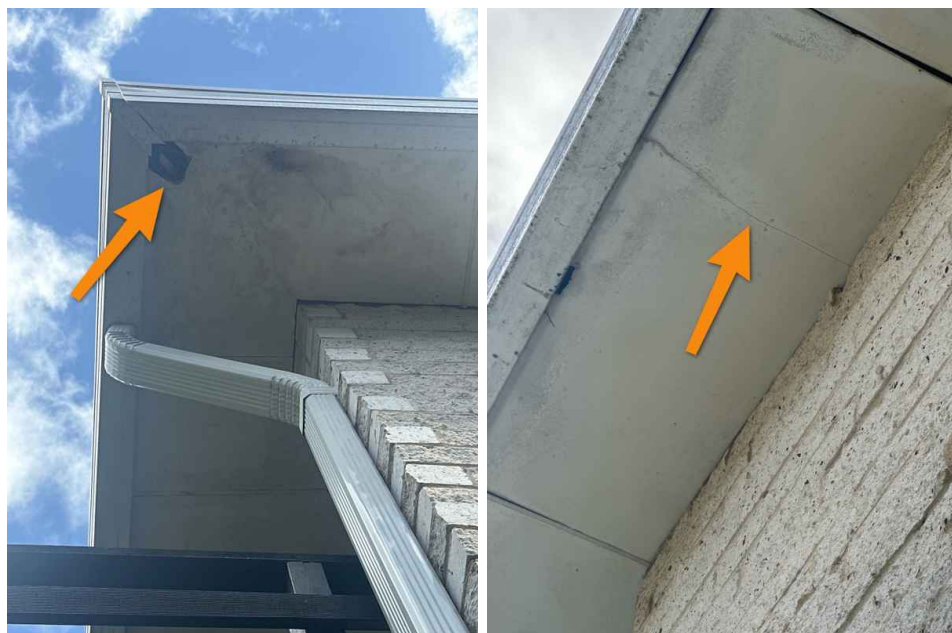
## 5.6.1 Eaves &amp; Fascia

**EAVES - DAMAGED**

One or more sections of the eaves are damaged. Recommend qualified roofer evaluate & repair.

Contact a qualified roofing professional.

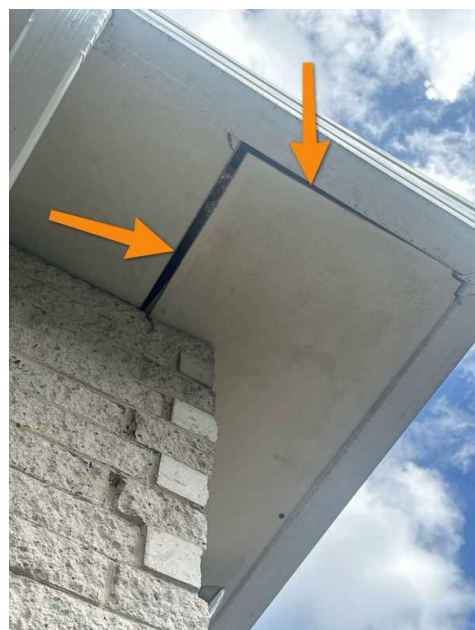
#### 5.6.2 Eaves & Fascia

### EAVES DISLODGED FROM FASCIA

Eave sheet has become dislodged from fascia groove. It is recommended the fascia to be fixed back in so there is no gap so water ingress can not occur. Contact a qualified carpenter for repairs.

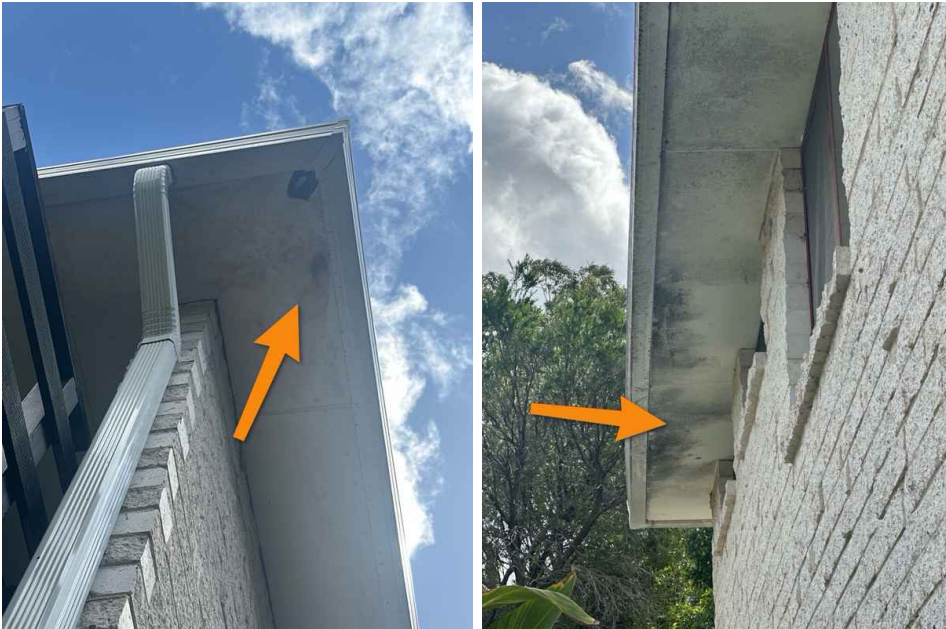
#### 5.6.3 Eaves & Fascia

### EAVES - WATER STAINS / MOULD

Water stains / mould were observed under the roof eaves. This may indicate an active leak. Recommend qualified roofer evaluate & repair.

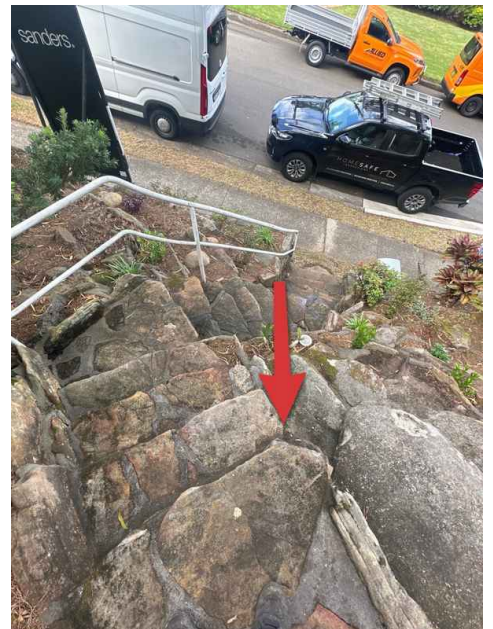
## 5.7.1 Stairs

**NO HANDRAIL/BALUSTRADE**

No handrail/balustrade on stairs. This is a safety issue. It is recommended one is installed to prevent falls.

Contact a qualified professional.

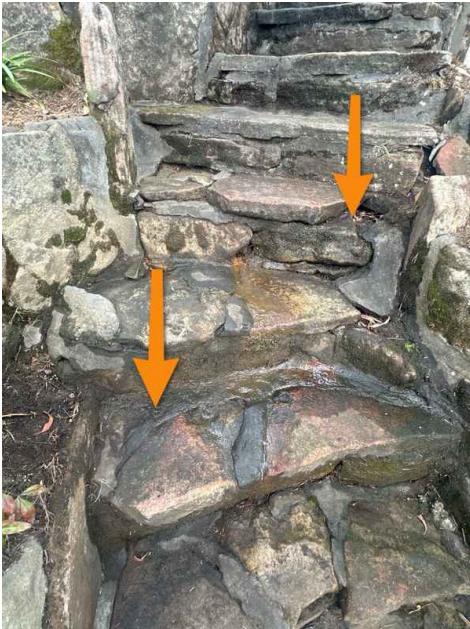
## 5.7.2 Stairs

**LOOSE ROCK / WATER**

Loose rocks noted to stairs. This is being caused from excessive water run off coming through the stairs. This is probably being caused from inadequate drainage systems on the property.

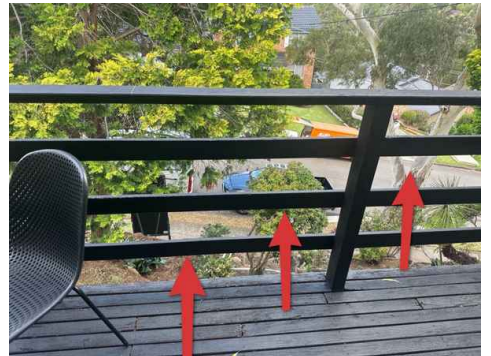
## 5.9.1 Balcony

**BALUSTRADE UNSAFE  
<125MM**

There is an unsafe opening in the railing. The spacing on the rail should not exceed 125mm. An opening greater than 125mm is a serious safety hazard especially for children.

In some circumstances, this regulation was non-existent dependent on the age of the dwelling and technically there is no requirement to rectify it. We strongly advise you to rectify to comply for safety concerns to young children

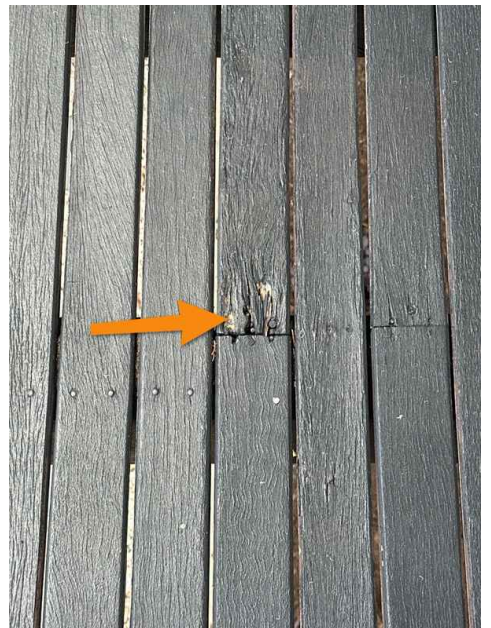
## 5.9.2 Balcony

**MOISTURE DAMAGE /  
ROT TO DECKING**

Moisture damage / rot was observed on deck boards & components.

Contact a qualified professional.

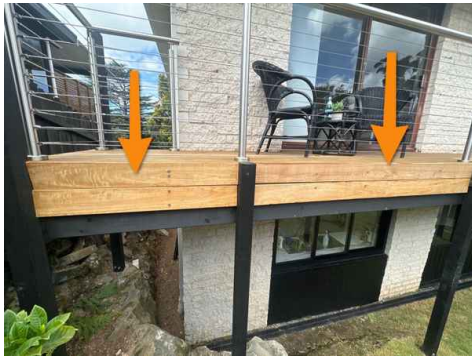
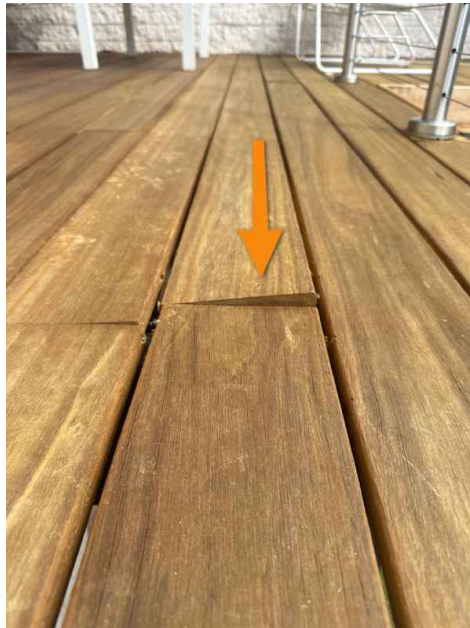
## 5.9.3 Balcony

**LOOSE DECKING BOARDS**

Loose / unfinished decking boards on balcony. Contact a qualified carpenter for finishes.

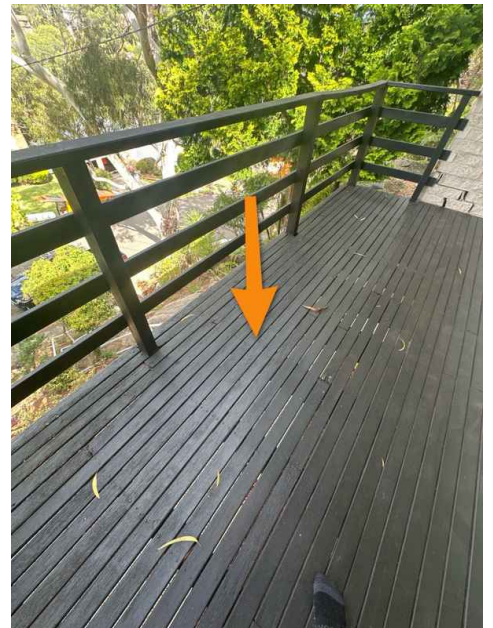
## 5.9.4 Balcony

**MOVEMENT /  
BOUNCE**

Movement / bounce noted to balcony. More supports might need to be installed.

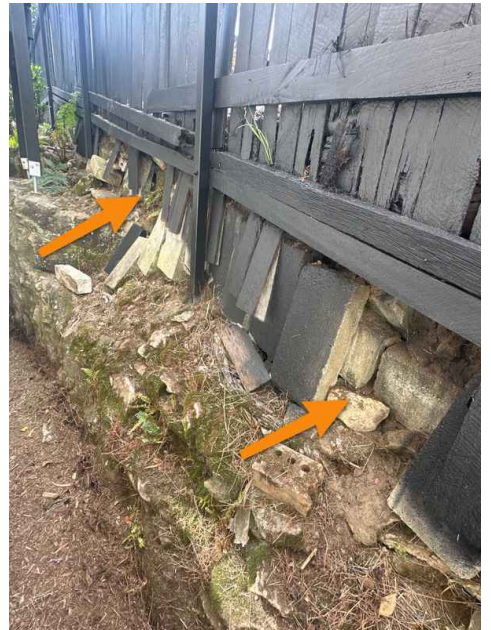
## 5.12.2 Retaining Walls

**LOOSE RETAINING WALL**

Contact a qualified masonry professional.

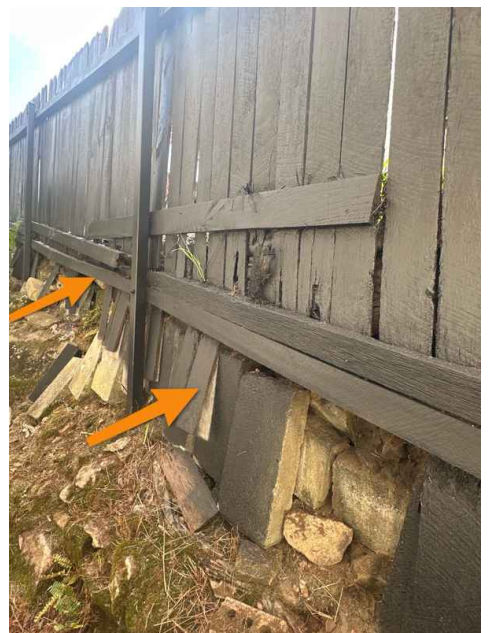
## 5.13.1 Fences and Gates

**FENCE ROT / DAMAGE**

Fence rot/damage. This could lead to a safety issue if not fixed sooner rather than later

Contact a qualified fencing contractor

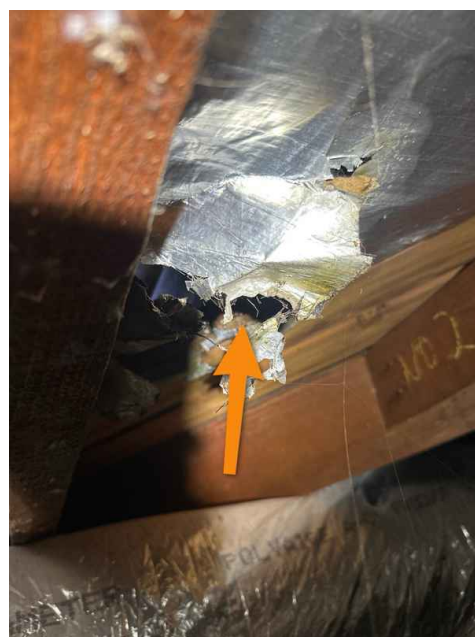
### SARKING DETERIORATION

Sarking deteriorated/ damaged / aged in areas

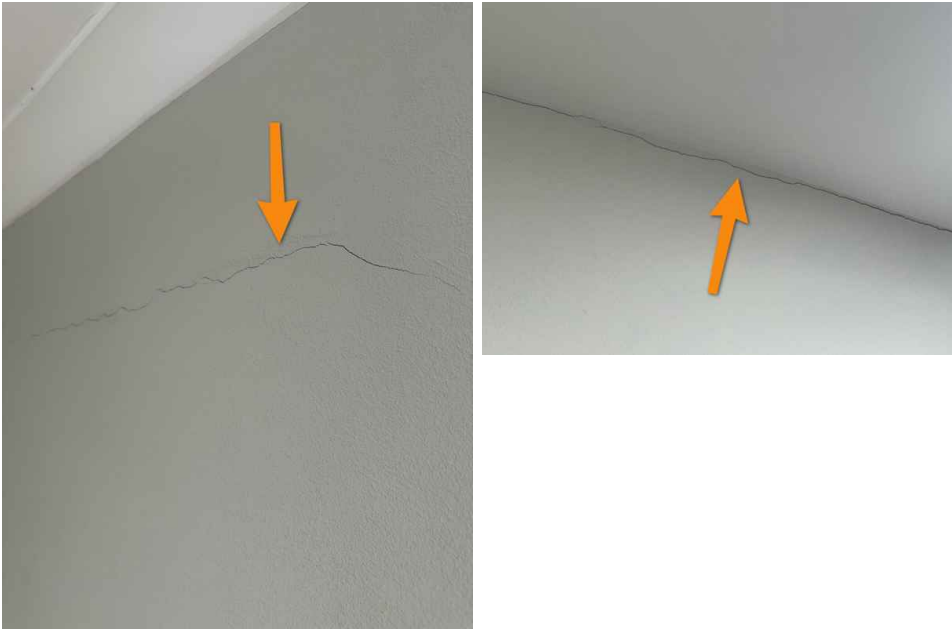
#### MINOR SETTLEMENT CRACKS

Settlement Cracks Noted. These are generally typical. Patch and paint may suffice. These cracks should be monitored and if they widen it is recommended that a structural engineer be contacted for assessment

Contact a qualified professional.

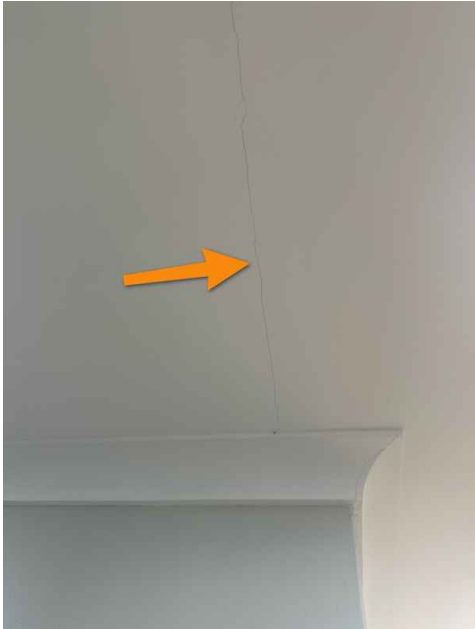
7.5.1 Ceilings

SHEET JOINS

Ceiling sheet joins cracks evident. This is likely due to thermal expansion

Contact a qualified professional.

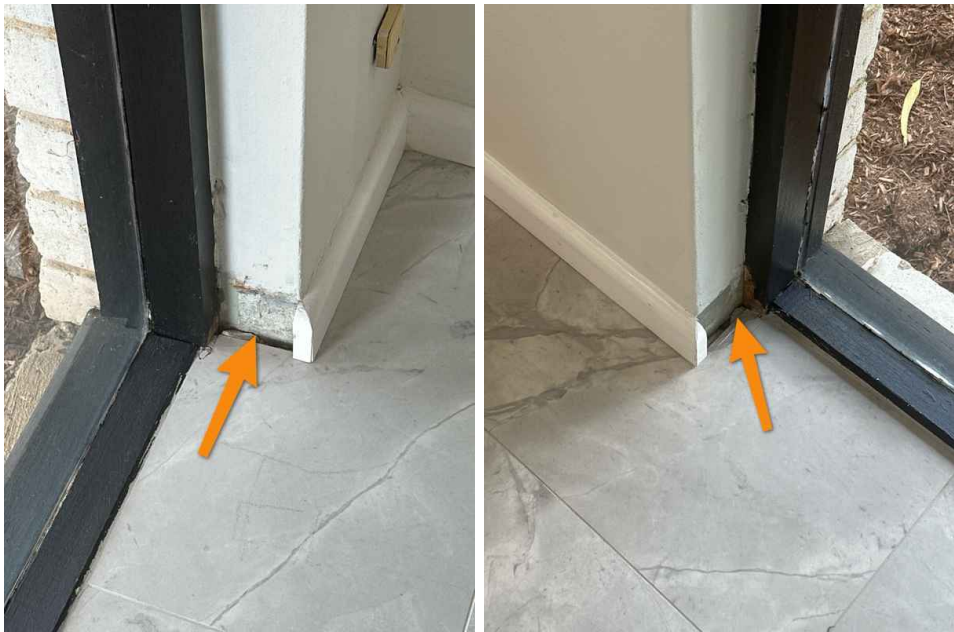
8.4.1 Walls

SKIRTING LOOSE OR MISSING

Skirting is loose/missing install/fix as needed

Contact a qualified professional.

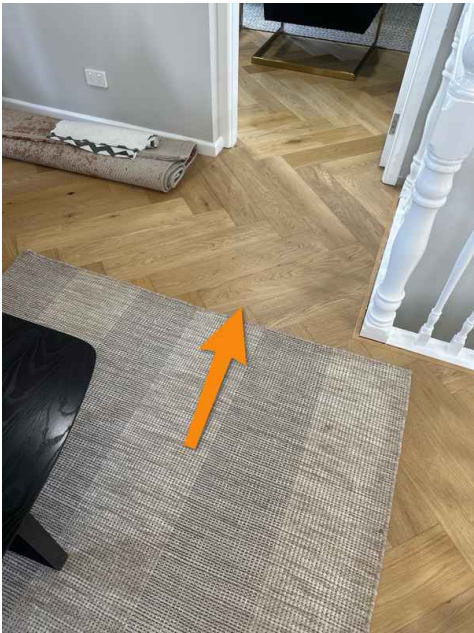
9.3.1 Floors

Unevenness visible in the floor - Recommendations: A qualified carpenter should be engaged for advice and recommendations re-leveling.

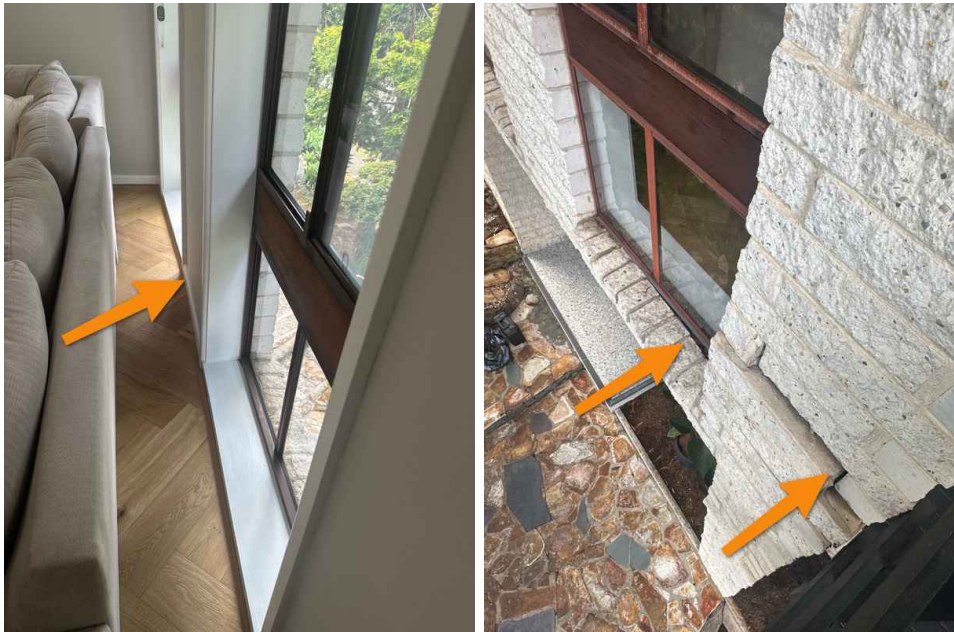
9.4.1 Walls

WALL NOT STRAIGHT

Wall is not straight. This could be due to the cracking of the exterior to the brick work and it has pulled the internal wall out of level.

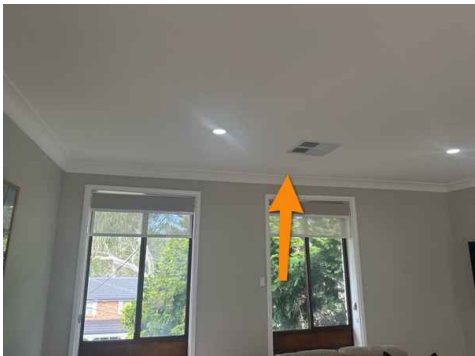
9.5.1 Ceilings

UNEVENNESS

Unevenness noted to the ceiling lining. This is probably due to timber alignment in the roof void / poor workmanship.

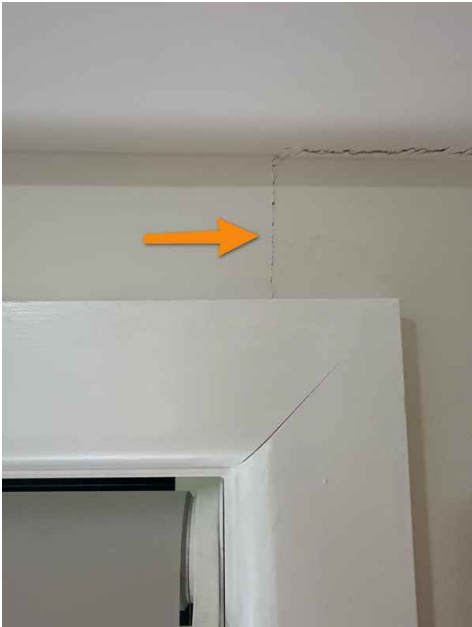
### SHEET JOIN CRACKS

Sheet join cracks noted. This is probably due to thermal expansion. Patch and paint will suffice

Contact a qualified professional.

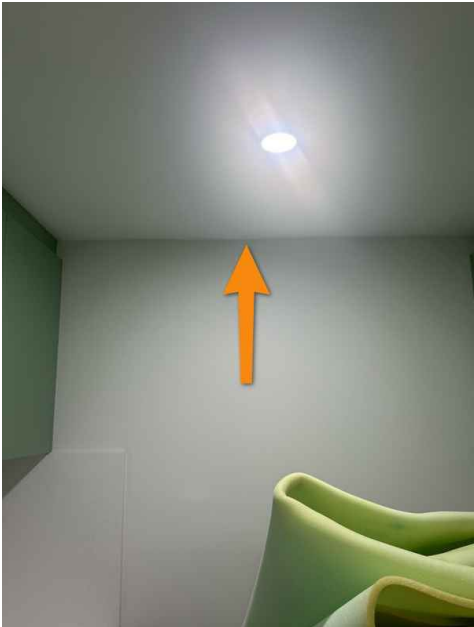
Minor unevenness noted to the ceiling lining. This could be due to timber alignment / poor workmanship. Further investigation required.

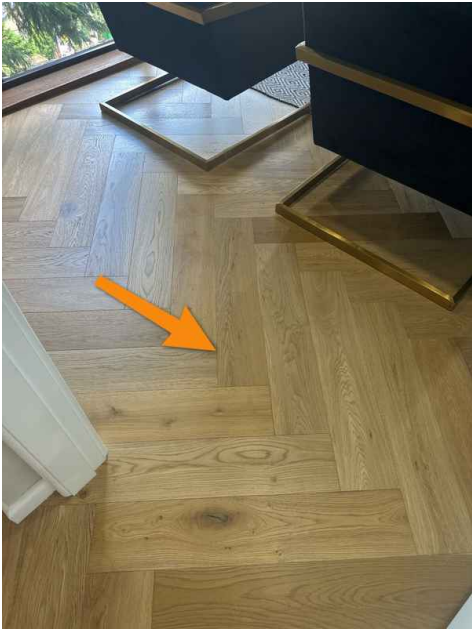
15.3.1 Floors

Unevenness visible in the floor - Recommendations: A qualified carpenter should be engaged for advice and recommendations re-leveling.

Recommendation  
Contact a qualified carpenter.

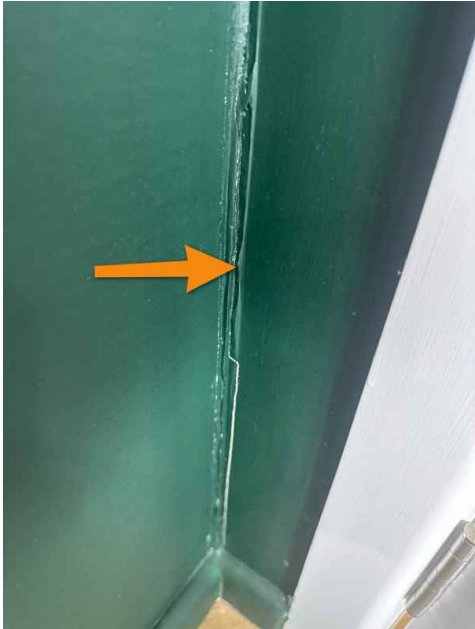
15.4.1 Walls

POOR PATCHING

Contact a qualified professional.

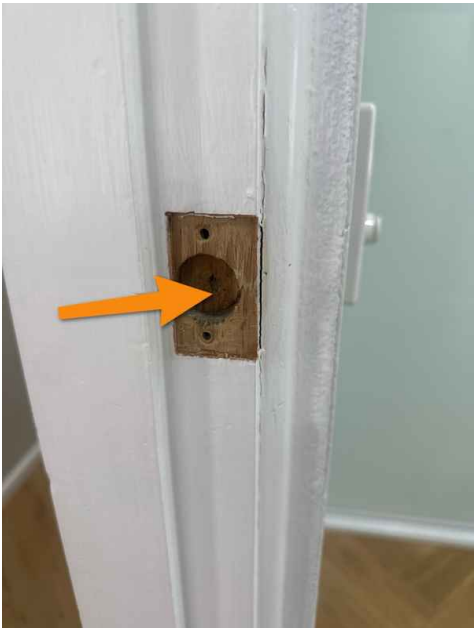
18.1.1 Doors

Minor Defect/Repair Recommendations

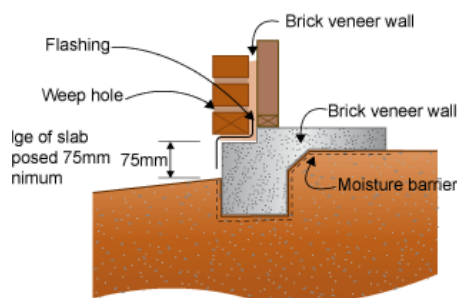
### Is the slab edge exposed - No

No, the slab edge should be exposed to a minimum of 75mm around the entire dwelling. It is impossible to ascertain termite entry if the concrete slab is not exposed. Termite damage may exist.

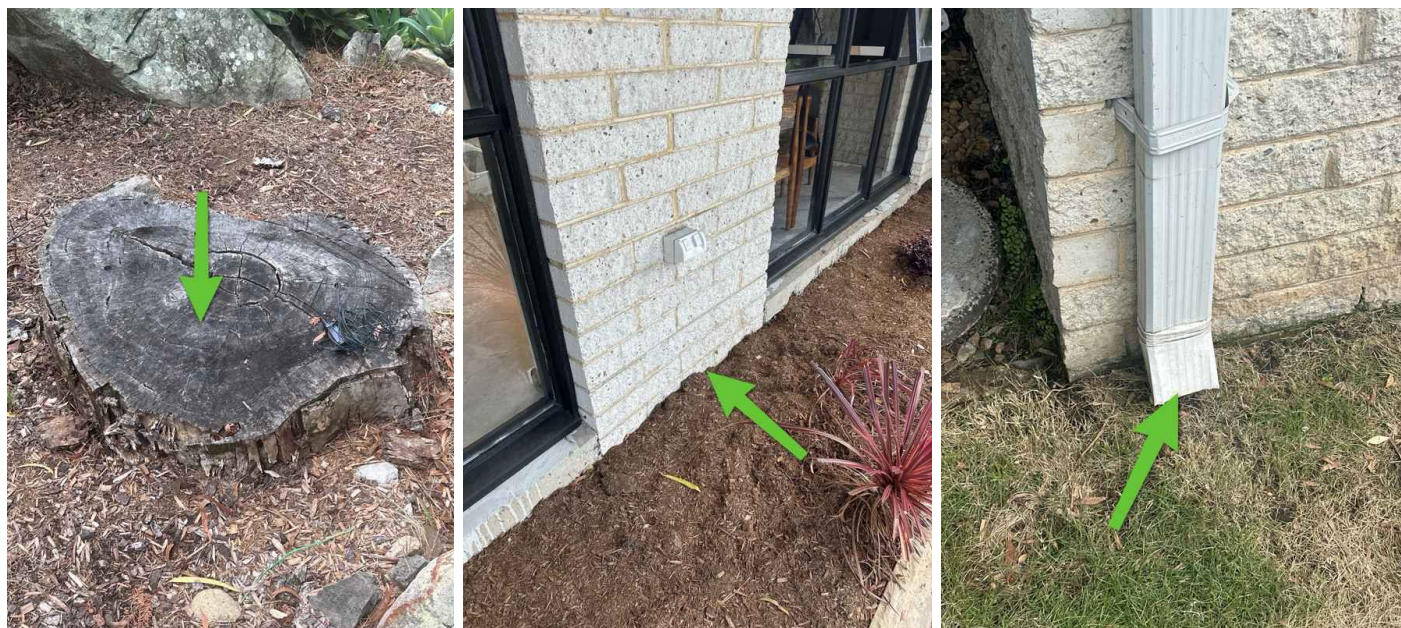
Mulch & Garden Beds Next to House, Slab Edge, Timber Debris, Timber Sleepers, D/P Connection, Tree Stumps, Fence in Contact with Ground, Roof void access, Tree/Leafy Environment

Conductive conditions are areas that promote termite activity. The above areas are recommended that repairs be completed to help minimise the risk of termite attacks.
