HOMESAFE INSPECTIONS

BUILDING & PEST INSPECTION

83 Ninth Ave
Loftus, NSW 2232

28/02/2024

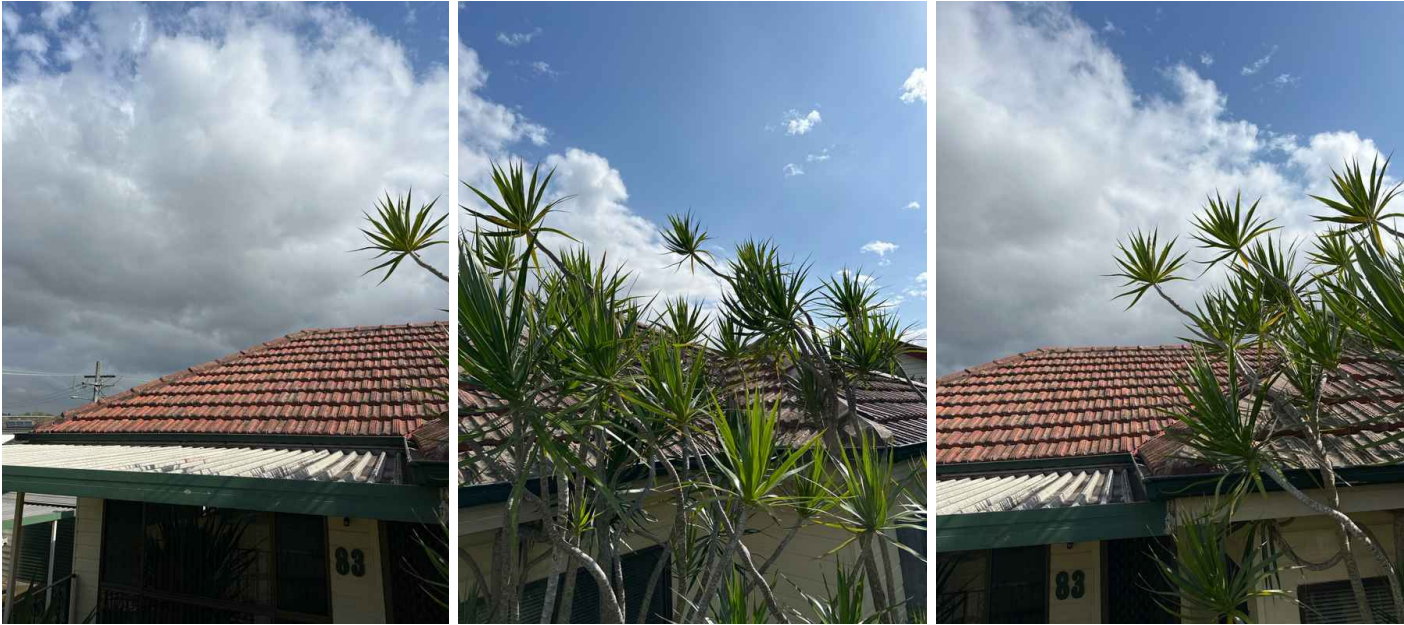
Tile Fretting observed. Common on older properties with terracotta tiles. Fretting on a terracotta roof tile has various causes and salt is one common culprit which breaks the tiles down to powder form. A short-term solution is to replace the tiles that are badly fretting.

Contact a qualified roofing professional.

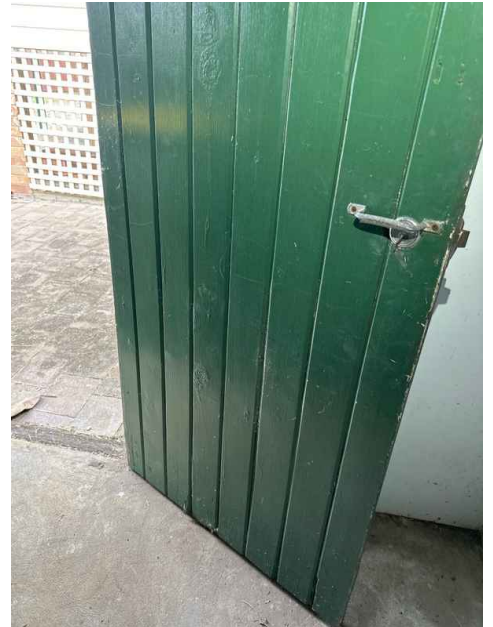
AGE/DETERIORATION

Age/deterioration noted to door.

Contact a qualified carpenter.

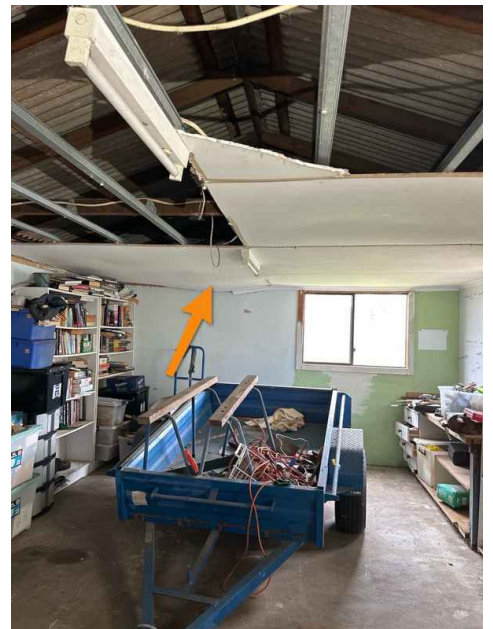
4.3.1 Ceiling

DAMAGED LINING

Damage to lining noted

Contact a qualified Gyprock and plaster service

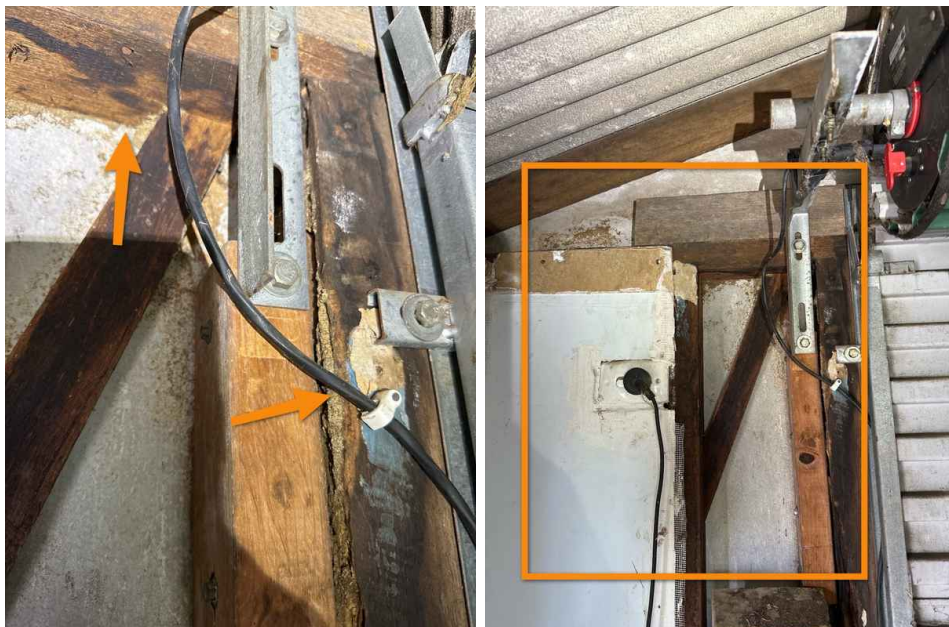
4.4.1 Internal Wall

TIMBER PEST ATTACK

Old termite damage and mudding noted. It is recommended that a timber pest management system be implemented to prevent further attacks.

Contact a qualified professional.

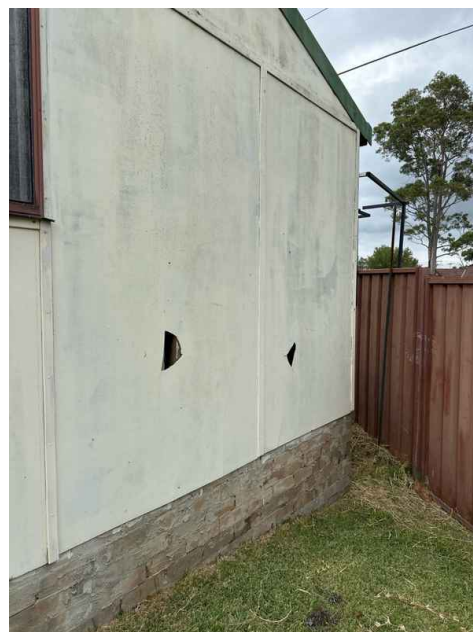
4.6.1 External Wall Cladding

IMPACT DAMAGE

Impact damage noted to the exterior.

Contact a qualified carpenter.

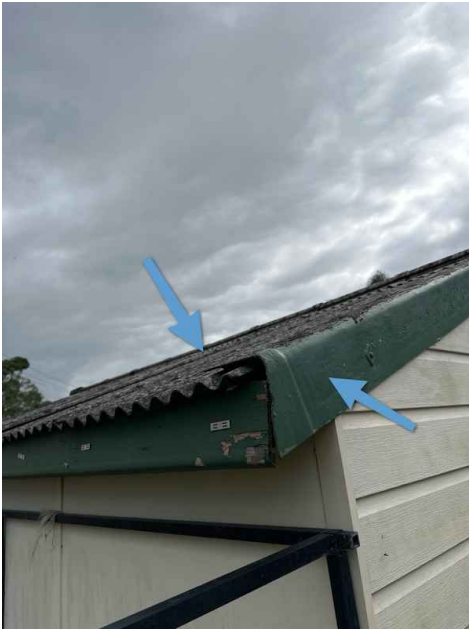
4.7.1 Roof & Gutter

Likely Asbestos roof sheeting has been installed. It is recommended that an asbestos test be done

Contact a qualified professional.

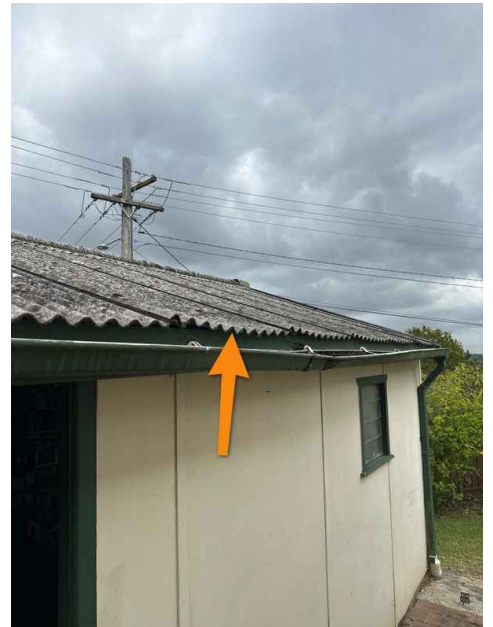
4.7.2 Roof & Gutter

GUTTER LOOSE

The gutter has become loose due to timber rot to the fascia. New fascia should be installed and the gutter to be re-installed

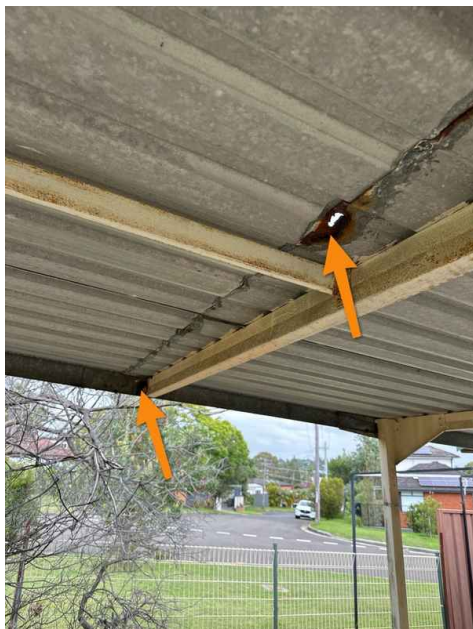
RUST PENETRATION

rust/penetrations - rust noted to the roof components and framework. Replacement required

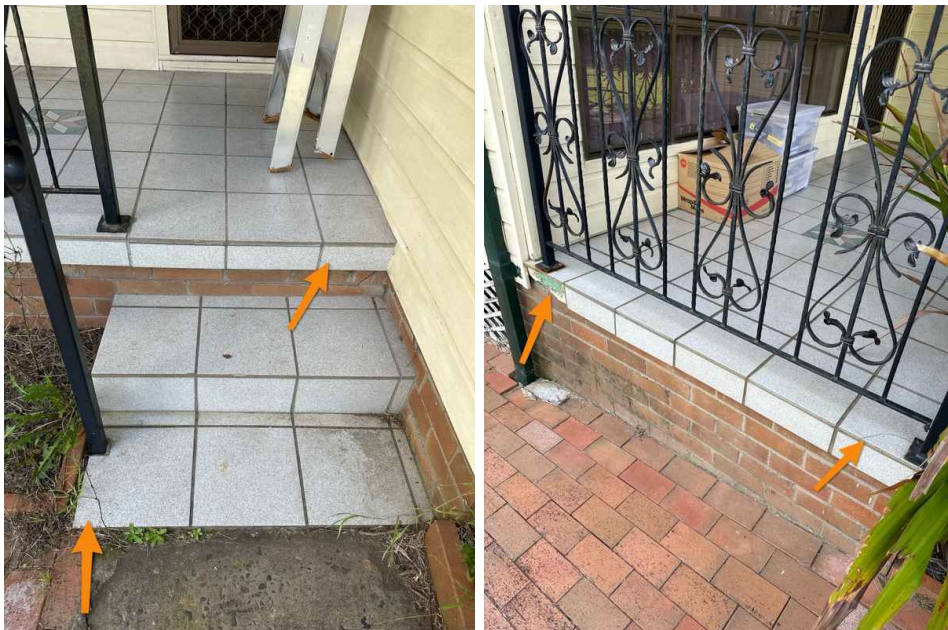
TILE CRACKS

Tile cracks evident on entry patio/porch

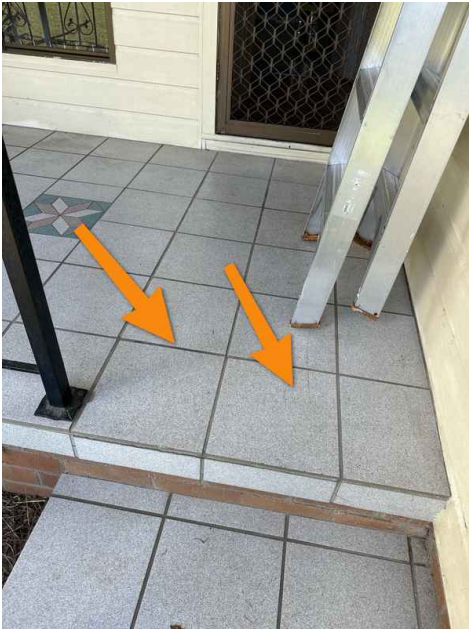
6.3.2 Entry

DRUMMY TILES

Drummy tiles noted. Further deterioration likely.

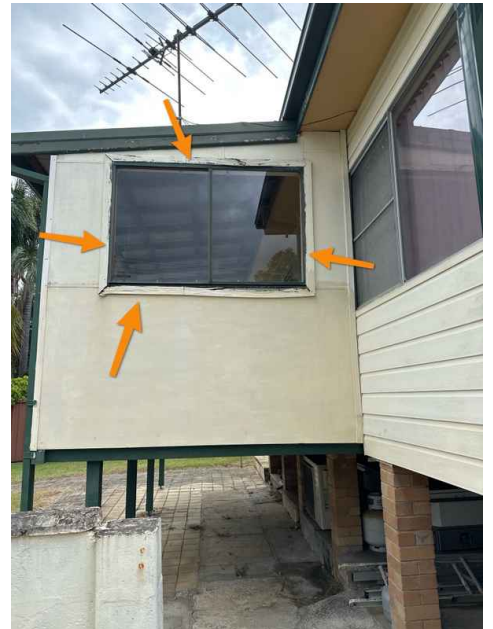
6.5.1 Exterior Windows

TIMBER FUNGAL DECAY

Timber fungal decay is evident in sections of the window framework - Some areas should be replaced.

Contact a qualified window repair/installation contractor.

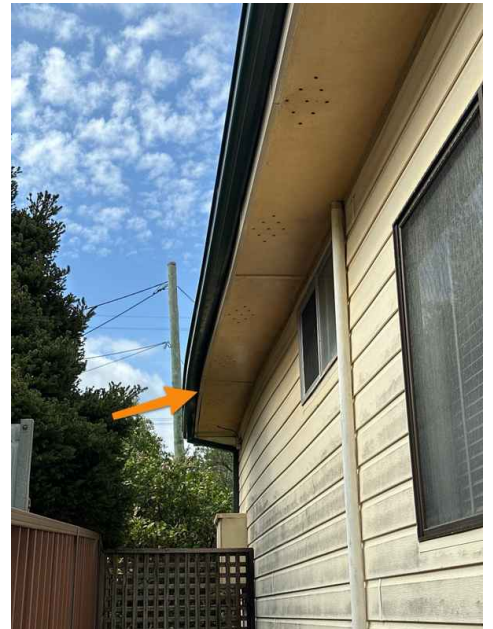
6.6.2 Eaves & Fascia

EAVES DISLODGED FROM FASCIA

Eave sheet has become dislodged from fascia groove. It is recommended the fascia to be fixed back in so there is no gap so water ingress can not occur. Contact a qualified carpenter for repairs.

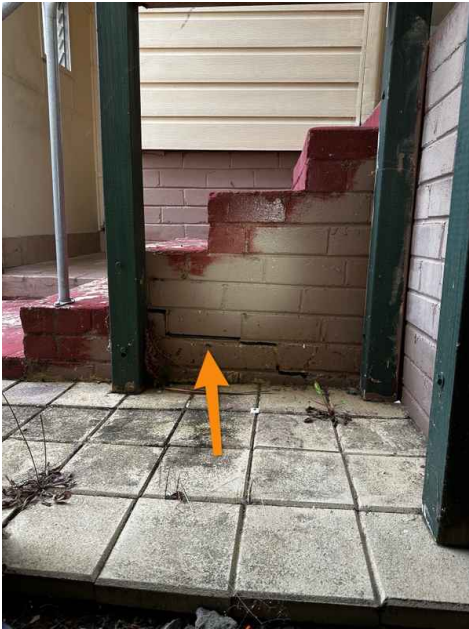
6.8.1 Stairs

SETTLEMENT CRACKS

Settlement/movement cracking.

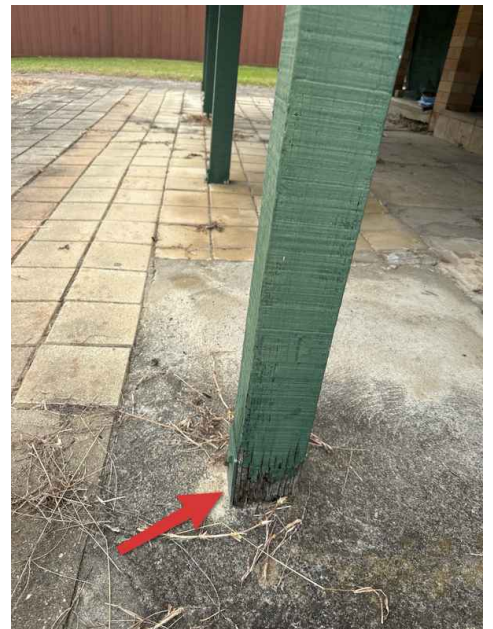
6.10.1 Balcony

ROT TO POSTS

Rot noted to balcony posts. This is a safety issue and should be fixed immediately.

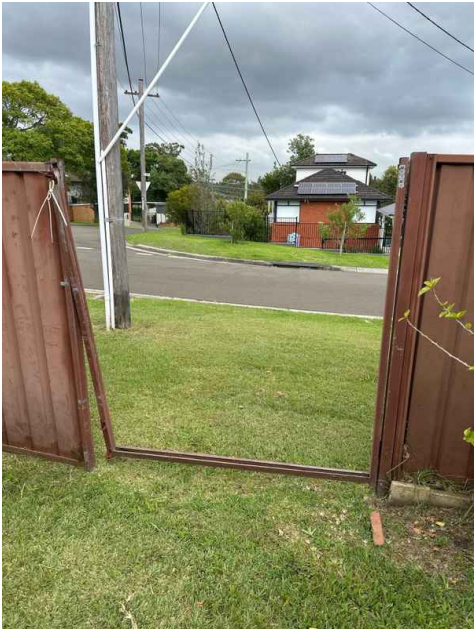
FENCE DAMAGE

Damage was noted to the fence

Recommendation
Contact a qualified fencing contractor

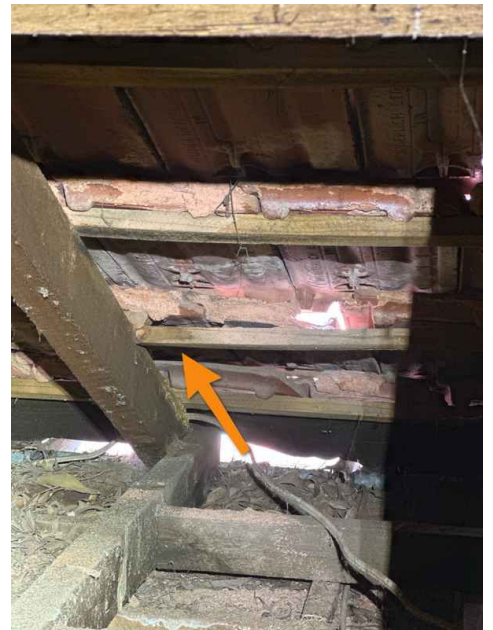
DAMAGED BATTEN

Damaged batten noted. Repair required

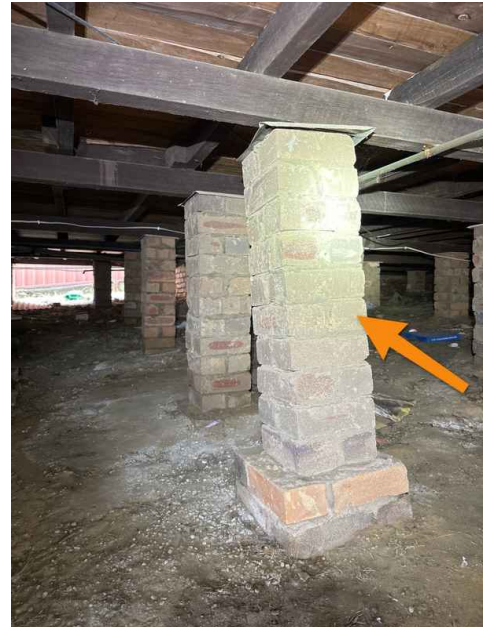
Evidence of minor subsidence (Sinking) was noted to the footings/piers that will require re-packing or re-building.

Contact a qualified masonry professional.

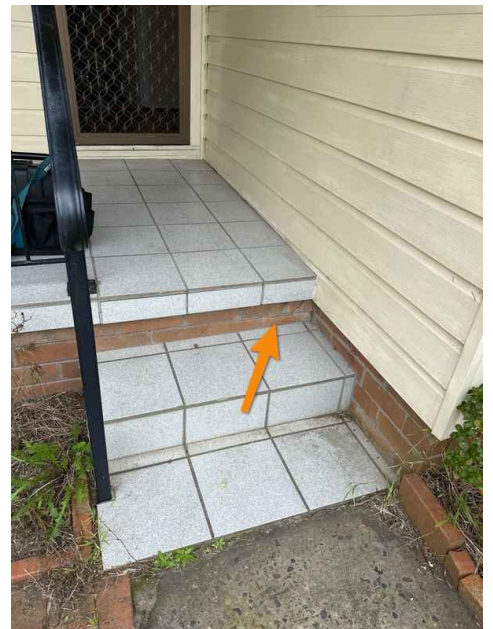
7.4.2 Piers & Foundation

FOUNDATION CRACKS - MINOR

Minor cracking was noted at the foundation. This is common as concrete ages and shrinkage surface cracks are normal. Recommend monitoring for more serious shifting/displacement.

Contact a qualified structural engineer.

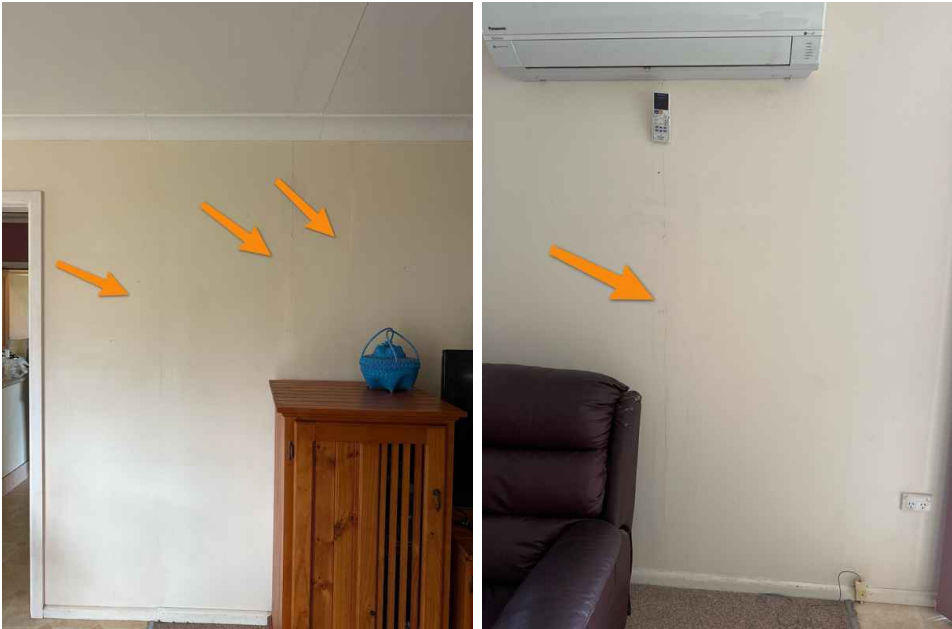
10.4.1 Walls

SHEET JOIN CRACKS

Sheet join cracks noted. This is probably due to thermal expansion. Patch and paint will suffice

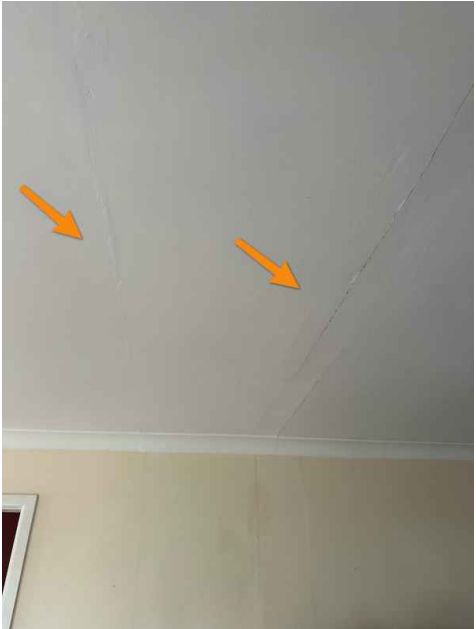
10.5.1 Ceilings

SHEET JOINS

Ceiling sheet joins cracks evident. This is likely due to thermal expansion

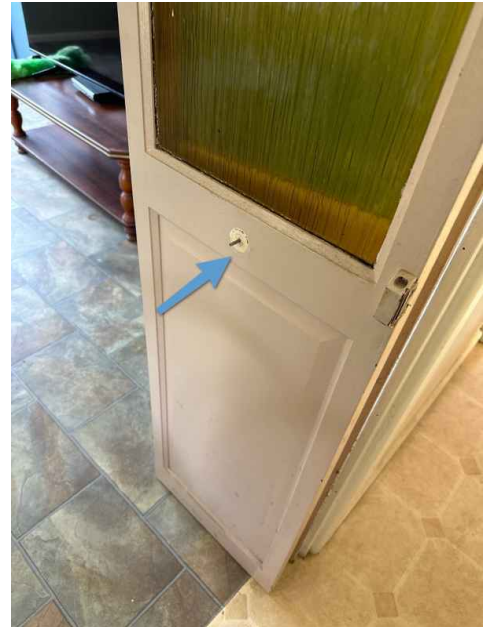
**HARDWARE
LOOSE/DAMAGED**

The door lock hardware is loose possibly damaged.

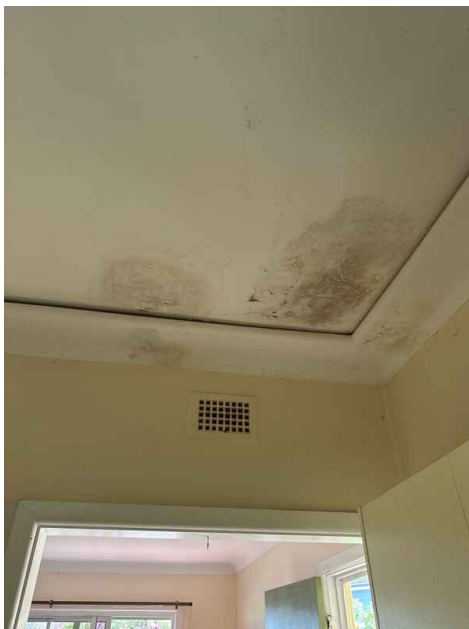
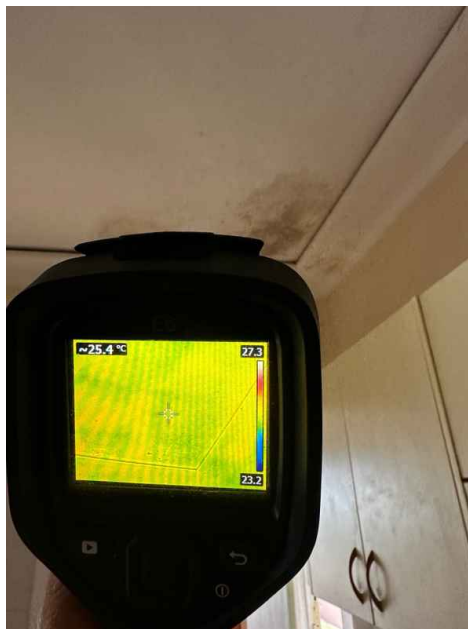
12.5.1 Ceilings

STAINS - DRY

Ceiling stains - No elevated moisture readings obtained. Recommendations: These may have been repaired, however, you will need to monitor after a prolonged period of rainfall - If leaking persists, a qualified plumber should be engaged for advice and recommendations. All water-damaged plaster replaced by a qualified plasterer.

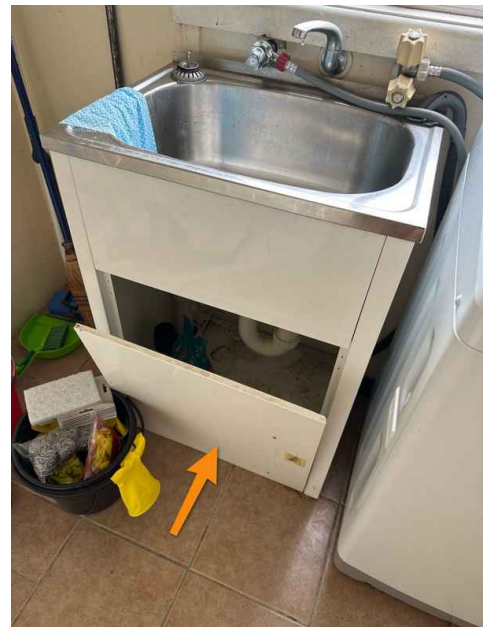
AGE/DETERIORATION

General deterioration and wear to sink, cupboards, and benches. Replacement recommended.

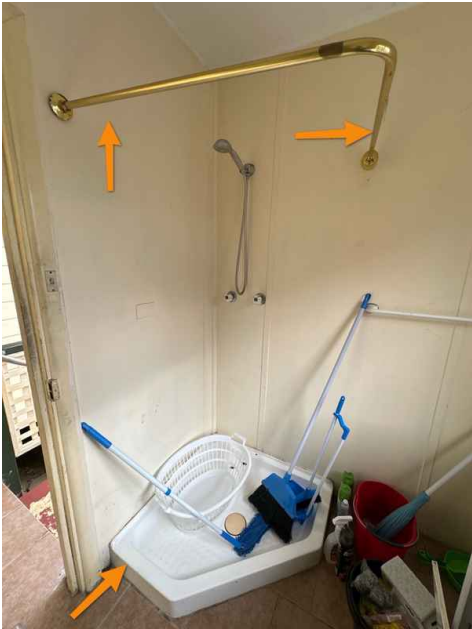
13.8.1 shower

DETERIORATION

Deterioration noted to the shower components. This should be removed

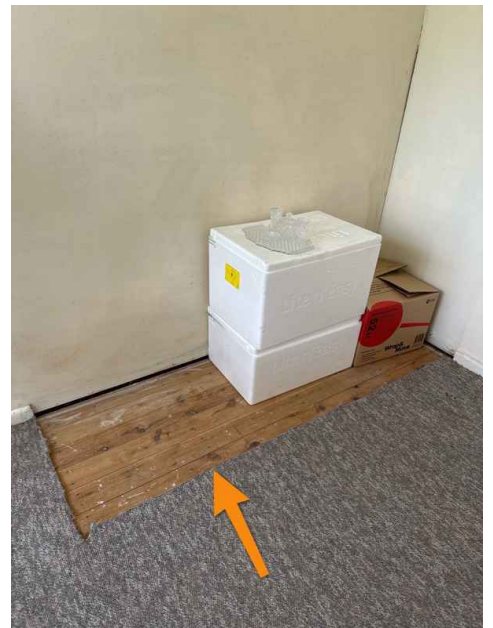
14.3.1 Floors

CARPET DAMAGE

Section of damaged carpet noted. It is recommended that a qualified carpet specialist be contacted for assessment.

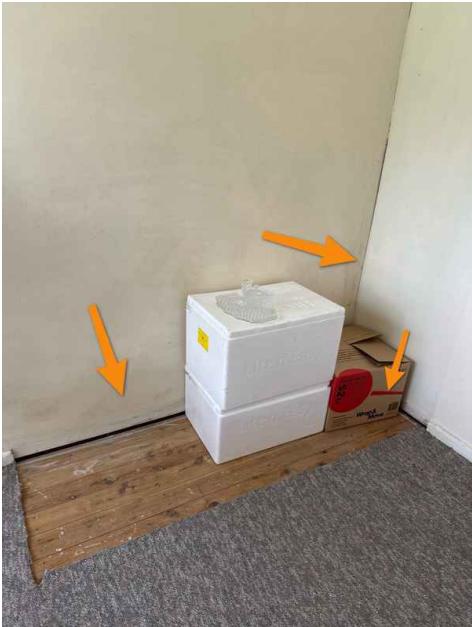
14.4.1 Walls

SKIRTING LOOSE OR MISSING

Skirting is loose/missing install/fix as needed

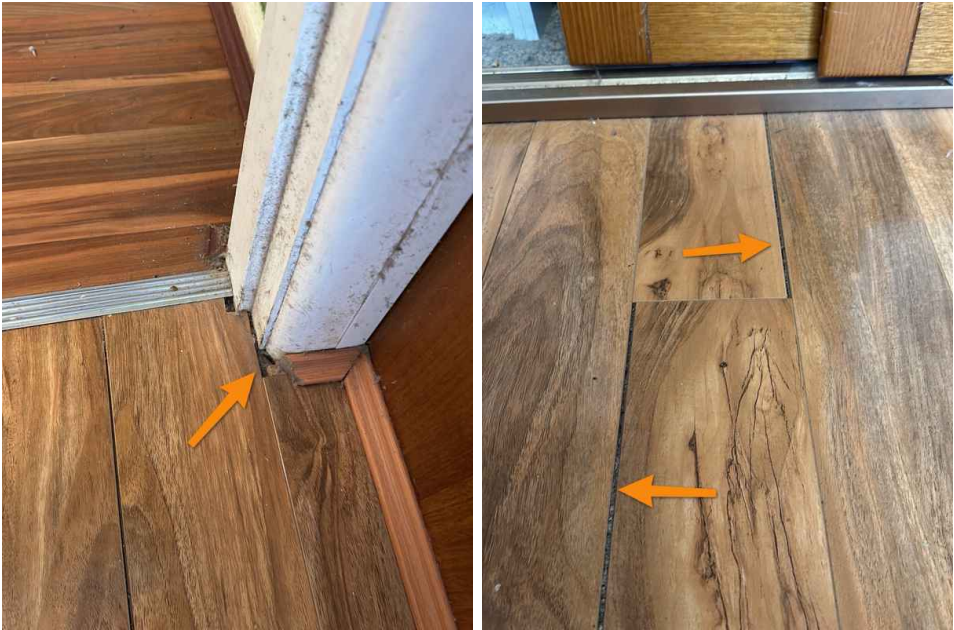
15.3.1 Floors

Untradesmenlike finish noted.

Contact a qualified professional.

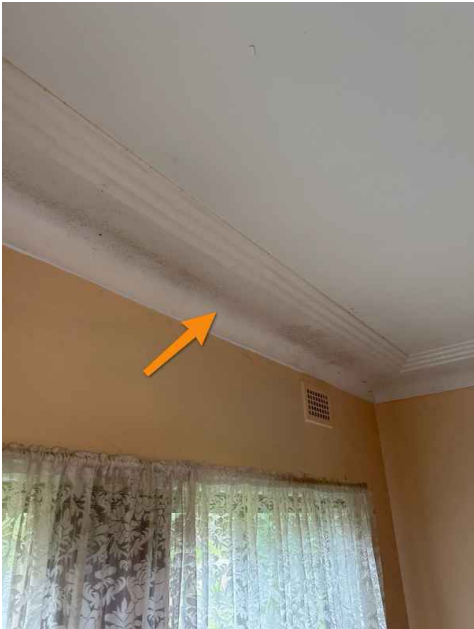
15.5.1 Ceilings

POSSIBLE MOLD

There are possible signs of fungi growth on ceiling. Recommend a qualified mold inspector evaluate.

Contact a qualified mold inspection professional.
