HOMESAFE INSPECTIONS

## BUILDING & PEST INSPECTION

119 Glencoe St  
Sutherland, NSW 2232

05/04/2024

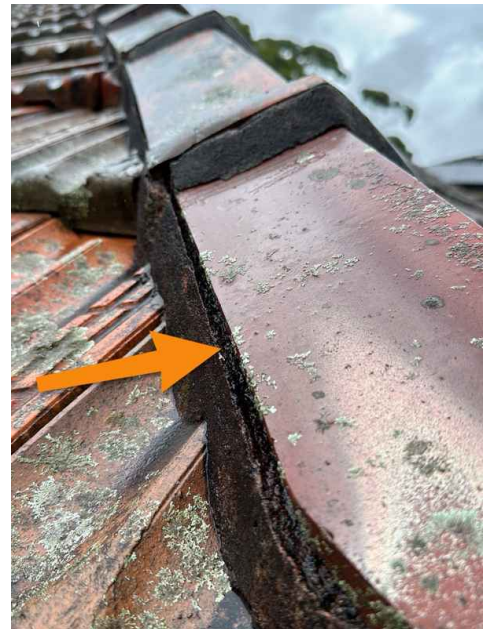
### MORTAR CRACKS

Mortar cracks visible. We recommend having these repaired by a licensed roofer as they contribute to water ingress. Whilst common on properties of this age we recommend repair it may result in water ingress into the roof cavity

Contact a qualified roofing professional.

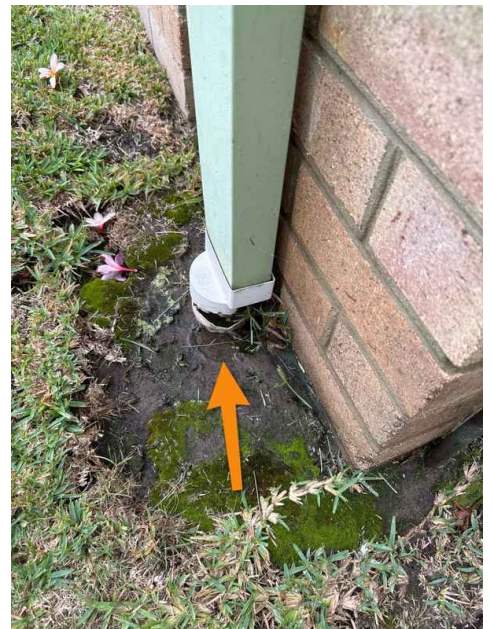
3.3.1 Downpipes

**BASE CRACKING**

The down pipe base is damaged/cracked. This has the potential to cause leaking and blockages

Contact a qualified plumbing contractor.

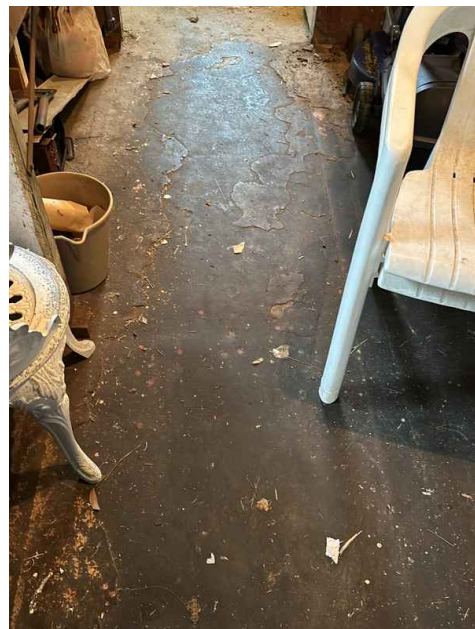
#### UNABLE TO INSPECT

Unable to inspect due to floor lining

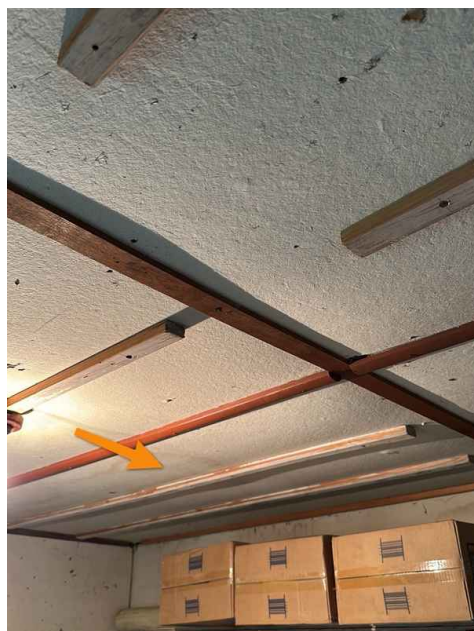
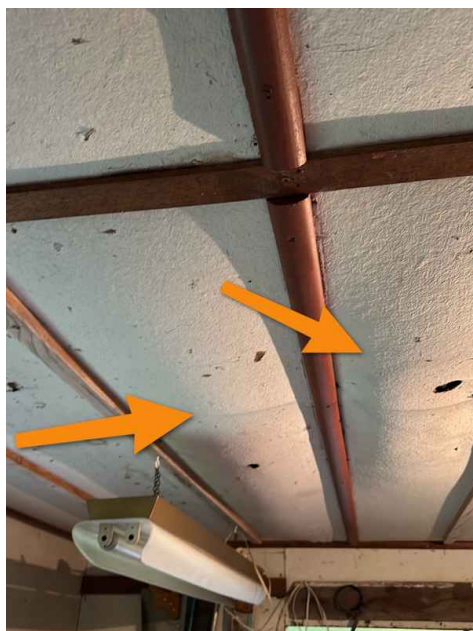
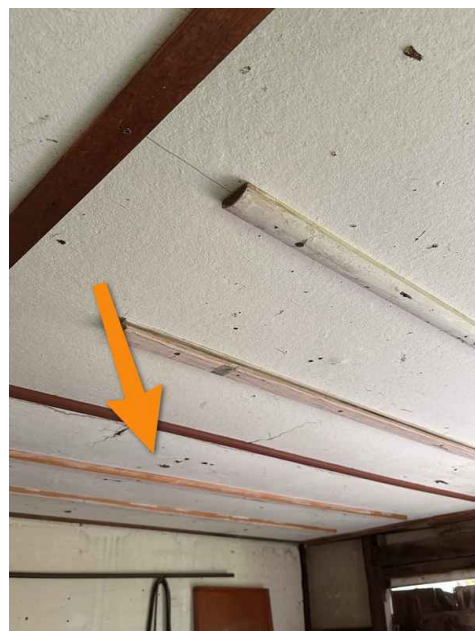
### 4.3.1 Ceiling

General aging and/or denting and/or wear and tear or the previous patching is evident on the ceiling linings.

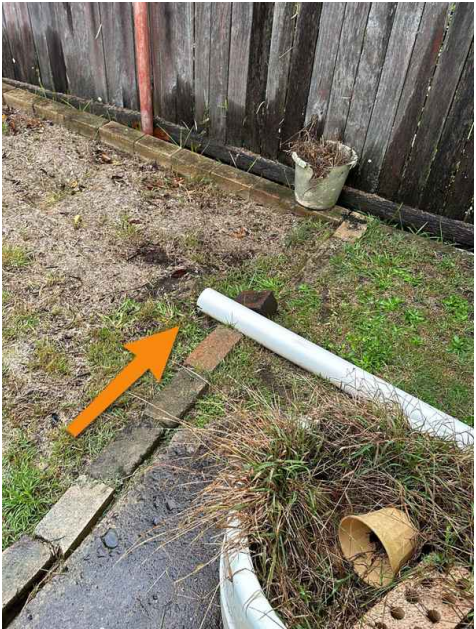
### 4.7.1 Roof & Gutter

#### NOT CONNECTED

Down pipe/s not connected to storm water discharge - Down pipes not connected to storm water have the potential to cause differential settlement to the footings, cause rising damp and is also conducive to termite infestation.

Recommendation  
Contact a qualified plumbing contractor.

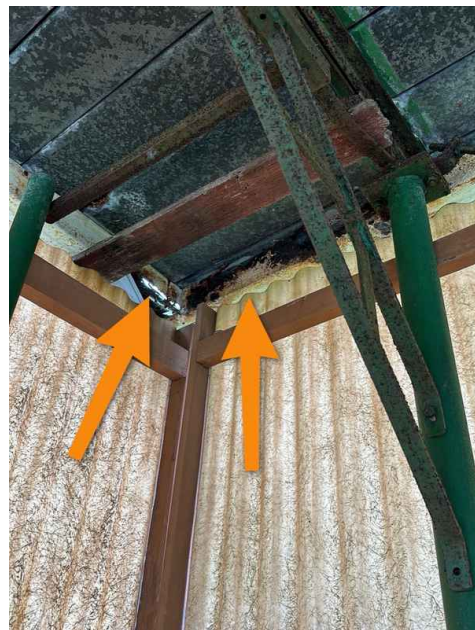
#### RUST PENETRATION

Gutter rust/penetrations - The gutter has excessive rust where leaking will occur.

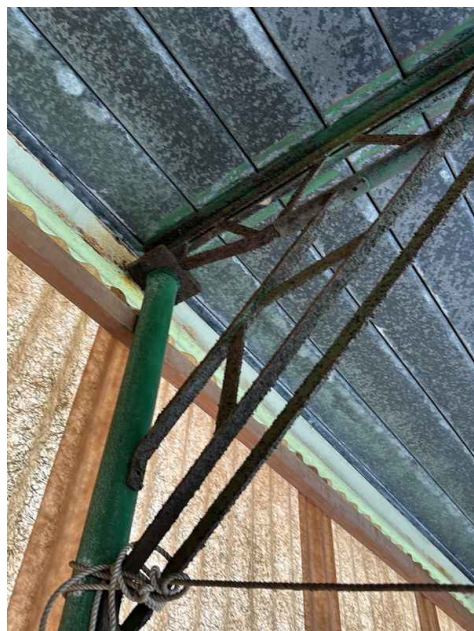
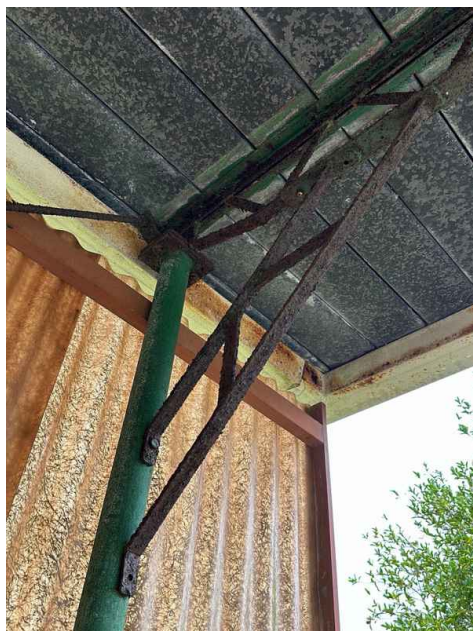
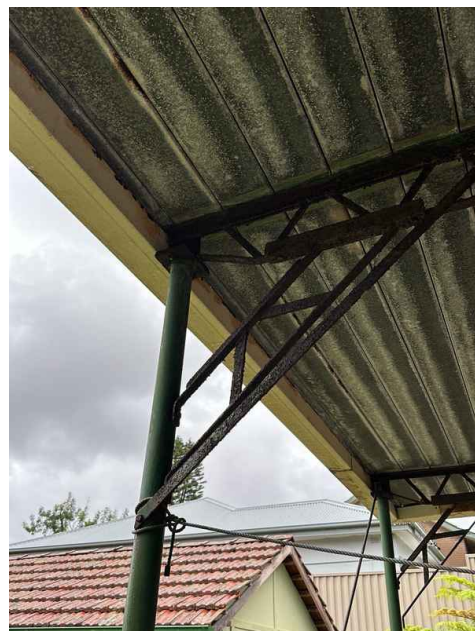
### 5.3.2 Roof & Gutter

#### FRAME RUST

The carport frame is showing signs of rust and needs maintenance  
Recommend scaling back all metal treating and painting to preserve

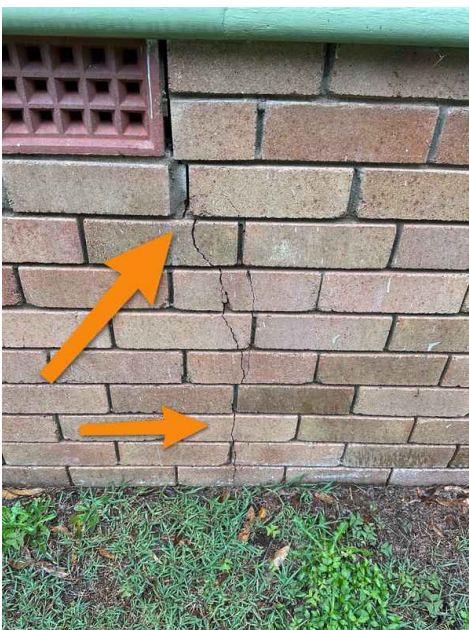
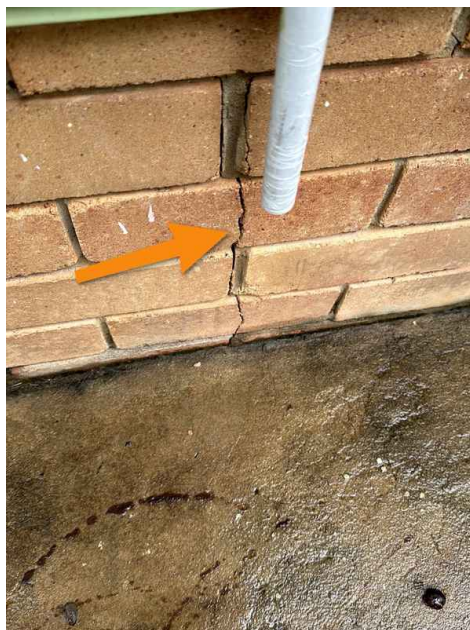
### 6.2.1 External

#### **CRACKING - MINOR**

There appears to have been some settlement in the building which has caused some cracking to the walls. These cracks are categorized as 0 to 2mm which is minor and typical for a building of this type and age. This can also cause some doors to bind or be out of square. In the inspector's opinion these cracks are due to settlement, usually due to ground movement and subsequent movement to building materials can be expected. Any cracks should be monitored and if cracks increase in size, further investigation should be carried out by a structural engineer.

Contact a qualified carpenter.

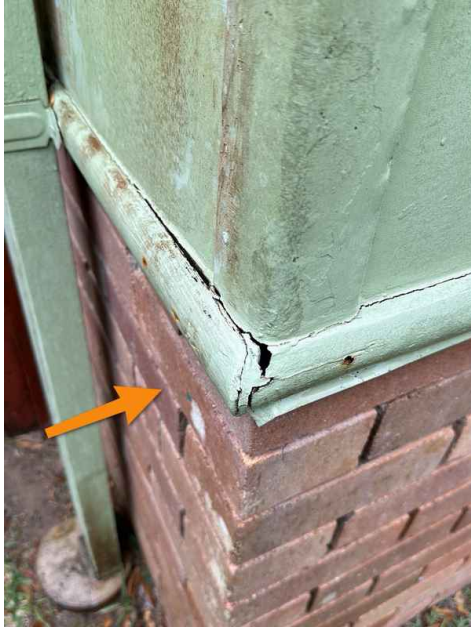
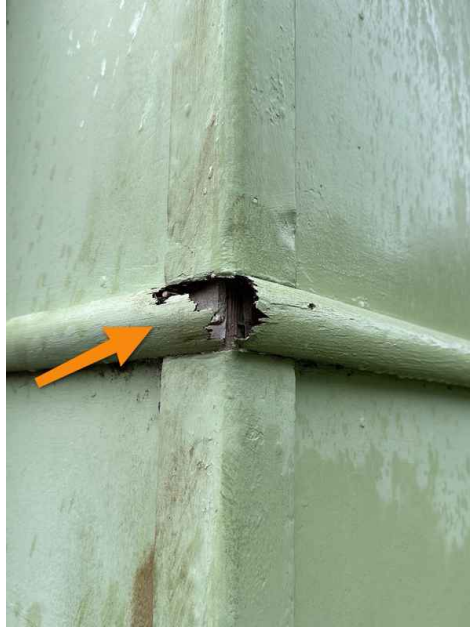
## 6.2.2 External

**MINOR ROT**

Minor rot noted to the external wall lining.

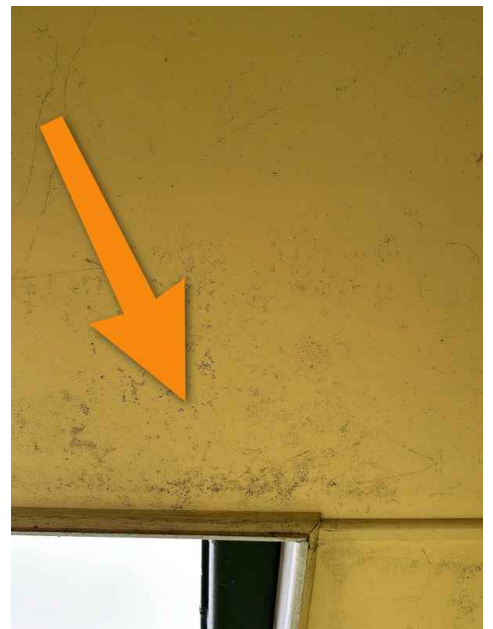
## 6.4.1 Entry

**POTENTIAL MOULD  
CEILING**

Potential mould noted to the ceiling lining. Clean and repaint.

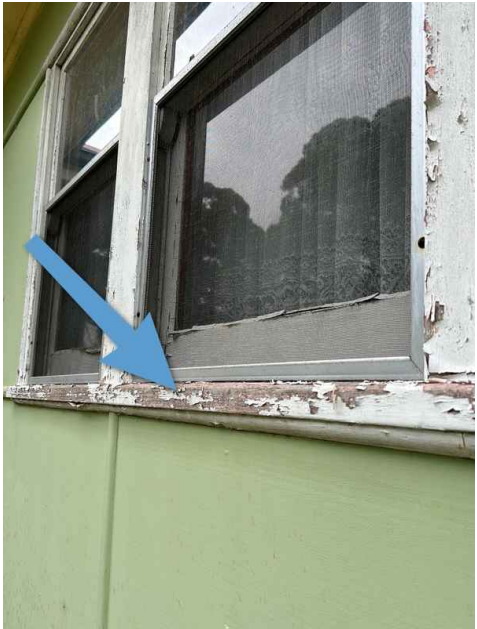
## 6.6.1 Exterior Windows

**PAINT DETERIORATION**

Paint deterioration noted to the external window/s. It is recommended that these be painted to help protect from the elements.

Recommendation  
Contact a qualified professional.

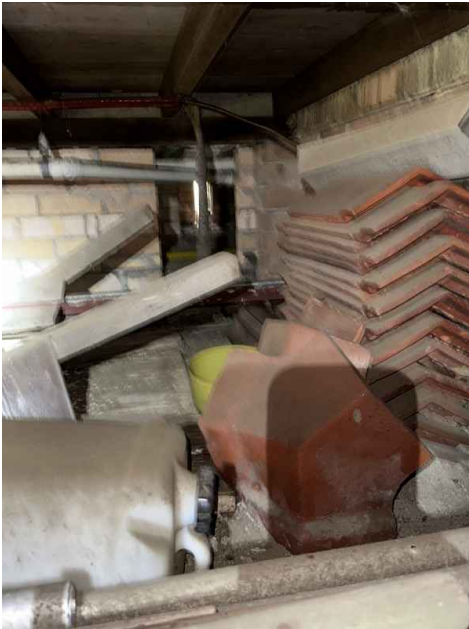
### **NO ACCESS TO AREAS**

Some areas of the subfloor were inaccessible.  
Areas below rooms where we could not inspect the subfloor:  
under laundry

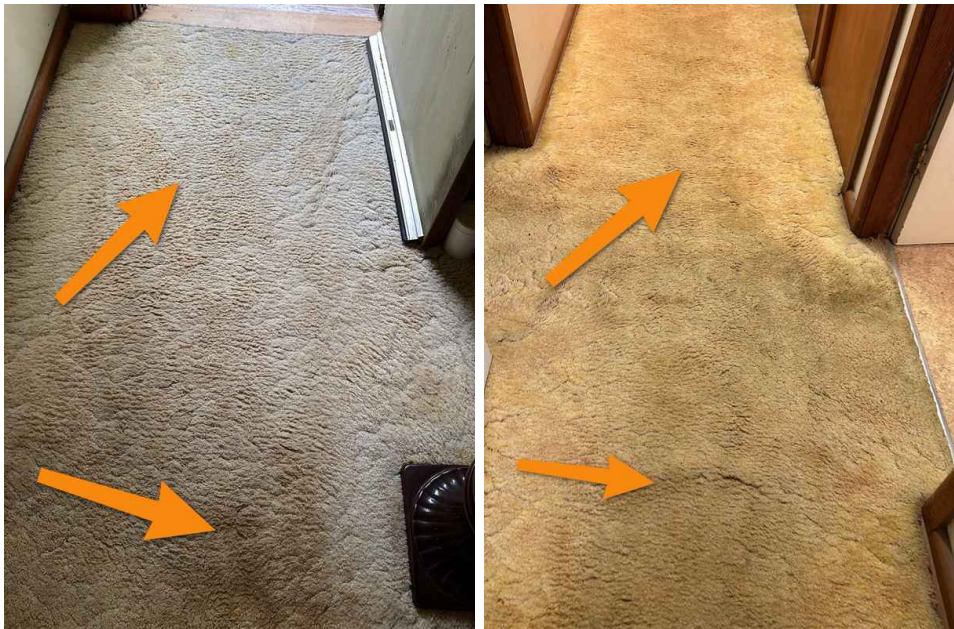
### MODERATE WEAR

Moderate surface wear noted. Recommend a qualified flooring contractor evaluate for possible re-finish.

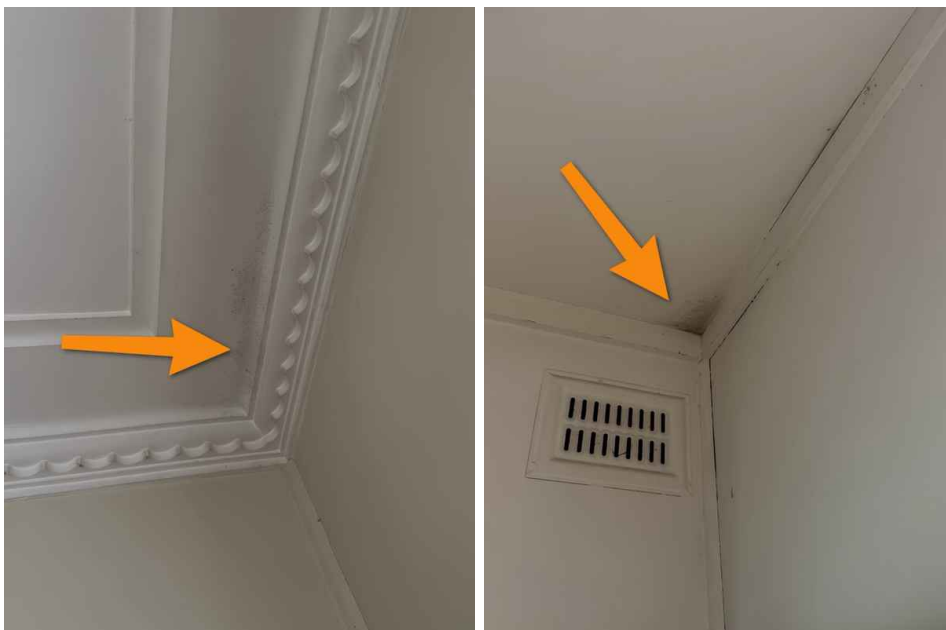
### 10.4.1 Ceilings

There are possible signs of fungi growth on one or more ceilings it is unknown if this is a safety hazard. Recommend a qualified mold inspector evaluate.

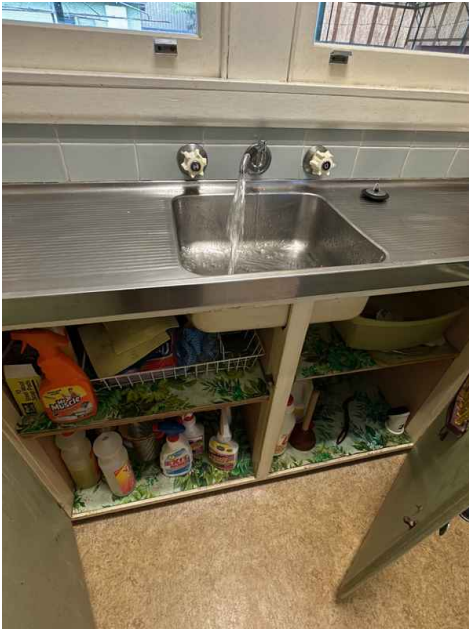
OWNER POSSESSIONS

There are owner's possessions, items in cupboards/under sink & personal belongings present which is preventing a thorough inspection of some areas of the Kitchen from being undertaken.

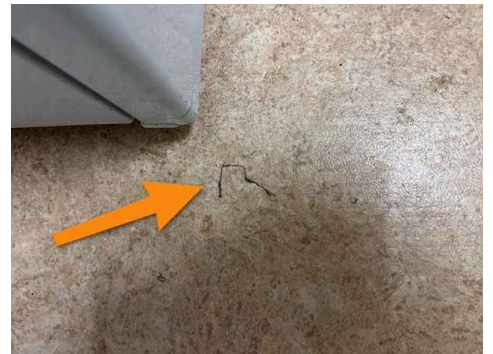
### LINO FLOOR DETERIORATION

The lino floor has begun to lift. It is recommended that a qualified Lino flooring specialist be contacted for repairs.

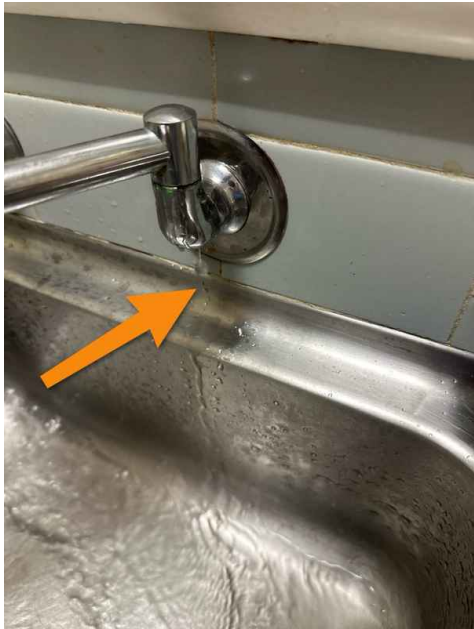
11.7.1 Sink, Cabinetry &  
Benchtops

### TAP LEAKING

Leaking tap noted. It is recommended that a qualified plumber be contacted for repairs

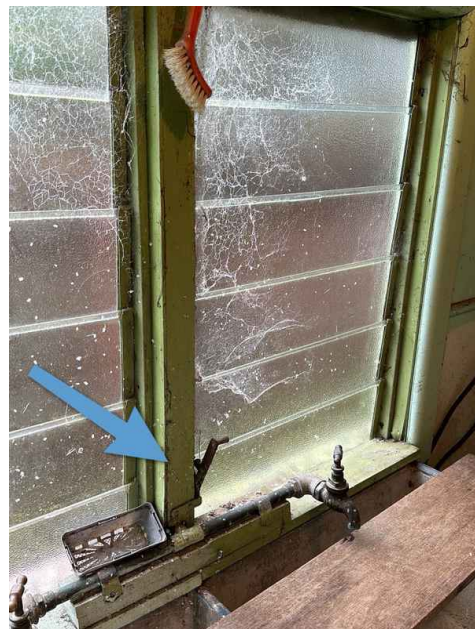
**AGE/DETERIORATION**

General age & deterioration - The window frame/components showed evidence of ageing and wear. Recommendations: General maintenance works required.

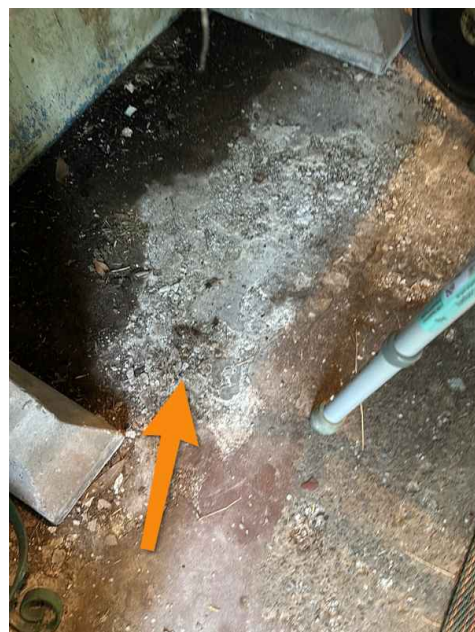
## 13.3.1 Floors

**CONCRETE  
DETERIATING**

The surface of the concrete over time has started to break up  
Recommend engaging a qualified concreter for advice

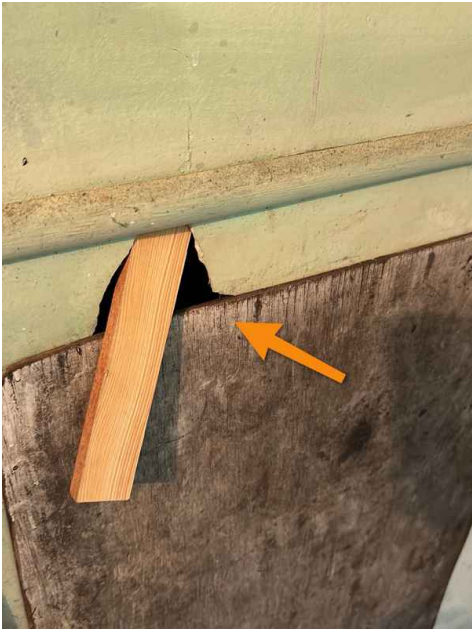
**IMPACT DAMAGE**

Impact damage noted. Patch and paint will generally suffice,  
however, see a qualified plasterer for further advice

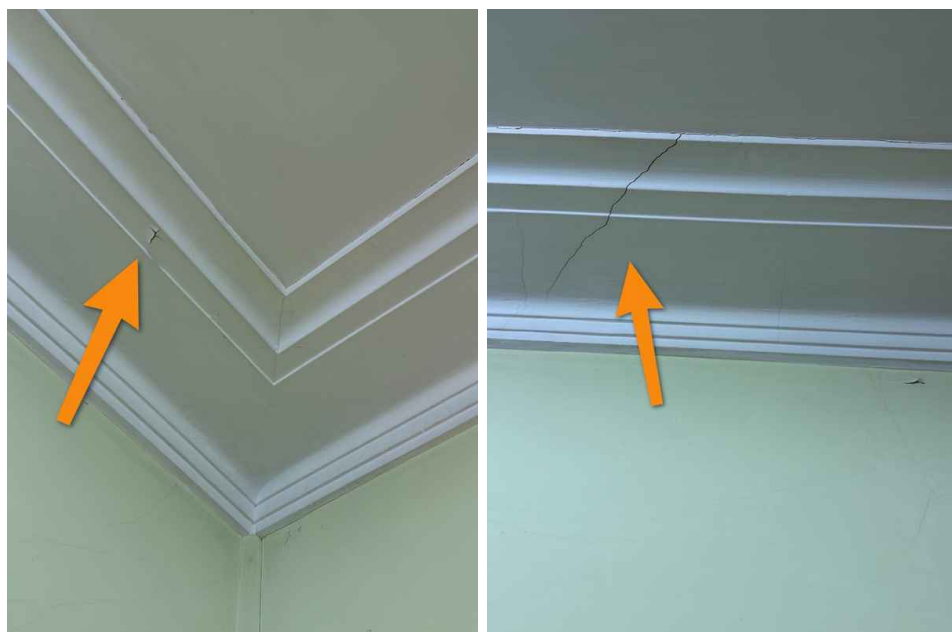
### 15.5.1 Ceilings

#### **PAINT DETERIORATION**

Celling paint deterioration in one or more areas. Recommend a qualified painter evaluate and apply a new coat.

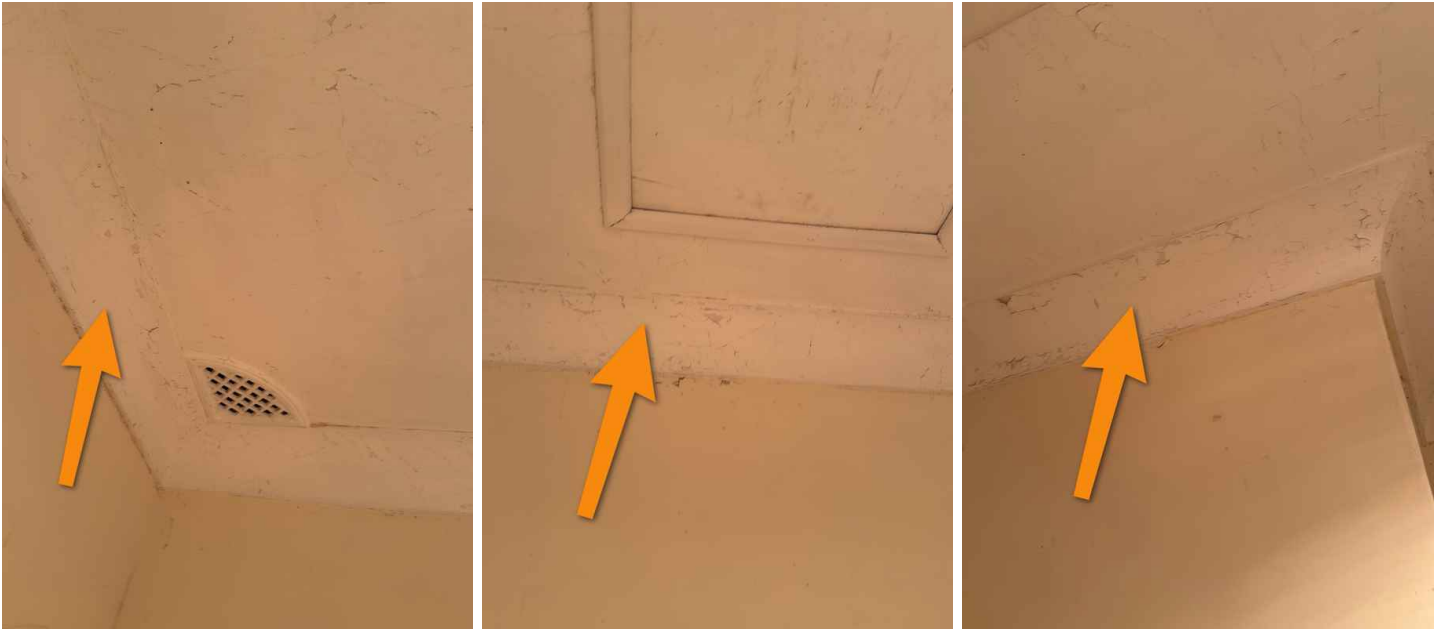
**PAINT DETERIORATION**

Paint deterioration noted.
