APCS- Pool Safety Compliance Report

10 Kurrewa Place, Kareela NSW 2232

Document No. 000009

Conducted on 4/09/2018

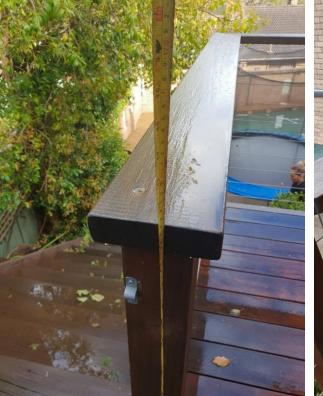
Appendix 3 4/9/18

Features diagram		
Barrier FGL FGL 500 min. Pool Barrier Fencing - Measurements		
Is finished ground level a permanent stable surface?	Yes	
Is the height of fence from top of fence to finished ground >1200mm (for non-boundary fence)?	No	 Appendix 3-5: The pool barrier doe not meet the minimum height of 1200mm from ground surface. Solution: Increase the height of the pool barrier by securing timber, Perspex, metal or similar materials to the top of the current barrier to achieve the minimum height. Solution B: Or secure a new barrier down at the pool area from the boundary fence to the building. The pool barrier must meet the pool barrier fencing measurements listed above and below in this report.

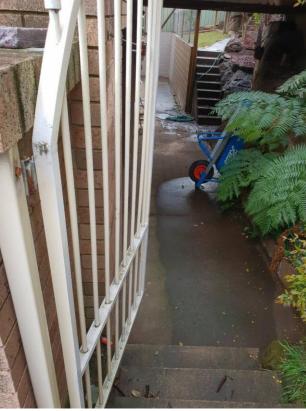
Vertical spaces no more than 100mm?	No	 Appendix 9: There is a gap of greater than 100mm between some of the tension wires. Possible Solution: Secure timber, metal, Perspex or similar material to the front of the fence to achieve a gap of less than 100mm. Solution B: Listed Above 	
Appendix 9 4/9/18			
 Self-closing device closes he gate from any position, with a stationary start, without the application of a manual force and operates the latch? latch 2. From approximately half-open 3. From fully open position 4. Apply 25kg weight to gate whilst open for 30 seconds. Remove weight and let gate close under own propulsion. 	No	 Appendix 10: The gate does not self- close from all open positions. Possible Solution: Adjust the tension on the hinges Or Install self-closing devices and ensure the gate and latch are aligned correctly 	
Appendix 10 4/9/18			
From gate resting on latch position?	No	Same as above

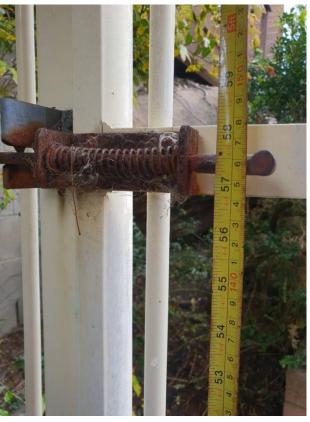
Appendix 11 4/9/18

From partially open positions?	No	Same as above

From fully open position?	No	Same as above
From any position after a 25kg weight has been placed on the top rail or component, 100mm from the outer edge of the locking stile of the gate for 30 seconds and then removed?	No	Same as above
Lift gate upwards and pull downwards with a force of 250N. The above movement of the gate must not: 1. Release the latch 2. unhinge the gate 3. increase gap under gate to >100mm	Failed	Same as above
Latch shall not be able to: 1. be inadvertently adjusted during operation 2. Locked in the 'open' position 3. adjusted without use of tools	Compliant	
Release point for latch? Either: - No less than 1500mm from finished ground level, OR - On inside and protected by 450mm shield, so no gaps >10mm present.	No	Appendix 12: The release point for the latch does not meet the minimum height requirement. Solution: Adjust the current latch or install a new latch point that is a minimum of 1500mm from the ground.
