6. DEFECT SCHEDULE

6.1. AUTOMATIC FIRE DETECTION AND ALARM SYSTEM (INCLUDING SMOKE ALARMS)

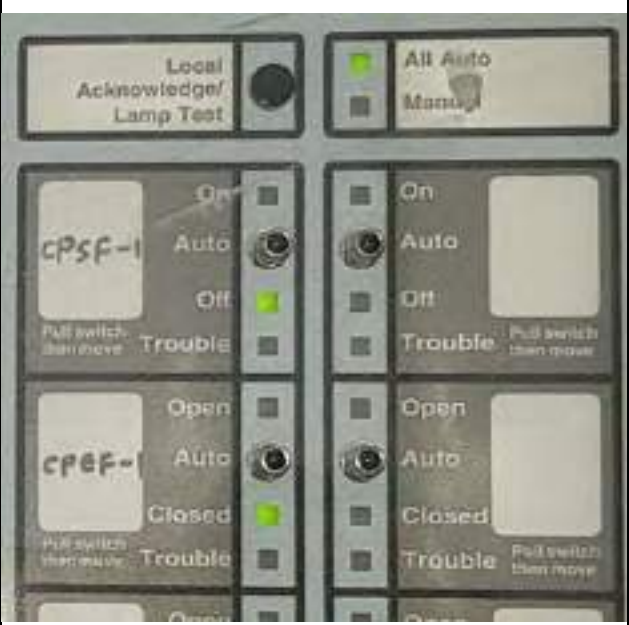
6.1.3.	DEFECT	FIRE FAN CONTROLS INCORRECTLY LABELLED

DESCRIPTION	Labelling on the control switch for the carpark exhaust fan (CPEF-1) does not comply with the wording requirements of Clause 7.15.3 of AS1670.1 - 2015. To comply with Clause 7.15.3 of AS1670.1 – 2015, control switches for fans shall be labelled 'OFF, AUTO, ON'.	
	LOCATION(S)	Main fire indicator panel Ground floor	
	BREACH(ES)	Failure to comply with: <ol style="list-style-type: none"> 1 Home Building Act 1989 NSW under Section 18B Clauses (a) & (c) 2 BCA – Table E2.2a – General Provisions 3 Clause 5.5 of AS1668.1 – 2015 4 Clause 7.15.3 of AS1670.1 – 2015 	
	METHOD OF REPAIR	The control switch for the carpark exhaust switch CPEF-1 will need to be reprogrammed to one of the spare fan control modules or the labelling on the existing control switch will need to be changed to read 'OFF, AUTO, ON'.

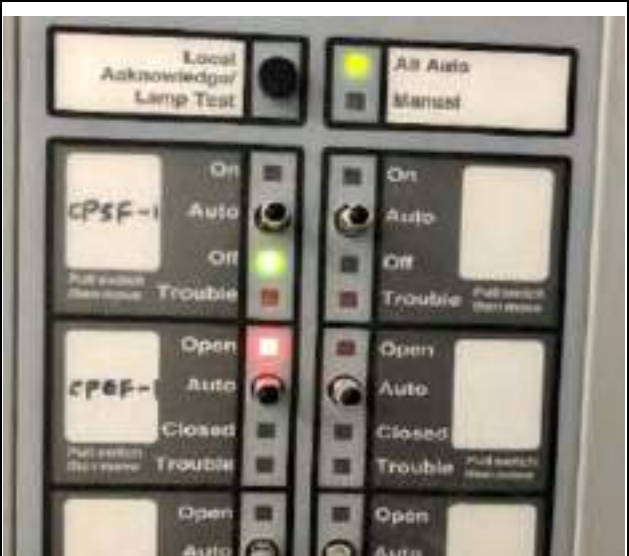
6.1.4.	DEFECT	INCORRECT OPERATION OF CARPARK SUPPLY AIR FAN IN FIRE MODE
	DESCRIPTION	<p>The operation of the carpark supply air fan does not comply with Clause 7.6.8.4 of AS1670.1 – 2015.</p> <p>The carpark supply air fan was found to shutdown on a general fire trip.</p> <p>To comply with Clause 7.6.8.4 of AS1670.1 – 2015, activation of a general fire trip shall cause the ventilation system to operate at full ventilation rate, unless smoke is detected in the supply air stream.</p> <p>Note: a detector has been installed in the supply air ductwork to shutdown the fan upon detection of smoke in the supply air stream, however it is not clear if this detector has been correctly programmed to initiate shutdown of the supply air fan when required.</p>
	LOCATION(S)	Main fire indicator panel Ground floor
	BREACH(ES)	<p>Failure to comply with:</p> <ol style="list-style-type: none"> 1 Home Building Act 1989 NSW under Section 18B Clauses (a) & (c) 2 BCA – Table E2.2a – General Provisions 3 Clause 5.5 of AS1668.1 – 2015 4 Clause 7.6.8.4 of AS1670.1 – 2015

METHOD OF REPAIR	<p>The fire indicator panel will need to be reprogrammed to operate as follows:</p> <ol style="list-style-type: none"> 1 General fire trip to cause all carpark fans (CPSF-1 & CPEF-1) to operate at full ventilation rate 2 Activation of the smoke detector in the supply air duct to shutdown supply air fan. 3 Supply air fan shutdown to be non-latching, such that it shall restart upon clearance of smoke from the smoke detector in the supply air duct.

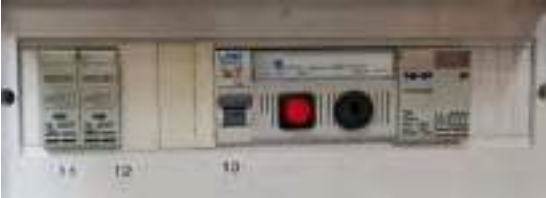
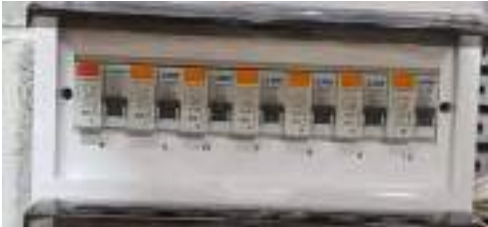
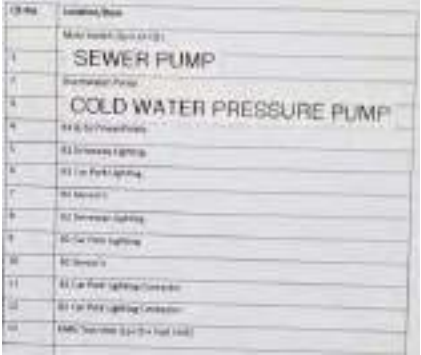
6.2.1.	DEFECT	EMERGENCY LIGHTING CIRCUIT BREAKERS NOT LABELLED	<p>House Services board 1 in Main switch room</p>

DESCRIPTION	<p>The test switch and circuit breakers that supply power to emergency lights are not labelled.</p> <p>To comply with Clause 2.4 of AS2293.1 – 2005 every circuit breaker, switch or fuse which, if turned off or removed, will cause the emergency lighting to operate shall have the following notice affixed immediately adjacent to it.</p> <p>WARNING: INTERRUPTING SUPPLY WILL DISCHARGE EMERGENCY LIGHTING BATTERIES</p>		
LOCATION(S)	Main switch room and Level G electrical cupboard		
BREACH(ES)	<p>Failure to comply with:</p> <ol style="list-style-type: none"> 1 Home Building Act 1989 NSW under Section 18B Clauses (a) & (c) 2 BCA – Clause E4.2 – Emergency lighting requirements 3 Clause 2.4 of AS2293.1 – 2005

METHOD OF REPAIR	<p>Install warning notices adjacent to the test switch and each circuit breaker that supplies power to an emergency light</p> <p>Signage installed shall have the following wording:</p> <p>WARNING: INTERRUPTING SUPPLY WILL DISCHARGE EMERGENCY LIGHTING BATTERIES</p>

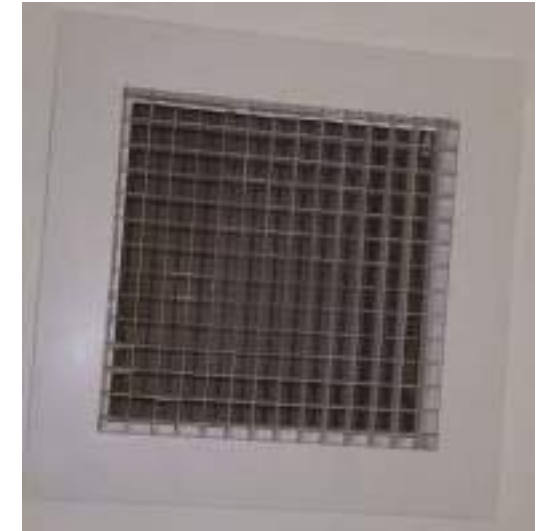
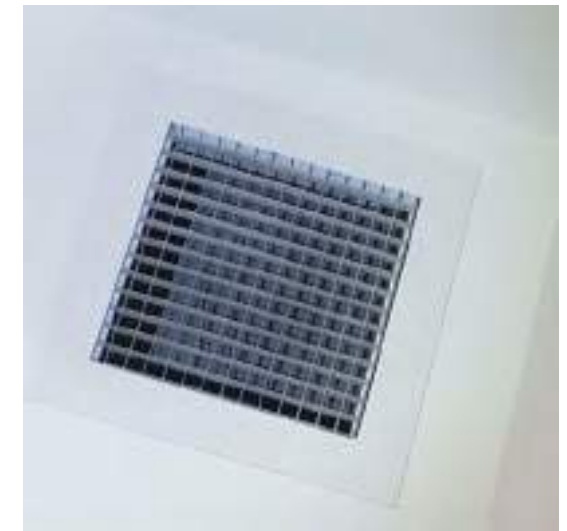
6.3.2.	DEFECT	NO FIRE DAMPERS INSTALLED
	DESCRIPTION	<p>No fire dampers have been installed to the lift lobby fresh air duct serving all lift lobbies within the eastern block.</p> <p>A common shaft is provided which contains the fresh air supply duct serving Level LG to Level L4 of the building. To comply with Table 3 of Specification C1.1 of the BCA the walls to a ventilation shaft in a Class 2 part of the building shall achieve a FRL of 90/90/90 (if loadbearing) or -/90/90 (if non-loadbearing).</p> <p>To comply with Clause 3.3 of AS1668.1, openings in building elements that are required to have an FRL shall be protected with fire dampers.</p> <p>To comply with Clause 2.5 of AS1668.1, fire dampers must comply with AS1682.2.</p>
	LOCATION(S)	Lift lobbies on levels LG, L1, L2, L3 & L4
	BREACH(ES)	<p>Failure to comply with:</p> <ol style="list-style-type: none"> 1 Home Building Act 1989 NSW under Section 18B Clauses (a) & (c) 2 BCA – Table 3 of Specification C1.1 – Type A construction: FRL of building elements 3 Clause 3.3 of AS1668.1 – 2015 4 Clause 2.5 of AS1668.1 – 2015 5 Section 6 of AS1682.2 – 2015.

METHOD OF REPAIR	<p>Fire dampers will need to be installed in the shaft wall for the lift lobby fresh air supply on Levels LG, L1, L2, L3 & L4</p> <p>The fire dampers selected and installed shall comply with Section 6 of AS1682.2 – 2015 and all relevant manufacturers' installation instructions.</p>

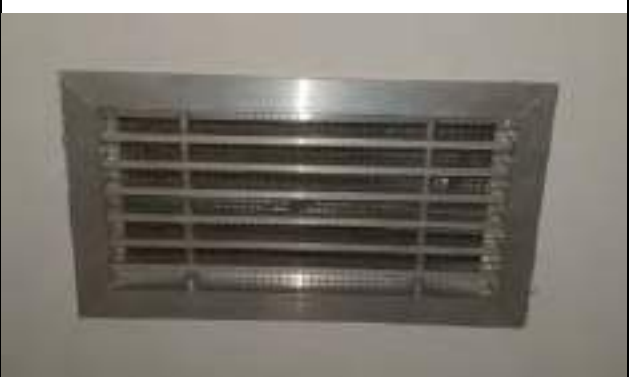
6.3.3.	DEFECT	NO FIRE DAMPER LOCATED

DESCRIPTION	<p>A fresh air supply is provided to the Service Room on Level LG. No documentation is provided that details where this fresh air supply is fed from and if the ducting serving this fresh air supply passes through any building elements that are required to have a FRL.</p> <p>Similarly there are no access panels or the like in the ceiling of this room to determine if the ducting passes through any building elements that are required to have a FRL.</p> <p>To comply with Table 3 of Specification C1.1 of the BCA the walls to a ventilation shaft in a Class 2 part of the building shall achieve a FRL of 90/90/90 (if loadbearing) or -/90/90 (if non-loadbearing).</p> <p>To comply with Clause 3.3 of AS1668.1, openings in building elements that are required to have an FRL shall be protected with fire dampers.</p> <p>To comply with Clause 2.5 of AS1668.1, fire dampers must comply with AS1682.2.</p>

LOCATION(S)	Service Room on Level LG	
	BREACH(ES)	Further investigation required.	
	METHOD OF REPAIR	<p>Further investigation will be required once the mechanical services baseline data has been provided (refer 6.3.1 above).</p> <p>If the ducting serving this fresh air supply is found to pass through any building elements that are required to achieve an FRL, a fire damper will need to be provided and an access panel will need to be installed, such that access to the fire damper is available for routine service inspections.</p>

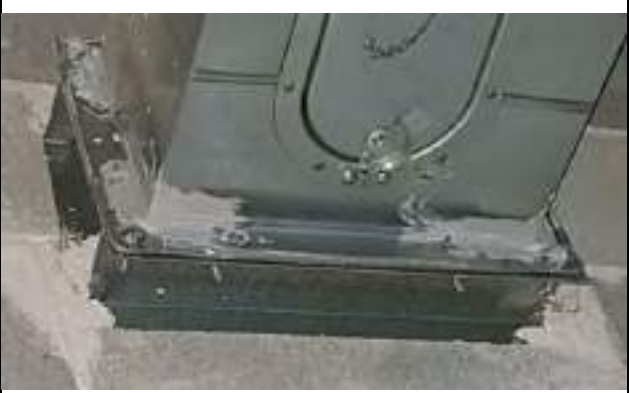
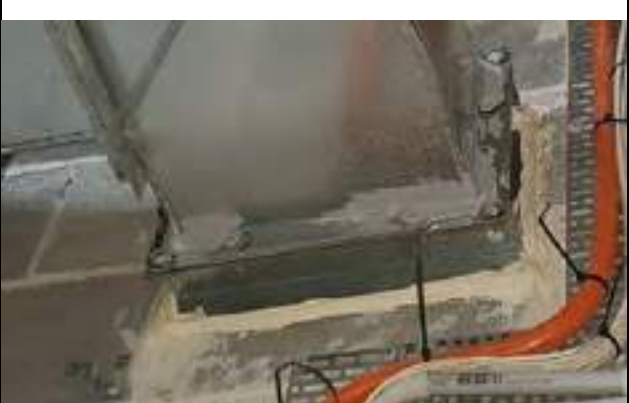
6.3.4.	DEFECT	INCORRECTLY INSTALLED FIRE DAMPER

DESCRIPTION	<p>The fire damper installed where the supply air ductwork serving the main switch room passes through the wall of the main switch room has not been installed correctly as follows:</p> <ul style="list-style-type: none"> • Steel bolts have been used in the breakaway connection • The angles surrounding the fire damper are not twice the width of the perimeter gap • The fire damper is not labelled <p>Based on the Architectural plans all walls to the main switch room are required to achieve a FRL of -/120/120.</p> <p>To comply with Clause C2.13 of the BCA a main switchboard which sustains emergency equipment operating in the emergency mode must be separated from the remainder of the building by construction having a FRL of not less than 120/120/120.</p> <p>To comply with Clause 3.3 of AS1668.1, openings in building elements that are required to have an FRL shall be protected with fire dampers.</p> <p>To comply with Clause 2.5 of AS1668.1, fire dampers must comply with AS1682.2.</p> <p>To comply with Section 6 of AS1682.2, breakaway joints must be provided so that any deformation or collapse of the ductwork does not dislodge the fire damper and the size of the opening in the structure shall not exceed the damper size by more than the width of one mounting flange on the face of the structure.</p>

LOCATION(S)	Main switch room		
	BREACH(ES)	<p>Failure to comply with:</p> <ol style="list-style-type: none"> 1 Home Building Act 1989 NSW under Section 18B Clauses (a) & (c) 2 BCA – Clause C2.13 – Electricity supply system 3 Clause 3.3 of AS1668.1 – 2015 4 Clause 2.5 of AS1668.1 – 2015 5 Section 6 of AS1682.2 – 2015. 		
	METHOD OF REPAIR	<p>Nylon bolts will need to be provided to the breakaway connection, and The opening for the fire damper will need to be reduced, or the mounting flanges will need to be increased in width, to ensure that:</p> <ul style="list-style-type: none"> • The installation complies with a tested prototype to AS1682.2-2015 • The gaps surrounding the fire damper are adequately sealed in accordance with a tested prototype

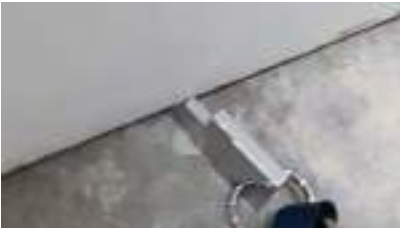
Hydrant pump room

6.4.1.	DEFECT	NON-COMPLIANT GAPS TO FIRE DOORS
	DESCRIPTION	<p>The gap below a number of fire doors exceeds 10mm.</p> <p>To comply with Clause 2 of Specification C3.4 of the BCA, a required fire door must comply with AS1905.1 – 2015.</p> <p>To comply with Clause 5.5.1 of AS1905.1 – 2015 the gap between a fire door and the floor covering shall not exceed 10mm.</p>
	LOCATION(S)	<ul style="list-style-type: none"> • Level B2 hydrant pump room • Level B1 south fire stair • Level B1 bin room • Level LG fire stair
	BREACH(ES)	<p>Failure to comply with:</p> <ol style="list-style-type: none"> 1 Home Building Act 1989 NSW under Section 18B Clauses (a) & (c) 2 Spec C3.4 of the BCA – Fire doors, smoke doors, fire windows and shutters 3 Clause 5.5.1 of AS1905.1 – 2015
	METHOD OF REPAIR	<p>Fire doors will need to be replaced or will need to be rectified as follows:</p> <p>Either:</p> <ul style="list-style-type: none"> • Install proprietary fire door upgrade seals (equivalent to Kilargo FDBU20 or FDBU60 upgrade kits), • Install non-combustible threshold plates to provide a compliant door clearance gap, or • Build-up the flooring level using a non-combustible product (concrete or similar) to provide a compliant door clearance gap. <p>Alternatively, provide evidence to the Owners that the doors installed have been approved with a gap between the door and floor of greater than 10mm.</p>

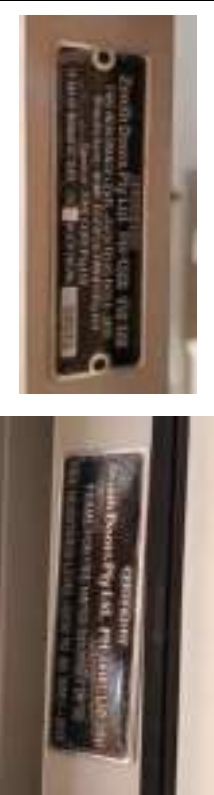
6.4.4.	DEFECT	FIRE DOOR COMPLIANCE TAGS NOT MECHANICALLY FIXED

DESCRIPTION	<p>Fire door compliance tags fitted to the fire door leaves and fire door frames have not been mechanically fixed in place (adhesive fix only was observed).</p> <p>To comply with Clause 6.1.3 of AS1905.1 – 2015, tags shall be permanently and mechanically fixed to minimise the possibility of detachment during the service life of the doorset by the following methods:</p> <ul style="list-style-type: none"> • Blind rivets attaching the tag to the metal frame. • Small clout or tack nails attaching the metal tag to the timber door leaf <p>This is considered to be a systemic defect.</p>	
	LOCATION(S)	All areas	
	BREACH(ES)	<p>Failure to comply with:</p> <ol style="list-style-type: none"> 1 Home Building Act 1989 NSW under Section 18B Clauses (a) & (c) 2 Clause C3.11 of the BCA – Bounding construction: Class 2 and 3 buildings and Class 4 parts 3 Spec C3.4 of the BCA – Fire doors, smoke doors, fire windows and shutters 4 Clause 6.1.3 of AS1905.1 – 2015

METHOD OF REPAIR	Install blind rivets and tack nails (as appropriate) to all fire door tags.

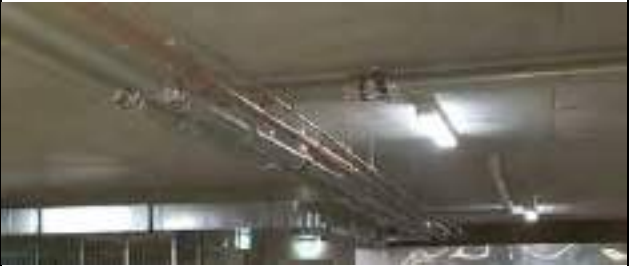
6.6.1.	DEFECT	HYDRANT PIPEWORK NOT LABELLED

DESCRIPTION	<p>Hydrant pipework passing through the carpark at B1 level is not labelled. To comply with Clause E1.3 of the BCA, hydrant systems must comply with AS2419.1.</p> <p>To comply with Clause 8.6.3 of AS2419.1 – 2005 pipework is required to be labelled in accordance with AS1345.</p> <p>To comply with Sections 7 and 9 of AS1345 – 1995, pipe markers shall be provided at spacings not greater than 8m along hydrant pipework. These labels shall have a red background and shall identify the flow direction.</p>	
	LOCATION(S)	B1 carpark	
	BREACH(ES)	<p>Failure to comply with:</p> <ol style="list-style-type: none"> 1 Home Building Act 1989 NSW under Section 18B Clauses (a) & (c) 2 BCA – Clause E1.3 – Hydrants 3 Clause 8.6.3 of AS2419.1 – 2005 4 Sections 7 & 9 of AS1345 – 1995 	
	METHOD OF REPAIR	Install labelling in accordance with AS1345 along hydrant pipework in carpark.

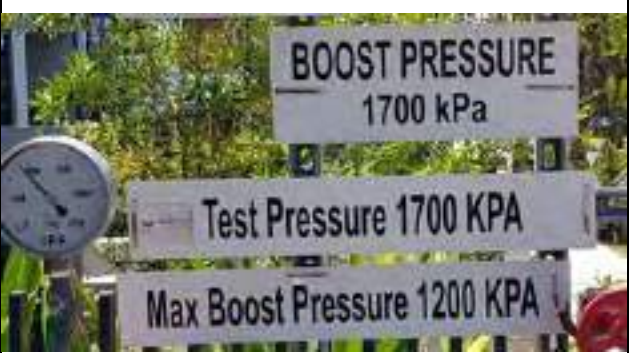
6.6.3.	DEFECT	CONFLICTING BOOST PRESSURE SIGNAGE

DESCRIPTION	<p>Signage at the booster connection has conflicting boost pressures stated. Two signs are installed as follows:</p> <ul style="list-style-type: none"> • BOOST PRESSURE 1700 kPa • MAX BOOST PRESSURE 1200 KPA <p>To comply with Clause E1.3 of the BCA a fire hydrant system must comply with AS2419.1.</p> <p>To comply with Tables 2.2 & 2.3 of AS2419.1 – 2005, the minimum required residual pressure at the most disadvantaged hydrant is 700kPa when flowing a hydrant at 10 L/sec.</p> <p>To achieve a pressure of 700kPa at the most disadvantaged hydrant on level 4, it is expected that a boost pressure of 1200kPa or less would be necessary at the booster.</p> <p>To comply with Clause 7.10 of AS2419.1 – 2005, signage must be provided at the booster connection to advise attending fire brigade personnel of the pressure required at the booster connection and/or pump discharge to achieve the required pressure at the most disadvantaged hydrant.</p>

LOCATION(S)	Fire brigade booster connection	
	BREACH(ES)	<p>Failure to comply with:</p> <ol style="list-style-type: none"> 1 Home Building Act 1989 NSW under Section 18B Clauses (a) & (c) 2 BCA – Clause E1.3 – Hydrants 3 Clause 7.10 of AS2419.1 – 2005 	
	METHOD OF REPAIR	<ol style="list-style-type: none"> 1. The original hydraulic designer will need to provide clarification on required boost pressure or a hydraulic consultant will need to be engaged to review the system pipework and determine the boost pressure requirements at the booster connection and pump discharge. 2. The boost pressure signage will then need to be amended to display the correct boost pressure. 3. Any additional (incorrect) signage would need to be removed.

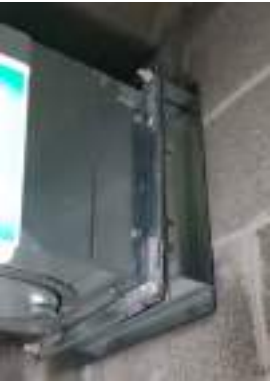
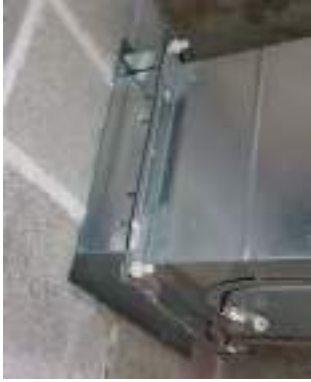
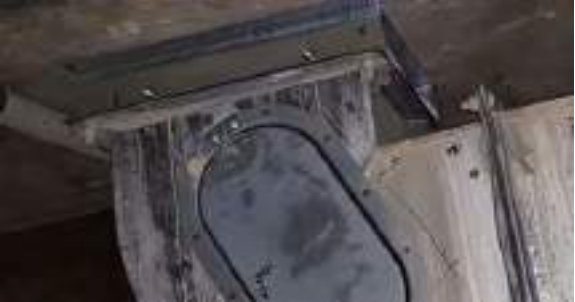
6.6.6.	DEFECT	HYDRANT PUMP ROOM VENTILATION NOT ADEQUATELY PROTECTED

DESCRIPTION	<p>Fire dampers have been installed in the ventilation ductwork where it penetrates the wall to the hydrant pump room and the floor slab between Levels B2 & B1.</p> <p>To comply with Clause E1.3 of the BCA a fire hydrant system must comply with AS2419.1.</p> <p>To comply with Clause 6.4.1 of AS2419.1, a hydrant pump room must be adequately ventilated for the aspiration and cooling of pump drivers.</p> <p>The installation of fire dampers in the ventilation ductwork, if exposed to heat from a fire in the carpark, could close and prevent ventilation of the pump room when the pump is required to operate.</p> <p>This requirement has been further clarified in the most recent issue of AS2419.1 (2021), which states the pump room must be ventilated with fresh air to maintain the aspiration and cooling of pump drivers for the required duration of pump operation.</p>

LOCATION(S)	<p>Hydrant pump room – supply air duct Hydrant pump room – exhaust duct Slab between Levels B2 & B1 – exhaust duct</p>	
	BREACH(ES)	<p>Failure to comply with:</p> <ol style="list-style-type: none"> 1 Home Building Act 1989 NSW under Section 18B Clauses (a) & (c) 2 BCA – Clause E1.3 – Hydrants 3 Clause 6.4.1 of AS2419.1 – 2005 	
	METHOD OF REPAIR	<ol style="list-style-type: none"> 1 The existing fire dampers will need to be removed and ductwork reinstated through wall and slab 2 The ductwork throughout the carpark will need to be protected using fire rated construction for the full length of the ductwork between the hydrant pump room and: <ul style="list-style-type: none"> • the exterior of the building in the case of the supply air duct, and • the fire isolated shaft that extends to the roof of the building (adjacent lift) in the case of the exhaust air duct

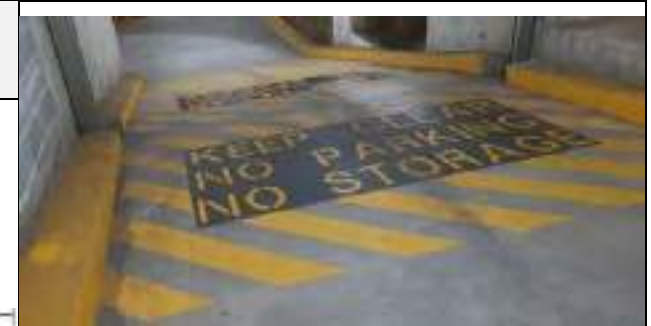
Hatched line markings have been provided, however they only extend 2.5m from the shutter on the upper part of the vehicle ramp.

LOCATION(S)	Vehicle ramp between Levels B1 & B2	
	BREACH(ES)	Failure to comply with: <ol style="list-style-type: none"> 1 Home Building Act 1989 NSW under Section 18B Clauses (a) & (c) 2 Table 1.2 of Fire Engineering Report (138309.FER001b dated 9 May 2019) prepared by Holmes Fire 	
	METHOD OF REPAIR	Extend hatched line markings to extend not less than 2.8m from the shutter on the upper part of the ramp.

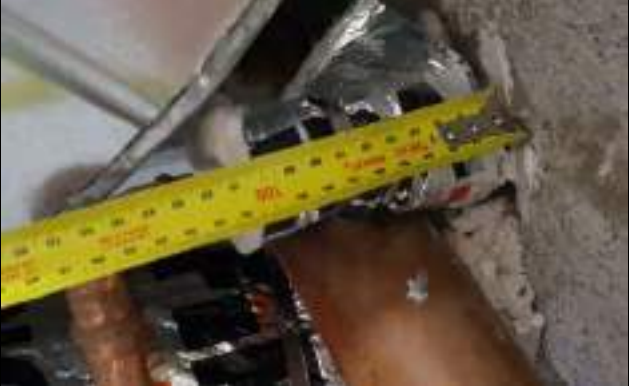
<p>6.8.1.</p>	<p>DEFECT</p>	<p>COPPER PIPE INADEQUATELY INSULATED</p>

<p>DESCRIPTION</p>	<p>A copper pipe (for the hydrant installation pressure) has not been adequately insulated in accordance with a tested system, where it passes through the wall between the hydrant pump room and fire stair.</p> <p>Insulation wrap has been applied to the pipe, however the length of wrap is approximately 100mm on the pump room side of the wall.</p> <p>To comply with C3.15 of the BCA, service penetrations through fire rated construction must be identical to a tested prototype that has been tested in accordance with AS4072.1 & AS1530.4.</p> <p>To comply with the manufacturer's tested system that achieves a FRL of -/120/120, the insulation wrap (TBA Firefly Penowrap) must extend 300mm and be fixed using 3 stainless steel cable ties on both sides of the wall. Refer below extract from Warringtonfire report FAS190236 Revision: RIR1.7.</p>

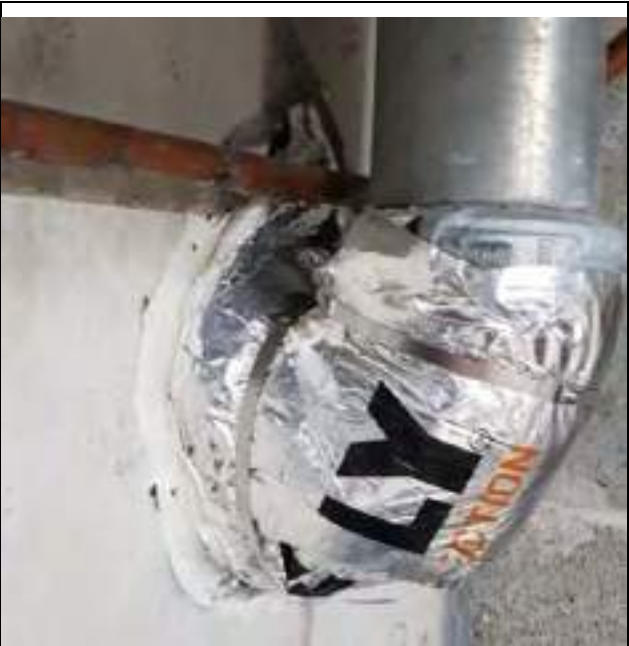
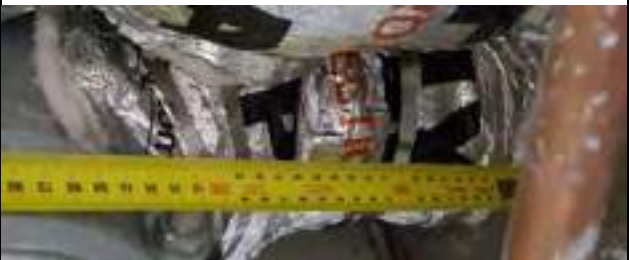
6.8.2.	DEFECT	STEEL PIPE INADEQUATELY INSULATED															
	DESCRIPTION	<p>Two steel pipes (for the hydrant installation discharge pipe) have not been adequately insulated in accordance with a tested system, where they pass through the wall of the hydrant pump room.</p> <p>Insulation wrap has been applied to the pipe, however the length of wrap is less than 300mm on the pump room side of the wall.</p> <p>To comply with C3.15 of the BCA, service penetrations through fire rated construction must be identical to a tested prototype that has been tested in accordance with AS4072.1 & AS1530.4.</p> <p>To comply with the manufacturer's tested system that achieves a FRL of -/120/120, the insulation wrap (TBA Firefly Penowrap) must extend 300mm and be fixed using 3 stainless steel cable ties on both sides of the wall. Refer below extract from Warringtonfire report FAS190236 Rev RIR1.7 dated 01/09/21.</p>

<p>V134</p> <p>Steel Pipes 8 mm OD up to 55 mm OD with a min' wall thickness of 0.91 mm and 55 mm OD up to 114mm OD with a min' wall thickness of 1.22 mm.</p>	 	<p>Max' 120mm Core Hole. Run a 10 mm bead of TBA Firefly™ Intumesc. around the perimeter of the pipe over the annular gap (Min' 2mm max 5 mm). Then wrap with TBA Firefly™ Penowrap® for a distance of 300 mm. Secured with 3 x S/Steel Zip Ties. Wrap both sides of wall</p>	<p>Min' 100 mm thick Masonry, Concrete block or Habel block wall. Capable of minimum FRL-/120/120 (Item 22)</p>	<p>-/120/120</p>				<p>Capable of minimum FRL -/90/90 (Item 35)</p>	<p>-/90/90</p>				<p>Capable of minimum FRL -/60/60 (Item 36)</p>	<p>-/60/60</p>
<p>V134</p> <p>Steel Pipes 8 mm OD up to 55 mm OD with a min' wall thickness of 0.91 mm and 55 mm OD up to 114mm OD with a min' wall thickness of 1.22 mm.</p>	 	<p>Max' 120mm Core Hole. Run a 10 mm bead of TBA Firefly™ Intumesc. around the perimeter of the pipe over the annular gap (Min' 2mm max 5 mm). Then wrap with TBA Firefly™ Penowrap® for a distance of 300 mm. Secured with 3 x S/Steel Zip Ties. Wrap both sides of wall</p>	<p>Min' 100 mm thick Masonry, Concrete block or Habel block wall. Capable of minimum FRL-/120/120 (Item 22)</p>	<p>-/120/120</p>													
			<p>Capable of minimum FRL -/90/90 (Item 35)</p>	<p>-/90/90</p>													
			<p>Capable of minimum FRL -/60/60 (Item 36)</p>	<p>-/60/60</p>													
	LOCATION(S)	Hydrant pump room															
	BREACH(ES)	<p>Failure to comply with:</p> <ol style="list-style-type: none"> 1 Home Building Act 1989 NSW under Section 18B Clauses (a) & (c) 2 BCA – Clause C3.15 – Openings for service installations 3 Manufacturer's tested or approved system 															
	METHOD OF REPAIR	Install Penowrap for a distance of 300mm, fixed with 3 x stainless steel cable ties to the steel pipe on the hydrant pump room side of the wall.

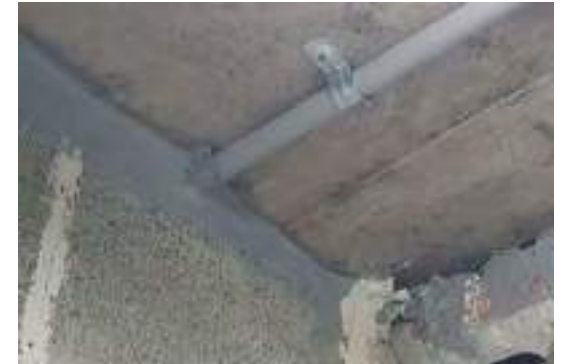
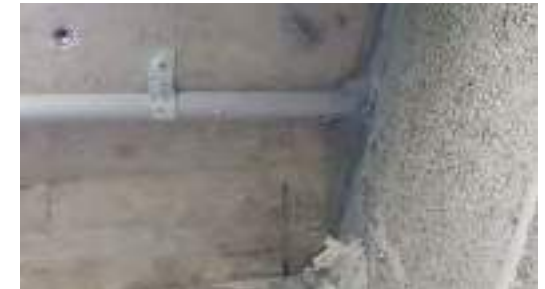
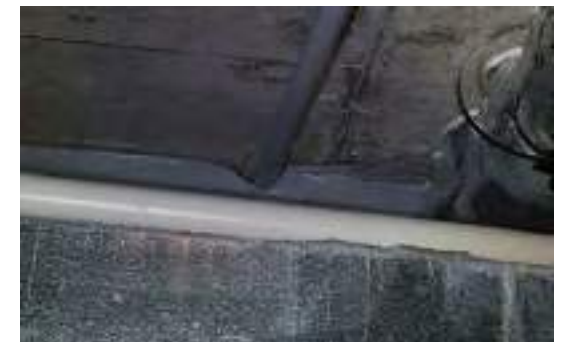
6.8.3.	DEFECT	PVC CONDUITS NOT FIRE STOPPED
	DESCRIPTION	<p>The conduit for the fire detection system has not been adequately fire stopped where it passes through the walls to the hydrant pump room.</p> <p>To comply with C3.15 of the BCA, service penetrations through fire rated construction must be identical to a tested prototype that has been tested in accordance with AS4072.1 & AS1530.4.</p> <p>An acrylic mastic has been used to partially seal these conduits, however there is no tested system that achieves the required FRL using acrylic mastic to seal electrical conduits.</p>
	LOCATION(S)	<p>Hydrant pump room wall Hydrant pump room airlock wall</p>
	BREACH(ES)	<p>Failure to comply with:</p> <ol style="list-style-type: none"> 1 Home Building Act 1989 NSW under Section 18B Clauses (a) & (c) 2 BCA – Clause C3.15 – Openings for service installations 3 Manufacturer’s tested or approved system
	METHOD OF REPAIR	<ol style="list-style-type: none"> 1 Either: <ol style="list-style-type: none"> a. Install suitable fire collars to the PVC conduit, on both sides of the wall. <p>OR</p> <ol style="list-style-type: none"> b. Cut back conduit and remove section of conduit where it passes through the wall. Then reseal the cable using an acrylic fire rated mastic where it passes through the wall

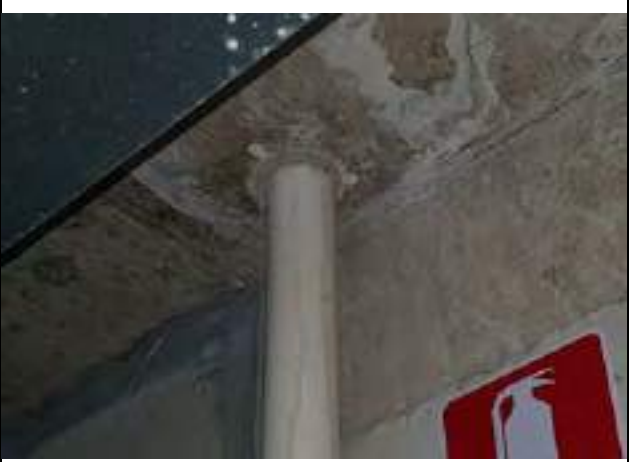
6.8.5.	DEFECT	NO FIRE COLLAR

DESCRIPTION	A PVC pipe penetration through the slab outside the north fire stair does not have a fire collar installed. To comply with C3.15 of the BCA, service penetrations through fire rated construction must be identical to a tested prototype that has been tested in accordance with AS4072.1 & AS1530.4.	
	LOCATION(S)	Level B2 outside north fire stair	
	BREACH(ES)	Failure to comply with: <ul style="list-style-type: none"> 1 Home Building Act 1989 NSW under Section 18B Clauses (a) & (c) 2 BCA – Clause C3.15 – Openings for service installations 3 Manufacturer’s tested or approved system 	
	METHOD OF REPAIR	Install a fire collar (fixed to the underside of the slab) to this PVC pipe penetration.

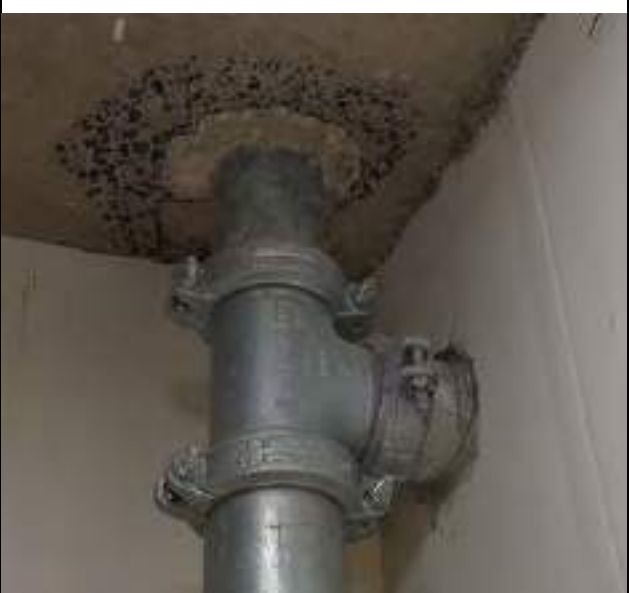
6.8.6.	DEFECT	STEEL PIPE INADEQUATELY INSULATED

DESCRIPTION	<p>A steel pipe (for the hydrant system) has not been adequately insulated in accordance with a tested system, where it passes through the wall of the south fire stair.</p> <p>Insulation wrap has been applied to the pipe on the carpark side of the wall, however no wrap has been installed on the fire stair side of the wall.</p> <p>To comply with C3.15 of the BCA, service penetrations through fire rated construction must be identical to a tested prototype that has been tested in accordance with AS4072.1 & AS1530.4.</p> <p>To comply with the manufacturer's tested system that achieves a FRL of -/120/120, the insulation wrap (TBA Firefly Penowrap) must extend 300mm and be fixed using 3 stainless steel cable ties on both sides of the wall. Refer below extract from Warringtonfire report FAS190236 Rev RIR1.7 dated 01/09/21.</p>

V134 Steel Pipes 8 mm OD up to 55 mm OD with a min' wall thickness of 0.91 mm and 55 mm OD up to 114mm OD with a min' wall thickness of 1.22 mm.	 	Max' 120mm Core Hole. Run a 10 mm bead of TBA Firefly™ Intumescic around the perimeter of the pipe over the annular gap (Min' 2mm max 5 mm) Then wrap with TBA Firefly™ Penowrap® for a distance of 300 mm. Secured with 3 x 5/16" Steel Zip Ties. Wrap both sides of wall	Min' 100 mm thick Masonry, Concrete block or Habel block wall. Capable of minimum FRL-/120/120 (Item 22)	-/120/120				Capable of minimum FRL -/90/90 (Item 35)	-/90/90				Capable of minimum FRL -/60/60 (Item 36)	-/60/60
V134 Steel Pipes 8 mm OD up to 55 mm OD with a min' wall thickness of 0.91 mm and 55 mm OD up to 114mm OD with a min' wall thickness of 1.22 mm.	 	Max' 120mm Core Hole. Run a 10 mm bead of TBA Firefly™ Intumescic around the perimeter of the pipe over the annular gap (Min' 2mm max 5 mm) Then wrap with TBA Firefly™ Penowrap® for a distance of 300 mm. Secured with 3 x 5/16" Steel Zip Ties. Wrap both sides of wall		Min' 100 mm thick Masonry, Concrete block or Habel block wall. Capable of minimum FRL-/120/120 (Item 22)	-/120/120													
				Capable of minimum FRL -/90/90 (Item 35)	-/90/90													
				Capable of minimum FRL -/60/60 (Item 36)	-/60/60													
	LOCATION(S)	Level B2 south fire stair																
	BREACH(ES)	Failure to comply with: <ol style="list-style-type: none"> 1 Home Building Act 1989 NSW under Section 18B Clauses (a) & (c) 2 BCA – Clause C3.15 – Openings for service installations 3 Manufacturer's tested or approved system 																
	METHOD OF REPAIR	Install Penowrap for a distance of 300mm, fixed with no less than 3 x stainless steel cable ties to the steel pipe on the fire stair side of the wall.

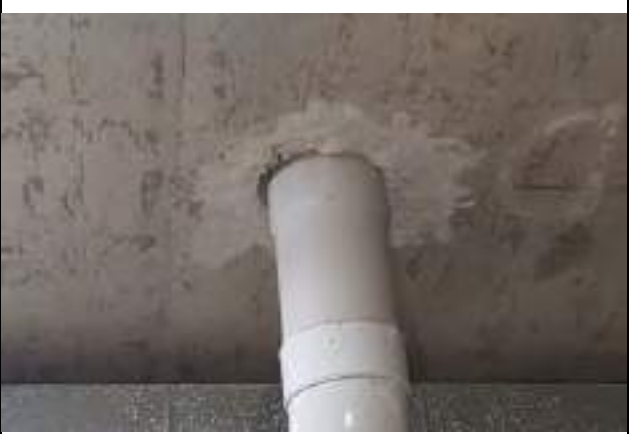
6.8.7.	DEFECT	NO FIRE COLLAR

DESCRIPTION	A PVC pipe penetration through the slab above carspace 10 does not have a fire collar installed. To comply with C3.15 of the BCA, service penetrations through fire rated construction must be identical to a tested prototype that has been tested in accordance with AS4072.1 & AS1530.4.	
	LOCATION(S)	Level B1 above carspace 10	
	BREACH(ES)	Failure to comply with: <ul style="list-style-type: none"> 1 Home Building Act 1989 NSW under Section 18B Clauses (a) & (c) 2 BCA – Clause C3.15 – Openings for service installations 3 Manufacturer’s tested or approved system 	
	METHOD OF REPAIR	Install a fire collar (fixed to the underside of the slab) to this PVC pipe penetration.

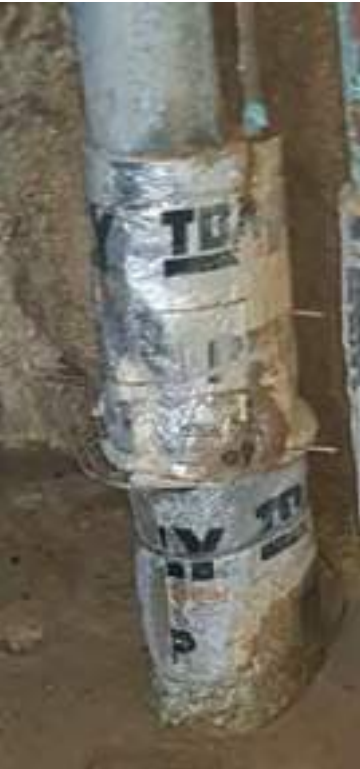
6.8.8.	DEFECT	INADEQUATE SEPARATION BETWEEN PIPE PENETRATIONS

DESCRIPTION	<p>A steel and copper pipe penetrate the concrete slab in close proximity to one another near the south fire stair.</p> <p>The fire stopping manufacturer does not have a tested system for a steel and copper pipe to be considered as a single penetration.</p> <p>To comply with C3.15 of the BCA, service penetrations through fire rated construction must be identical to a tested prototype that has been tested in accordance with AS4072.1 & AS1530.4.</p> <p>To comply with AS4072.1 – 2005, a minimum separation of 40mm is required between service penetrations unless otherwise tested in another configuration.</p>	
	LOCATION(S)	Level B1 outside south fire stair	
	BREACH(ES)	<p>Failure to comply with:</p> <ol style="list-style-type: none"> 1 Home Building Act 1989 NSW under Section 18B Clauses (a) & (c) 2 BCA – Clause C3.15 – Openings for service installations 3 AS4072.1 – 2005 4 Manufacturer’s tested or approved system

METHOD OF REPAIR	<ol style="list-style-type: none"> 1 Reconfigure pipework to ensure the pipes penetrate the slab with a minimum separation distance of 40mm. 2 Fire seal the repositioned pipe penetrations and patch the slab in accordance with a tested system.

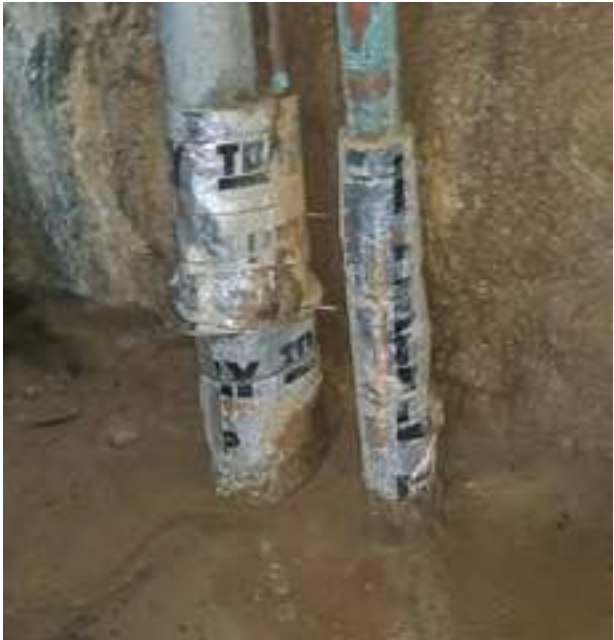
6.8.9.	DEFECT	POTENTIAL DAMAGE TO INSULATION WRAP

DESCRIPTION	<p>Two copper and steel pipe penetrations through the slab outside the south fire stair have water pooling around the penetration.</p> <p>It is not clear at this stage if the insulation wrap surrounding these pipes has deteriorated to a point where it is ineffective in providing the required insulation rating, however the integrity of the wrap should be inspected once the issue causing the water to pool in this area has been resolved.</p> <p>Manufacturer recommends that wrap is installed in dry locations and has advised that continual exposure to water may result in the foil delaminating from the core material of the wrap.</p> <p>Additionally there is an obvious potential for pipe corrosion in future.</p> <p>FURTHER INVESTIGATION OF THE WATER SOURCE AND RECTIFICATION IS REQUIRED</p>	
	LOCATION(S)	Level B1 outside south fire stair

BREACH(ES)	<p>Failure to comply with:</p> <ol style="list-style-type: none"> 1 Home Building Act 1989 NSW under Section 18B Clauses (a) & (c) 2 BCA – Clause C3.15 – Openings for service installations 3 Manufacturer’s recommendations 	
	METHOD OF REPAIR	<ol style="list-style-type: none"> 1 Resolve the issue causing the water to pool in this area. 2 Inspect Penowrap insulation for deterioration. 3 Replace if deemed necessary.

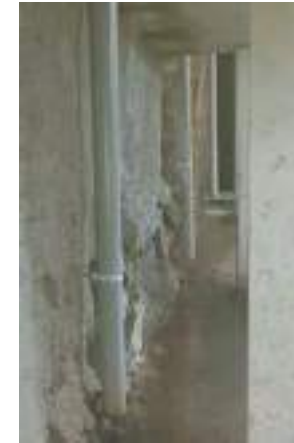
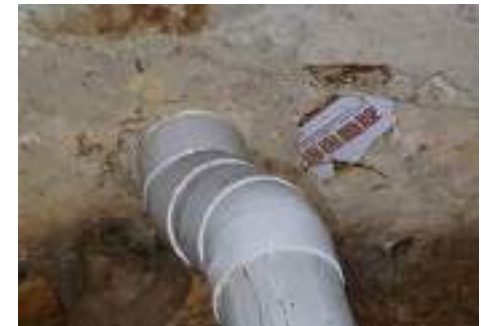
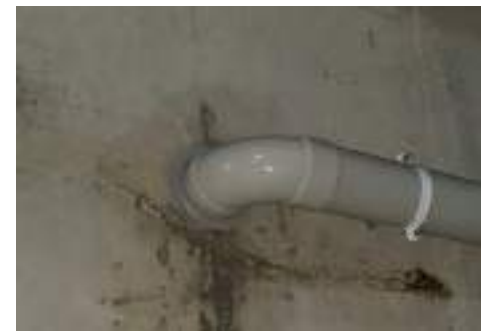
6.8.10.	DEFECT	NO FIRE COLLARS
	DESCRIPTION	Four PVC pipe penetrations through the slab do not have any fire collars installed. To comply with C3.15 of the BCA, service penetrations through fire rated construction must be identical to a tested prototype that has been tested in accordance with AS4072.1 & AS1530.4.
	LOCATION(S)	Level B1 south end of carpark
	BREACH(ES)	Failure to comply with: <ul style="list-style-type: none"> 1 Home Building Act 1989 NSW under Section 18B Clauses (a) & (c) 2 BCA – Clause C3.15 – Openings for service installations 3 Manufacturer’s tested or approved system
	METHOD OF REPAIR	1 Install fire collars (fixed to the underside of the slab) to these PVC pipe penetrations.

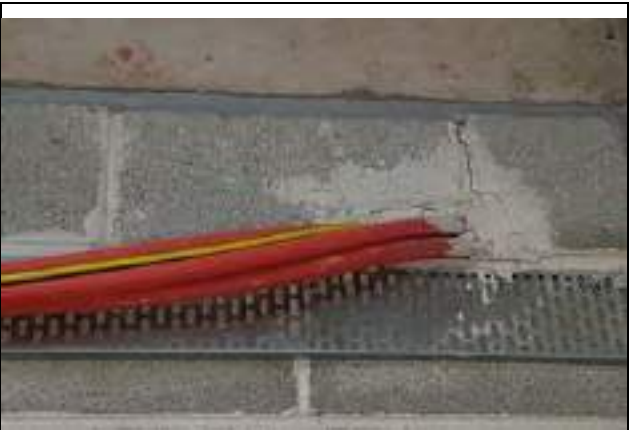
6.8.11.	DEFECT	MAINS CABLE INADEQUATELY INSULATED
	DESCRIPTION	<p>A mains cable has not been adequately insulated in accordance with a tested system, where it passes through the wall of the main switch room.</p> <p>Insulation wrap has been applied to the cable on the carpark side of the wall, however no wrap has been installed on the main switch room side of the wall.</p> <p>To comply with C3.15 of the BCA, service penetrations through fire rated construction must be identical to a tested prototype that has been tested in accordance with AS4072.1 & AS1530.4.</p> <p>To comply with the manufacturer's tested system that achieves a FRL of -/120/120, the insulation wrap (TBA Firefly Penowrap) must extend 300mm and be fixed using 3 stainless steel cable ties on both sides of the wall. Refer below extract from Warringtonfire report 23671 RIR11.0 dated 09/04/20.</p>

BREACH(ES)	<p>Failure to comply with:</p> <ol style="list-style-type: none"> 1 Home Building Act 1989 NSW under Section 18B Clauses (a) & (c) 2 BCA – Clause C3.15 – Openings for service installations 3 Manufacturer's tested or approved system
	METHOD OF REPAIR	<ol style="list-style-type: none"> 1 Remove existing cement patch, fire seal the annular gap between the cable and the wall. 2 Install Penowrap for a distance of 300mm, fixed with no less than 3 x stainless steel cable ties to the cable bundle on the main switch room side of the wall.

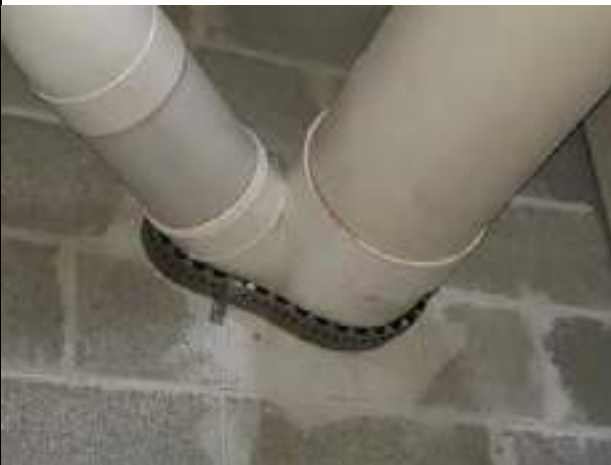
6.8.13.	DEFECT	INCORRECTLY INSTALLED FIRE COLLAR

DESCRIPTION	A surface mounted fire collar has been installed around a “Y” fitting that is partially located within the wall on a large PVC pipe near the carwash bay. This type of fire collar has not been tested to protect this type of pipe fitting in this manner. To comply with C3.15 of the BCA, service penetrations through fire rated construction must be identical to a tested prototype that has been tested in accordance with AS4072.1 & AS1530.4.	
	LOCATION(S)	Level B1 carwash bay	
	BREACH(ES)	Failure to comply with: 1 Home Building Act 1989 NSW under Section 18B Clauses (a) & (c) 2 BCA – Clause C3.15 – Openings for service installations 3 Manufacturer’s tested or approved system	
	METHOD OF REPAIR	1 Construct a fire rated bulkhead around the pipe penetration 2 Install fire collars where the pipes penetrate the fire rated bulkhead

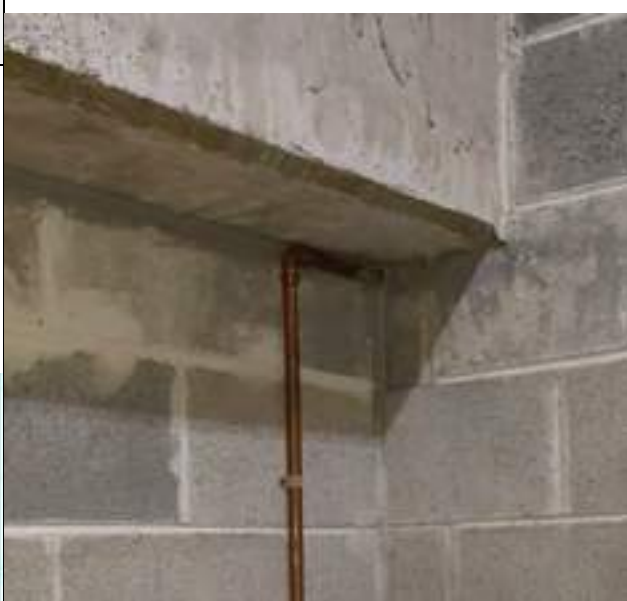
6.8.14.	DEFECT	COPPER PIPE NOT INSULATED

DESCRIPTION	<p>A copper pipe has not been insulated in accordance with a tested system, where it passes through the wall between the carwash bay and the bin room.</p> <p>To comply with C3.15 of the BCA, service penetrations through fire rated construction must be identical to a tested prototype that has been tested in accordance with AS4072.1 & AS1530.4.</p> <p>To comply with the manufacturer's tested system that achieves a FRL of -/90/90, insulation wrap (TBA Firefly Penowrap) must be installed to a length of 300mm and be fixed using 3 stainless steel cable ties on both sides of the wall. Refer below extract from Warringtonfire report FAS190236 Revision: RIR1.7.</p>

<p>Copper Pipe 8 mm up to 51mm OD with a min' wall thickness of 0.91 mm</p>	<p>Max' 52mm Core Hole. Run a 10 mm bead of TBA Firefly™ Intumescence around the base of the pipe over the annular gap (Min' 0mm max 5 mm) then wrap with TBA Firefly™ Penowrap® for a distance of 300 mm. Secured with 3 x 3/16" Steel Zip Ties. Wrap both sides of wall</p>	<p>Min' 100 mm thick Masonry, Concrete block or Hebel block wall. Capable of minimum FRL -/120/120 (Item 22)</p>	-/120/120			<p>Capable of minimum FRL -/90/90 (Item 35)</p>	-/90/90			<p>Capable of minimum FRL -/60/60 (Item 36)</p>	-/60/60
  <p>Copper Pipe 8 mm up to 51mm OD with a min' wall thickness of 0.91 mm</p>	<p>Max' 52mm Core Hole. Run a 10 mm bead of TBA Firefly™ Intumescence around the base of the pipe over the annular gap (Min' 0mm max 5 mm) then wrap with TBA Firefly™ Penowrap® for a distance of 300 mm. Secured with 3 x 3/16" Steel Zip Ties. Wrap both sides of wall</p>	<p>Min' 100 mm thick Masonry, Concrete block or Hebel block wall. Capable of minimum FRL -/120/120 (Item 22)</p>	-/120/120													
		<p>Capable of minimum FRL -/90/90 (Item 35)</p>	-/90/90													
		<p>Capable of minimum FRL -/60/60 (Item 36)</p>	-/60/60													
	LOCATION(S)	B1 level wall between carwash bay and bin room														
	BREACH(ES)	<p>Failure to comply with:</p> <ol style="list-style-type: none"> 1 Home Building Act 1989 NSW under Section 18B Clauses (a) & (c) 2 BCA – Clause C3.15 – Openings for service installations 3 Manufacturer's tested or approved system 														
	METHOD OF REPAIR	Install Penowrap for a distance of 300 mm, fixed with 3 x stainless steel cable ties to the copper pipe on both sides of the wall.

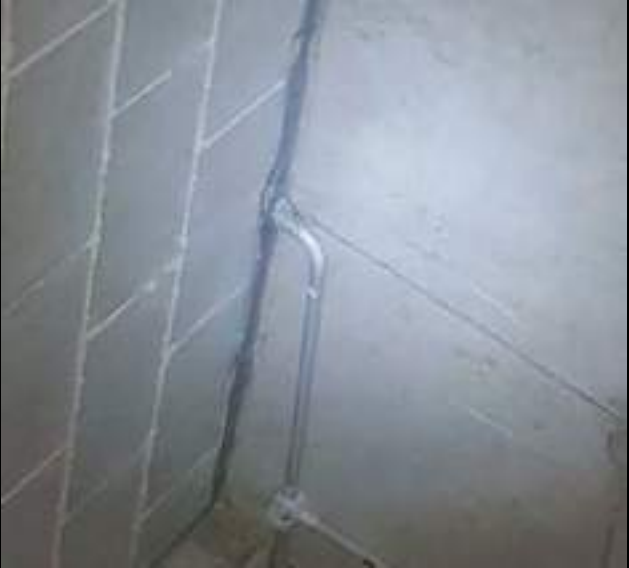
6.8.15.	DEFECT	PVC CONDUIT NOT FIRE STOPPED

DESCRIPTION	<p>A conduit for the fire detection system has not been adequately fire stopped where it passes through the wall between a void area on the B1 side of the fire shutter and the B@ side of the fire shutter .</p> <p>To comply with C3.15 of the BCA, service penetrations through fire rated construction must be identical to a tested prototype that has been tested in accordance with AS4072.1 & AS1530.4.</p> <p>An acrylic mastic has been used to partially seal this conduit, however there is no tested system that achieves the required FRL using acrylic mastic to seal electrical conduits.</p>	
	LOCATION(S)	B1 level void area near fire shutter	
	BREACH(ES)	<p>Failure to comply with:</p> <ol style="list-style-type: none"> 1 Home Building Act 1989 NSW under Section 18B Clauses (a) & (c) 2 BCA – Clause C3.15 – Openings for service installations 3 Manufacturer’s tested or approved system

METHOD OF REPAIR	<ol style="list-style-type: none"> 1 Either: <ol style="list-style-type: none"> a. Install suitable fire collars to PVC conduit on both sides of the wall. <p>OR</p> <ol style="list-style-type: none"> b. Cut back conduit and remove section of conduit where it passes through the wall. Then reseal the cable using and acrylic fire rated mastic where it passes through the wall

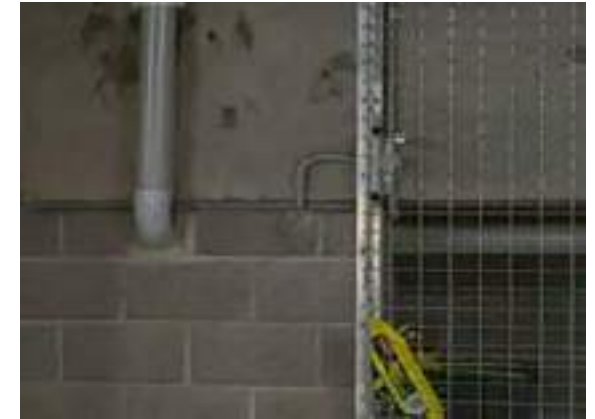
6.8.16.	DEFECT	NO FIRE COLLARS
	DESCRIPTION	Two PVC pipe penetrations through the wall to the shaft containing the pump room supply air duct do not have any fire collars installed. To comply with C3.15 of the BCA, service penetrations through fire rated construction must be identical to a tested prototype that has been tested in accordance with AS4072.1 & AS1530.4.
	LOCATION(S)	Level B1 near fire rated shutter
	BREACH(ES)	Failure to comply with: <ul style="list-style-type: none"> 1 Home Building Act 1989 NSW under Section 18B Clauses (a) & (c) 2 BCA – Clause C3.15 – Openings for service installations 3 Manufacturer’s tested or approved system
	METHOD OF REPAIR	<ul style="list-style-type: none"> 1 Enlarge the opening around each PVC pipe and install wall collars or intumescent pipe wraps between the wall and each pipe. OR <ul style="list-style-type: none"> 2 Construct fire rated bulkheads (or similar) around each pipe penetration and seal each pipe where it penetrates the fire rated bulkheads.

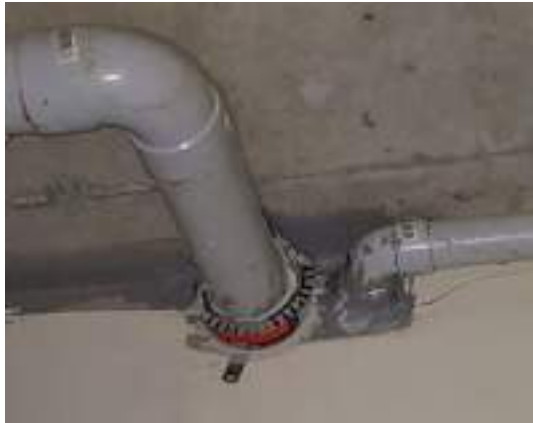
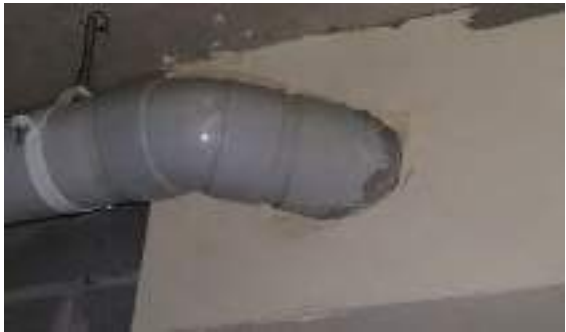
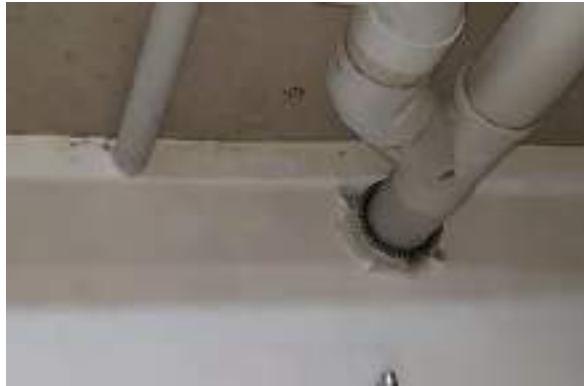
6.8.17.	DEFECT	NO FIRE COLLAR
	DESCRIPTION	<p>Two PVC pipe penetrations through a plasterboard bulkhead outside the Bin room do not have any fire collars installed.</p> <p>It would appear that this bulkhead has been constructed to address some service penetrations that were unable to be fire stopped where they pass through the wall of the bin room.</p> <p>To ensure the bulkhead provides effective fire separation between the carpark and the bin room and to comply with C3.15 of the BCA, the service penetrations through the fire rated construction must be identical to a tested prototype that has been tested in accordance with AS4072.1 & AS1530.4.</p> <p>Additionally, the bulkhead must be re-constructed to provide a two-way FRL if it is to be considered to be the fire rated element separating the Bin room from the carpark. Reason: a single sided plasterboard bulkhead will only provide a one-way FRL.</p>

LOCATION(S)	Level B1 outside Bin room
	BREACH(ES)	<p>Failure to comply with:</p> <ol style="list-style-type: none"> 1 Home Building Act 1989 NSW under Section 18B Clauses (a) & (c) 2 BCA – Clause C3.15 – Openings for service installations 3 Manufacturer’s tested or approved system
	METHOD OF REPAIR	<ol style="list-style-type: none"> 1 Reconstruct the bulkhead using a fire rated board system to provide two-way fire separation, and 2 Install wall collars or intumescent pipe wraps between the fire rated board and each pipe.

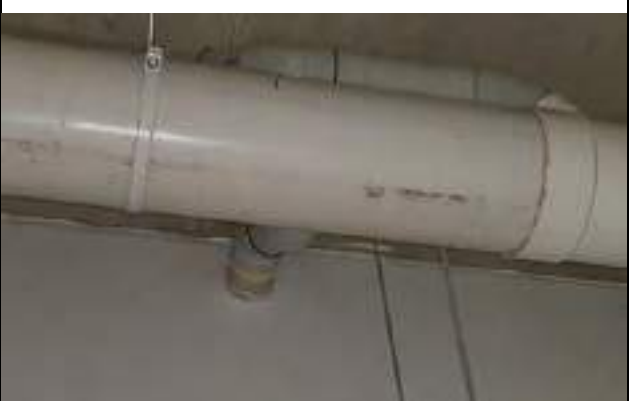
6.8.18.	DEFECT	NO FIRE COLLAR

DESCRIPTION	A PVC pipe penetration through the western wall of the Bin room does not have any fire collar installed. To comply with C3.15 of the BCA, service penetrations through the fire rated construction must be identical to a tested prototype that has been tested in accordance with AS4072.1 & AS1530.4.	
	LOCATION(S)	Level B1 Bin room	
	BREACH(ES)	Failure to comply with: <ul style="list-style-type: none"> 1 Home Building Act 1989 NSW under Section 18B Clauses (a) & (c) 2 BCA – Clause C3.15 – Openings for service installations 3 Manufacturer’s tested or approved system 	
	METHOD OF REPAIR	1 Install fire collars to this PVC pipe penetration on both sides of the wall.

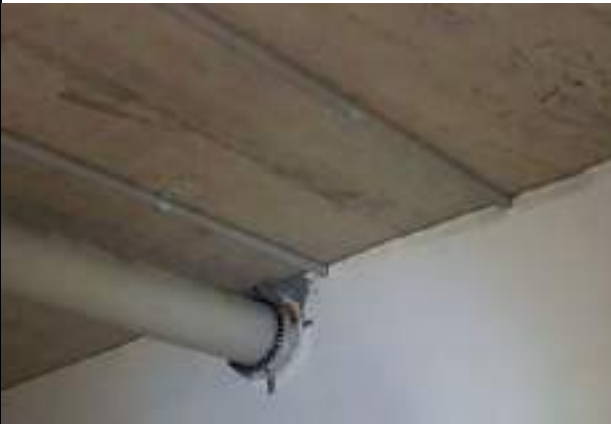
6.8.19.	DEFECT	PVC CONDUITS NOT FIRE STOPPED

DESCRIPTION	Two conduit penetrations through the eastern wall of the Bin room do not have any fire collars installed. To comply with C3.15 of the BCA, service penetrations through the fire rated construction must be identical to a tested prototype that has been tested in accordance with AS4072.1 & AS1530.4.	
	LOCATION(S)	Level B1 Bin room	
	BREACH(ES)	Failure to comply with: <ul style="list-style-type: none"> 1 Home Building Act 1989 NSW under Section 18B Clauses (a) & (c) 2 BCA – Clause C3.15 – Openings for service installations 3 Manufacturer’s tested or approved system 	
	METHOD OF REPAIR	1 Either: <ul style="list-style-type: none"> a. Install suitable fire collars to PVC conduits on both sides of the wall. OR <ul style="list-style-type: none"> b. Cut back conduits and remove section of conduits where they pass through the wall. Then reseal the cables using and acrylic fire rated mastic where they pass through the wall

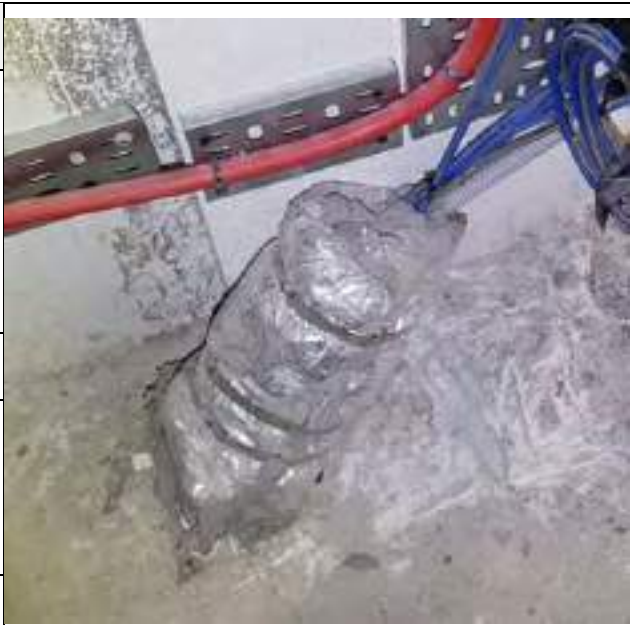
6.8.20.	DEFECT	INCORRECTLY FIRE STOPPED CABLE PENETRATION

DESCRIPTION	<p>A cable penetration through the slab in the communications cupboard has conduits passing through the slab.</p> <p>To comply with C3.15 of the BCA, service penetrations through the fire rated construction must be identical to a tested prototype that has been tested in accordance with AS4072.1 & AS1530.4.</p> <p>To comply with the manufacturer's tested system which has been backfilled with concrete, cables must not be installed in conduits.</p>	
	LOCATION(S)	Level LG communications cupboard	
	BREACH(ES)	<p>Failure to comply with:</p> <ol style="list-style-type: none"> 1 Home Building Act 1989 NSW under Section 18B Clauses (a) & (c) 2 BCA – Clause C3.15 – Openings for service installations 3 Manufacturer's tested or approved system 	
	METHOD OF REPAIR	<ol style="list-style-type: none"> 1 Cut back acoustic conduits flush with concrete 2 Install 60mm Maxilite fire rated board to the topside of the slab 3 Sela cable penetrations using Trafalgar acrylic mastic 4 Reinstall Twrap to a length of 300mm above the Maxilite board.

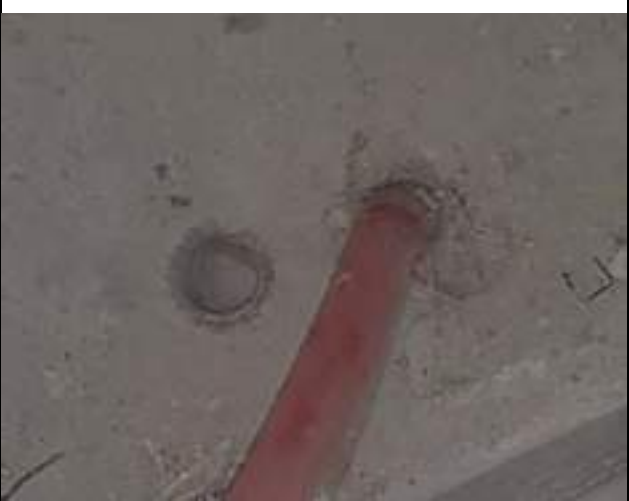
6.8.21.	DEFECT	CABLE NOT FIRE STOPPED

DESCRIPTION	A red cable through the slab to Level L1 has not been fire stopped. To comply with C3.15 of the BCA, service penetrations through the fire rated construction must be identical to a tested prototype that has been tested in accordance with AS4072.1 & AS1530.4.	
	LOCATION(S)	Level LG communications cupboard	
	BREACH(ES)	Failure to comply with: <ul style="list-style-type: none"> 1 Home Building Act 1989 NSW under Section 18B Clauses (a) & (c) 2 BCA – Clause C3.15 – Openings for service installations 3 Manufacturer’s tested or approved system 	
	METHOD OF REPAIR	1 Apply a bead of acrylic mastic to the annular gap between the cable and the slab
