6. DEFECT SCHEDULE

6.1. AUTOMATIC FIRE DETECTION AND ALARM SYSTEM (INCLUDING SMOKE ALARMS)

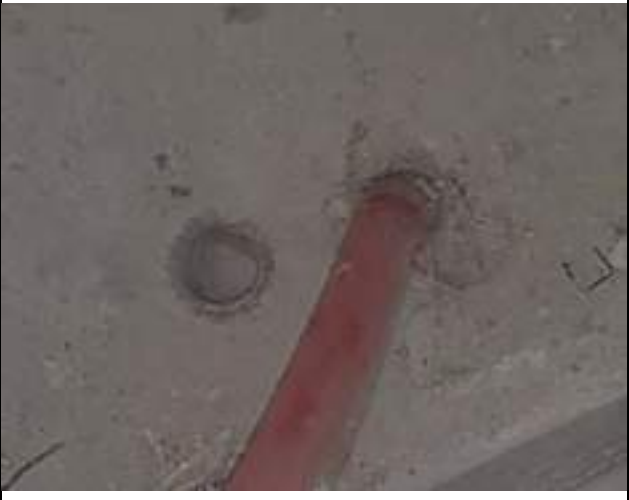
6.8.22.	DEFECT	PARTIAL CORE HOLE THROUGH SLAB

DESCRIPTION	A partial core hole through the slab to Level L1 has not been backfilled to the full depth of the slab. To comply with Specification C1.1, floor slabs are required to maintain a required minimum thickness to ensure the slab achieves a FRL of 90/90/90.	
	LOCATION(S)	Level LG communications cupboard	
	BREACH(ES)	Failure to comply with: <ul style="list-style-type: none"> 1 Home Building Act 1989 NSW under Section 18B Clauses (a) & (c) 2 BCA – Specification C1.1 	
	METHOD OF REPAIR	1 Backfill the partial core hole to the full depth of the slab.

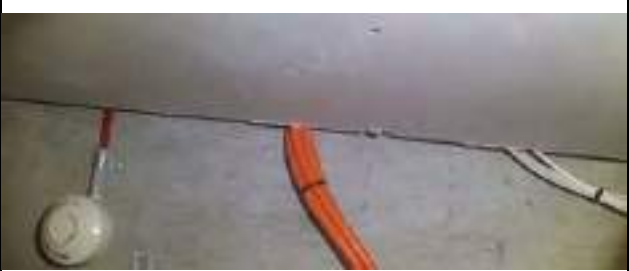
6.8.23.	DEFECT	CABLES NOT SMOKE SEALED

DESCRIPTION	<p>Cable between the electrical cupboard and the corridor (above false ceiling) have not been smoke sealed.</p> <p>This electrical cupboard contains electricity meters.</p> <p>To comply with Clause D2.7 of the BCA, electricity meters may be located in a corridor, hallway or the like leading to a fire isolated exit if the services are enclosed by non-combustible construction or a fire protective covering with doorways and openings suitably sealed against smoke spreading from the enclosure.</p>	
	LOCATION(S)	Level L1 electrical cupboard	
	BREACH(ES)	<p>Failure to comply with:</p> <ol style="list-style-type: none"> 1 Home Building Act 1989 NSW under Section 18B Clauses (a) & (c) 2 BCA – Clause D2.7 – Installations in exits and paths of travel 	
	METHOD OF REPAIR	<ol style="list-style-type: none"> 1 Smoke seal the annular gap between all cables and the wall using an acrylic mastic

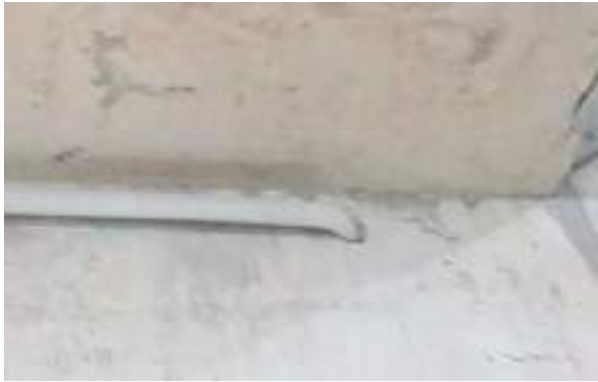
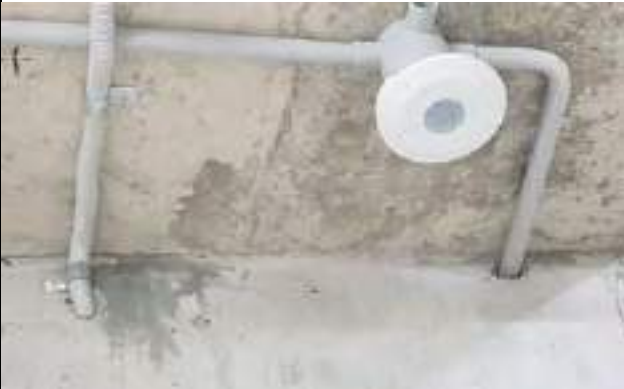
6.8.24.	DEFECT	PVC CONDUITS NOT FIRE STOPPED

DESCRIPTION	<p>Conduit penetrations through the walls of the fire stair do not have any fire collars installed.</p> <p>To comply with C3.15 of the BCA, service penetrations through the fire rated construction must be identical to a tested prototype that have been tested in accordance with AS4072.1 & AS1530.4.</p>	
	LOCATION(S)	Fire stair all levels	
	BREACH(ES)	<p>Failure to comply with:</p> <ol style="list-style-type: none"> 1 Home Building Act 1989 NSW under Section 18B Clauses (a) & (c) 2 BCA – Clause C3.15 – Openings for service installations 3 Manufacturer’s tested or approved system 	
	METHOD OF REPAIR	<ol style="list-style-type: none"> 1 Either: <ol style="list-style-type: none"> a. Install suitable fire collars to PVC conduits on both sides of the wall. OR b. Cut back conduits and remove section of conduits where they pass through the wall. Then reseal the cables using and acrylic fire rated mastic where they pass through the wall

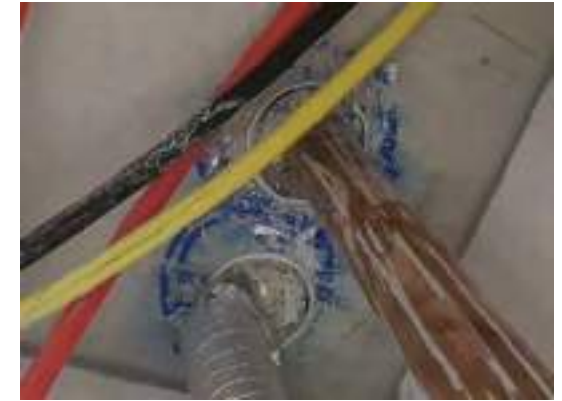
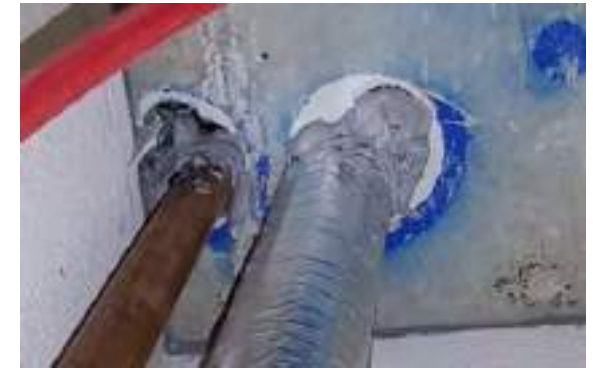
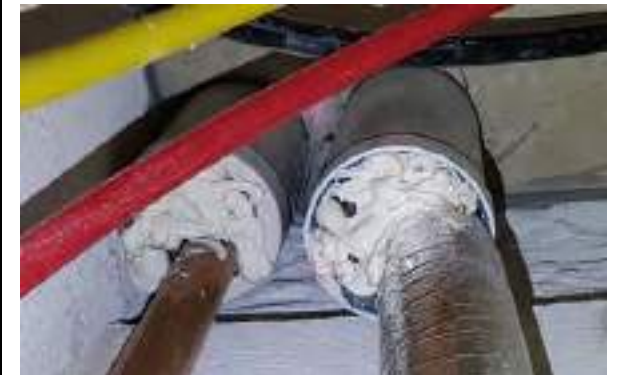
6.8.25.	DEFECT	COPPER PIPE PENETRATIONS NOT IN ACCORDANCE WITH TESTED SYSTEM					
	DESCRIPTION	<p>Copper pipe penetrations within the hydraulic risers throughout the building have PVC inserts within the slab. Additionally some penetrations have been partially back-filled with mastic.</p> <p>To comply with C3.15 of the BCA, service penetrations through the fire rated construction must be identical to a tested prototype that has been tested in accordance with AS4072.1 & AS1530.4.</p> <p>To comply with the Manufacturer's tested system, the copper pipes pass through the slab and no PVC or mastic is contained within the slab. Refer below extract from Warringtonfire report FAS190236 Rev RIR1.7 dated 01/09/21.</p> <table border="1" data-bbox="546 507 1541 975"> <tr> <td data-bbox="546 507 741 975"> <p>Copper Pipe 8 mm up to 50.8 mm OD. With a min' wall thickness of 0.91 mm</p> <p>H55</p> </td> <td data-bbox="741 507 972 975">   </td> <td data-bbox="972 507 1182 975"> <p>Run a 10 mm bead of TBA Firefly™ Intumastic around the perimeter of the pipe over the annular gap (Min 0mm max 5 mm). Then wrap 300 mm to the top side only using TBA Firefly™ Penowrap® secured with 3 x 316stl Cable ties</p> </td> <td data-bbox="1182 507 1424 975"> <p>Min' 120mm thick Concrete, Masonry or Hebel Floor. Capable of minimum FRL 90/90/90 (Item 34)</p> </td> <td data-bbox="1424 507 1541 975"> <p>-/90/90</p> </td> </tr> </table>	<p>Copper Pipe 8 mm up to 50.8 mm OD. With a min' wall thickness of 0.91 mm</p> <p>H55</p>	 	<p>Run a 10 mm bead of TBA Firefly™ Intumastic around the perimeter of the pipe over the annular gap (Min 0mm max 5 mm). Then wrap 300 mm to the top side only using TBA Firefly™ Penowrap® secured with 3 x 316stl Cable ties</p>	<p>Min' 120mm thick Concrete, Masonry or Hebel Floor. Capable of minimum FRL 90/90/90 (Item 34)</p>	<p>-/90/90</p>
<p>Copper Pipe 8 mm up to 50.8 mm OD. With a min' wall thickness of 0.91 mm</p> <p>H55</p>	 	<p>Run a 10 mm bead of TBA Firefly™ Intumastic around the perimeter of the pipe over the annular gap (Min 0mm max 5 mm). Then wrap 300 mm to the top side only using TBA Firefly™ Penowrap® secured with 3 x 316stl Cable ties</p>	<p>Min' 120mm thick Concrete, Masonry or Hebel Floor. Capable of minimum FRL 90/90/90 (Item 34)</p>	<p>-/90/90</p>			
	LOCATION(S)	Hydraulic risers throughout building					
	BREACH(ES)	<p>Failure to comply with:</p> <ol style="list-style-type: none"> 1 Home Building Act 1989 NSW under Section 18B Clauses (a) & (c) 2 BCA – Clause C3.15 – Openings for service installations 3 Manufacturer's tested or approved system 					
	METHOD OF REPAIR	<ol style="list-style-type: none"> 1 Install two layers of Intubatt to topside of slab, ensuring an annular gap between the pipe and Intubatt of no greater than 5mm. 2 Seal annular gap between the pipes and Intubatt with acrylic sealant 3 Wrap pipe with Penowrap to a distance of 300mm above Intubatt and secure with 3 stainless steel cable ties.

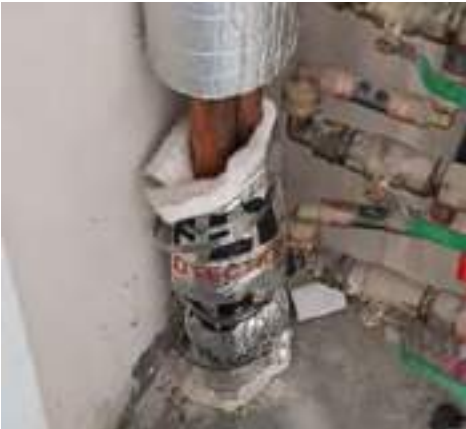
6.8.26.	DEFECT	COPPER PIPE PENETRATIONS NOT IN ACCORDANCE WITH TESTED SYSTEM

DESCRIPTION	Two copper pipes penetrate the concrete slab in close proximity to one another. To comply with C3.15 of the BCA, service penetrations through the fire rated construction must be identical to a tested prototype that has been tested in accordance with AS4072.1 & AS1530.4. To comply with AS4072.1 – 2005, a minimum separation of 40mm is required between service penetrations unless otherwise tested in another configuration.	
	LOCATION(S)	Hydraulic risers on Levels 3 & 4	
	BREACH(ES)	Failure to comply with: <ul style="list-style-type: none"> 1 Home Building Act 1989 NSW under Section 18B Clauses (a) & (c) 2 BCA – Clause C3.15 – Openings for service installations 3 AS4072.1 – 2005 4 Manufacturer’s tested or approved system 	
	METHOD OF REPAIR	<ul style="list-style-type: none"> 1 Reconfigure pipework to ensure the pipes penetrate the slab with a minimum separation distance of 40mm. 2 Fire seal the repositioned pipe penetrations and patch the floor in accordance with a tested system.

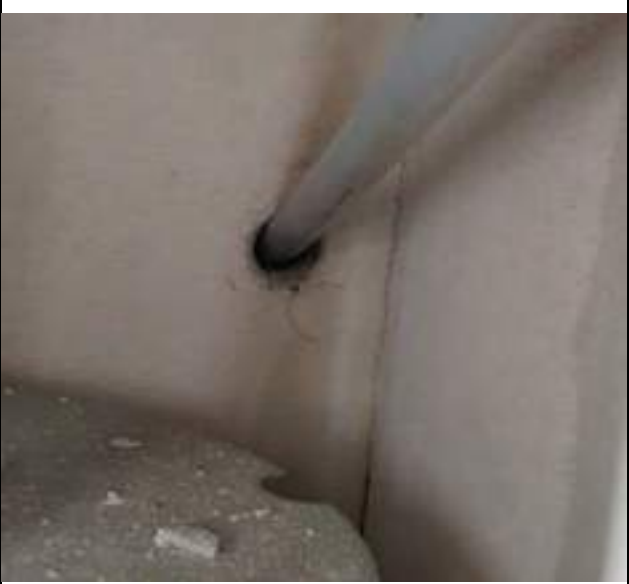
6.8.29.	DEFECT	PVC CONDUITS NOT FIRE STOPPED

DESCRIPTION	<p>A conduit penetration through the rear wall of the rear wall of the garbage shaft does not have any fire collars installed.</p> <p>To comply with C3.15 of the BCA, service penetrations through the fire rated construction must be identical to a tested prototype that have been tested in accordance with AS4072.1 & AS1530.4.</p>	
	LOCATION(S)	Garbage shaft Level 4	
	BREACH(ES)	<p>Failure to comply with:</p> <ol style="list-style-type: none"> 1 Home Building Act 1989 NSW under Section 18B Clauses (a) & (c) 2 BCA – Clause C3.15 – Openings for service installations 3 Manufacturer’s tested or approved system 	
	METHOD OF REPAIR	<ol style="list-style-type: none"> 1 Either: <ol style="list-style-type: none"> a. Install suitable fire collars to PVC conduit on both sides of the wall. OR b. Cut back conduit and remove section of conduit where it passes through the wall. Then reseal the cables using and acrylic fire rated mastic where it passes through the wall

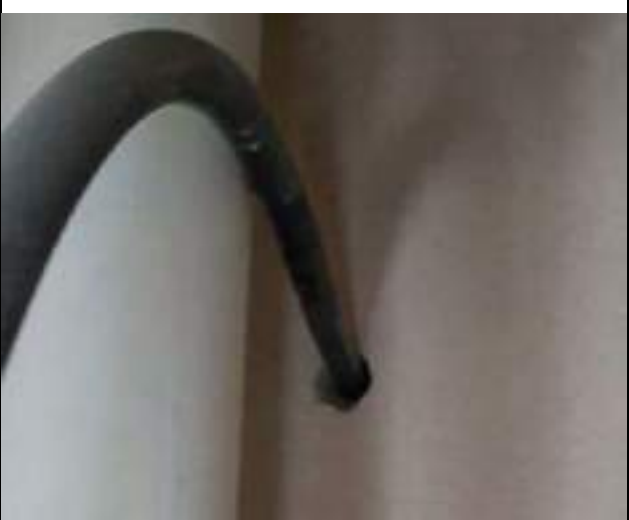
6.8.30.	DEFECT	NO FIRE COLLAR

DESCRIPTION	<p>A PEX pipe penetration through the rear wall of the rear wall of the garbage shaft does not have any fire collars installed.</p> <p>To comply with C3.15 of the BCA, service penetrations through the fire rated construction must be identical to a tested prototype that has been tested in accordance with AS4072.1 & AS1530.4.</p>	
	LOCATION(S)	Garbage shaft Level 4	
	BREACH(ES)	<p>Failure to comply with:</p> <ol style="list-style-type: none"> 1 Home Building Act 1989 NSW under Section 18B Clauses (a) & (c) 2 BCA – Clause C3.15 – Openings for service installations 3 Manufacturer’s tested or approved system 	
	METHOD OF REPAIR	<ol style="list-style-type: none"> 1 Install fire collars to this PEX pipe penetration on both sides of the wall.

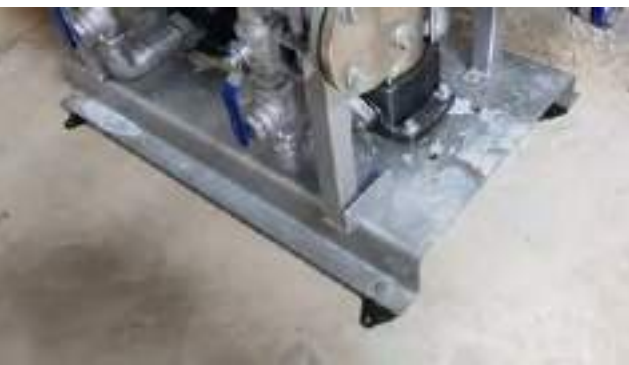
6.10.1.	DEFECT	COLD WATER PUMP NOT BOLTED TO PUMP PLINTH

DESCRIPTION	<p>The domestic cold water pump is not bolted to the pump plinth.</p> <p>To reduce the risk of damage to the pipework, the pump should be secured to the pump plinth via the vibration isolators attached to the pump base.</p>	
	LOCATION(S)	Hydrant pump room	
	BREACH(ES)	<p>Failure to comply with:</p> <ol style="list-style-type: none"> 1 Home Building Act 1989 NSW under Section 18B Clauses (a) & (c) 	
	METHOD OF REPAIR	Bolt the pump base to the pump plinth via the vibration isolators attached to the pump base.

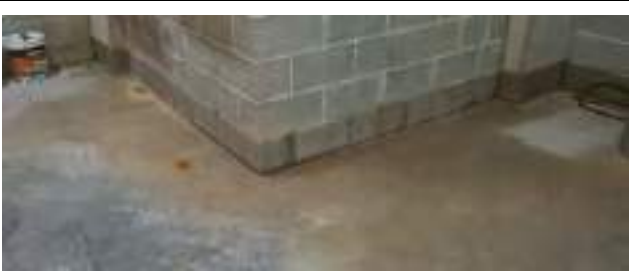
6.10.2.	DEFECT	WATER INGRESS TO MAIN SWITCH ROOM

DESCRIPTION	There is evidence of water ingress into the main switch room on B1 Level. The walls appear to have been treated with some form of paint to the walls bounding the carpark perimeter drain. FURTHER INVESTIGATION REQUIRED BY WATER PROOFING SPECIALIST	
	LOCATION(S)	Main switch room	
	BREACH(ES)	To be determined by water proofing specialist	
	METHOD OF REPAIR	To be determined by water proofing specialist

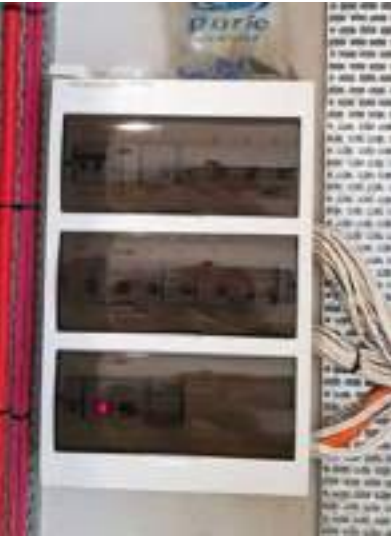
6.10.4.	DEFECT	NO ELECTRICAL SCHEDULE PROVIDED AT DISTRIBUTION BOARD

DESCRIPTION	There is no electrical schedule provided at House Services Board 2 FURTHER INVESTIGATION REQUIRED BY ELECTRICAL SPECIALIST	
	LOCATION(S)	Electrical cupboard on Level G	
	BREACH(ES)	To be determined by electrical specialist	
	METHOD OF REPAIR	To be determined by electrical specialist

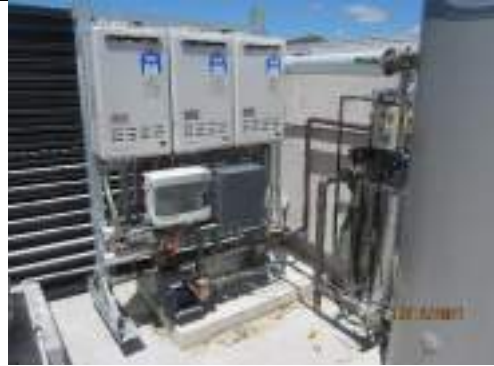
<p>Termination of membrane – Mechanical ventilation service supports</p> <p>The Author observed that the waterproofing termination to the ventilation mechanical service supports has not been carried out in accordance with AS4654.2 in that a plinth is required as provided for the hot water services.</p> <p>Termination and Waterproofing - Perimeter of roof and roof hobs</p> <p>The Author observed that waterproofing has not been provide to the roof perimeter and roof hobs and the waterproofing to the interior of the roof hobs has not been carried out in accordance with AS4654.2. Furthermore, the Author noted that the building contract specifies ‘waterproofing membrane even if not over habitable spaces’.</p> <p>Please refer to following Extract – Building contract page 50 of PPR 6.4.4 Roof and roof finishes.</p> <p>PPR for 11-15 Mitchell Avenue Jannall</p> <hr/> <p>6.4.4 Roof and Roof Finishes</p> <p>3) Any concrete flat roofs are to have a waterproof membrane even if not over habitable spaces.</p> <p>Findings</p> <p>The Author is of the view that the Builder has failed to carry out the works in accordance with manufacturers guidelines, AS4654.2 and National Constructions Code 2016 Volume 1 F1.4.</p>

<p>Plinths provided for hot water services</p>

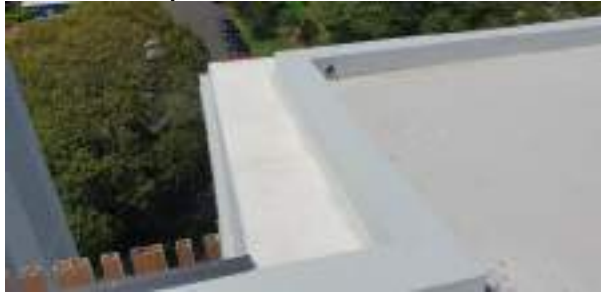
<p>Section of roof not waterproofed to Building U</p>

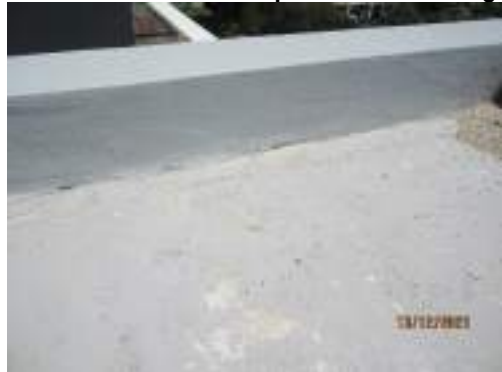
<p>Waterproofing not terminated in accordance with AS4654.2</p>

<p>B</p>	<p>Cause(s)</p> <ul style="list-style-type: none"> • Failure of the Builder to carry out the works with due care, skill and diligence • Failure of the Builder to carry out works in accordance with manufacturers guidelines. • Failure of the Builder to carry out works in accordance with AS4654.2:2012 • Failure of the Builder to carry out the works in accordance with the National Construction Code 2016 Volume 1 F1.4 	
<p>C</p>	<p>Breach(es)</p> <p>Failure to comply with the following:</p> <ul style="list-style-type: none"> ▪ Home Building Act 1989 (NSW) under Section 18B Clauses 1(a) & (c); ▪ Manufacturers guidelines. ▪ AS4654.2:2012 Waterproofing membranes for external above-ground use Part 2: Design and installation. ▪ National Construction Code 2016 Volume 1 F1.4 	<p>For more description photographs, please refer to R-1-5 of the table.</p>

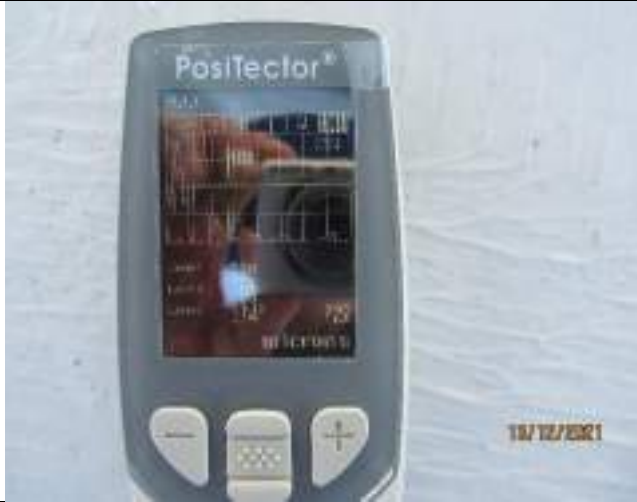
R-1-3

Test indicating 722 micron thickness

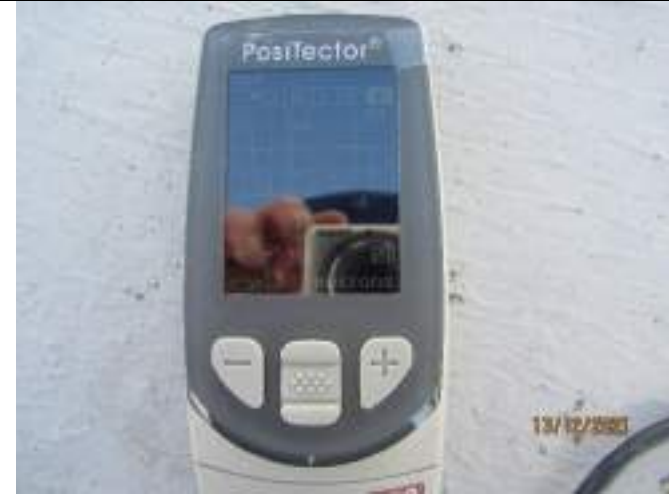
Test indicating 477 micron thickness

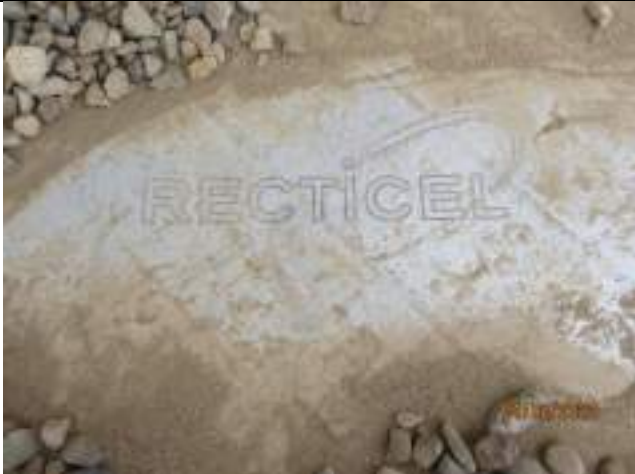
ITEM	COMMENTARY	PHOTOGRAPH(S)
R-2		
A	<p>Location & Description Lower roof Insulation – Building L and U</p> <p>The Author has observed that the roof insulation identified as RECTICEL Eurothane Eurodeck –</p> <ol style="list-style-type: none"> Evidence of deterioration of insulation material. Geo fabric used in place of vapour barrier specified by manufacturer. No mechanical fixings provided as specified by manufacturer. Waterproofing has not been provided in accordance with manufacturers guidelines. Falls to drainage inlets not in accordance with manufacturers guidelines <p>For clarification, please refer to following details following Section R-2-1, R-2-2, R-2-3 and in Appendix B of this report.</p> <p>The Author noted that the BASIX commitments on PBD Architects construction certificate drawings A0000 issue B require roof insulation to have a thermal insulation R-value of R4.0. The Author observed that the Builder has installed 40mm thick insulation panels with an R-Value of R1.8. Please refer to R-2-4 Extract Insulation requirements PBD Architects drawings A0000 issue B in the following tables.</p> <p>The Author is of the view, that the roof insulation has not been installed in accordance with the manufacturers guidelines and contract plans and specifications.</p>

<p data-bbox="1599 708 2029 735">Evidence identifying product installed</p>

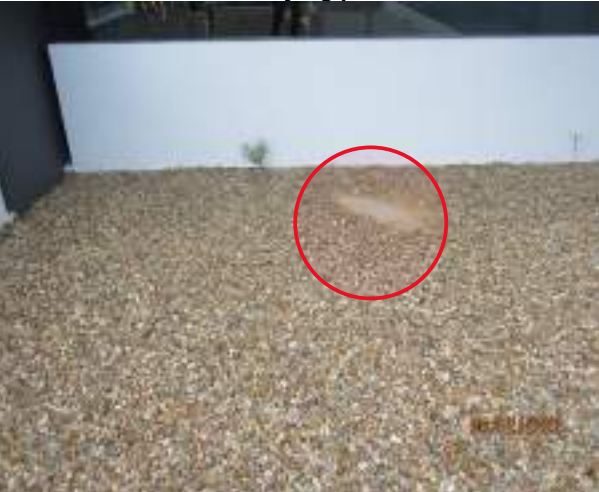
<p data-bbox="1520 1238 2107 1299">Location of evidence of product at Build L Level 4L adjacent to foyer balcony</p>

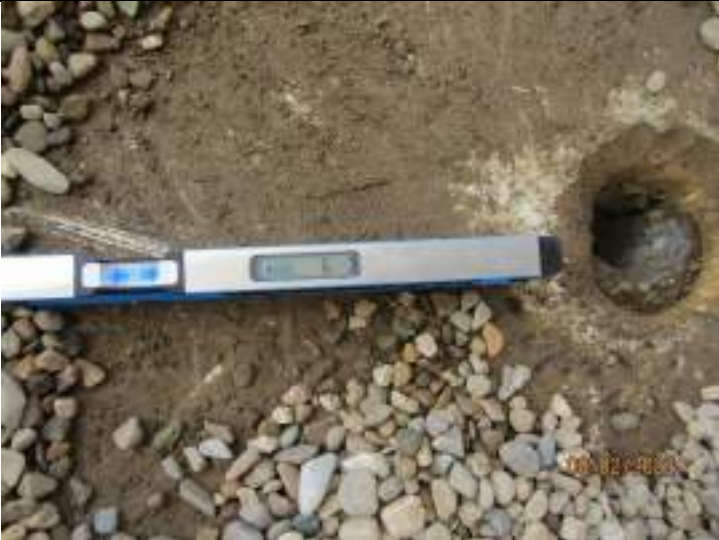
Description Photograph(s) R-2-3	
<p>Roof Drainage</p> <p>'Ponding' adds additional load to a roof, looks unsightly, and can shorten the lifespan of the roofing membrane. To ensure adequate drainage, any flat roof should have a minimum finished fall of 1:80. In reality, this means designing for twice the minimum fall to account for building inaccuracies, roof deflection and building settlement.</p>

<p>Extract RECTICEL Flat Roof Specification Guide requires minimum finish fall of 1:80</p>	<p>Insufficient fall to drainage inlets</p>

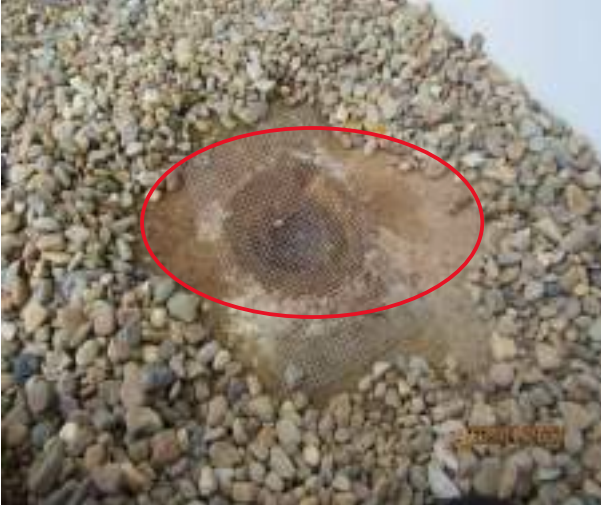
ITEM	COMMENTARY	PHOTOGRAPH(S)
R-3		
A	<p>Location & Description Lower roof drainage - Building L and U</p> <p>The Author has observed that</p> <p>A) Metal mesh has been loosely placed over the stormwater drainage inlet and no netting to pebbled roof areas.</p> <p>B) No bird netting has been provided as to contract specifications.</p> <p>The Author is of view,</p> <p>A) The use of the metal mesh and installation is not a suitable solution to prevent materials and stone ballast from falling into drainage inlet and the defect originated due to poor workmanship employed by the builder at the time of construction.</p> <p>B) The building contract Page 50 Clause 6.4.4 Roof and Roof finishes of the Principal's Project Requirements specifies <i>'All non-trafficable areas to be covered with pebbles and netting (ensuring the pebbles cannot be removed by birds).'</i></p> <p>The Author is of the view that the Builder has failed to carry out the works in accordance with the contract plans and specifications.</p>

<p>Metal mesh placed over darinage inlet located southwestern side of roof</p>

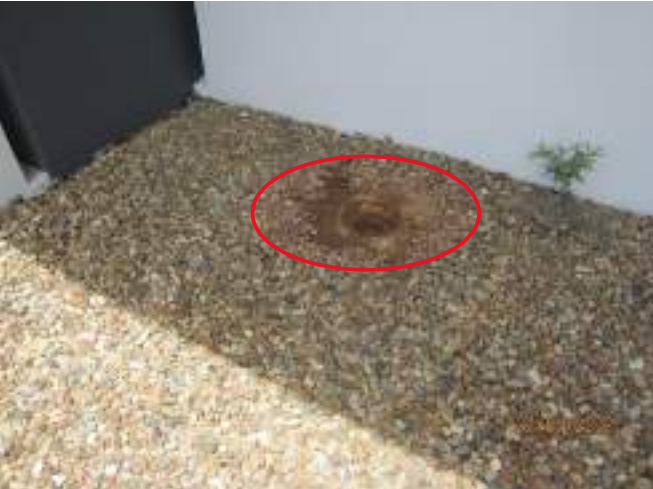
<p>Location of drainage inlet southwestern side of roof</p>

<p>D</p>	<p>Proposed Rectification Scope of Works</p> <p>CONCURRENT AND IN CONJUNCTION WITH REPAIRS IN RELATION TO ITEM R-2</p> <p>Allow to:</p> <ol style="list-style-type: none"> 1. Labour to install galvanized inlet grates to stormwater inlets to Buildings L and U 2. Supply galvanized inlet grates 3. Labour and install bird netting to pebbled roof areas to Building L and U 4. Supply bird netting and ancillaries 5. Clean site and leave in a tidy condition upon completion of work

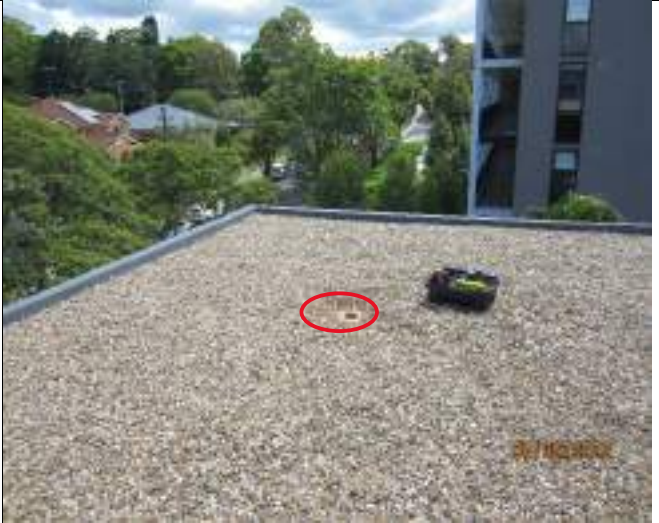
<p>Location of drainage inlet to southwest lower roof Building U NOTE: No bird netting provided to pebbled roof areas</p>
----------	--	--

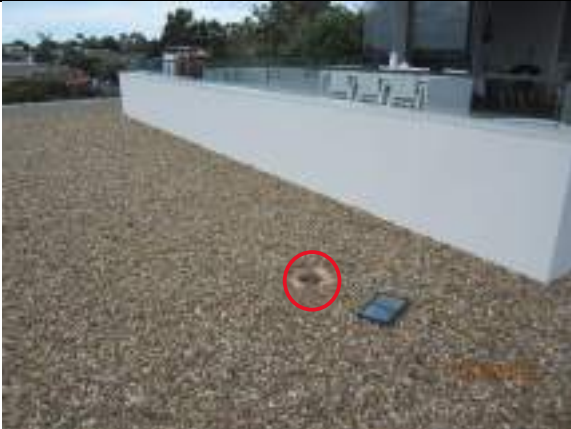
A photograph showing a flat roof area covered with small, light-colored pebbles. A white concrete parapet wall runs along the edge of the roof. In the foreground, a circular drainage inlet is visible, circled in red. A small blue object, possibly a mobile phone, lies on the pebbles near the inlet. The background shows some greenery and a building under construction.
<p>Extract page 50 PPR 6.4.4 specifying netting to pebbles</p>	<p>Image showing location of drainage inlet to norther side of Building L</p> <p>NOTE: No bird netting provided to pebbled roof areas</p>

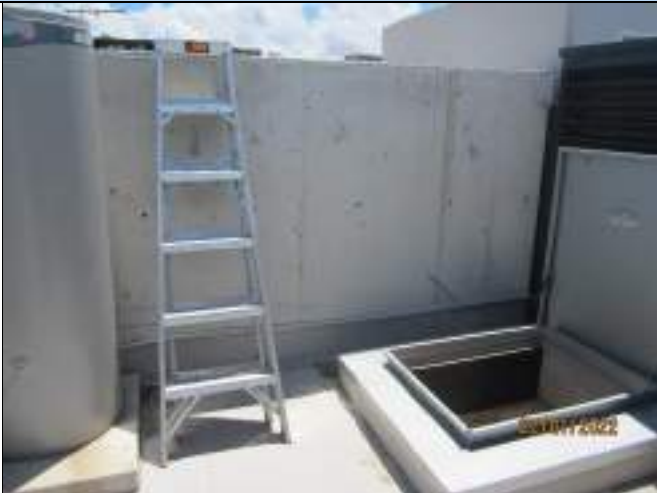
ITEM	COMMENTARY	PHOTOGRAPH(S)
R-4		
A	<p>Location & Description Building L – Ladder</p> <p>The Author has observed an aluminum ladder is in use to access roof of Building U from Building L.</p> <p>The Author noted that the building contract Page 50 Clause 6.4.4 Roof and Roof finishes of the Principal’s Project Requirements specifies ‘Safety access system to be provided for maintenance and services as required for safe working standards on roof as per health and safety codes.’</p> <p>For clarity, please refer to the following extract page 50 PPR 6.4.4 -</p> <p>PPR for 11-15 Mitchell Avenue Jannali</p> <hr/> <p>6.4.4 Roof and Roof Finishes</p> <ul style="list-style-type: none"> a) Any concrete flat roofs are to have a waterproof membrane even if not over habitable spaces. b) All non-trafficable areas to be covered with pebbles and netting (ensuring the pebbles cannot be removed by birds), except plantroom deck area. c) Metal deck roofing areas to manufacturer’s specification and to include for all vapour barriers, insulation and sarking, with all matching fascia boards and gutters. All downpipes to be concealed as per hydraulics design. d) All services and plant equipment located on the roof must be adequately screened. e) In the case that any plant on the roof can be viewed pre-completion or post construction, additional screening will have to be provided to an approved standard. f) Any hob constructed on the roof must receive a waterproof paintable membrane or painted finish. g) All roofing to have the required drainage and/or syphonic drainage as necessary. h) Safety access systems and latching points are to be provided for maintenance and services as required for safe working standards on roofs as per health and safety codes.

<p>Ladder used to access roof of Building U</p>

<p>The Author is of the view that the ladder is comply with AS1657:2018 7.3.1 and 7.44 Fixed platforms, walkways, stairways and ladders – Design, construction and installation, as the width of the upper steps is less than 450mm and ladder is not securely fastened. For clarity, please refer to following before-mentioned extracts -</p> <p style="text-align: center;">37 AS 1657:2018</p> <p>7.3 STEP-TYPE LADDERS</p> <p>7.3.1 Width and angle of slope</p> <p>The width of the step-type ladder between the stiles shall be not less than 450 mm and not greater than 750 mm.</p> <p>The angle of slope of step-type ladders shall be in accordance with the requirements of Section 2.</p> <p>7.4.4 Fastenings</p> <p>The ladder shall be secured with fastenings at the top and at the foot of the ladder, and secured at intervals as necessary for conformance with the requirements of Clause 7.1.2.</p>	
<p>B</p>	<p>Cause(s)</p> <ul style="list-style-type: none"> • Safety access system not provided as to contract specifications.

D	<p>Proposed Rectification Scope of Works</p> <p>CONCURRENT AND IN CONJUNCTION WITH REPAIRS IN RELATION TO ITEM R-1</p> <p>Allow to:</p> <ol style="list-style-type: none">1. Provide site supervision. Supervisor to coordinate access and facilitate the works throughout the whole process.2. Gain access to required areas in accordance with Safework requirements.3. Supply and install ladder in accordance with AS1657:2018 7.3.1 and 7.444. Labour to place waste material in waste bin, clean site and leave in a tidy condition upon completion of work	
---	--	--

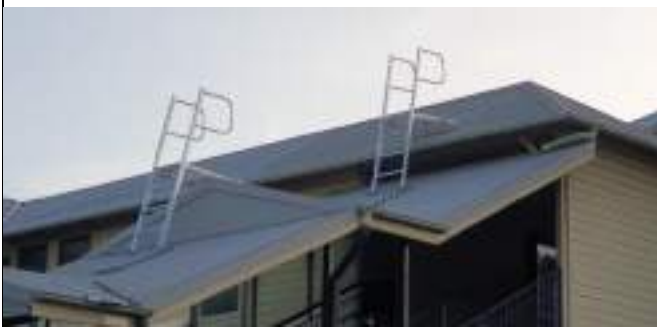
<p>Sample of roof ladder</p>

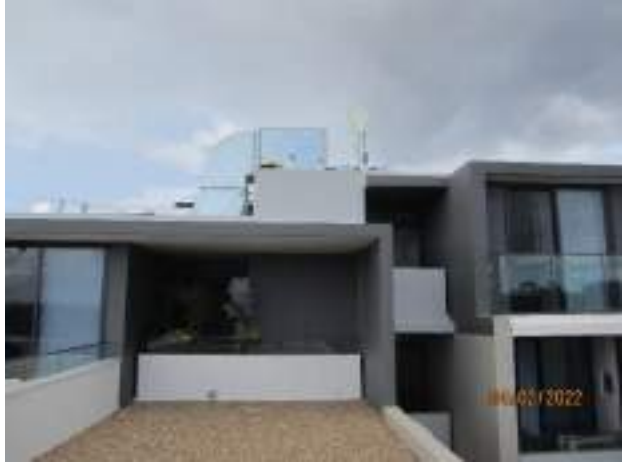
ITEM	COMMENTARY	PHOTOGRAPH(S)
R-5		
A	<p>Location & Description Building L – Exposed Roof Services</p> <p>The Author has observed that mechanical and plumbing service to the northern side of Building L have not been screened.</p> <p>The Author noted that the building contract Page 50 Clause 6.4.4 Roof and Roof finishes of the Principal’s Project Requirements specifies ‘All services and plant equipment located on the roof must be adequately screened.’</p> <p>For clarity, please refer to the following extract from PPR 6.4.4 –</p> <p>PPR for 11-15 Mitchell Avenue Jannali</p> <hr/> <p>6.4.4 Roof and Roof Finishes</p> <ul style="list-style-type: none"> a) Any concrete flat roofs are to have a waterproof membrane even if not over habitable spaces. b) All non-trafficable areas to be covered with pebbles and netting (ensuring the pebbles cannot be removed by birds), except plantroom deck area. c) Metal deck roofing areas to manufacturer’s specification and to include for all vapour barriers, insulation and sarking, with all matching fascia boards and gutters. All downpipes to be concealed as per hydraulics design. d) All services and plant equipment located on the roof must be adequately screened.

<p>Exposed mechanical services to roof of Building L & U</p>

D	<p>Proposed Rectification Scope of Works</p> <p>CONCURRENT AND IN CONJUNCTION WITH REPAIRS IN RELATION TO ITEM R-1</p> <p>Allow to:</p> <ol style="list-style-type: none">1. Provide site supervision. Supervisor to coordinate access and facilitate the works throughout the whole process.2. Gain access to required areas in accordance with Safework requirements.3. Supply powder coated metal louvre panels, posts, railing, gate, gate furniture and ancillaries4. Labour to install screening materials and ancillaries5. Labour to place waste material in waste bin, clean site and leave in a tidy condition upon completion of work6. Dispose of building waste	
---	---	--

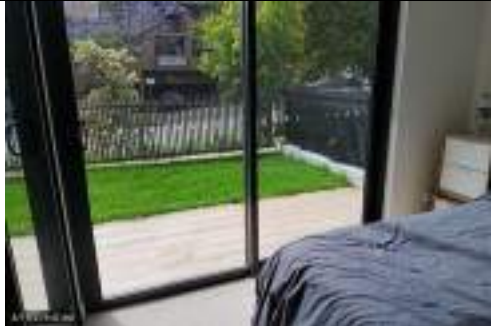
<p>Unit G02 Bed 2</p>

ITEM	COMMENTARY	PHOTOGRAPH(S)
C - 1		
A	<p>Location & Description Door installation – Waterstop and weatherproof flashing</p> <p>The Author has observed that no water stop has been provided to the doors to all units.</p> <p>The Author noted that the defect was identified in Section 8.3 of the Construction Adviser (Giaouris) Report.</p> <p>The Author concurs with Giaouris view that the installation has not been carried out in accordance with AS4654.2.</p> <p>The Author is of the view that the defect is systematic failure of the Builder to carry out the works with due care and diligence in accordance with AS4654.2 and the NCC Volume 1 2016.</p> <p>The Author noted that the NCC Volume 1 2016 Part F1.4 states –</p> <p><i>Waterproofing membranes for external above ground use must comply with AS 4654.1 and AS4654.2; and that the</i></p> <p><i>Performance Requirements FP1.4 Weatherproofing require - A roof and external wall (including openings around windows and doors) must prevent the penetration of water that could cause—</i></p> <p><i>(a) unhealthy or dangerous conditions, or loss of amenity for occupants; and</i></p> <p><i>(b) undue dampness or deterioration of building elements.</i></p> <p>The Author is of the view that based on the NCC Verification Methods FV1.1 Weatherproofing methods of assessing and testing that where the doors have been installed there is a Very high Risk Severity that door installation is defective.</p> <p>It then follows that the doors identified by the Author in Table C-1-1 of this item in relation to the defective works should be rectified to comply with requirements of the NCC and AS4654.2.</p>

<p>D</p>	<p>Proposed Rectification Scope of Works</p> <p>Allow to:</p> <p>Apply following rectification methodology to each unit and door identified in Table C-1-1</p> <ol style="list-style-type: none"> 1. Provide site supervision. Supervisor to coordinate access and facilitate the works throughout the whole process. 2. Gain access to required areas in accordance with Safework requirements. 3. Cover and protect adjacent surfaces during the rectification work 4. Labour to pull back carpet to provide access to carry out repairs 5. Labour to remove sliding door and store in a secure location 6. Labour to clean down existing waterproofing, reactivate waterproofing, install new waterproofing waterstop angle behind sliding door, aluminium angle colour matched to aluminium frame, Install new waterproofing, angle and fillet to hob and waterstop 7. Labour to reinstall sliding door suite, finishes, sealant to vertical and horizontal tile junction, install storm moulds to sliding door frame 8. Labour to complete paint repair affected finishes 9. Supply paint ancillaries 10. Labour to reinstate carpet 11. Make good any surfaces affected as part of the works, to their prior condition. 12. Clean site and leave in a tidy condition upon completion of work 	<p>Unit 204 Bed 2 sliding door</p>

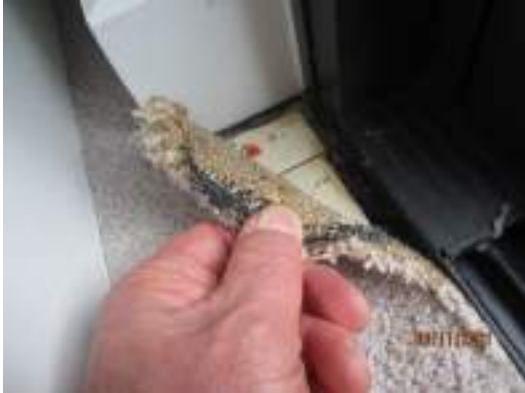
<p>Unit G03 No waterstop</p>

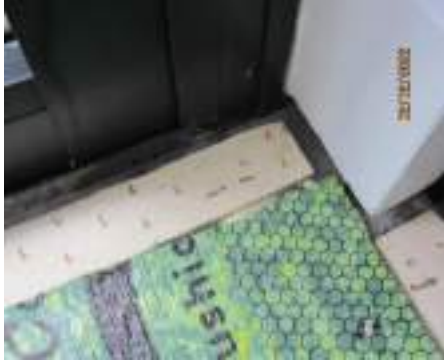
<p>Unit 304 No Waterstop</p>

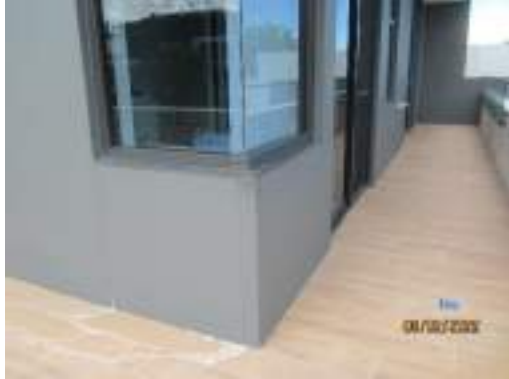
<p>Unit 403 doors to southside of balcony terrace</p>

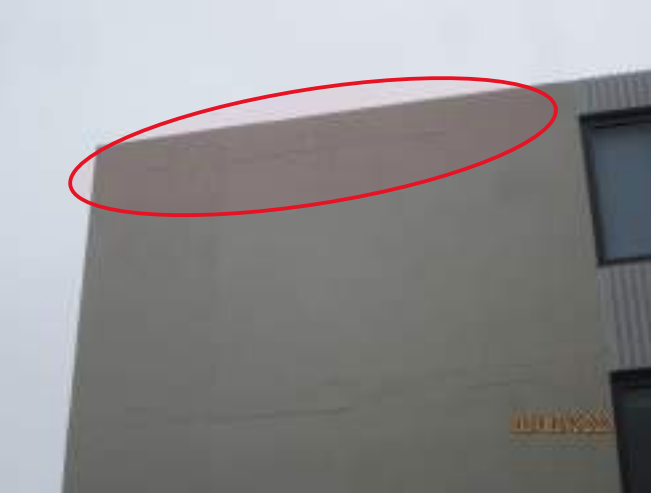
<p>The Author observed that the render repair applied had crazed cracking and was drummy.</p> <p><u>Provision of flashing and waterproofing to parapets, hobs and roof perimeter</u></p> <p>The Author is of the view that the efflorescence and damage to the rendered finish has originated due to the lack of flashing and waterproofing to the buildings parapets, hobs and roof perimeter, that has allowed water to penetrate and migrate the wall and substrate, causing the efflorescence staining, cracking and delamination of the rendered finish.</p> <p>The Author is of the view, that the builder had identified the requirement for flashing, as the builder has provided metal flashing to the terrace balcony balustrade of units 401 and 403, and that a similar methodology should have been applied to the parapets, hobs and roof perimeter that are also fully exposed to the weather.</p> <p>The Author is of the view that the builder has failed to carry out the works with due care and skill and in accordance with National Construction Code Volume 1 2016 FP1.4 Weatherproofing.</p>

D	<p>Proposed Rectification Scope of Works</p> <p>Allow to:</p> <ol style="list-style-type: none">1. Provide site supervision. Supervisor to coordinate access and facilitate the works throughout the whole process.2. Gain access to required areas in accordance with Safework requirements.3. Supply and install scaffold in hard to reach areas4. Supply and install custom made powder coated metal flashing to parapets and roof perimeter5. Supply fixings, sealants, and ancillaries6. Labour to remove efflorescence staining and repair paint finish to nearest junction and make good, affected finishes7. Supply paint, cleaning materials and ancillaries8. Dismantle and remove scaffold9. Labour to place waste material in waste bin, clean site and leave in a tidy condition upon completion of work10. Dispose of building waste

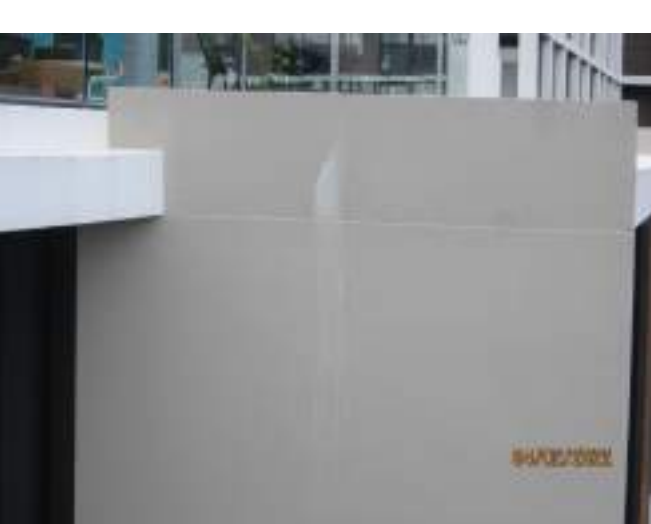
<p>C</p>	<p>Breach(es)</p> <p><i>Failure to comply with the following:</i></p> <ul style="list-style-type: none"> ▪ <i>Home Building Act 1989 (NSW) under Section 18B Clauses 1(a) & (c);</i> ▪ <i>National Construction Code 2016 Vol1 FP1.4 Weatherproofing</i> 	<p>Efflorescence staining to building façade</p>

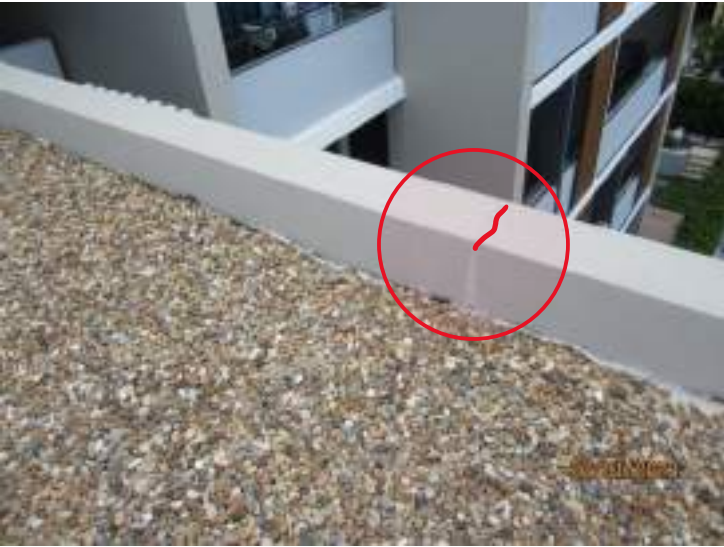
Efflorescence staining to western side of building L façade above entry inline with crack on top of façade parapet indicated in red

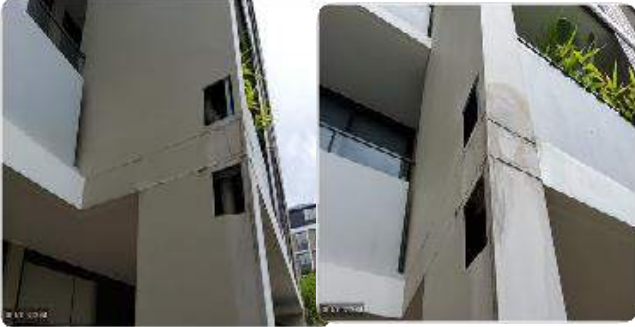
<p>Image showing northeast corner of column taken from courtyard of unit G07</p>

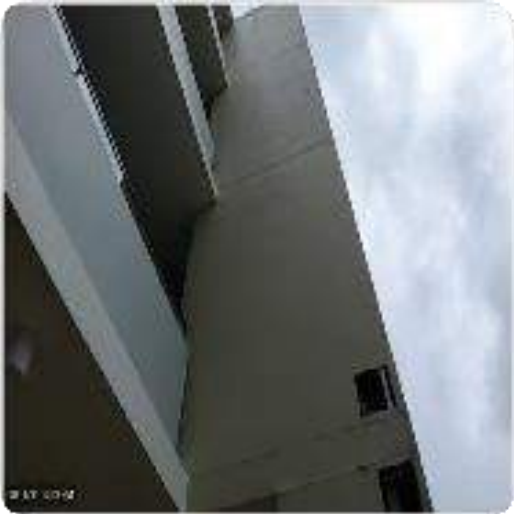
<p>Image showing column extending above all levels to roof</p>

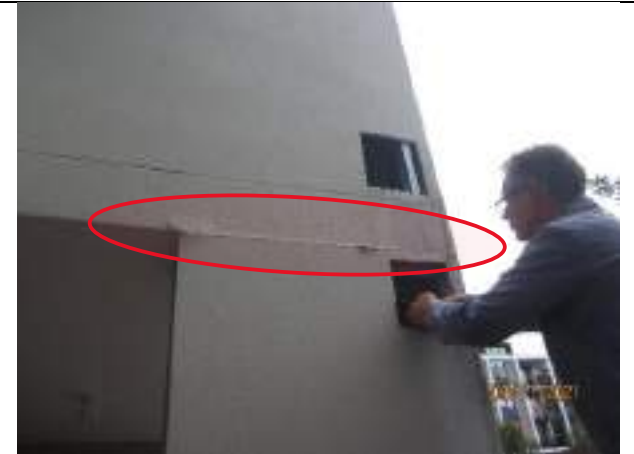
The Author observed that the gasket seal to the horizontal joint to the eastside and northside of the column below the slab had ruptured and the alignment between the underside of concrete slab and the top of the rendered lining was distorted primary to the eastern side of the column, and that sections of the render finish had cracked and were delaminating from the slab edge above the render lightweight cladding.

The Author is of the view that the damage caused to the horizontal gasket seal and rendered finish described is due to the deflection of the cantilevered slab and settlement of the building.

Images showing openings cut in column to northeast corner reported by occupants to have been done by the Builder., and evidence of damage caused due to deflexion of cantilevered concrete slab.

The Author recommends that the issue be investigated by suitable qualified structural engineer.

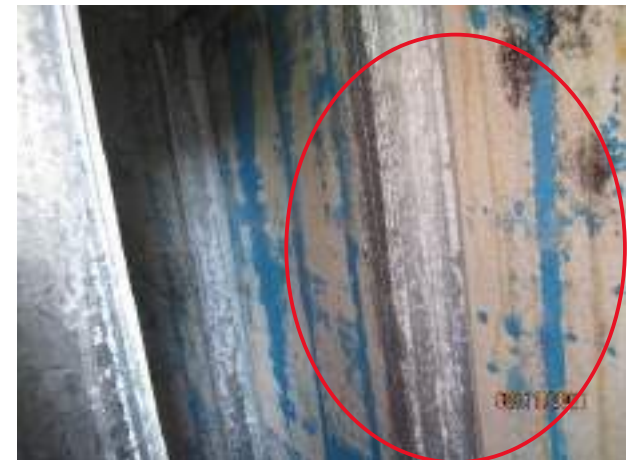
Yellow staining to interior surface of cladding

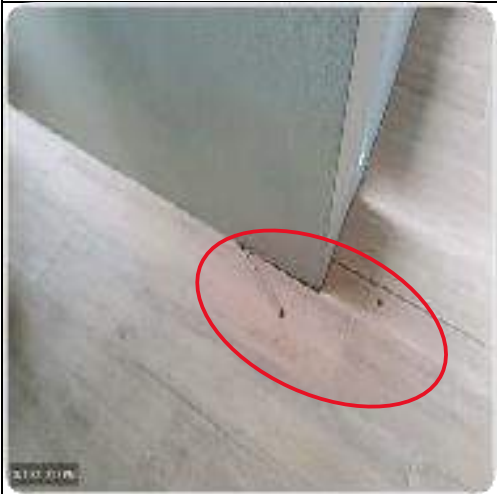
Image showing flexibale sealant that removed by the Builder to conduct dye test at the junction on the southwestern corner of the column to unit 107 that was reported at the time inspection to the Author by the owner occupant of unit 107.

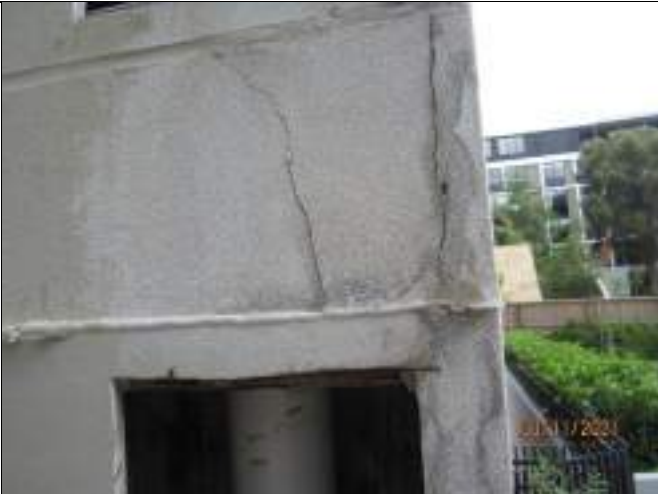
Evidence of moisture damage to northeast corner of column

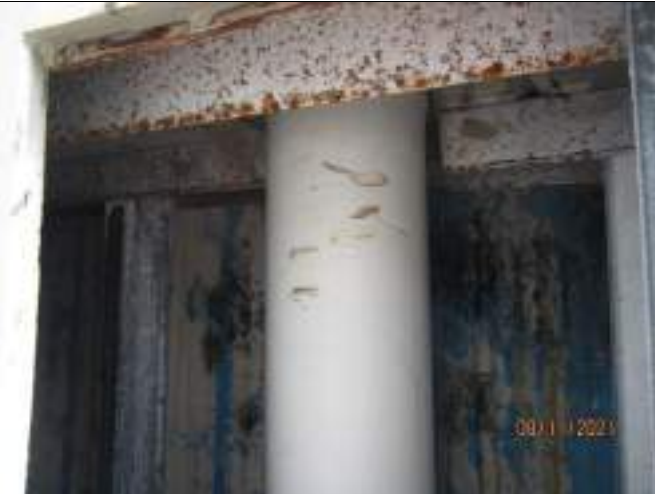
Evidence of corrosion to steel frame to interior of column exposed on northeast corner.

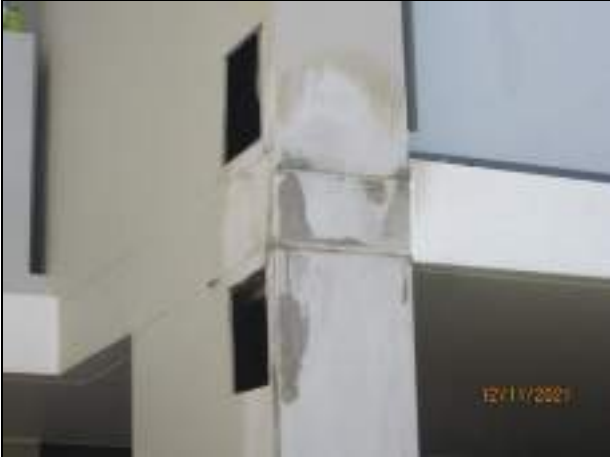
Evidence of moisture penetration following rain on day of inspection

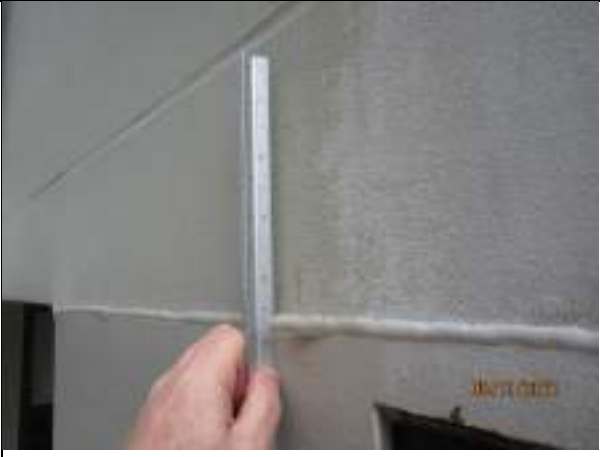
Evidence of rupturing of gasket sealant to horizontal joint and distortion to alignment of building elements caused due to deflexion of cantilevered concrete slab

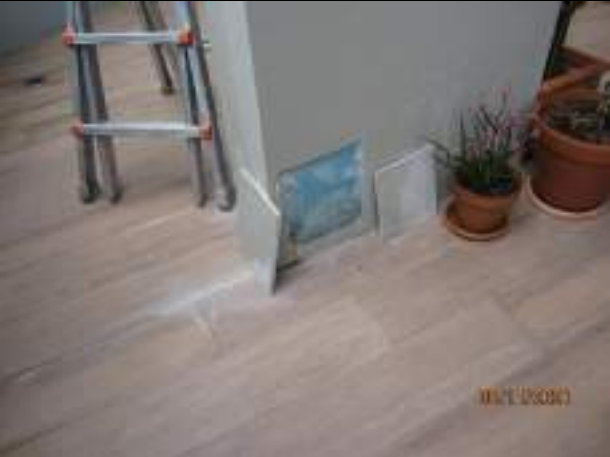
Column material exposed to northwest side of the column reported to the Author at the time inspection to have been done by the Builder.

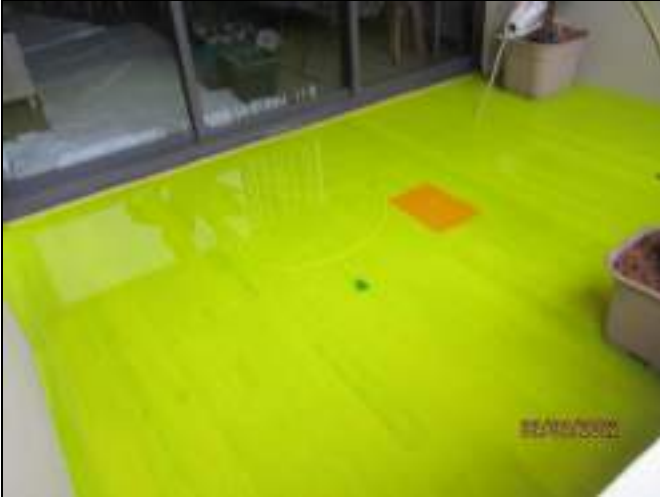
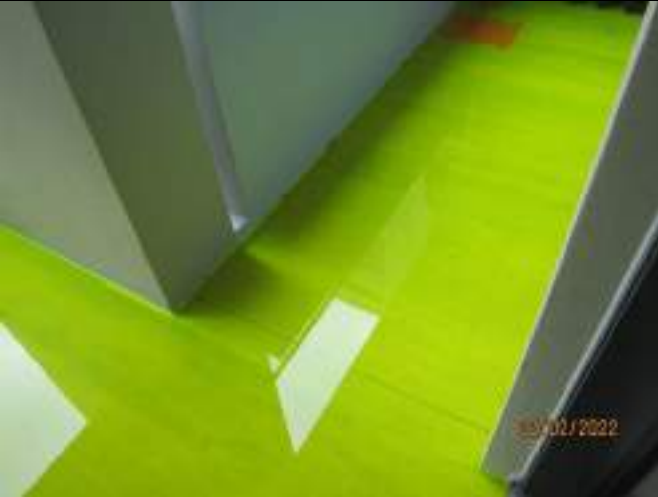
Flood testing using effluorescent dye to U107 Balcony

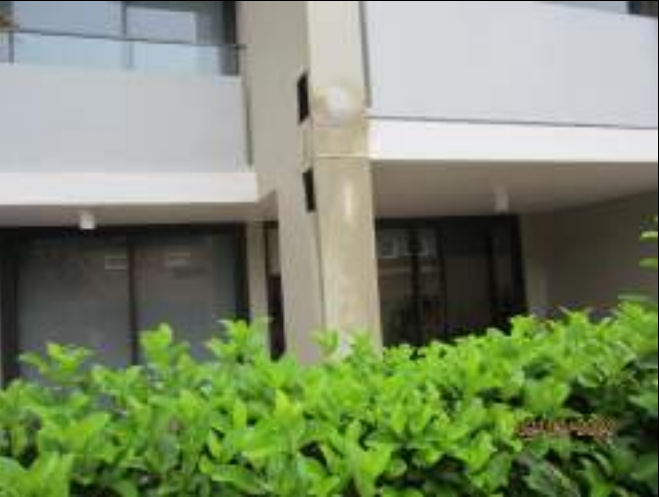
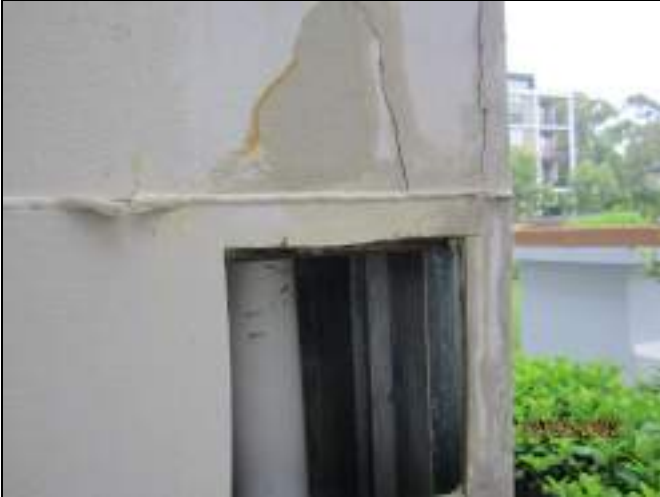
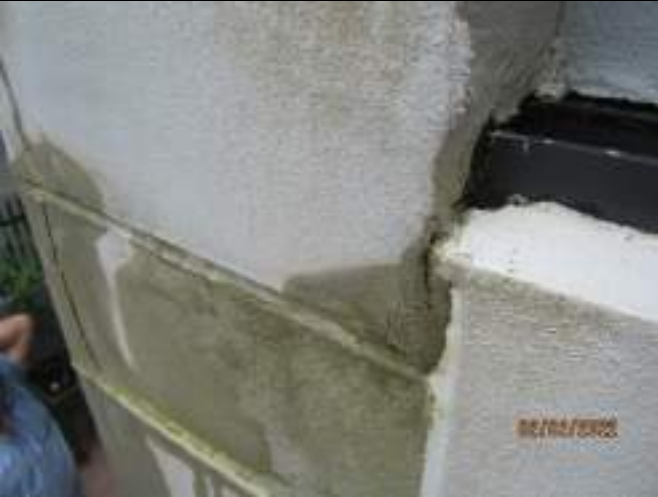
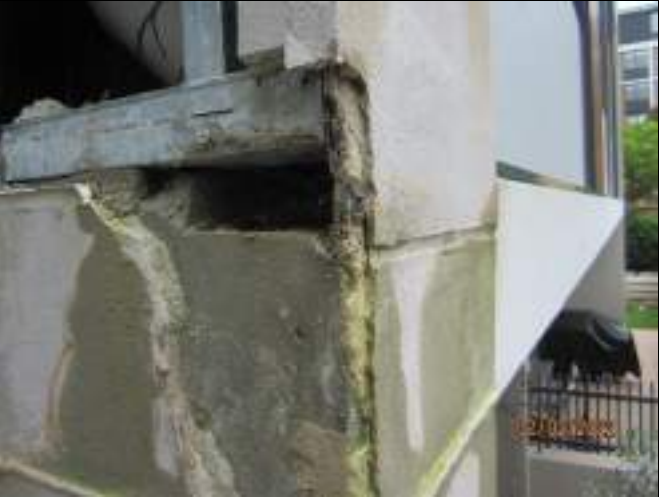
Evidence of water flood test penetrating column to northeast column of unit 107

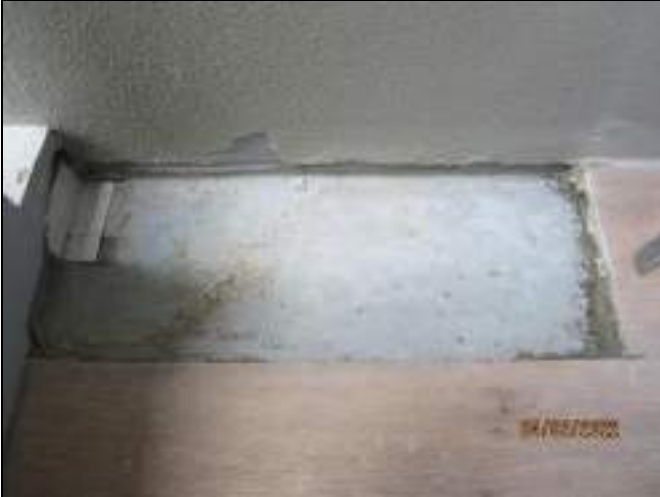
Tile removed adjacent to northeast column and overflow to balcony
