6. DEFECT SCHEDULE

6.1. AUTOMATIC FIRE DETECTION AND ALARM SYSTEM (INCLUDING SMOKE ALARMS)

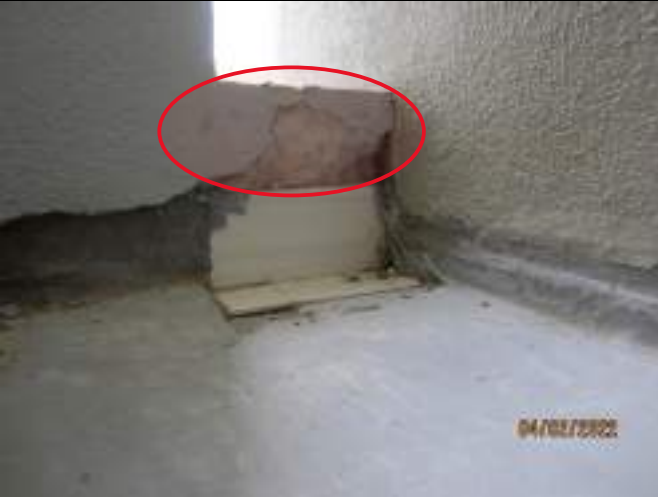
Overflow built up above PVC has not been waterproofed

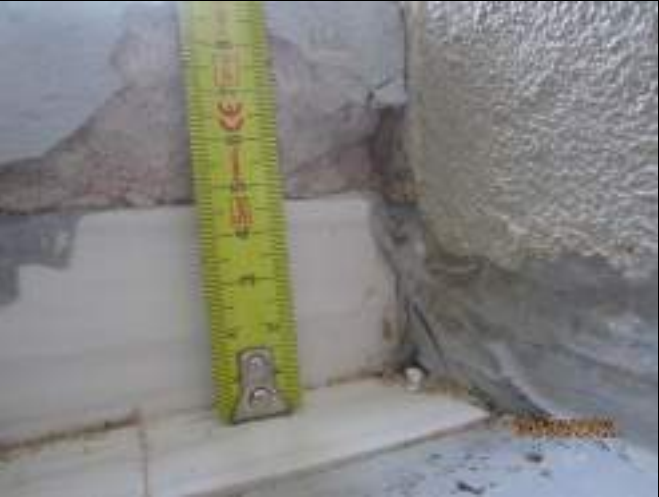
- A section 45mm PVC angle had been used to form the vertical waterproofing termination to the inlet of the overflow, and that the waterproofing membrane did not extend fully to the height and over the surface of the overflow and that the rendered column cladding was abutting the edge of the overflow hob.
- From a small section of the waterproofing membrane removed, that no fillet of bond breaker had been used at the horizontal and vertical junctions.
- Evidence of pin holes to the waterproof membrane.

45mm PVC angle used at form upturn to waterproofing

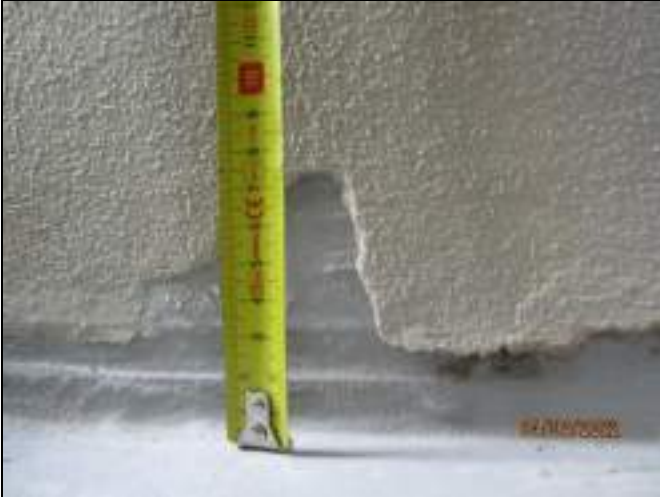
Height of upturn to waterproofing to northeast column above 70mm

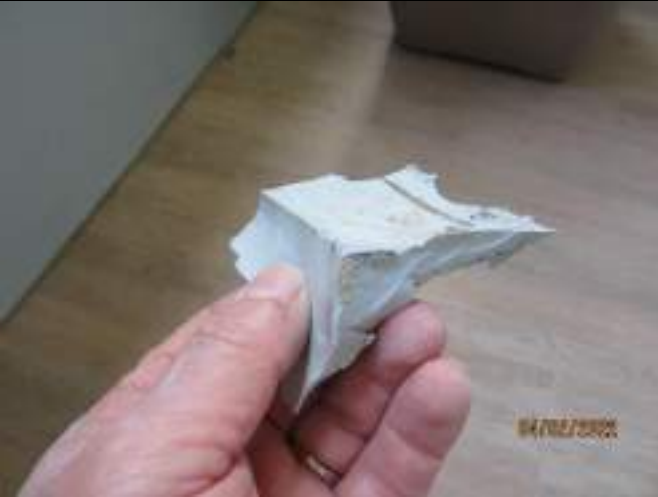
No bond breaker or fillet provided at horizontal junction

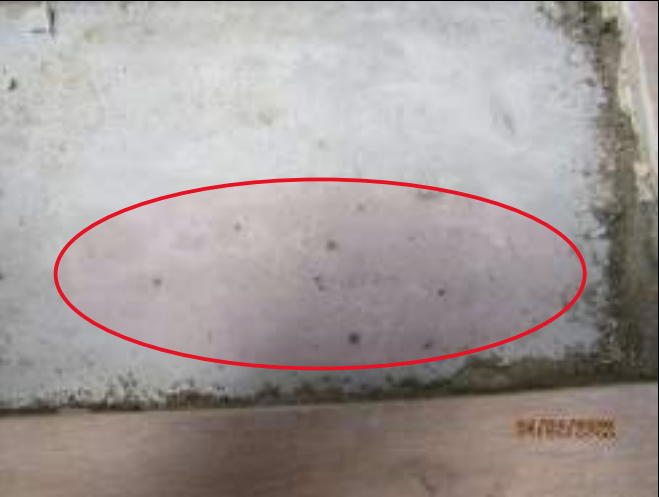
Evidence of pin holes to waterproof membrane

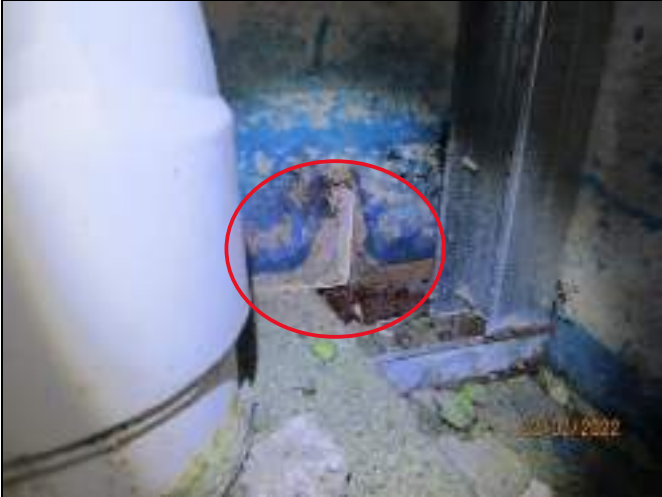
Evidence of water flood test penetrating interior of column to northeast column of unit 107. PVC angle used to form vertical termination penetrating lining to column.

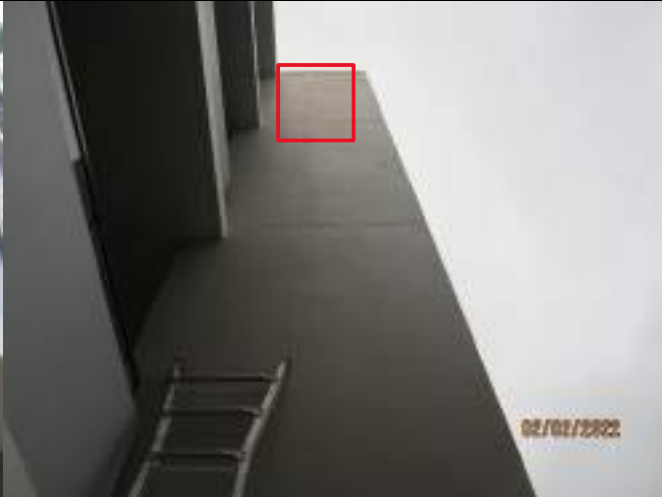
Evidence of water flood test penetrating column to northeast column to balcony of unit 107

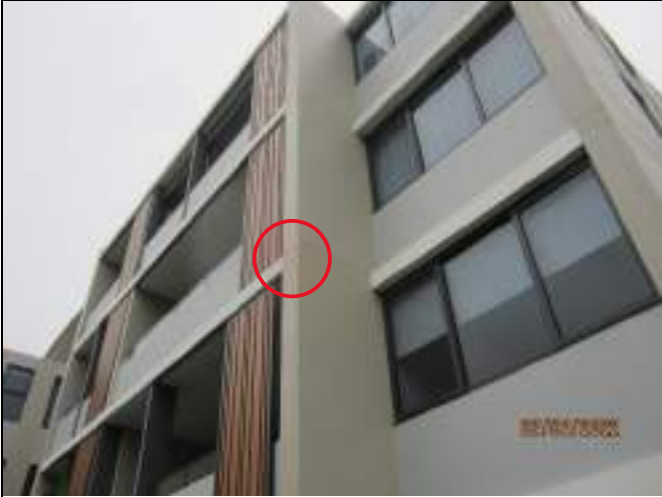
Evidence of rainwater leaks above northeast lightweight wall to Building U

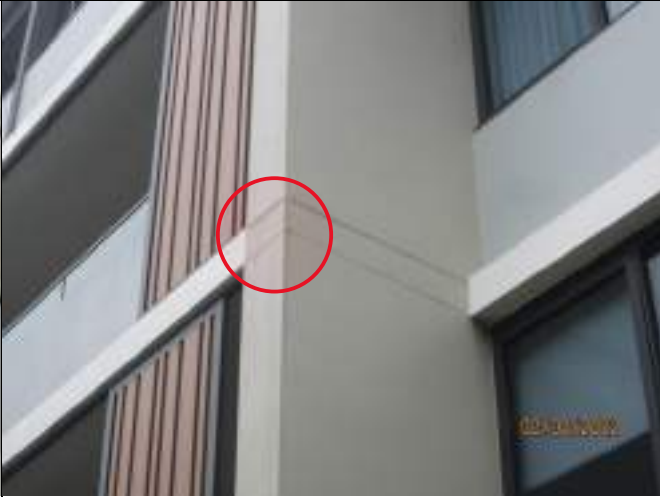
Evidence of rainwater leaks above northwest lightweight balcony wall to Building U

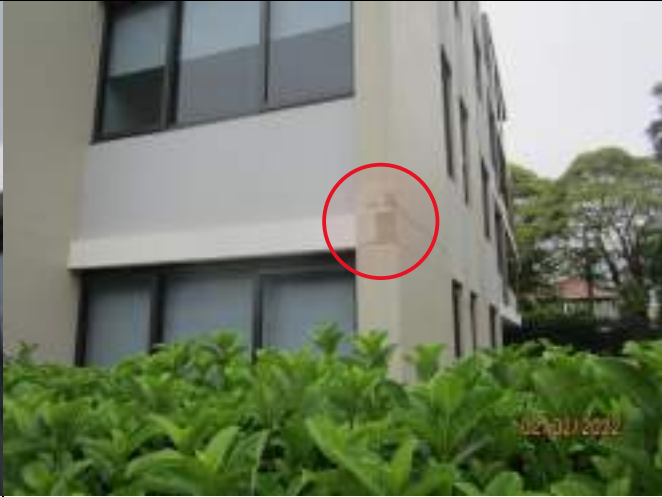
Evidence of rainwater leaks above northwest light weight balcony wall to Building U

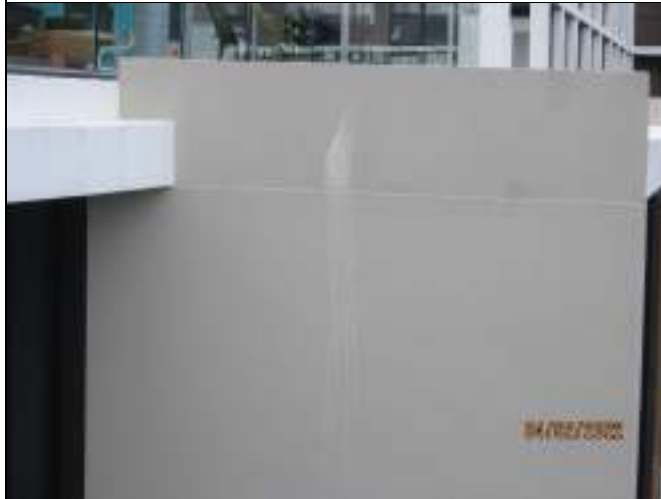
**EVIDENCE OF DEFLEXION (SAG) TO CANTILEVERED CONCRETE SLAB CAUSING DISLODGE-
MENT OF SEALANT AND DAMAGE TO RENDERED LININGS TO NO
STRUCTURAL LIGHT WEIGHT WALL AT GROUND LEVEL TO NORTHEAST COLUMN OF BUILDING U.**

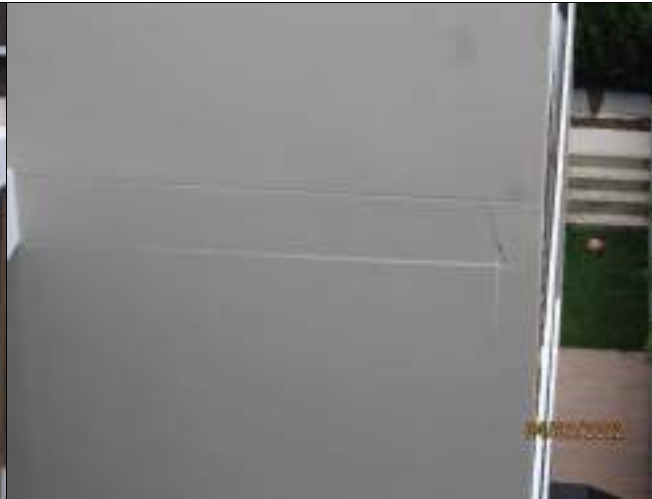
Evidence of water penetration to linings on northeast column to Building U

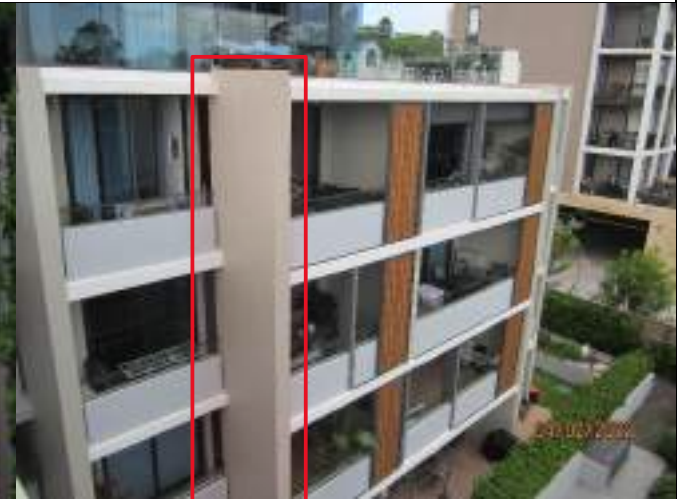
Evidence of water penetration and deflexion in cantilevered concrete slab northeast balconies of Building U

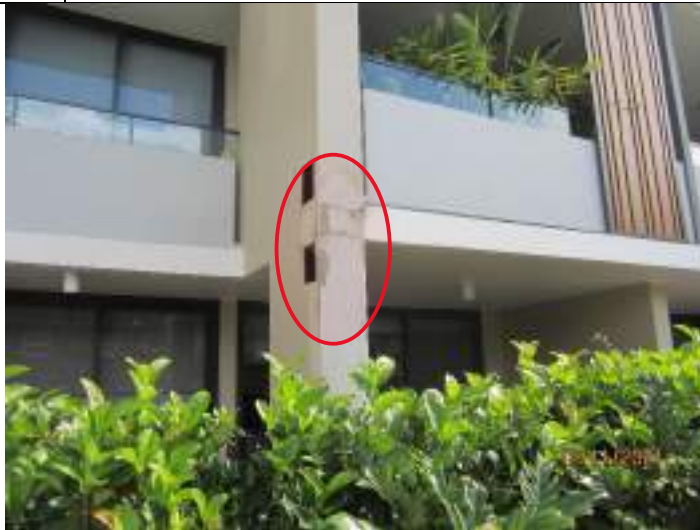
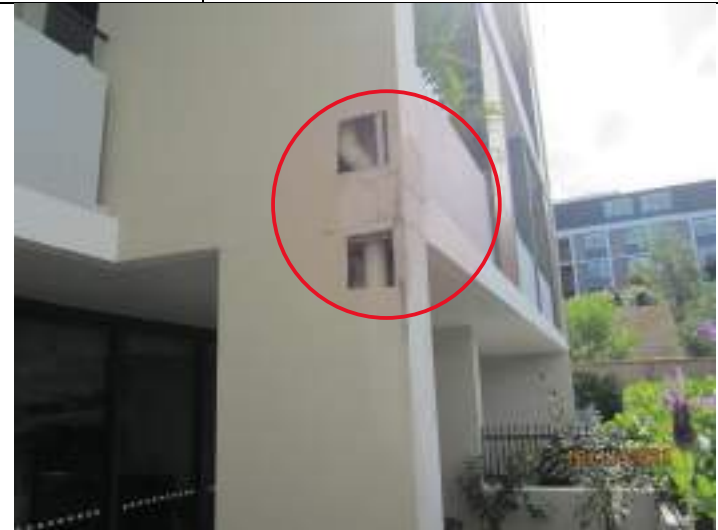
ITEM	COMMENTARY	PHOTOGRAPH(S)
C-4		
A	<p>Location & Description Light weight balcony columns and walls to units G07-107, G06-206</p> <p>The Author observed at the time of inspection –</p> <ul style="list-style-type: none"> • Water damage to the northeast and northwest light weight rendered wall and columns to units G07-107, 106, G06-206. • An opening has been made to the northeast column in the courtyard above and below the slab of unit 107 at the northeast corner of the column. The Author was informed by the Owner/Occupant of unit 107 at the time of inspection, that the opening had been made by the Builder in carrying out an invasive investigation and testing to determine cause of water leaks. • Evidence of repair to base of light weight wall to northwest corner of unit 106. <p>The Author is of the view that the defects described originated due -</p> <ul style="list-style-type: none"> • Poor workmanship employed by the Builder at the time of construction • Failure of the Builder to carry out the works in accordance with plans and specification. • Failure of the Builder to carry out the works in accordance with AS4654.2 • Failure of the Builder to carry out the works in accordance with NCC FP1.4 - Weatherproofing

Evidence of destructive investigation carried out by Builder and moisture damage to eastern coloumn to unit G07 and unit 107

D	<p>Proposed Rectification Scope of Works</p> <p>CONCURRENT AND IN CONJUNCTION WITH REPAIRS IN RELATION TO ITEM C-2</p> <p>NOTE: WEATHERPROOFING, SCAFFOLD, COVER AND PROTECTION OF ADJACENT FINISHES INCLUDED IN ITEM C-2</p> <p>Allow to:</p> <ol style="list-style-type: none">1. Provide site supervision. Supervisor to coordinate access and facilitate the works throughout the whole process.2. Gain access to required areas in accordance with Safework requirements.3. Labour to repair damaged finishes4. Materials and ancillaries to repair damaged finishes5. Clean site and leave in a tidy condition upon completion of work6. Dispose of building waste	
---	--	--

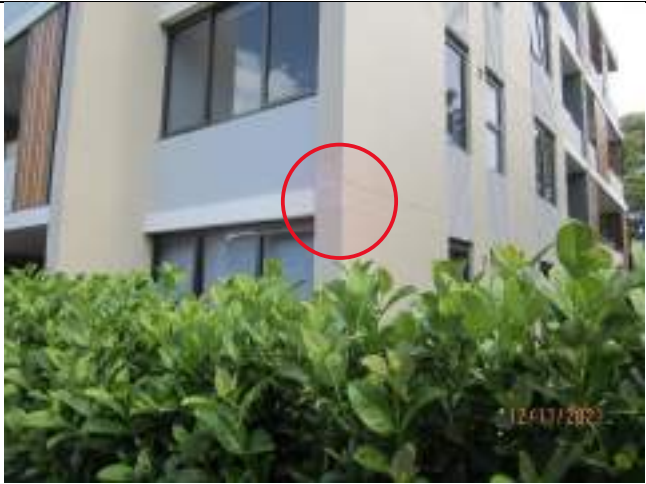
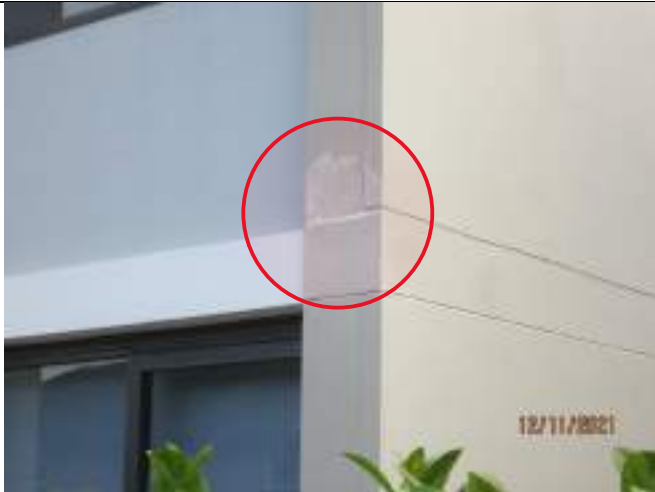
Evidence of moisture damage and repair carried out by Builder to column on northwestern corner of unit 106

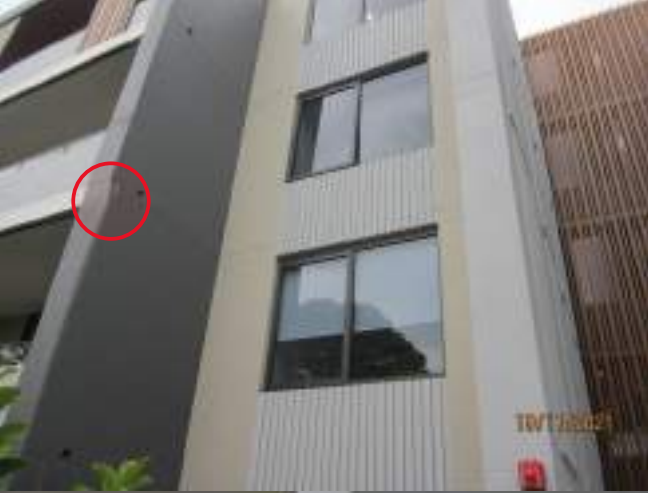
ITEM	COMMENTARY	PHOTOGRAPH(S)
C-5		
A	<p>Location & Description Balcony Unit 205 – Efflorescence</p> <p>The Author observed efflorescence staining to the top of concrete slab at the southeast balcony of Unit 205 that evidence of a moisture penetration.</p> <p>During inspection following periods of rain, the Author observed moisture penetrating at the top of the concrete slab in the location of efflorescence staining to unit 205, and moisture penetrating the eastern side of the lightweight rendered wall in location above unit 205 and below at the balcony slab to unit 105.</p> <p>The Author noted that the defect was identified in Attachment F Section 10.6 of TCA report.</p> <p>The Author is of the view that the defect originates due to the failure to provide weatherproofing to the wall parapet at the roof level.</p>

D	<p>Proposed Rectification Scope of Works</p> <p>CONCURRENT AND IN CONJUNCTION WITH REPAIRS IN RELATION TO ITEM C-2</p> <p>Allow to:</p> <ol style="list-style-type: none"> 1. Provide site supervision. Supervisor to coordinate access and facilitate the works throughout the whole process. 2. Gain access to required areas in accordance with Safework 	<p>Location and evidence of efflorescence staining to southeast unit 205 balcony.</p>

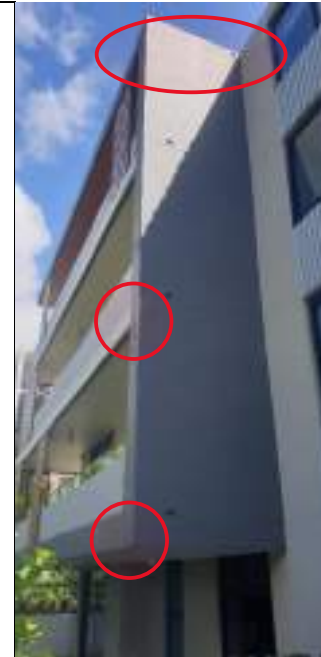
Location of moisture penetration and efflorescence staining

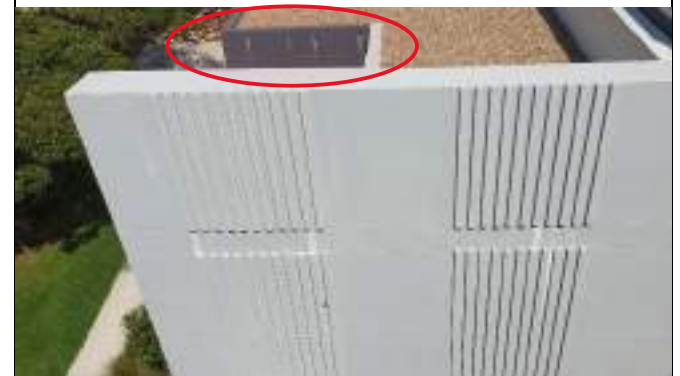
Evidence of efflorescence staining to parapet wall at roof level

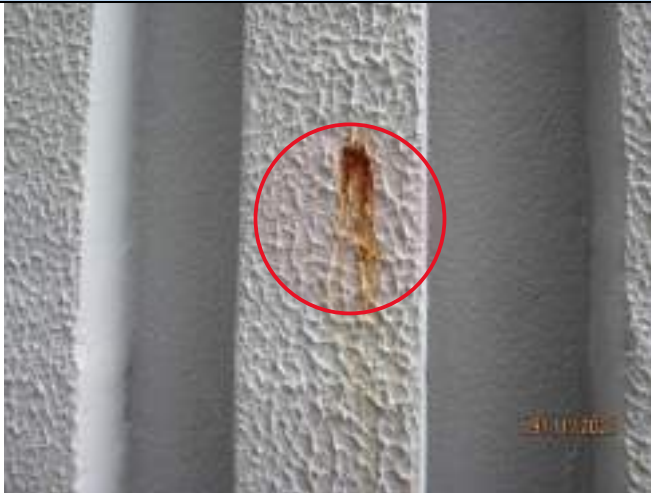
ITEM	COMMENTARY	PHOTOGRAPH(S)
C-6		
A	<p>Location & Description Building L and U Façade - Decorative battens</p> <p>The Author has observed evidence of –</p> <ol style="list-style-type: none"> 1. Corrosion of the metal fixings to southern side Building L and U façade. 2. Cracks to the aerated concrete decorative battens installed to the building façade to north and west of building L and south of building U. 3. Gaps to decorative battens installed to the building façade to north and west of building L and south of building U. <p>During inspection the found metal fixings with the demolition waste from waterproofing repair to southern building side of entry with evidence of corrosion.</p> <p>The Author noted that the Item had been identified in Attachment F Section 10.6 item C20 of TCA report.</p> <p>The Author is of the view that Builder originated due to the has failure to use suitable fixings for installation of aerated decorative battens and poor workmanship employed by the Builder at the time of construction.</p>

<p>Evidence of corrosion of fixings to aerated concrete battening on eastern side of main entry</p>

<p>D</p>	<p>Proposed Rectification Scope of Works</p> <p>Allow to:</p> <ol style="list-style-type: none"> 1. Provide site supervision. Supervisor to coordinate access and facilitate the works throughout the whole process. 2. Gain access to required areas in accordance with Safework requirements. 3. Cover and protect adjacent surfaces during the rectification work. 4. Supply and install scaffold to provide safe working platform 5. Labour to remove damaged, poorly installed battens and prepare surface for install of new battens 6. Supply new batten material, ancillaries, and fixings 7. Labour to full seal new and existing battens, apply textures finish and paint new and existing battens, repair and make good, affected finishes 8. Supply paint and ancillaries 9. Labour to remove and dispose of building waste 10. Dismantle and remove scaffold 11. Clean site and leave in a tidy condition upon completion of work 12. Waste disposal 	<p>Location of evidence of corrosion of fixings to aerated concrete battening on eastern side of main entry</p>

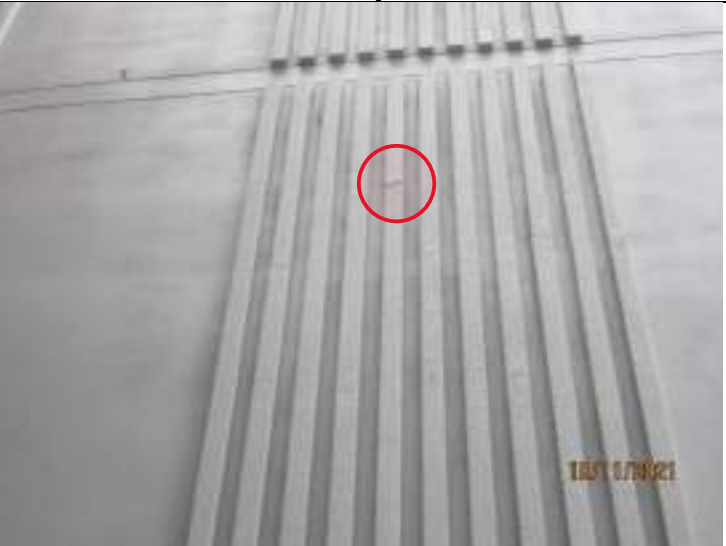
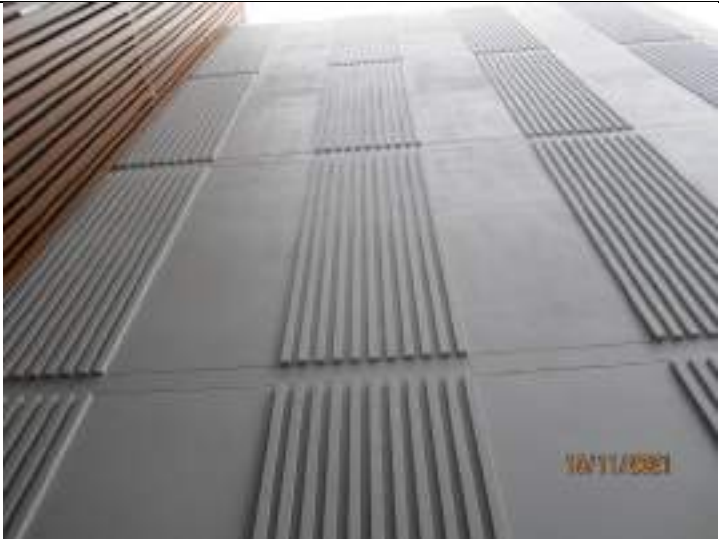
Evidence of damage to battening to eastern wall of main entry

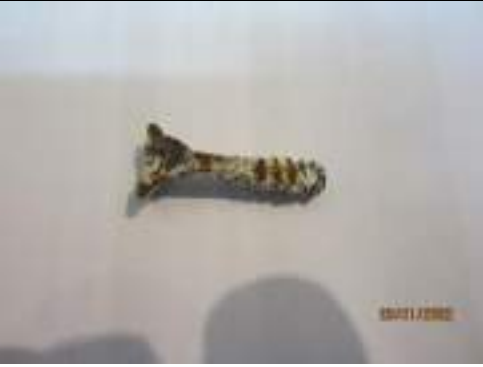
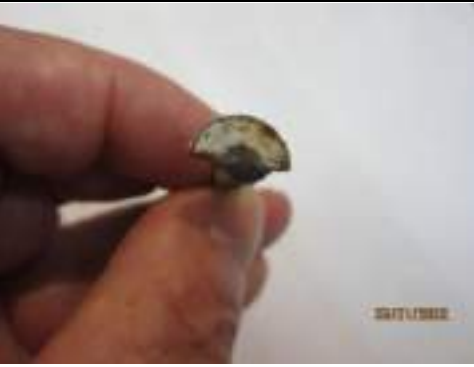
Evidence of corrosion to metal screws used to fix battens found with demolition waste located in Basement 2 storage area

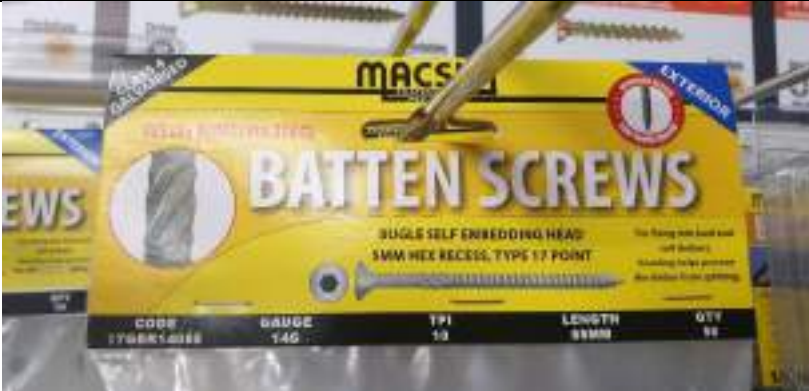
14 gauge timber screws used to fix aerated concrete battens

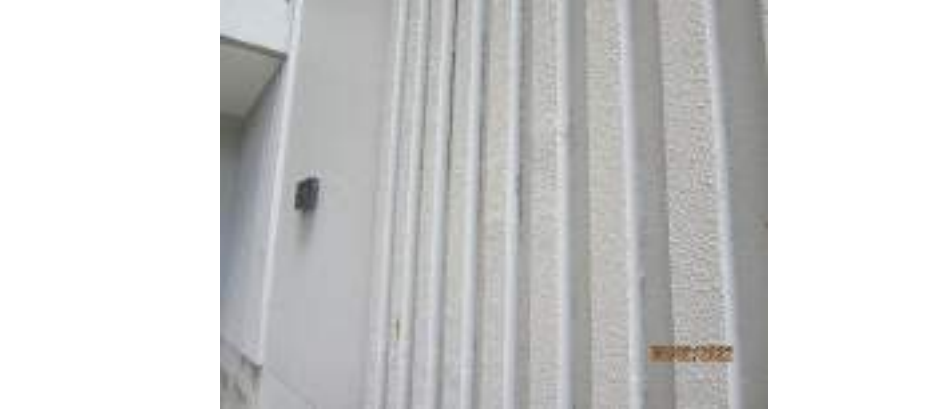
Evidence of cracks and gaps to battens fixed to southeastern side of entry

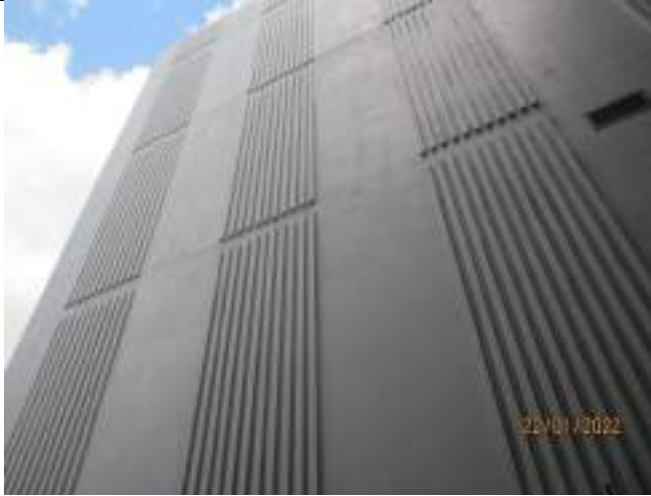
ITEM	COMMENTARY	PHOTOGRAPH(S)
C-7		
A	<p>Location & Description HEBEL cladding installation</p> <p>Hebel panel drainage and pressure equalisation – Item C7 identified in Attachment F Section 10.6 and 8.26 of TCA report.</p> <p>The Author has observed that there is no provision for drainage or pressure equalization to the Hebel panels to the façades of building L and U.</p> <p>The Author noted that the defective works had been identified in Section 10.6 and 8.26 of Mr Giaouris report dated 7 December 2020. However, the Author noted that Hebel installation guidelines referenced by Mr Giaouris states PE/drainage slots to be located no greater than 3 metre spacing. Therefore, the Author is of the view that work is defective in the locations where the spacing exceed or do not conform to the manufacturers guidelines.</p> <p>To clarify, please refer to extract from Section 8.26.3 of Mr Giaouris report -</p> <p>Pressure Equalisation Slots</p> <div style="border: 1px solid red; border-radius: 10px; padding: 5px; margin: 10px 0;"> <p>PE Slots (Weepa) allow pressure equalisation to the wall cavity and permit drainage of any water from the cavity. Ideally located at control joints (CJ) and at no greater than 3 metre spacing.</p> </div> <p>The Author is of the view that where the works have not been carried out in accordance with manufacturers guidelines that the works are defective and the defect originated due to poor workmanship employed by the Builder at the time of construction.</p>

<p>No provision for Hebel panel drainage and pressure equalisation to southwestern façade above southern entry building L</p>

<p>D</p>	<p>Proposed Rectification Scope of Works Allow to:</p> <ol style="list-style-type: none"> 1. Provide site supervision. Supervisor to coordinate access and facilitate the works throughout the whole process. 2. Gain access to required areas in accordance with Safework requirements. 3. Cover and protect adjacent surfaces during the rectification work. 4. Supply and install scaffold to provide working deck to all levels in location described to western façade to Building L and northern façade of Building U. 5. Labour to cut slot in Hebel panel to install Weepa protector, install Weepa protectors and patch and repair affected finishes in accordance with manufacturers guidelines. 6. Labour to repair render and paint façade to provide even finish 7. Supplier Weepa protectors 8. Supply Dulux render system materials, paint and ancillaries 9. Make good any surfaces affected as part of the works, to their prior condition. 10. Dismantle and remove scaffold 11. Clean site and leave in a tidy condition upon completion of work 12. Waste disposal 	<p>Insufficient provision for Hebel drainage and pressure equalisation under windows drainage to western façade building L</p>

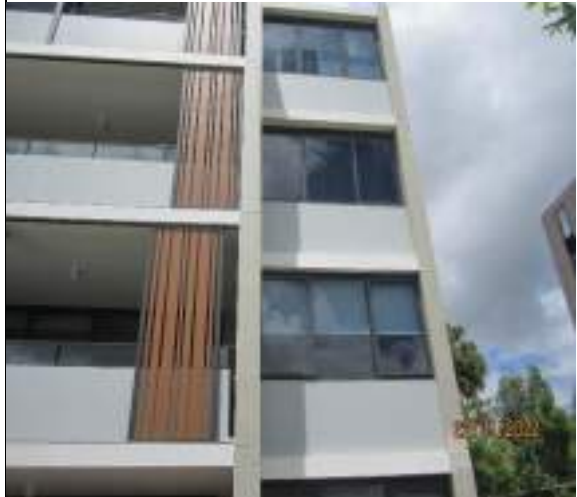
<p>Insufficient provision for Hebel drainage and pressure equalisation under windows drainage to northwestern façade building U</p>

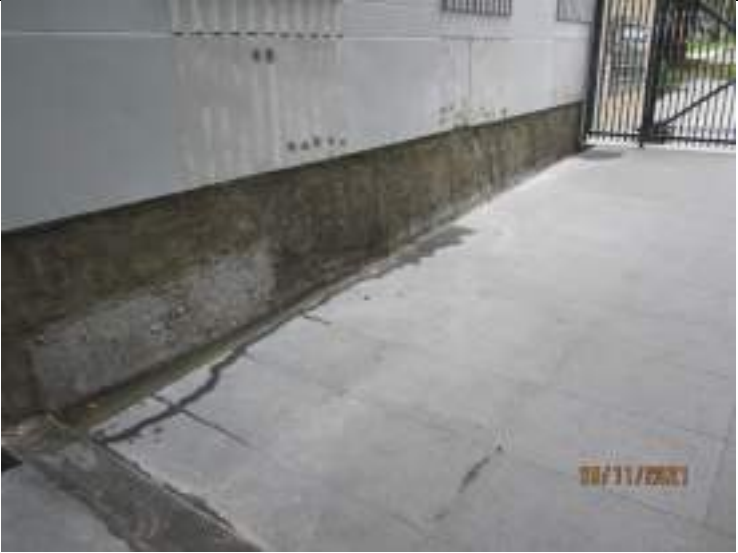
Render base coat applied to waterproofing membrane

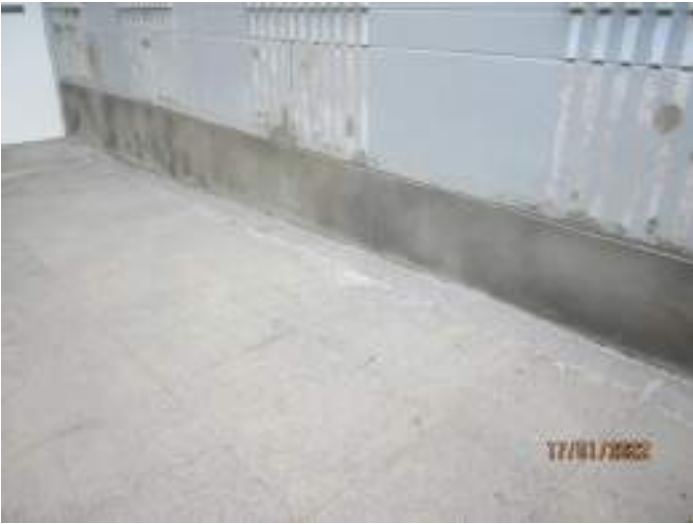
Render finish applied to waterproofing

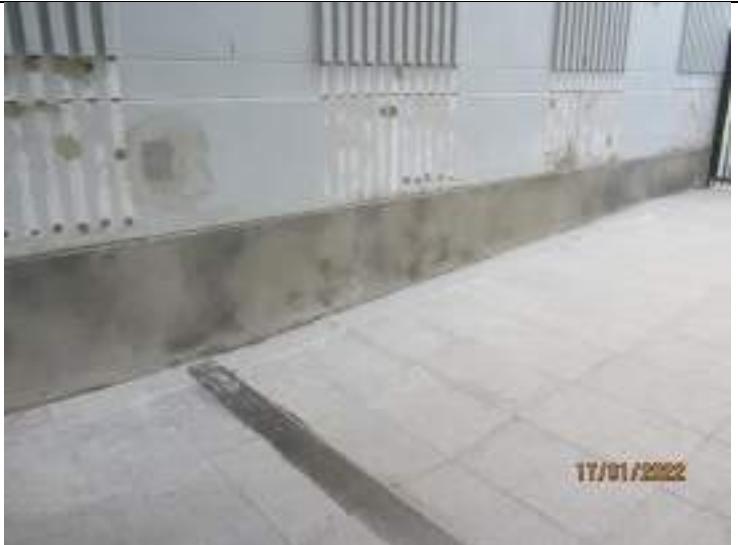
Render finish applied to waterproofing is drummy

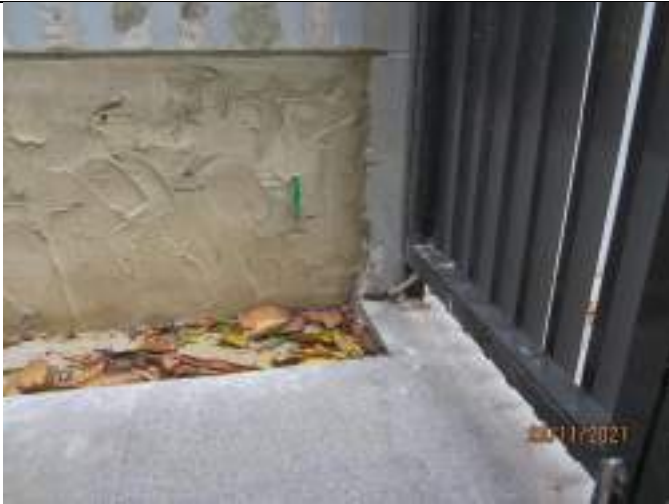
Weepa's installed to base of wall have no useful function

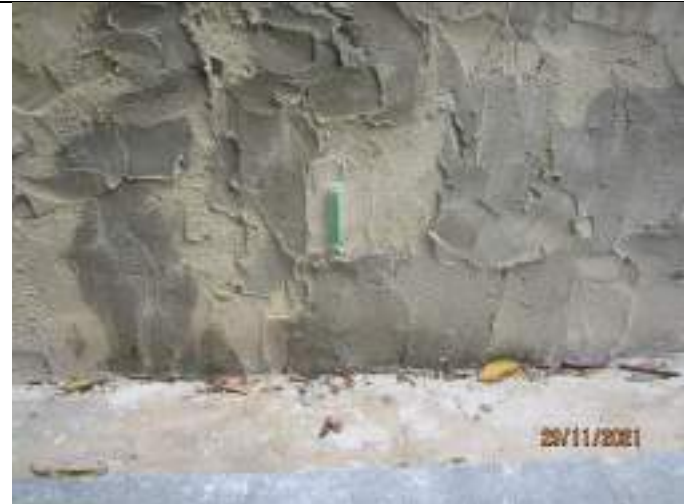
Weepa's installed to base of wall have no useful function

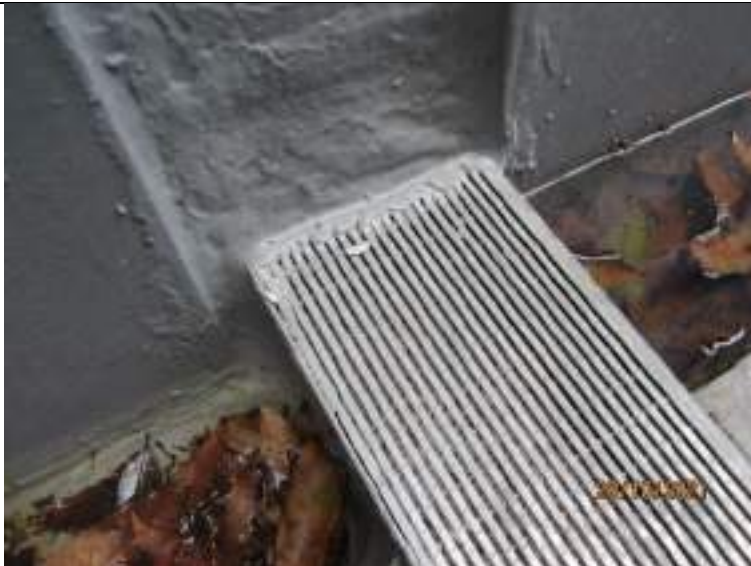
Waterproofing applied over stormwater grate

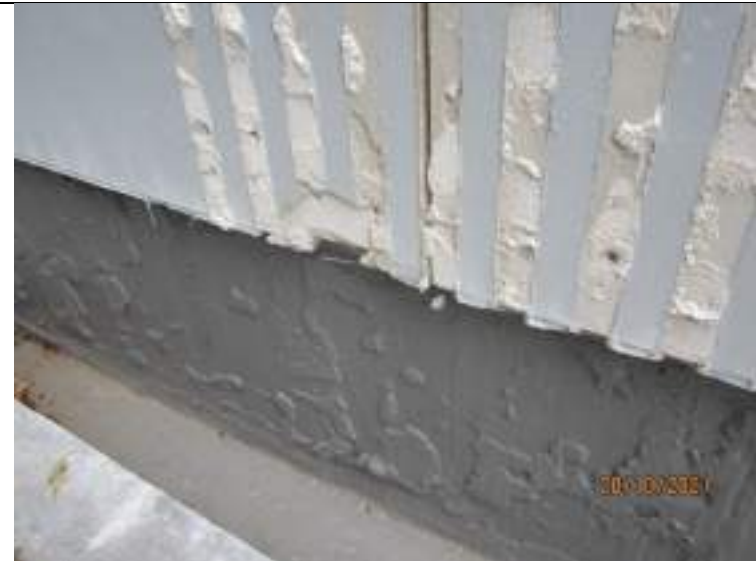
Waterproofing membrane applied over rough substrate

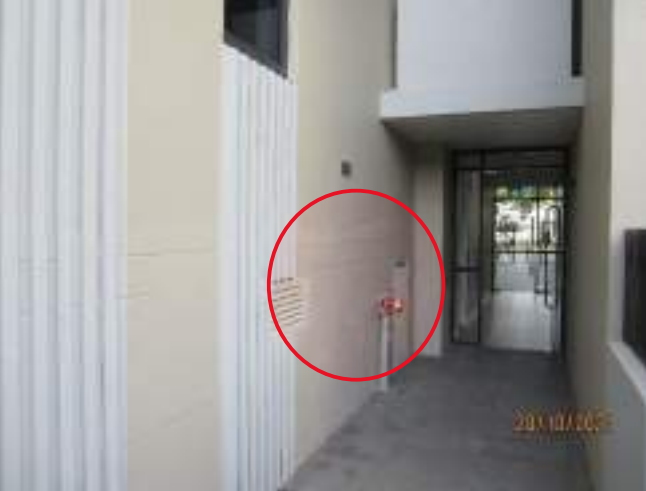
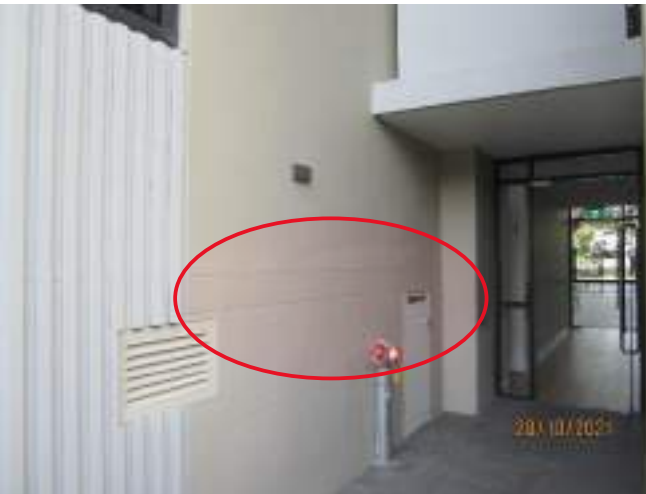
ITEM	COMMENTARY	PHOTOGRAPH(S)
C-9		
A	<p>Location & Description Eastern façade - Northern side of entry</p> <p>The Author observed at the time of inspection that the paint finish to Eastern façade - Northern side of entry has uneven cover.</p> <p>The Author is of the view that the defect originated due to poor workmanship employed by the Builder at the time construction.</p>

D	<p>Proposed Rectification Scope of Works Allow to:</p> <ol style="list-style-type: none"> 1. Provide site supervision. Supervisor to coordinate access and facilitate the works throughout the whole process. 2. Gain access to required areas in accordance with Safework requirements. 3. Cover and protect adjacent surfaces during the rectification work. 4. Labour to apply paint system to provide even cover 5. Supply paint to match existing architectural finishes 6. Supply paint ancillaries 7. Clean site and leave in a tidy condition upon completion of work

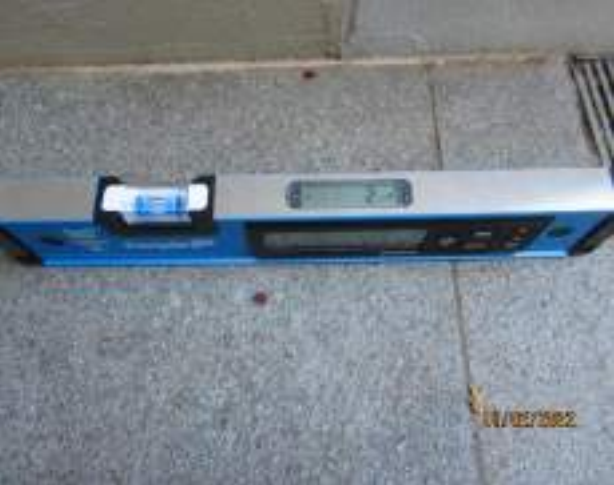
ITEM	COMMENTARY	PHOTOGRAPH(S)
C-10		
A	<p>Location & Description Northern side of entry – Stone paving</p> <p>The Author observed that the rainwater is ponding at the western end of the stormwater drain to the south side of the entry.</p> <p>The Author conducted fall test using a digital level and found that the paving surface did not have sufficient fall. The Author noted that the defect was identified in TCA (Giaouris) report Item C3 identified in Attachment F Section 10.6.</p> <p>The Author is of the view, the water ponding on the surface presents risk of injury resulting from slipping due to ponding water, and therefore the works do not conform to the requirements of the NCC 2016 Volume 3 FP2.1.</p> <p>For clarity, please refer to following extract from National Construction Code 2016 Volume 3 FP2.1 –</p> <p>Surface drainage systems (2) b) The severity of potential damage to property, loss of amenity, illness or injury that would result from the failure of the system.</p> <p>The Author is of the view that the defect originated due to poor workmanship employed by the Builder at the time of construction.</p>

<p>Test indicating insufficient fall to southside of drain</p>

<ol style="list-style-type: none">4. Labour to remove stone paving with insufficient fall to the south and north side of stormwater drain and storage in secure location5. Labour to place and form tile screed to provide sufficient fall to stormwater drain, reinstate stone paving and grout joints and provide flexible sealant to wall and tile joints6. Supply tile screed materials, grouts, and sealants7. Clean site and leave in a tidy condition upon completion of work	
--	---	--

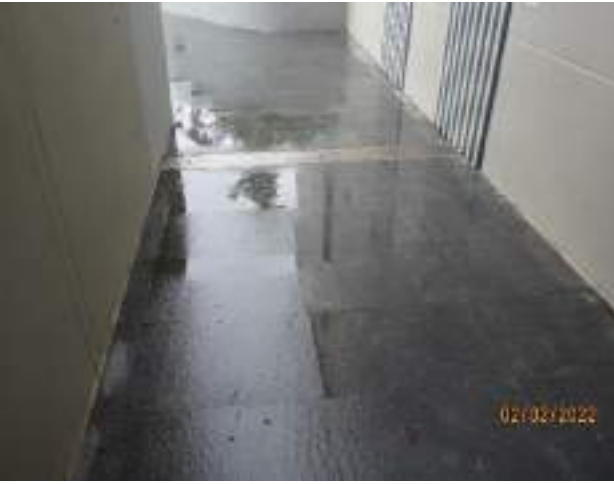
<p>Rainwater ponding to south and north at western end of stormwater drain</p>

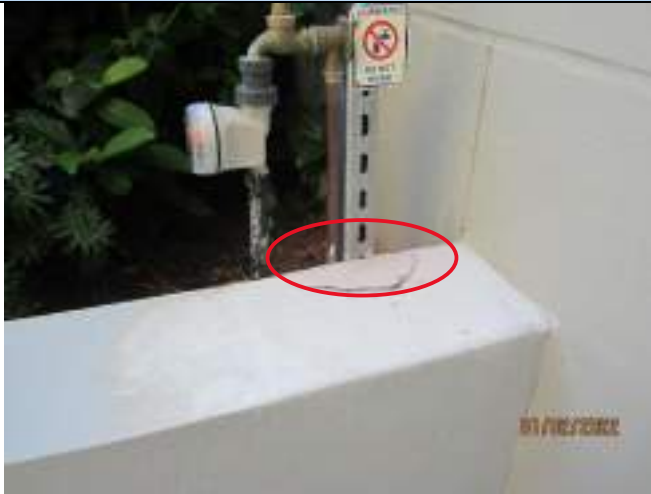
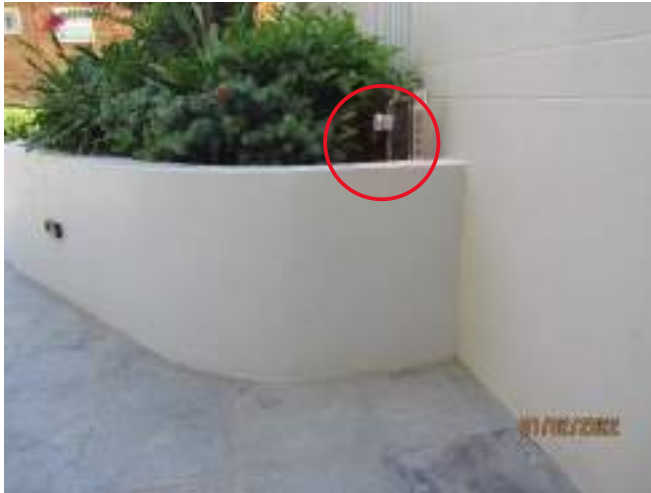
ITEM	COMMENTARY	PHOTOGRAPH(S)
C-11		
A	<p>Location & Description Planter Box – Northwestern side of Building L</p> <p>The Author has observed that damage and incomplete repair to render finish to the top of planter box wall at the water tap located to the south end of the planter box.</p> <p>The Author is of the view that the damage and incomplete works originated due to poor workmanship employed by the Builder at the time of construction.</p>

B	<p>Cause(s)</p> <ul style="list-style-type: none"> Poor workmanship employed by the builder at the time of construction. 	
C	<p>Breach(es) <i>Failure to comply with the following:</i></p> <ul style="list-style-type: none"> Home Building Act 1989 (NSW) under Section 18B Clauses 1 (a) NSW Guide to Standards & Tolerances 2017 G – Responsibility to rectify – Builders are liable to repair damage caused to property in the course of completing their building work.

D	<p>Proposed Rectification Scope of Works Allow to:</p> <ol style="list-style-type: none"> Provide site supervision. Supervisor to coordinate access and facilitate the works throughout the whole process. Gain access to required areas in accordance with Safework requirements. Cover and protect adjacent surfaces during the rectification work. Labour to repair damaged render and apply paint to match existing architectural finishes Supply polymer cement render, paint and ancillaries Clean site and leave in a tidy condition upon completion of work

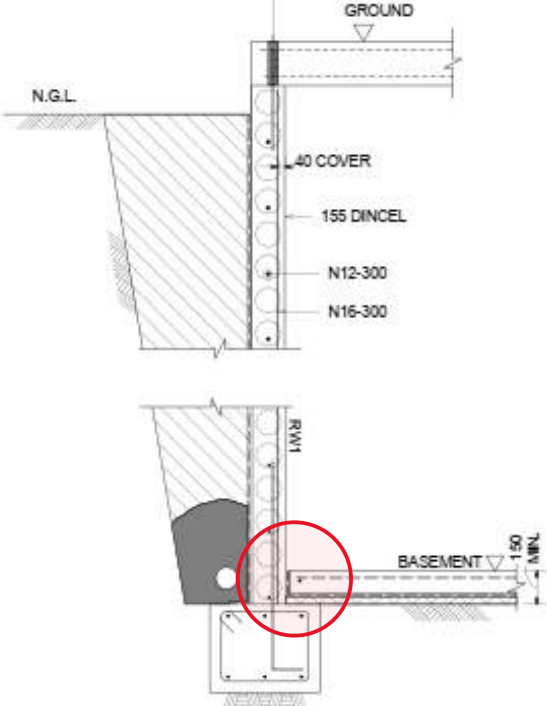
ITEM	COMMENTARY	PHOTOGRAPH(S)
B1-1		
A	<p>Location & Description Basement level 2 Stairs - Eastern wall</p> <p>The Author has observed that there following rain, water is penetrating location of the Dintel wall at –</p> <ol style="list-style-type: none"> 1. To the northern wall above stair landing Basement 2 level of the Fire stair 2 <ol style="list-style-type: none"> 1. The Author conducted a percussion test in the location of the water leak above stair landing Basement 2 level of the Fire stair 2 and found the location of the leak to be drummy. The Author is of the view that the percussion test indicated there is a concrete void in the core of the Dintel in the location of leak. <p>The Author is also of the view that as the stormwater drain at the to the ground level door has not been fully sealed at both end of the top of the grated drain allows rainwater to flow above the location of leak to the Dintel wall.</p> <ol style="list-style-type: none"> 2. At the base of the wall to the southern wall at Basement 2 level of Fire stair 2 <ol style="list-style-type: none"> 2. In relation to the water leak at the base of the wall to the southern wall at Basement 2 level of Fire stair 2, the found that the Dintel wall had not been set down below the slab as to the manufacturers guidelines. <p>The Author is of the view that the Builder has failed to carry out the works in accordance with the manufacturers installation guidelines and engineers design, and that the defects originated due to poor workmanship employed by the Builder at the time of construction.</p>

B	<p>Cause(s)</p> <ul style="list-style-type: none"> • Poor workmanship employed by the Builder at the time of construction. 	<p>Water pooling on floor due to water leak from Dintel at northern wall above stair landing Basement 2 level of the Firestair 2</p>
C	<p>Breach(es) Failure to comply with the following:</p> <ul style="list-style-type: none"> ▪ Home Building Act 1989 (NSW) under Section 18B Clauses 1(a) ▪ Manufacturers guidelines ▪ Plans and specifications

<ul style="list-style-type: none"> National Construction Code Volume 1 2016 FP1.2 Preventing rainwater from entering buildings <i>Surface water</i> must not enter the building.

<p>D</p>	<p>Proposed Rectification Scope of Works Allow to:</p> <ol style="list-style-type: none"> 1. Provide site supervision. Supervisor to coordinate access and facilitate the works throughout the whole process. 2. Gain access to required areas in accordance with Safework requirements. 3. Cover and protect adjacent surfaces during the rectification work. 4. Labour to break out Dincel lining to reveal void in location of water leak, fill void with epoxy based two part waterproofing compound and make flush with Dincel surface. 5. Supply two part epoxy waterproofing product 6. Labour saw cut, demolish and remove concrete approximately 200mm out from base of wall in location of water leak to south, and extend cutting and demolition of concrete to provide drain to other side of wall to southwest corner to drain in location of stormwater inlet at base of excavation adjacent to southwest corner of Firer stairs. 7. Labour to install galvanized angle to base of Dincel wall at newly formed drain and fix galvanized metal grated drainage material over drainage channel. 8. Supply galvanized grated drainage materials and ancillaries 9. Clean site and leave in a tidy condition upon completion of work 10. Dispose of building waste 	<p>TYPICAL RW1 DINCEL RETAINING WALL</p> <p>Xavier Knight footing detail Drawings S0211 – Showing slab located above base of Dincel wall.</p>

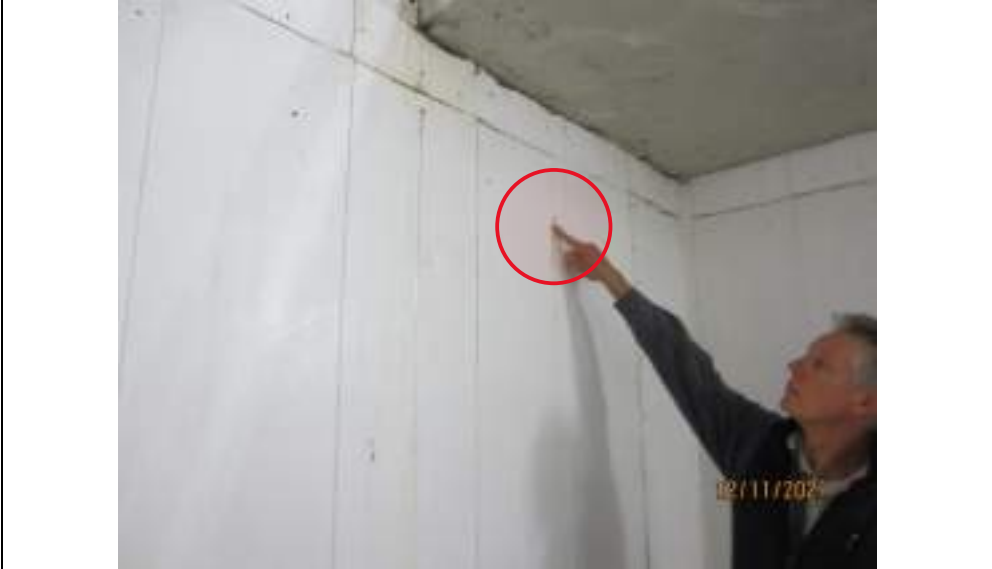
Water penetration identified at stair landing on eastern wall above basement level 1

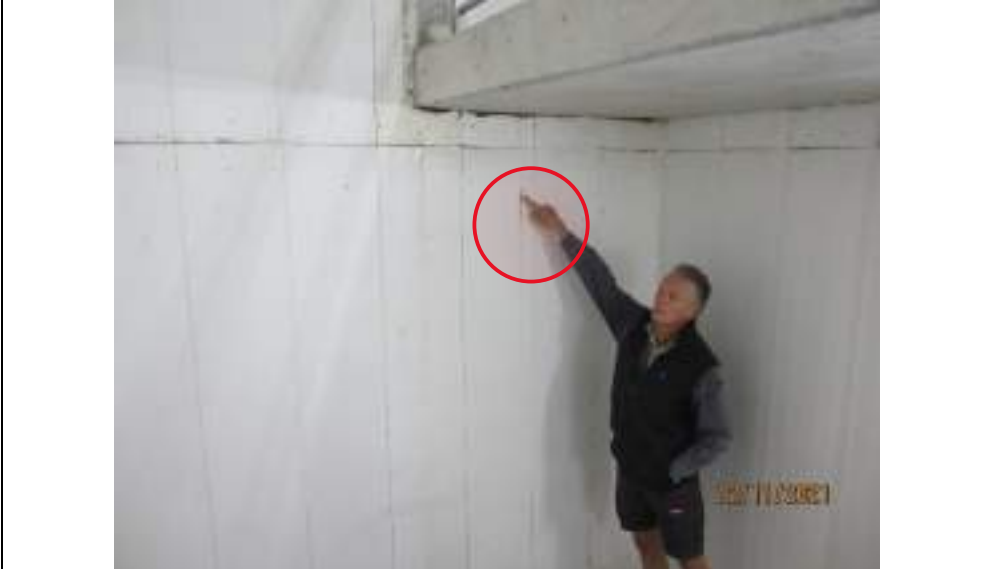
Location of water penetration at eastern wall on stair landind above basement level 1

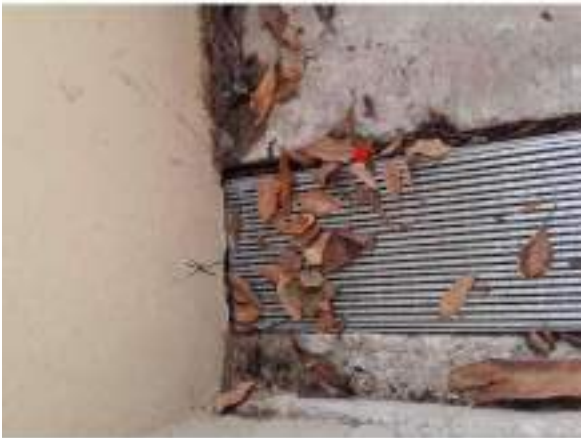
Gaps to drain at base of Fire stair door

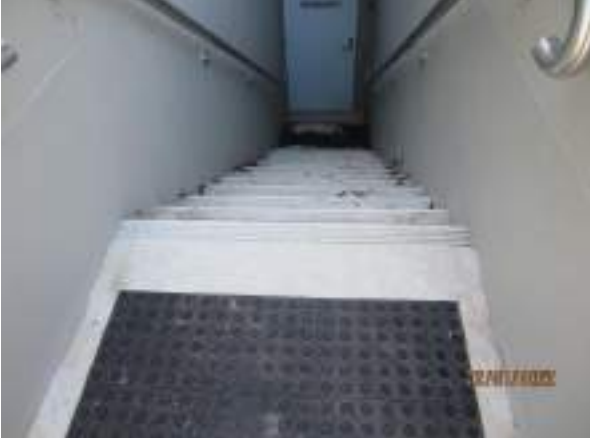
Drain located at base of external stairs Fire stair door

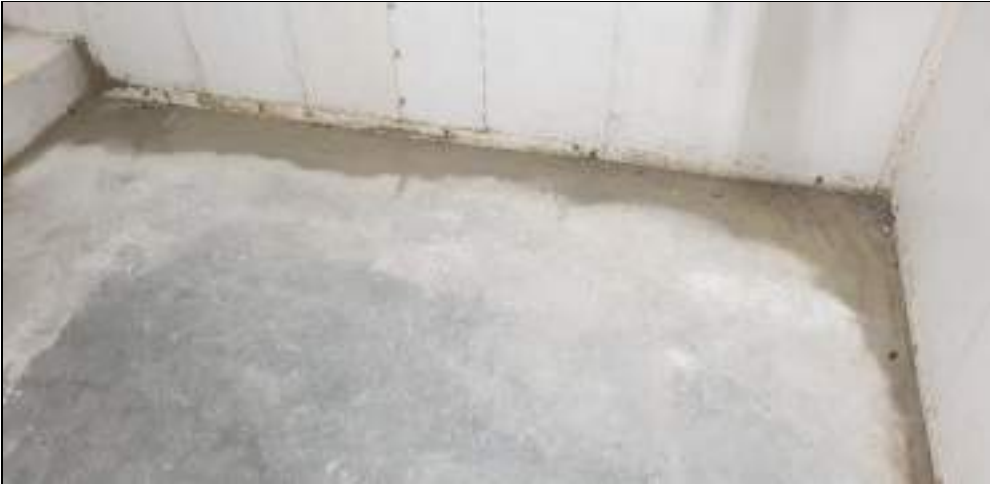
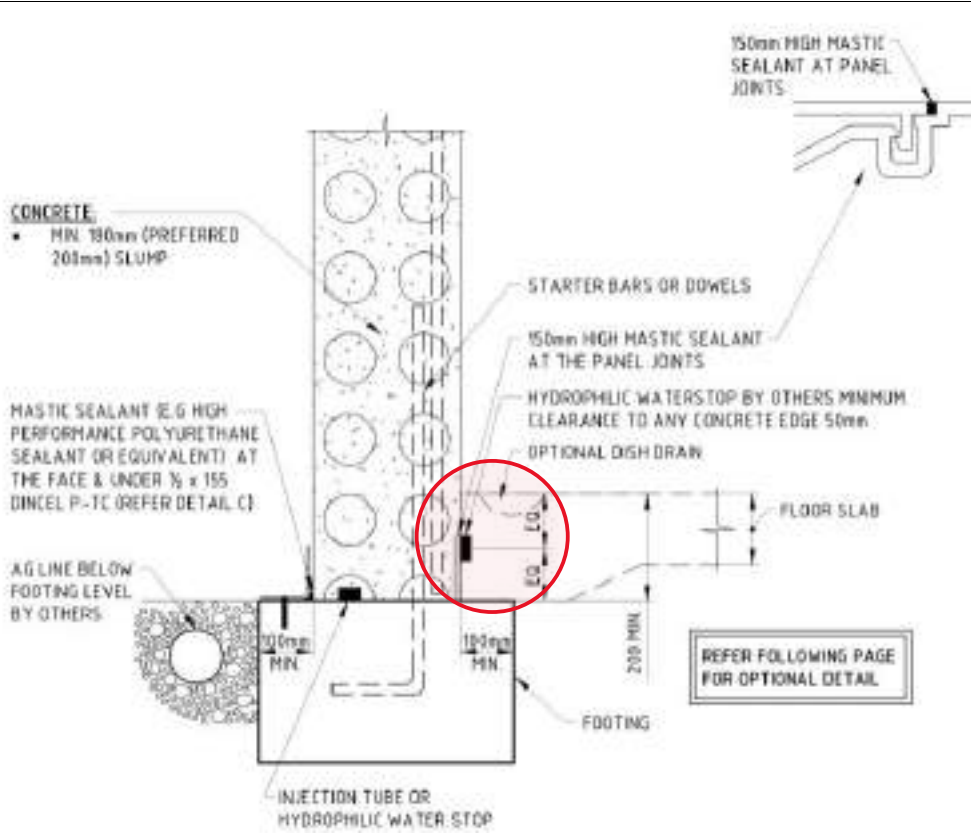
Based of Dincel not set down below slab as to manufacturers guidelines

Dincel basement wall detail showing slab above base of wall
