6. DEFECT SCHEDULE

6.1. AUTOMATIC FIRE DETECTION AND ALARM SYSTEM (INCLUDING SMOKE ALARMS)

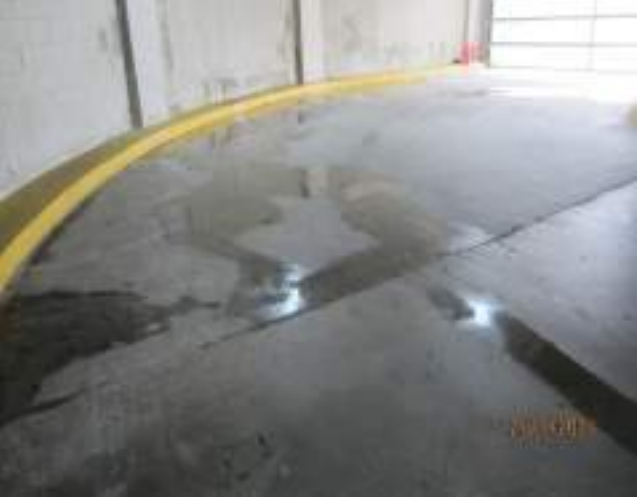
ITEM	COMMENTARY	PHOTOGRAPH(S)
B1-2		
A	<p>Location & Description Basement level 1 North retaining wall Entry – Evidence of moisture penetration</p> <p>The Author has observed water penetrating the northern retaining wall at the entry basement 1, and evidence of isolated waterproofing repairs carried in the location of the water leaks.</p> <p>The Author noted that the building contract requires completed basements <u>must be dry at all times</u>.</p> <p>Please refer to extract 6.3.1 from PPR of the building contact -</p> <p>6.3 Basement</p> <p>6.3.1 Drainage and Waterproofing</p> <p>a) Completed basements must be dry at all times.</p> <p>b) Subsoil drainage systems and vapour barriers must be installed as per design.</p> <p>c) The proposed method of mitigation of ground water ingress through the basement structure is to be confirmed via a brief, sketches or details prior to commencement. The Principal reserves the right to review the scope if required.</p> <p>The Author is of the view, that Builder has failed to carry out the waterproofing in accordance with the plans and specification, and that the defect originated due to poor workmanship employed by the Builder at the time of construction.</p>

<p>Water ponding originating from water leaks to northern retaining wall at basement 1 entry</p>

B	<p>Cause(s)</p> <ul style="list-style-type: none"> Defective waterproofing to retaining wall originating from poor workmanship employed by the Builder at the time of construction. 	
C	<p>Breach(es)</p> <p><i>Failure to comply with the following:</i></p> <ul style="list-style-type: none"> Home Building Act 1989 (NSW) under Section 18B Clauses 1(a);(c) Plans and specifications Building contract

<p>D</p>	<p>Proposed Rectification Scope of Works Allow to:</p> <ol style="list-style-type: none"> 1. Provide site supervision. Supervisor to coordinate access and facilitate the works throughout the whole process. 2. Gain access to required areas in accordance with Safework requirements. 3. Cover and protect adjacent surfaces during the rectification work. 4. Labour to break out masonry in location of water leaks, fill opening with epoxy based two part waterproofing compound and make flush with wall surface. 5. Supply two part epoxy waterproofing product 6. Labour to apply Drizoro Max seal over wall to provide even texture over wall surface 7. Labour to paint masonry wall to provide even finish 8. Supply epoxy waterproofing compound, Drizoro Max seal, paint and ancillaries 9. Clean site and leave in a tidy condition upon completion of work 10. Dispose of building waste

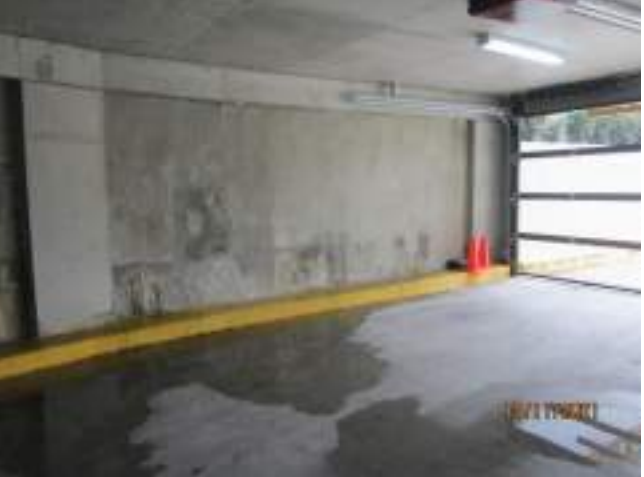
<p>Water ponding orinating from water leaks to northern retaining wall at basement 1 entry</p>

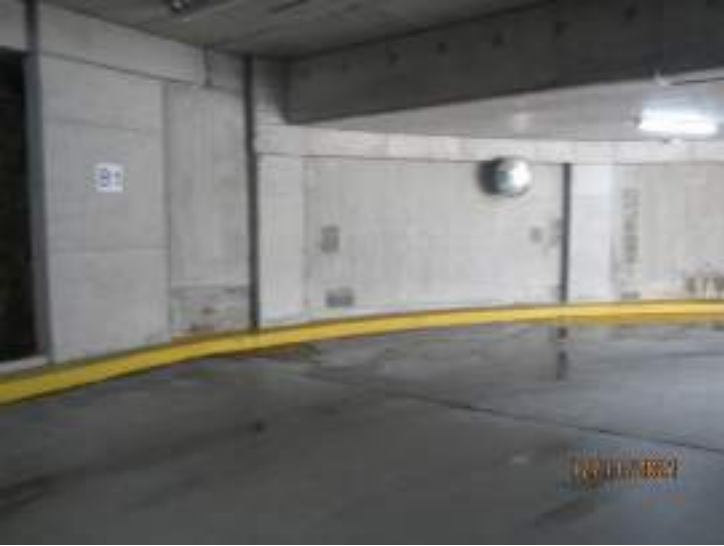
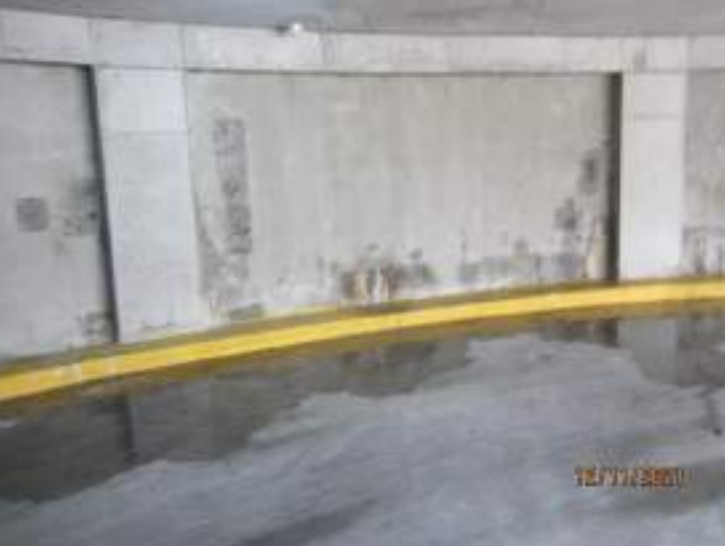
<p>Water ponding orinating from water leak to western end basement 1 entry retaining wall</p>	<p>Water ponding orinating from water leak to western end basement 1 entry retaining wall</p>

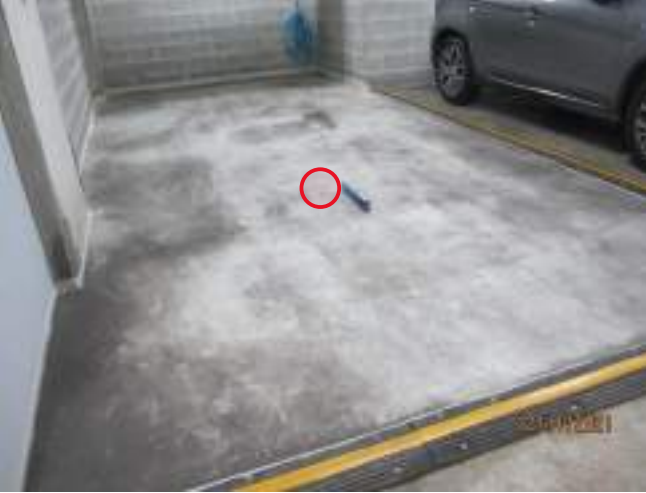
<p>Location of floor waste</p>

ITEM	COMMENTARY	PHOTOGRAPH(S)
B1-3		
A	<p>Location & Description Basement 1 - Car wash bay The Author has observed that the car wash bay has no fall to the drainage inlet.</p> <p>The Author noted that the condition 21 of the development consent DA 18/0393 requires that the wash-bay must be graded to an internal drainage point. Please refer to extract from the Development consent DA 18/0393 condition 21</p> <p>21. Car Wash Bays To prevent contamination of the stormwater drainage system a car-wash bay must be provided on site:</p> <p>A. Design The wash-bay must be graded to an internal drainage point and connected to the sewer.</p> <p>The Author is of the view that the Builder has failed to carry out the works in accordance with the council conditions and that the defects originated from poor workmanship employed by the builder at the time of construction.</p>

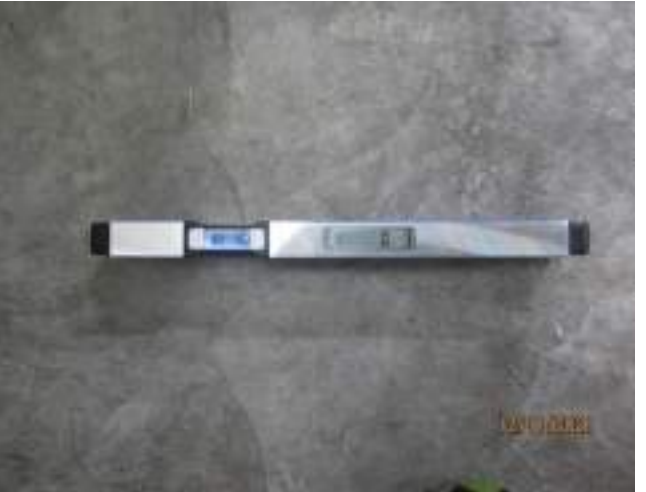
<p>Zero fall indicated to western side of drainage inlet</p>

B	<p>Cause(s)</p> <ul style="list-style-type: none"> Poor workmanship employed by the Builder at the time of construction. 	
C	<p>Breach(es) Failure to comply with the following:</p> <ul style="list-style-type: none"> Home Building Act 1989 (NSW) under Section 18B Clauses 1(a);(c) Condition 21 of the development consent DA 18/0393 	
D	<p>Proposed Rectification Scope of Works Allow to:</p> <ol style="list-style-type: none"> Provide site supervision. Supervisor to coordinate access and facilitate the works throughout the whole process. Gain access to required areas in accordance with Safework requirements. Cover and protect adjacent surfaces during the rectification work. Labour to remove perimeter barrier to south and west of carwash bay

5. Labour to acid etch concrete surface to prepare for Roxset Epoxy Mortar Screed.
6. Supply, place and finish Roxset Epoxy Screed with grades to drainage inlet
7. Labour to reinstate barriers to west and south of carwash bay
8. Clean site and leave in a tidy condition upon completion of work
9. Dispose of building waste

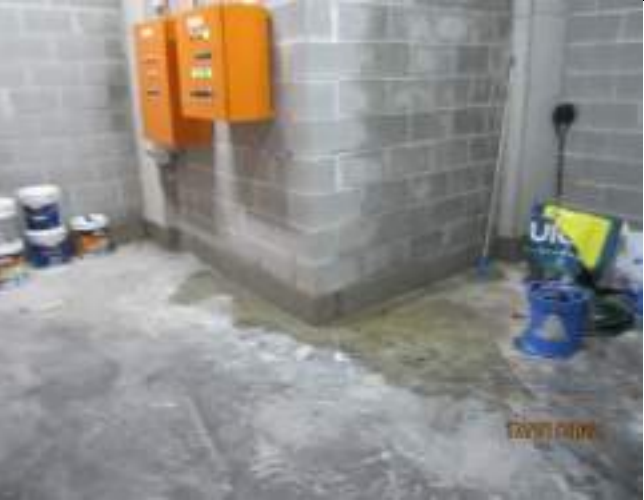
ITEM	COMMENTARY	PHOTOGRAPH(S)
B1-4		
A	<p>Location & Description Basement 1 Switch room – Evidence of waterproofing failure</p> <p>The Author has observed evidence of defective waterproofing to the base of the southwestern wall in the basement 1 switch room.</p> <p>On further investigation of the defective works the Author is of the view that the waterproofing system applied to the interior and external side of the wall has been carried out to repair or mitigate waterproofing issues that originated at the time of construction.</p> <p>The Author noted that the building contract requires completed basements <u>must be dry at all times.</u></p> <p>Please refer to extract 6.3.1 from PPR of the building contract - 6.3 Basement 6.3.1 Drainage and Waterproofing</p> <p>a) Completed basements must be dry at all times.</p> <p>b) Subsoil drainage systems and vapour barriers must be installed as per design.</p> <p>c) The proposed method of mitigation of ground water ingress through the basement structure is to be confirmed via a brief, sketches or details prior to commencement. The Principal reserves the right to review the scope if required.</p> <p>The Author is of the view that defective works originated due to poor workmanship employed by the Builder at the time of construction and that the remediation work carried out the Builder has failed to rectify the defect.</p>

<p>Evidence of waterproofing failure to southwest wall of switch room</p>

B	<p>Cause(s)</p> <ul style="list-style-type: none"> • Poor workmanship employed by the Builder at the time of construction • <i>Plans and specifications</i> • <i>Building contract</i> • Failure of the Builder to rectify the defective works

<p>C</p>	<p>Breach(es) <i>Failure to comply with the following:</i></p> <ul style="list-style-type: none"> ▪ <i>Home Building Act 1989 (NSW) under Section 18B Clauses 1(a);(c)</i> ▪ <i>National Construction Code Volume 1 2016 FP1.2 Preventing rainwater from entering buildings</i> ▪ <i>Surface water</i> must not enter the building. ▪ <i>Building contract</i>

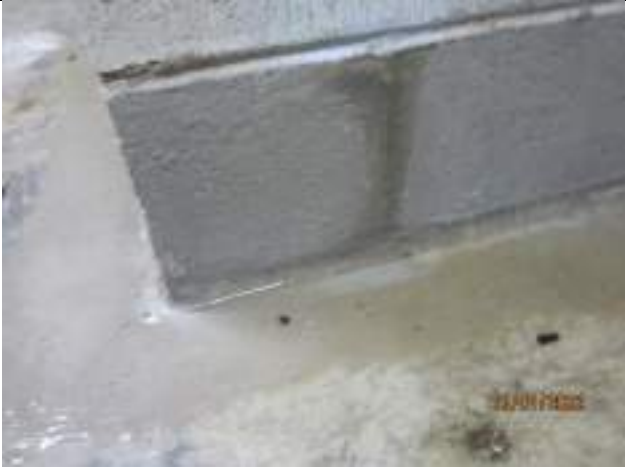
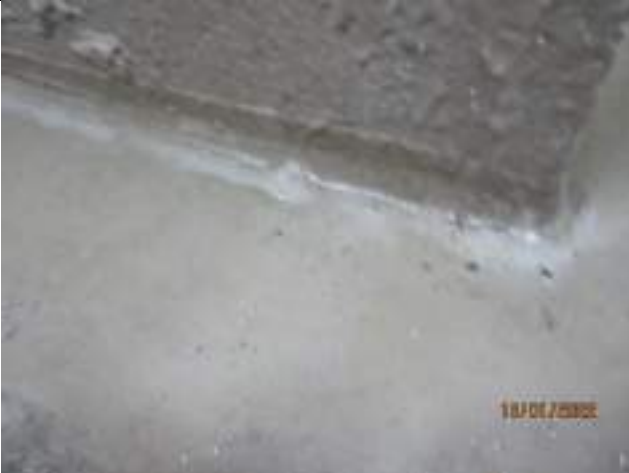
A photograph showing a close-up of a concrete wall base with water. The wall surface is light-colored, and there is a dark, wet area at the base. A date stamp '18/01/2022' is visible in the bottom right corner.
<p>Evidence of water penetrating base of southwest wall to interior of swtch room</p>	<p>Evidence of water penetrating base of southwest wall to interior of swtch room</p>

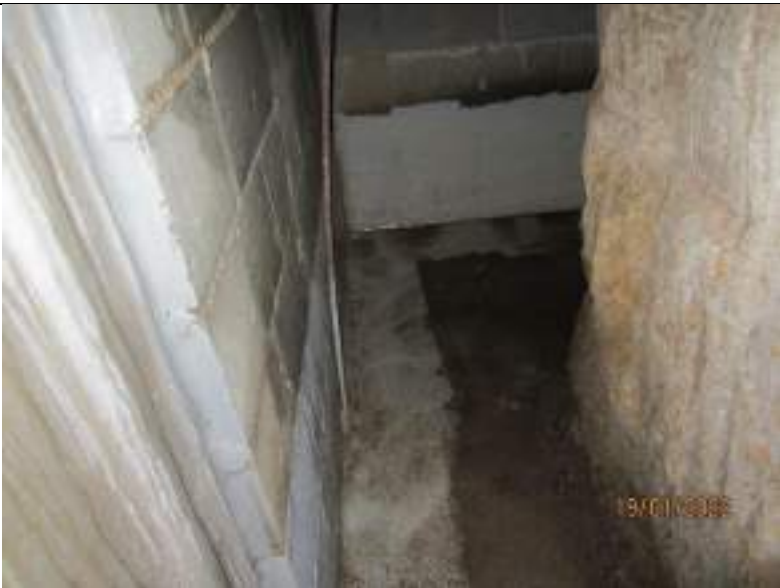
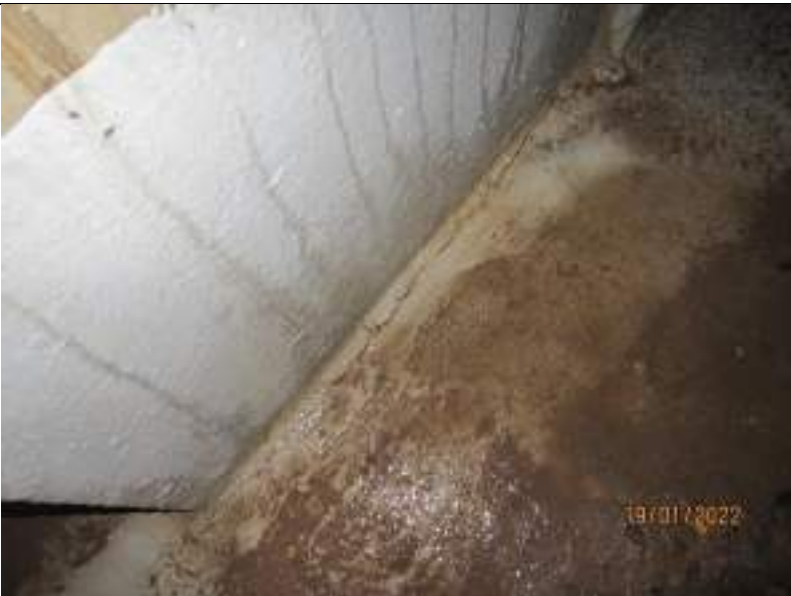
<p>Evidence of waterproofing repair to rear of southwest wall of switch room</p>	<p>Evidence of waterproofing repair to rear of southwest wall of switch room</p>

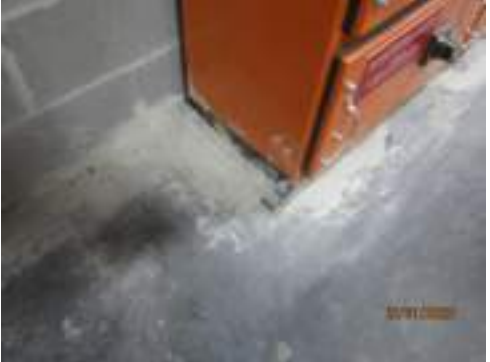
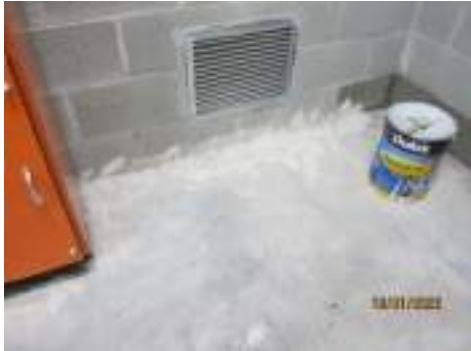
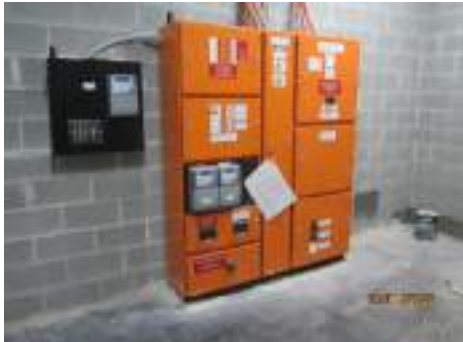
ITEM	COMMENTARY	PHOTOGRAPH(S)
B1-5		
A	<p>Location & Description Basement 1 – Switch room</p> <p>The Author has observed that there is a significant amount of cement slurry and cement staining on the floor the eastern side of the switch room and at the base of the main switch board.</p> <p>The Author is of the view that Builder has failed to adequately clean the work area of completed of works, and that the defect originated due to poor workmanship employed by the Builder at the time of construction.</p>

B	<p>Cause(s)</p> <ul style="list-style-type: none"> Poor workmanship employed by the Builder at the time of construction. 	
C	<p>Breach(es) <i>Failure to comply with the following:</i></p> <ul style="list-style-type: none"> Home Building Act 1989 (NSW) under Section 18B Clauses 1(a) Incomplete contract works

D	<p>Proposed Rectification Scope of Works Allow to:</p> <ol style="list-style-type: none"> Provide site supervision. Supervisor to coordinate access and facilitate the works throughout the whole process. Gain access to required areas in accordance with Safework requirements. Labour to remove cement mortar and staining from floor and wall Clean site and leave in a tidy condition upon completion of work Dispose of building waste

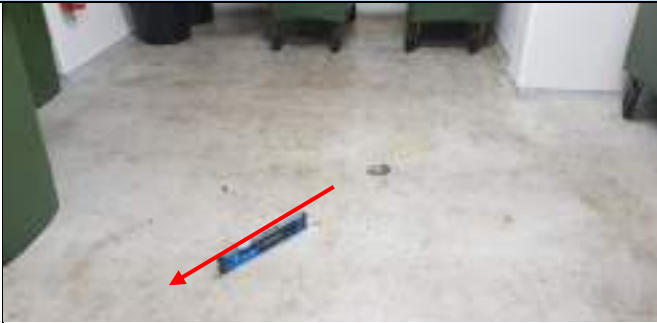
ITEM	COMMENTARY	PHOTOGRAPH(S)
B1-6		
A	<p>Location & Description Basement 1 -Garbage Room</p> <p>The Author has observed while carry out testing using a spirit level, that the surface finish fall was directed away from the sewer drainage inlet.</p> <p>The Author noted that the PBD Architects construction certificate drawings A1002 – Note: Finish falls to sewer waste as per Sydney Water requirements. Please refer to following extract in this items table.</p> <p>The Author is of the view that the Builder has failed to carry out the works in accordance with the plans and specifications and that the defect originated due to poor workmanship employed by the Builder at the time of construction.</p>

<p>Surface fall directed away from inlet to northeast of drain</p>
B	<p>Cause(s)</p> <ul style="list-style-type: none"> Poor workmanship employed by the Builder at the of construction. 	
C	<p>Breach(es) <i>Failure to comply with the following:</i></p> <ul style="list-style-type: none"> Home Building Act 1989 (NSW) under Section 18B Clauses 1(a);(b) To carry out the works in accordance with the plans and specifications

D	<p>Proposed Rectification Scope of Works Allow to:</p> <ol style="list-style-type: none"> Provide site supervision. Supervisor to coordinate access and facilitate the works throughout the whole process. Gain access to required areas in accordance with Safework requirements. Cover and protect adjacent surfaces during the rectification work. Labour to remove bins and materials and place in a secure location Labour to acid etch concrete surface to prepare for Roxset Epoxy Mortar Screed. Supply, place and finish Roxset Epoxy Screed with grades to drainage inlet Labour to reinstate bins and equipment on completion of floor finish Clean site and leave in a tidy condition upon completion of work Dispose of building waste

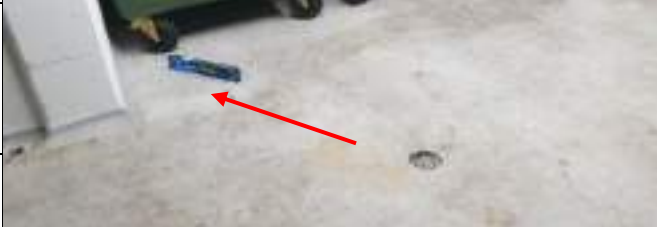
<p>Surface fall directed away from inlet to western side of drain</p>

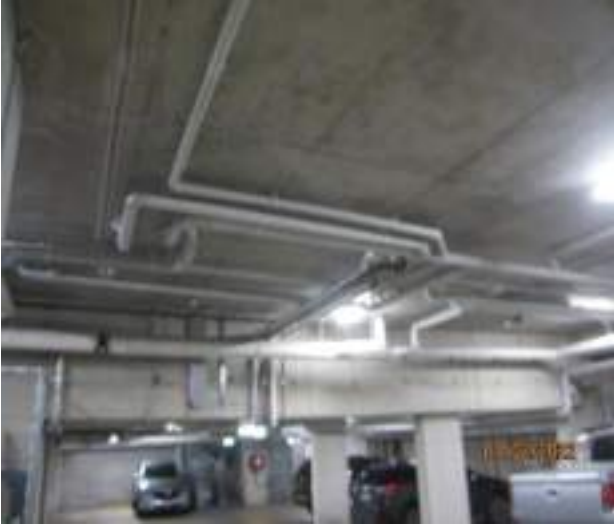
ITEM	COMMENTARY	PHOTOGRAPH(S)																											
B1-7																													
A	<p>Location & Description Basement 1 – Floor insulation Units G01 to G07</p> <p>The Author has observed that there is no insulation installed to the concrete floor slab to units G01 to G07 as specified on the construction certificate architectural plans.</p> <p>For clarity, please refer to following from BASIX commitments on drawings A0000 construction certificate plans prepared by PBD Architects -</p>

<p data-bbox="1496 1283 2141 1347">No evidence of insulation to under side of concrete slab of units G01 to G07.</p>
Certification Number: 0003200790																													
Unit No.	Floor Insulation R2.0	Wall insulation R1.5																											
G001	X	X																											
G002	X																												
G003	X																												
G004	X	X																											
G005	R3.0	X																											
G006	X																												
G007	X																												
B	<p>Cause(s)</p> <ul style="list-style-type: none"> <li data-bbox="434 1353 1458 1385">Failure by the Builder to carry out the works in accordance with the plans and specifications.

C	Breach(es) <i>Failure to comply with the following:</i> <ul style="list-style-type: none">▪ <i>Home Building Act 1989 (NSW) under Section 18B Clauses 1(a)</i>▪ <i>Incomplete contract works</i>

D	Proposed Rectification Scope of Works Allow to: <ol style="list-style-type: none">1. Provide site supervision. Supervisor to coordinate access and facilitate the works throughout the whole process.2. Gain access to required areas in accordance with Safework requirements.3. Cover and protect adjacent surfaces during the rectification work.4. Supply mobile scaffold to provide working platform5. Labour to install Kingspan insulation panels6. Supply R2.0 and R3.0 insulation as per plans and specifications7. Supply fixings and ancillaries8. Clean site and leave in a tidy condition upon completion of work9. Dispose of building waste

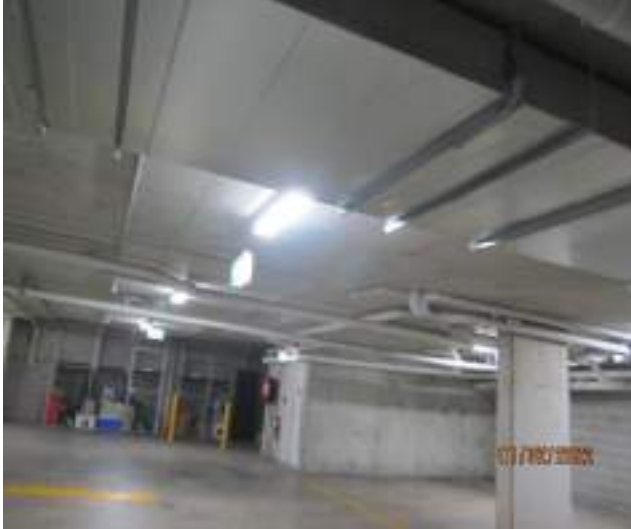
<p>No evidence of insulation to under side of concrete slab of units G01 to G07.</p>

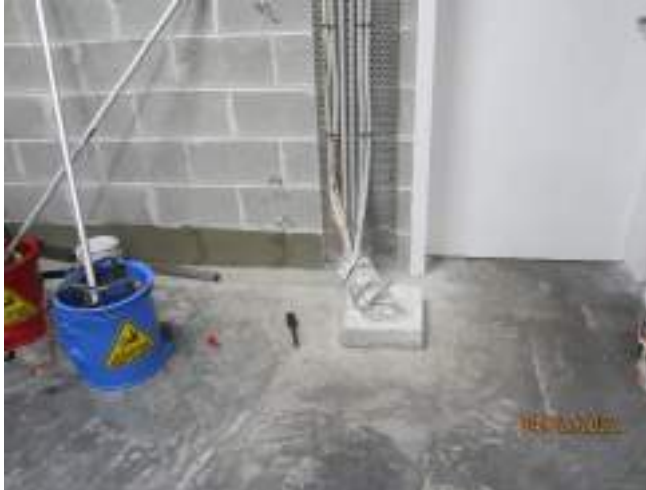
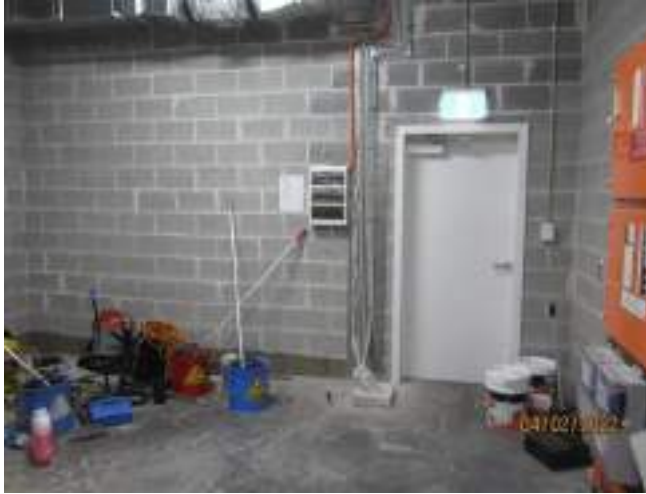
ITEM	COMMENTARY	PHOTOGRAPH(S)
B1-8		
A	<p>Location & Description Basement 1 – Switch room</p> <p>The Author has observed that there is exposed electrical wiring to the northern side of the switch room at the entry that is crudely covered above a small concrete plinth at the floor.</p> <p>The Author is of the view that the electrical works described do not comply with AS3000:2018 Electrical installations, and that the defect originated due to poor workmanship employed by the Builder at the time of construction.</p>

B	<p>Cause(s)</p> <ul style="list-style-type: none"> Poor workmanship employed by the Builder at the time of construction. 	
C	<p>Breach(es) <i>Failure to comply with the following:</i></p> <ul style="list-style-type: none"> Home Building Act 1989 (NSW) under Section 18B Clauses 1(a) AS3000:2018 Electrical installations Incomplete contract works

D	<p>Proposed Rectification Scope of Works Allow to:</p> <ol style="list-style-type: none"> Provide site supervision. Supervisor to coordinate access and facilitate the works throughout the whole process. Gain access to required areas in accordance with Safework requirements. Labour to remove cement mortar and staining from floor Labour to install custom metal trunking to exposed wiring Supply custom metal trunking and fixings Clean site and leave in a tidy condition upon completion of work Dispose of building waste

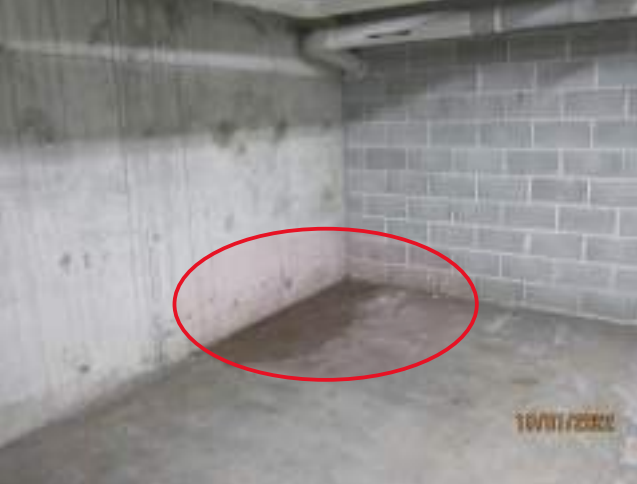
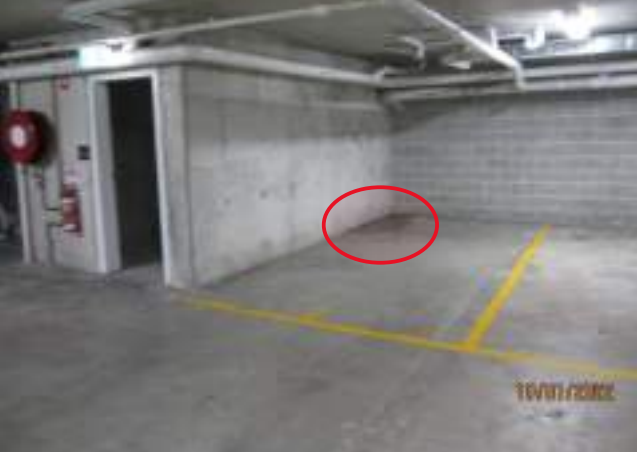
ITEM	COMMENTARY	PHOTOGRAPH(S)
B2-1		
A	<p>Location & Description Basement 2 – Parking bay 2</p> <p>The Author has observed a rainwater leak from above the northeast corner of parking bay 2.</p> <p>The Author noted that the building contract requires completed basements <u>must be dry at all times</u>.</p> <p>6.3 Basement</p> <p>6.3.1 Drainage and Waterproofing</p> <p>a) Completed basements must be dry at all times.</p> <p>b) Subsoil drainage systems and vapour barriers must be installed as per design.</p> <p>c) The proposed method of mitigation of ground water ingress through the basement structure is to be confirmed via a brief, sketches or details prior to commencement. The Principal reserves the right to review the scope if required.</p> <p>The Author is of the view that the defect originated due to poor workmanship employed by the Builder at the time of construction.</p>

B	<p>Cause(s)</p> <ul style="list-style-type: none"> Poor workmanship employed by the Builder at the time of construction.

<p>Location of pooling water from rainwater leak at carpark 2</p>

D	<p>Proposed Rectification Scope of Works Allow to:</p> <ol style="list-style-type: none"> Provide site supervision. Supervisor to coordinate access and facilitate the works throughout the whole process. Gain access to required areas in accordance with Safework requirements. Labour to install flashings to prevent water from leaking onto basement floor Supply flashings materials and ancillaries Clean site and leave in a tidy condition upon completion of work

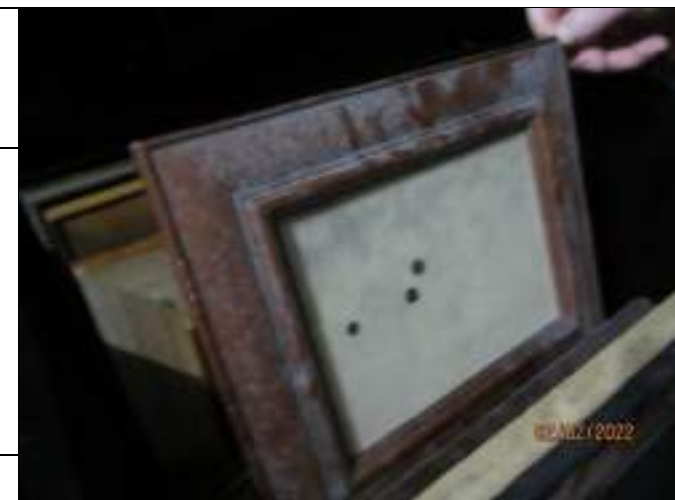
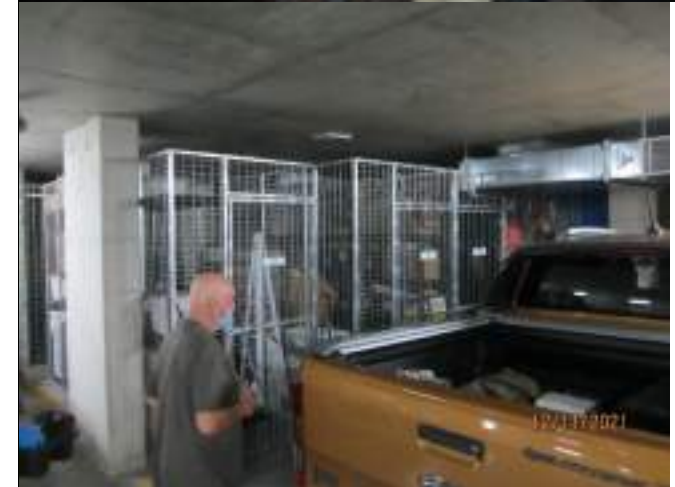
ITEM	COMMENTARY	PHOTOGRAPH(S)
B2-2		
A	<p>Location & Description Basement 2 – Storage area near stairway 1 (Ventilation)</p> <p>The Author has observed evidence of mould grow forming on materials in storage area. During several inspections the Author noted, there was a damp smell in the air and in the early mornings a strong smell of motor vehicle fumes.</p> <p>The Author is of the view that due to the sections of the perimeter of the basement carpark and storage and exposure to moisture from seepage from rainwater and pump out tank located under the slab of the basement and that the presents of moisture from the sources has caused the development of mould.</p> <p>During inspection an owner occupant of the property stated to the Author that the mechanical ventilations is set to activate 2 hours in the morning and 2 hours in the early evening.</p> <p>The Author is of the view that the mechanical ventilation as a measure mitigate the presents of moisture is inadequate.</p> <p>The Author noted that Premium Consulting Engineers provided mechanical design certificate in relation to the mechanical ventilation, however the Author has not been provided with evidence of testing that the mechanical ventilation system is adequate to mitigate the presents of moisture in the basement area. Please refer to copy of Premium Consulting Engineers design certificate in Appendix B of this report.</p> <p>The Author noted that Premium Consulting Engineers mechanical design certificate does not state that the <i>'certification shall confirm that the system will protect the health of occupants of the carpark at anytime it is used and satisfies the atmospheric contaminate exposure rates specified in the Worksafe Australia document: Workplace Exposure Standards for Airborne Contaminants.'</i> For clarity, please refer to extract of condition 27 of the development consent DA18/0393 in the following sections of this table.</p> <p>The Author is of the view testing should be carried out by a suitably qualified consultant to confirm if the mechanical ventilation system satisfies the conditions of the development approval.</p>

<p>B</p>	<p>Cause(s)</p> <ul style="list-style-type: none"> • Presents of moisture from rainwater seepage • Insufficient ventilation
<p>C</p>	<p>Breach(es) <i>Failure to comply with the following:</i></p> <ul style="list-style-type: none"> ▪ <i>Home Building Act 1989 (NSW) under Section 18B Clauses 1(a);(b)</i> ▪ <i>Condition 27 DA 18/0393</i> ▪ <i>National Construction Code Volume 1 2016 FP4.4 – FP4.4 Mechanical ventilation to control odours and contaminants</i> <i>A mechanical air-handling system installed in a building must control—</i> <i>(a) the circulation of objectionable odours; and</i> <i>(b) the accumulation of harmful contamination by micro-organisms, pathogens and toxins.</i>
<p>D</p>	<p>Proposed Rectification Scope of Works Allow:</p> <p>PROVISIONAL ALLOWANCE FOR A SUITABLE QUALIFIED VENTILATION ENGINEER TO CARRY OUT TESTING AND PROVIDE REMEDIATION SOLUTION TO MITIGATE DAMAGE RESULTING FROM MOULD GROWTH AND HEALTH OF BUILDING OCCUPANTS.</p>

Evidence of mould on surface of materials in storage to southwest corner of Basement 2

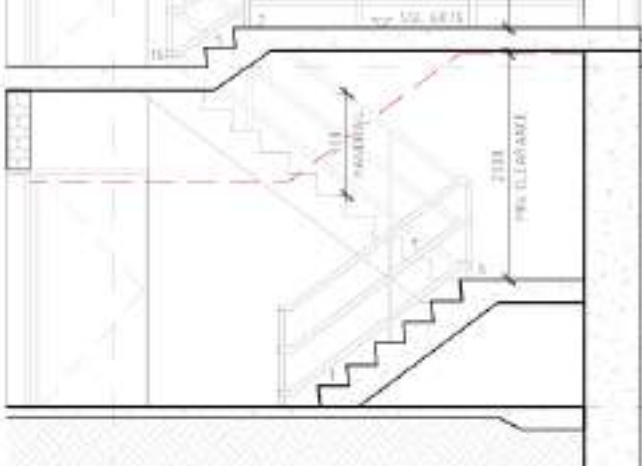
ITEM	COMMENTARY	PHOTOGRAPH(S)
B2-3		
A	<p>Location & Description Basement 2 – Stairway 1</p> <p>The Author has observed that the height clearance of 1954mm at the landing to the stairway on basement 2, does not meet the minimum required height of 2000mm noted on PBD Architects construction certificate plan drawing no. A4101 Fire Stair 2 details.</p> <p>For clarity, please refer to following extract from before mentioned reference -</p> <p>Extract – PBD Architects construction certificate plan drawing no. A4101 Fire Stair 1 details</p>

<p>The Author noted that the defect was identified in Section 8.14 of Mr Giaouris report date 7 December 2020.</p> <p>The Author is of the view, works have not been carried out in accordance with the contract plans specifications and do not meet the requirements of the NCC Volume 1 2016 F3.1(iii).</p> <p>For clarity, please refer relevant extract from NCC –</p> <ul style="list-style-type: none"> ▪ <i>National Construction Code Volume 1 2016 F3.1(iii) – F3.1 (iii) above a stairway, ramp, landing or the like — 2 m measured vertically above the nosing line of stairway treads or the floor surface of the ramp, landing or the like</i>

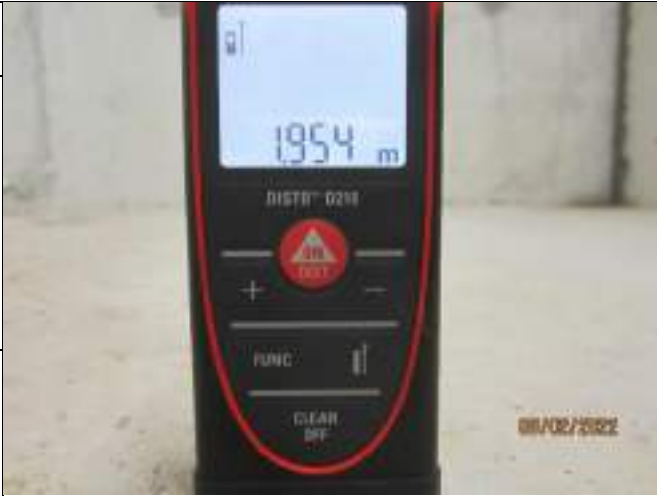
<p>Height clearance measured from landing 1954mm</p>

<p>B</p>	<p>Cause(s)</p> <ul style="list-style-type: none"> Pour workmanship employed by the Builder at the time of construction.

Digital measurement reading 1954mm

<p>C</p>	<p>Breach(es)</p> <p><i>Failure to comply with the following:</i></p> <ul style="list-style-type: none"> Home Building Act 1989 (NSW) under Section 18B Clauses 1(a);(b);(d) &(f) Contract plans and specifications National Construction Code Volume 1 2016 F3.1(iii) – F3.1 (iii) above a stairway, ramp, landing or the like — 2 m measured vertically above the nosing line of stairway treads or the floor surface of the ramp, landing or the like 	
<p>D</p>	<p>Proposed Rectification Scope of Works</p> <p>Allow to:</p> <ol style="list-style-type: none"> Provide site supervision. Supervisor to coordinate access and facilitate the works throughout the whole process. Gain access to required areas in accordance with Safework requirements. Cover and protect adjacent surfaces during the rectification work. Labour to lay bricks to underside of bottom riser above stair landing to underpin and support stairs above. Labour to demolish and remove landing and bottom stair flight to provide access to rectify landing height clearance Labour to provide formwork to form up new stairs and landing, fix reinforcement to engineers detail, place and finish concrete Supply steel reinforcement, ancillaries, concrete and pump Labour to install new stair railing in accordance with NCC Volume 1 2016 D2.17(v) Supply steel railing materials and ancillaries Labour to apply non-slip finish to tread nose in accordance with AS4586 Supply non-slip materials for stair tread Provisional allowance for Registered Structural engineers design, inspection and certification Clean site and leave in a tidy condition upon completion of work Dispose of building waste

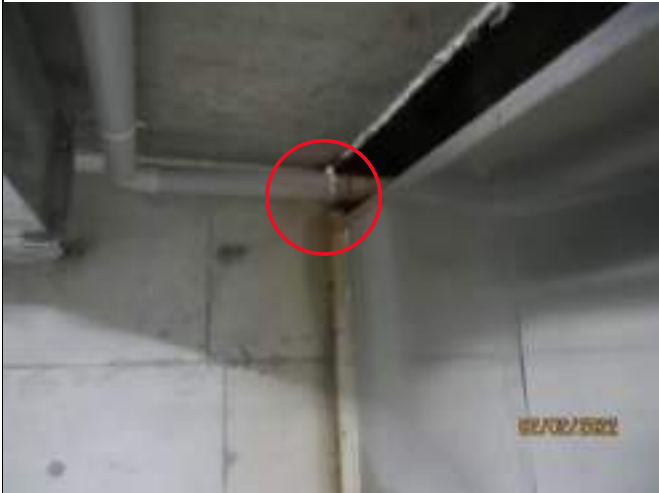
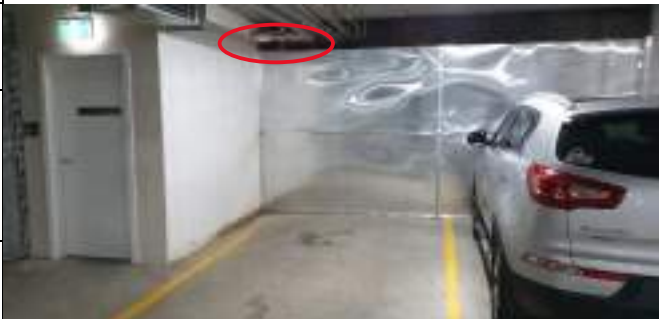
ITEM	COMMENTARY	PHOTOGRAPH(S)
B2-4		
A	<p>Location & Description Basement 2 – Parking bay 25 (Water leak)</p> <p>The Author has observed a rainwater leak from above the northeast corner of parking bay 25.</p> <p>The Author noted that the building contract requires completed basements <u>must be dry at all times</u>.</p> <p>6.3 Basement</p> <p>6.3.1 Drainage and Waterproofing</p> <p>a) Completed basements must be dry at all times.</p> <p>b) Subsoil drainage systems and vapour barriers must be installed as per design.</p> <p>c) The proposed method of mitigation of ground water ingress through the basement structure is to be confirmed via a brief, sketches or details prior to commencement. The Principal reserves the right to review the scope if required.</p> <p>The Author is of the view that the defect originated due to poor workmanship employed by the Builder at the time of construction.</p>

B	<p>Cause(s)</p> <ul style="list-style-type: none"> Poor workmanship employed by the Builder at the time of construction.

C	<p>Breach(es)</p> <p>Failure to comply with the following:</p> <ul style="list-style-type: none"> Home Building Act 1989 (NSW) under Section 18B Clauses 1(a);(b) Contract plans and specifications 	
D	<p>Proposed Rectification Scope of Works</p> <p>Allow to:</p> <ol style="list-style-type: none"> Provide site supervision. Supervisor to coordinate access and facilitate the works throughout the whole process. Gain access to required areas in accordance with Safework requirements. Labour to install flashings to prevent water from leaking onto basement floor Supply flashings materials and ancillaries Clean site and leave in a tidy condition upon completion of work 	<p>Location of rainwater link originating from seepage above at carpark 25</p>

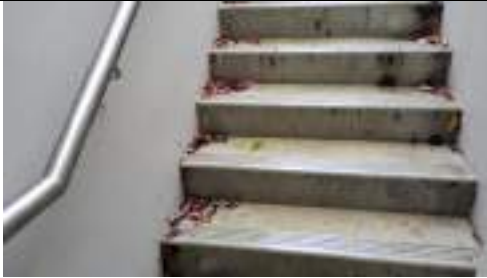
ITEM	COMMENTARY	PHOTOGRAPH(S)
FS-1		
A	<p>Location & Description</p> <p>Fire stairs – Non-Slip finish</p> <p>The Author noted that the issue had been identified in TCA (Giaouris) Report Item C-52 Attachment F Section 10.6</p> <p>The Author observed that the Fire Stairs to the property had a yellow paint strip to the nose of threads that did not have a non-slip finish.</p> <p>The Author found has assumed that the yellow line marking paint found in the storage at Basement 1 was used to paint the stairs.</p> <p>The Author is of the view that the Builder has failure to carry out the works with due care and diligence and in accordance with AS4586.</p>

<p>Eastern external stairs have not been provide with non-slip edge</p>

D	<p>Proposed Rectification Scope of Works</p> <p>Allow to:</p> <ol style="list-style-type: none"> 1. Provide site supervision. Supervisor to coordinate access and facilitate the works throughout the whole process. 2. Gain access to required areas in accordance with Safework requirements. 3. Cover and protect adjacent surfaces during the rectification work. 4. Labour to apply non-slip resistant painted finish to nose of stair treads to all areas 5. Supply non-slip resistant paint and ancillaries 6. Clean site and leave in a tidy condition upon completion of work 7. Dispose of building waste 	<p>Internal Fire Stairs have not been painted with non-slip finish</p>

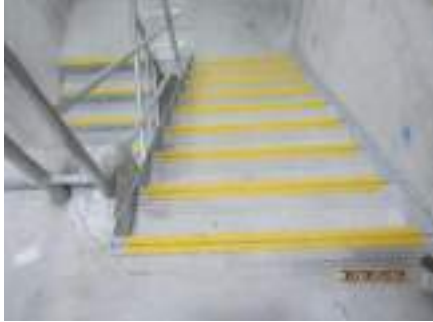
B	<p>Cause(s)</p> <ul style="list-style-type: none"> • Failure of the Builder to carry out the works with due care and diligence. 	
C	<p>Breach(es)</p> <p><i>Failure to comply with the following:</i></p> <ul style="list-style-type: none"> ▪ Home Building Act 1989 (NSW) under Section 18B Clauses 1 (a)&(d) ▪ AS4586 Slip resistance

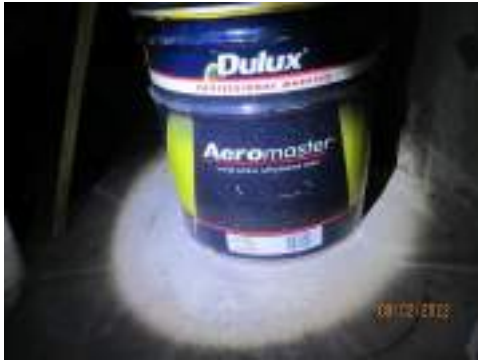
<p>Line marking paint found in storage Basement 1</p>

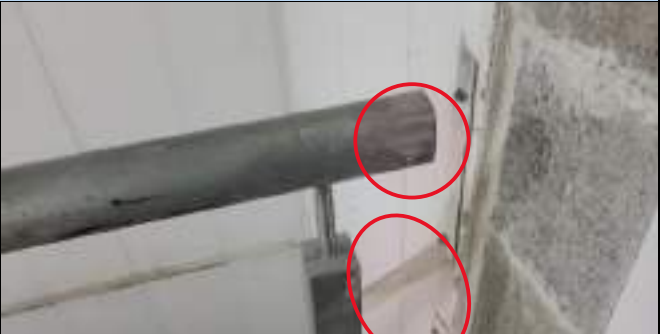
ITEM	COMMENTARY	PHOTOGRAPH(S)
FS-2		
A	<p>Location & Description Fire Stairs 2 (Ground floor) East- Railing</p> <p>The Author has observed that the cut end to the metal railing has sharp edges and that a section Dincel at the junction to the masonry wall has not been trimmed.</p> <p>The Author noted that the issue had been identified in TCA (Giaouris) Report Item C-54 Attachment F Section 10.6</p> <p>The Author is of the view that the Builder has failed to carry out the works with due care and skill.</p>

B	<p>Cause(s)</p> <ul style="list-style-type: none"> Poor workmanship employed by the builder at the time of construction. 	
C	<p>Breach(es)</p> <p><i>Failure to comply with the following:</i></p> <ul style="list-style-type: none"> Home Building Act 1989 (NSW) under Section 18B Clauses 1 (a) Incomplete contract works 	<p>Fire Stairs 2 (Ground floor) East - Sharp edges to end of railing and section of Dincel not trimmed</p>

D	<p>Proposed Rectification Scope of Works</p> <p>Allow to:</p> <ol style="list-style-type: none"> Provide site supervision. Supervisor to coordinate access and facilitate the works throughout the whole process. Gain access to required areas in accordance with Safework requirements. Labour to machine off sharp edges to make safe and trim Dincel wall material Clean site and leave in a tidy condition upon completion of work Dispose of building waste

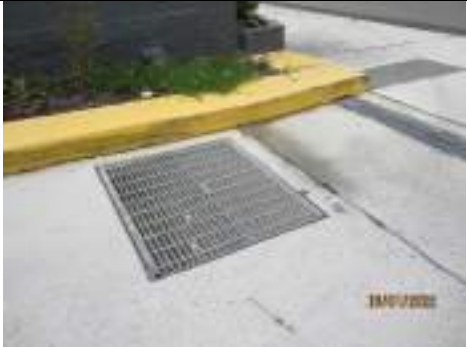
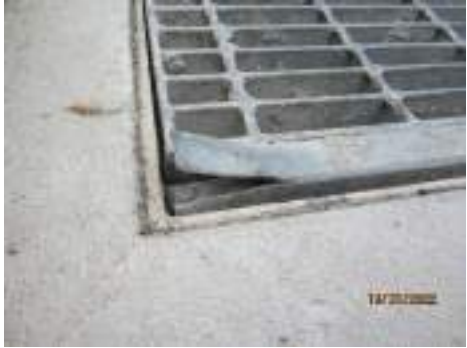
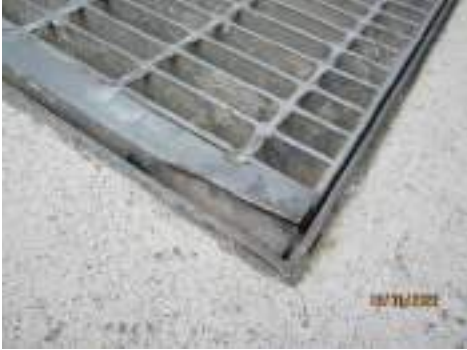
ITEM	COMMENTARY	PHOTOGRAPH(S)
OSD-1		
A	<p>Location & Description</p> <p>Driveway OSD metal access grate</p> <p>The Author observed that metal OSD access grate located to the northeast corner of the driveway has damage to the western side of the grate at the hinge.</p> <p>The Author is of the view, that the damage originated from poor workmanship employed by the builder at the time of construction.</p>

B	<p>Cause(s)</p> <ul style="list-style-type: none"> Poor workmanship employed by the builder at the time of construction. 	
C	<p>Breach(es)</p> <p><i>Failure to comply with the following:</i></p> <ul style="list-style-type: none"> <i>Home Building Act 1989 (NSW) under Section 18B Clauses 1 (a)</i> <i>NSW Guide to Standards & Tolerances 2017 G – Responsibility to rectify – Builders are liable to repair damage caused to property in the course of completing their building work.</i>

D	<p>Proposed Rectification Scope of Works</p> <p>Allow to:</p> <ol style="list-style-type: none"> Provide site supervision. Supervisor to coordinate access and facilitate the works throughout the whole process. Gain access to required areas in accordance with Safework requirements. Labour to remove damaged grate and install new grate Supply new steel grate Clean site and leave in a tidy condition upon completion of work Dispose of building waste

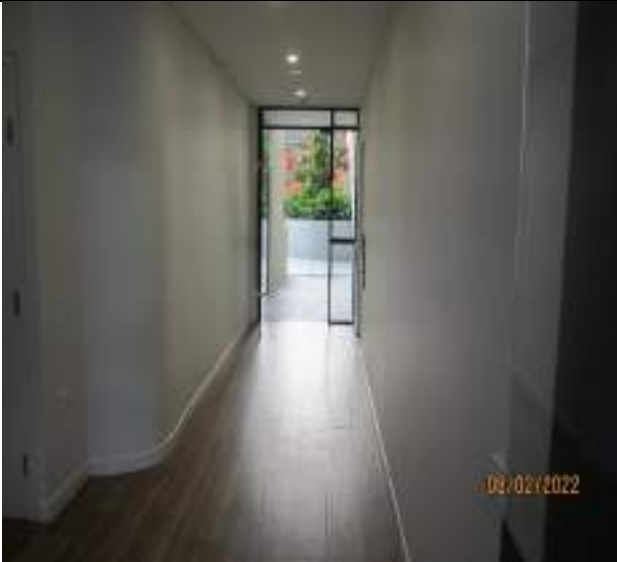
ITEM	COMMENTARY	PHOTOGRAPH(S)
1-GRD		
A	<p>Location & Description Entry Lobby – Interior finishes</p> <p>The Author has been instructed that the Builder did not complete the interior fit out to the Entry Lobby in accordance with the contract plans and specifications.</p> <p>The Author noted that the following clauses in Annexure Part P-PPR of the building contract in relation to the Entry Lobby works -</p> <p>6.4.5 f) Lobby finishes are to be documented by the Architect and/or as approved by the Principal</p> <p>6.4.5 h) Lobby has special interior design from contractor, which need approval from principal. And additional finish package of lobby will implementation of the interior design by contractor.</p> <p>For clarity, please refer to following extract from building contract as stated above -</p> <p>6.4.5 Entry Lobby</p> <ul style="list-style-type: none"> a) Lobby entry doors are to be glazed swing doors or as specified by the architect. b) All lobby access is to be via security access system. c) Audio and video intercom door stations are to be recessed and in proximity to the door and protected from the elements. These are to be connected to all apartments where each unit is to have an audio-visual handset of a high quality standard to be approved by the Principal. d) Main entry lobbies are to receive additional lighting beyond principle requirements. e) Egress from lobby doors are to be via an approved mortise lock and handle. f) Lobby finishes are to be as documented by the Architect, and/or as approved by the Principal. g) All lobbies that permit entry from the street or basement carpark are to have a tile floor finish or as specified by the architect. h) Lobby has special interior design from contractor, which need approval from principle. And additional finish package of lobby will implementation of the interior design by contractor <p>Page 50 of 57</p> <p style="text-align: right;">H2 X16</p>

<p>Entry Lobby entry from South</p>

<p>D</p>	<p>Proposed Rectification Scope of Works</p> <p>Allow to:</p> <ol style="list-style-type: none"> 1. Provide site supervision. Supervisor to coordinate access and facilitate the works throughout the whole process. 2. Gain access to required areas in accordance with Safework requirements. 3. Cover and protect adjacent surfaces during the rectification work. 4. Labour to prepare walls and ceilings for installation of custom joinery and fixtures 5. Supply interior custom joinery, finishes and signage as to Studio 91 jbw design and plans 6. Electrical labour to isolate to make safe, pre-wire and fit electrical services, lighting following install of interior joinery and commission on completion. 7. Supply feature light fittings and ancillaries 8. Supply framing materials, ancillaries, custom joinery, signage and finishes 9. Labour to fix and install custom joinery and finishes 10. Labour to paint affected finishes 11. Supply paint and ancillaries 12. Labour to make good, affected finishes 13. Clean site and leave in a tidy condition upon completion of work 14. Dispose of building waste 15. Waste disposal

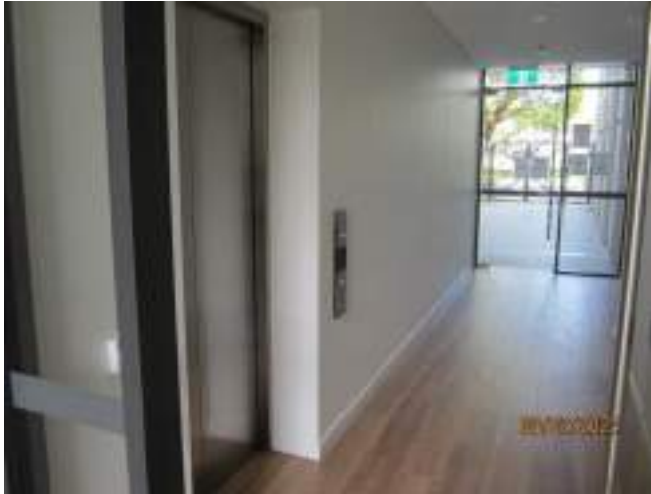
<p>Entry Lobby entry from North</p>

<p>The Author has been instructed that the interior design prepared by the Studio91 jbw for in the following Tables 1-GRD-1, 1-GRD-2 and 1-GRD-3 of this report had been approved by the Principal to be constructed by the Builder.</p> <p>The Author has observed on inspection that the interior finishes to the Entry Lobby that the works have not been completed as to Studio 91 jbw design and plans.</p> <p>The Author is of the view that the interior finishes and works have not been completed in accordance with contract plans and specifications.</p>

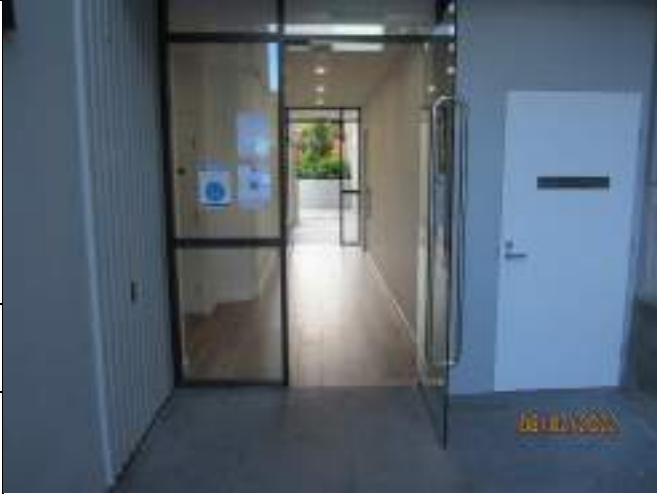
<p>B</p>	<p>Cause(s)</p> <ul style="list-style-type: none"> • Failure to complete the works in accordance with the contract plans and specifications 	
<p>C</p>	<p>Breach(es)</p> <p><i>Failure to comply with the following:</i></p> <ul style="list-style-type: none"> ▪ Home Building Act 1989 (NSW) under Section 18B Clauses 1 (a) ▪ Contract plans and specifications

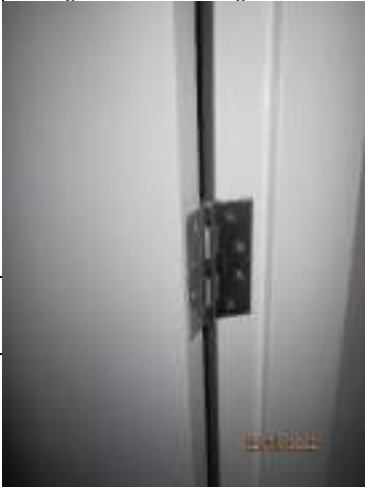
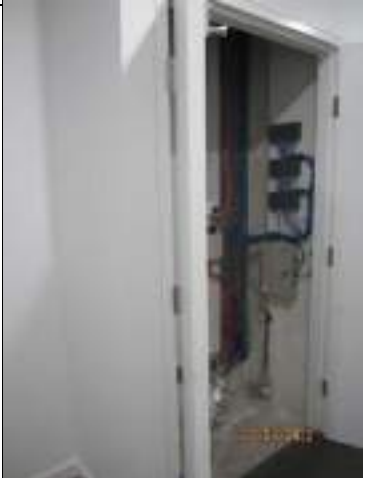
ITEM	COMMENTARY	PHOTOGRAPH(S)
2 -GRD		
A	<p>Location & Description Ground level foyer – Building L</p> <p>The Author has observed screws are missing to the hinges to service doors.</p> <p>The Author is of the view, that the defect originated from poor workmanship employed by the Builder at the time of construction.</p>	<p>Missing screws to door hinge</p>

B	<p>Cause(s)</p> <ul style="list-style-type: none"> Poor workmanship employed by the Builder at the time of construction 	
C	<p>Breach(es) <i>Failure to comply with the following:</i></p> <ul style="list-style-type: none"> Home Building Act 1989 (NSW) under Section 18B Clauses 1(a) Incomplete contract works 	
D	<p>Proposed Rectification Scope of Works Allow to:</p> <ol style="list-style-type: none"> Provide site supervision. Supervisor to coordinate access and facilitate the works throughout the whole process. Gain access to required areas in accordance with Safework requirements. Labour to fix screws to hinges Clean site and leave in a tidy condition upon completion of work
