6. DEFECT SCHEDULE

6.1. AUTOMATIC FIRE DETECTION AND ALARM SYSTEM (INCLUDING SMOKE ALARMS)

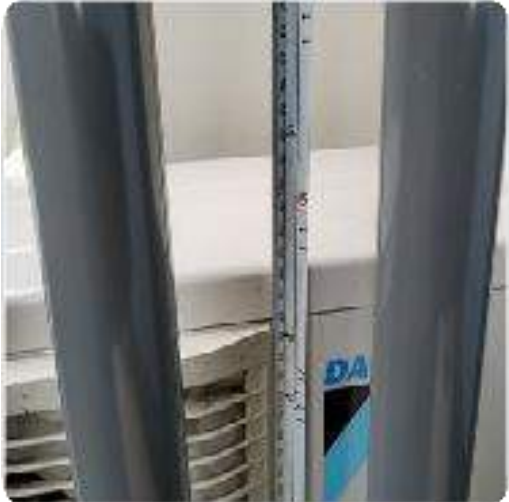
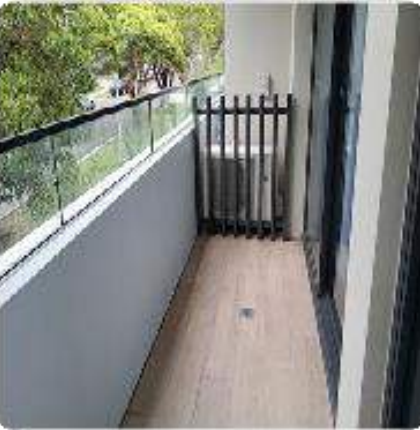
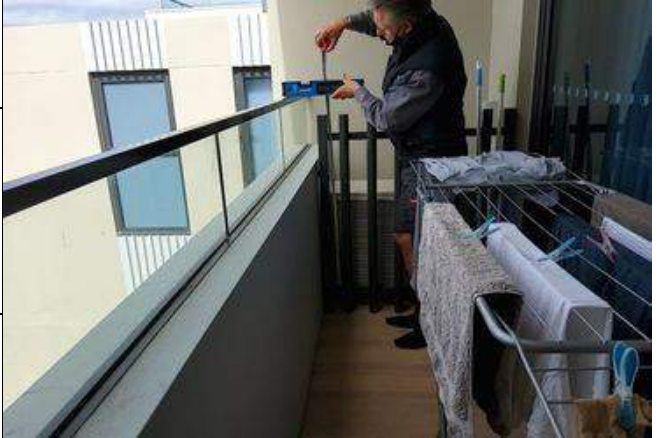
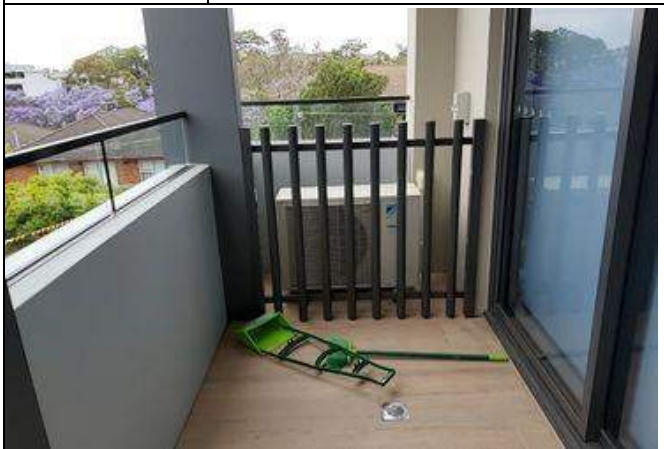
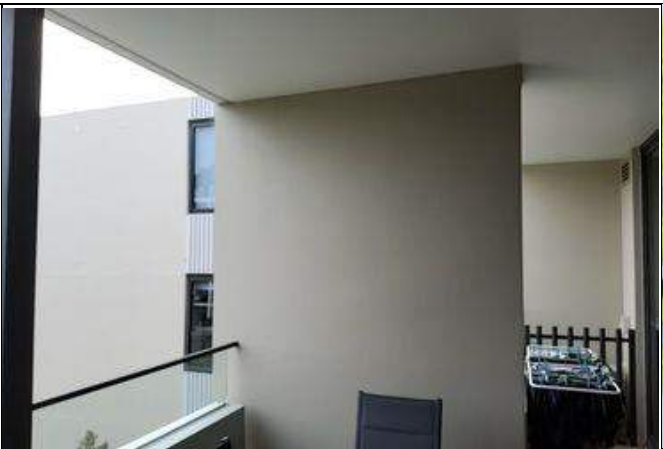
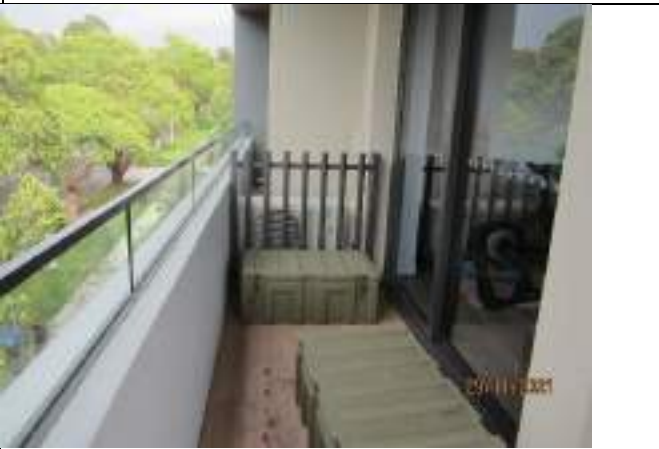
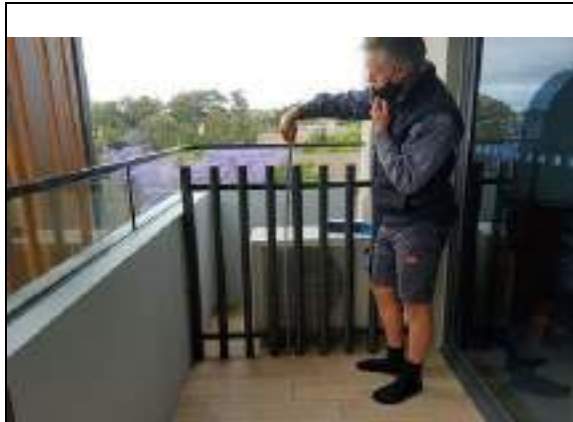
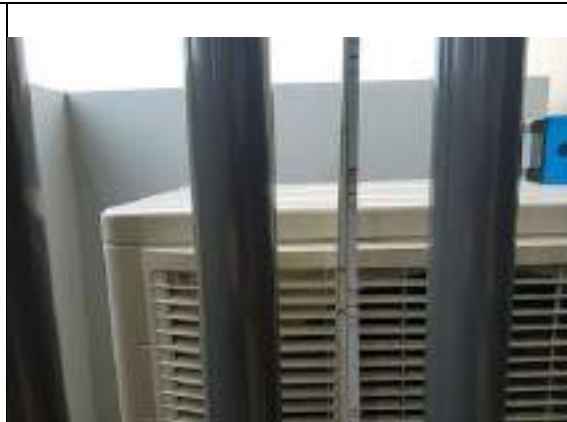
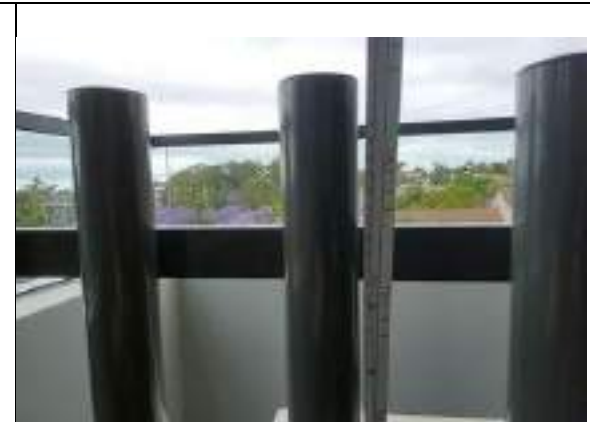
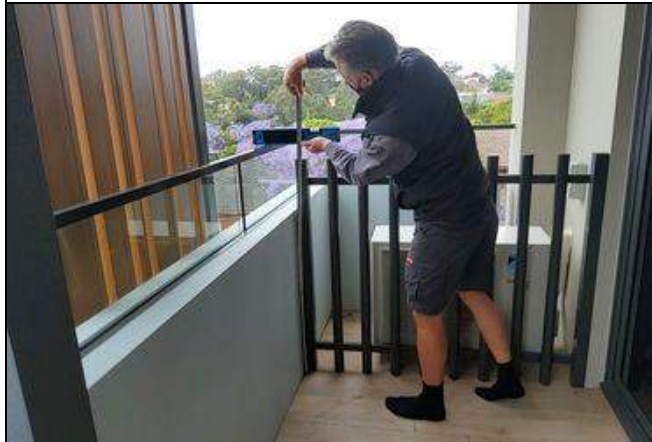
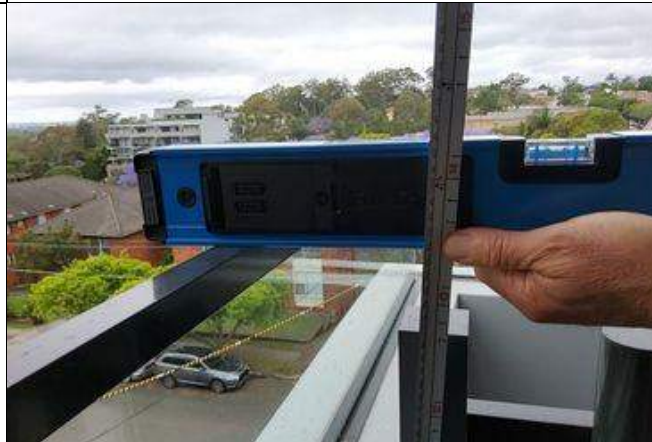
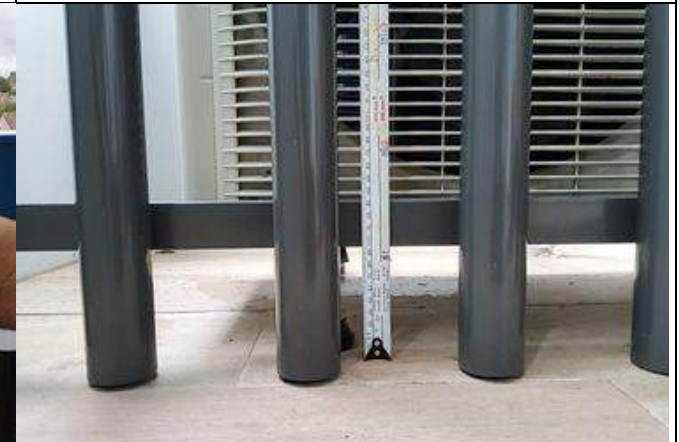
ITEM	COMMENTARY	PHOTOGRAPH(S)															
1-AC																	
A	<p>Location & Description Balcony (Air conditioner barrier) Unit 202, 204,207,302,304,307</p> <p>The Author has observed there is a metal barrier that has been installed by the Builder to the front of the air conditioner to the southern side of the balcony</p> <p>The Author measured the height of the air conditioners and found height to the top of air conditions ranged from approximately 550mm - 660mm off the finished floor level.</p> <p>The Author is of the view, that the barrier rail does not comply with the National Construction Code 2016 Vol1 D2.16 in preventing the facilitation of climbing.</p> <p>For clarity, please refer extract from National Construction Code 2016 Vol1 D 2.16 Barriers to prevent falls</p>

<p>The Author noted that the builders in Annexure Part P_PP item 6.6.7 of the building contract, specified 'louvered aluminium cage' for the air conditioning condensers. Please refer to extract of contract item 6.6.7 in this table of the report.</p> <p>The Author is of the view, a suitable qualified consultant be engaged to provide a design solution that prevents the facilitation of climbing in accordance with National Construction Code.</p> <p>In determining a proposed scope of works for this item the Author has allowed a provisional sum for the cost of a suitability qualified consultant to provide a design solution and cost to replace the existing metal barrier rail.</p>	3. Barrier climbability			Location		Requirement	(a)	Fire-isolated stairways, fire-isolated ramps and other areas used primarily for emergency purposes, excluding— (i) external stairways; and (ii) external ramps.	No requirement.	(b)	Class 7 (other than <i>carparks</i>) and Class 8 buildings.		(c)	For floors more than 4 m above the surface beneath in all other locations.	Any horizontal or near horizontal elements between 150 mm and 760 mm above the floor must not facilitate climbing.

<p>Top of air conditioner measures approximately 660mm off floor level unit 204.</p>

<p>B</p>	<p>Cause(s)</p> <ul style="list-style-type: none"> • Failure of Builder to carry out the in accordance with the National Construction Code 2016 Vol1 D2.16 in preventing the facilitation of climbing.

Unit 302 Air condition located on northeast corner of balcon

Unit 302 Air conditioner height approximately 550mm

Unit 302 Height of top horizontal rail approximately 980mm

Unit 302 Height of balcony balustrade approximately 1140mm

Unit 302 height of horizontal rail on barrier approximately 140mm

<p>Unit 307</p>
<p>C</p>	<p>Breach(es) <i>Failure to comply with the following:</i></p> <ul style="list-style-type: none"> ▪ Home Building Act 1989 (NSW) under Section 18B Clauses 1(a) & (c); ▪ National Construction Code 2016 Vol1 D2.16 in preventing the facilitation of climbing. ▪ Contract works - Annexure Part P_PP item 6.6.7 of the building contract 	
<p>D</p>	<p>Proposed Rectification Scope of Works Allow to: Provisional allowance -</p> <ul style="list-style-type: none"> • A suitably qualified consultant to provide a design solution to prevent the facilitation of climbing. • Replacement of existing balcony air conditioning barrier

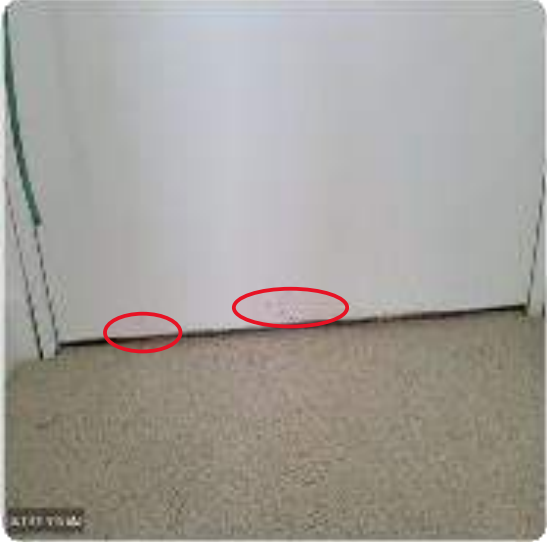
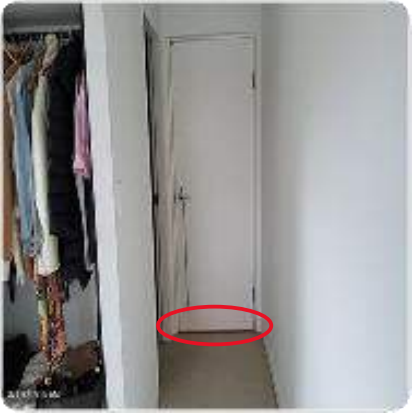
ITEM	COMMENTARY	PHOTOGRAPH(S)
1-G02		
A	<p>Location & Description Main bedroom door</p> <p>The Author has observed staining to the paintwork at the bottom of the bedroom door.</p> <p>The Author is of the view, that the defect originated from poor workmanship employed by the Builder at the time of construction.</p>

B	<p>Cause(s)</p> <ul style="list-style-type: none"> Poor workmanship employed by the Builder at the time of construction 	
C	<p>Breach(es) <i>Failure to comply with the following:</i></p> <ul style="list-style-type: none"> Home Building Act 1989 (NSW) under Section 18B Clauses 1(a) NSW Guide to Standards and tolerances 2017 13.2 Surface finish of paintwork <i>Paintwork is defective if the application has blemishes such as paint runs, paint sags, wrinkling, dust, bare or starved painted areas, colour variations, surface cracks, irregular and coarse brush marks, sanding marks, blistering, non-uniformity of gloss level and other irregularities in the surface that are visible from a normal viewing position. (Highlighting added)</i>

D	<p>Proposed Rectification Scope of Works Allow to:</p> <ol style="list-style-type: none"> Provide site supervision. Supervisor to coordinate access and facilitate the works throughout the whole process. Gain access to required areas in accordance with Safework requirements. Cover and protect adjacent surfaces during the rectification work. Labour to remove staining to paint finish and make good Clean site and leave in a tidy condition upon completion of work

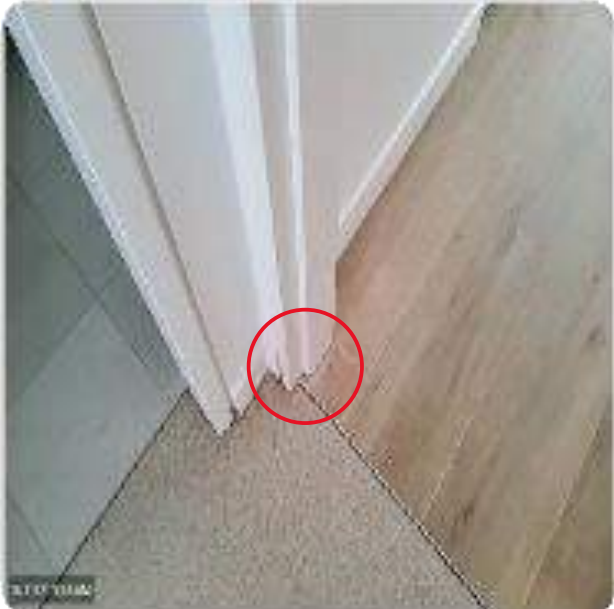
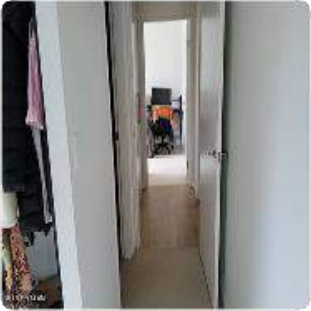
ITEM	COMMENTARY	PHOTOGRAPH(S)
2-G02		
A	<p>Location & Description</p> <p>Main bedroom door jamb</p> <p>The Author has observed a paint stain on the floor at the door jamb to main bedroom.</p> <p>The Author is of the view, that the defect originated from poor workmanship employed by the Builder at the time of construction.</p>

B	<p>Cause(s)</p> <ul style="list-style-type: none"> Poor workmanship employed by Builder at the time of construction 	
C	<p>Breach(es)</p> <p><i>Failure to comply with the following:</i></p> <ul style="list-style-type: none"> Home Building Act 1989 (NSW) under Section 18B Clauses 1(a) AS2311:2017 Guide to the painting of buildings 	
D	<p>Proposed Rectification Scope of Works</p> <p>Allow to:</p> <ol style="list-style-type: none"> Provide site supervision. Supervisor to coordinate access and facilitate the works throughout the whole process. Gain access to required areas in accordance with Safework requirements. Cover and protect adjacent surfaces during the rectification work. Labour to remove staining and make good, affected finishes Clean site and leave in a tidy condition upon completion of work

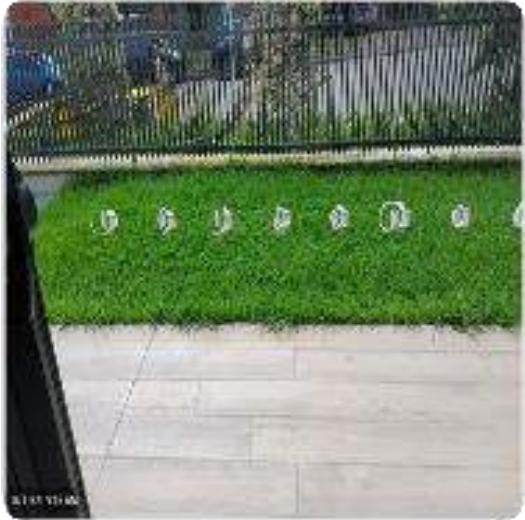
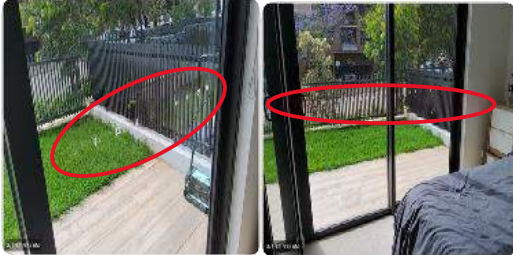
ITEM	COMMENTARY	PHOTOGRAPH(S)
3-G02		
A	<p>Location & Description - Bedroom 2 - Sliding door</p> <p>The Author has observed deterioration of manufacturers glass indicator motif.</p> <p>The Author is of the view, that the material has prematurely deteriorated based on the period on which the building work was completed.</p>

B	<p>Cause(s)</p> <ul style="list-style-type: none"> Premature deterioration of a building element 	
C	<p>Breach(es) <i>Failure to comply with the following:</i></p> <ul style="list-style-type: none"> Home Building Act 1989 (NSW) under Section 18B Clauses 1(f) Building contract - Defect liability period – Product warranty 	
D	<p>Proposed Rectification Scope of Works Allow to:</p> <ol style="list-style-type: none"> Provide site supervision. Supervisor to coordinate access and facilitate the works throughout the whole process. Gain access to required areas in accordance with Safework requirements. Window manufacturer to remove existing and fix new proprietary indicator motifs. Cover and protect adjacent surfaces during the rectification work. Clean site and leave in a tidy condition upon completion of work

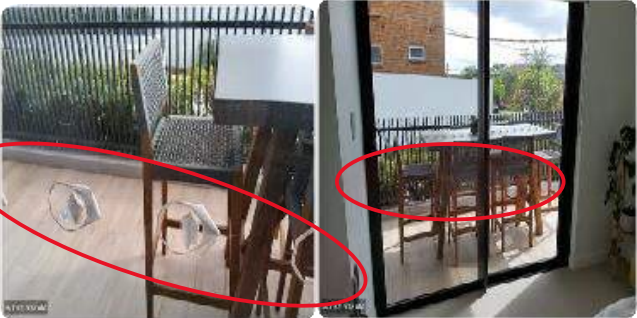
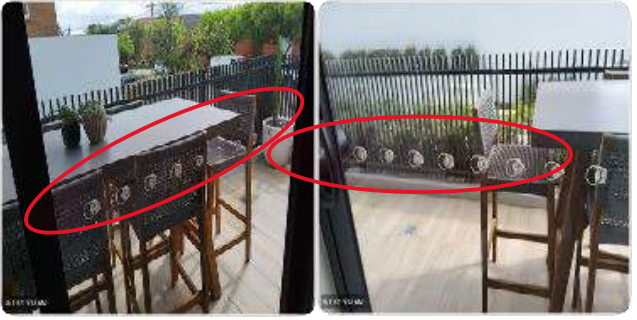
ITEM	COMMENTARY	PHOTOGRAPH(S)
4-G02		
A	<p>Location & Description Main bedroom – Sliding door The Author has observed deterioration of manufacturers glass indicator motif.</p> <p>The Author is of the view, that the material has prematurely deteriorated based on the period on which the building work was completed.</p>

B	<p>Cause(s)</p> <ul style="list-style-type: none"> Premature deterioration of a building element 	
C	<p>Breach(es) Failure to comply with the following:</p> <ul style="list-style-type: none"> Home Building Act 1989 (NSW) under Section 18B Clauses 1(f) Building contract - Defect liability period – Product warranty 	
D	<p>Proposed Rectification Scope of Works Allow to:</p> <ol style="list-style-type: none"> Provide site supervision. Supervisor to coordinate access and facilitate the works throughout the whole process. Gain access to required areas in accordance with Safework requirements. Window manufacturer to remove existing and fix new proprietary indicator motifs. Cover and protect adjacent surfaces during the rectification work. Clean site and leave in a tidy condition upon completion of work

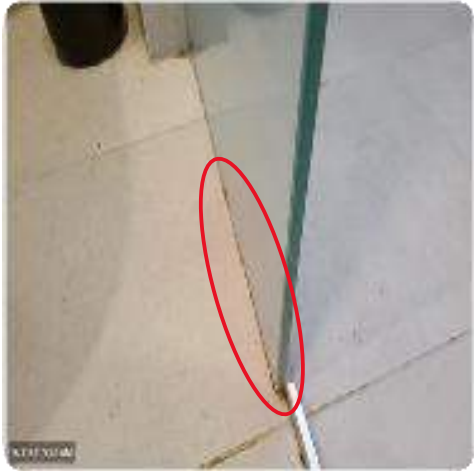
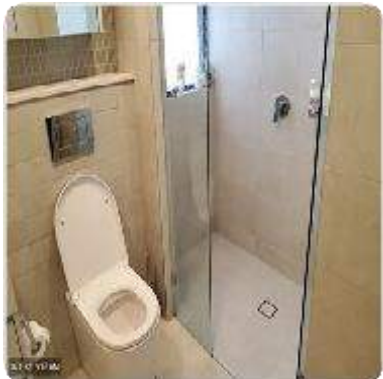
ITEM	COMMENTARY	PHOTOGRAPH(S)
5-G02		
A	<p>Location & Description Ensuite shower screen</p> <p>The Author has observed sealant fixing to fixed shower screen is loose and is not fully sealed.</p> <p>The Author is of the view, that the defect originated due to poor workmanship employed by the Builder at the time of construction. As the fixing of the base of glass panel is reliant on the flexible sealant being applied to adequately secure the shower screen and provide a waterproof seal at the water stop angle.</p>

B	<p>Cause(s)</p> <ul style="list-style-type: none"> Poor workmanship employed by Builder at the time of construction 	
C	<p>Breach(es)</p> <p><i>Failure to comply with the following:</i></p> <ul style="list-style-type: none"> Home Building Act 1989 (NSW) under Section 18B Clauses 1 (a) Building contract - Defect liability period – Product warranty 	
D	<p>Proposed Rectification Scope of Works</p> <p>Allow to:</p> <ol style="list-style-type: none"> Provide site supervision. Supervisor to coordinate access and facilitate the works throughout the whole process. Gain access to required areas in accordance with Safework requirements. Cover and protect adjacent surfaces during the rectification work. Labour to apply construction adhesive waterproofing sealant Supply construction adhesive waterproofing sealant Make good any surfaces affected as part of the works, to their prior condition. Clean site and leave in a tidy condition upon completion of work

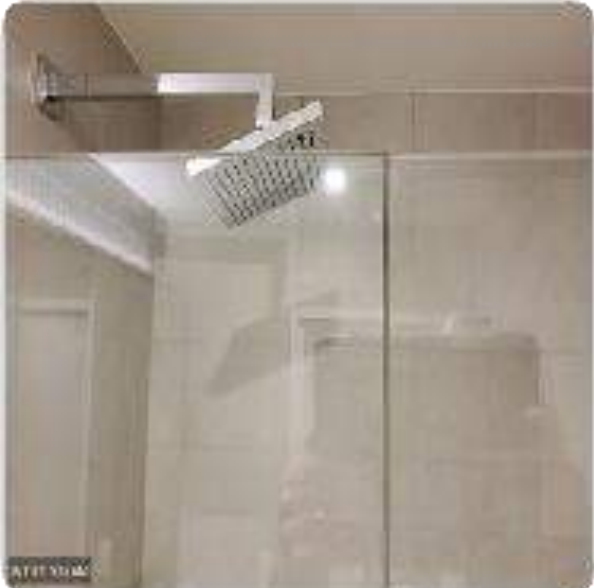
ITEM	COMMENTARY	PHOTOGRAPH(S)
6-G02		
A	<p>Location & Description Main Bathroom – Shower screen The Author has observed space between fixed panel and door requires more clearance</p> <p>The Author is of the view, that the defect originated from poor workmanship employed by the Builder at the time of construction. As the installer of the shower screen should have provided sufficient clearance.</p>

B	<p>Cause(s)</p> <ul style="list-style-type: none"> Poor workmanship employed by Builder at the time of construction 	
C	<p>Breach(es) Failure to comply with the following:</p> <ul style="list-style-type: none"> Home Building Act 1989 (NSW) under Section 18B Clauses 1(a) Building contract - Defect liability period – Product warranty 	
D	<p>Proposed Rectification Scope of Works Allow to:</p> <ol style="list-style-type: none"> Provide site supervision. Supervisor to coordinate access and facilitate the works throughout the whole process. Gain access to required areas in accordance with Safework requirements. Labour to adjust shower screen door to provide sufficient clearance Cover and protect adjacent surfaces during the rectification work. Make good any surfaces affected as part of the works, to their prior condition. Clean site and leave in a tidy condition upon completion of work

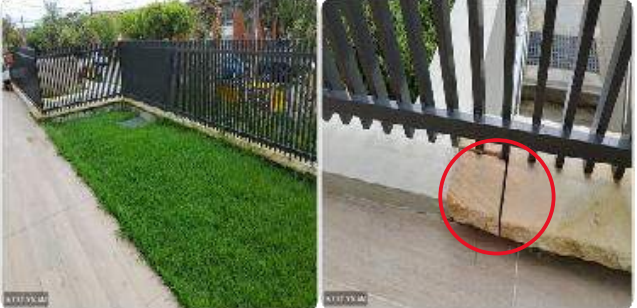
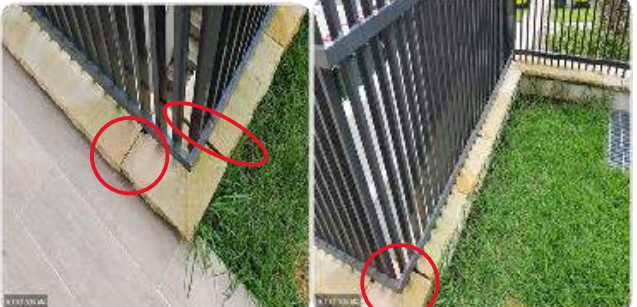
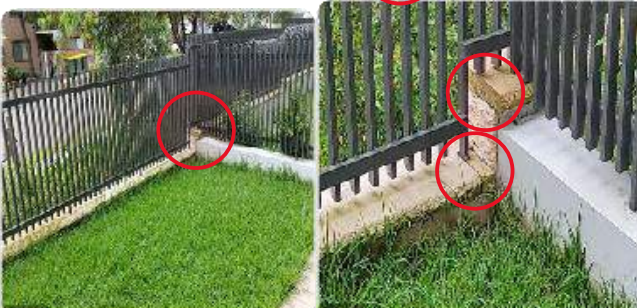
ITEM	COMMENTARY	PHOTOGRAPH(S)
7-G02		
A	<p>Location & Description Eastern exterior sandstone capping</p> <p>The Author has observed joints are not filled to the eastern external sandstone at balustrade</p> <p>The Author is of the view, that the works have not been completed in accordance with the building contract.</p>

B	<p>Cause(s)</p> <ul style="list-style-type: none"> Failure of Builder to complete the works in accordance with the contract specifications. 	
C	<p>Breach(es) <i>Failure to comply with the following:</i></p> <ul style="list-style-type: none"> Home Building Act 1989 (NSW) under Section 18B Clauses 1(a) Building contract – Incomplete works

D	<p>Proposed Rectification Scope of Works Allow to:</p> <ol style="list-style-type: none"> Provide site supervision. Supervisor to coordinate access and facilitate the works throughout the whole process. Gain access to required areas in accordance with Safework requirements. Labour to fill joints to sandstone capping Materials to fill joints Cover and protect adjacent surfaces during the rectification work. Make good any surfaces affected as part of the works, to their prior condition. Clean site and leave in a tidy condition upon completion of work

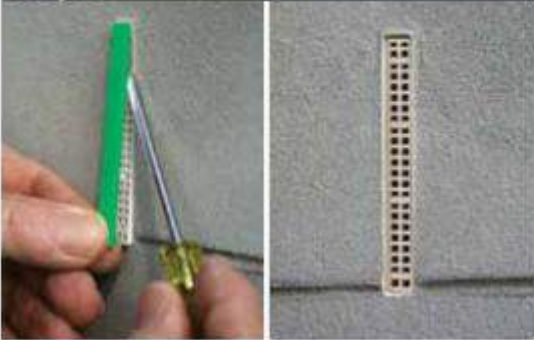
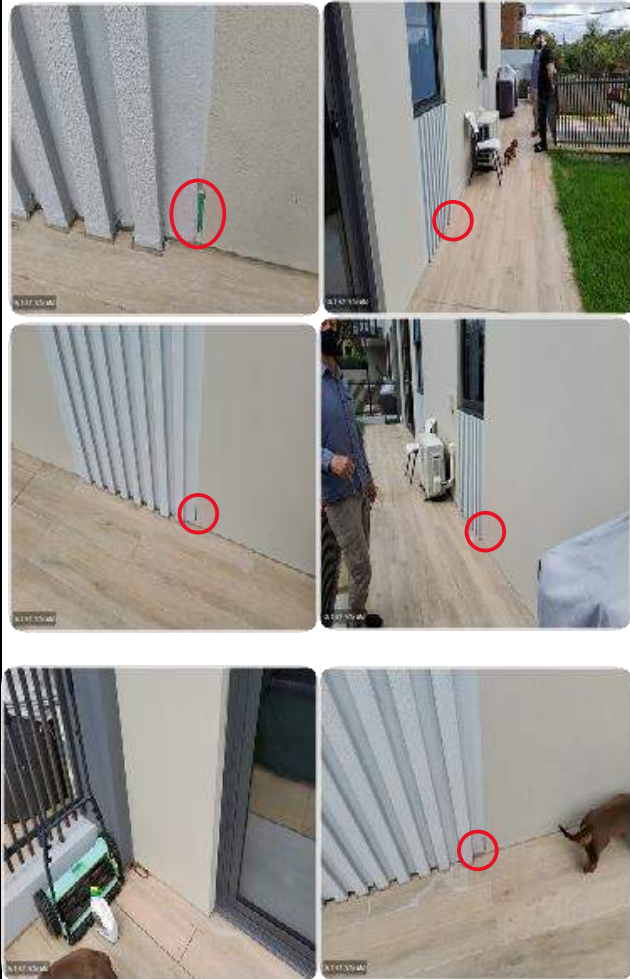
ITEM	COMMENTARY	PHOTOGRAPH(S)
<p>8-G02</p> <p>A</p>	<p>Location & Description Eastern Exterior – pressure equalization slots and Weepa protector installation Item C18 identified in Attachment F Section 10.6 of TCA report</p> <p>The Author has observed that pressure equalization slots and Weepa have not been installed in accordance with the manufacturers guidelines.</p> <p>For clarity – Pressure equalization (PE) slots Extract Hebel High Rise Apartments – Design and Installation Guide</p> <p>PRESSURE EQUALISATION (PE) SLOTS</p> <p>PE Slots (Weepa) allow pressure equalisation to the wall cavity and permit drainage of any water or moisture from the cavity. Ideally located at control joints (CJ), 75mmx10mm pressure equalisation slots shall be installed at no greater than 3 metre spacings.</p> <p>Weepa protector installation guide –</p> <div data-bbox="394 943 1095 1324"> <p>Step 8</p>

<p>After finish and clean-up remove the mortar guard for beautiful weepholes.</p> </div> <p>The Author is of the view, that the defects originated at the time of construction and that the works have not been completed in accordance with manufacturers guidelines.</p>

<p>B</p>	<p>Cause(s)</p> <ul style="list-style-type: none"> • Poor workmanship employed by Builder at the time of construction; • Failure of Builder to carry out the in accordance with manufacturers guidelines.
<p>C</p>	<p>Breach(es)</p> <p><i>Failure to comply with the following:</i></p> <ul style="list-style-type: none"> ▪ <i>Home Building Act 1989 (NSW) under Section 18B Clauses 1(a);</i> ▪ <i>Manufacturers installation guidelines – Refer Heble and Weepa protector installation guide</i> ▪ <i>Building contract specifications</i>
<p>D</p>	<p>Proposed Rectification Scope of Works</p> <p>Allow to:</p> <ol style="list-style-type: none"> 1. Provide site supervision. Supervisor to coordinate access and facilitate the works throughout the whole process. 2. Gain access to required areas in accordance with Safework requirements. 3. Cover and protect adjacent surfaces during the rectification work. 4. Labour to remove construction covers from Weepa protectors 5. Labour to cut slot in Hebel panel to install Weepa protector, install Weepa protectors and patch and repair affected finishes in accordance with manufacturers guidelines. 6. Supplier Weepa protectors 7. Supply Dulux render system materials 8. Make good any surfaces affected as part of the works, to their prior condition. 9. Clean site and leave in a tidy condition upon completion of work

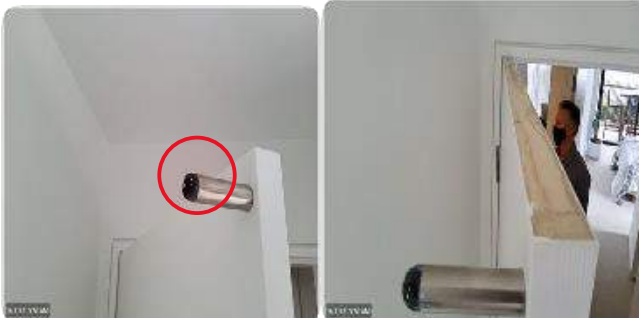
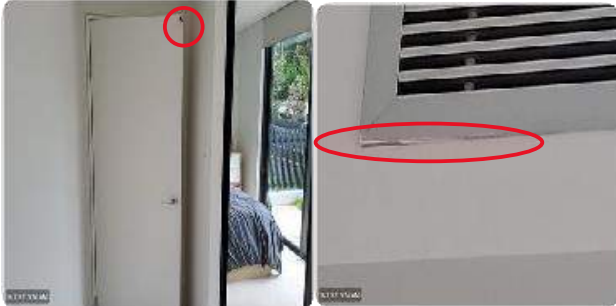
ITEM	COMMENTARY	PHOTOGRAPH(S)
9-G02		
A	<p>Location & Description Bedroom 2 – Passage doors, air conditioning vent</p> <p>The Author has observed the door is not fully sealed and there are paint stains on door stop and air conditioning metal vent.</p> <p>The Author is of the view, that the defect originated due to poor workmanship employed by the Builder at the time of construction.</p>

B	<p>Cause(s)</p> <ul style="list-style-type: none"> Poor workmanship employed by Builder at the time of construction 	
C	<p>Breach(es)</p> <p><i>Failure to comply with the following:</i></p> <ul style="list-style-type: none"> Home Building Act 1989 (NSW) under Section 18B Clauses (a) & (c); AS2311:2017 Guide to the painting of buildings NSW Guide to standards & tolerances 2017-9.6 Sealing of doors

D	<p>Proposed Rectification Scope of Works</p> <p>Allow to:</p> <ol style="list-style-type: none"> Provide site supervision. Supervisor to coordinate access and facilitate the works throughout the whole process. Gain access to required areas in accordance with Safework requirements. Cover and protect adjacent surfaces during the rectification work. Labour to remove door and seal door leaf in accordance with AS2311:2017 Guide to the painting of buildings Labour to reinstall door and remove paint from door stop and air conditioning vent Make good any surfaces affected as part of the works, to their prior condition. Clean site and leave in a tidy condition upon completion of work

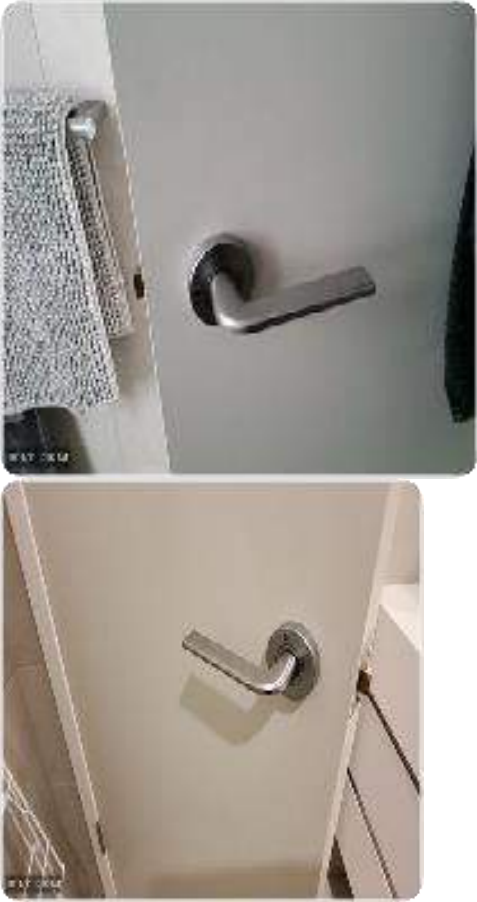
ITEM	COMMENTARY	PHOTOGRAPH(S)
10-G02		
A	<p>Location & Description Bathroom and ensuite door privacy sets</p> <p>The Author has observed there is no lock pin to lock privacy sets.</p> <p>The Author is of the view, that the Builder has failed to complete the works in accordance with the building contract.</p>

B	<p>Cause(s)</p> <ul style="list-style-type: none"> • Poor workmanship employed by Builder at the time of construction; • Failure of Builder to carry complete the works in accordance with the building contract 	
C	<p>Breach(es) Failure to comply with the following:</p> <ul style="list-style-type: none"> ▪ Home Building Act 1989 (NSW) under Section 18B Clauses 1(a) ▪ Contract – Incomplete works 	
D	<p>Proposed Rectification Scope of Works Allow to:</p> <ol style="list-style-type: none"> 1. Provide site supervision. Supervisor to coordinate access and facilitate the works throughout the whole process. 2. Gain access to required areas in accordance with Safework requirements. 3. Labour to install privacy set lock pins 4. Supply privacy set lock pins 5. Cover and protect adjacent surfaces during the rectification work. 6. Make good any surfaces affected as part of the works, to their prior condition. 7. Clean site and leave in a tidy condition upon completion of work

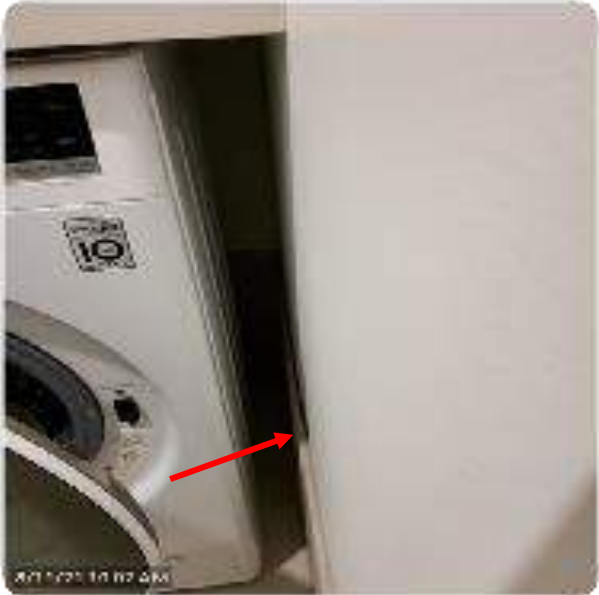
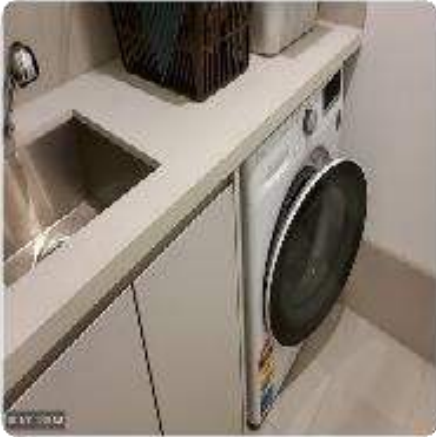
ITEM	COMMENTARY	PHOTOGRAPH(S)
11-G02		
A	<p>Location & Description Laundry tiling</p> <p>The Author has observed skirting tile at washing machine space has not been fully sealed.</p> <ul style="list-style-type: none"> ▪ The Author is of the view, that the works have not been completed in accordance with <i>AS3958.1:2007 Part 1: Guide to the installation of ceramic tiles</i>.

B	<p>Cause(s)</p> <ul style="list-style-type: none"> • Failure of Builder to complete the works in accordance AS3958.1:2007 Part 1: Guide to the installation of ceramic tiles 	
C	<p>Breach(es) Failure to comply with the following:</p> <ul style="list-style-type: none"> ▪ <i>Home Building Act 1989 (NSW) under Section 18B Clauses 1(a) & (c);</i> ▪ <i>AS3958.1:2007 Part 1: Guide to the installation of ceramic tiles</i> ▪ <i>Contract – Incomplete works</i> 	
D	<p>Proposed Rectification Scope of Works Allow to:</p> <ol style="list-style-type: none"> 1. Provide site supervision. Supervisor to coordinate access and facilitate the works throughout the whole process. 2. Gain access to required areas in accordance with Safework requirements. 3. Labour to apply sealant to skirting tile joint 4. Supply sealant to match existing finishes 5. Cover and protect adjacent surfaces during the rectification work. 6. Make good any surfaces affected as part of the works, to their prior condition. 7. Clean site and leave in a tidy condition upon completion of work

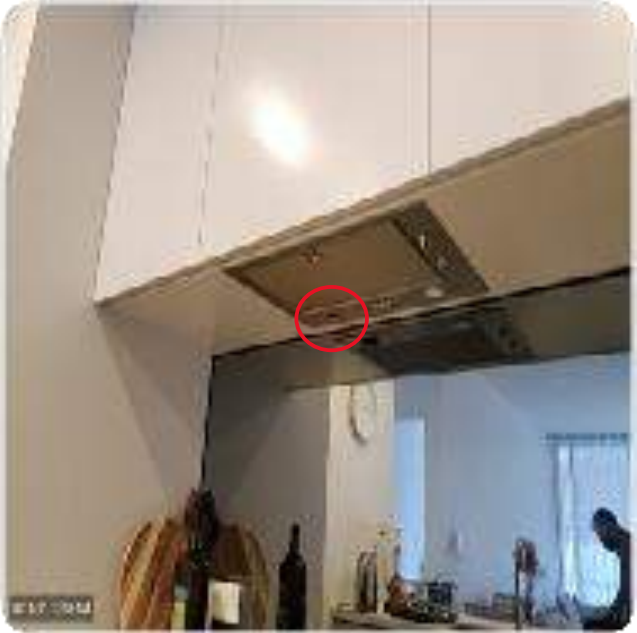
ITEM	COMMENTARY	PHOTOGRAPH(S)
12-G02		
A	<p>Location & Description Kitchen rangehood</p> <p>The Author has observed one light globe is missing to the kitchen range hood.</p> <p>The Author is of the view, that the Builder failed to complete the works in accordance with the building contract.</p>

B	<p>Cause(s)</p> <ul style="list-style-type: none"> • Failure of Builder to complete the works in accordance with the building contract. 	
C	<p>Breach(es)</p> <p><i>Failure to comply with the following:</i></p> <ul style="list-style-type: none"> ▪ <i>Home Building Act 1989 (NSW) under Section 18B Clauses 1(a)</i> ▪ <i>Incomplete contract works</i> 	
D	<p>Proposed Rectification Scope of Works</p> <p>Allow to:</p> <ol style="list-style-type: none"> 1. Provide site supervision. Supervisor to coordinate access and facilitate the works throughout the whole process. 2. Gain access to required areas in accordance with Safework requirements. 3. Labour to install rangehood light 4. Supply 1 x rangehood light 5. Cover and protect adjacent surfaces during the rectification work. 6. Make good any surfaces affected as part of the works, to their prior condition. 7. Clean site and leave in a tidy condition upon completion of work

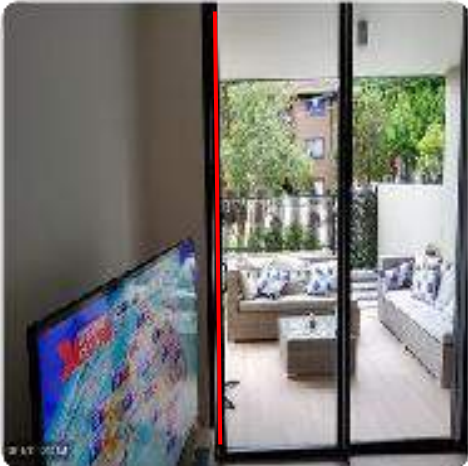
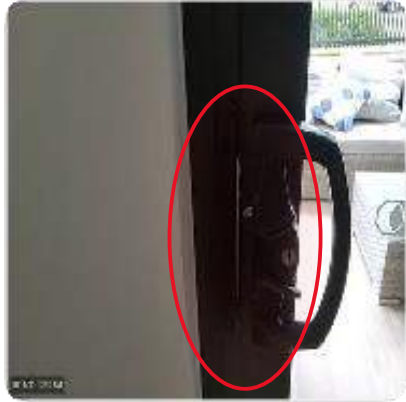
ITEM	COMMENTARY	PHOTOGRAPH(S)
1-G03		
A	<p>Location & Description Living room – Sliding door</p> <p>The lot owner report to the Author at the time of inspection that the lock to the living sliding door was not locking. The Author has observed the sliding door lock was out of alignment and not catching the lock latch.</p> <p>The Author is of the view, that the defect originated due to poor workmanship employed by the Builder at the time of construction.</p>

B	<p>Cause(s)</p> <ul style="list-style-type: none"> • Poor workmanship employed by Builder at the time of construction • Faulty installation 	
C	<p>Breach(es) <i>Failure to comply with the following:</i></p> <ul style="list-style-type: none"> ▪ <i>Home Building Act 1989 (NSW) under Section 18B Clauses 1(a)</i> 	
D	<p>Proposed Rectification Scope of Works Allow to:</p> <ol style="list-style-type: none"> 1. Provide site supervision. Supervisor to coordinate access and facilitate the works throughout the whole process. 2. Gain access to required areas in accordance with Safework requirements. 3. Labour to adjust alignment of door and restore lock function. 4. Cover and protect adjacent surfaces during the rectification work. 5. Make good any surfaces affected as part of the works, to their prior condition. 6. Clean site and leave in a tidy condition upon completion of work

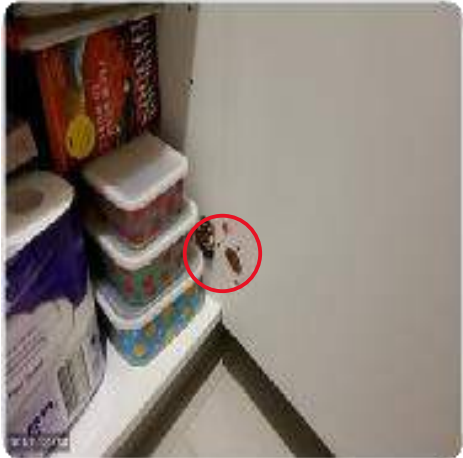
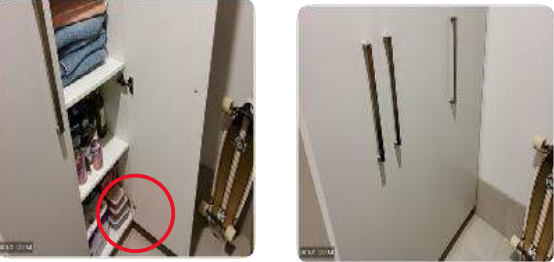
ITEM	COMMENTARY	PHOTOGRAPH(S)
2-G03		
A	<p>Location & Description Laundry cabinet</p> <p>The Author has observed the northern door bottom hinge is missing, and the door is binding.</p> <p>The Author is of the view, that the building has failure to complete the works in accordance with the building contract.</p>

B	<p>Cause(s)</p> <ul style="list-style-type: none"> • Poor workmanship employed by Builder at the time of construction; • Failure of Builder to complete the works in accordance with the building contract 	
C	<p>Breach(es) Failure to comply with the following:</p> <ul style="list-style-type: none"> ▪ Home Building Act 1989 (NSW) under Section 18B Clauses 1(a) ▪ Incomplete contract works 	
D	<p>Proposed Rectification Scope of Works Allow to:</p> <ol style="list-style-type: none"> 1. Provide site supervision. Supervisor to coordinate access and facilitate the works throughout the whole process. 2. Gain access to required areas in accordance with Safework requirements. 3. Labour to install missing hinge 4. Supply 1 x hinge 5. Cover and protect adjacent surfaces during the rectification work. 6. Make good any surfaces affected as part of the works, to their prior condition. 7. Clean site and leave in a tidy condition upon completion of work

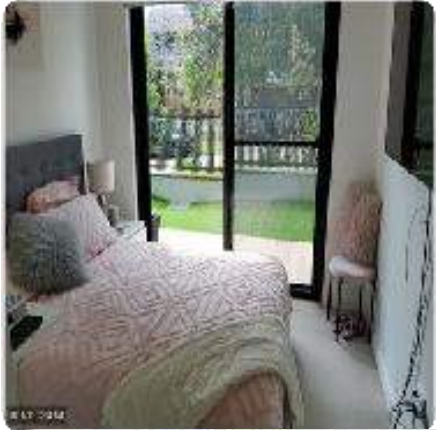
ITEM	COMMENTARY	PHOTOGRAPH(S)
3-G03		
A	<p>Location & Description - Bedroom 2 to sliding door</p> <p>The Author has observed deterioration of manufacturers glass indicator motif.</p> <p>The Author is of the view, that the material has prematurely deteriorated based on the period on which the building work was completed.</p>

B	<p>Cause(s)</p> <ul style="list-style-type: none"> Premature deterioration of a building element 	
C	<p>Breach(es)</p> <p><i>Failure to comply with the following:</i></p> <ul style="list-style-type: none"> Home Building Act 1989 (NSW) under Section 18B Clauses 1(f) Building contract - Defect liability period – Product warranty 	
D	<p>Proposed Rectification Scope of Works</p> <p>Allow to:</p> <ol style="list-style-type: none"> Provide site supervision. Supervisor to coordinate access and facilitate the works throughout the whole process. Gain access to required areas in accordance with Safework requirements. Window manufacturer to remove existing indicators and fix new proprietary indicator motifs. Cover and protect adjacent surfaces during the rectification work. Clean site and leave in a tidy condition upon completion of work

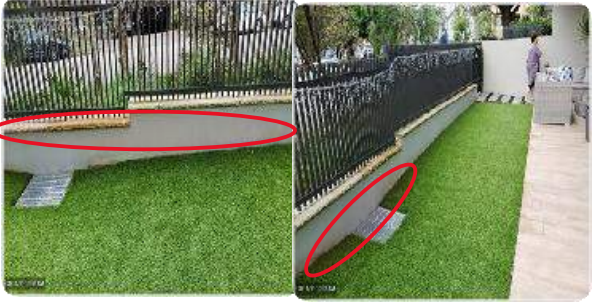
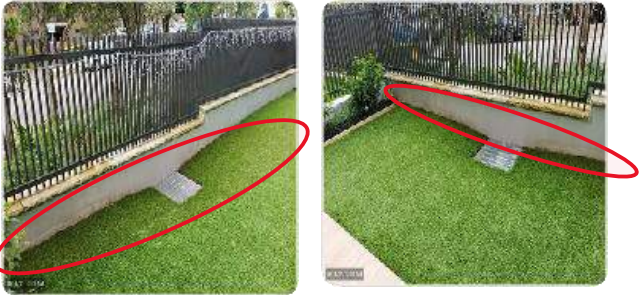
ITEM	COMMENTARY	PHOTOGRAPH(S)
4-G03		
A	<p>Location & Description</p> <p>Eastern exterior – Painting masonry fence</p> <p>The occupant reported to the Author at the time of inspection that the Builder changed landscaping levels to rectify drainage issues to the eastern lawn area. The resulting change of landscape levels has exposed unpainted sections of the eastern rendered wall.</p> <p>The Author is of the view, that the Builder has failed to complete the rectification works and make good, affected finishes.</p>

B	<p>Cause(s)</p> <ul style="list-style-type: none"> • Failure of Builder to complete the rectifications works 	
C	<p>Breach(es)</p> <p><i>Failure to comply with the following:</i></p> <ul style="list-style-type: none"> ▪ <i>Home Building Act 1989 (NSW) under Section 18B Clauses 1(a)</i>

D	<p>Proposed Rectification Scope of Works</p> <p>Allow to:</p> <ol style="list-style-type: none"> 1. Provide site supervision. Supervisor to coordinate access and facilitate the works throughout the whole process. 2. Gain access to required areas in accordance with Safework requirements. 3. Labour to clean and prepare wall for painting Labour to apply paint system in accordance with AS2311:2017 Guide to the painting of buildings 4. Supply paint and ancillaries 5. Cover and protect adjacent surfaces during the rectification work. 6. Make good any surfaces affected as part of the works, to their prior condition. 7. Clean site and leave in a tidy condition upon completion of work

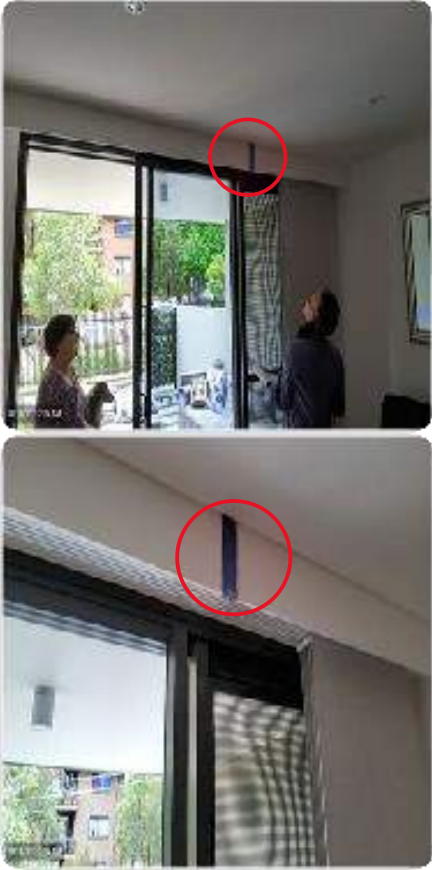
ITEM	COMMENTARY	PHOTOGRAPH(S)
5-G03		
A	<p>Location & Description Living room - Pelmet</p> <p>The Author has observed paint repair to the living pelmet has not been completed.</p> <p>The Author is of the view, that the Builder has failure to complete the rectifications works.</p>

B	<p>Cause(s)</p> <ul style="list-style-type: none"> • Failure of Builder to complete the rectifications works 	
C	<p>Breach(es) Failure to comply with the following:</p> <ul style="list-style-type: none"> ▪ Home Building Act 1989 (NSW) under Section 18B Clauses 1(a) ▪ Building contract – Defect liability period 	
D	<p>Proposed Rectification Scope of Works Allow to:</p> <ol style="list-style-type: none"> 1. Provide site supervision. Supervisor to coordinate access and facilitate the works throughout the whole process. 2. Gain access to required areas in accordance with Safework requirements. 3. Labour to complete paint repair to affected area 4. Supply paint ancillaries 5. Cover and protect adjacent surfaces during the rectification work. 6. Make good any surfaces affected as part of the works, to their prior condition. 7. Clean site and leave in a tidy condition upon completion of work

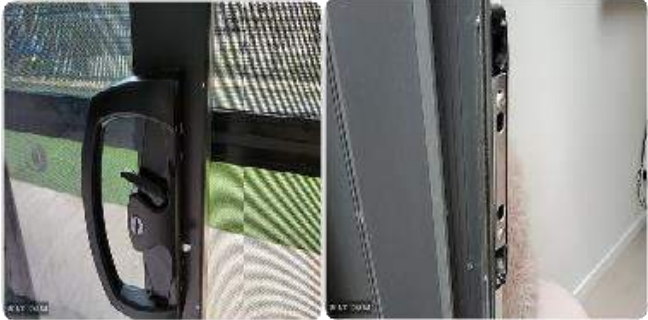
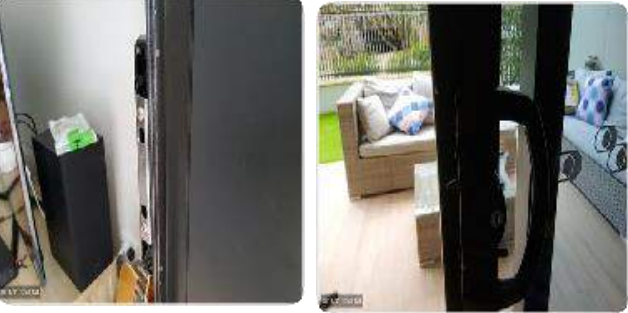
ITEM	COMMENTARY	PHOTOGRAPH(S)
6-G03		
A	<p>Location & Description Living and bedroom 2 – Sliding doors</p> <p>The Author has observed latch screws to sliding doors in living and bed 2 are protruding and have scratched the sliding jamb section at the lock.</p> <p>The Author is of the view, that the defect originated at the time of construction.</p>

B	<p>Cause(s)</p> <ul style="list-style-type: none"> • Faulty manufacturing 	
C	<p>Breach(es) Failure to comply with the following:</p> <ul style="list-style-type: none"> ▪ Home Building Act 1989 (NSW) under Section 18B Clauses (a) & (c); ▪ Building contract – Defect liability period Product warranty 	
D	<p>Proposed Rectification Scope of Works Allow to:</p> <ol style="list-style-type: none"> 1. Provide site supervision. Supervisor to coordinate access and facilitate the works throughout the whole process. 2. Gain access to required areas in accordance with Safework requirements. 3. Labour to change over for suitable fixings 4. Cover and protect adjacent surfaces during the rectification work. 5. Make good any surfaces affected as part of the works, to their prior condition. 6. Clean site and leave in a tidy condition upon completion of work

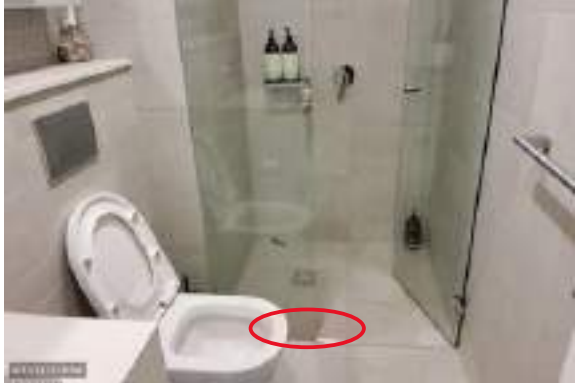
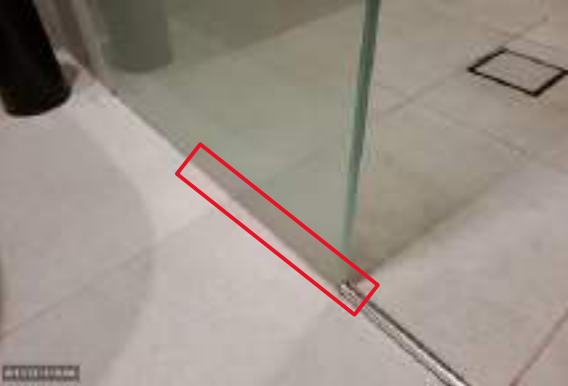
ITEM	COMMENTARY	PHOTOGRAPH(S)
7-G03		
A	<p>Location & Description Main bathroom – Shower screen</p> <p>The Author has observed sealant fixing to fixed shower screen is loose and is not fully sealed.</p> <p>The Author is of the view, that the defect originated due to poor workmanship employed by the Builder at the time of construction. As the fixing of the base of glass panel is reliant on the flexible sealant being applied to adequately secure the shower screen and provide a waterproof seal at the water stop angle.</p>

B	<p>Cause(s)</p> <ul style="list-style-type: none"> Poor workmanship employed by Builder at the time of construction 	
C	<p>Breach(es) Failure to comply with the following:</p> <ul style="list-style-type: none"> Home Building Act 1989 (NSW) under Section 18B Clauses 1 (a) Building contract - Defect liability period – Product warranty 	
D	<p>Proposed Rectification Scope of Works Allow to:</p> <ol style="list-style-type: none"> Provide site supervision. Supervisor to coordinate access and facilitate the works throughout the whole process. Gain access to required areas in accordance with Safework requirements. Cover and protect adjacent surfaces during the rectification work. Labour to apply construction adhesive waterproofing sealant Supply construction adhesive waterproofing sealant Make good any surfaces affected as part of the works, to their prior condition. Clean site and leave in a tidy condition upon completion of work

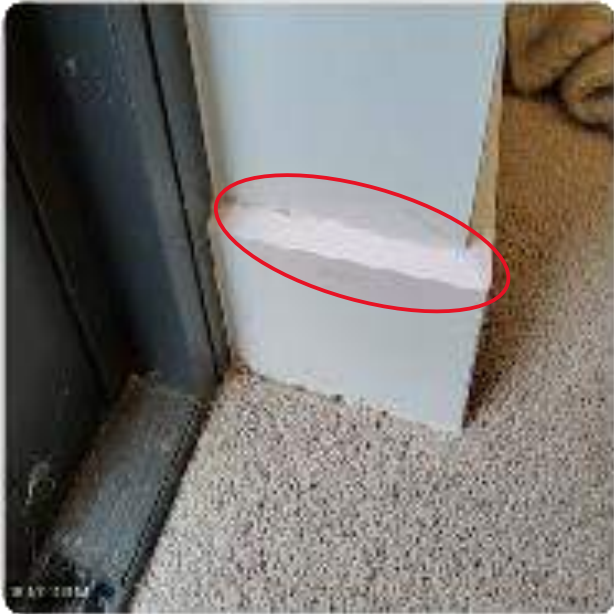
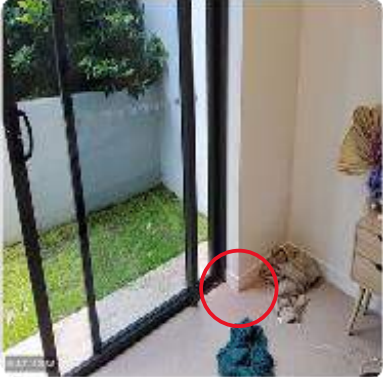
ITEM	COMMENTARY	PHOTOGRAPH(S)
1-G04		
A	<p>Location & Description Main bedroom – Skirting painting</p> <p>The Author has observed poor paint finish to skirting board on western side of sliding door.</p> <p>The Author is of the view, that the defect originated from poor workmanship employed by the Builder at the time of construction.</p>

B	<p>Cause(s)</p> <ul style="list-style-type: none"> Poor workmanship employed by Builder at the time of construction; 	
C	<p>Breach(es) Failure to comply with the following:</p> <ul style="list-style-type: none"> Home Building Act 1989 (NSW) under Section 18B Clauses 1(a) NSW Guide to Standards and tolerances 2017 13.2 Surface finish of paintwork Paintwork is defective if the application has blemishes such as paint runs, paint sags, wrinkling, dust, bare or starved painted areas, colour variations, surface cracks, irregular and coarse brush marks, sanding marks, blistering, non-uniformity of gloss level and other irregularities in the surface that are visible from a normal viewing position. (Highlighting added)

D	<p>Proposed Rectification Scope of Works Allow to:</p> <ol style="list-style-type: none"> Provide site supervision. Supervisor to coordinate access and facilitate the works throughout the whole process. Gain access to required areas in accordance with Safework requirements. Cover and protect adjacent surfaces during the rectification work. Labour to repair paint work Paint and ancillaries Make good any surfaces affected as part of the works, to their prior condition. Clean site and leave in a tidy condition upon completion of work

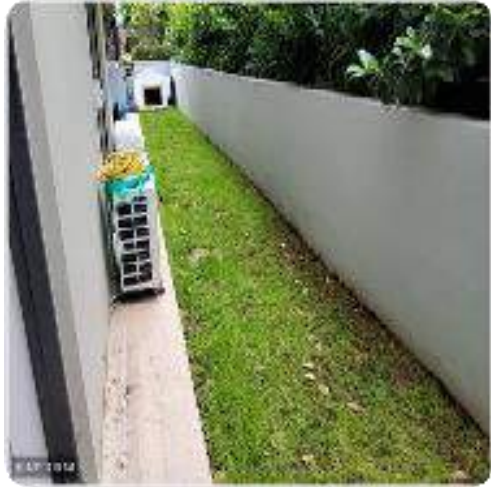
<p>Southern lawn area</p>

ITEM	COMMENTARY	PHOTOGRAPH(S)
<p>2-G04</p> <p>A</p>	<p>Location & Description Southern exterior - Drainage</p> <p>The occupants reported to the Author at the time of inspection, that stormwater is flooding the courtyard to the southern exterior. The Author observed that there is a storm water outlet above the tiled floor surface in the southwest corner of the yard area.</p> <p>The occupants reported there is a stormwater line underneath the grassed area on the southern side of the exterior located in the lawn area, and that the storm water line has two rises, and that the stormwater line runs to the stormwater pit in the southeast corner of the yard which is situated underneath the doghouse.</p> <p>The Author reviewed the works as executed stormwater design and found that occupants statements were consistent with the approved design. However, the permissible drain inlet (PD) shown of the design to the southwestern end of the lawn area was not visible on inspection.</p> <p>For clarity, refer to following extract of subject drainage taken from stormwater design indicating location of proposed drainage inlet -</p>

<p>The Author is of the view, that there is insufficient surface drainage inlet to the southern lawn area and the drainage outlet located to the southwest end of the area should be connected into the stormwater system.</p>

<p>D</p>	<p>Proposed Rectification Scope of Works Allow to:</p> <ol style="list-style-type: none"> 1. Provide site supervision. Supervisor to coordinate access and facilitate the works throughout the whole process. 2. Gain access to required areas in accordance with Safework requirements. 3. Cover and protect adjacent surfaces during the rectification work. 4. Labour to excavate and expose stormwater line, connect and extend additional inlets and terminate at surface level with grated drain to the southwest and mid-section of southern lawn area. 5. Supply stormwater connections and ancillaries 6. Make good any surfaces and landscaping affected as part of the works, to their prior condition. 7. Clean site and leave in a tidy condition upon completion of work

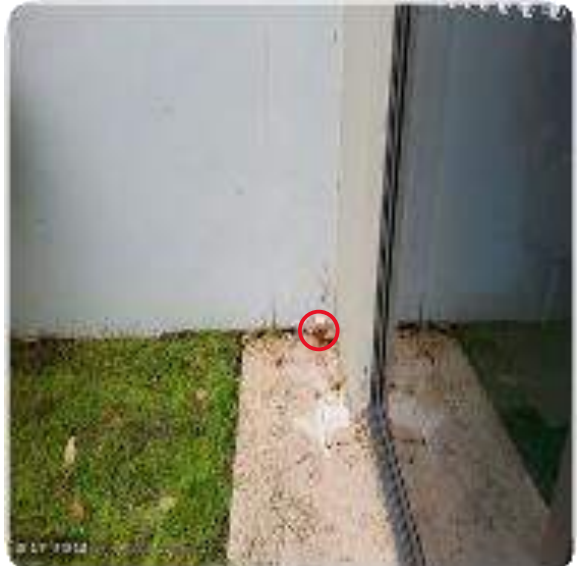
<p>Stormwater outlet to southwestern end of lawn area</p>
