6. DEFECT SCHEDULE

6.1. AUTOMATIC FIRE DETECTION AND ALARM SYSTEM (INCLUDING SMOKE ALARMS)

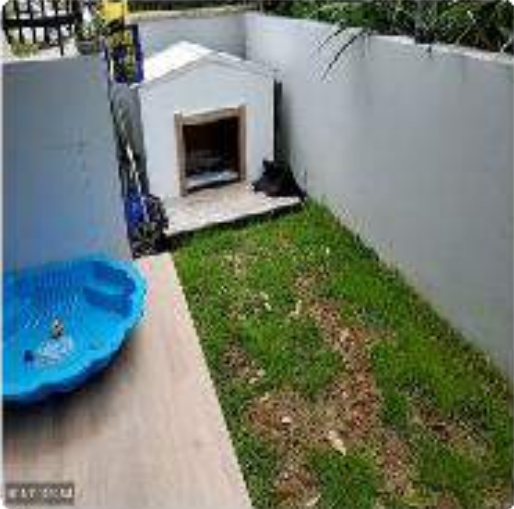
<p>B</p>	<p>Cause(s)</p> <ul style="list-style-type: none"> • Failure of Builder to carry out the work in accordance with AS3500.3 2018 Plumbing and drainage Part 5 Section 5: Surface water drainage system – Design 5.3.1.2 • Failure of Builder to carry out the works in accordance with building contract specifications. 	
<p>C</p>	<p>Breach(es) <i>Failure to comply with the following:</i></p> <ul style="list-style-type: none"> ▪ Home Building Act 1989 (NSW) under Section 18B Clauses 1(a) & (c); ▪ AS3500.3 2018 Plumbing and drainage Part 5 Section 5: Surface water drainage system – Design 5.3.1.2 ▪ Extract AS3500.3:2018 <p style="text-align: center;">55 AS/NZS 3500.3:2018</p> <p>5.3.1.2 Other than roof areas Stormwater from other than roof areas shall be collected and conveyed via site stormwater channels and inlets to site stormwater drains.</p> <ul style="list-style-type: none"> ▪ <i>Building contract specifications – Works to be carried out to Australian standards and in accordance with engineers design.</i> 	<p>Stormwater pit is located under doghouse at eastern end of lawn area</p>

<p>D</p>	<p>Proposed Rectification Scope of Works Allow to:</p> <ol style="list-style-type: none"> 1. Provide site supervision. Supervisor to coordinate access and facilitate the works throughout the whole process. 2. Gain access to required areas in accordance with Safework requirements. 3. Cover and protect adjacent surfaces during the rectification work. 4. Labour to excavate and expose stormwater line, connect and extend additional inlets and terminate at surface level with grated drain to the southwest and mid-section of southern lawn area. 5. Supply stormwater connections and ancillaries 6. Make good any surfaces and landscaping affected as part of the works, to their prior condition. 7. Clean site and leave in a tidy condition upon completion of work

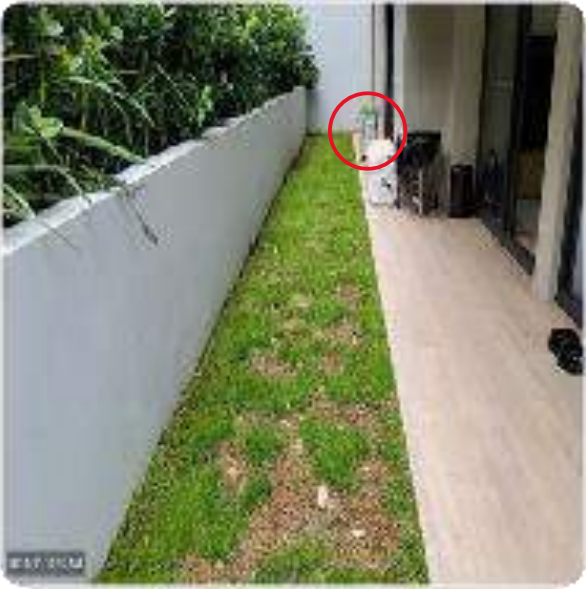
<p>Location of stormwater outlet to west of exterior</p>

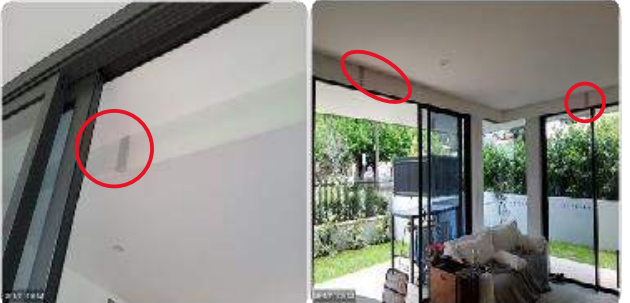
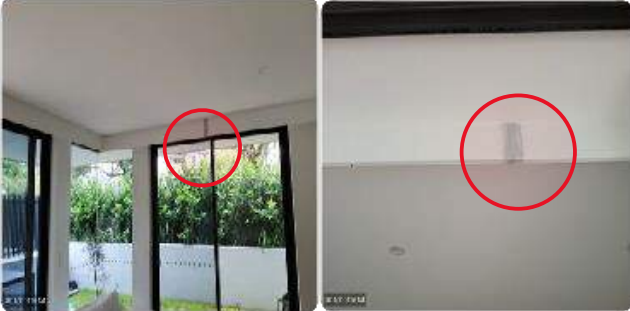
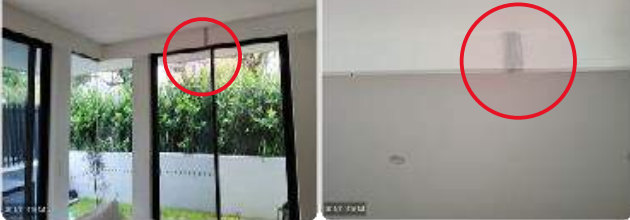
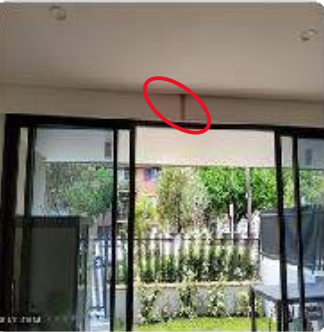
ITEM	COMMENTARY	PHOTOGRAPH(S)
3-G04		
A	<p>Location & Description Living area – Pelmet</p> <p>The Author has observed patching repair to pelmets above sliding doors is not complete.</p> <p>The Author is of the view, that the defect originated at the time of construction and that the Builder failed to complete the repair works.</p>

B	<p>Cause(s)</p> <ul style="list-style-type: none"> • Failure of Builder to complete the repair works. • <i>Building contract – Defect liability period</i>

C	<p>Breach(es) <i>Failure to comply with the following:</i></p> <ul style="list-style-type: none"> ▪ <i>Home Building Act 1989 (NSW) under Section 18B Clauses 1(a)</i> ▪ <i>Incomplete contract works</i>

D	<p>Proposed Rectification Scope of Works Allow to:</p> <ol style="list-style-type: none"> 1. Provide site supervision. Supervisor to coordinate access and facilitate the works throughout the whole process. 2. Gain access to required areas in accordance with Safework requirements. 3. Labour to complete paint repair to affected area 4. Supply paint ancillaries 5. Cover and protect adjacent surfaces during the rectification work. 6. Make good any surfaces affected as part of the works, to their prior condition. 7. Clean site and leave in a tidy condition upon completion of work

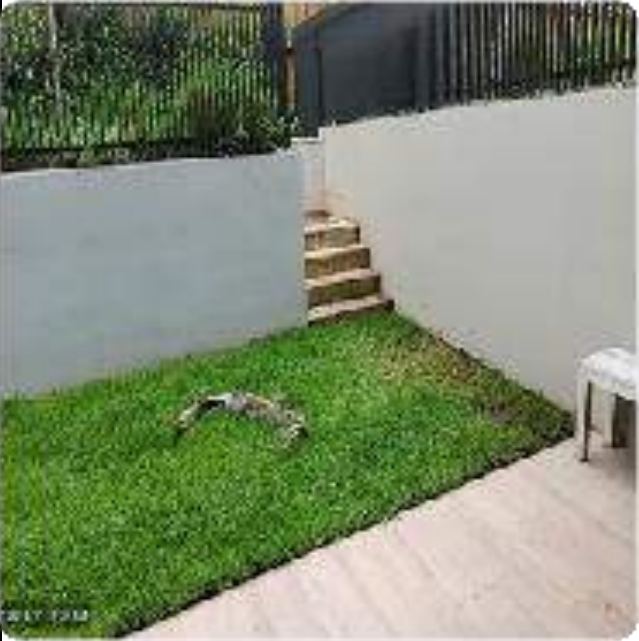
ITEM	COMMENTARY	PHOTOGRAPH(S)
<p>1-G05</p> <p>A</p>	<p>Location & Description Western exterior - Drainage</p> <p>It was reported to the Author at the time of inspection, that the grassed area to the western and southern exterior is extremely soggy following rain events. The Author observed that there was a 450x450 drainage pit located in the southwest corner of the exterior and 90mm drainage surface drains located to the far end of the grassed area to the southeast.</p> <p>On review of the stormwater design, it is the Author's view that there is insufficient provision for surface drainage the western and southern lawn area.</p> <p>For clarity, refer extract from works as executed Xavier Knight stormwater design indicating location of 450x450 pit to the southwestern corner of the lawn area -</p>

<p>Location of 450x450 to southwest corner of lawn area.</p> <p>Location of 90mm stormwater inlet to southeast of lawn area.</p>

<p>B</p>	<p>Cause(s)</p> <ul style="list-style-type: none"> • Failure of Builder to carry out the work in accordance with AS3500.3 2018 Plumbing and drainage Part 5 Section 5: Surface water drainage system – Design 5.3.1.2 • Failure of Builder to carry out the works in accordance with building contract specifications. 	<p>Insufficient drainage provided to Northwestern end of lawn area resulting sogging ground and ponding of water.</p>
<p>C</p>	<p>Breach(es) <i>Failure to comply with the following:</i></p> <ul style="list-style-type: none"> ▪ <i>Home Building Act 1989 (NSW) under Section 18B Clauses 1 (c);</i> ▪ AS3500.3 2018 Plumbing and drainage Part 5 Section 5: Surface water drainage system – Design 5.3.1.2 ▪ Extract AS3500.3:2018 <div style="text-align: center;"> <p>55</p> <p>AS/NZS 3500.3:2018</p> <p>5.3.1.2 <i>Other than roof areas</i></p> <p>Stormwater from other than roof areas shall be collected and conveyed via site stormwater channels and inlets to site stormwater drains.</p> </div> <ul style="list-style-type: none"> ▪ <i>Building contract specifications – Works to be carried out to Australian standards and the engineers design</i>

<p>D</p>	<p>Proposed Rectification Scope of Works Allow to:</p> <ol style="list-style-type: none"> 1. Provide site supervision. Supervisor to coordinate access and facilitate the works throughout the whole process. 2. Gain access to required areas in accordance with Safework requirements. 3. Cover and protect adjacent surfaces during the rectification work. 4. Labour to excavate and extend from existing stormwater pit on southwest corner. Provide additional inlets and terminate at surface level with grated drain to the east and mid-section of southern lawn area. 5. Supply 600x600 stormwater pit, 90mm PVC stormwater pipe, connections and ancillaries 6. Make good any surfaces and landscaping affected as part of the works, to their prior condition. 7. Clean site and leave in a tidy condition upon completion of work
